Wastewater Collection Pipe Rehabilitation (CIPP)

Circular Road Project

Grand Falls · Windsor

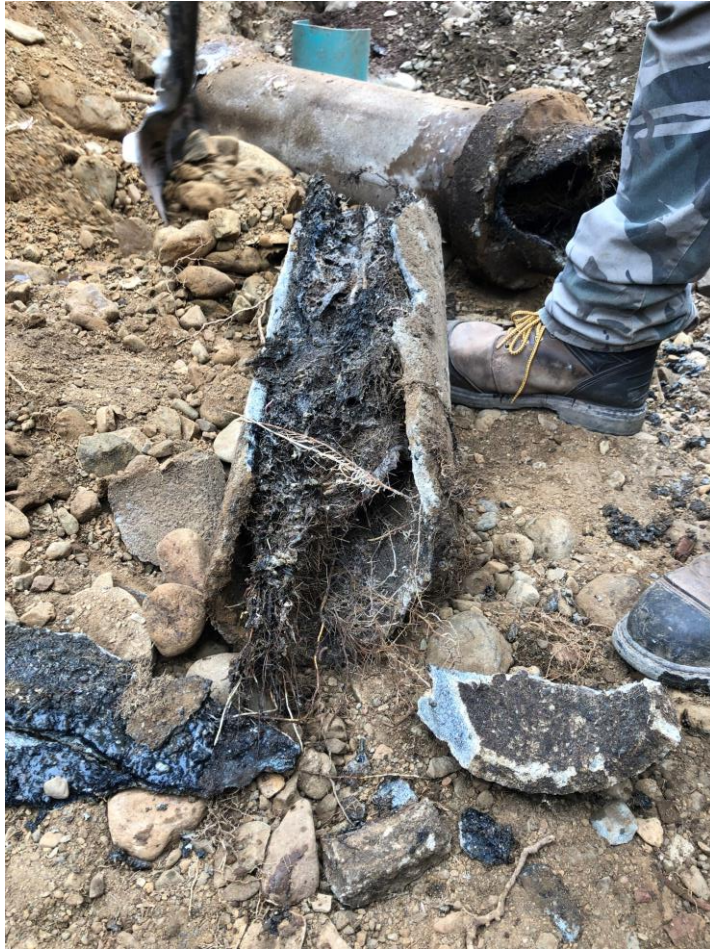
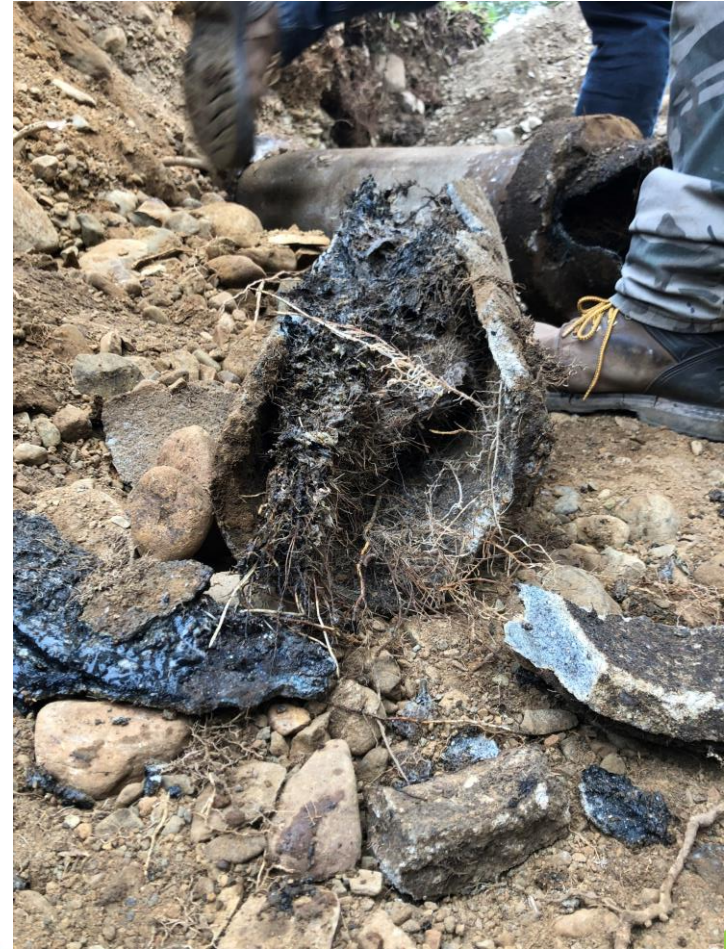
Heavy Root Intrusion
