Site Inspection Summary

Abandoned Oil Wells - Shoal Point

Purpose of Inspection Ongoing Monitoring of Abandoned Oil Wells at Shoal Point

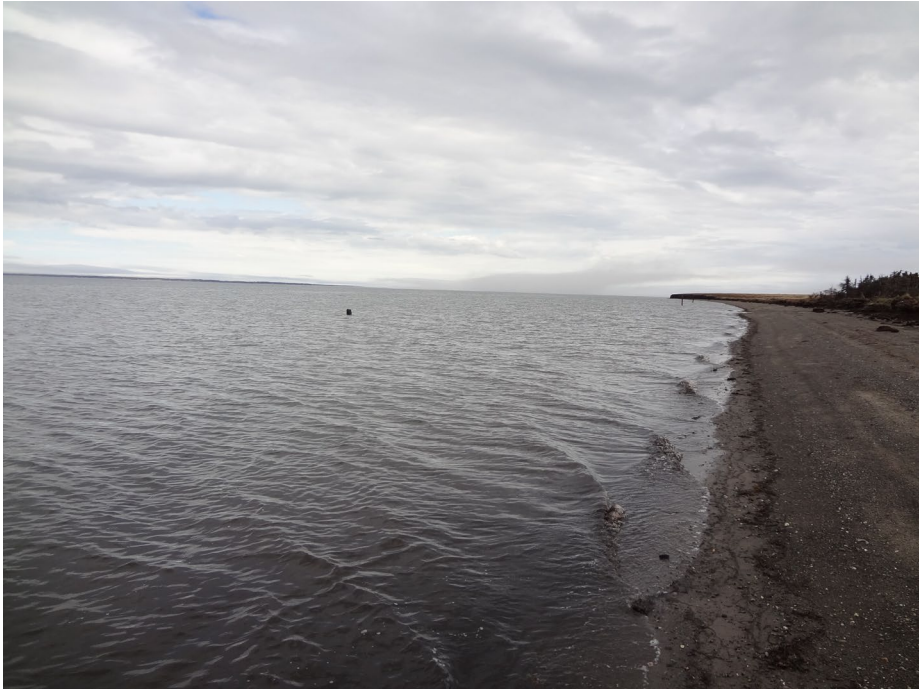
- The wells were in the water. High tide was projected for 1:45 pm.
- Wind was mild ~5 km/h and towards the shore.
- No visible sign of oil (sheening/bubbling) in the water in the vicinity of any of the wells.
- No oil odor detected in the vicinity of the wells.
- Only three well casings were observed. The well casing associated with the second well repair of November 2015 is missing.

Photo 1 – Abandoned wells at Shoal Point. Note only three casings are visible.

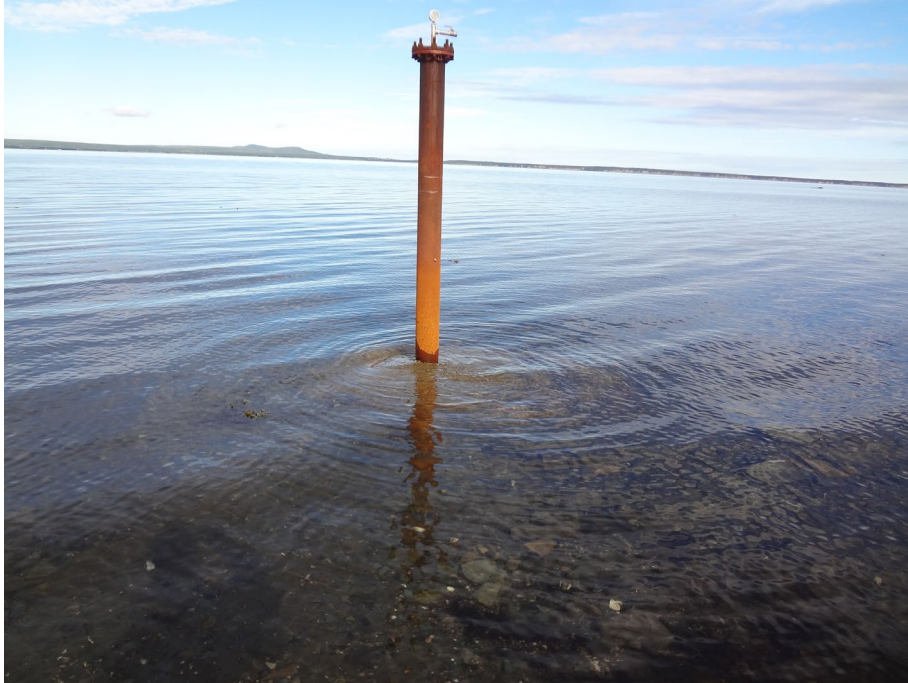
Photo 1 – Well Repair #1

- The well casings were partially submerged as the low tide was not particularly low (0.3 m). The wind was minimal and the water was calm. I remained at the site for over an hour and observed the four known well locations for signs of oil seepage. During my visit, I did not see any oil release from any of the well locations nor any oil sheening on the water surface or shoreline. There was a very faint oil odor detected along the shore near the first repaired well.

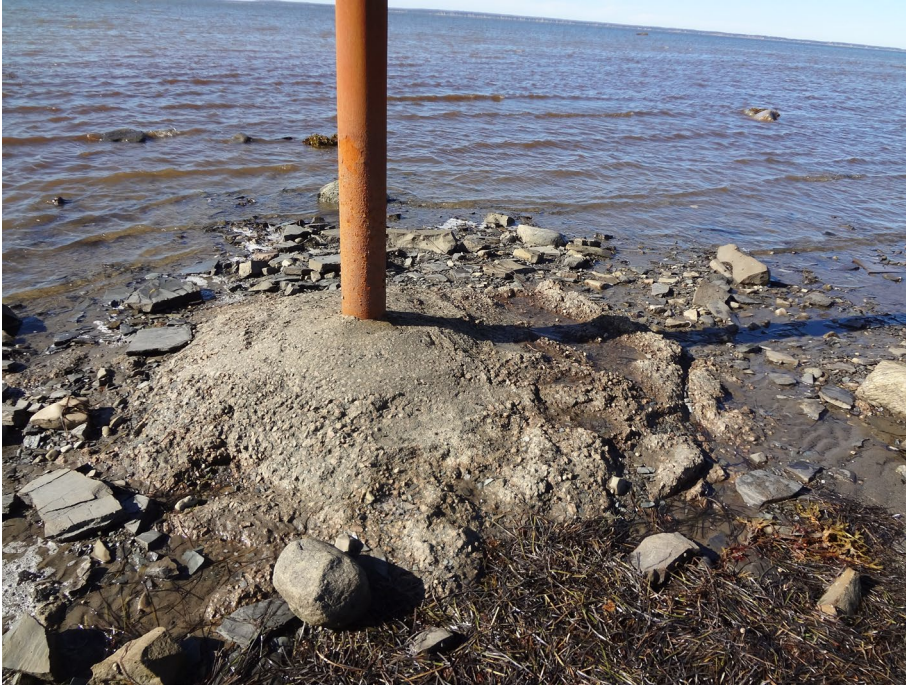
Photo 1 – Well Repair #1

- Well Repair #1 was out of the water. The pipe extension remains intact. Throughout the course of the site visit (~ 1 hour) a small amount of oil seepage was observed at a location along the perimeter of the concrete pad encapsulating the well. It is estimated that the rate of seepage was less than 5 millilitres per hour.
- No visible sign of oil was detected at any of the other well locations.
- Oil odor was detected at the seepage location but not elsewhere at the site.

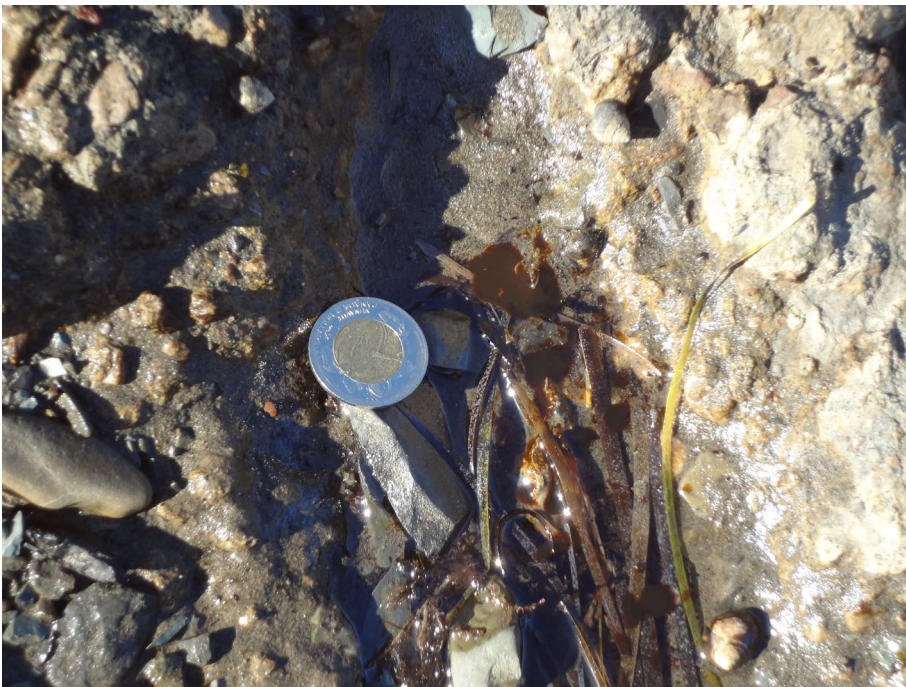
Photo 5 – Oil Seepage at Repaired Well #1

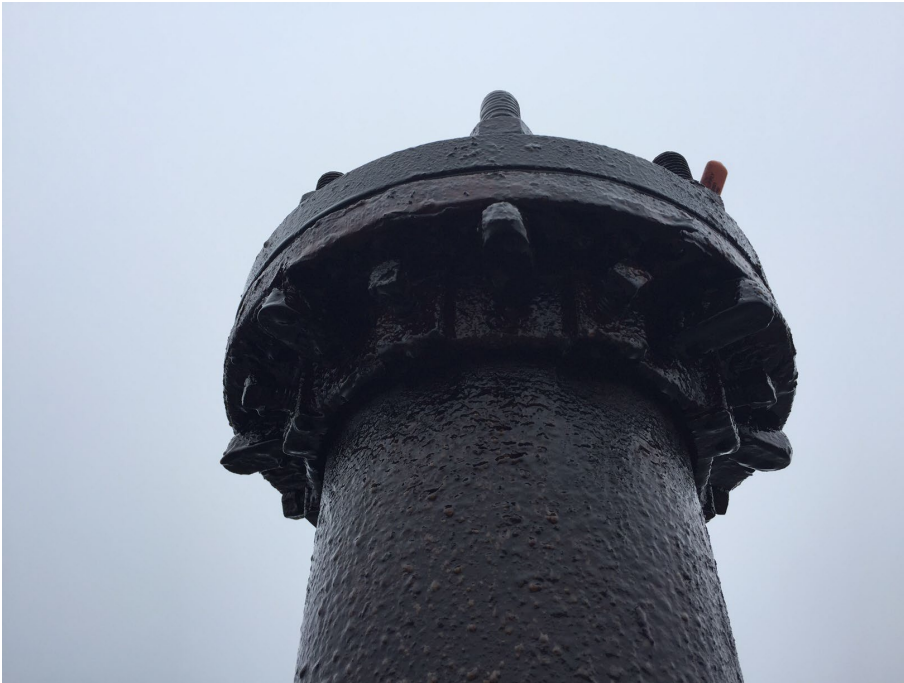
- The pipe extension associated with Well Repair #1 remains intact. The concrete base in the water is also intact.
- Oil residue is present at the top of the pipe and along the exterior of the casing.
- Oil seepage was observed in the vicinity of the well. The exact location of the seepage could not be pinpointed. Seepage appeared to originate at various locations within the water and consisted of sporadic oil releases.
- No visible sign of oil or odor was detected at the other well locations.
- An oil odour was evident along the shore downwind of Well Repair #1.

Photo 1 – Oil Coated Extension Pipe of Well Repair #1

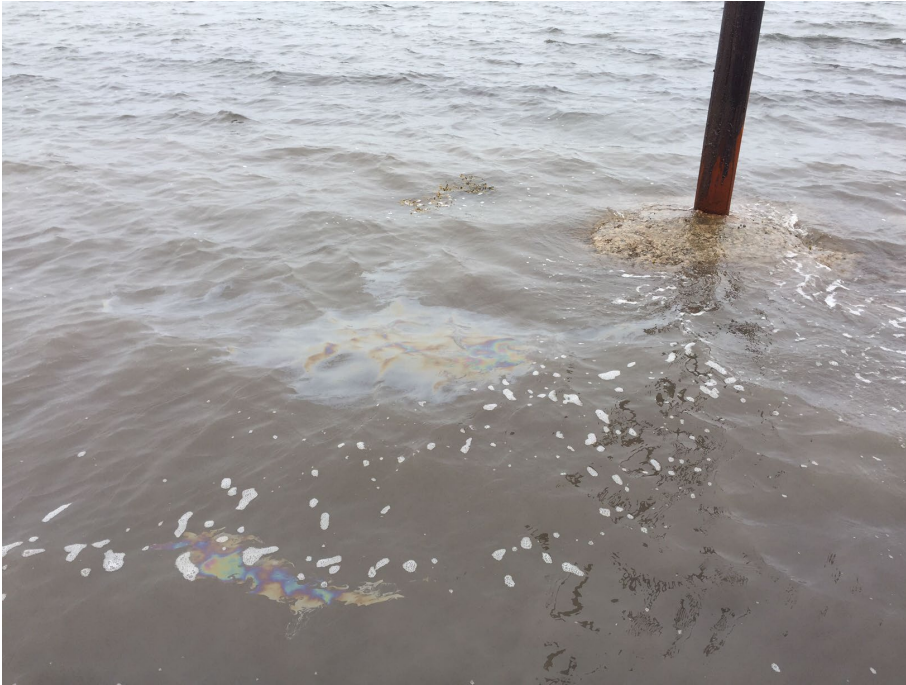
Photo 6 – Oil Seepage/Sheening near Well Repair #1

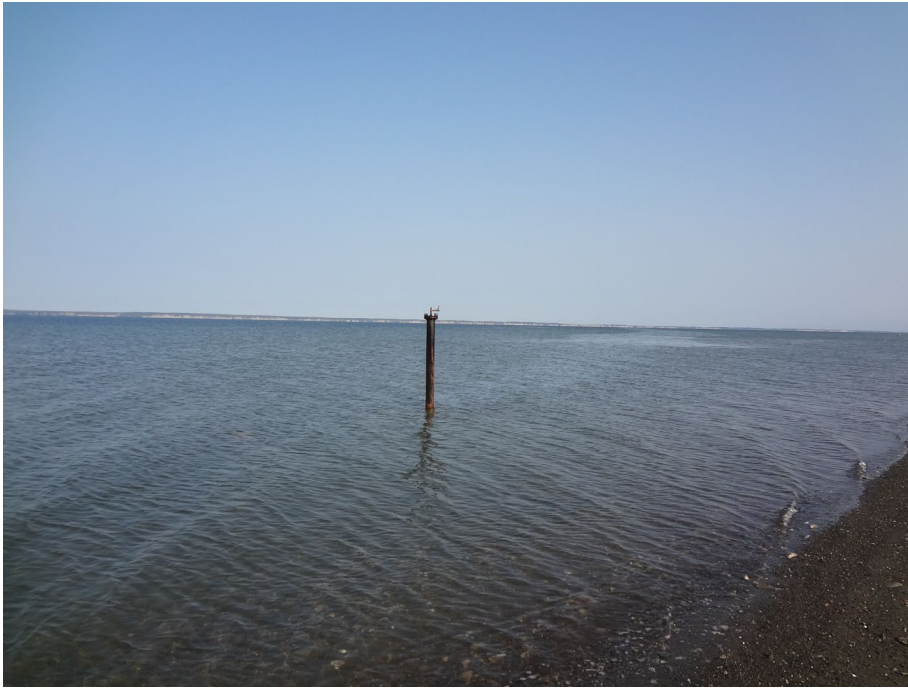
Photo 4 – Oil Sheen Originating from Well Repair #1

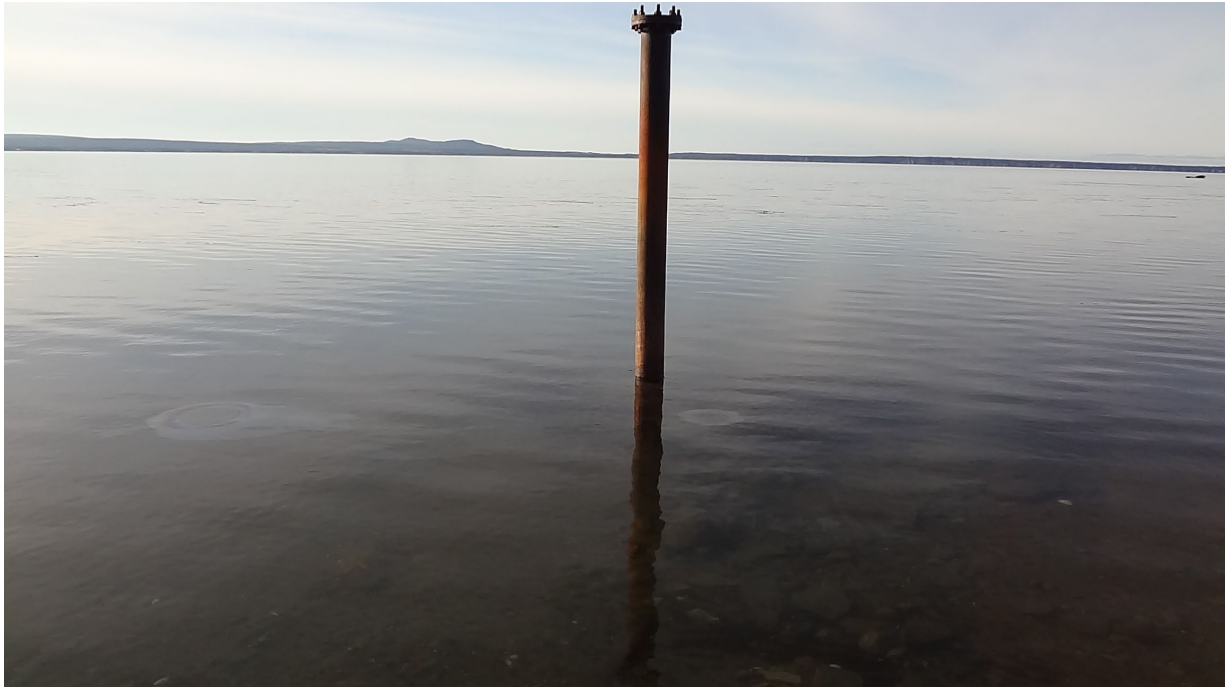
- Oil sheening is noted on the water surface in the general vicinity of Well Repair #1. Oil sheens are formed as small circular patterns originating at random locations within a 3 metre radius of the well casing.
- Oil sheens are quickly dispersed and there is no major sheening observed in the bay.
- Oil sheen patterns are forming at an average rate of one every 20 to 30 seconds.
- There is a faint oil odor downwind of the well.
- Oil sheening is not occurring at any other of the well locations associated with the site.

Photo 1 – Oil Sheening near Well Repair #1

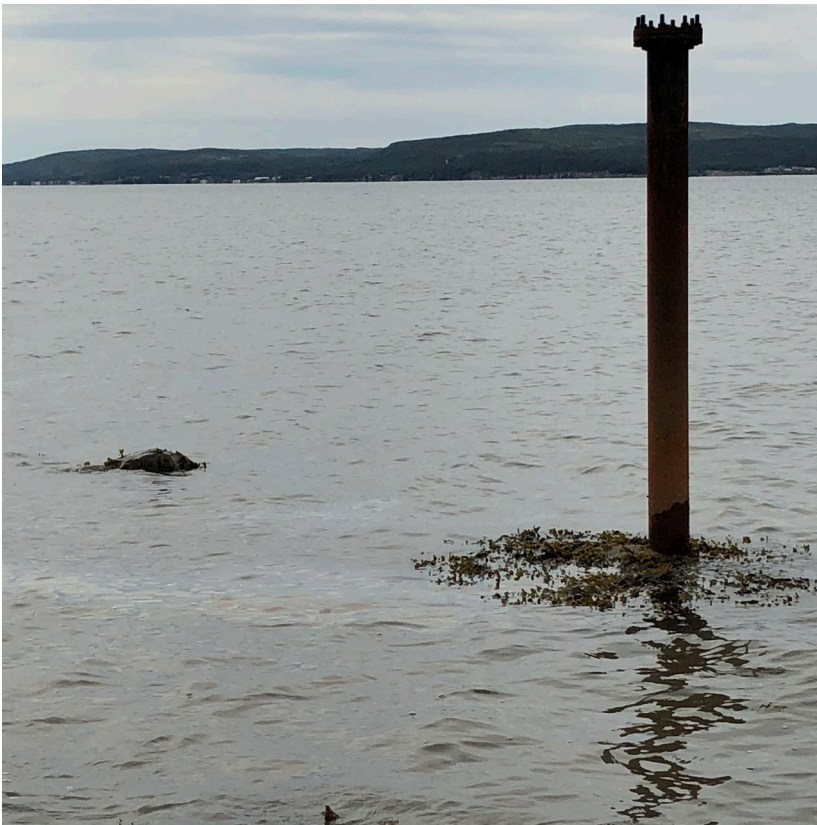
- The water level was relatively low with two of the three wells situated in the water only a short distance from the shore.
- Oil sheening was observed in the vicinity of Well Repair #1. The sheening originated from small oil releases (drops) at random locations in the water around the perimeter of the well base. The rate of release varied, but on average, is estimated to be one drop every 20-30 seconds.
- The direction of flow of the oil sheens was towards the shore.
- Oil seepage was not observed from any of the other well locations.
- Monitoring of the area for oil seepage will continue.

Photo 1 – Oil Sheening near Well Repair #1

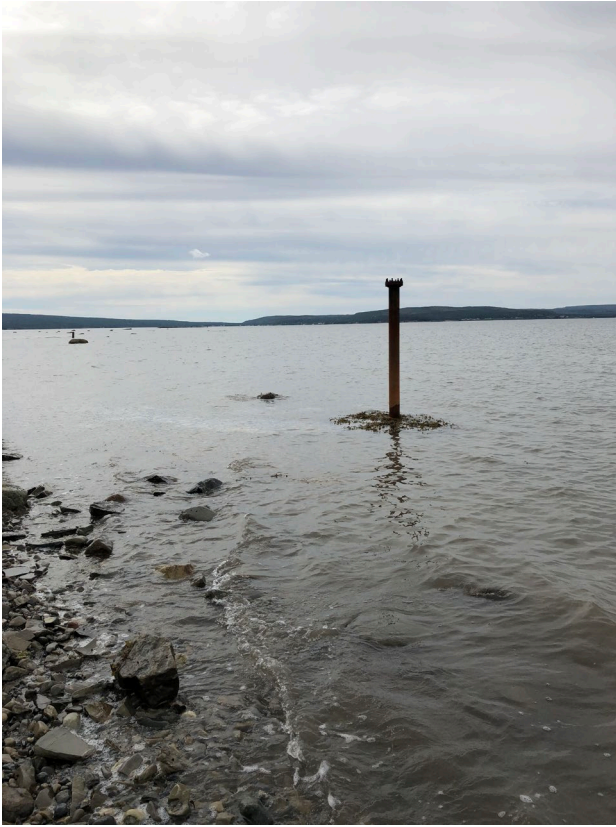
Photo 2 – Oil Sheening near Well Repair #1

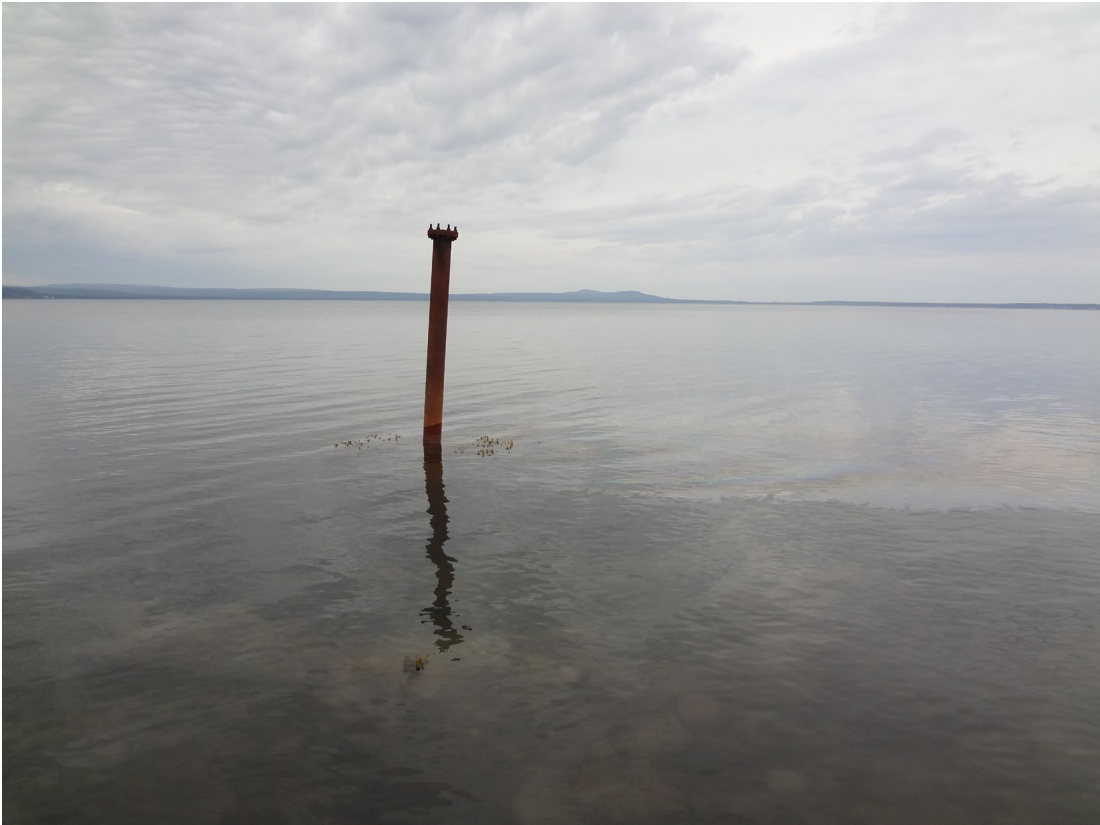
- The water level was relatively low with the wells situated in the water only a short distance from the shore.
- Oil sheening was observed in the vicinity of Well Repair #1. Sheening was predominant in the area around the well base. However, oil sheens were observed originating at random locations within the general well area.
- Tidal and wave action were minimal.
- Sheens formed as oil drops rose to the surface and expanded. Oil remained on the water surface for considerable time creating large sheen areas.
- Oil seepage was not observed from any of the other well locations.
- Monitoring of the area for oil seepage will continue.

Photo 2 – Oil Sheening in Vicinity of Abandoned Well Repair #1

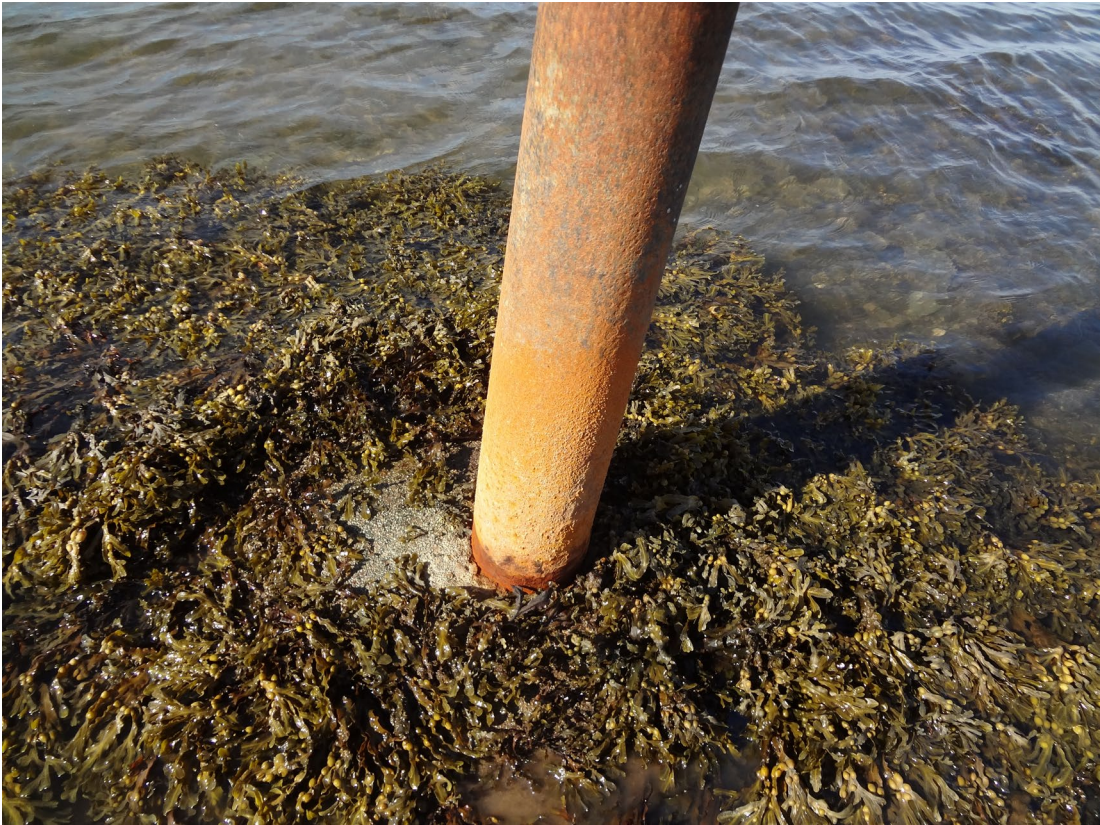
Photo 2 – Seaweed on Concrete Base of Well Repair #1

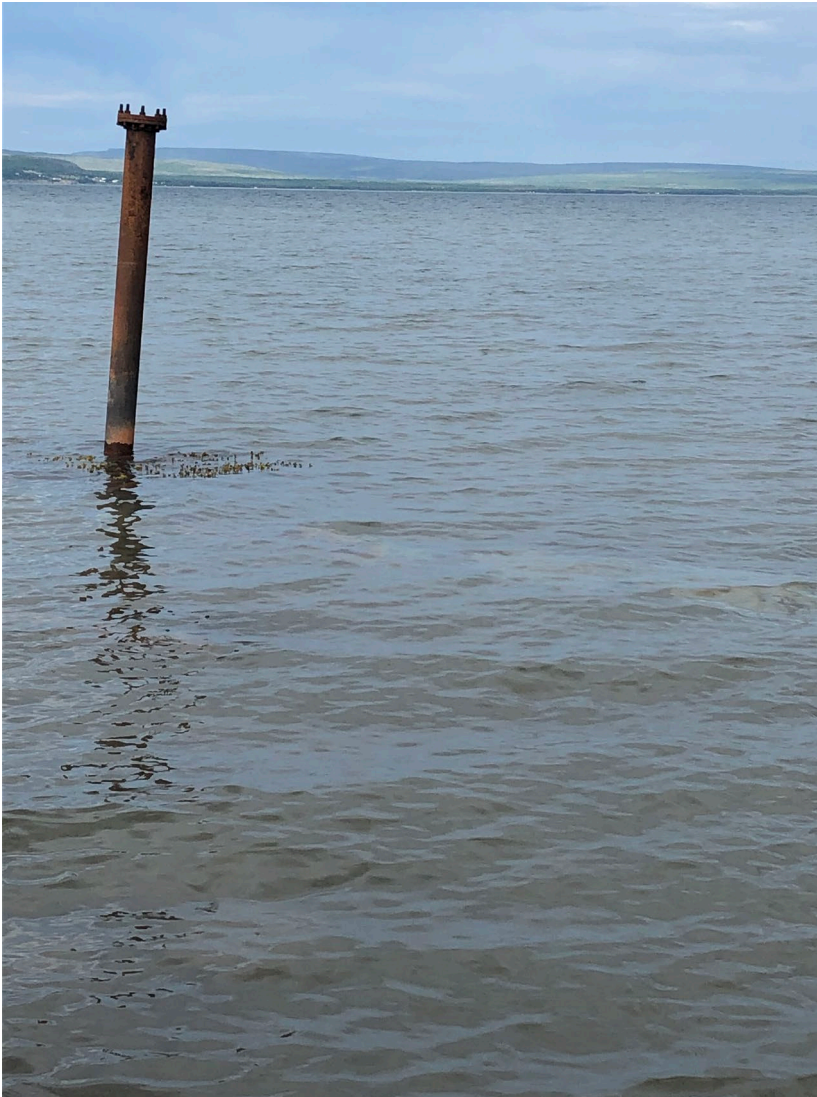
- Oil sheening was observed in the vicinity of Well Repair #1.
- Oil seepage was not observed at any of the other well locations.
- An oil odour was detected downwind from Well Repair #1.
- Oil sheening was visible along a section of beach at the water mark.
- Monitoring of the area will continue.

Photo 1 – Oil Sheening at Well Repair #1

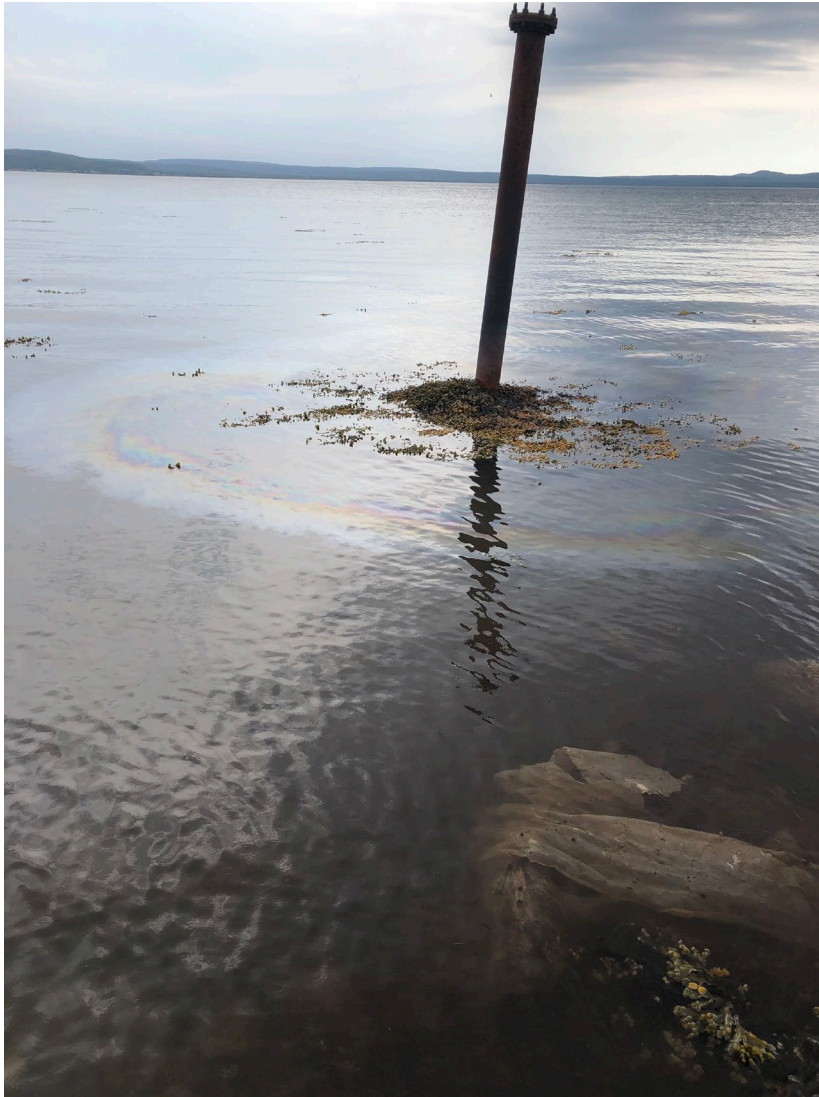
- Oil sheening was observed in the vicinity of Well Repair #1.
- Oil seepage/sheening was not observed at any of the other well locations or elsewhere in the bay.
- An oil odour was detected from the shore in the general vicinity of Well Repair #1.
- Monitoring of the area will continue.

Photo 1 – Oil Sheen near Well Repair #1

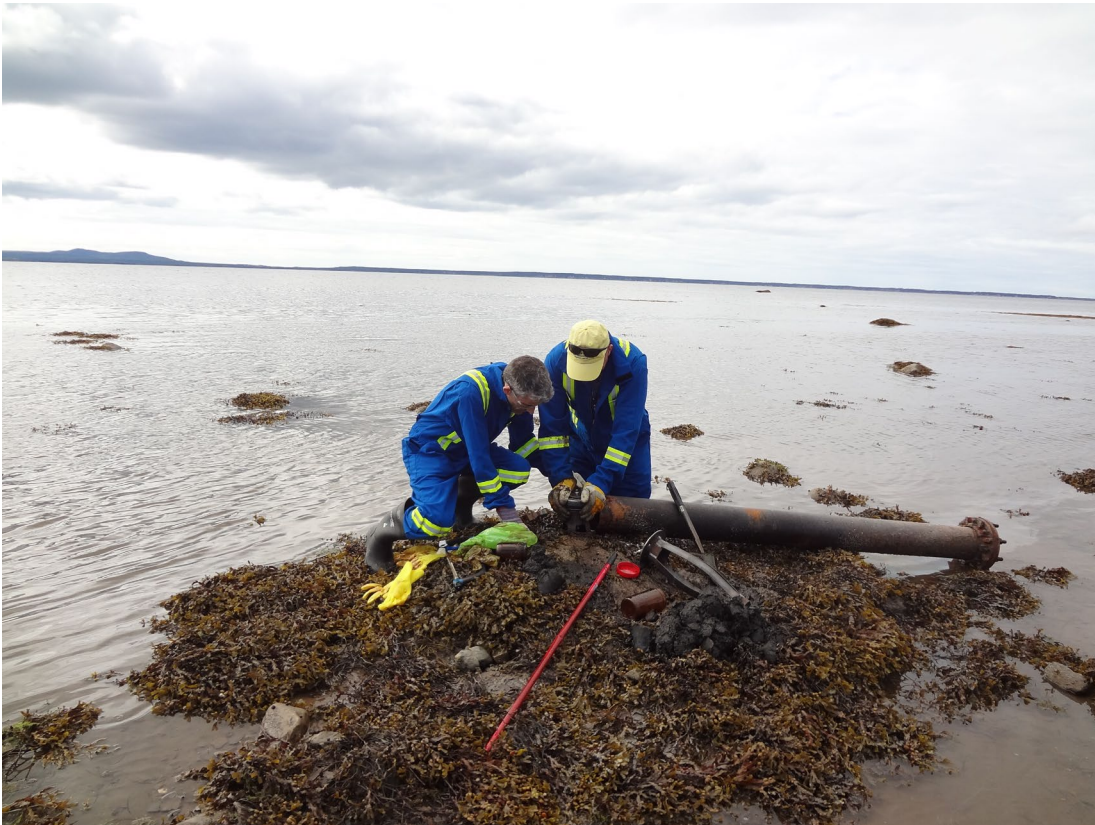
- Oil/water mixture continued to accumulate in the well casing after the installation of the plug. Active gas bubbles were observed on the surface within the well casing.

Photo 1 – Plug Installation Well #1
