**Project:** The Buchans Remediation Project – Phase II  
Residential and Public Areas Remediation  
Year 1 Construction Report

**Client:** Department of Environment and Conservation

**Consultant:** Hatch Mott MacDonald

**Contractor:** Marine Contractors Inc.

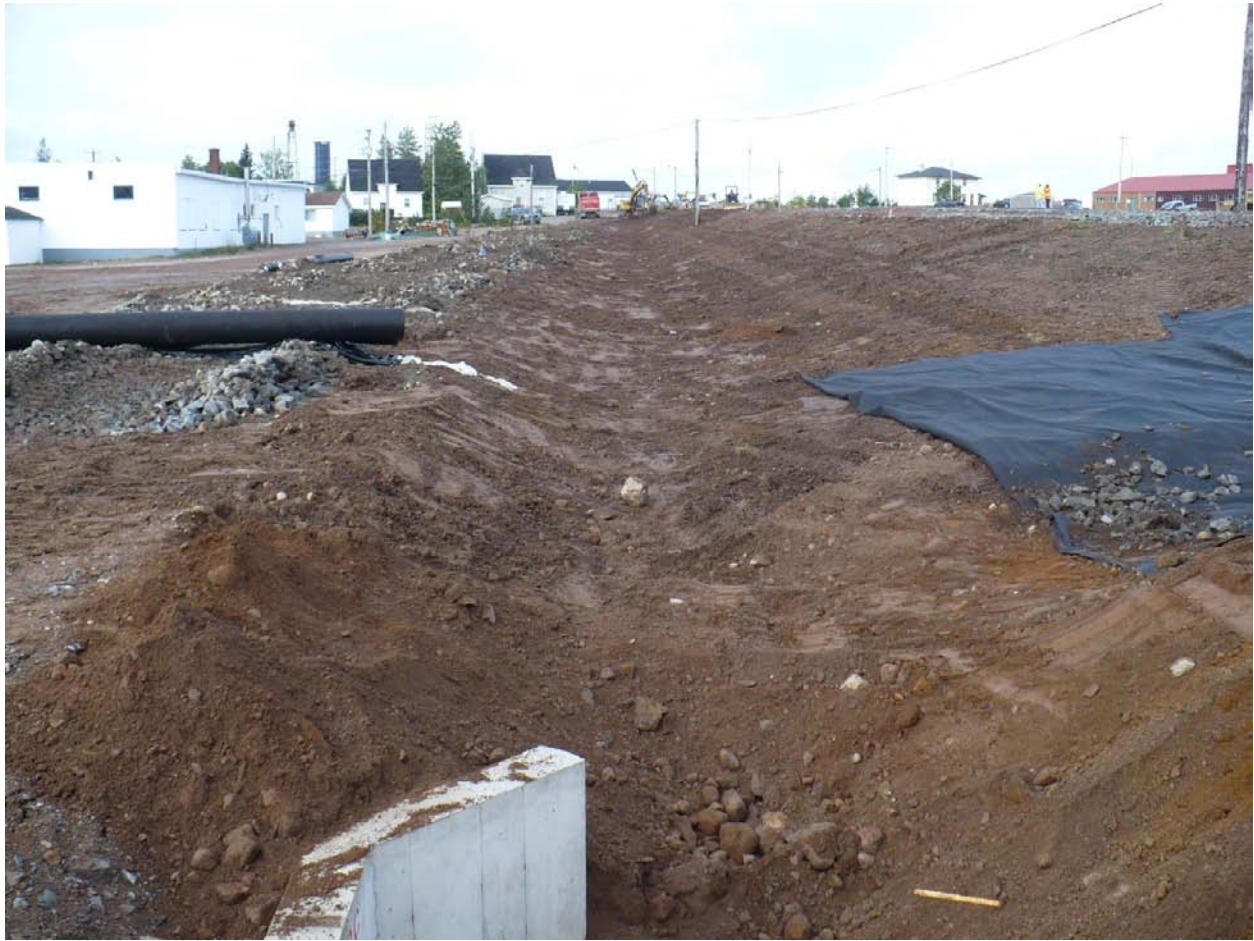
Photo#91

Photograph was taken on September 22, 2012 and shows the start of the installation of filter fabric along the slopes and ditch on the south side of the disposal field/RV Park.

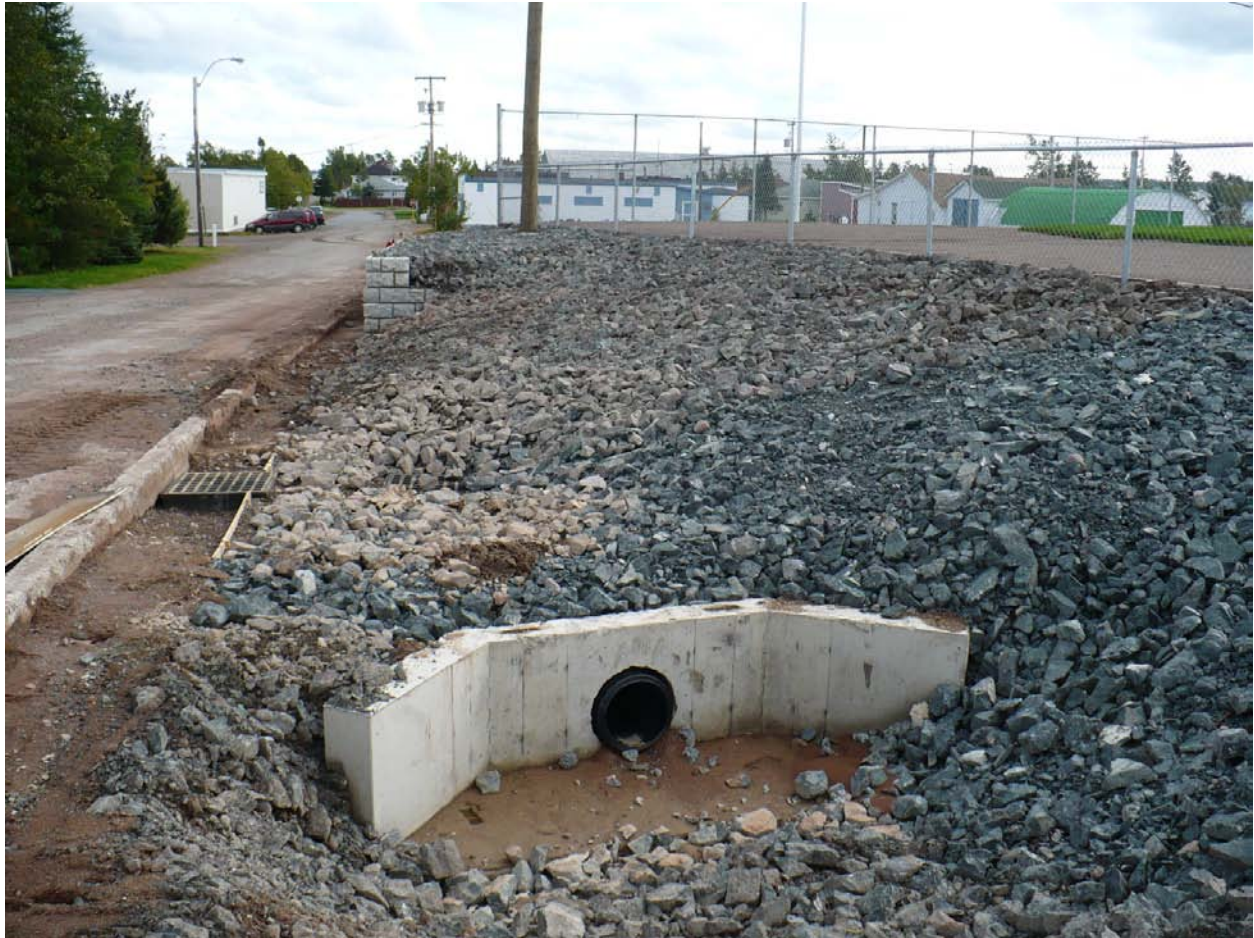
Photo#92

Photograph was taken on September 21, 2012 and shows the installation of a concrete headwall and ditch inlet on the east side of previously completed ballpark on Jackson Street. This ditch inlet will discharge into the existing storm sewer system along Jackson Street.

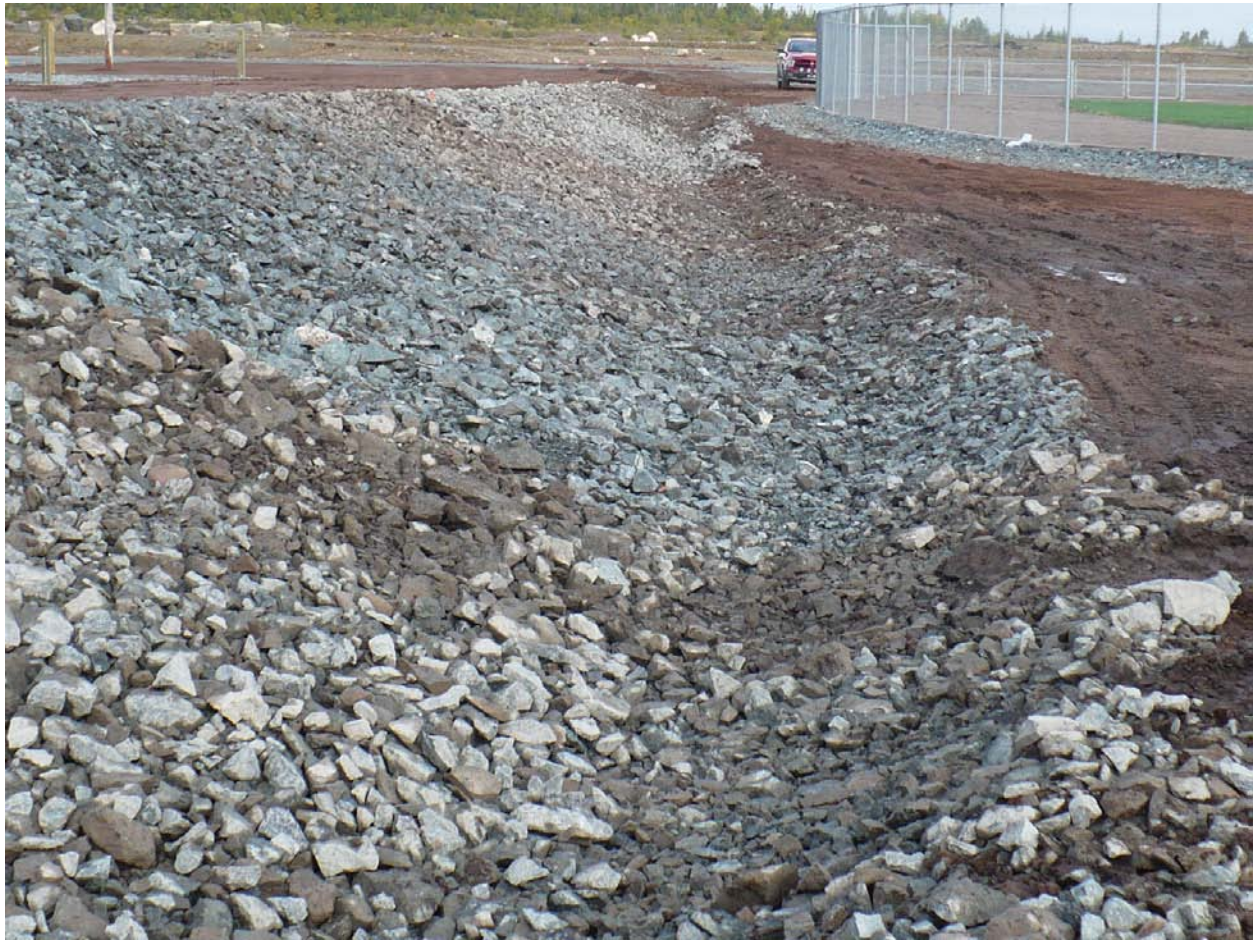
Photo#93

Photograph was taken on September 22, 2012 and shows the start of the installation of rock lined ditches along the disposal/RV park areas. Ditches are lined to prevent erosion of the disposal material and subsequent exposure to persons in this area.

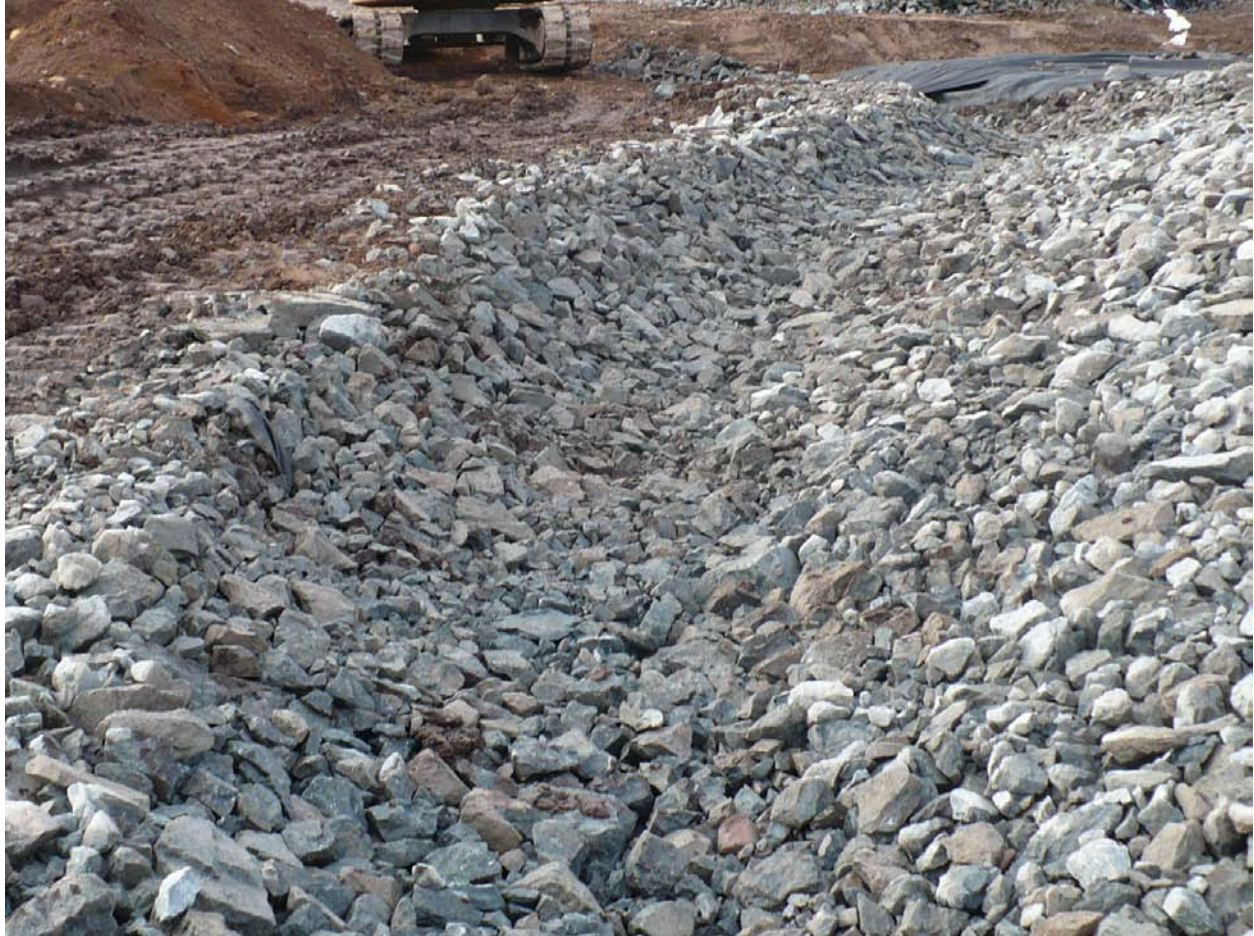
Photo#94

Photograph was taken on September 21, 2012 and shows the installation filter fabric and rock lined ditches on the east side of the Disposal Field/RV Park south of Forebay Road.

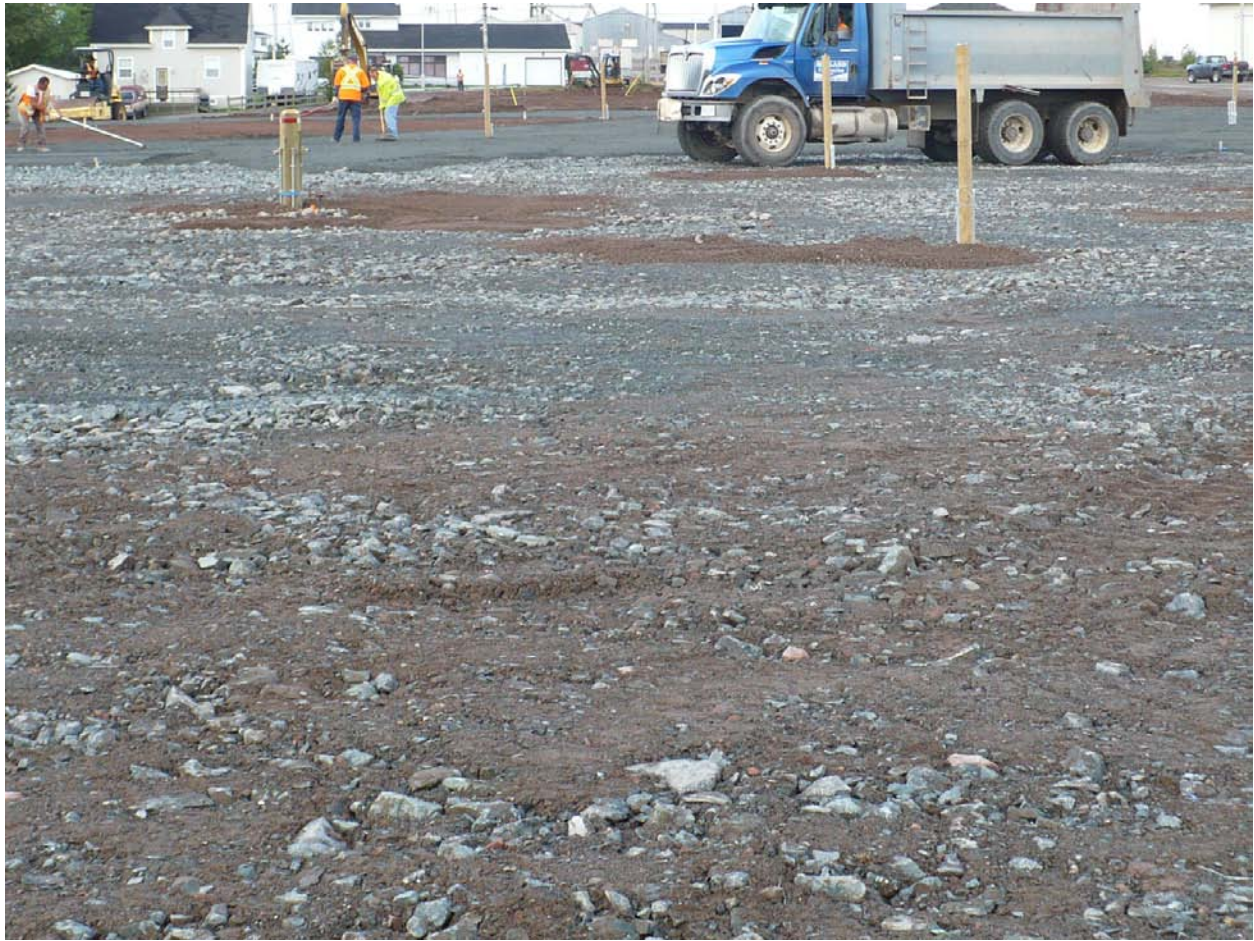
Photo#95

Photograph was taken on September 22, 2012 and shows the start of the installation of Class “A” material on the RV parks/disposal area. Note that this area has been also been capped with imported rock fill to stabilize the area for trailer traffic.

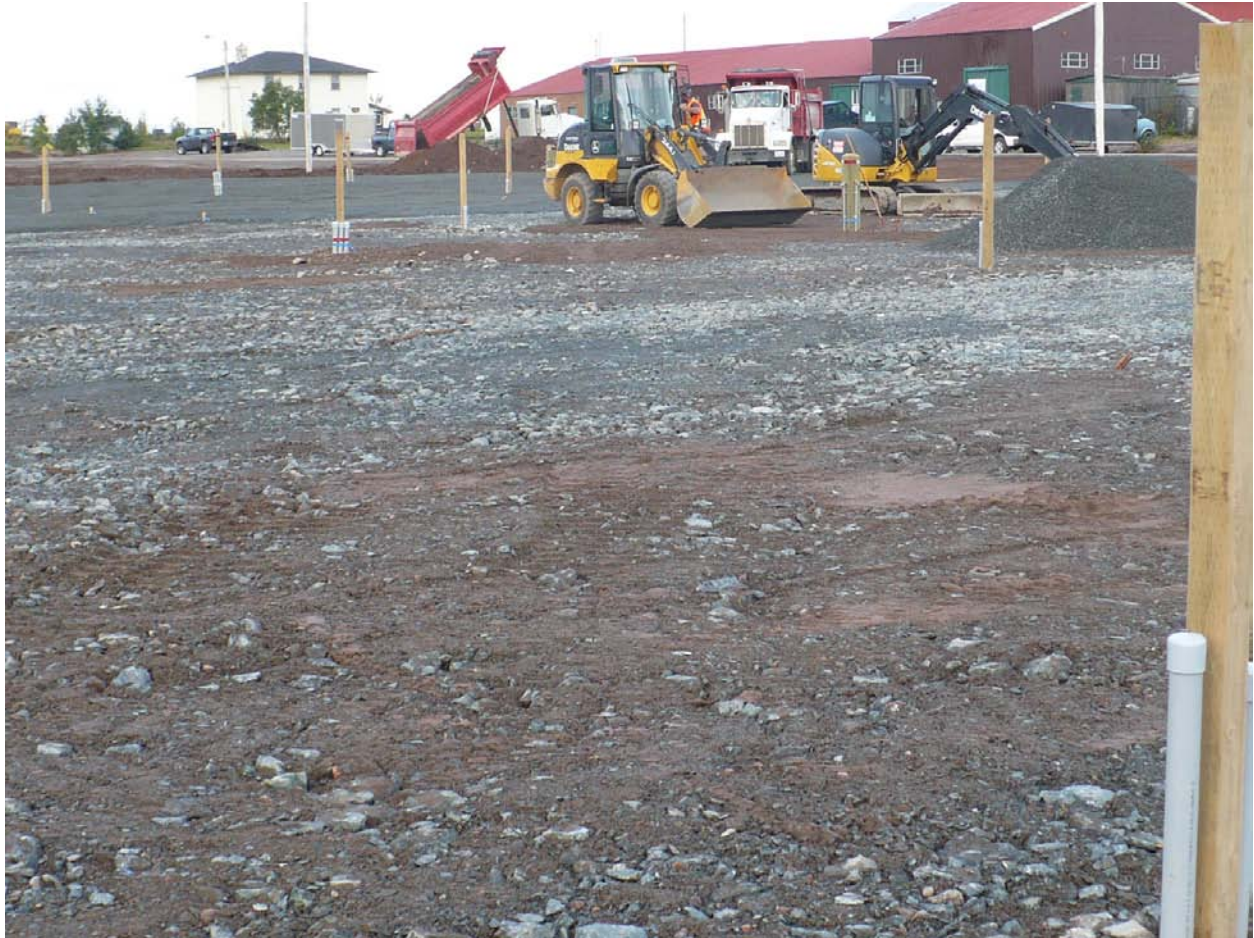
Photo#96

Photograph was taken on September 22, 2012 and shows the start of the installation of Class “A” material on the RV park. Note that this area has been also been capped with imported rock fill to stabilize the area for trailer traffic. Also shown is the installation of topsoil in preparation for hydro-sseeding of the disposal area south of Forebay Road.

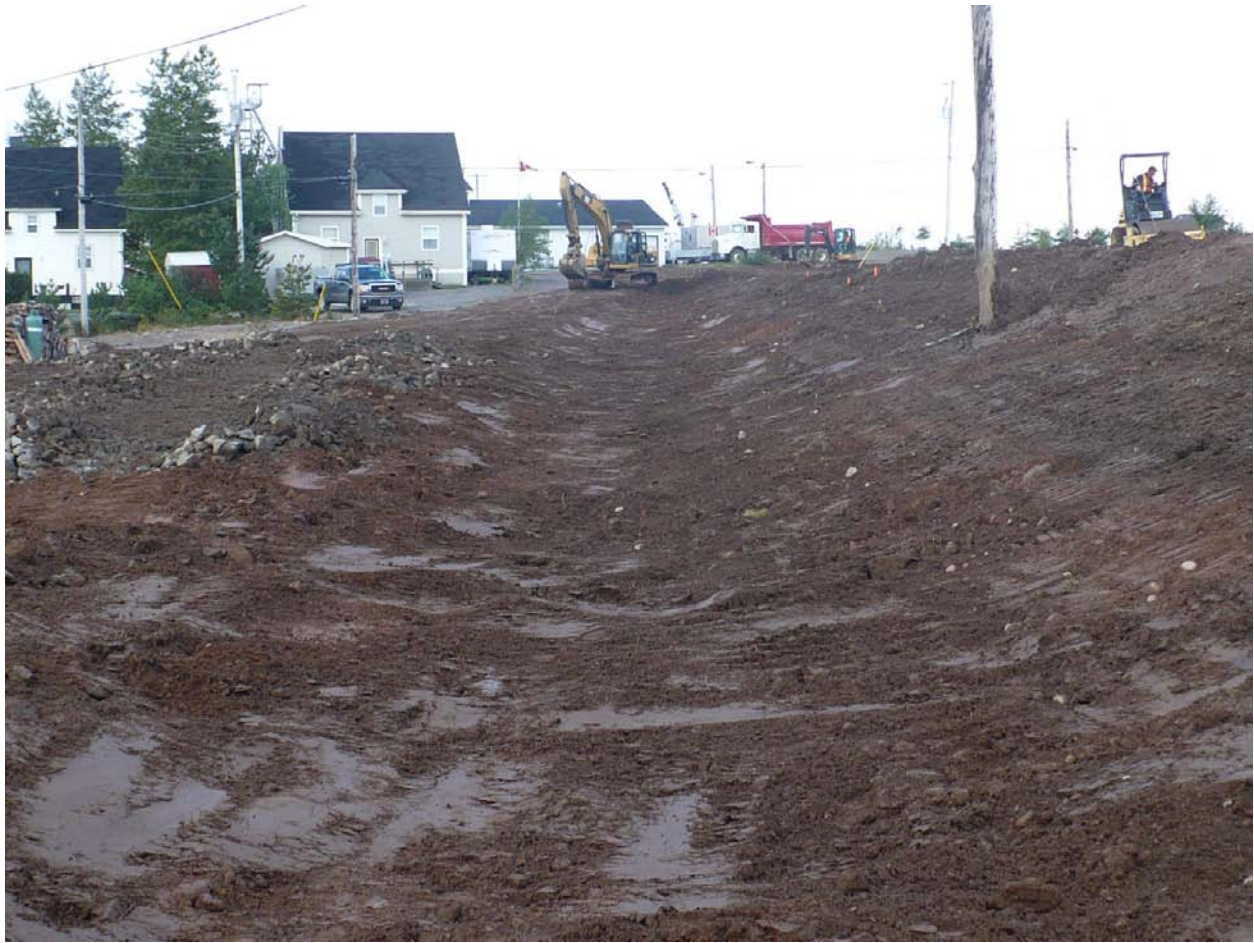
Photo#97

Photograph was taken on September 22, 2012 and shows the ditching and sloping and grading work ongoing on the excavated impacted material disposal area south of Forebay Road.

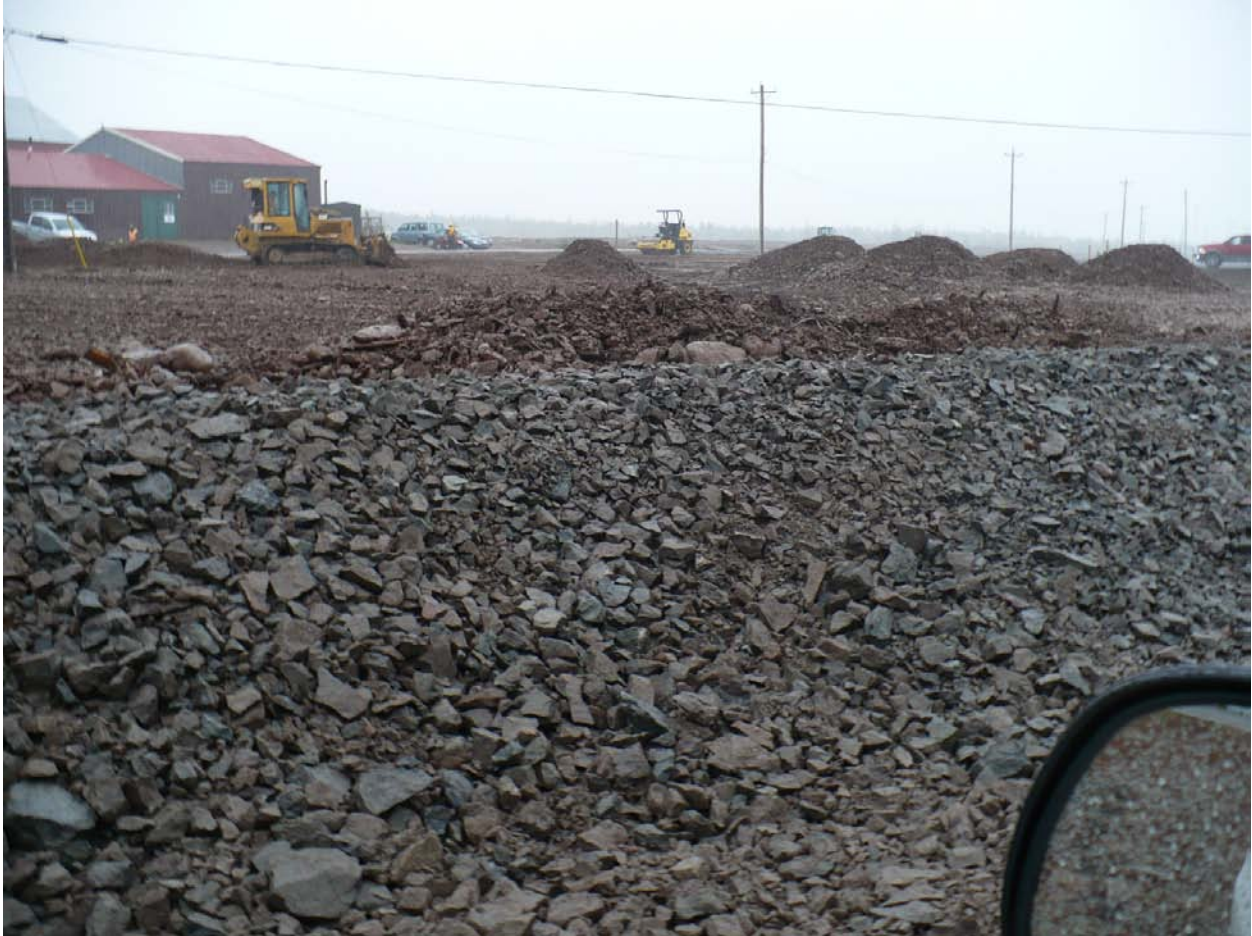
Photo#98

Photograph was taken on September 23, 2012 and shows of the installation of imported rock backfill on the impacted soils disposal area. This material is used to stabilize the soils on the disposal area and to prevent erosion and exposure of the impacted materials to the community. This area will subsequently receive a lift of topsoil and then it will be hydroseeded.

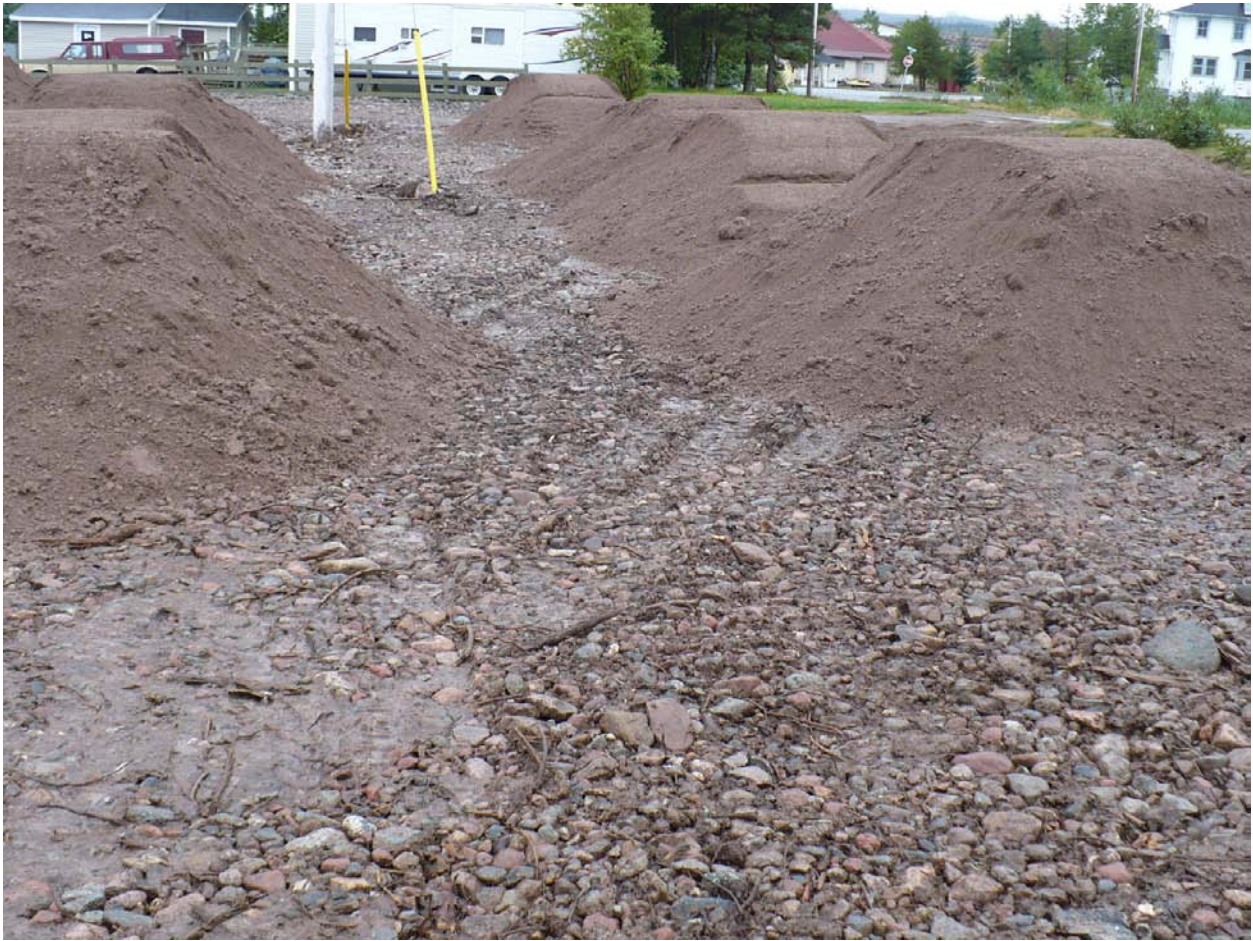
Photo#99

Photograph was taken on September 23, 2012 and shows the topsoil delivered to the disposal site after the rock fill stabilization layer has been installed and compacted. This topsoil will be spread to a 100 mm thickness and then be rolled and hydro seeded to seal the disposal area and to prevent erosion of the deposited impacted soil from the community.

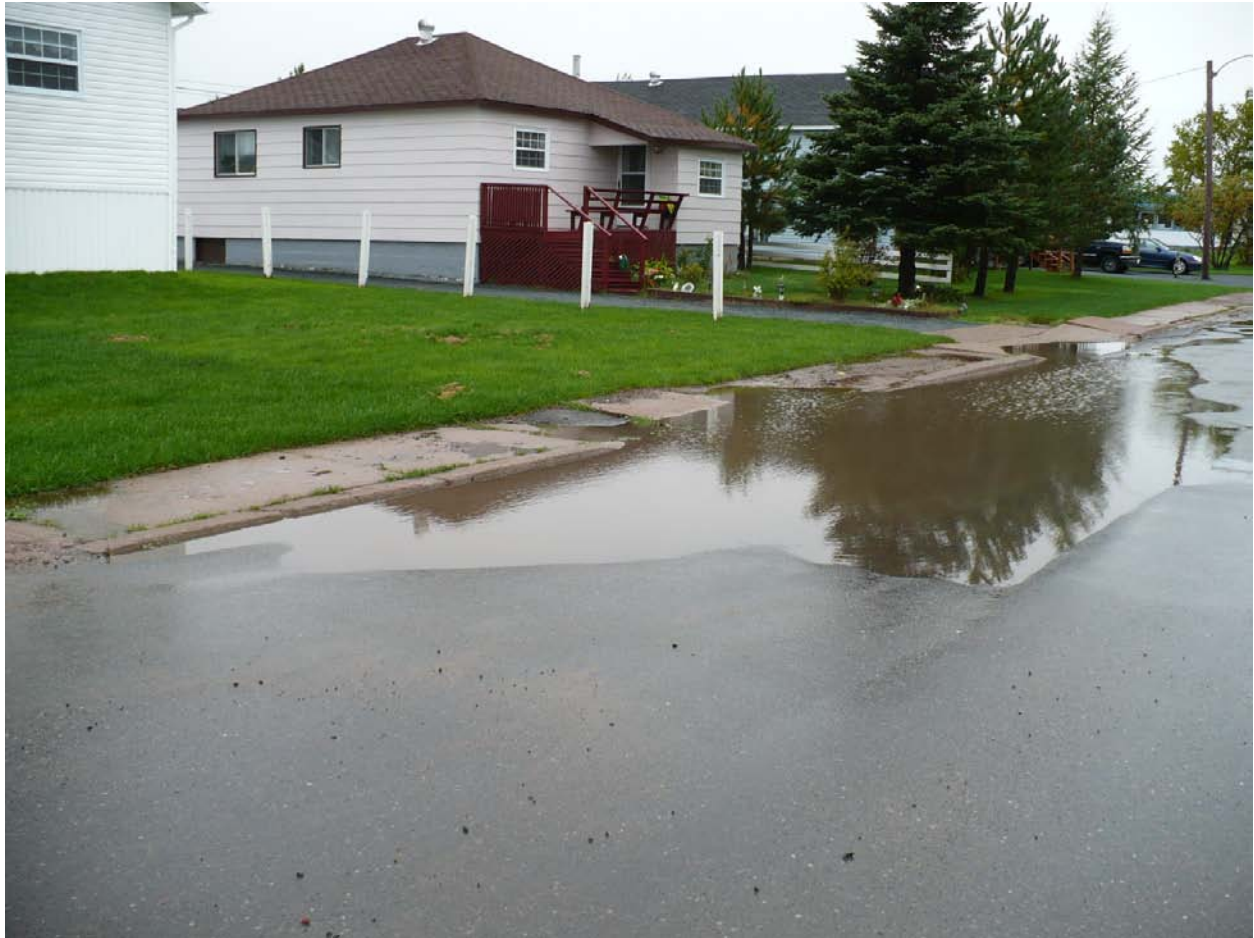
Photo#100

Photograph was taken on September 23, 2012 and shows the front lawn of 51 Jackson Avenue looking north from Water Street. Note the area on the street limits that has drainage issues.

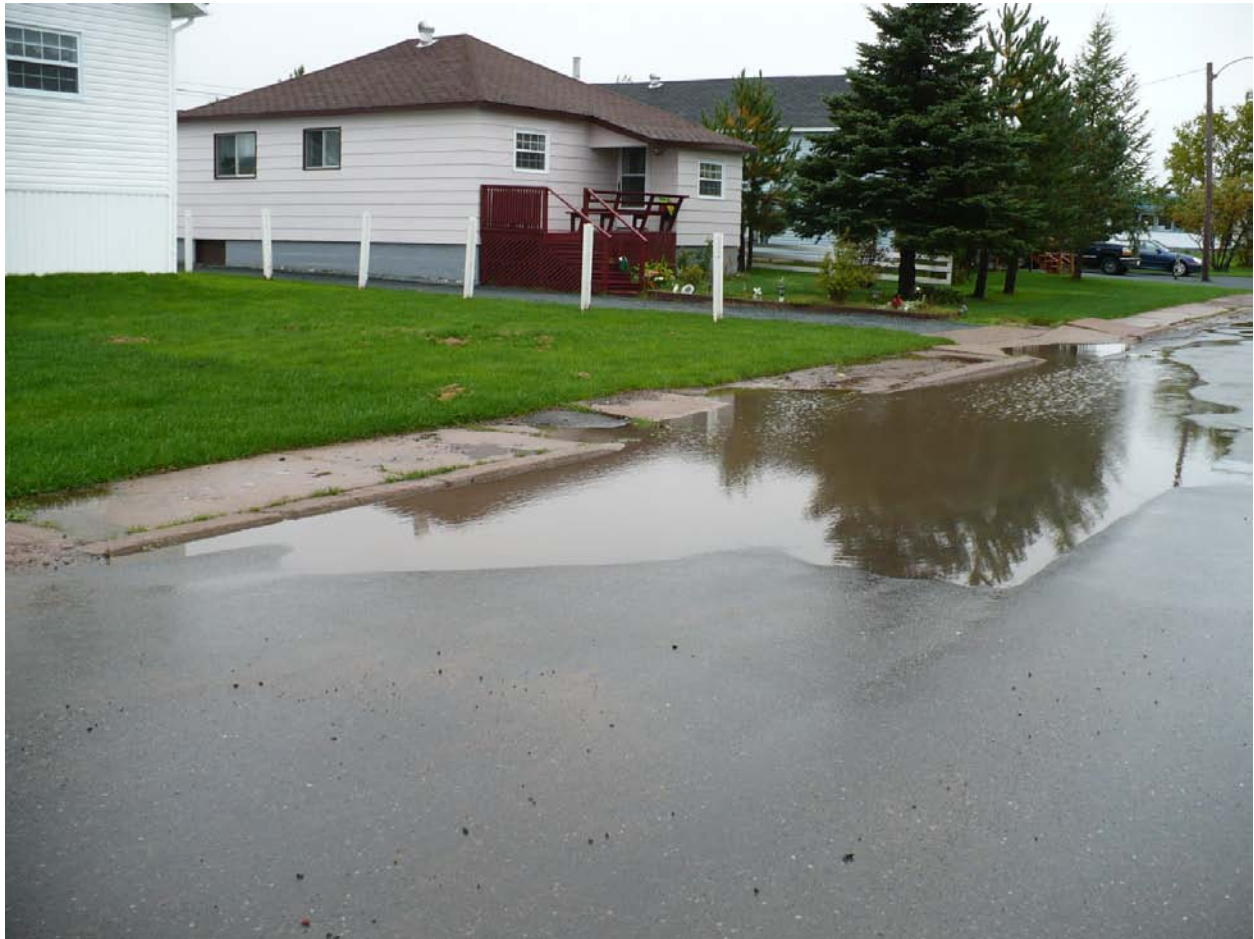
Photo#101

Photograph was taken on September 23, 2012 and shows the front lawn area of 53 Jackson Avenue after the sod has been installed and the driveway has had Class “A” installed. Note the existing street drainage issue in this area.

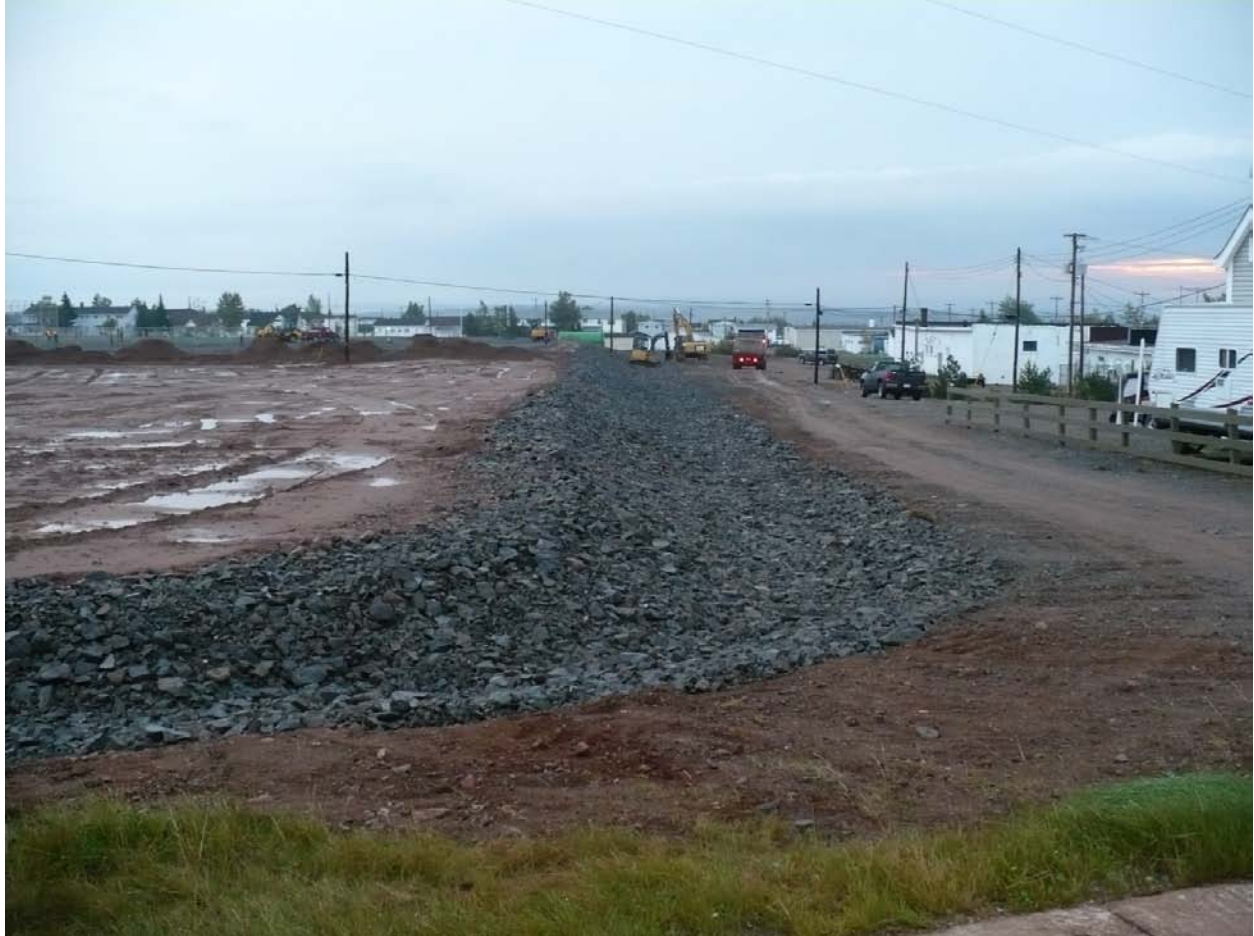
Photo#102

Photograph was taken on September 24, 2012 and shows the rock lined ditch at the south side of the impacted soils disposal area south of Forebay Road.

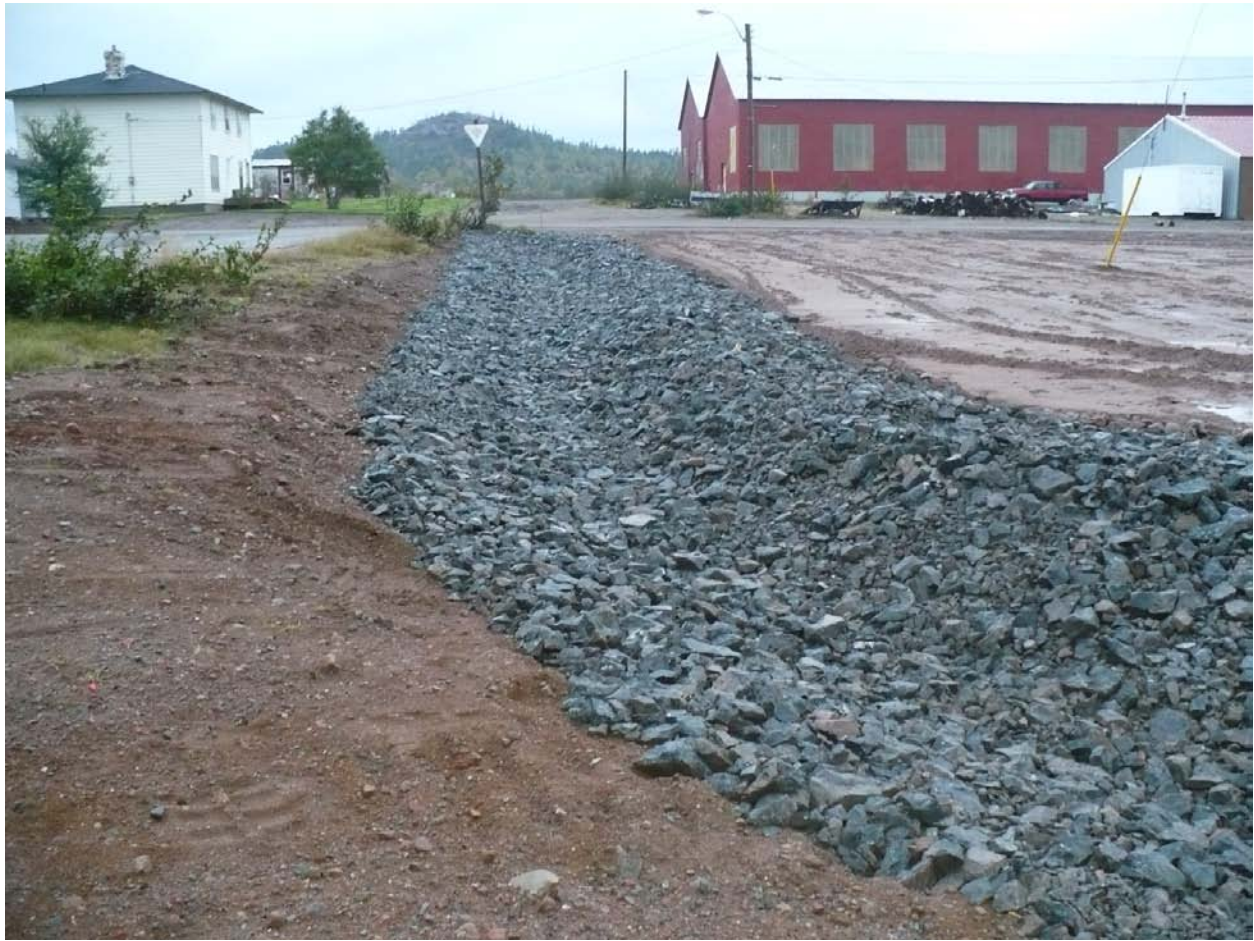
Photo#103

Photograph was taken on September 24, 2012 and shows the rock lined ditch at the west side of the impacted soils disposal area south of Forebay Road.

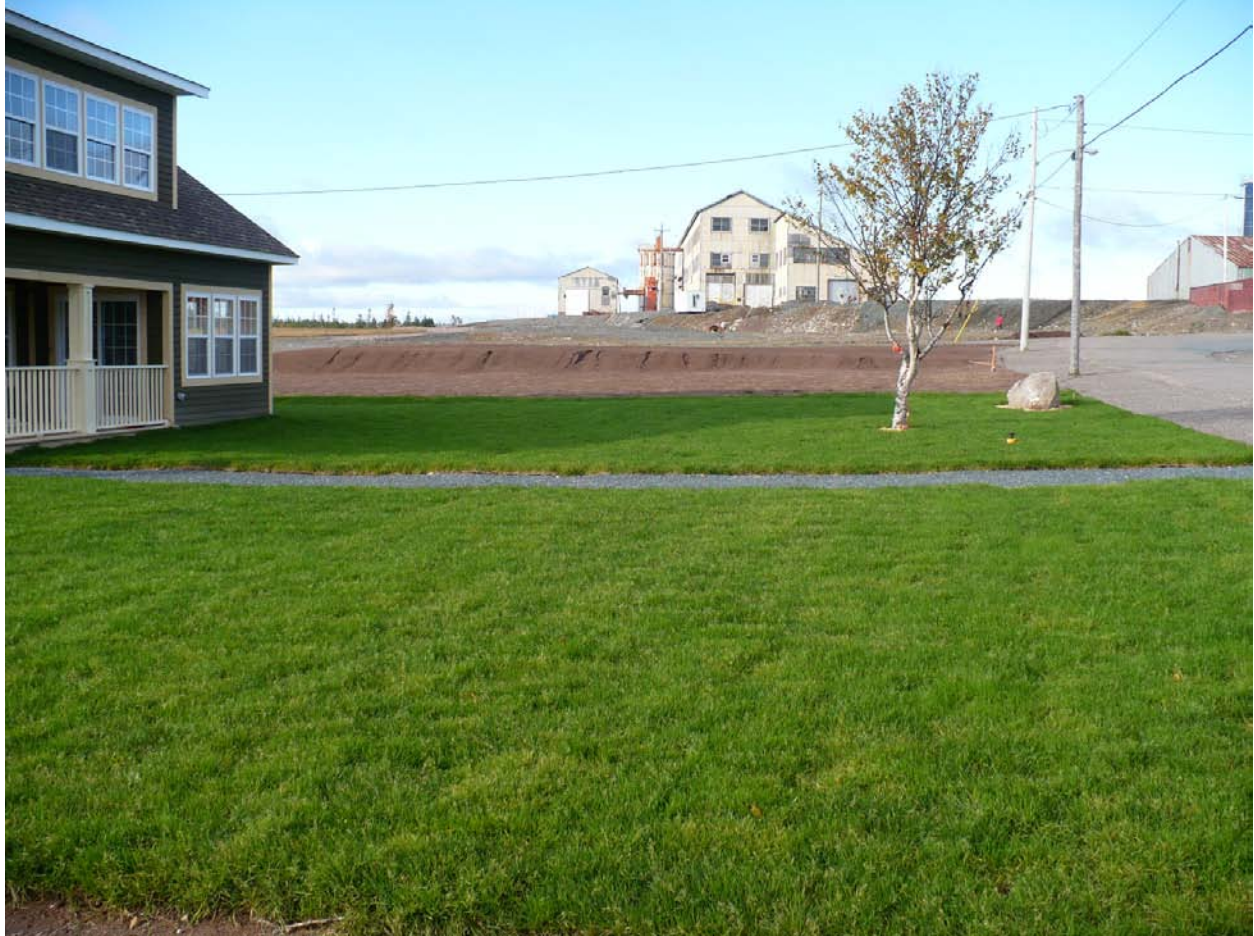
Photo#104

Photograph was taken on October 3, 2012 and shows the fully remediated area on the vacant lot at the west end of Water Street and also the area where the new house was developed adjacent to the tennis courts on Water Street.

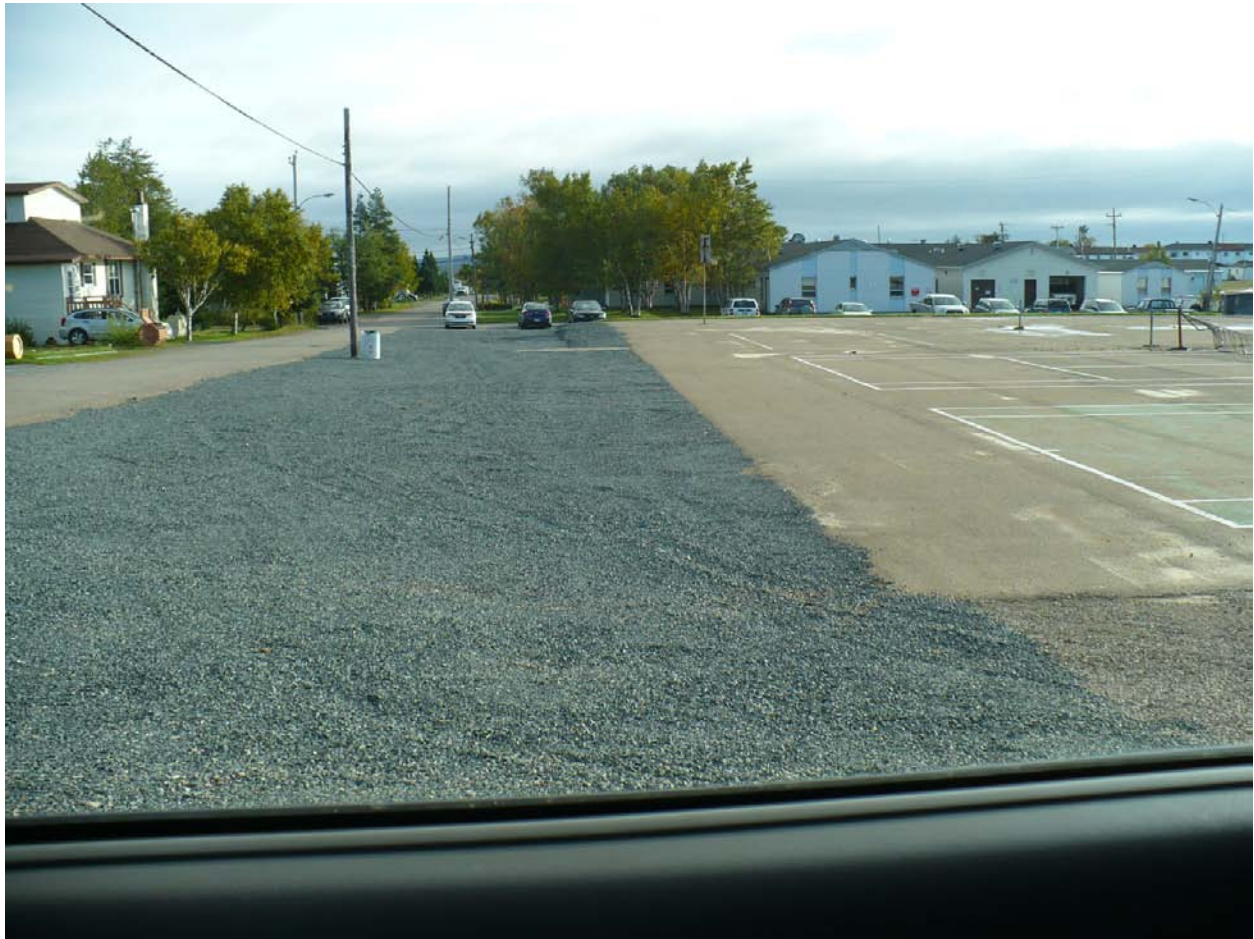
Photo#105

Photograph was taken on October 3, 2012 and shows the north edge of the tennis courts on Water Street that has now been completely remediated. Note the remediation area extends from asphalt to asphalt on the tennis courts and Water Street.

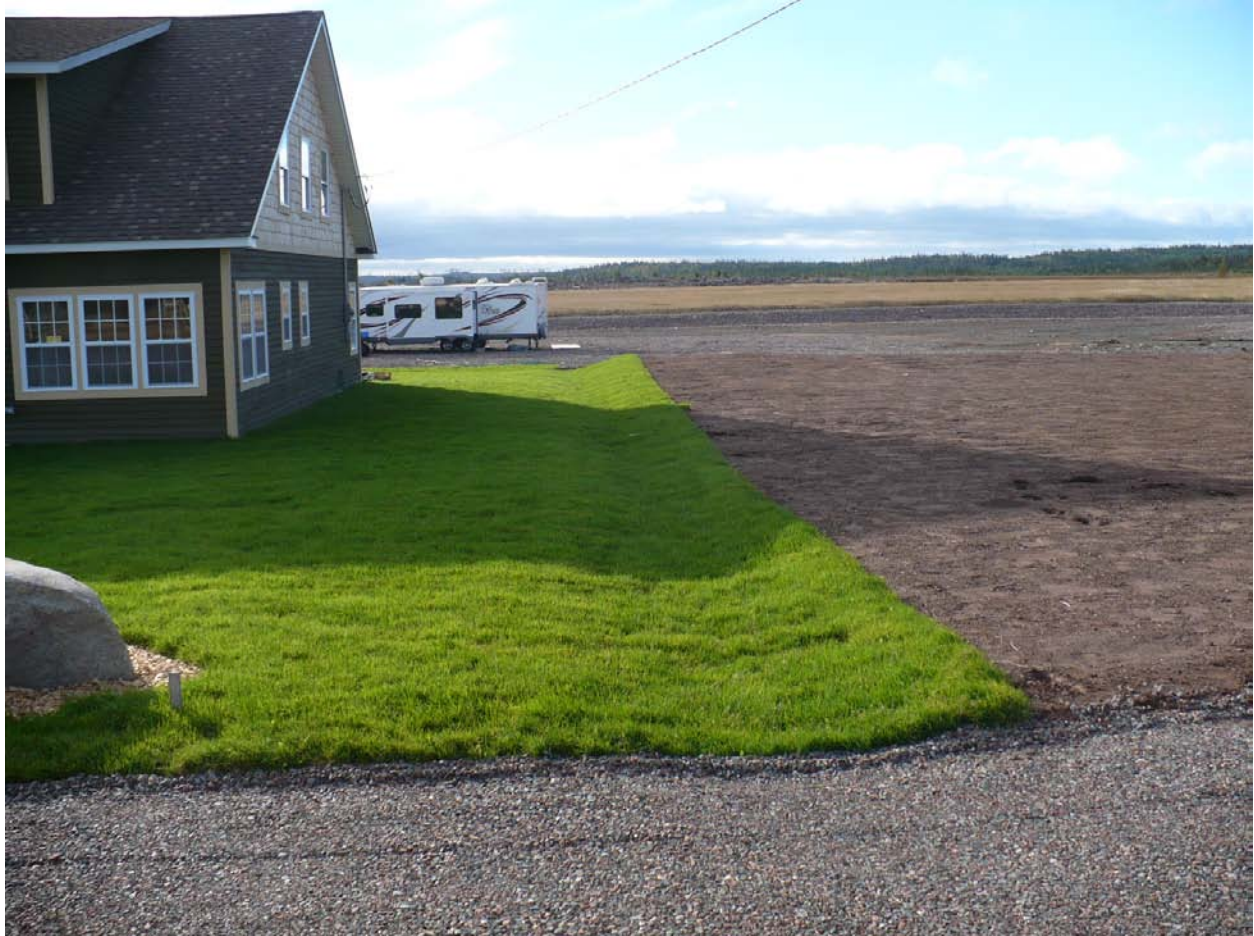
Photo#106

Photograph was taken on October 3, 2012 and shows the fully remediated area on the vacant lot at the west end of Water Street and also the area where the new house was developed adjacent to the tennis courts on Water Street.

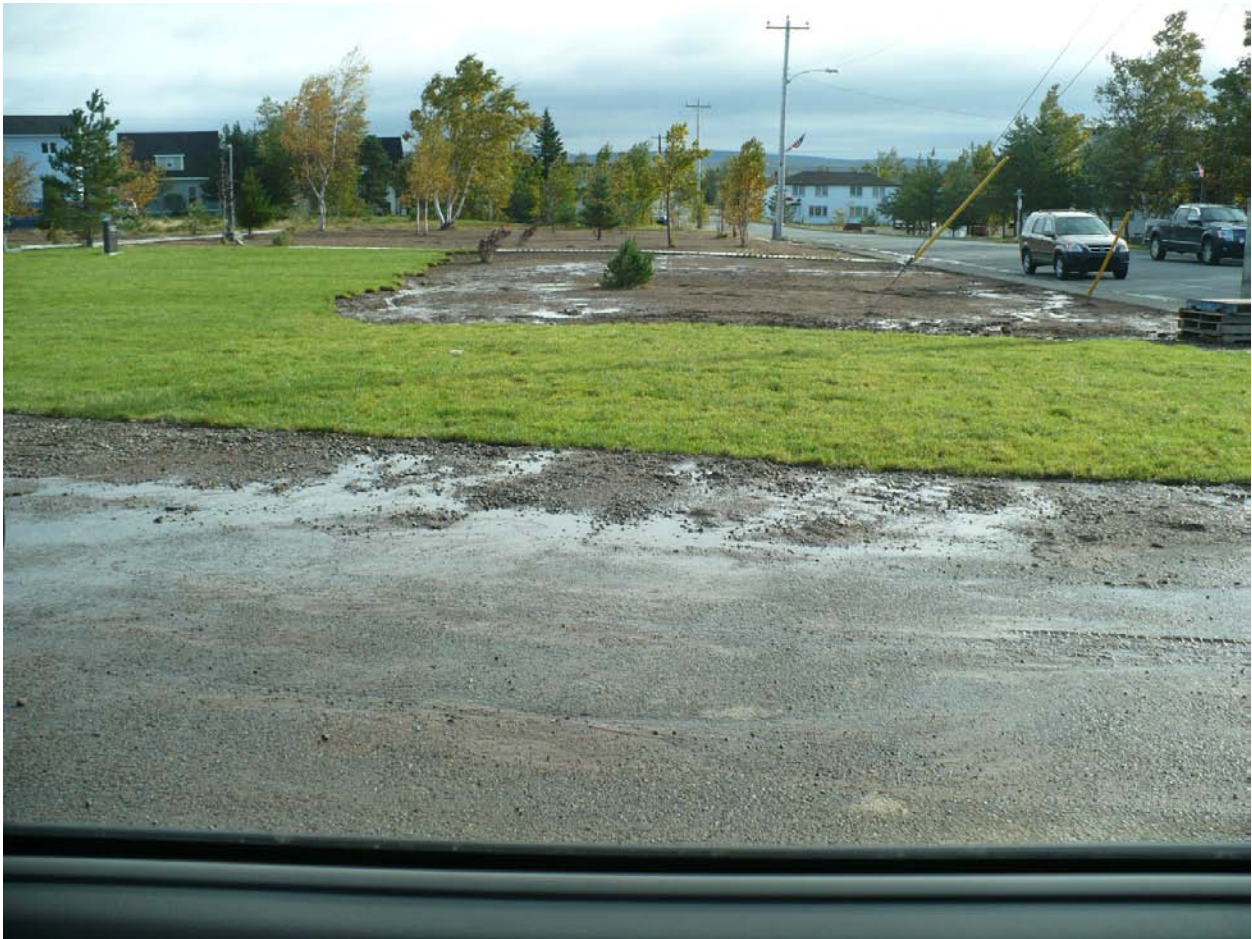
Photo#107

Photograph was taken on October 3, 2012 and shows a portion of the Veteran's Memorial Park with topsoil installed and some sod installation completed. All excavation of the park area has been completed and imported common fill material has been placed.

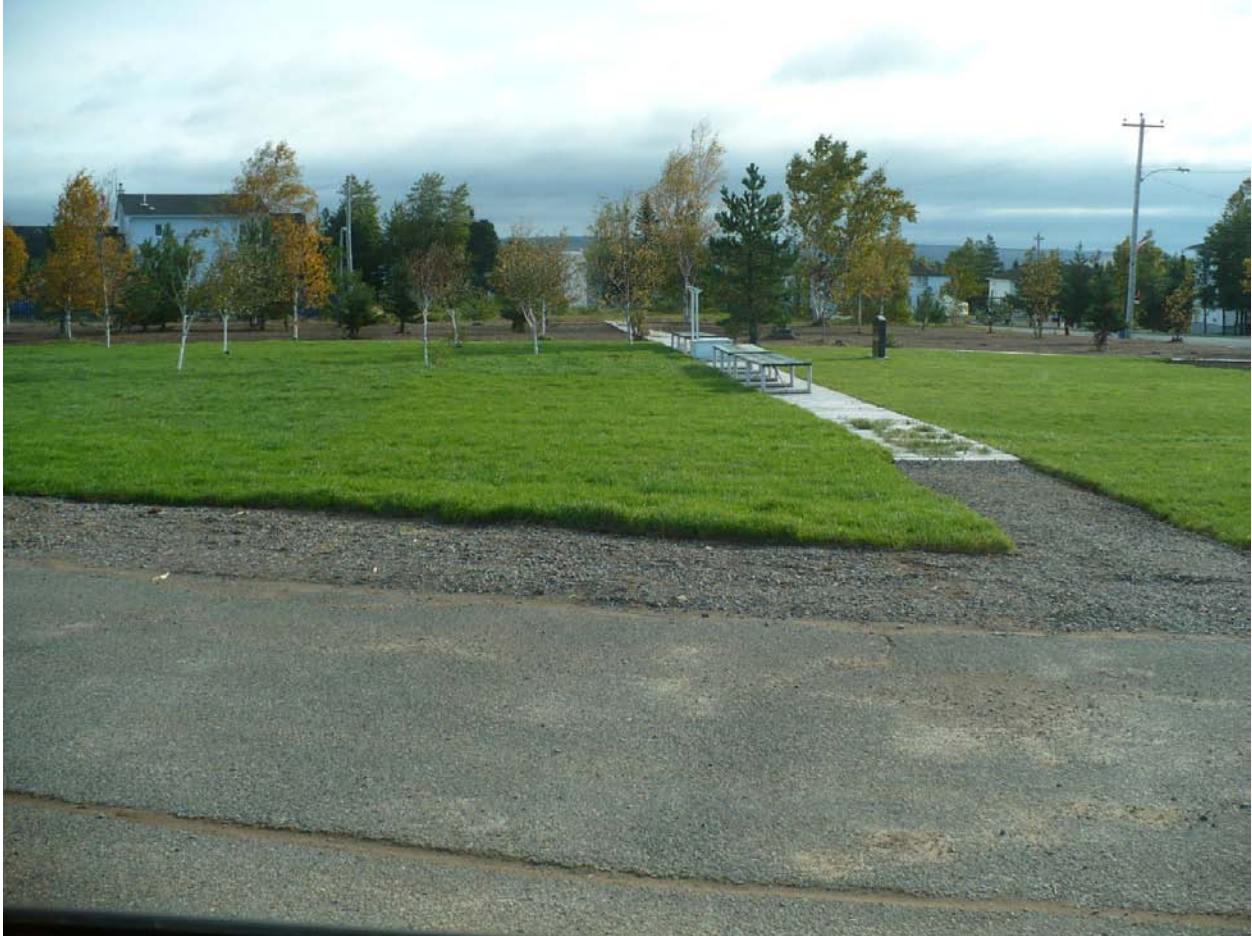
Photo#108

Photograph was taken on October 3, 2012 and shows a portion of the Veteran's Memorial Park with topsoil installed and some sod installation completed. All excavation of the park area has been completed and imported common fill material has been placed.
