**Project:** The Buchans Remediation Project – Phase II  
Residential and Public Areas Remediation  
Year 1 Construction Report

**Client:** Department of Environment and Conservation

**Consultant:** Hatch Mott MacDonald

**Contractor:** Marine Contractors Inc.

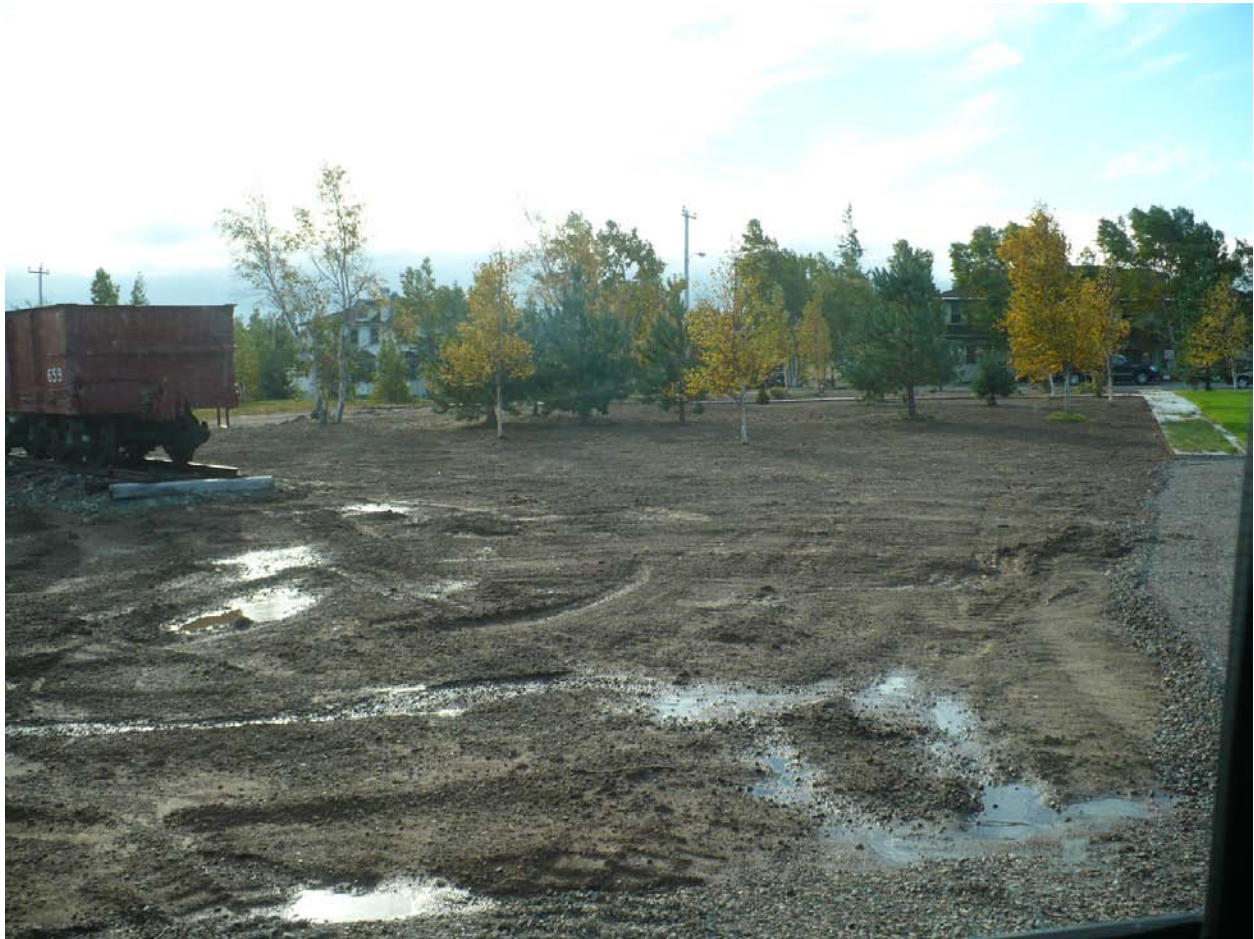
Photo#109

Photograph was taken on October 3, 2012 and shows a portion of the Veteran's Memorial Park with topsoil installed and some sod installation completed. This area needs to dry out prior to completing the installation of topsoil and proceeding with the installation of sods.

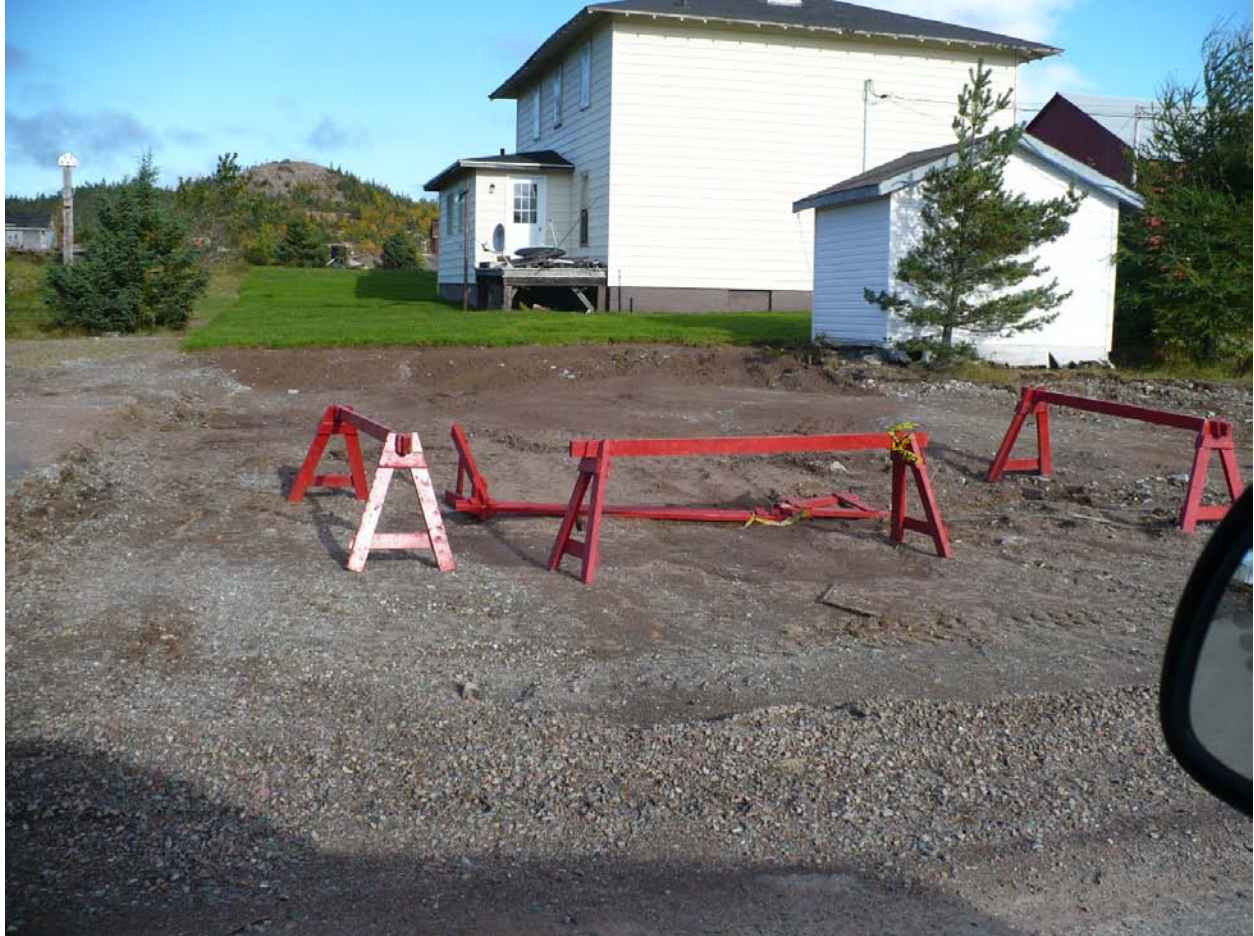
Photo#110

Photograph was taken on October 3, 2012 and shows the area at 7 Gilchrist Street where the oil tank was encountered during the excavation of impacted soils. This area was barricaded until tank removal. Note the installation of sods at the rear of the property that has previously been excavated and impacted materials have been removed and the area backfilled to the specifications.

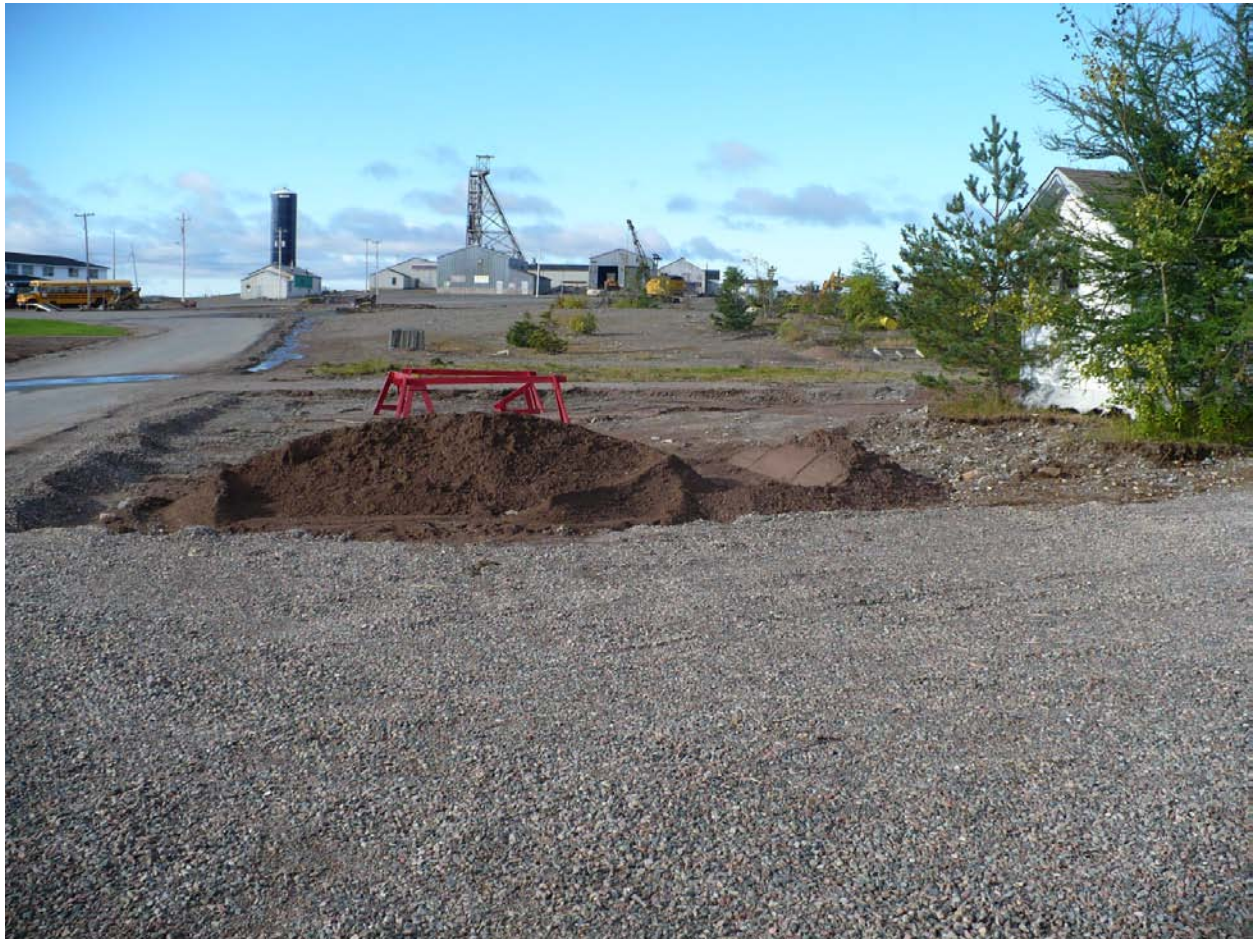
Photo#111

Photograph was taken on October 3, 2012 and shows the area at 7 Gilchrist Street where the oil tank was encountered during the excavation of impacted soils. This area was barricaded until tank removal.

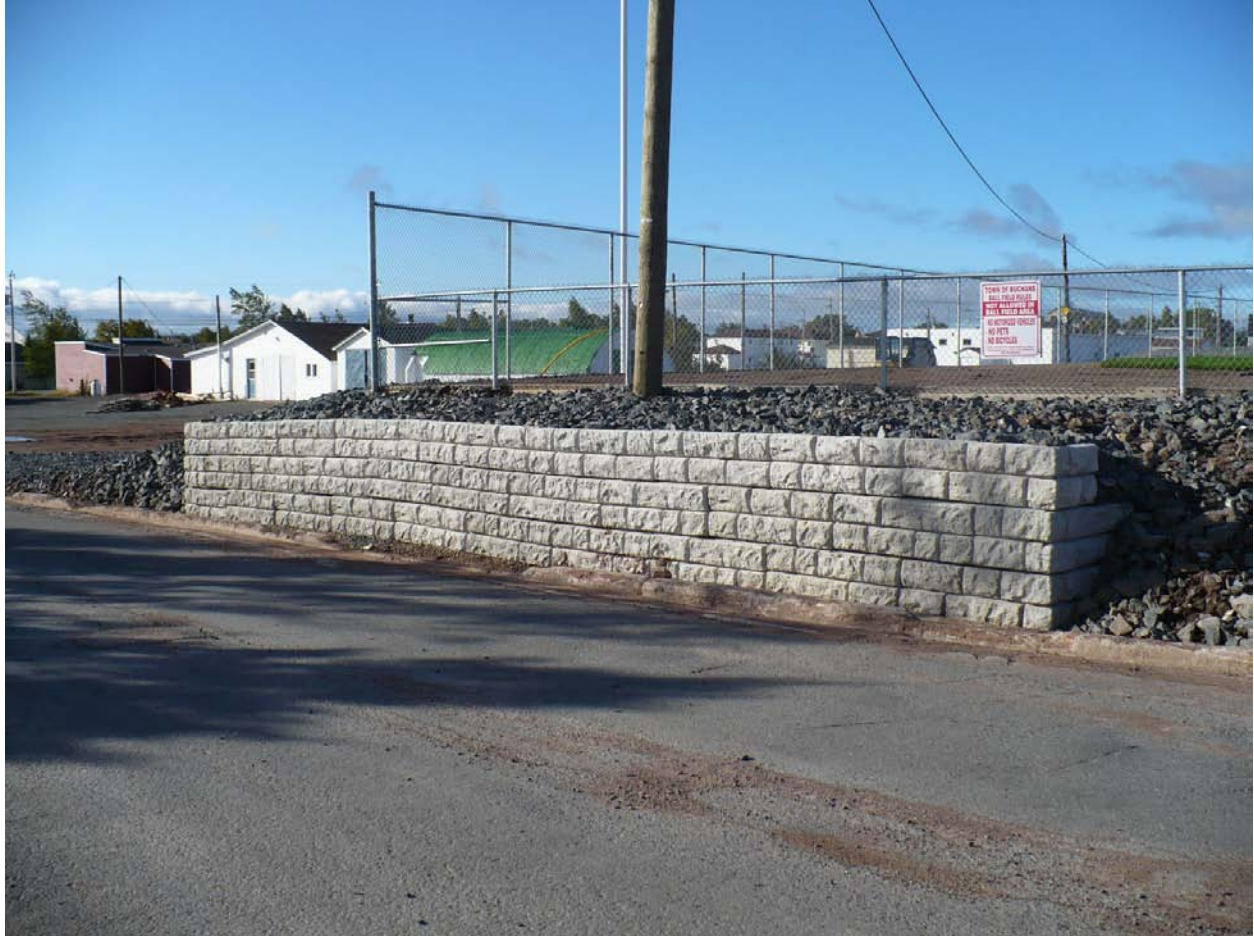
Photo#112

Photograph was taken on October 3, 2012 and shows the full retaining wall structure at the ball park on Jackson Avenue. This retaining wall was constructed to prevent erosion of the ball park area onto Jackson Avenue.

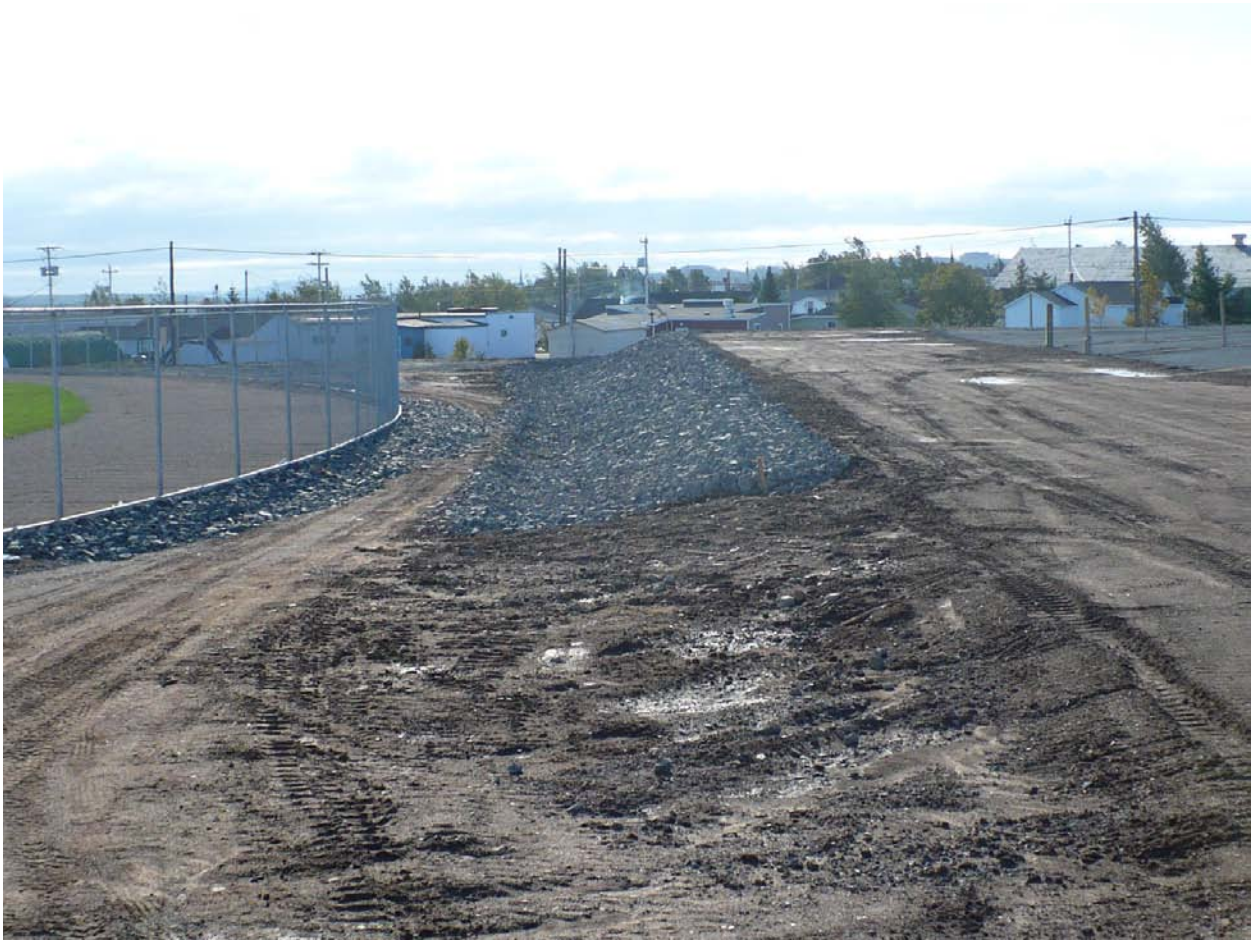
Photo#113

Photograph was taken on October 3, 2012 and shows the rock lined ditch on the east side of the impacted soils disposal area.

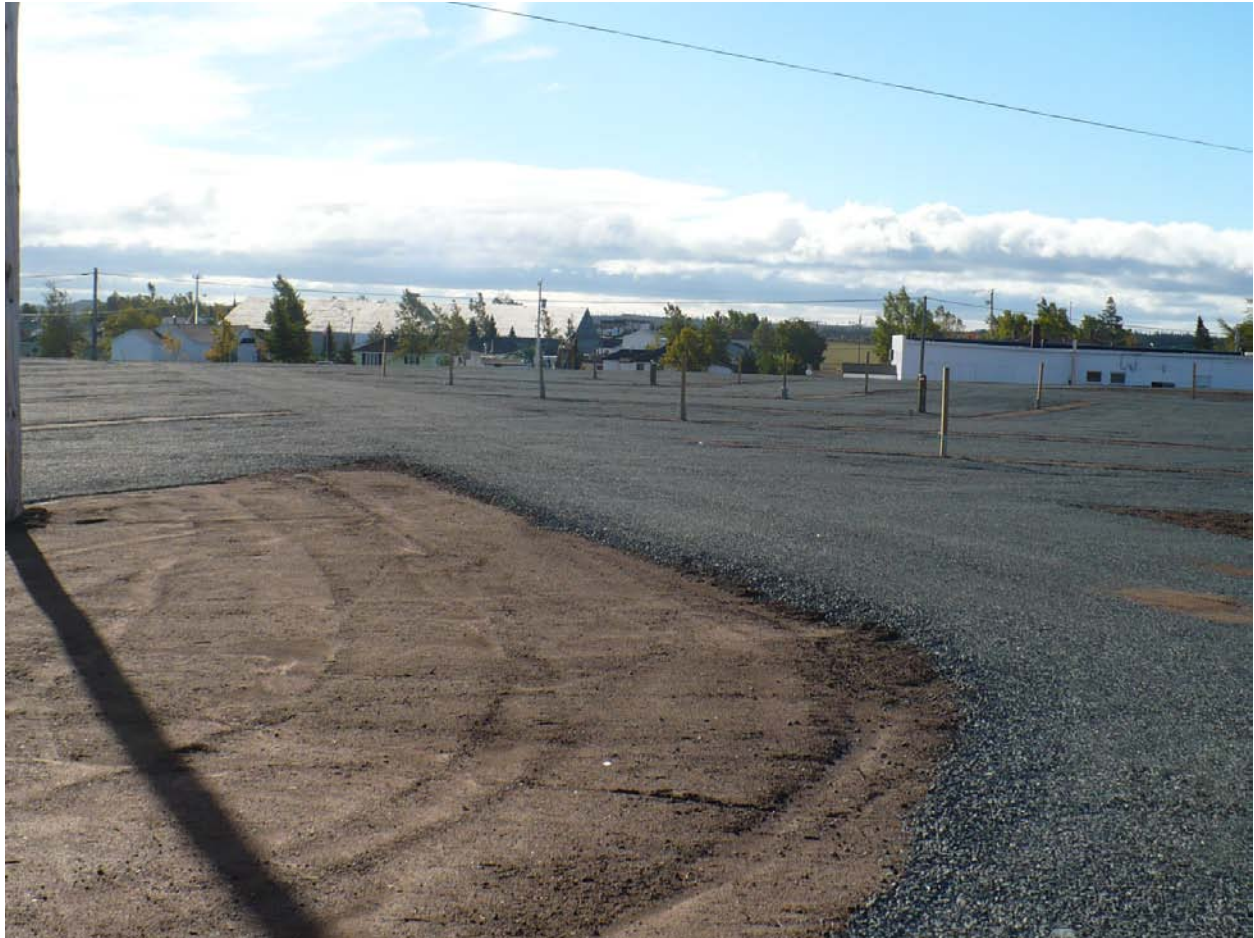
Photo#114

Photograph was taken on October 3, 2012 and shows the RV Park portion of the impacted soils disposal area with the Class “A” driveway areas completed and the parking areas for the trailers completed. Note that the water supply system has been installed and underground conduit for future electrical supply to each campsite has been completed.

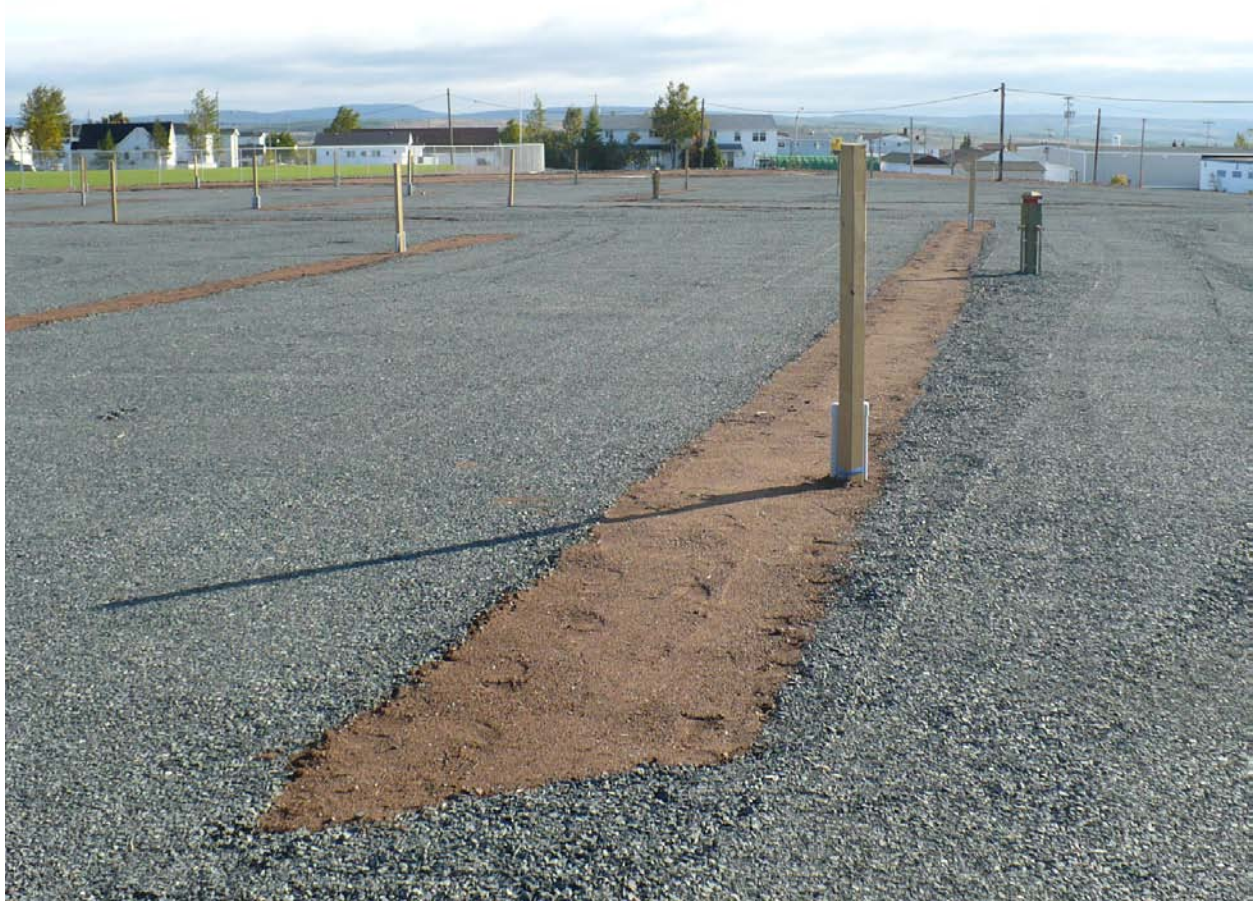
Photo#115

Photograph was taken on October 3, 2012 and shows the RV Park portion of the impacted soils disposal area with the Class “A” driveway areas completed and the parking areas for the trailers completed. Note that the water supply system has been installed and underground conduit for future electrical supply to each campsite has been completed.

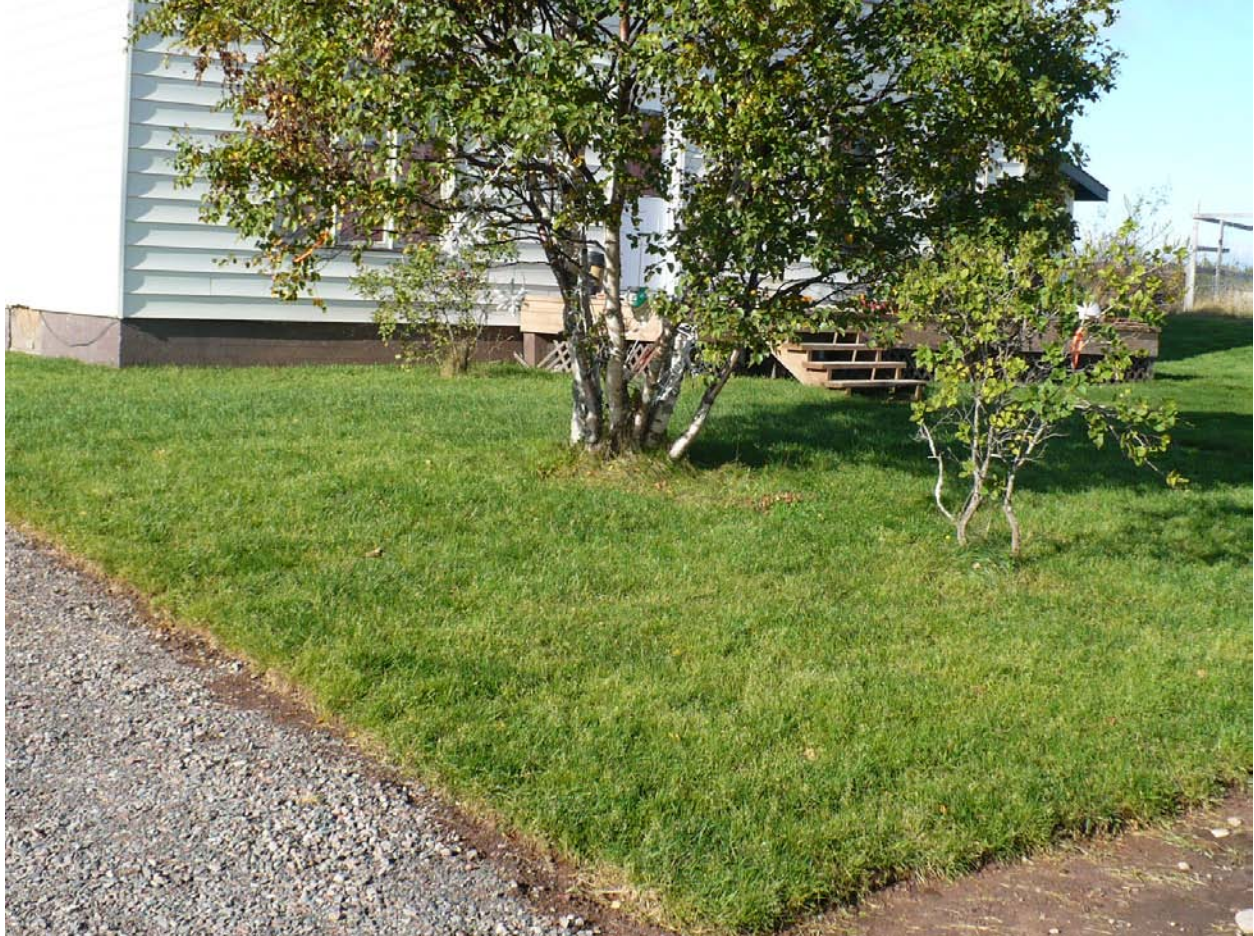
Photo#116

Photograph was taken on October 3, 2012 and shows the property at 7 Gilchrist after remediation has been completed.

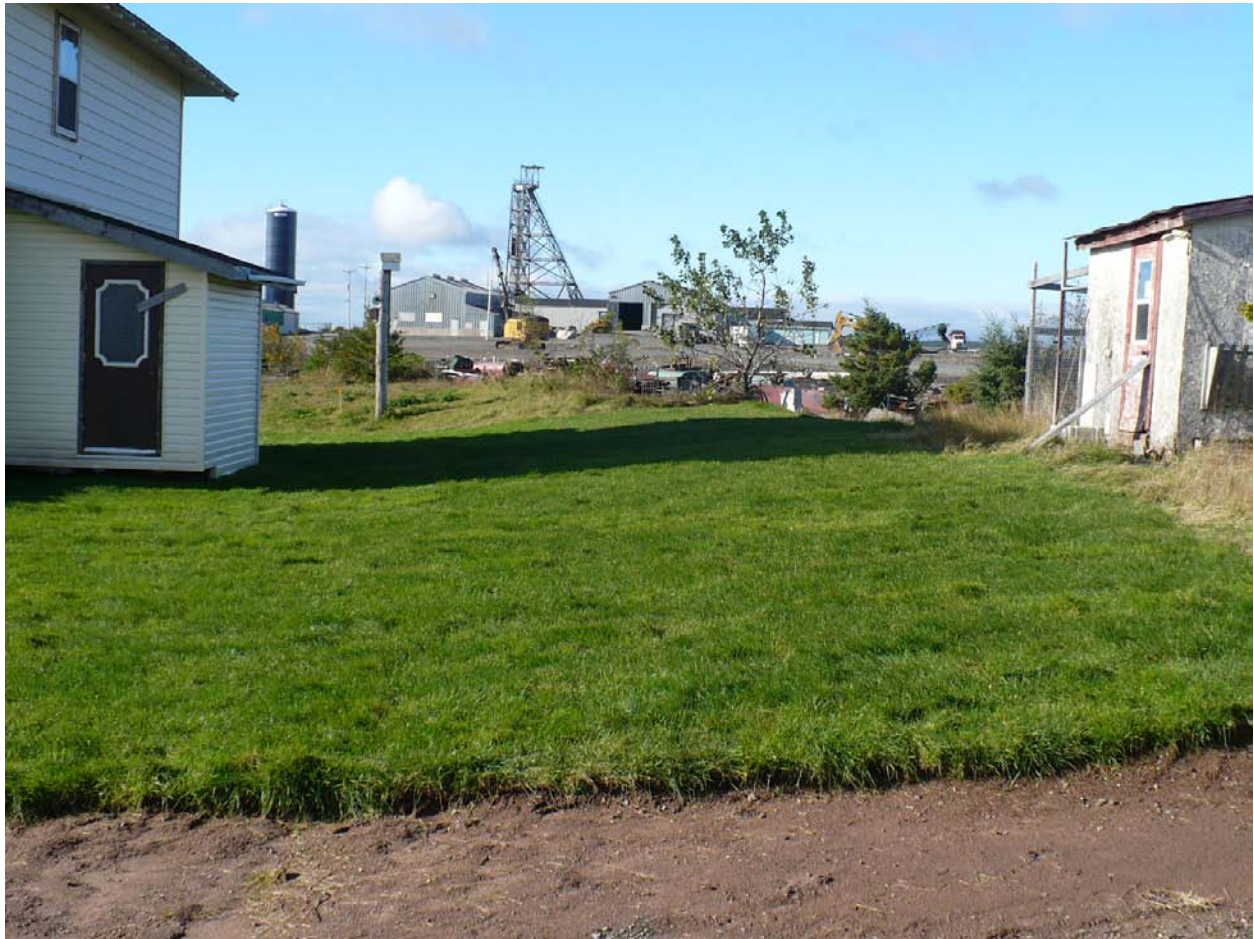
Photo#117

Photograph was taken on October 3, 2012 and shows the property at 7 Gilchrist after remediation has been completed.

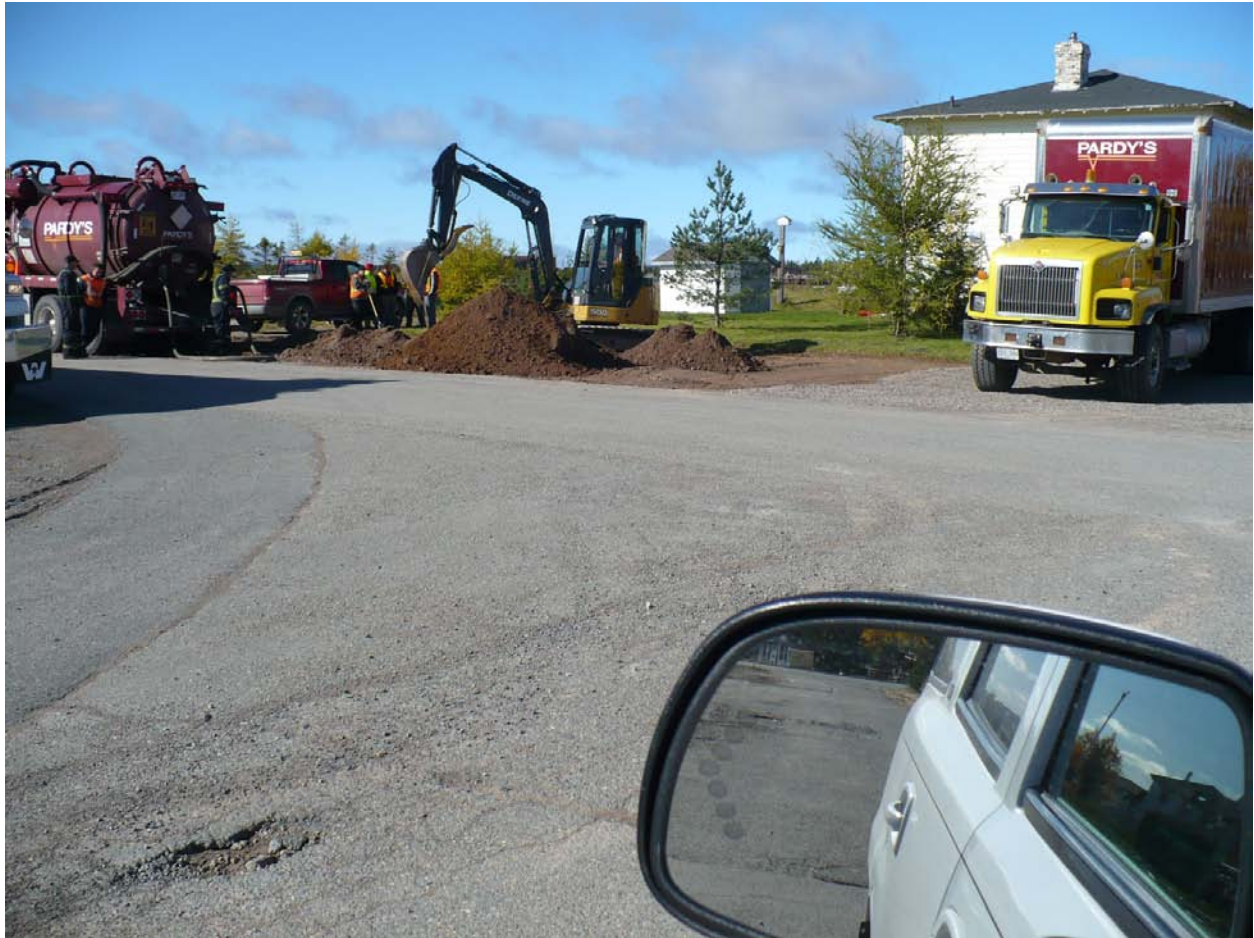
Photo#118

Photograph was taken on October 18, 2012 and shows the oil tank at 7 Gilchrist Street being prepared for removal. The tank has been pumped and then the area will be fully remediated.

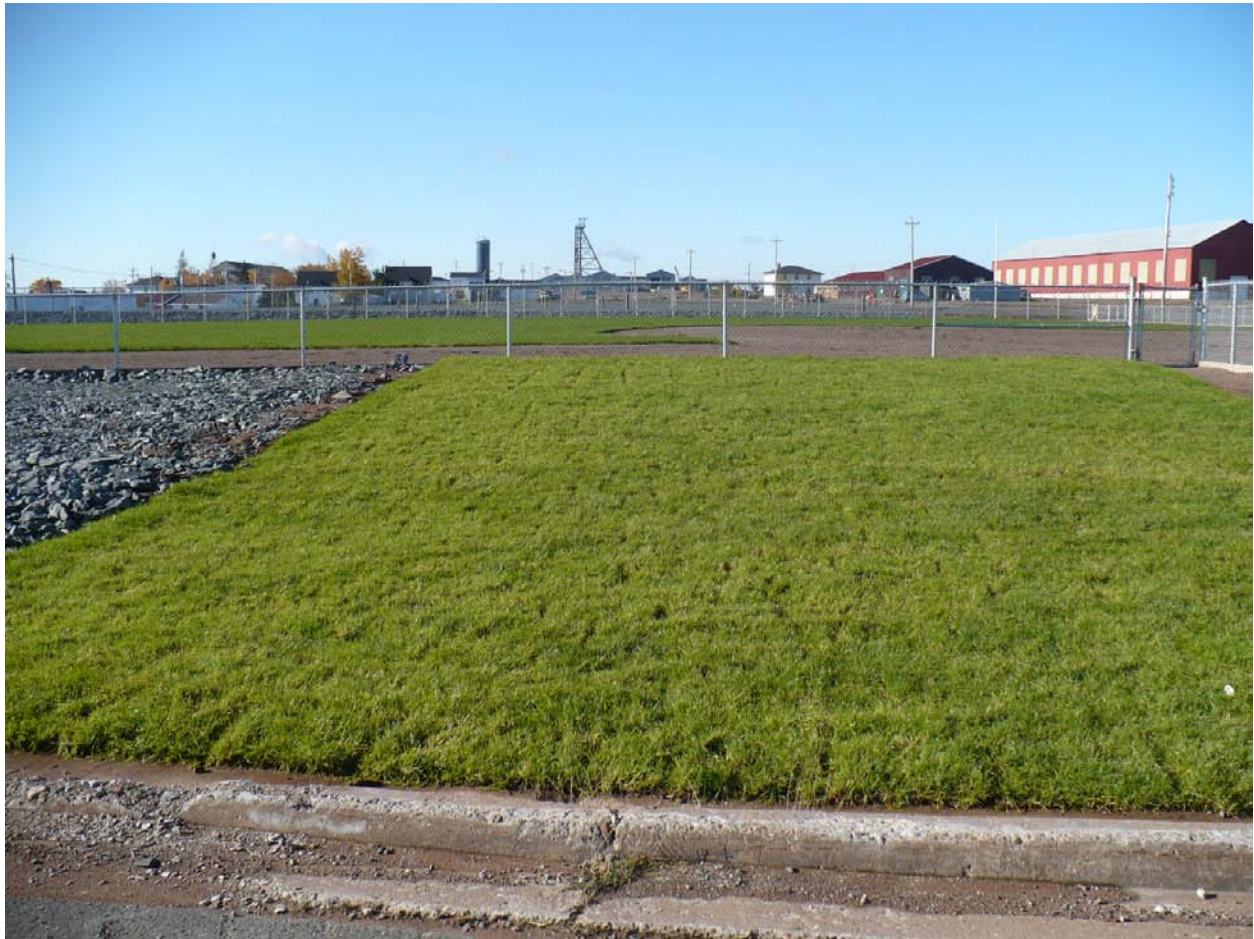
Photo#119

Photograph was taken on October 22, 2012 and shows the area east of the ball park on Jackson Avenue that has been backfilled with rock fill and then has had sod installed to prevent soil erosion from the ball park onto Jackson Avenue.

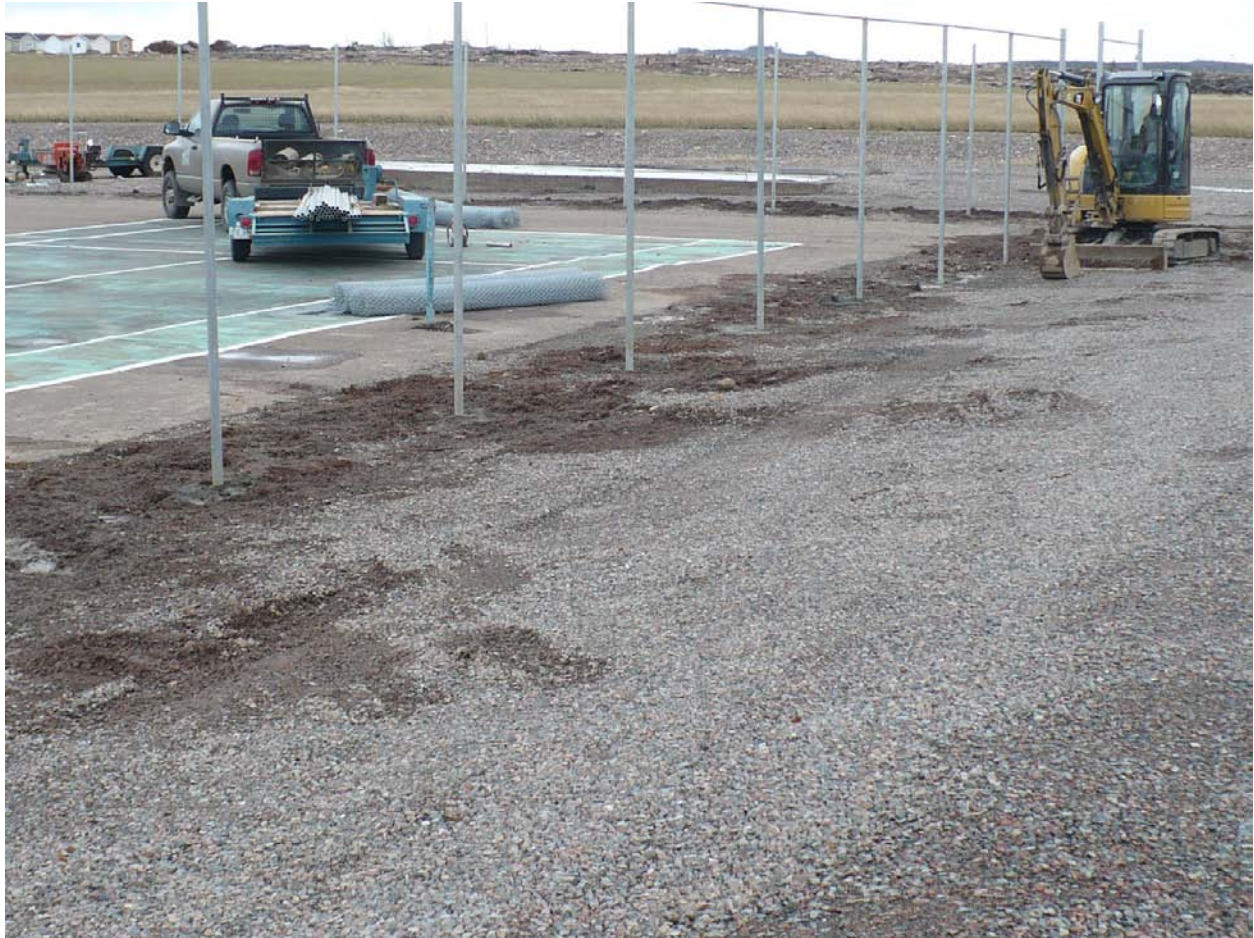
Photo#120

Photograph was taken on November 7, 2012 and shows the installation of the new chain link fence at the tennis courts. This fence was replaced to ensure that the remediated areas would not have to be disturbed by additional construction by the town after the remediation project has been closed completed.

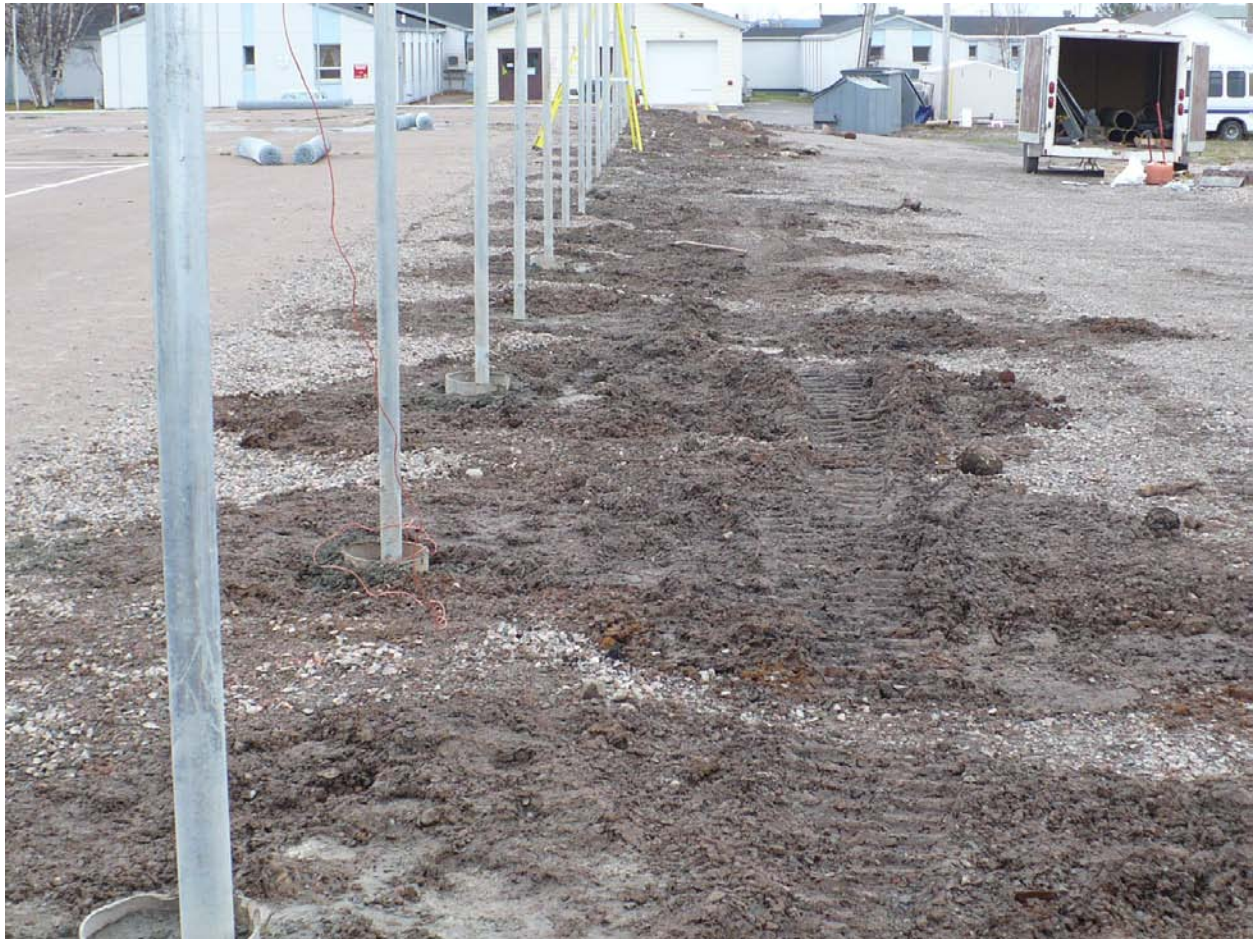
Photo#121

Photograph was taken on November 7, 2012 and shows the installation of the new chain link fence at the tennis courts. This fence was replaced to ensure that the remediated areas would not have to be disturbed by additional construction by the town after the remediation project has been closed completed.

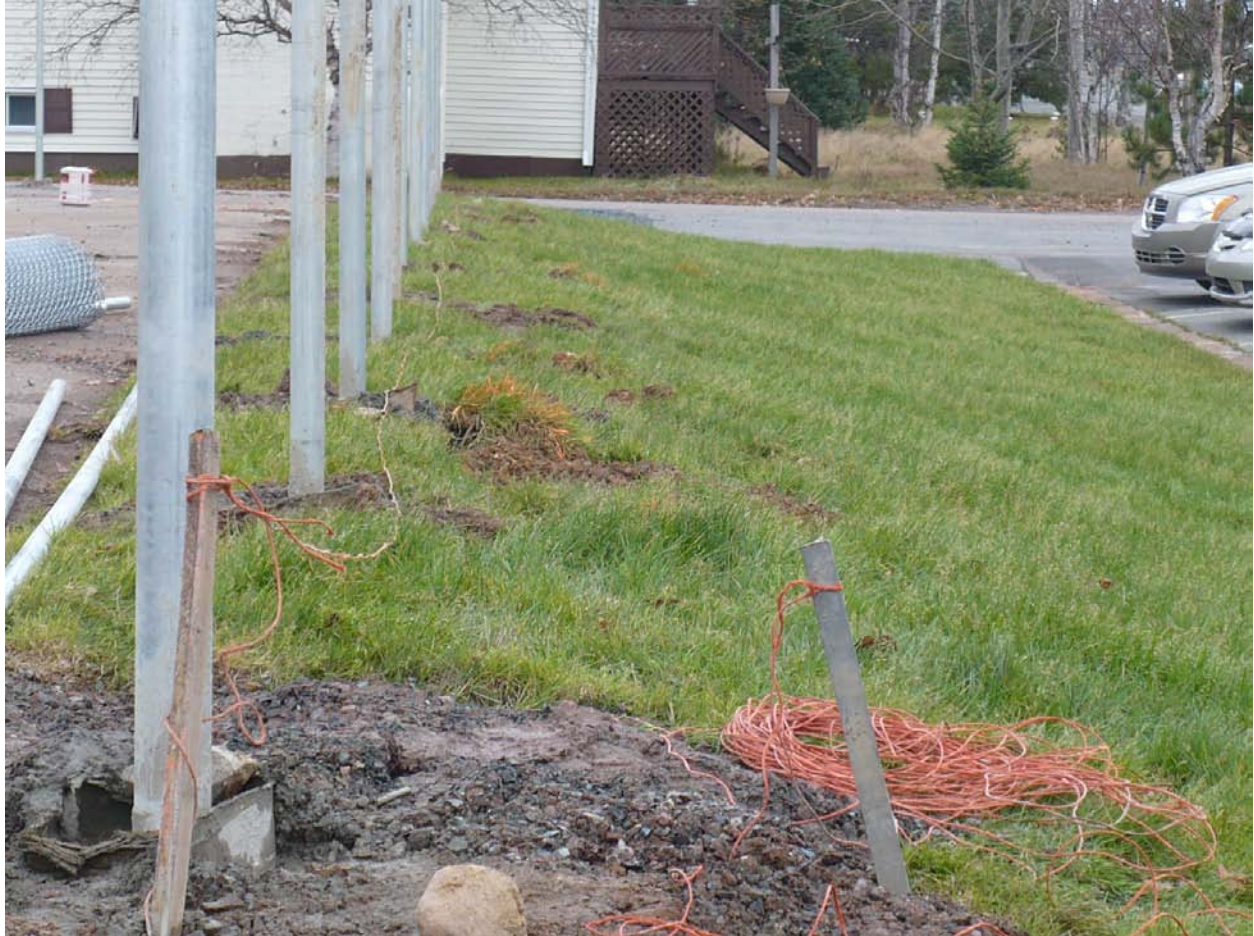
Photo#122

Photograph was taken on November 7, 2012 and shows the installation of the new chain link fence at the tennis courts. This fence was replaced to ensure that the remediated areas would not have to be disturbed by additional construction by the town after the remediation project has been closed completed. Note that this is on the east side of the tennis courts bordering the health care clinic and this area has had sod installed instead of Class "A".

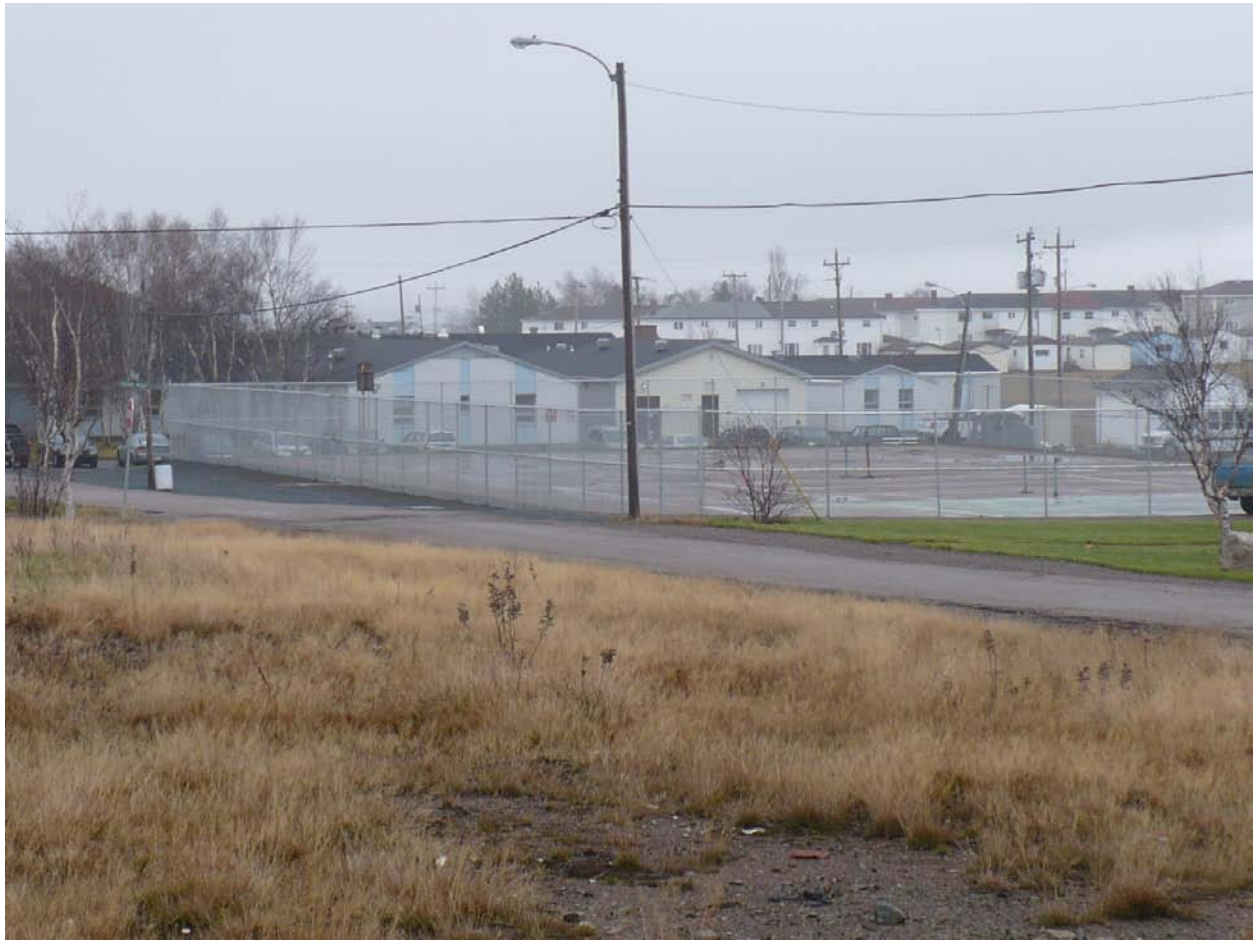
Photo#123

Photograph was taken on November 15, 2012 and shows the installation of the new chain link fence at the tennis courts. The fence was replaced to ensure that the remediated areas would not have to be disturbed by additional construction by the town after the remediation project has been closed completed.

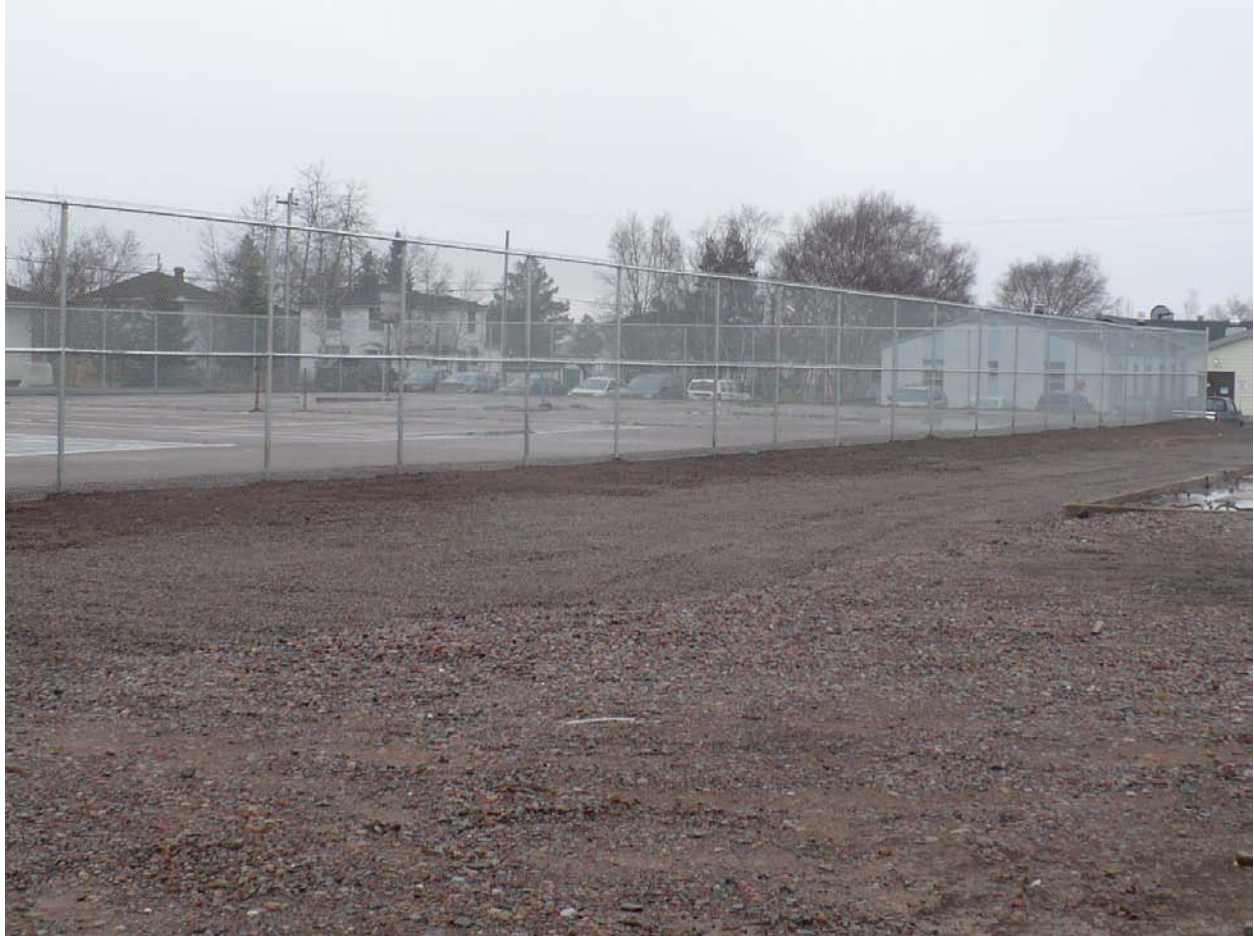
Photo#124

Photograph was taken on November 15, 2012 and shows the installation of the new chain link fence at the tennis courts. The fence was replaced to ensure that the remediated areas would not have to be disturbed by additional construction by the town after the remediation project has been closed completed.
