## **Inspection Report- Buchans River Bridge**

**Department of Environment and Conservation  
Inspection Report – Buchans River Bridge  
DOEC Project #734.302.5  
Buchans, NL  
May 31, 2012**

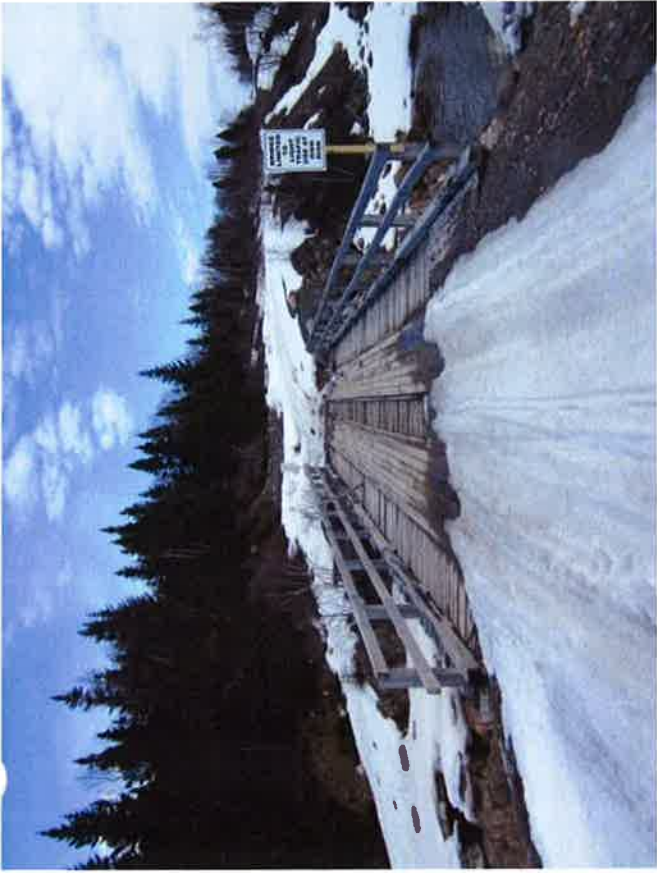
Photo 1

Upon first visiting the site, there were signs on each end stating that the bridge was for light traffic only. These signs appeared relatively new compared to the age of the bridge. They can be seen in Photo 1.

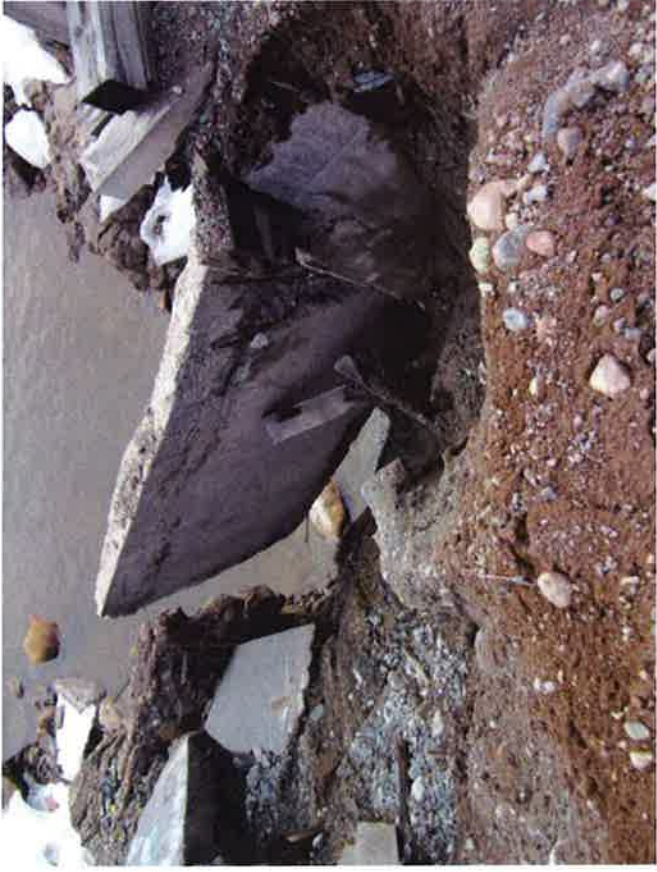
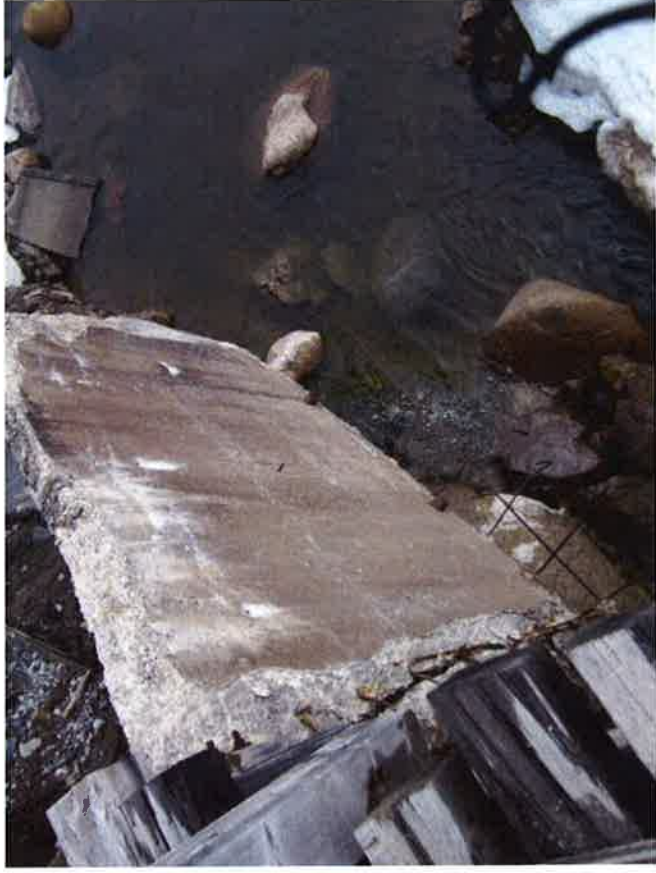
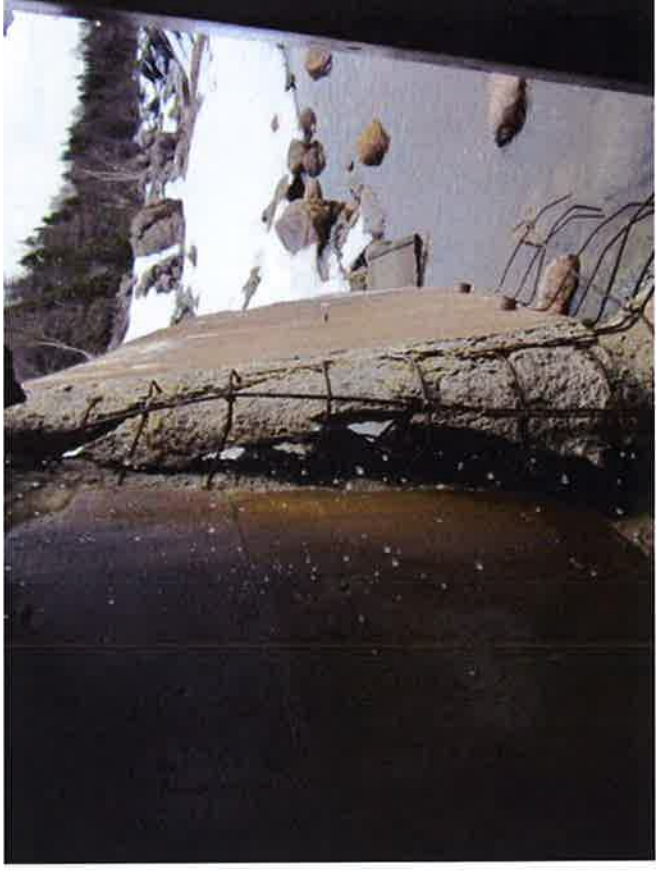
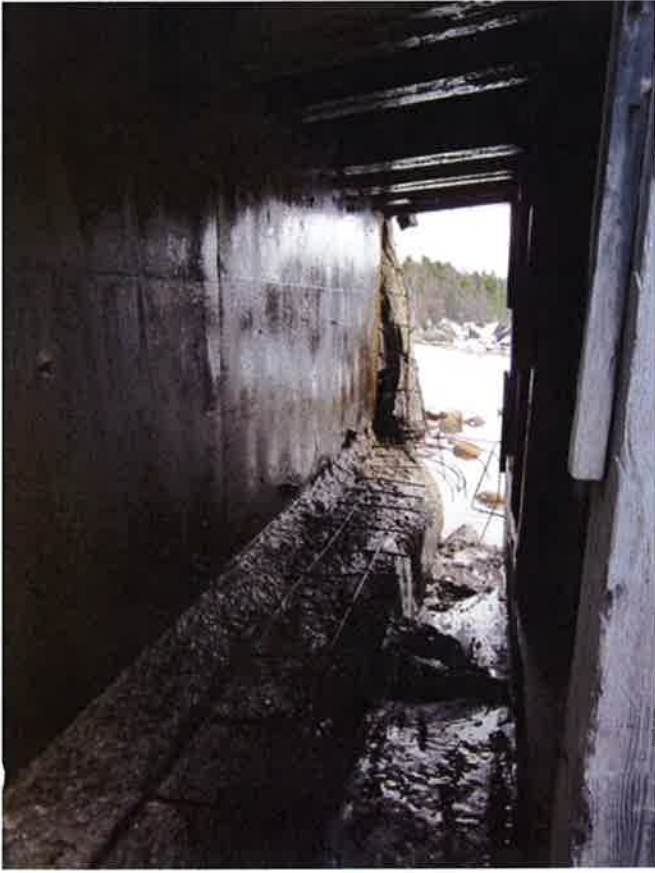
The east concrete abutment is extensively damaged. The concrete connecting the south wing wall to the main bearing wall is completely destroyed and the wing wall is only connected by the exposed rebar between the two. The toe of the footing for the main bearing wall has completely spalled off with only the rebar cage remaining. Photos 2 to 5 in Appendix B depict the damage to the east abutment.

It is recommended that the cast concrete abutment be replaced in its entirety as the design and construction of a new structure would likely cost less than determining the adequacy of the existing undamaged portions and designing and constructing replacements for the damaged portions. Further design is required to determine the size and layout of a replacement structure.

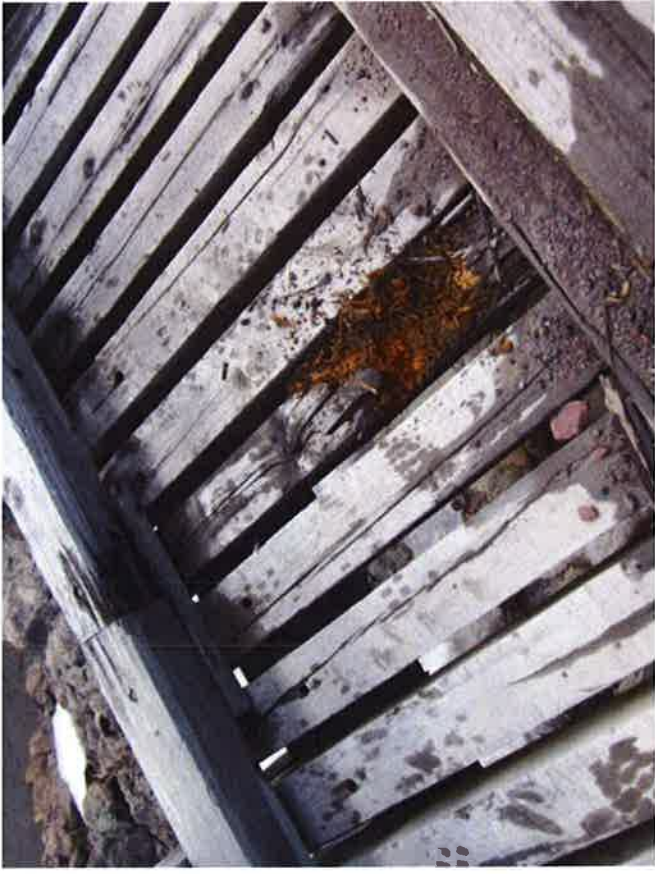
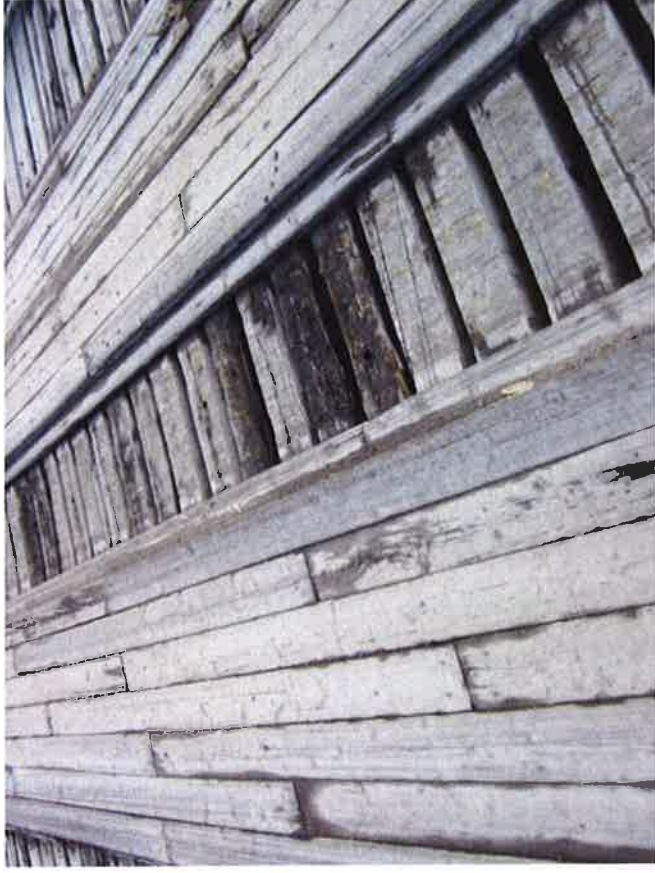
Much of the 6x6 timber decking was rotted, in some places to the point where you could kick the surface away. Evidence of this can be seen in Photos 6 and 7 in Appendix B. There were also some timbers near the west abutment that were completely destroyed due to heavy traffic loads and 4x4 timber has been installed to cover the hole in the decking. Photos 8 and 9 show the damage from below and above, respectively.

It is recommended that the 6x6 timber deck be replaced in full due to appreciable rot in many of the sections. The steel beams appear to only have sustained surface corrosion on the lower portions, however the riveted capacity and extent of rusting on the upper surface of the top flange and of the rivets cannot be determined and it is recommended that, in lieu of performing ultrasonic testing (UT) of the beams, they be replaced in full with a new steel section. Alternatively, UT measurements could be taken to determine the remaining thickness of the web and flanges and an assessment could be made at that time as to whether the beams have sufficient capacity to carry heavy traffic loads in their current condition.

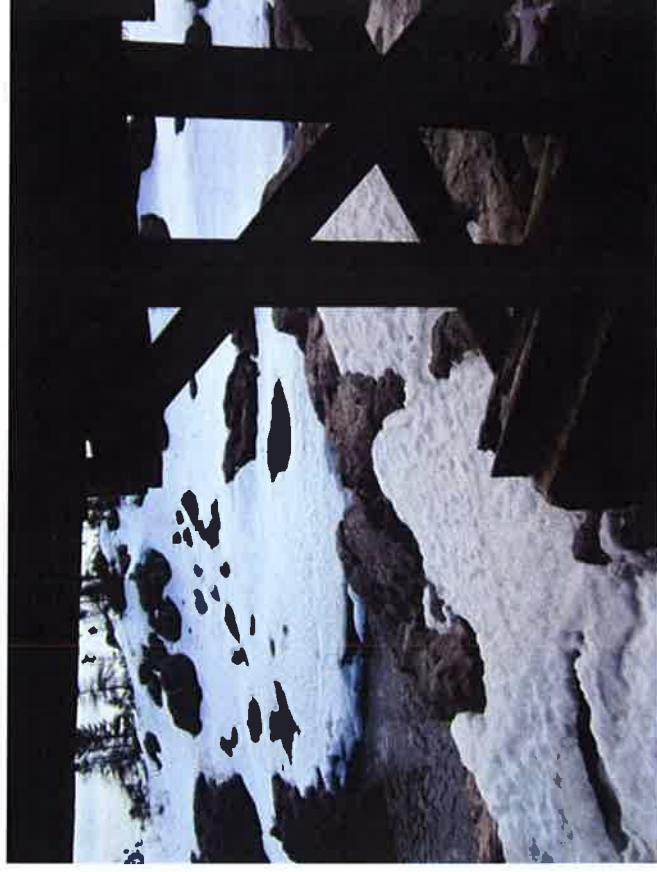
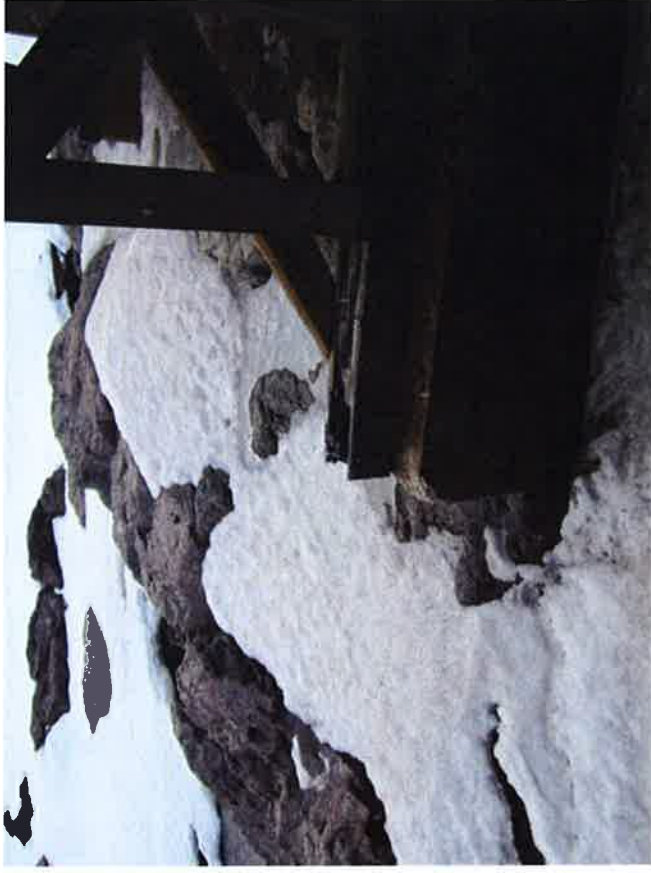
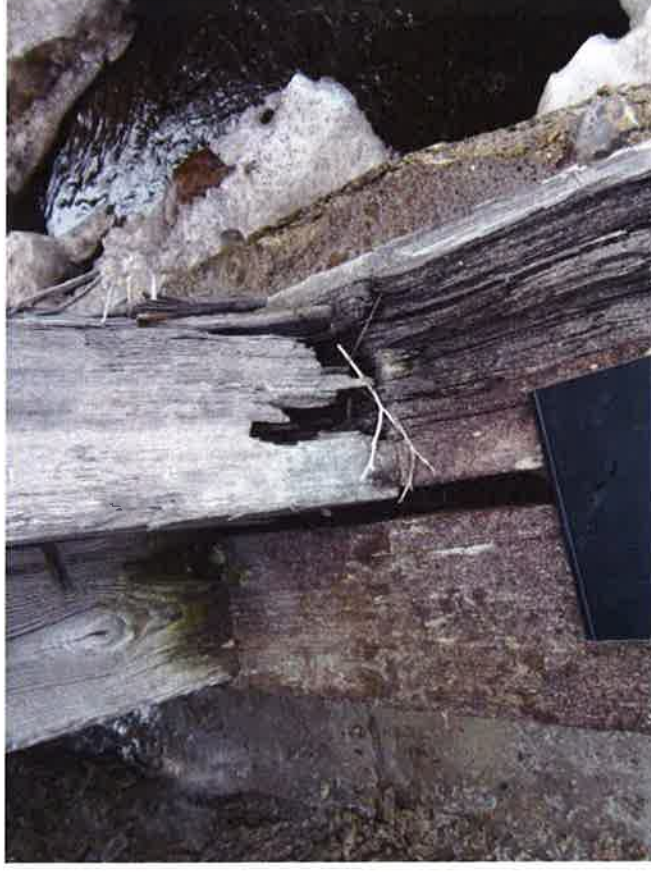
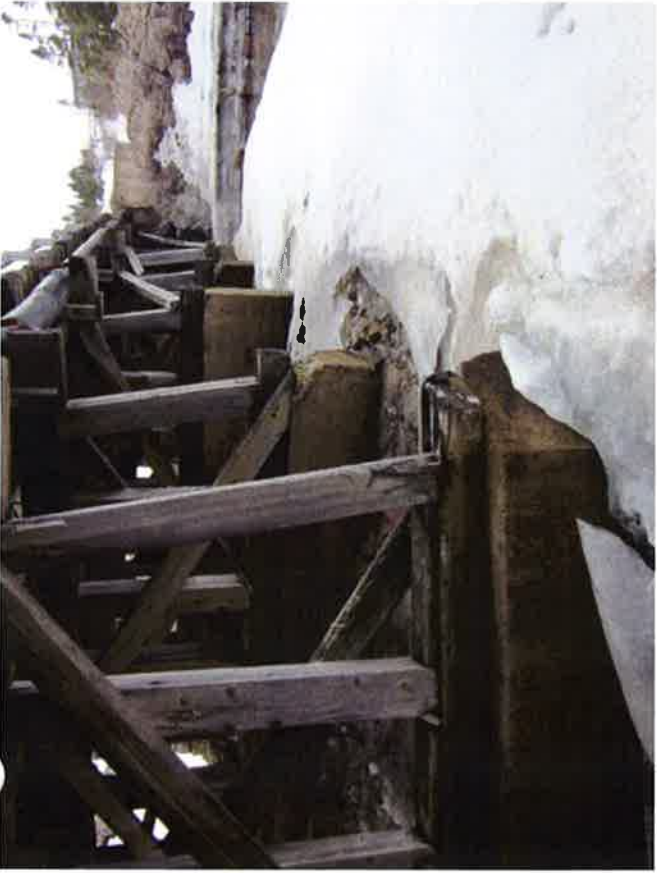
The timber frames below appeared to be in relatively good condition, with a few exceptions. One angled post was missing from the second-most easterly frame. There were also several end posts and bottom beams that showed some level of damage due to weathering and/or rot. Photos 10 to 13 depict this damage. There are also some longitudinal braces on the outside of the frames that have broken off as seen in Photo 14.

The outside, angled posts that have sustained damage at their base should be replaced with a section of equal dimension and grade. The inside posts appear to be acceptable from a visual inspection, however it is recommended that a representative sample of cores be taken to ensure they have not sustained damage due to rot within their cross section.

Any places where bracing or posts have been damaged or broken off will need to be replaced with sections of equal dimension and grade.
