Inspection Report- Buchans Penstock Bridge

**Department of Environment and Conservation
Inspection Report – Buchans Penstock Bridge
DOEC Project #734.302.5
Buchans, NL
Jan 25, 2013**

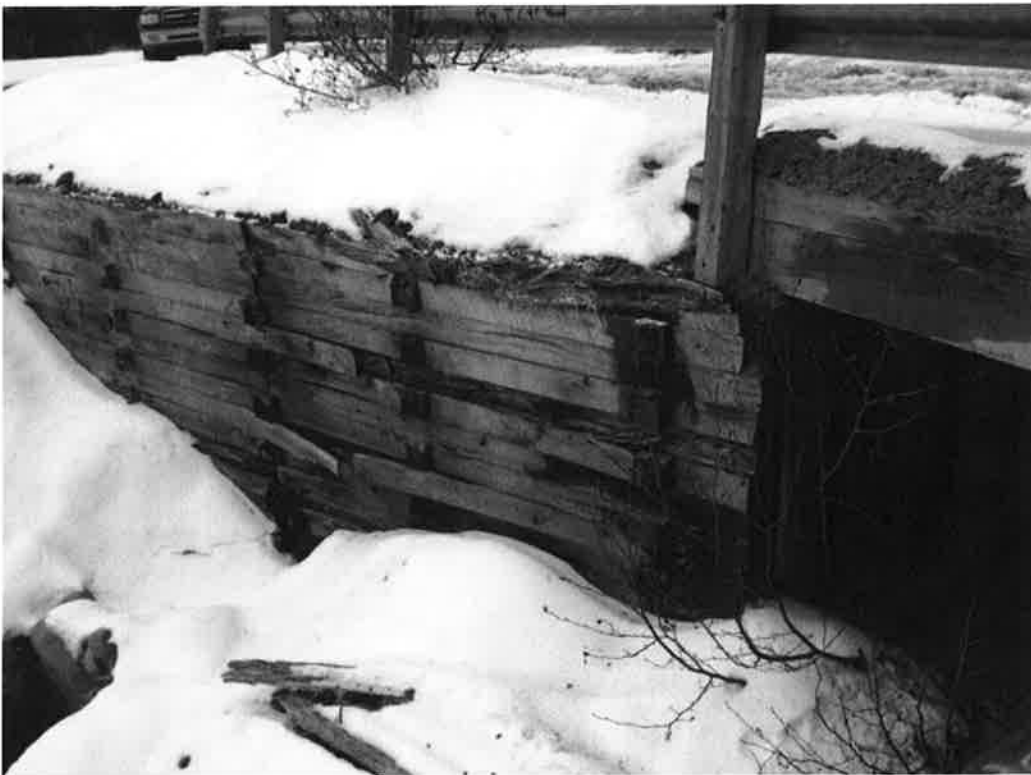
The piles and pile caps were all in good condition with no signs of damage or deterioration. The timber cribs forming the abutments had some timbers that had delaminated surfaces, but generally were not of concern structurally.

South East Wing Wall - Delamination

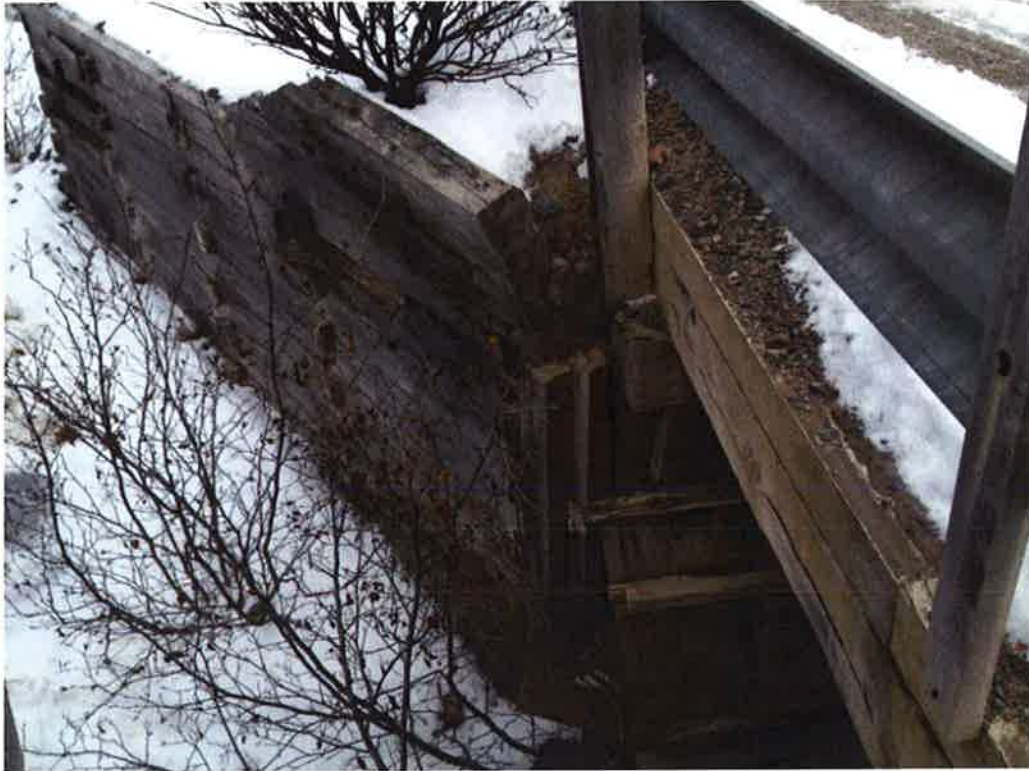
North West Wing Wall - Some Deformation at Top

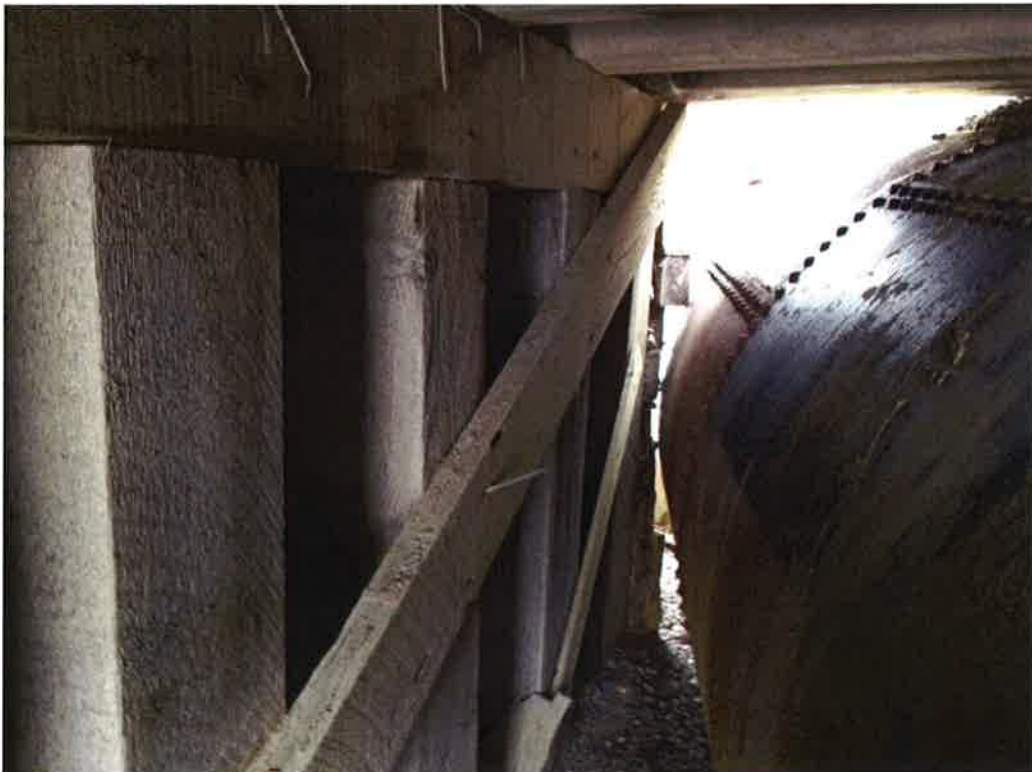
South Abutment Piles and Pile Cap

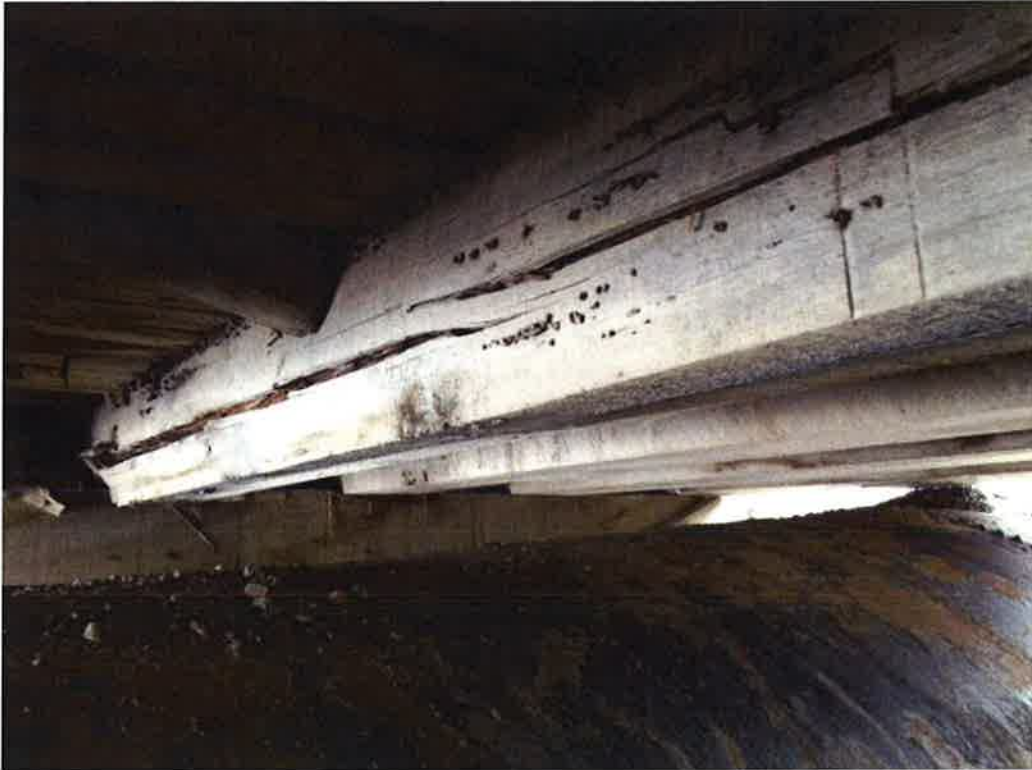
The 10x10 timber beams showed visible signs of overloading at some point as there are longitudinal splits in Beams #1, 4, 6, and 8. Beam #4 in particular was badly deteriorated and had failed in bearing and/or shear at both ends. Beam #6 was split near the centre of the span from apparent flexural failure.

Longitudinal Damage to Beam 4

Given that the timber beams have insufficient capacity to resist the design vehicle loading in new condition and that some of them have sustained significant damage, it is recommended to remove the middle four existing timbers and replace them with steel beams. These four timbers are the primary load bearing timbers for vehicle loads.

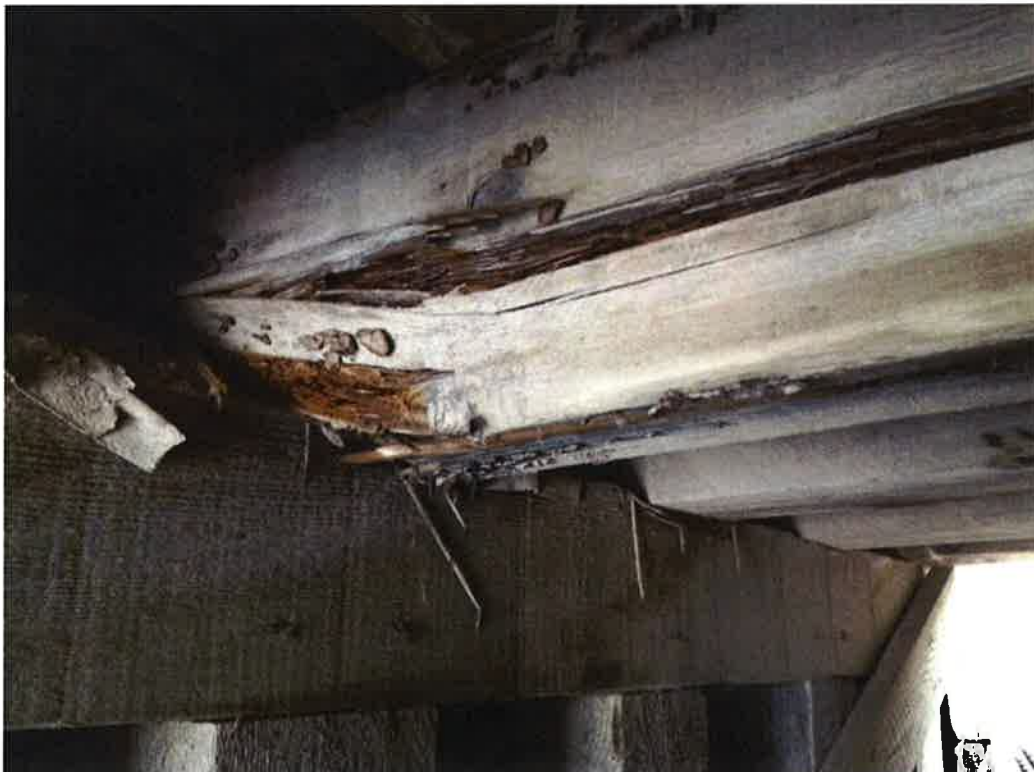
Bearing and Shear Damage to Beam 4 - South End

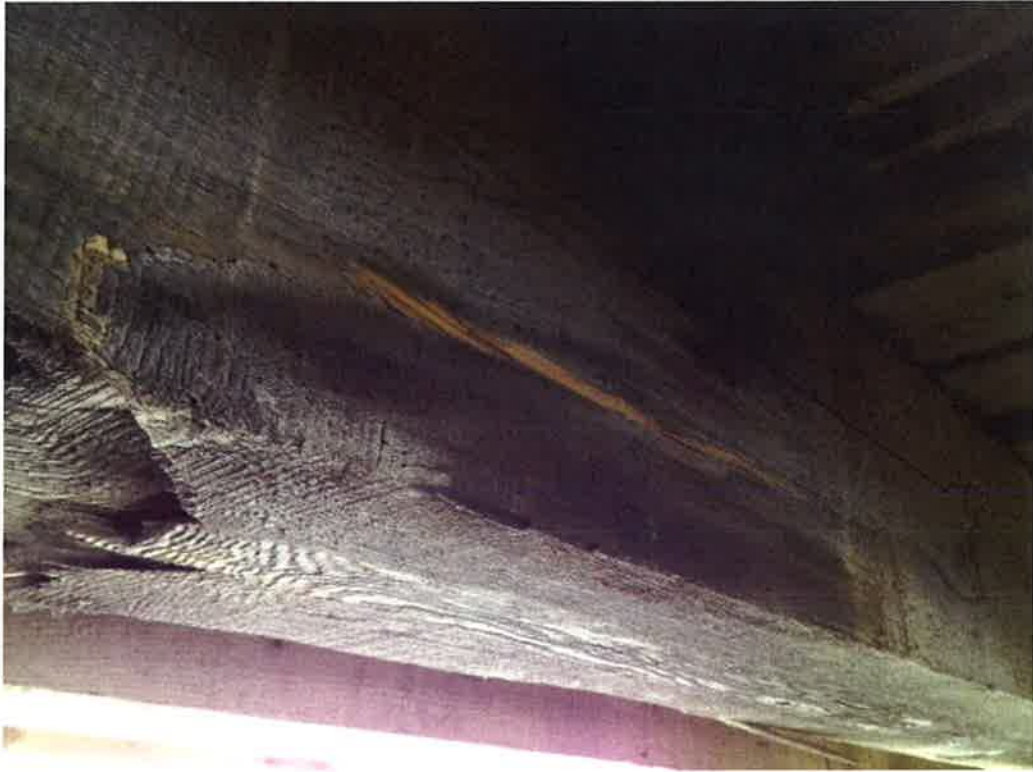
Longitudinal Damage to Beam 6 - Near Mid-Span

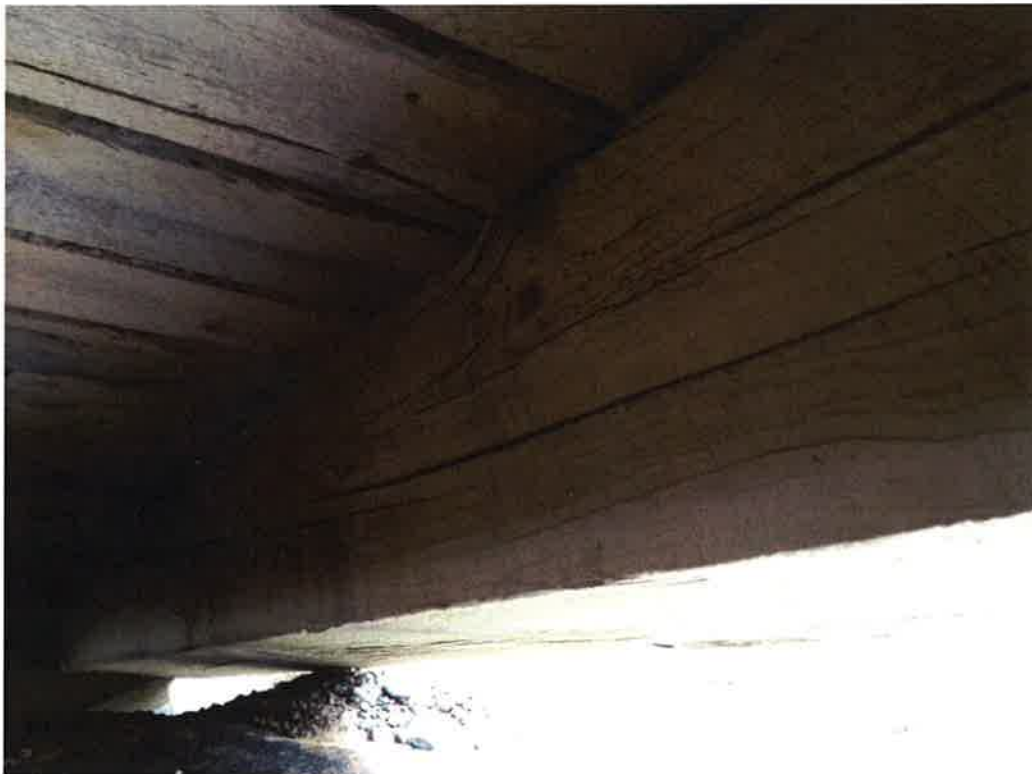
Longitudinal Splitting of End Beams
