July 9, 2009

TF9169801

**Re: Soil Remediation Program – Final Report
United Rentals Diesel Generator Spill, Butter Pot Provincial Park
Trans Canada Highway, Newfoundland and Labrador**

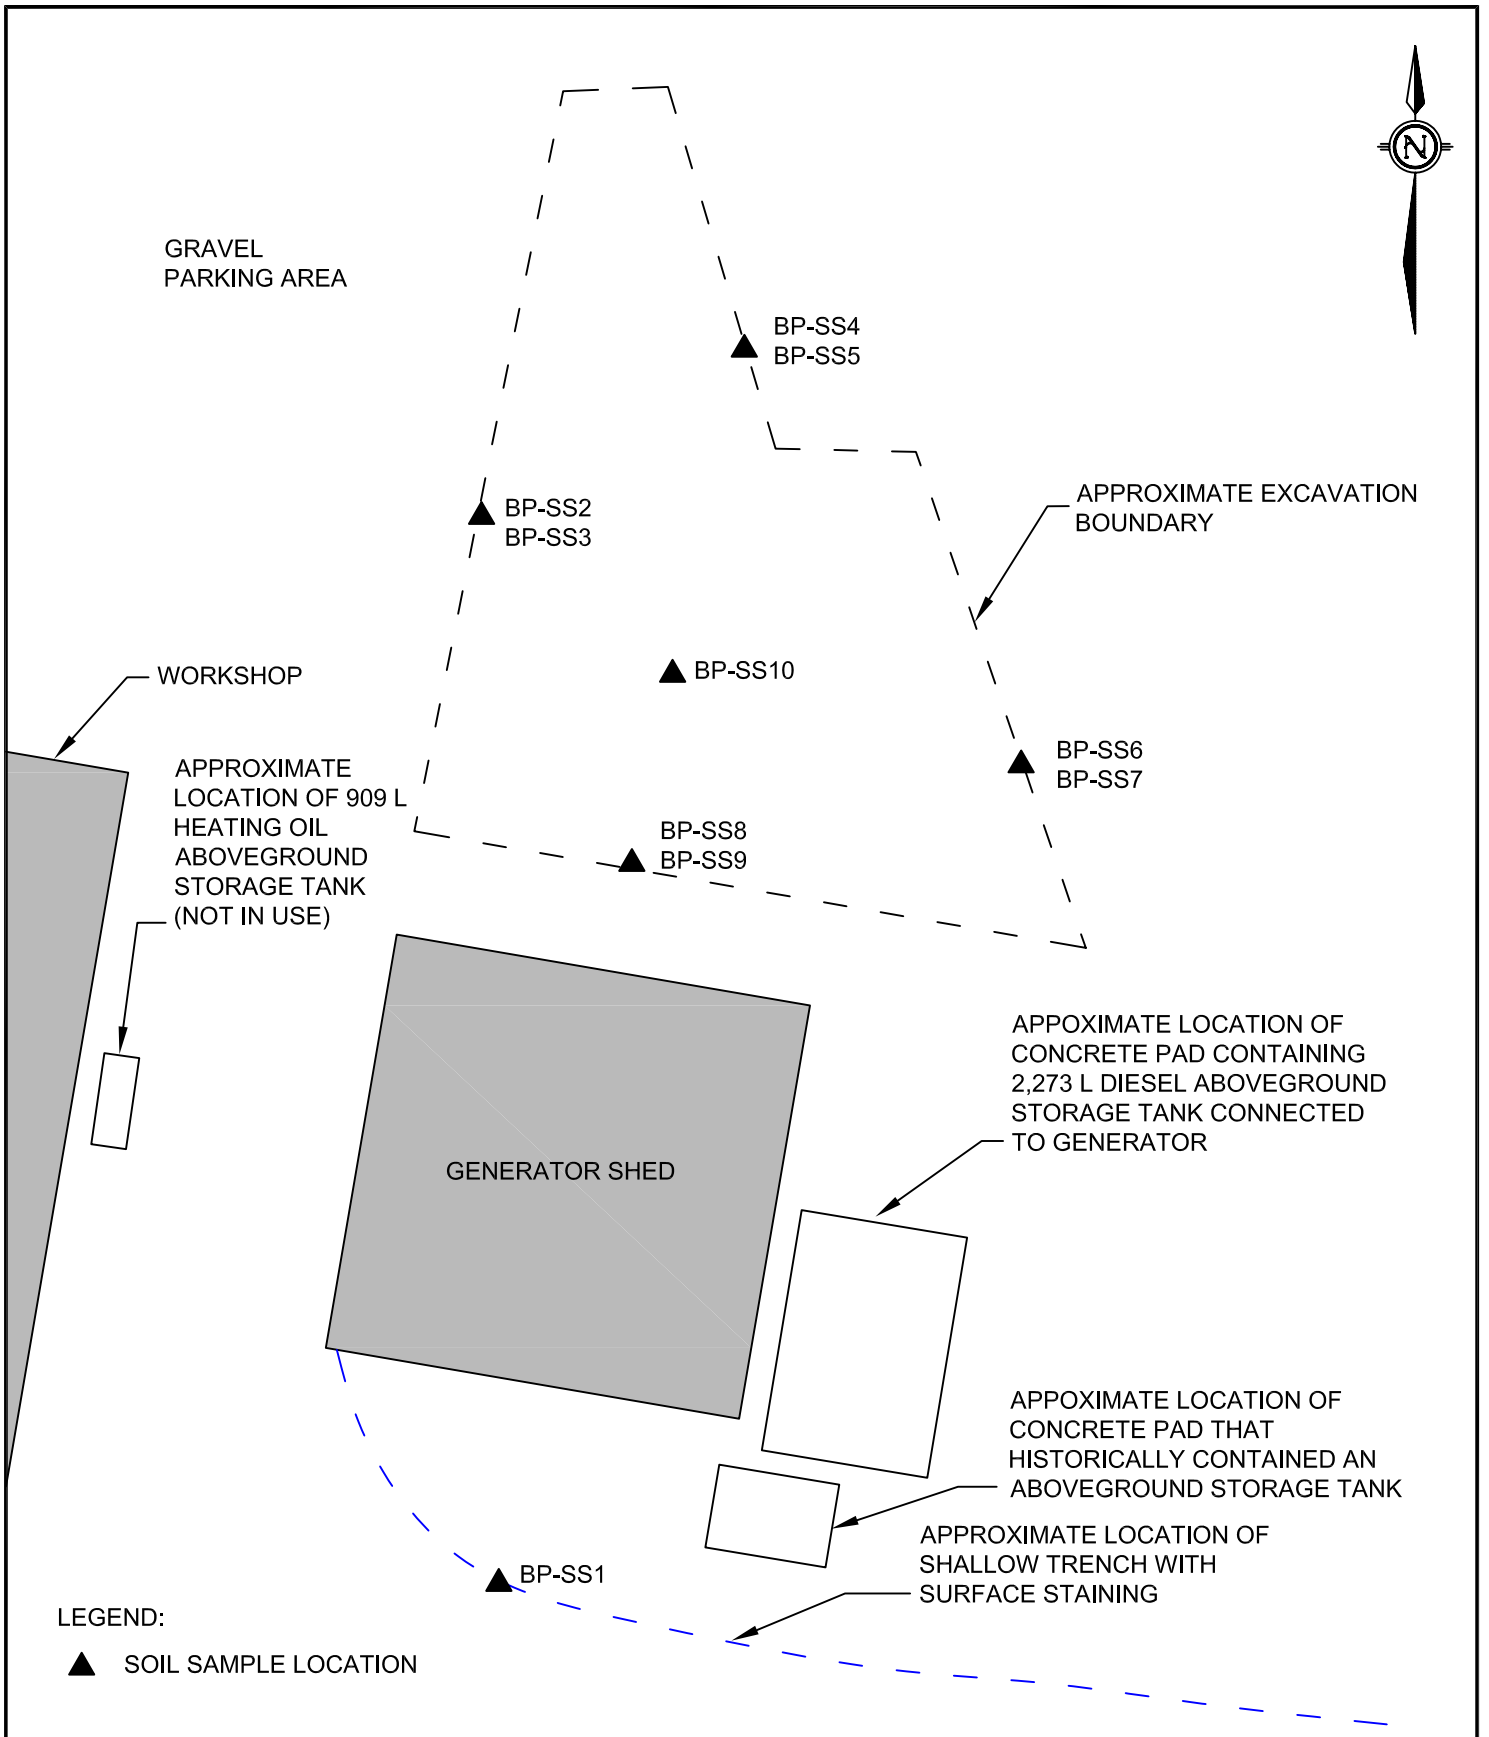
Date:	Project:		
	June 2009	SOIL REMEDIATION PROGRAM - UNITED RENTALS DIESEL GENERATOR SPILL, BUTTER POT PARK, NL		
ENVIRONMENTAL MANAGEMENT INC.	Drawn by:	Title:		
	C. Taylor	DETAILED SITE AND SAMPLE LOCATION PLAN		
	Approved by:	Scale:	Project No.:	Figure No.:
	L. Wiseman	NTS	TF9169801	2

Hydrocarbon odours were noted on the soil samples collected from the west wall, east wall, south wall and floor of the excavation at depths ranging from of 0.5 m to 1.8 m bgs. A hydrocarbon odour was also noted on the soil sample collected from the trench on the south side of the generator shed. SVH screening results for soil samples collected at the Site ranged from 11.1 parts per million (ppm) (BP-SS4) to 628.8 ppm (BP-SS7). Free phase petroleum hydrocarbon product was not encountered at any of the sampling locations within the remedial excavation or trench. The soil sampling locations are provided in Figure 2, Appendix A.

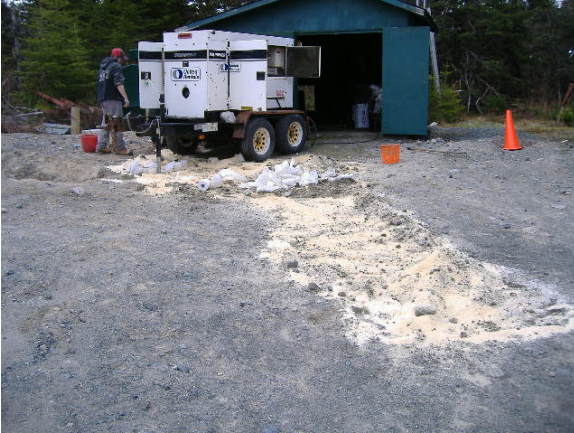
According to the Park Manager, a portable diesel generator was rented from United Rentals on May 15, 2009 for use at the park over the Victoria holiday weekend. The portable generator was placed on the north side of the generator shed, in close proximity to the shed door, and was connected to the 2,273 L diesel AST. A leak from the United Rentals generator was reportedly discovered on May 18, 2009 by park staff. The fuel supply and generator were immediately shut-off and the leak was reported to United Rentals. A local company that routinely services the park owned generator was called to the Site to assist with stopping the leak. Upon inspection, it appeared that a crack had formed in the fuel filter inside the generator casing causing diesel fuel to spray out of the generator casing, under pressure, onto the ground surface underneath the generator. According to the Park Manager, it was estimated that approximately 100 L to 150 L of diesel oil may have leaked from the generator before the fuel filter was replaced and the leak was stopped. Park staff attempted to absorb and contain the spilled diesel oil using several rolls of toilet paper, approximately 250 lb of sawdust and 12 bags of spill absorbent material (refer to Photo 11, Appendix B). The surface soil within the spill area was reported to have been hand excavated by park staff with shovels and mixed with sawdust and absorbent material. According to the Park Manager, some of the mixed soil and sawdust/absorbent material was burned in the gravel parking area and some was placed in garbage bags and stored on-Site (refer to Photos 12 and 13, Appendix B).

Photo 11: View of the diesel generator spill area (photo source: Keith Brown).

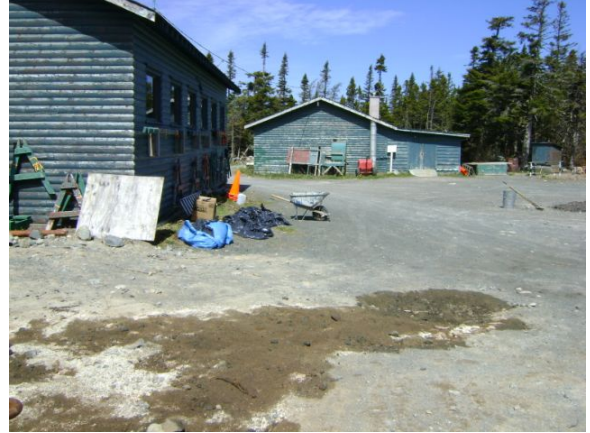
Photo 12: View of the diesel generator spill area and garbage bags containing impacted soil.

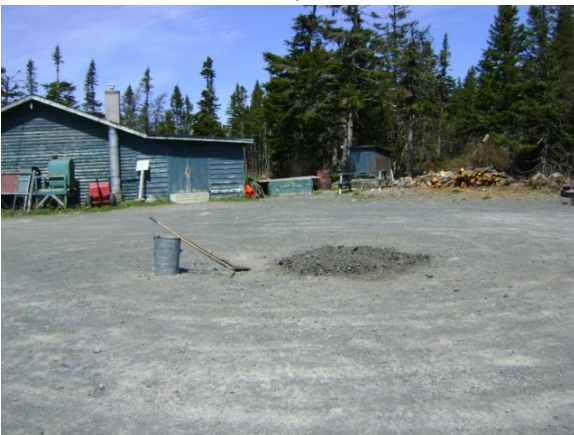
Photo 13: View of location where impacted soil/sawdust excavated from the diesel spill was burned.

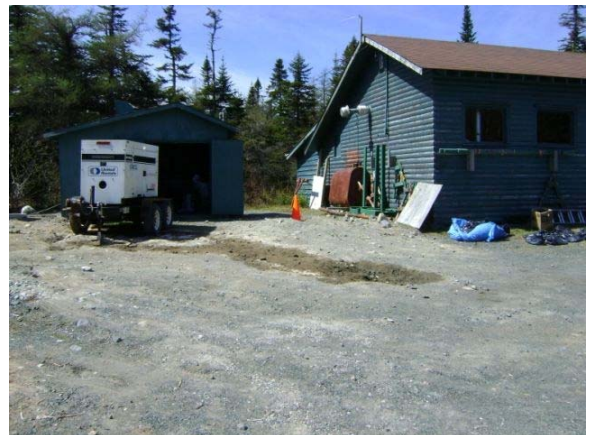
At the request of EMI, a representative of AMEC's St. John's office, conducted a visual inspection of the diesel spill area. During the inspection, an area of surface staining, measuring approximately 7 m long by 3 m wide, was observed on the north side of the generator shed, near the United Rentals generator (refer to Photo 14, Appendix B). Strong petroleum hydrocarbon odours were noted within the general area of the spill. Surface staining was also observed on the south side of the generator shed along a shallow trench and on the south exterior wall of the shed (refer to Photo 15, Appendix B). According to the Park Manager, the shallow trench was excavated in the Fall of 2008 for the purpose of installing electrical cables to the groomer storage shed. The surface staining in the trench was reportedly identified at that time and the electrical cable installation was not completed. The Park Manager indicated that the surface staining on the south side of the shed may have been the result of past practices of handling and dumping of waste oil from the park generator in this area of the Site. AMEC observed some used oil filters on the ground surface near the trench which appeared to be consistent with these reported practices. Surface staining was also observed on the concrete floor of the generator shed and there were uncovered containers of oil stored inside the shed at the time of the Site inspection (refer to Photo 16, Appendix B).

Photo 14: View of the location of the United Rentals diesel generator and the area of surface staining.

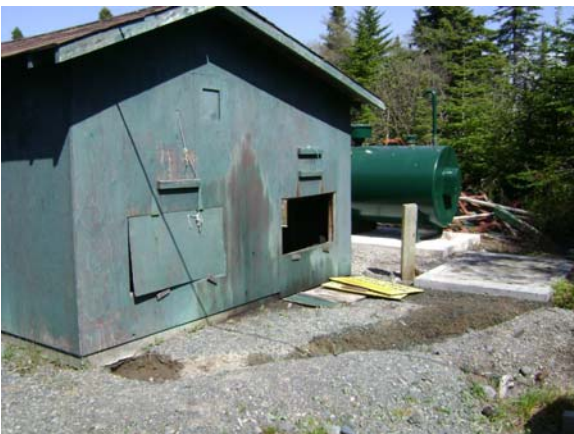
Photo 15: View of the area of surface staining on the south side of the generator shed.

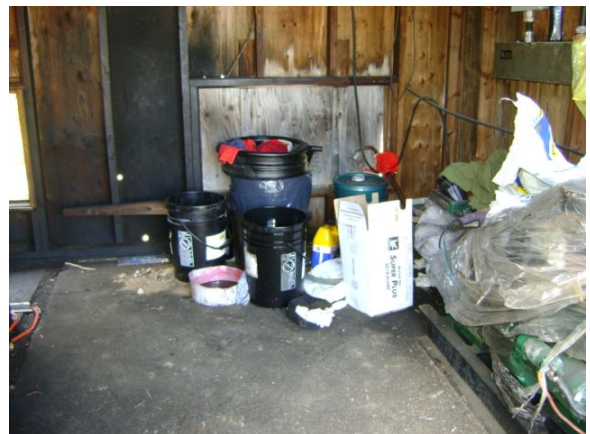
Photo 16: View of oil storage containers and staining on the concrete floor of the generator shed.

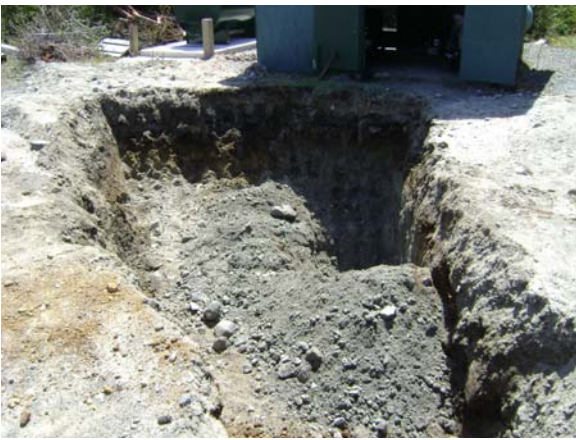
Photo 17: View of the soil conditions inside the remedial excavation.

Field measurements of the excavation area were recorded on May 22, 2009 following completion of the excavation activities. The excavation area measured approximately 28 m² with an average depth of 1.6 m bgs, for an approximate excavated soil volume of 45 m³ (i.e. approximately 90 metric tonnes) (refer to Photos 17 and 18, Appendix B). Upon completion of the SRP, the excavation was not backfilled with clean/imported fill, pending discussions with the EMI Project Manager and representatives of the GSC and the ENVC concerning the potential for further assessment and/or remediation at the Site. In the interim, wooden barricades and reflective snow fencing were installed around the boundaries of the excavation (refer to Photo 19, Appendix B).

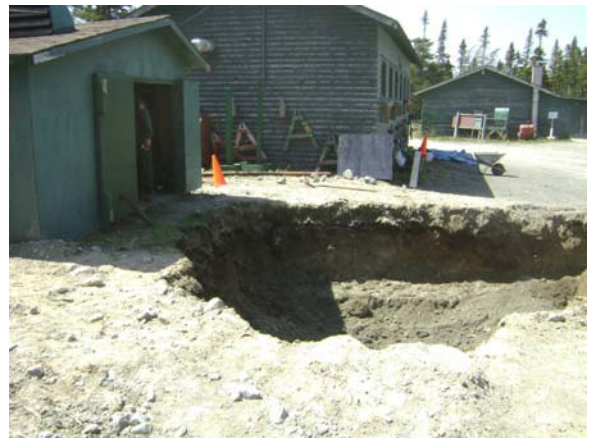
Photo 18: View of the remedial excavation on the north side of the generator shed.

Impacted soil was excavated from the diesel generator spill area down to bedrock at depths ranging from approximately 1.4 m below ground surface (bgs) to 2.0 m bgs. Based on the soil disposal documentation provided to AMEC by FEL, 87.82 metric tonnes (i.e. six tandem-dump truck loads) of petroleum hydrocarbon impacted soil were transported from the Site to NSI for treatment and disposal (refer to Appendix C).

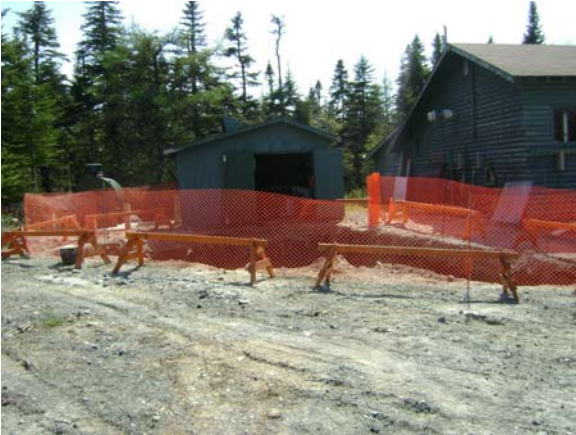
Photo 19: View of the barricades and snow fencing around the remedial excavation.

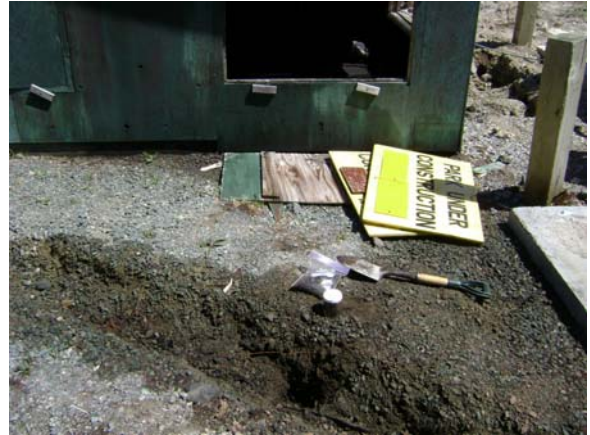
Photo 20: View of the soil sample location in the trench on the south side of the generator shed.
