## **FINAL REPORT**

### **COME BY CHANCE SECURE LANDFILL GROUNDWATER DRAINAGE SYSTEM**

March 2009

AMEC Reference No.: TF8112721

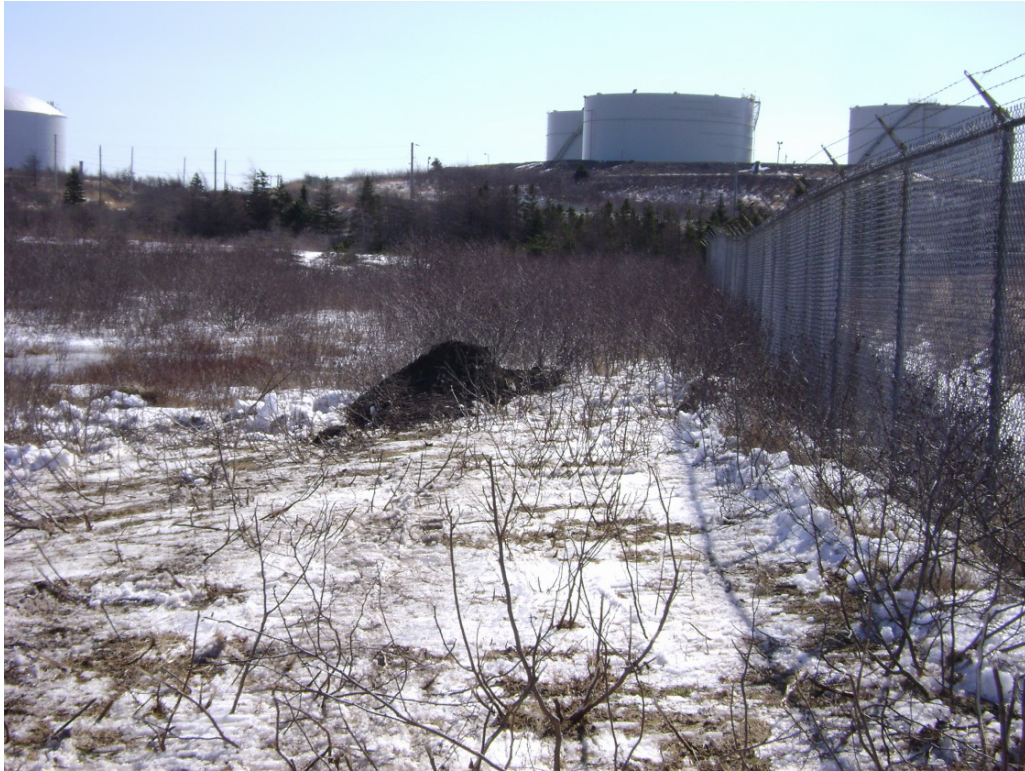
**Photo 1: Start Location of French Drain**

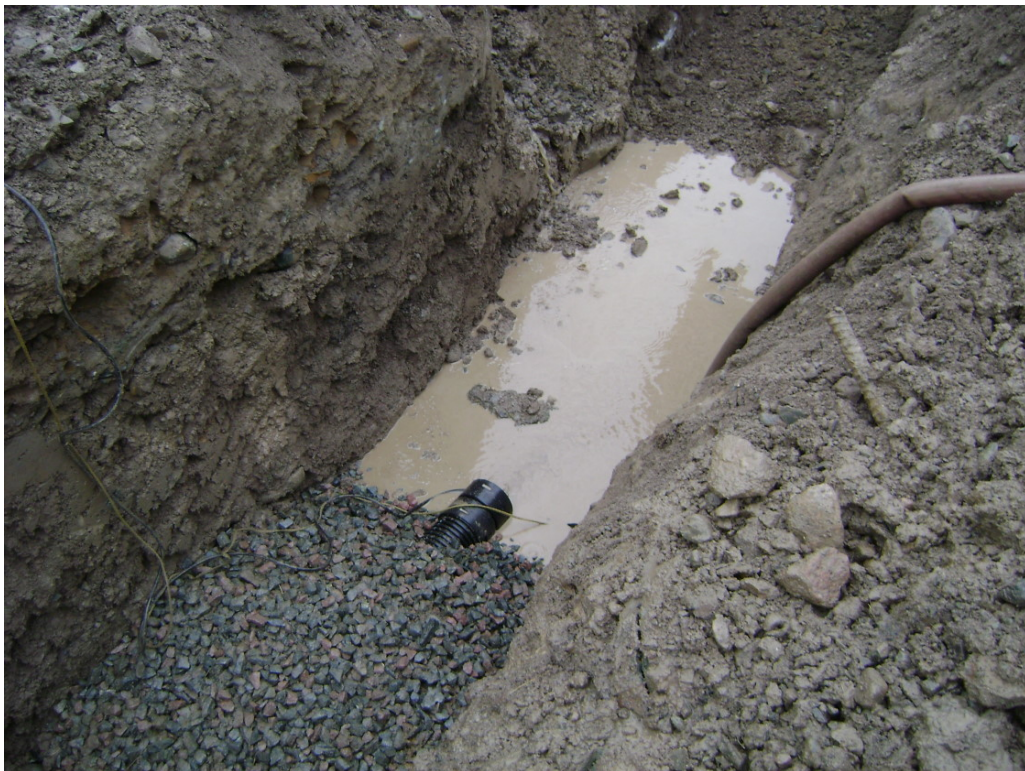
**Photo 2: Washed Stone Placed on Perforated Pipe – Typical**

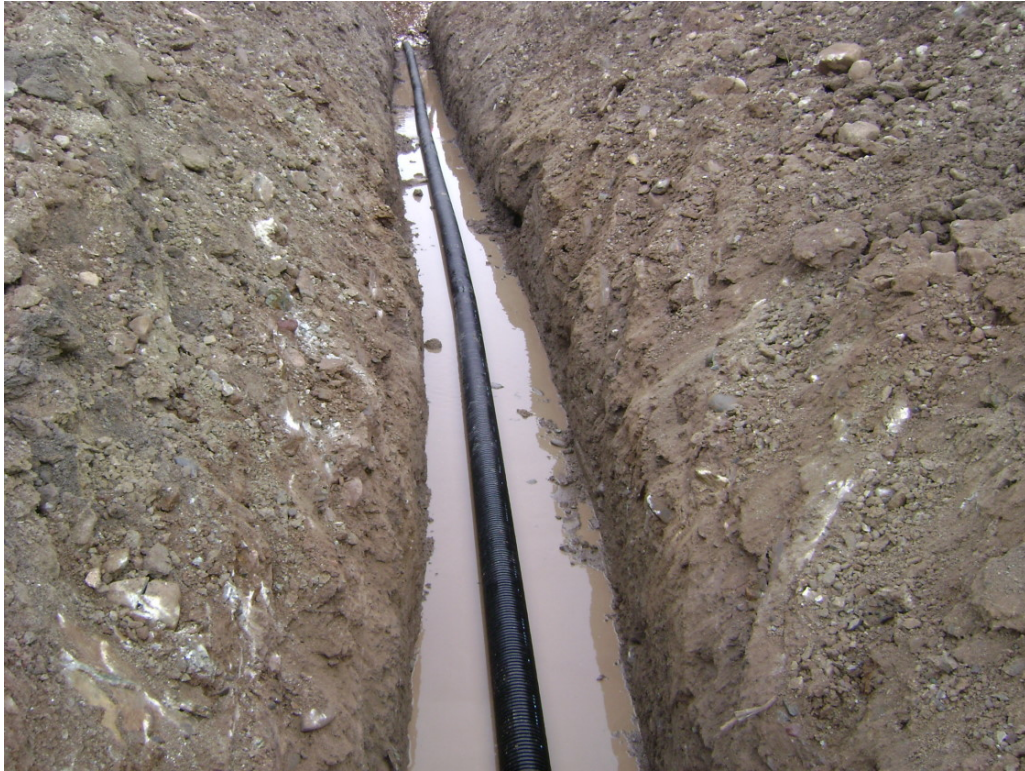
**Photo 3: Trenching for Pipe Placement – Typical**

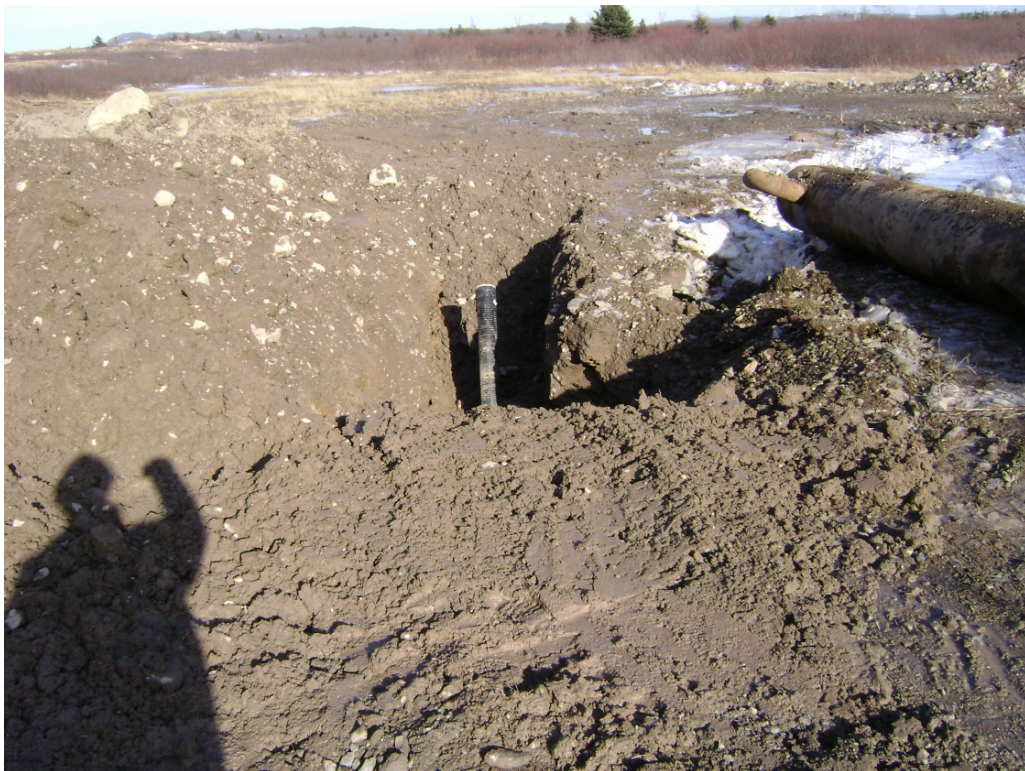
**Photo 4: Clean-Out - Typical**

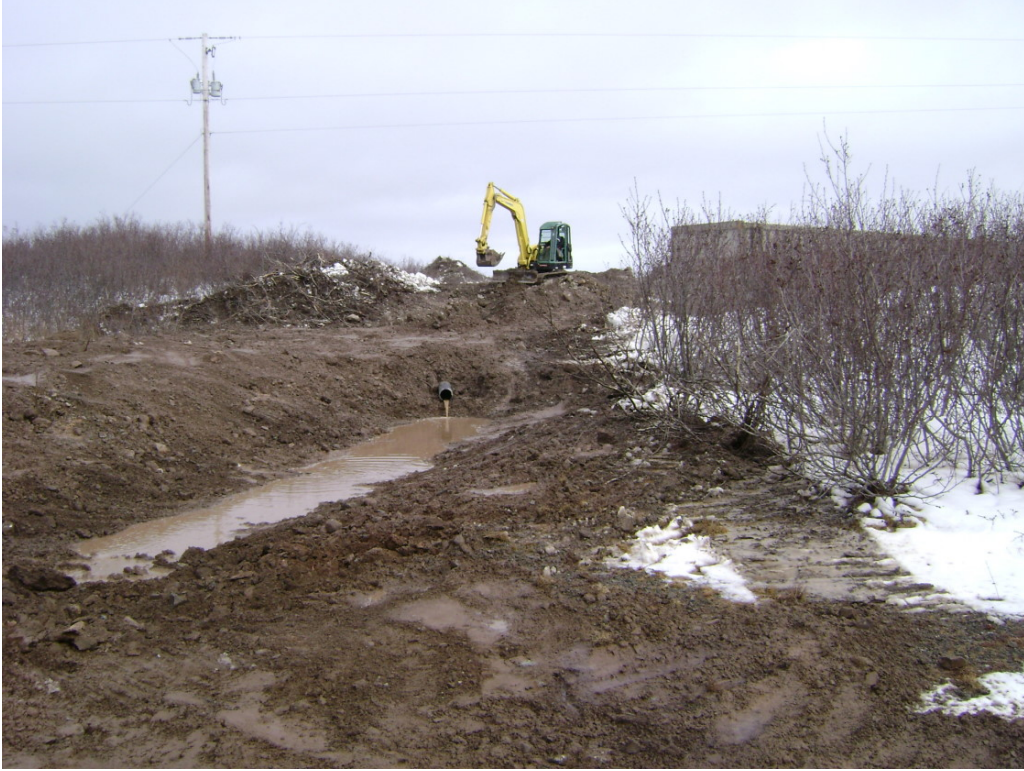
**Photo 5: Groundwater Drainage System Outlet – Prior to Rip-Rap Placement**

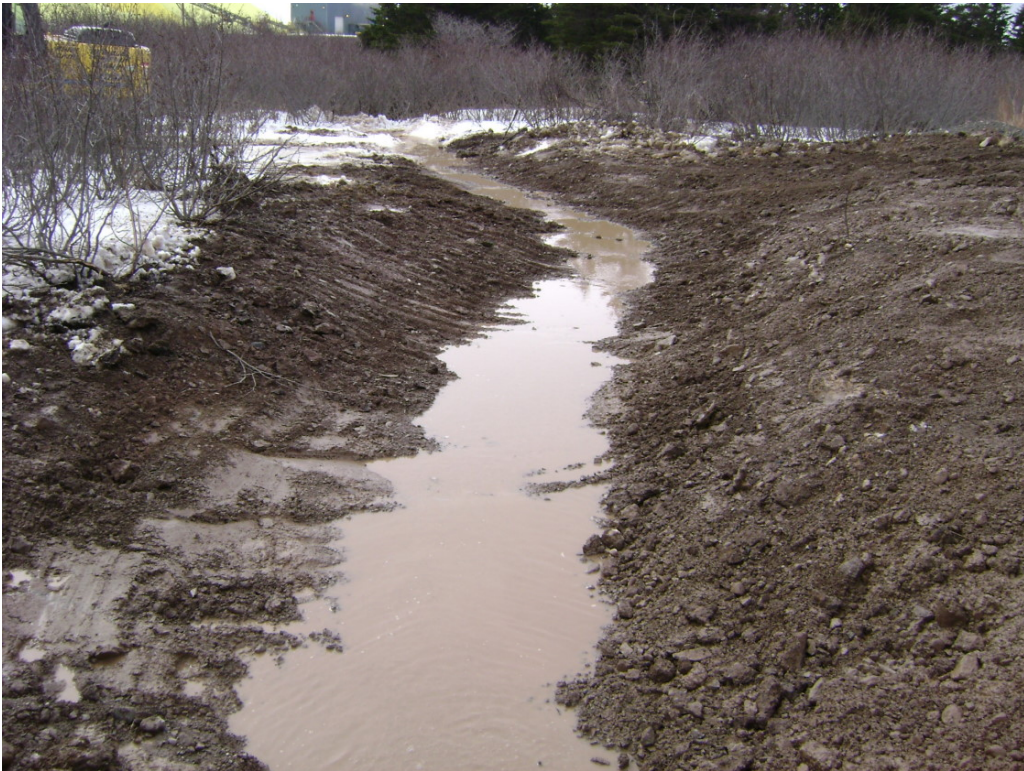
**Photo 6: Ditching at Outlet**

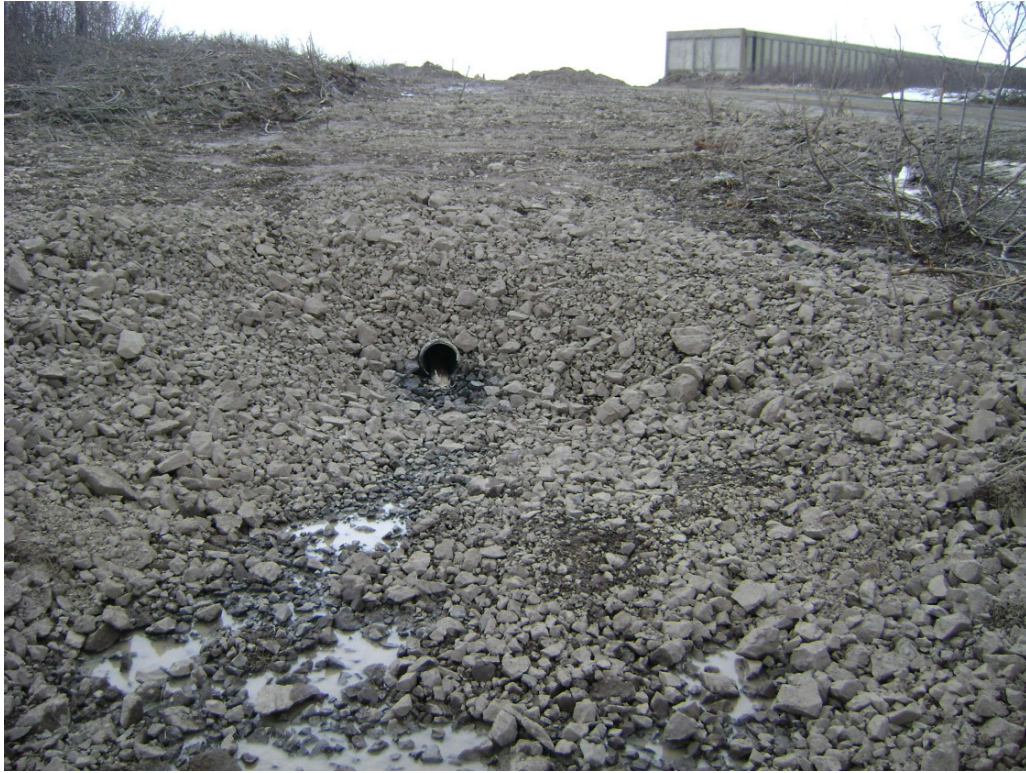
**Photo 7: Groundwater Drainage System Outlet – After Rip-Rap Placement**

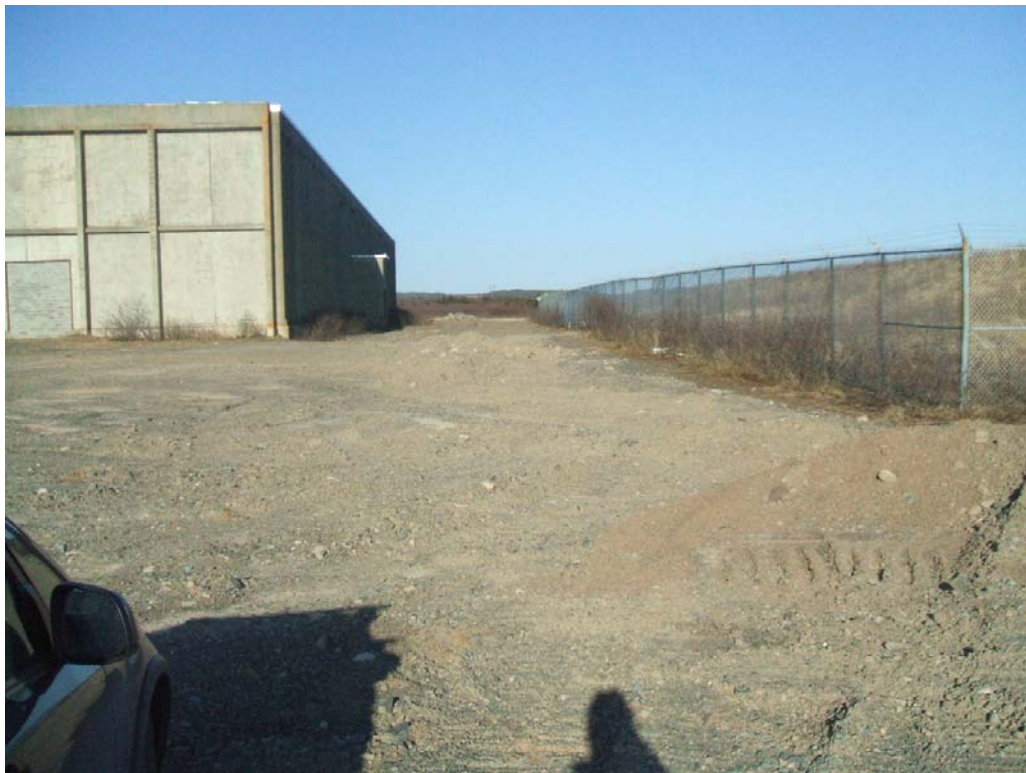
**Photo 8: French Drain Installed at North side of Landfill – Prior to Final Clean-up**

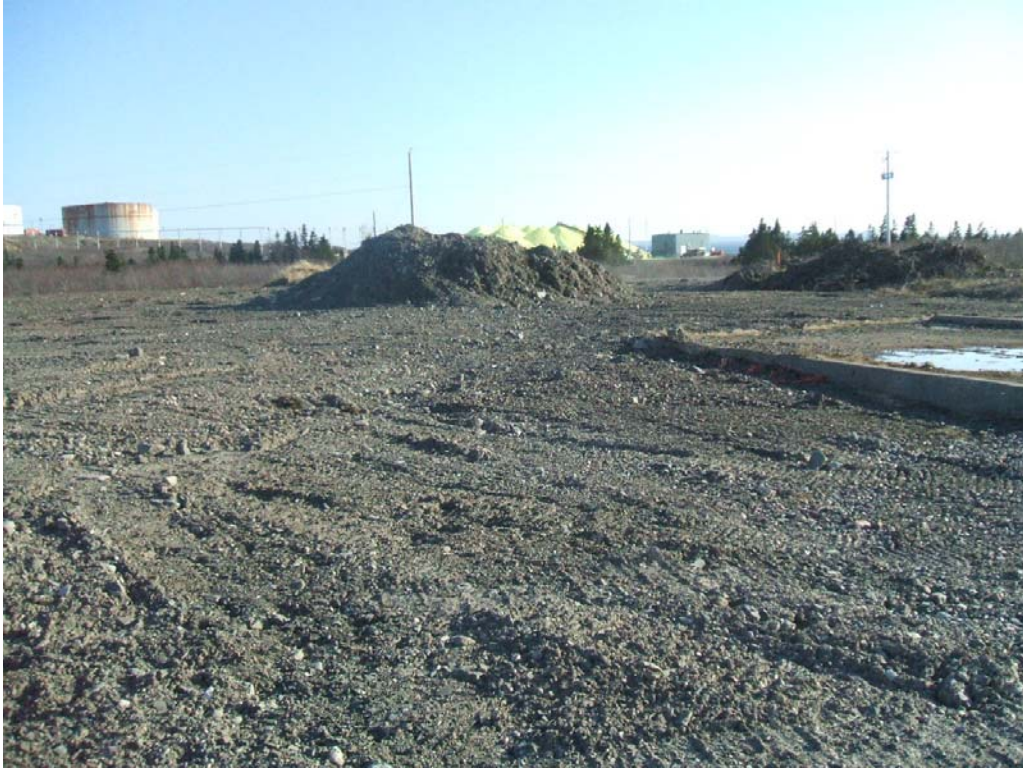
**Photo 9: Approximate Location of Storm Pipe Installation – Prior to Final Clean-up**
