Hazardous Building Materials Assessment

Marystown Shipyard
Marystown, NL

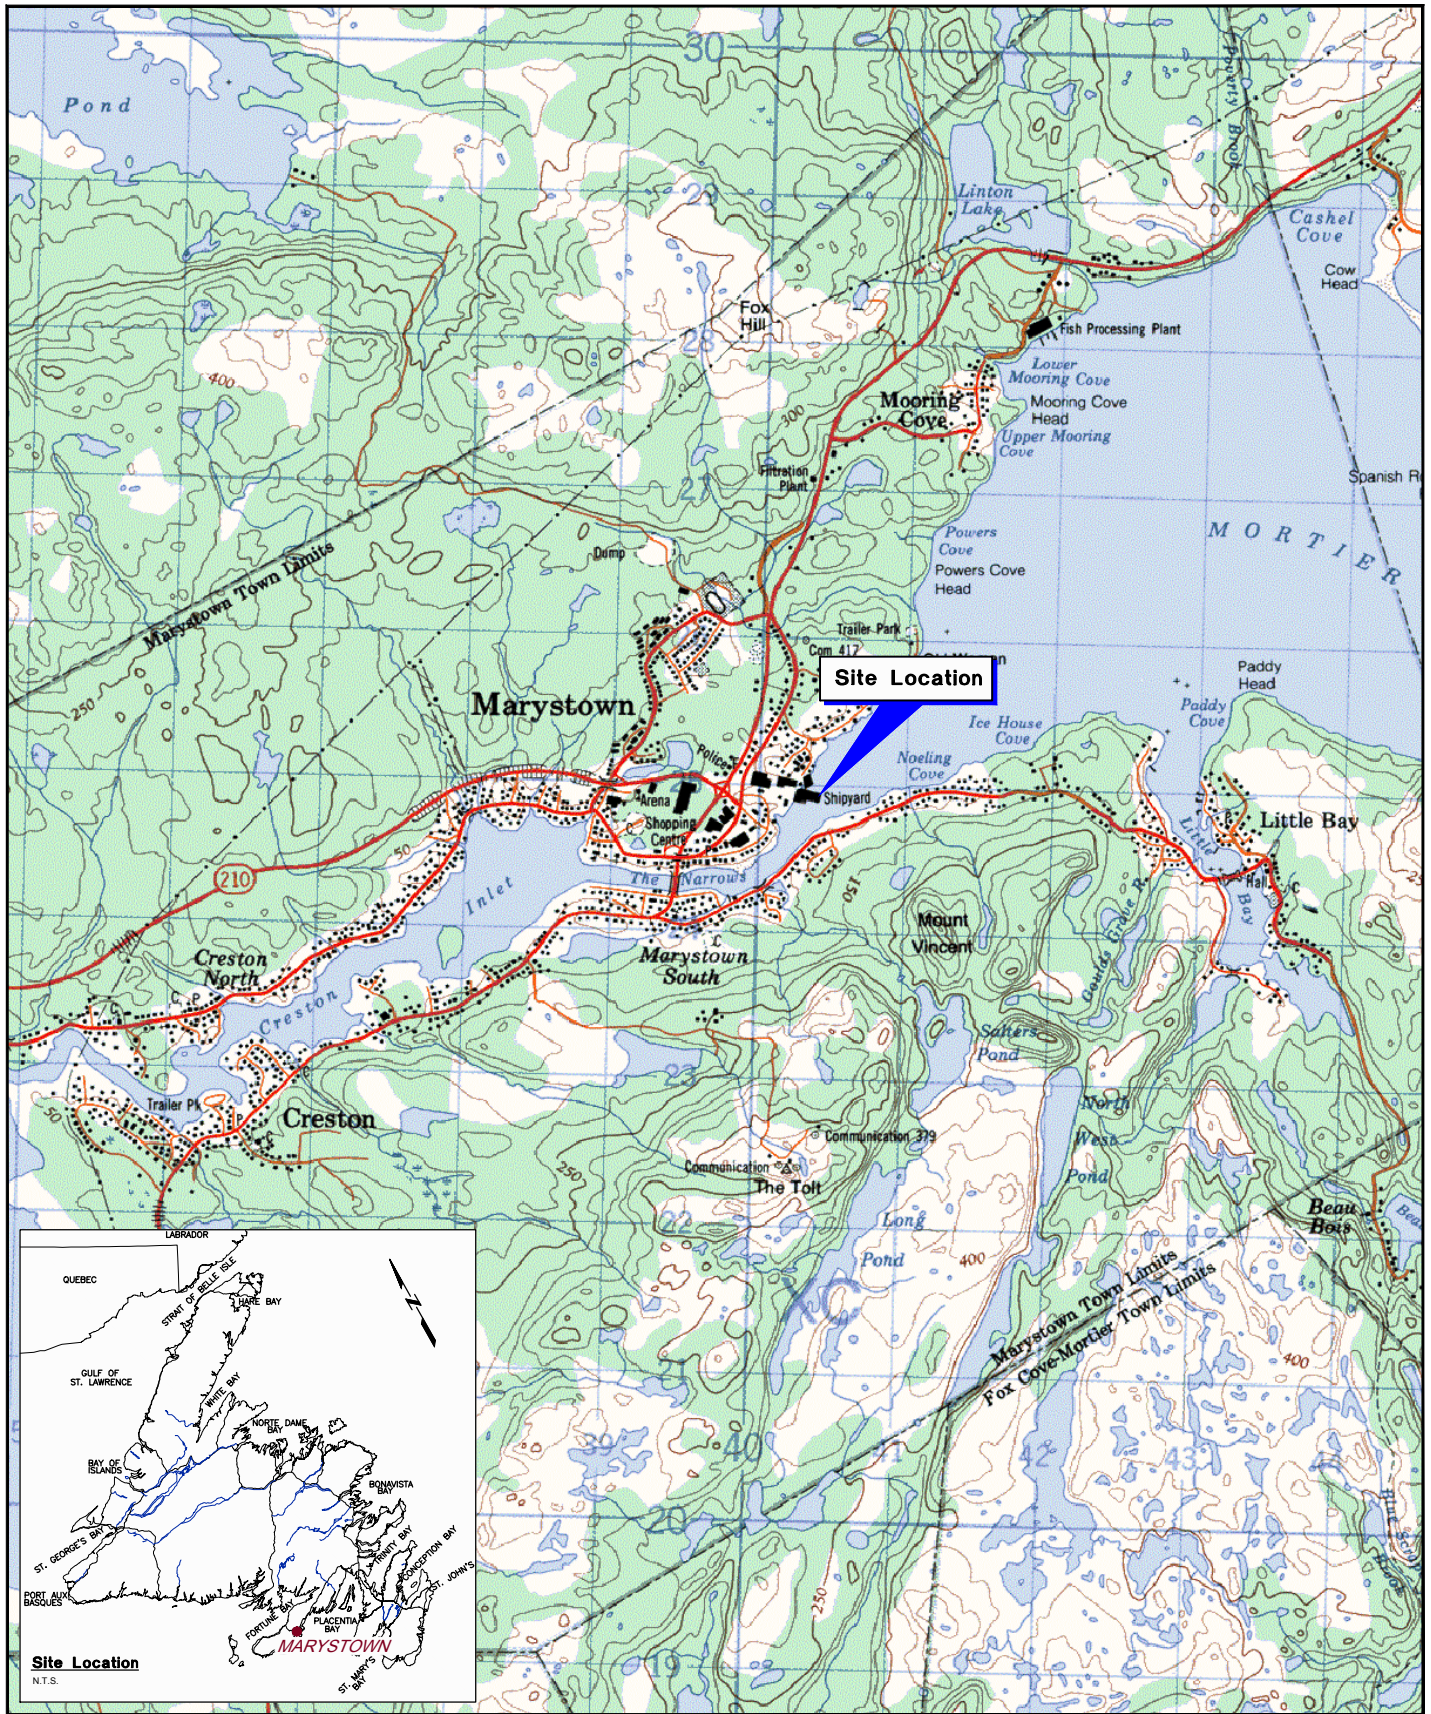
NL DEPARTMENT OF MUNICIPAL AFFAIRS AND ENVIRONMENT
 MARYSTOWN SHIPYARD, MARYSTOWN, NL
 HAZARDOUS BUILDING MATERIALS ASSESSMENT

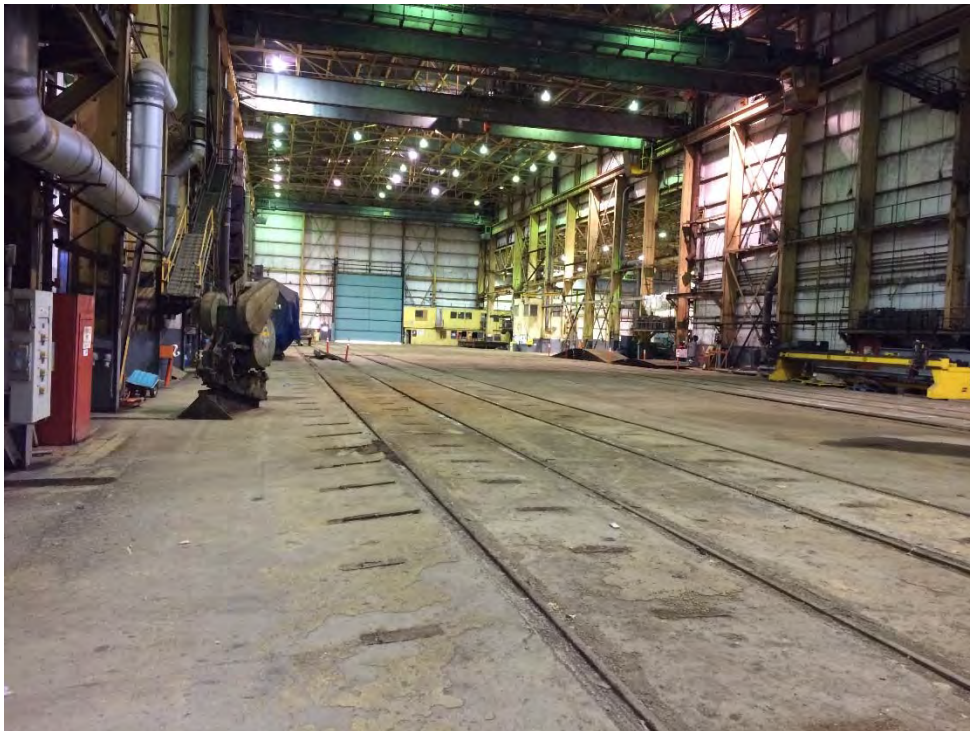
Photo 10: **Assembly & Erection Building** – Main Floor of erection and fabrication area where little to no paint flakes were noted on the floor or equipment.

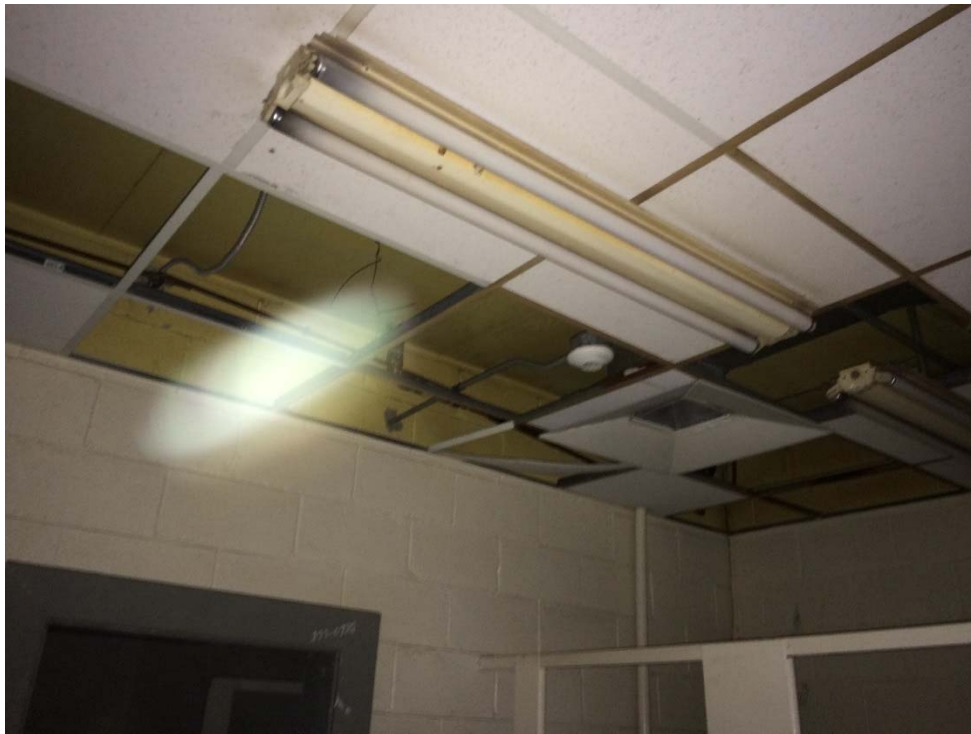
Photo 11: **Assembly & Erection Building** – Main Floor bathroom where **ceiling tile** was confirmed to have **no ACMs**; pipe insulation was not observed in the ceiling space.

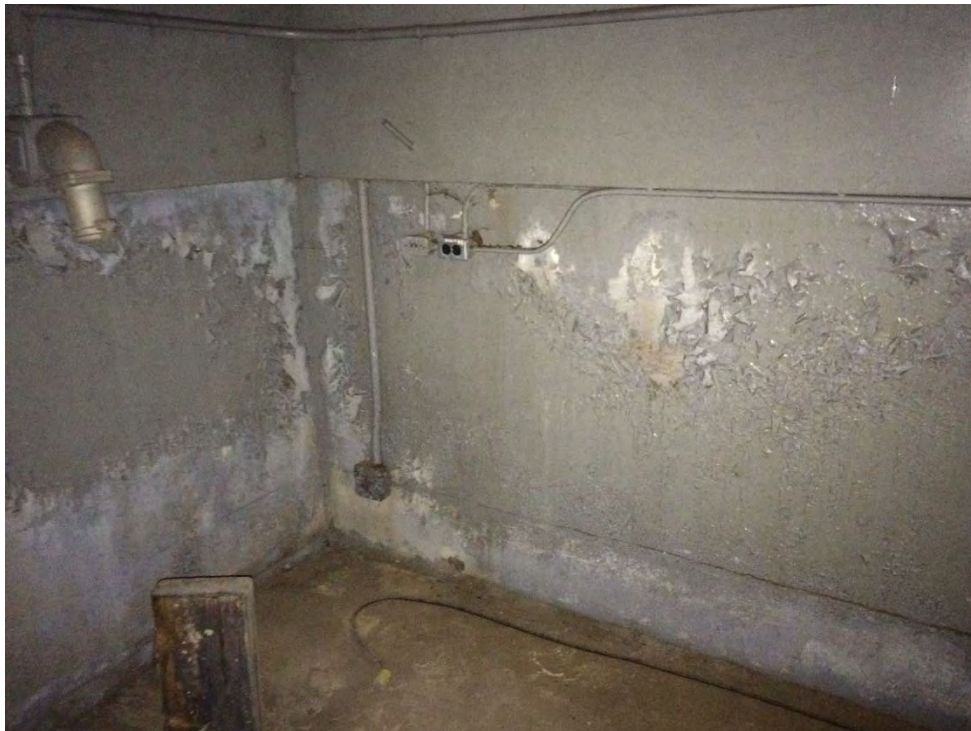
Photo 12: **Assembly & Erection Building** – Sheet Metal Shop walls where grey **paint** was confirmed to be **above Human Health** criterion and **below TDG** criterion.

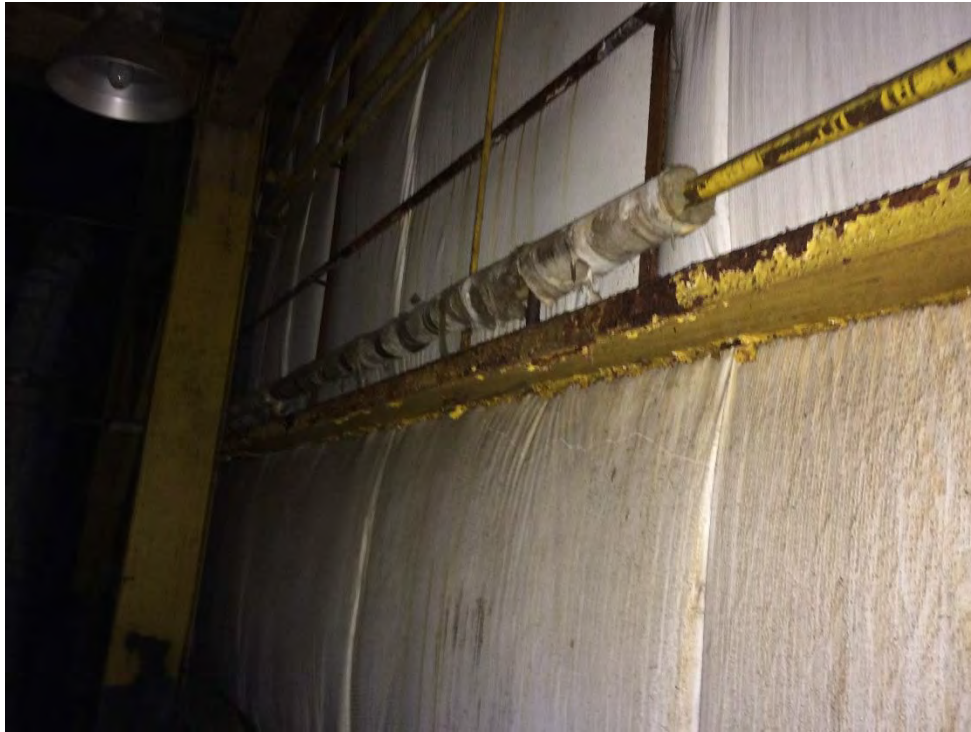
Photo 15: **Assembly & Erection Building** – Structural steel with occasional areas of peeling yellow **paint confirmed** to be lead-based. Also note **ACM pipe insulation** in poor condition.

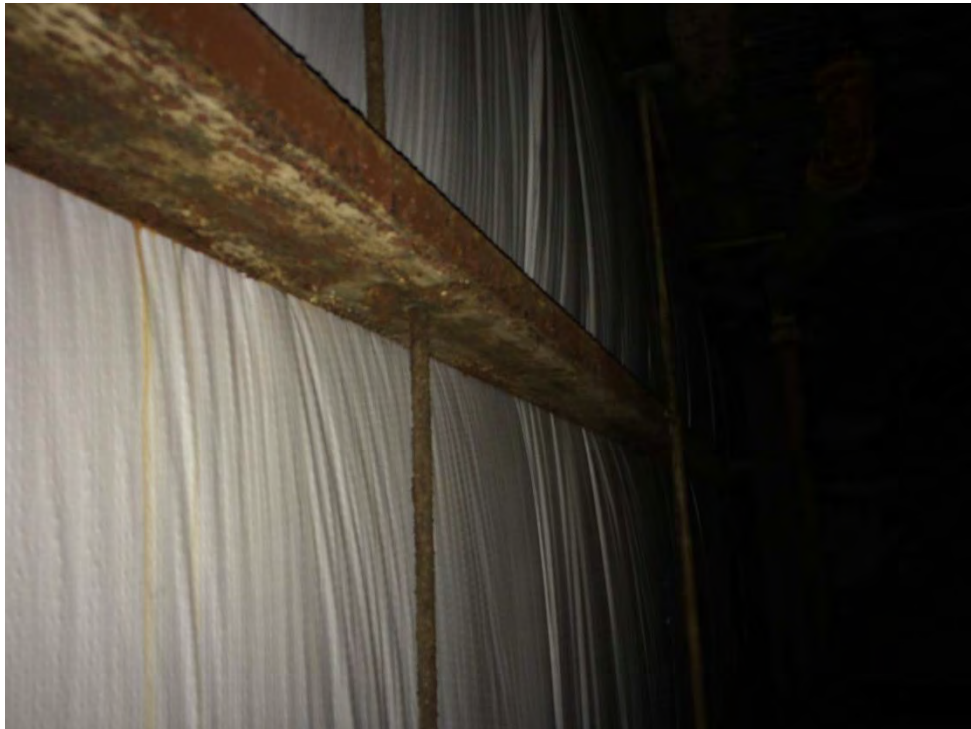
Photo 16: **Assembly & Erection Building** – Wheelabrator equipment area where small flaking was observed of black over cream over green **paint was confirmed** as lead-based.

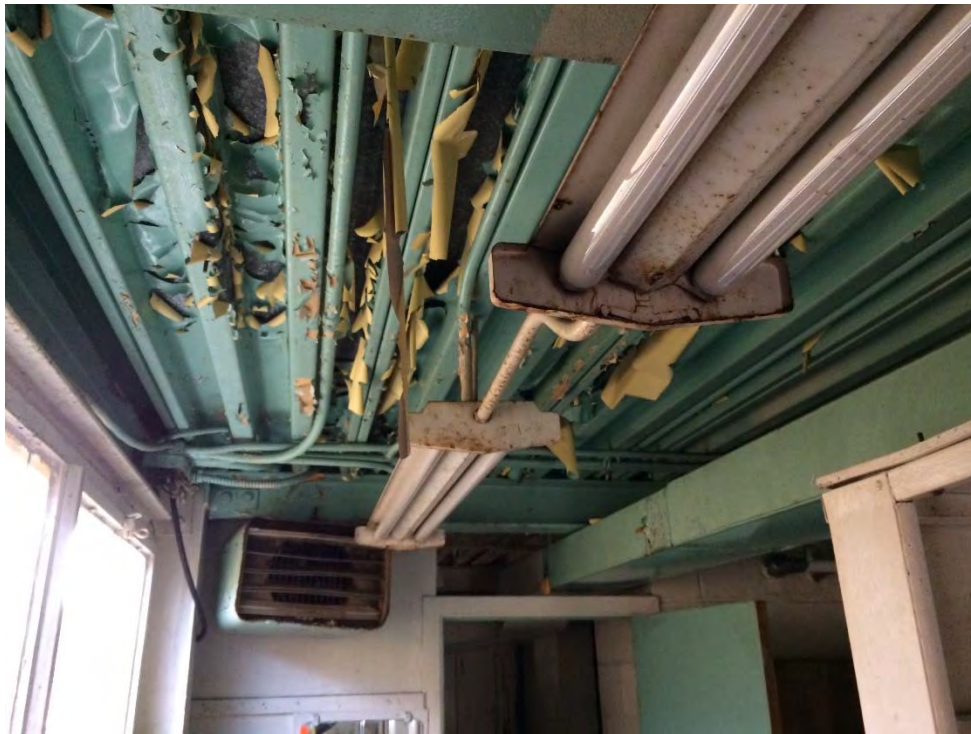
Photo 17: **Syncrolift Building** – Main Floor where peeling teal green over yellow paint was **confirmed** to be lead-based. ACM pipe insulation was not observed in the ceiling space.

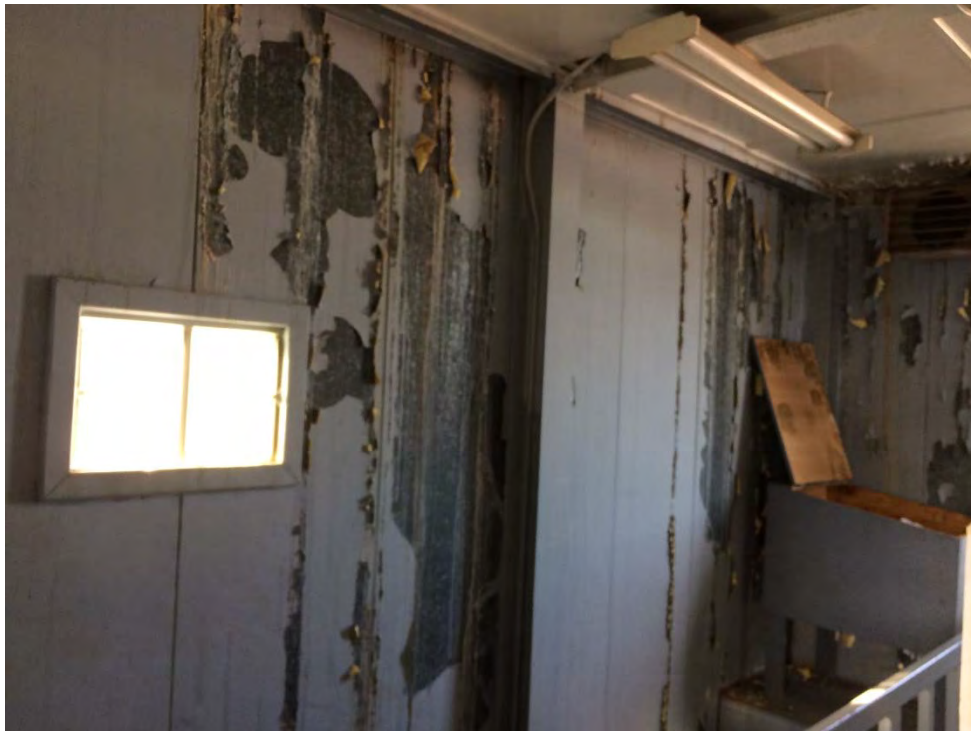
Photo 18: **Syncrolift Building** – Second Floor where peeling grey over green over yellow paint was **confirmed** to be **above Human Health** criterion and **below TDG** criterion. Vinyl floor tile and mastic were confirmed as ACM.

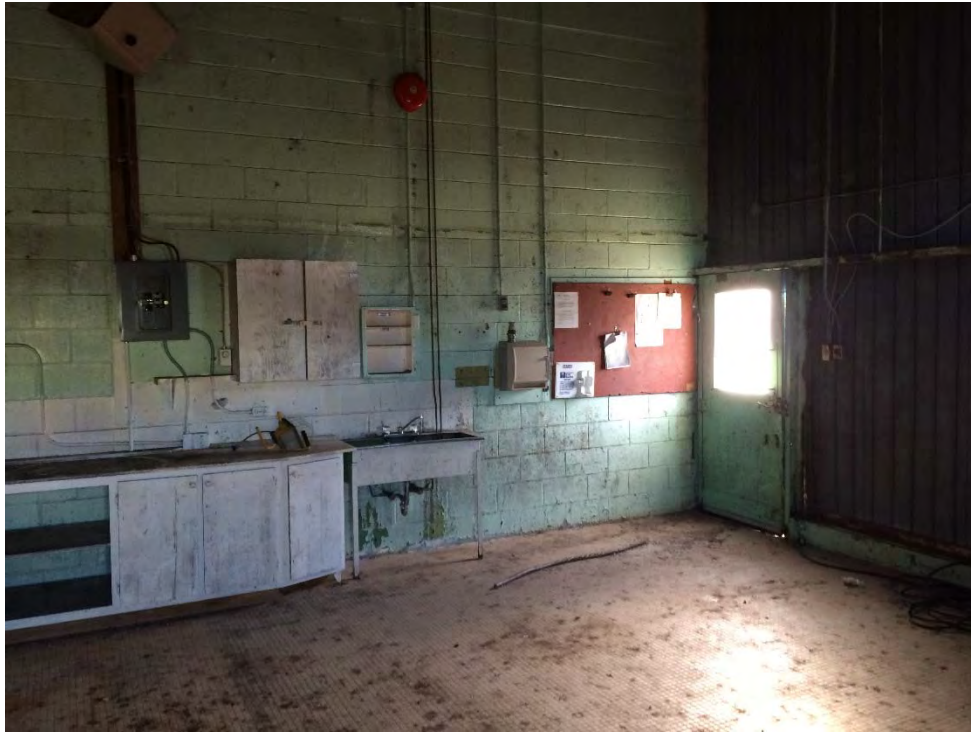
Photo 19: **Services Building** – Lunch Room where flaking or peeling paint or potential ACMs were not observed.

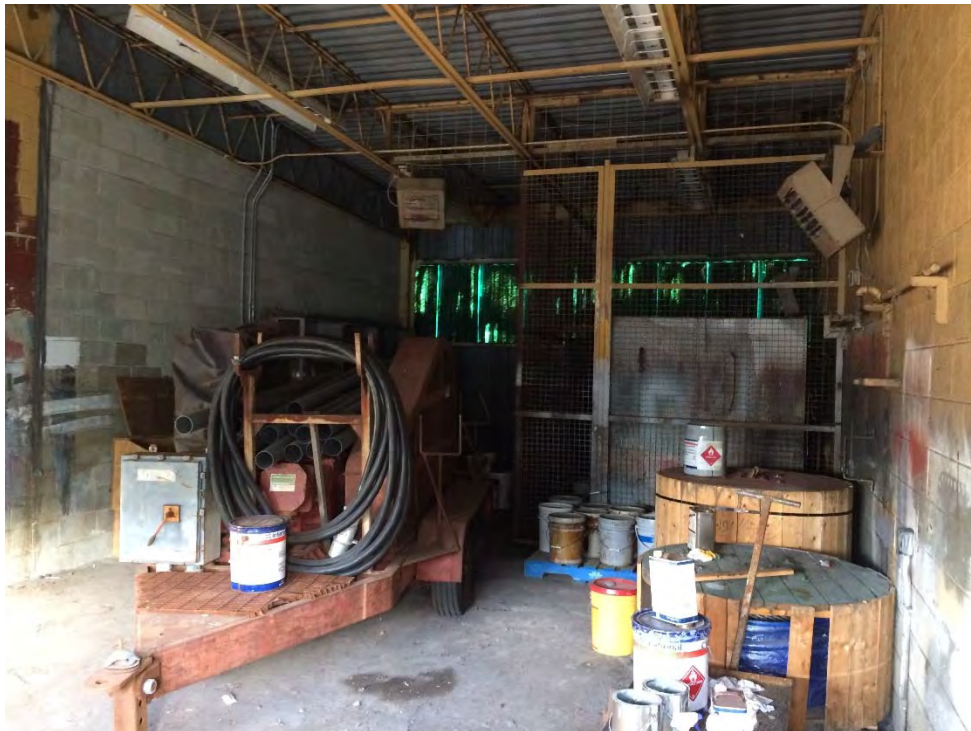
Photo 20: **Services Building** – Paint Shop or Water Blast Room where flaking or peeling paint or potential ACMs were not observed.

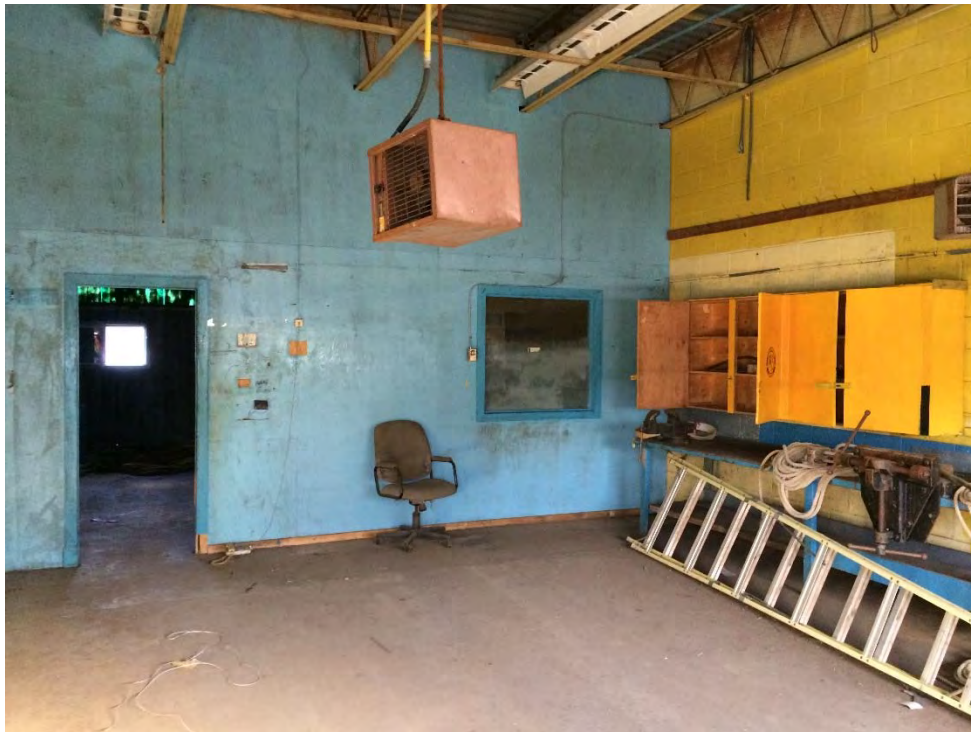
Photo 21: **Services Building** – Rigger's Room where flaking or peeling paint or potential ACMs were not observed.

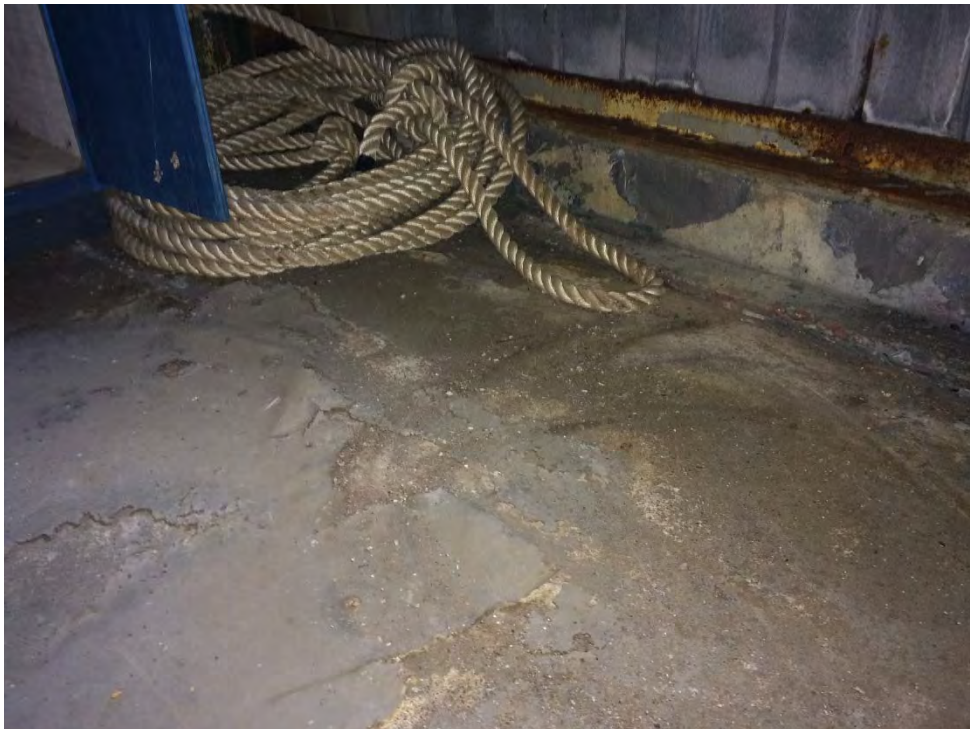
Photo 22: **Services Building** – Rigger's Room back area where peeling grey paint on the concrete floor and curb was **confirmed** as lead-based. Potential ACMs were not observed.

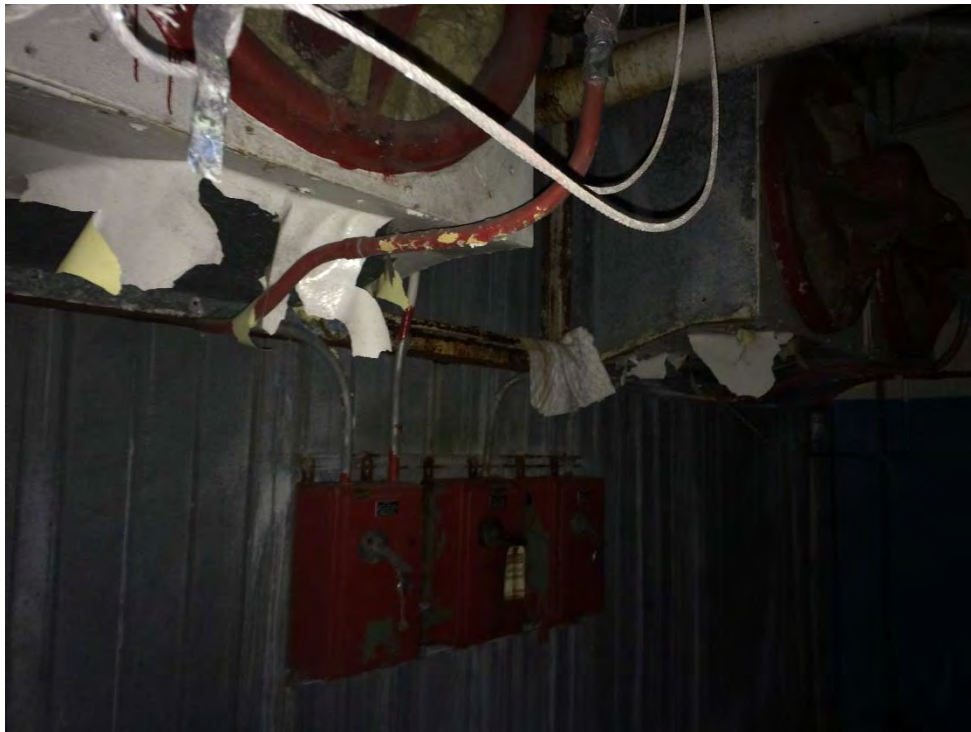
Photo 23: **Services Building** – Boiler Room exhaust fan housing with peeling white over yellow **paint** that was **confirmed** as lead-based. Potential ACMs were not observed, but may be present in various components of the boiler

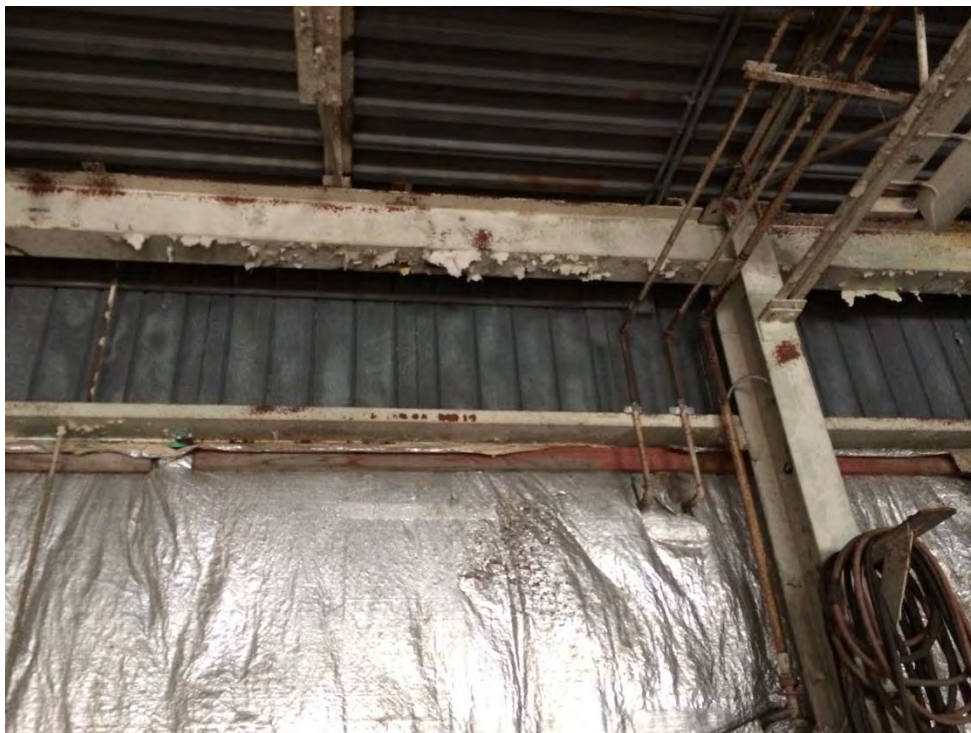
Photo 24: **Services Building** – Garage where white over yellow peeling **paint** was **confirmed** as lead-based; flakes were also observed on the floor. Potential ACMs were not observed.

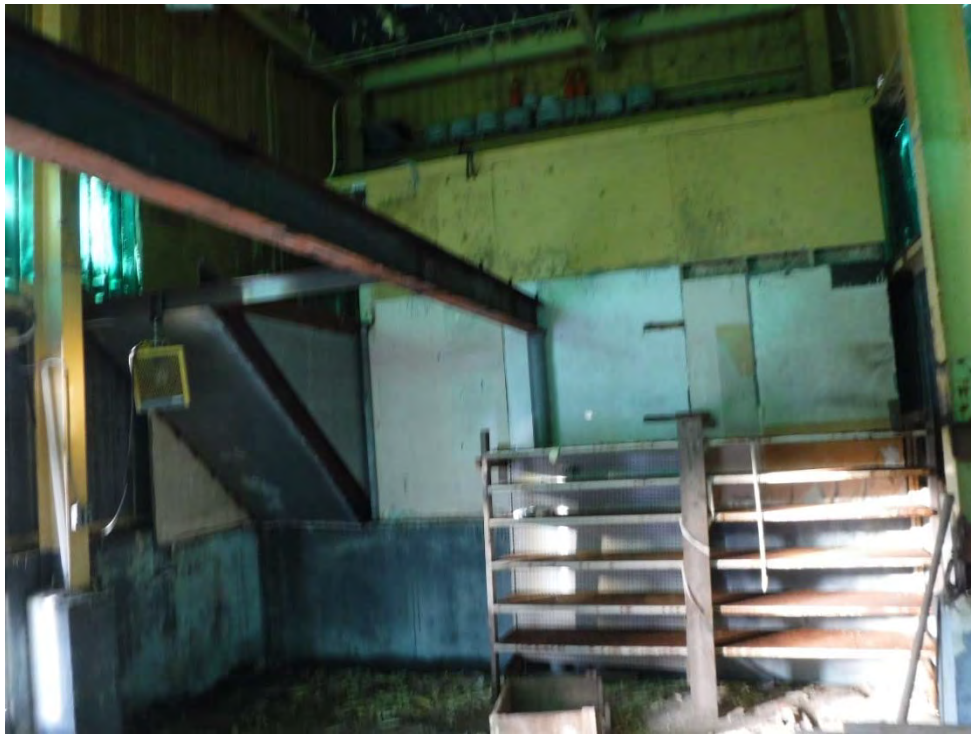
Photo 25: **Parts Building** – Loading bay where peeling yellow over cream **paint** was **confirmed** as lead-based. Paint flakes were noted to cover the floor area and potential ACMs were not observed.

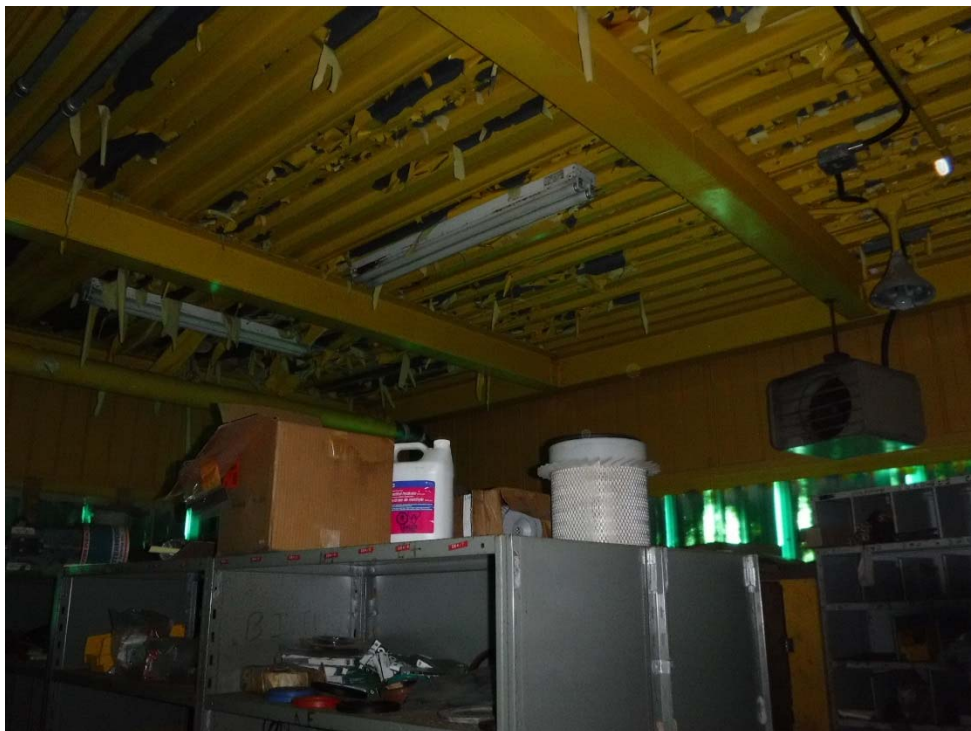
Photo 26: **Parts Building** – Stock room where peeling yellow over cream **paint** was **confirmed** as lead-based. Paint flakes were noted to cover the floor area and shelves; potential ACMs were not observed.

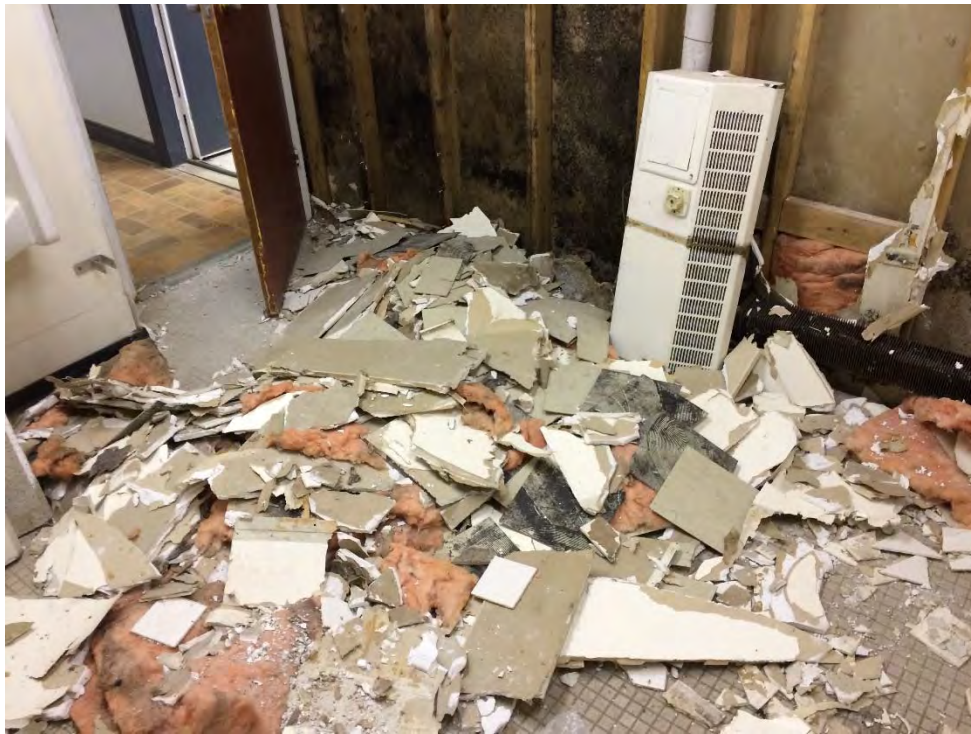
Photo 33: **Administration Building** – Main Floor Washroom where accessible ACM pipe insulation was previously removed. Note remaining debris following a water leak repair, but mould impacted surface remains in drywall.

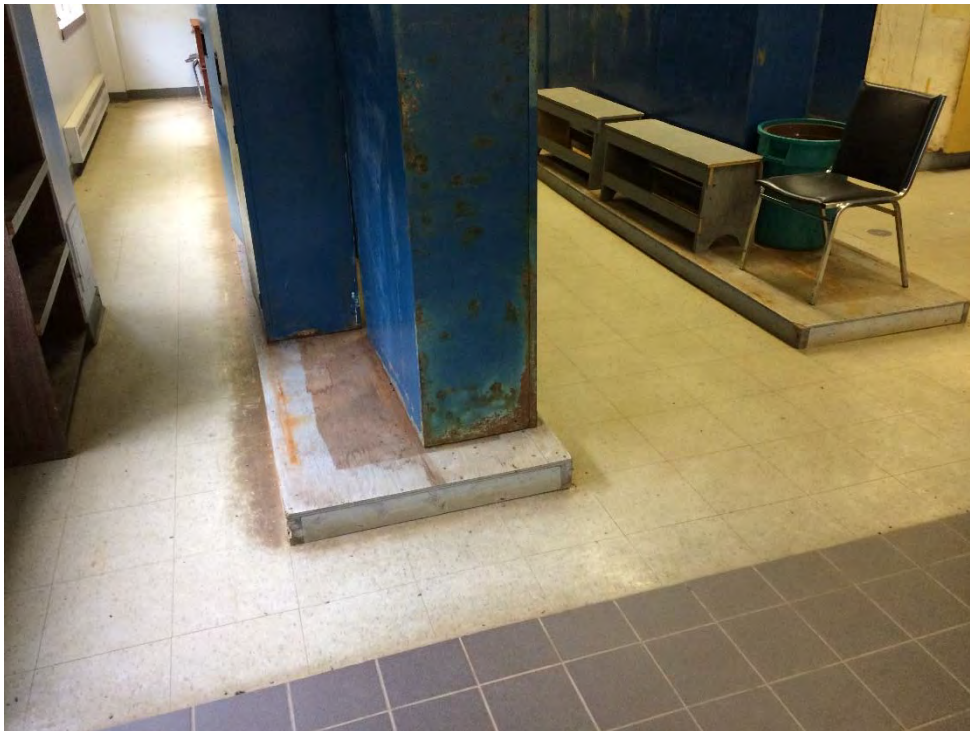
Photo 34: **Administration Building** – Main Floor Locker Room where **drywall plaster** was confirmed with **no ACMs**.

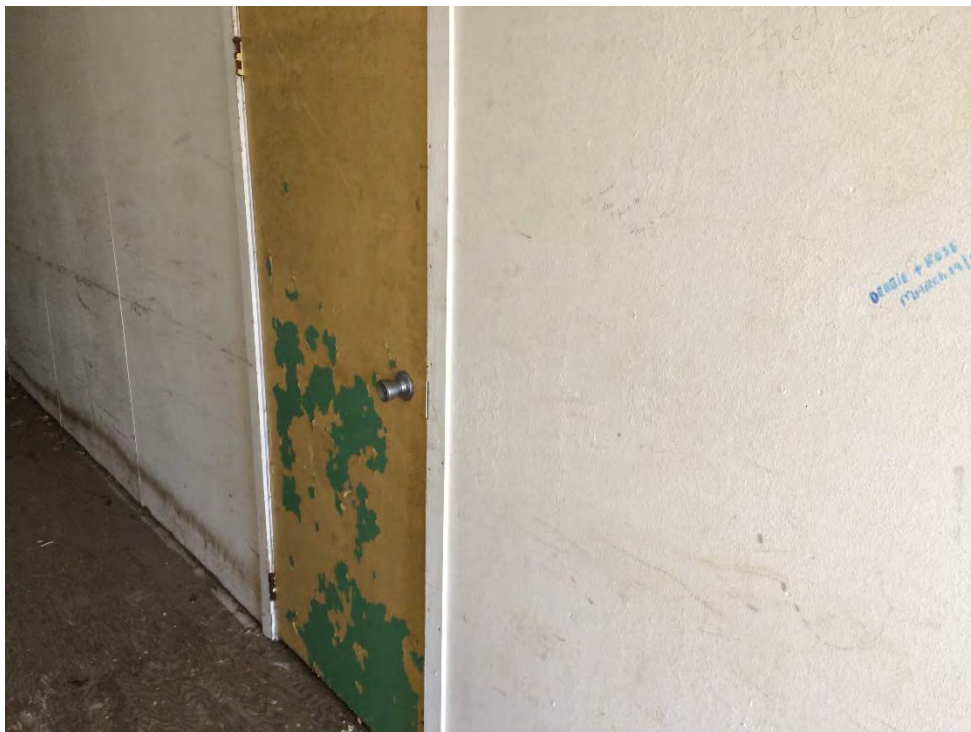
Photo 36: **Murley Building** – Second Floor storage room door with peeling and flaking yellow over green paint that was confirmed as lead-based. Small quantities of flaking paint were observed on the floor in the hallway.

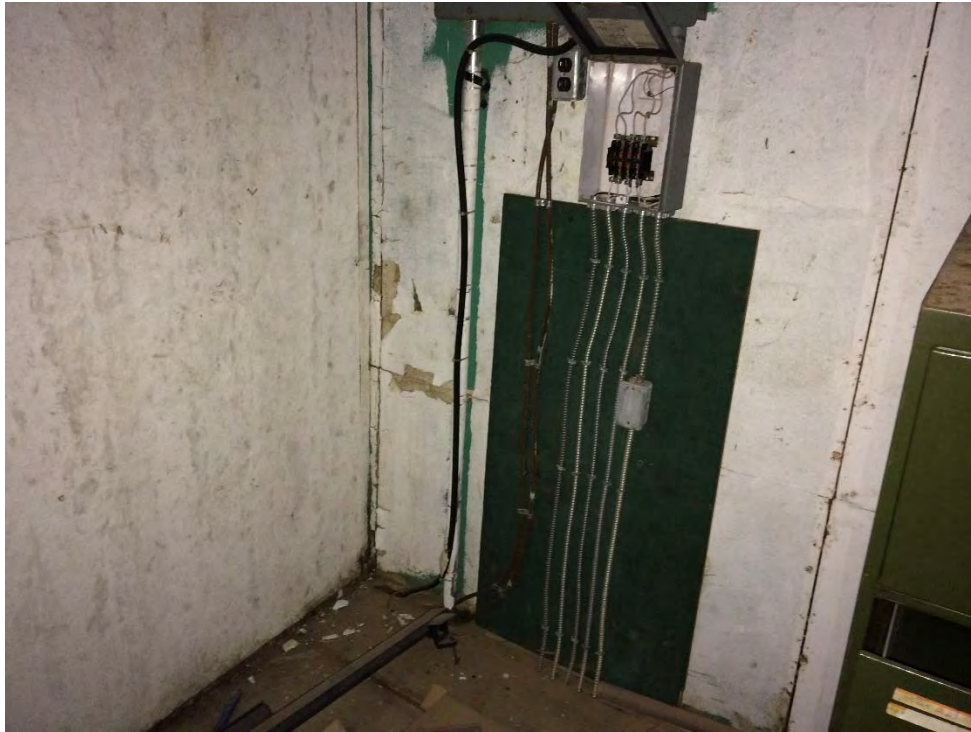
Photo 37: **Murley Building** – Second Floor storage room wall with flaking and peeling white paint that **confirmed** lead concentrations **above** the **Human Health** criterion. Some flaking paint was observed on the floor and cabinets.

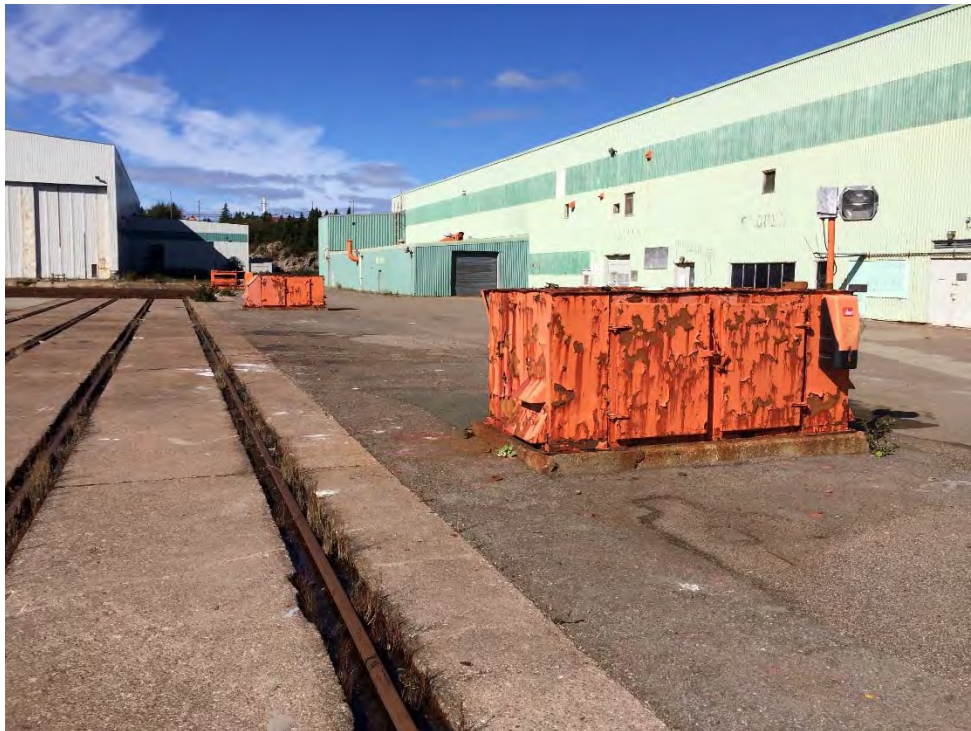
Photo 38: **Docking Berths & Side Transfer Area** – Steel electrical containment boxes with heavy corrosion and flaking orange paint that was **confirmed** as lead-based.
