Appendix 20a

CLIENT: NEWFOUNDLAND AND LABRADOR DEPARTMENT OF ENVIRONMENT AND CONSERVATION		SCALE: 1:10,000	DATE: JUNE 15, 2010
PROJECT TITLE: PHASE III ESA, HUMAN HEALTH AND ECOLOGICAL RISK ASSESSMENTS, REMEDIAL ACTION PLAN FOR THE FORMER U.S. MILITARY FACILITY OF NORTHWEST POINT, NL		DRAWN BY: N.M.	CHECKED BY: A.R.
DRAWING TITLE: LOCATION OF SURFACE DEBRIS		EDITED BY: -	REV. No. 0
		DRAWING No: 121410105-EE-20A	
		CAD FILE: 1044857-EE-18.DWG

Log of Surface Debris and Physical Hazards

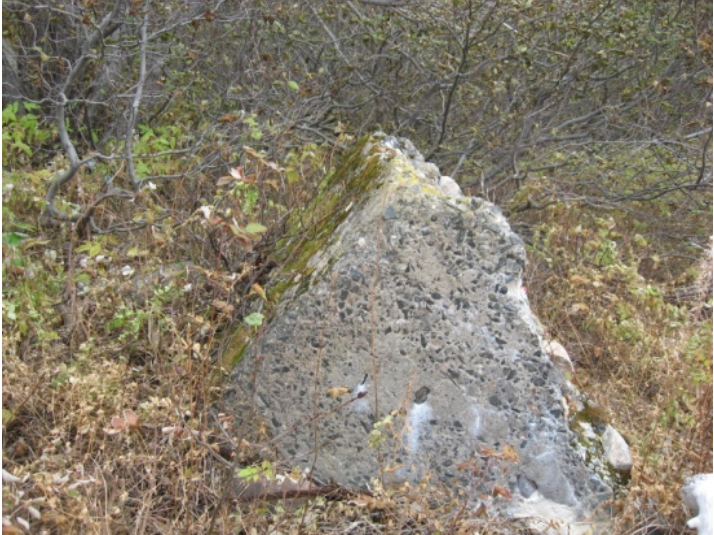
Location ID / Description	Photo(s)
<p><u>09-SD1</u></p> <p>Coordinates (NAD27) Easting: 694776 Northing: 5932363</p> <p>Description: 1 m³ concrete block, steel cable</p> <p>Location: Lake Melville shoreline, north of Underground Pipeline Site</p>

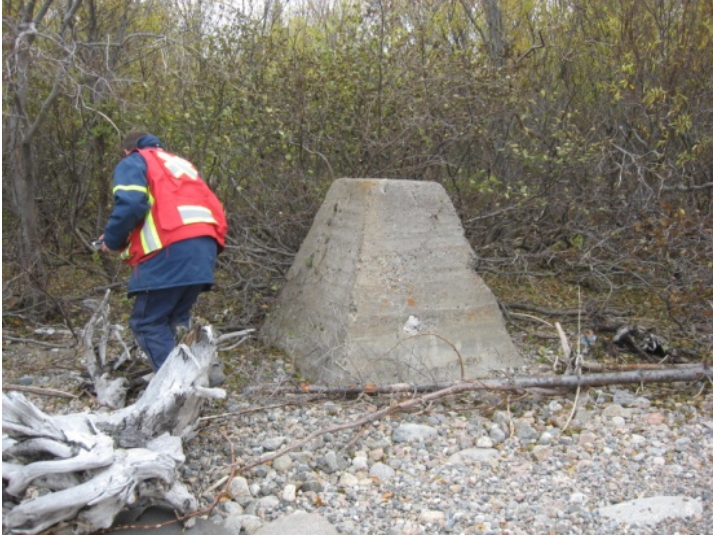
<p><u>09-SD2</u></p> <p>Coordinates (NAD27) Easting: 694715 Northing: 5932308</p> <p>Description: 1.5 m³ concrete anchor block</p> <p>Location: Lake Melville shoreline, Underground Pipeline Site</p>

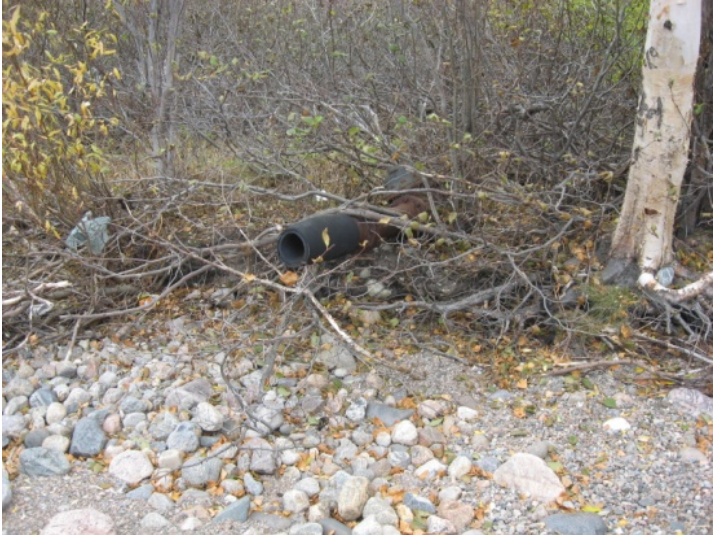
<p><u>09-SD3</u></p> <p>Coordinates (NAD27) Easting: 694728 Northing: 5932315</p> <p>Description: 6 m long 200 mm diameter steel pipe, valve</p> <p>Location: Lake Melville shoreline, Underground Pipeline Site</p>

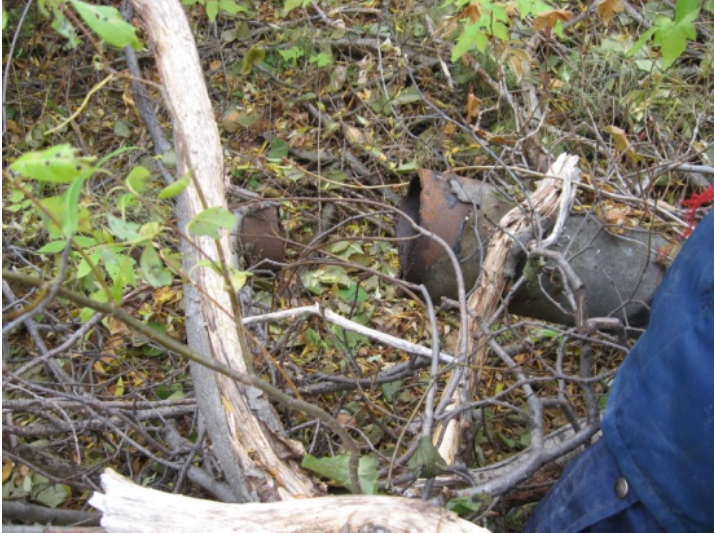
Location ID / Description	Photo(s)
<p><u>09-SD4</u></p> <p>Coordinates (NAD27) Easting: 694736 Northing: 5932309</p> <p>Description: 4 m of pipe protruding from ground</p> <p>Location: Underground Pipeline Site (09-Pipe2)</p>

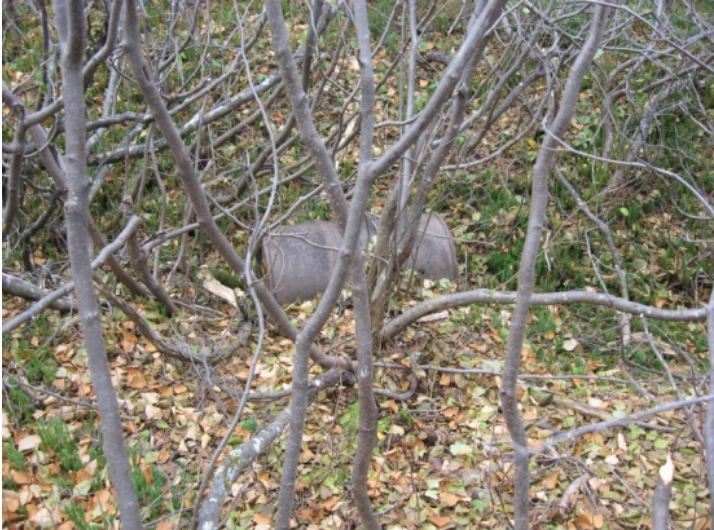
<p><u>09-SD5</u></p> <p>Coordinates (NAD27) Easting: 694737 Northing: 5932318</p> <p>Description: 10 m of steel cable</p> <p>Location: Lake Melville shoreline, Underground Pipeline Site</p>	<p>No photo taken</p>
<p><u>09-SD6</u></p> <p>Coordinates (NAD27) Easting: 694736 Northing: 5932176</p> <p>Description: 1 empty 200 L steel drum</p> <p>Location: Between Dock Road and Pipeline, east of Helicopter Pad Site</p>

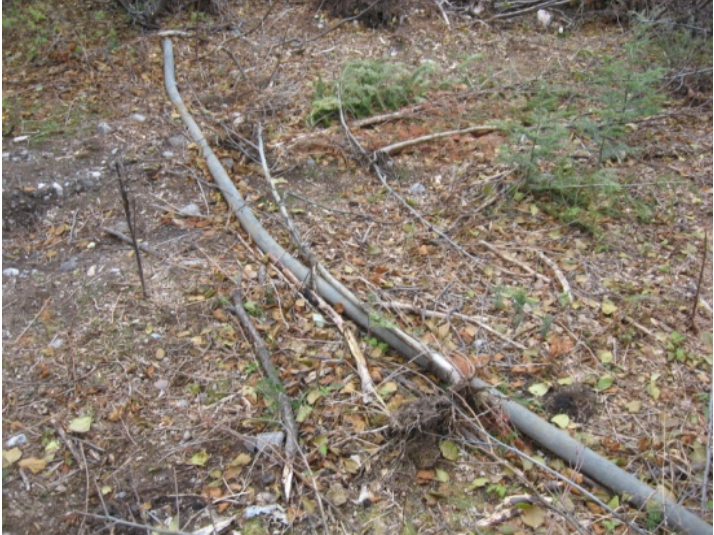
Location ID / Description	Photo(s)
<p><u>09-SD9</u></p> <p>Coordinates (NAD27) Easting: 694741 Northing: 5932095</p> <p>Description: 5 m long 50 mm diameter galvanized steel pipe</p> <p>Location: Dock Road Drum Storage Site</p>

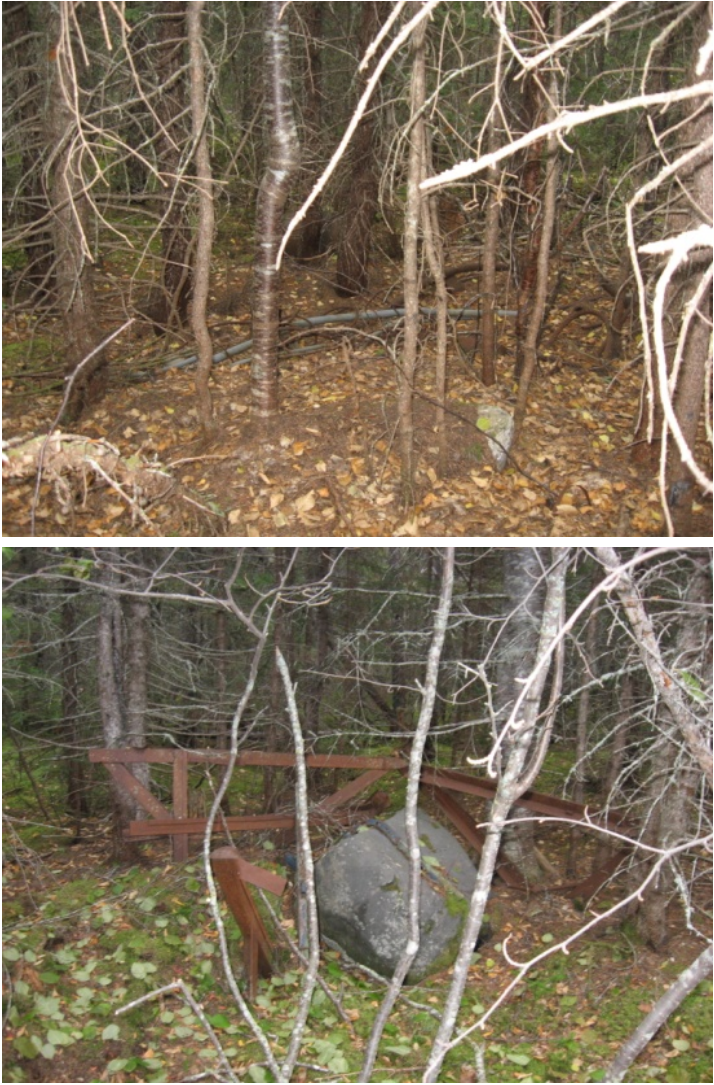
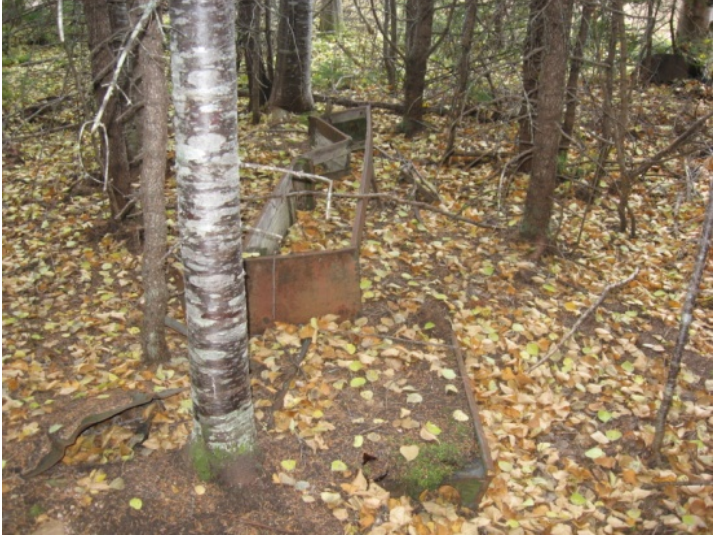
Location ID / Description	Photo(s)
<p><u>09-SD10 (continued)</u></p>

<p><u>09-SD10</u></p> <p>Coordinates (NAD27) Easting: 694787 to 694784 Northing: 5932088 to 5932116</p> <p>Description: 100 m x 30 m scattered surface and partially buried debris (plate steel, pipe, steel cable, drums, etc.)</p> <p>Location: Dock Road Drum Storage Site</p>

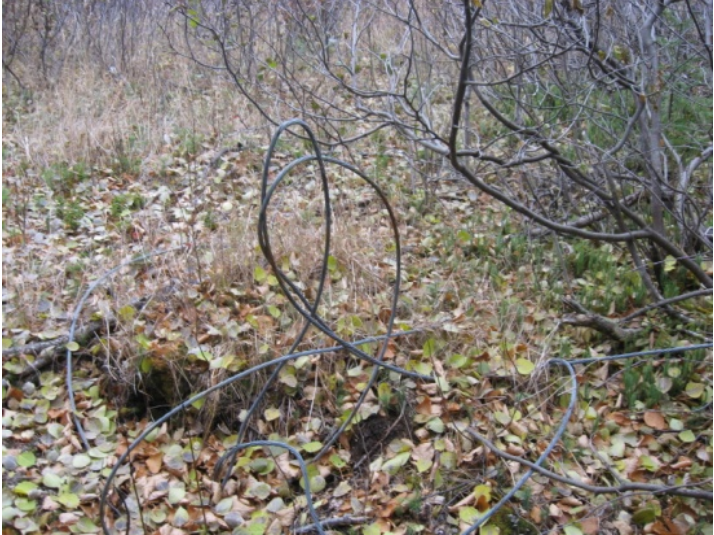
<p><u>09-SD11</u></p> <p>Coordinates (NAD27) Easting: 694762 Northing: 5932078</p> <p>Description: 20 m steel cable, 5 m long 50 mm diameter galvanized steel pipe</p> <p>Location: Dock Road Drum Storage Site</p>

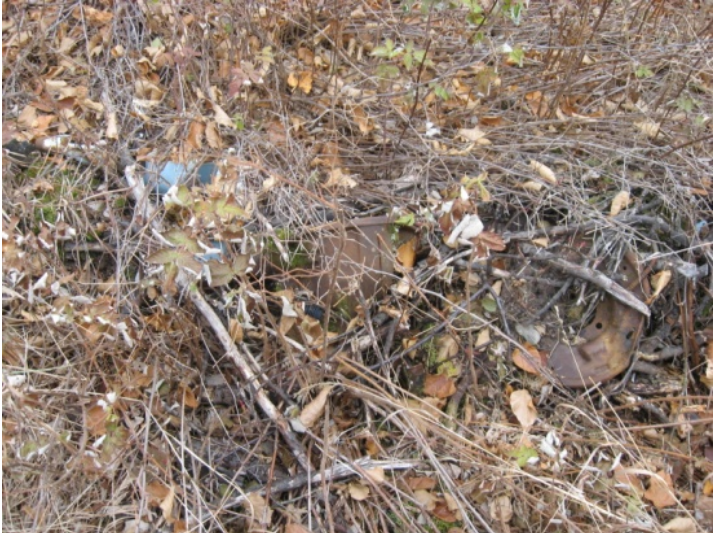
<p><u>09-SD12</u></p> <p>Coordinates (NAD27) Easting: 694767 Northing: 5932134</p> <p>Description: Partially buried rear end of car</p> <p>Location: Dock Road Drum Storage Site</p>

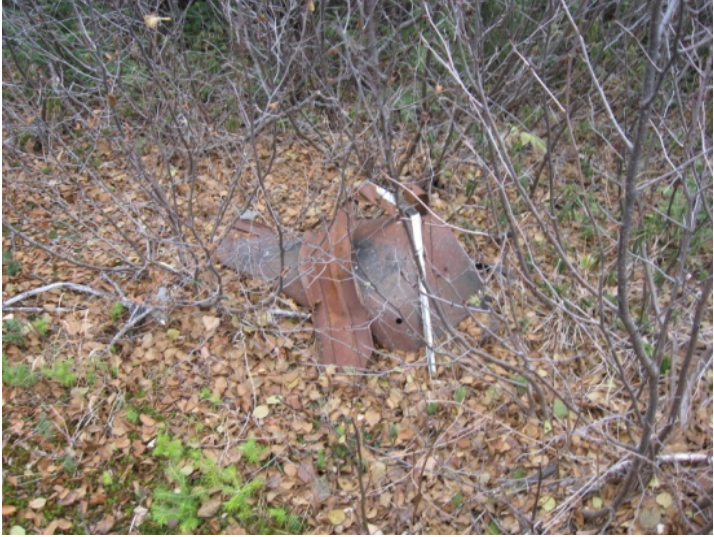
Location ID / Description	Photo(s)
<p><u>09-SD13</u></p> <p>Coordinates (NAD27) Easting: 694778 Northing: 5932165</p> <p>Description: 1 m² piece of steel</p> <p>Location: Dock Road Drum Storage Site</p>

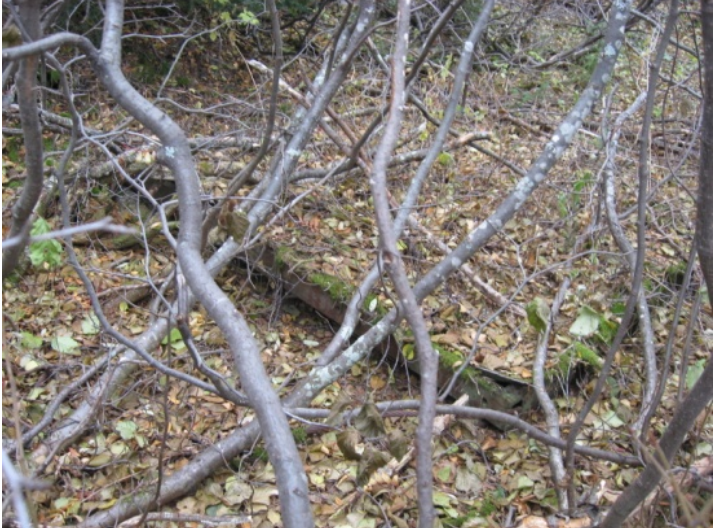
<p><u>09-SD14</u></p> <p>Coordinates (NAD27) Easting: 694763 Northing: 5932127</p> <p>Description: 2 m x 3 m tail gate</p> <p>Location: Dock Road Drum Storage Site</p>

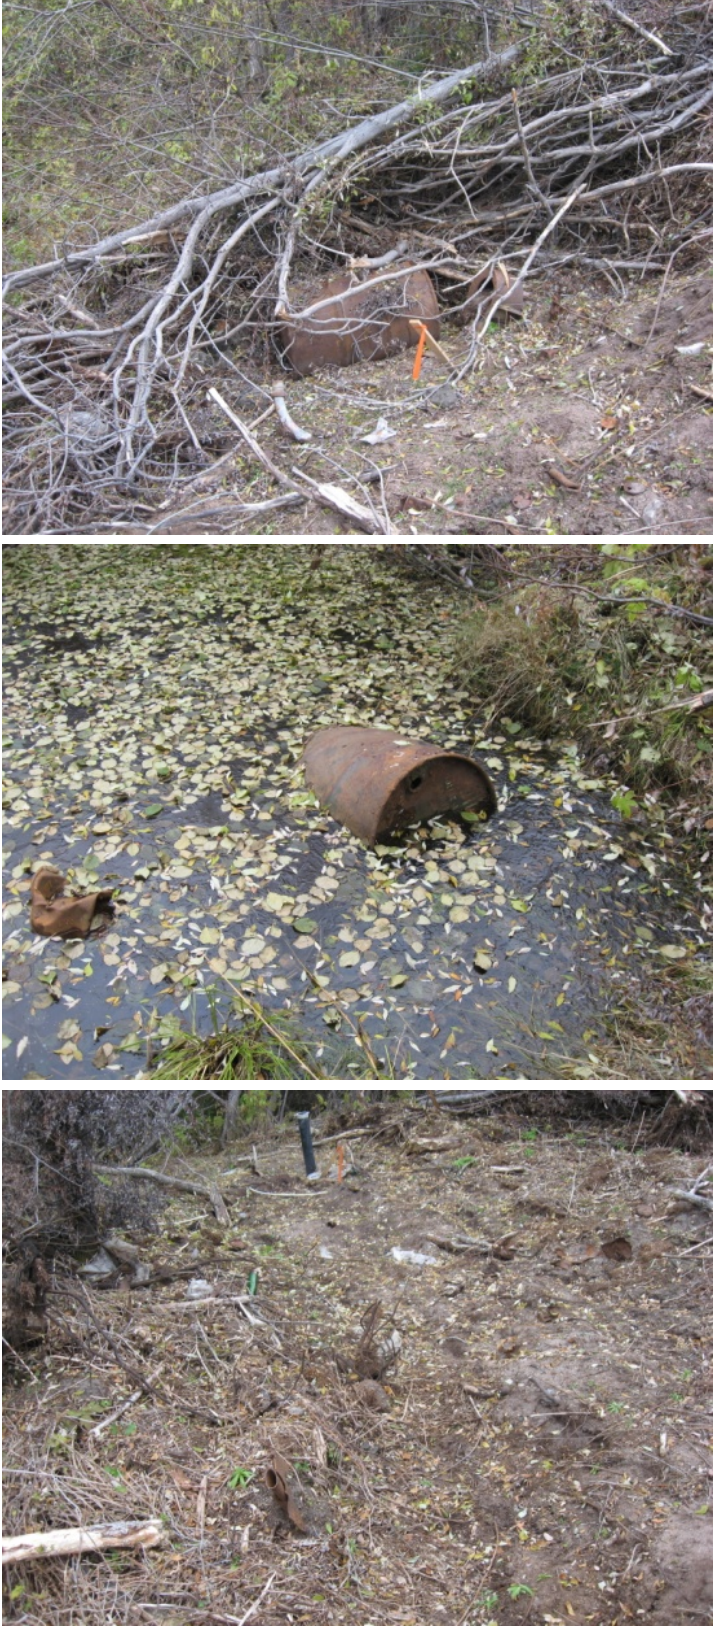
Location ID / Description	Photo(s)
<p><u>09-SD15</u></p> <p>Coordinates (NAD27) Easting: 694636 Northing: 5932032</p> <p>Description: 5 200 L drums, small amounts of surface and partially buried debris (metal, batteries, etc.)</p> <p>Location: Lake Melville Dump Site</p>

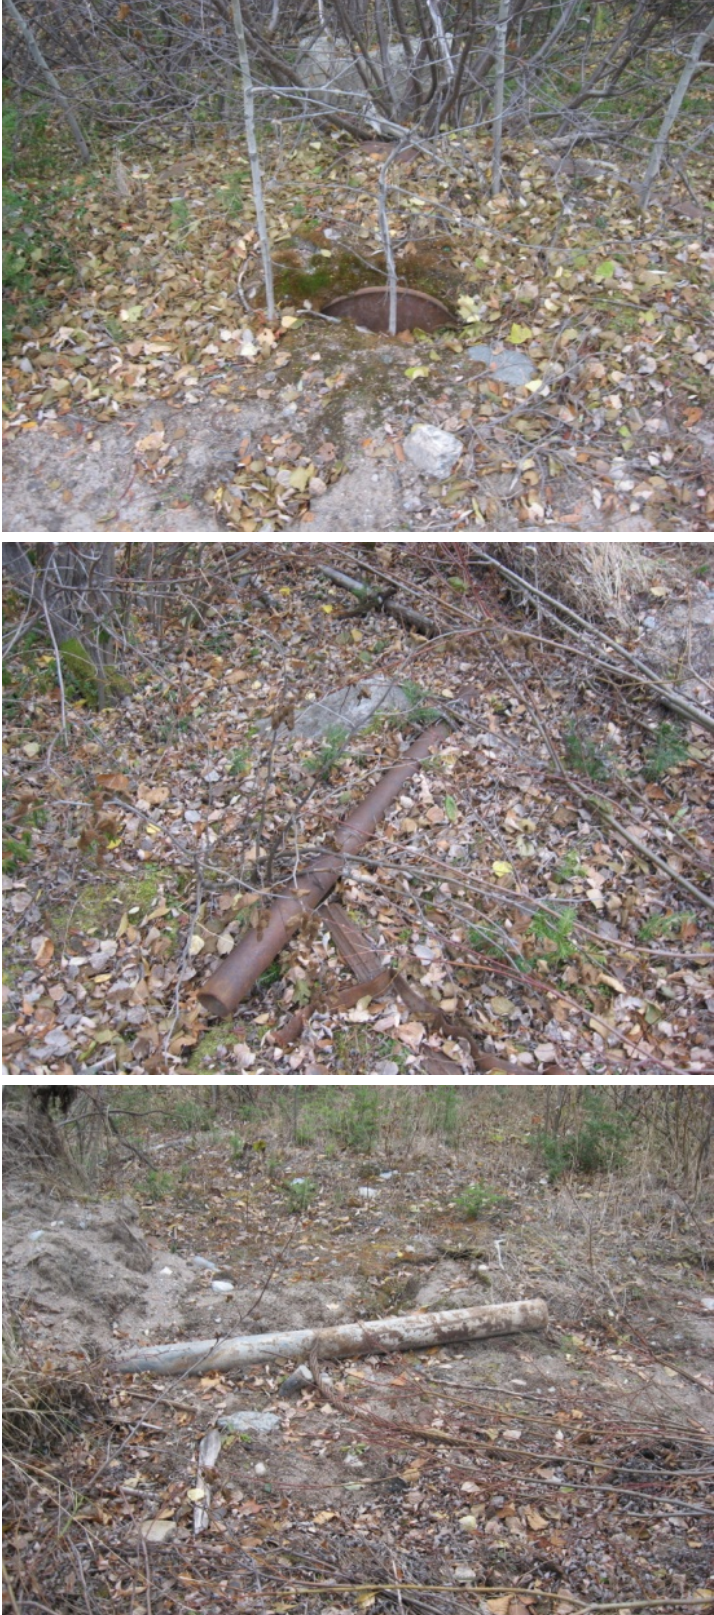
Location ID / Description	Photo(s)
<p data-bbox="186 905 289 934"><u>09-SD16</u></p> <p data-bbox="186 959 431 989">Coordinates (NAD27)</p> <p data-bbox="186 989 373 1018">Easting: 694799</p> <p data-bbox="186 1018 399 1047">Northing: 5931074</p> <p data-bbox="186 1073 553 1155">Description: Partially buried and surface metal debris (drums, pipe, cans)</p> <p data-bbox="186 1180 553 1209">Location: Camp Road Dump Site</p>

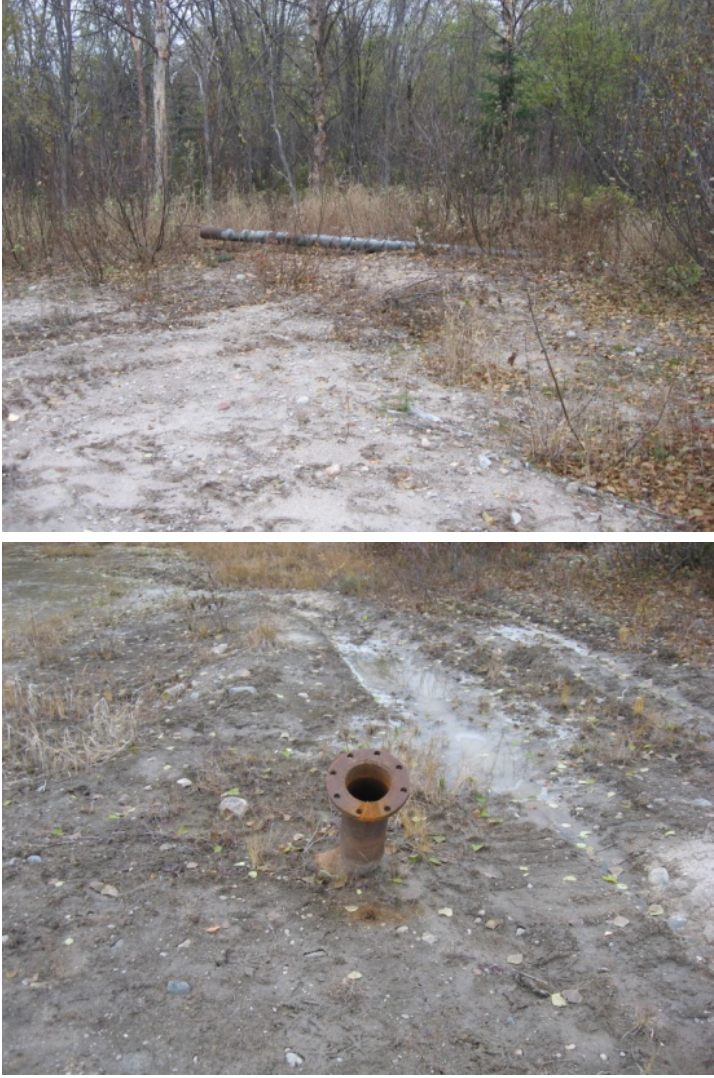
Location ID / Description	Photo(s)
<p><u>09-SD17</u></p> <p>Coordinates (NAD27) Easting: 694443 Northing: 5930981</p> <p>Description: 7 m long 200 mm diameter open steel pipe, 0.9 m of a 200 mm diameter open steel pipe protruding from ground</p> <p>Location: Between South Bulk Fuel Storage Site and Camp Road Drum Storage Site</p>

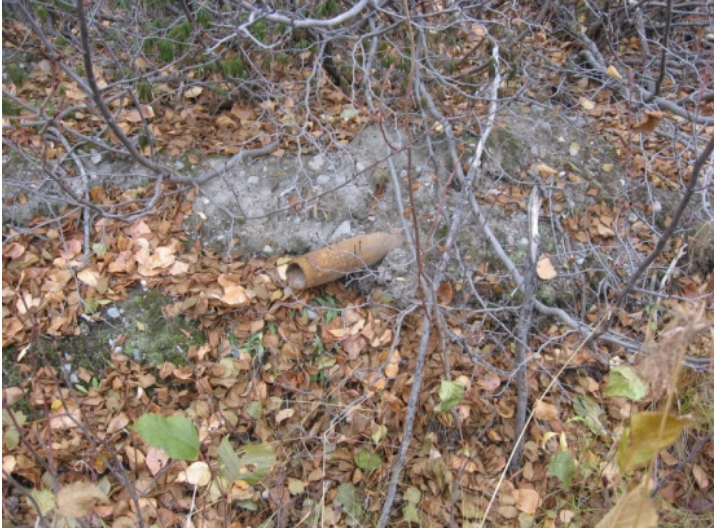
<p>The top photograph shows a long, dark-colored steel pipe lying horizontally on a sandy, light-colored ground surface in a wooded area with bare trees. The bottom photograph is a close-up of a pipe protruding from the ground, showing a flanged end with several bolts. The ground around the pipe is sandy and has some sparse vegetation.</p>
<p><u>09-SD18</u></p> <p>Coordinates (NAD27) Easting: 694317 Northing: 5931085</p> <p>Description: 0.4 m of 75 mm diameter steel pipe protruding from ground</p> <p>Location: North of VOR road, north of South Bulk Fuel Storage Site</p>

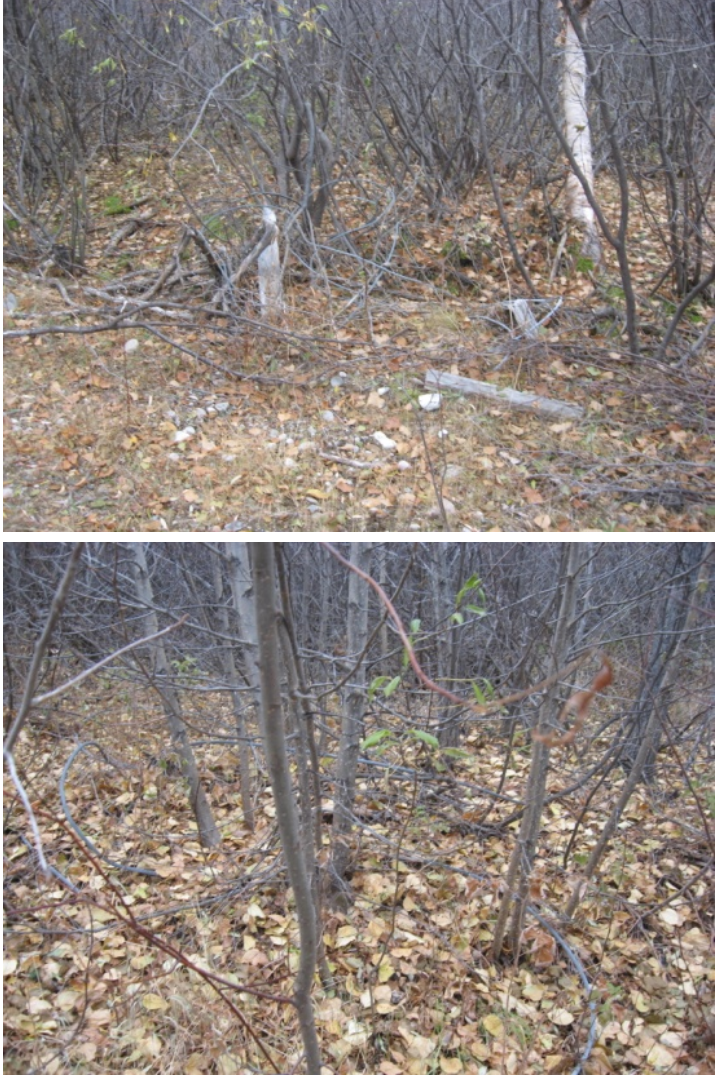
Location ID / Description	Photo(s)
<p><u>09-SD19</u></p> <p>Coordinates (NAD27) Easting: 694306 Northing: 5931223</p> <p>Description: 20 m of steel cable</p> <p>Location: North of Main Access Road, along sewer line</p>

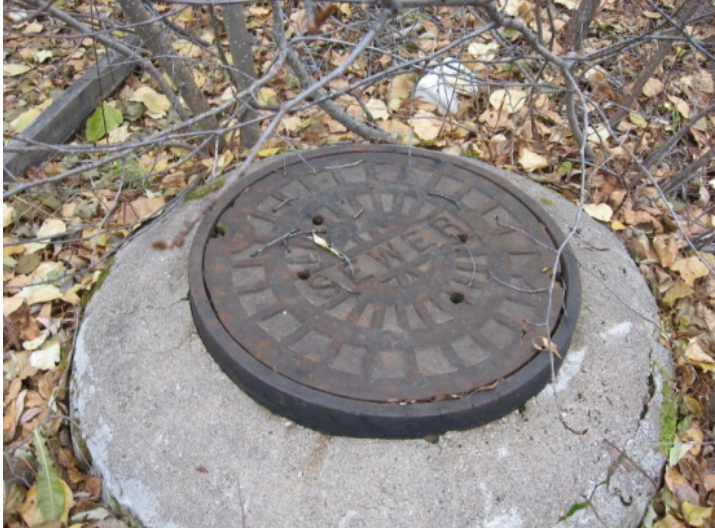
<p>The top photograph shows a wooded area with many bare, thin branches and a ground covered in fallen yellow and brown leaves. A piece of light-colored wood or debris lies on the ground. The bottom photograph shows a similar wooded area with a prominent, thick, reddish-brown branch in the foreground and a white plastic bag or piece of debris on the ground.</p>
<p><u>09-SD20</u></p> <p>Coordinates (NAD27) Easting: 694297 Northing: 5931229</p> <p>Description: Sewer manhole, 20 m of steel cable</p> <p>Location: North of Main Access Road, along sewer line</p>

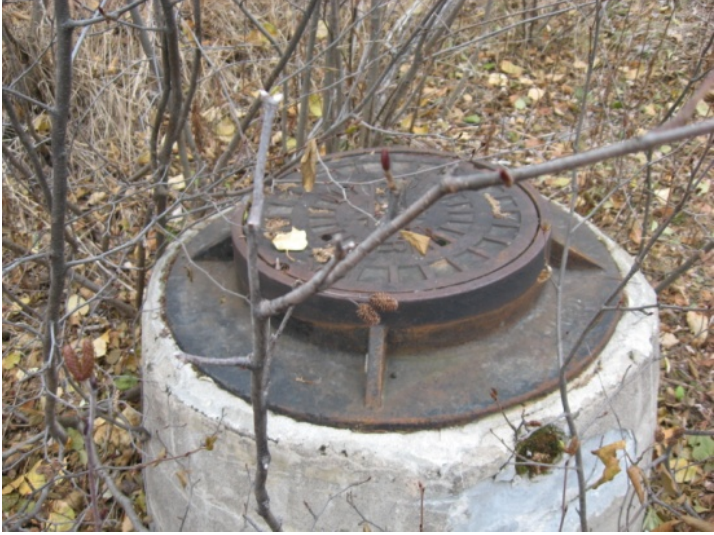
Location ID / Description	Photo(s)
<p><u>09-SD21</u></p> <p>Coordinates (NAD27) Easting: 694295 Northing: 5931235</p> <p>Description: Sewer manhole</p> <p>Location: North of Main Access Road, along sewer line</p>

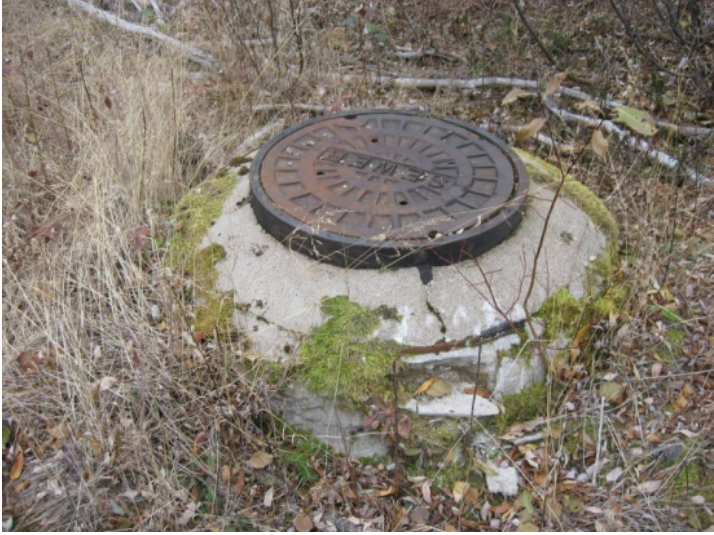
<p><u>09-SD22</u></p> <p>Coordinates (NAD27) Easting: 694294 Northing: 5931245</p> <p>Description: Sewer manhole</p> <p>Location: North of Main Access Road, along sewer line</p>

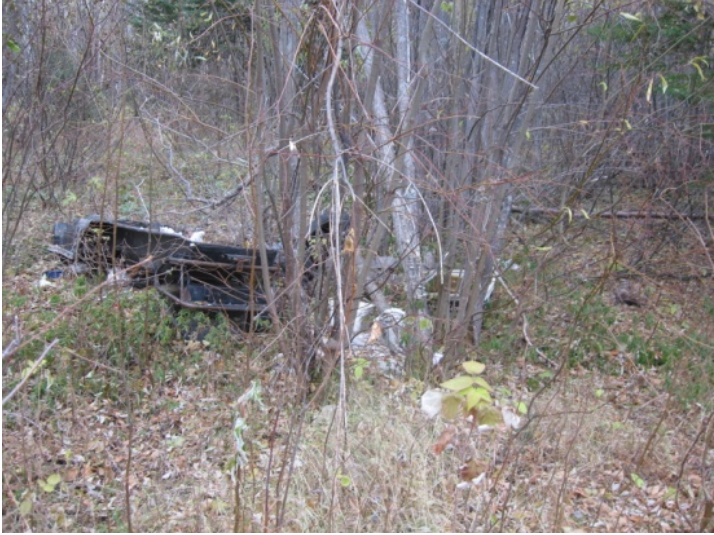
<p><u>09-SD23</u></p> <p>Coordinates (NAD27) Easting: 694296 Northing: 5931291</p> <p>Description: Domestic debris, old skidoo, outboard motor, tire</p> <p>Location: North Bulk Fuel Storage Site, near the former tower rubble location</p>

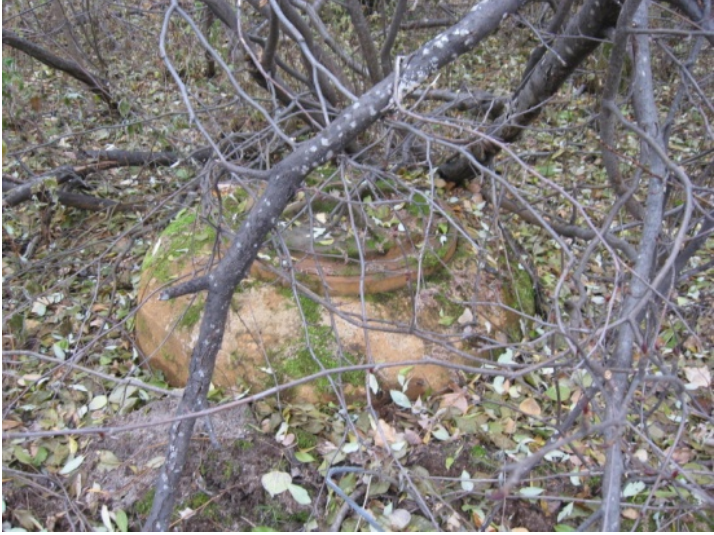
Location ID / Description	Photo(s)
<p><u>09-SD24</u></p> <p>Coordinates (NAD27) Easting: 694284 Northing: 5931368</p> <p>Description: Manhole cover</p> <p>Location: North Bulk Fuel Storage Site</p>

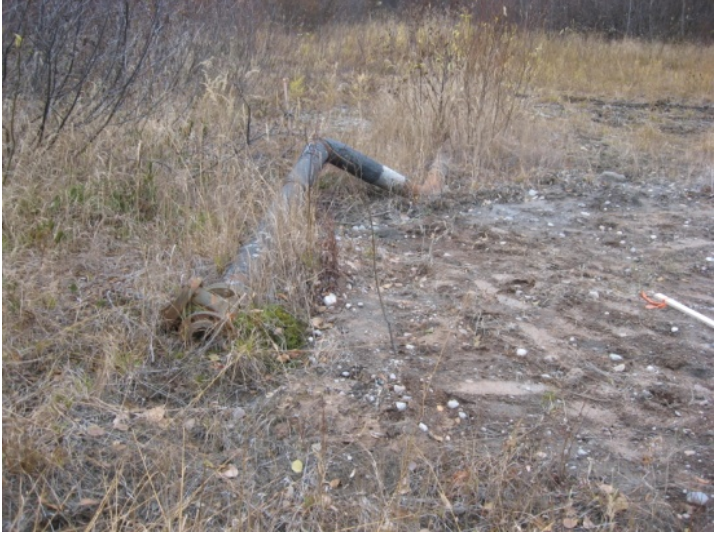
<p><u>09-SD25</u></p> <p>Coordinates (NAD27) Easting: 694254 Northing: 5931379</p> <p>Description: 12 m long 200 mm diameter steel pipe, valve</p> <p>Location: North Bulk Fuel Storage Site</p>

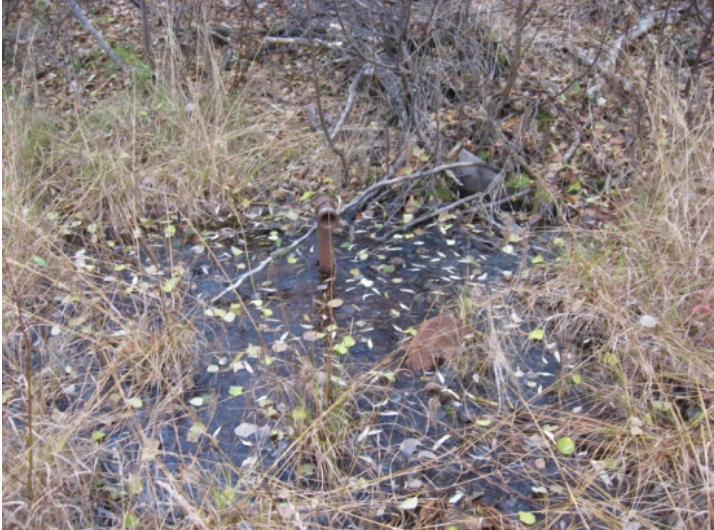
<p><u>09-SD26</u></p> <p>Coordinates (NAD27) Easting: 694255 Northing: 5931357</p> <p>Description: 0.3 m of 50 mm diameter steel pipe protruding from ground, valve</p> <p>Location: North Bulk Fuel Storage Site</p>

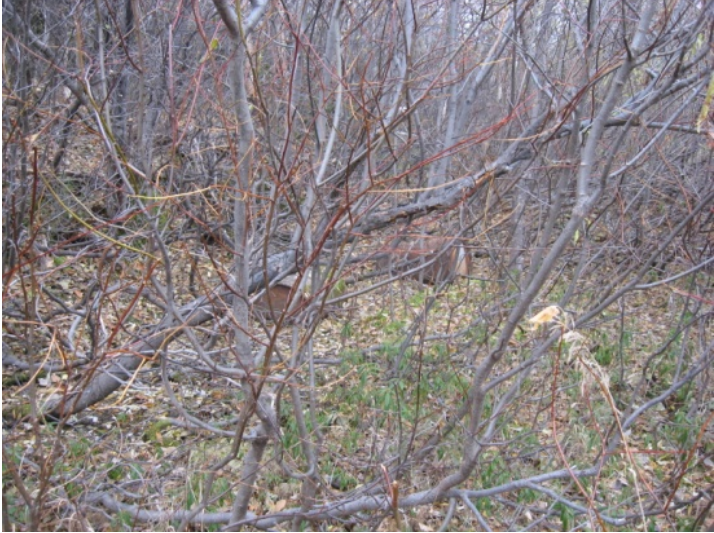
Location ID / Description	Photo(s)
<p><u>09-SD27</u></p> <p>Coordinates (NAD27) Easting: 694233 Northing: 5931353</p> <p>Description: 2 empty 200 L steel drums</p> <p>Location: North Bulk Fuel Storage Site</p>

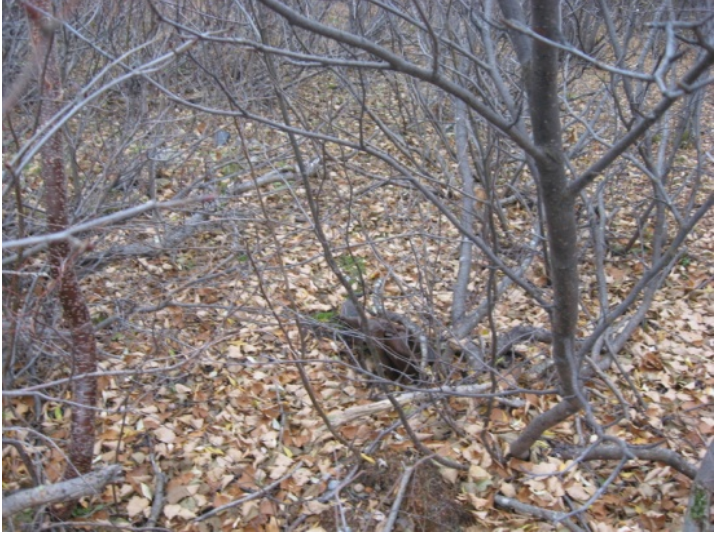
<p><u>09-SD28</u></p> <p>Coordinates (NAD27) Easting: 694288 Northing: 5931210</p> <p>Description: Steel drum, partially buried concrete debris</p> <p>Location: Sewer Site, north of Main Access Road</p>

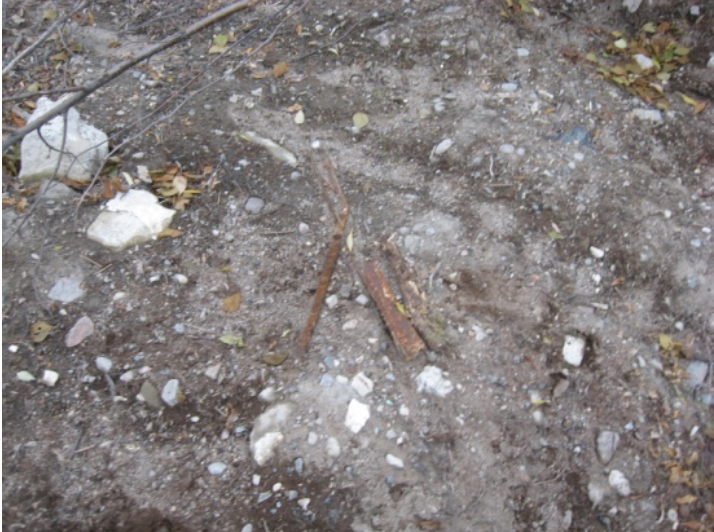
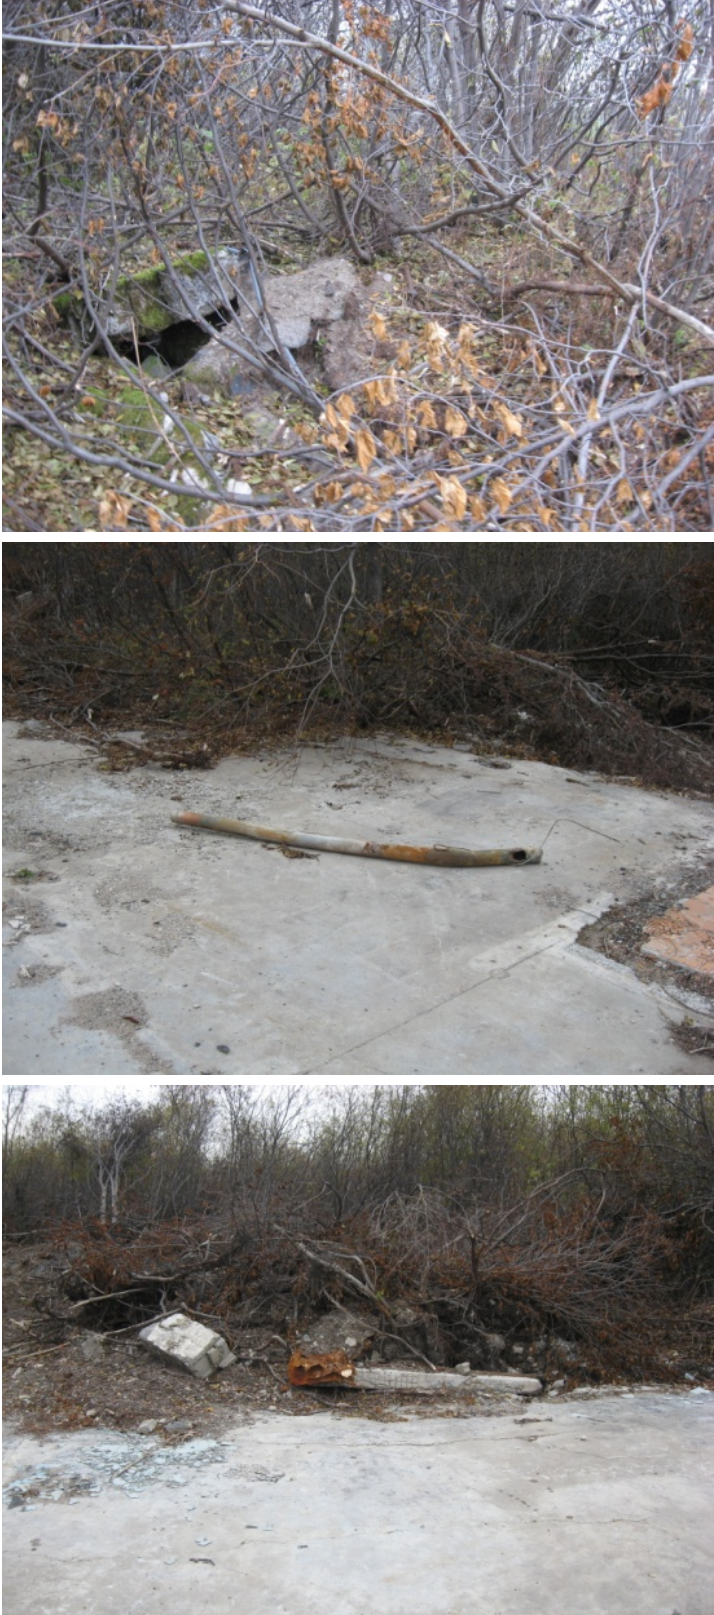
Location ID / Description	Photo(s)
<p data-bbox="186 1045 423 1073"><u>09-SD29 (continued)</u></p>

<p><u>09-SD29</u></p> <p>Coordinates (NAD27) Not recorded</p> <p>Description: 10 m² of partially buried pipe, metal and concrete debris</p> <p>Location: West Generator Site</p>

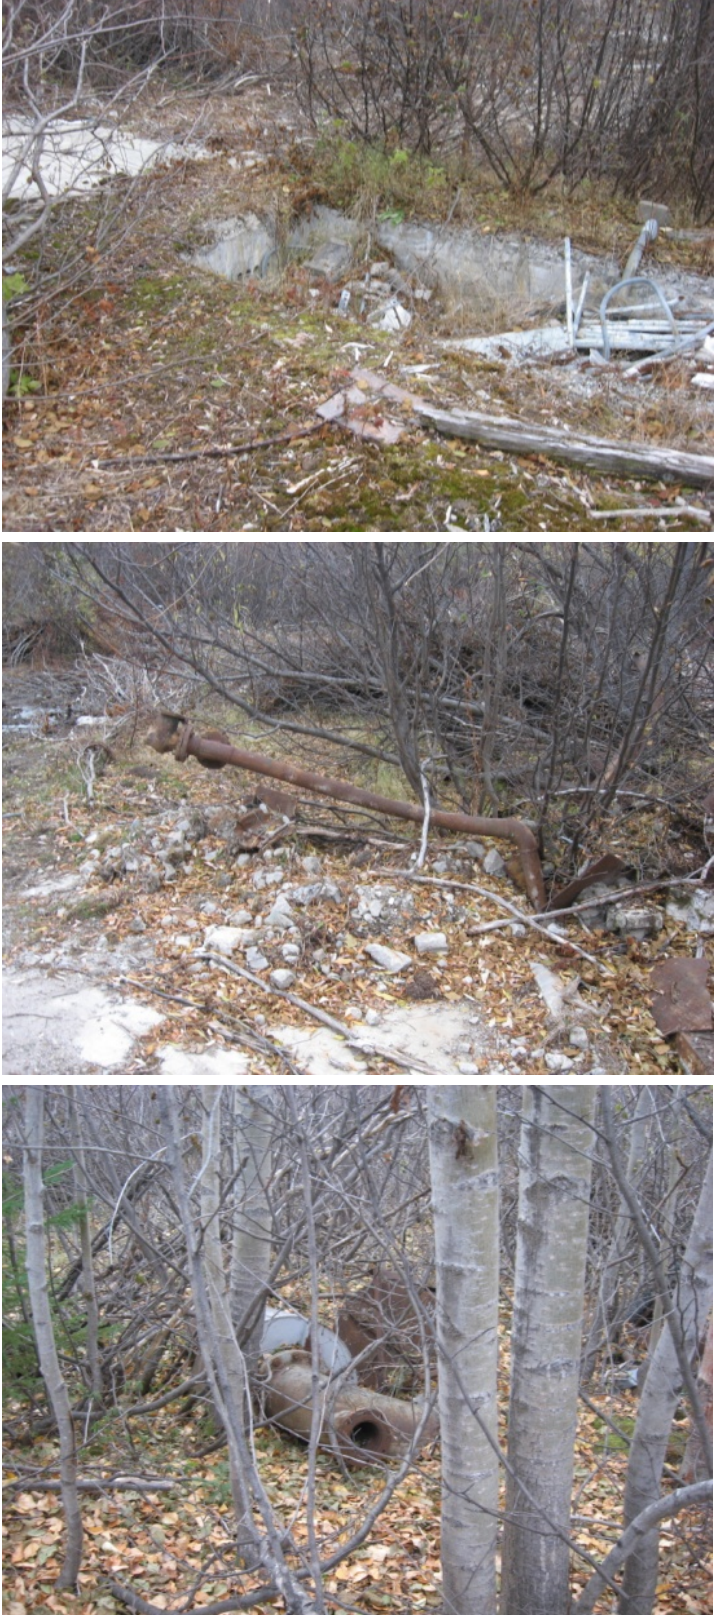
Location ID / Description	Photo(s)
<p data-bbox="186 877 289 909"><u>09-SD30</u></p> <p data-bbox="186 934 430 966">Coordinates (NAD27)</p> <p data-bbox="186 961 373 993">Easting: 694195</p> <p data-bbox="186 989 397 1020">Northing: 5931098</p> <p data-bbox="186 1045 560 1182">Description: 100 m stretch of partially buried metal and concrete (50 mm, 200 mm and 300 mm diameter pipes, metal sheeting, drums, valves, cable, etc.)</p> <p data-bbox="186 1207 527 1239">Location: West Generator Site</p>

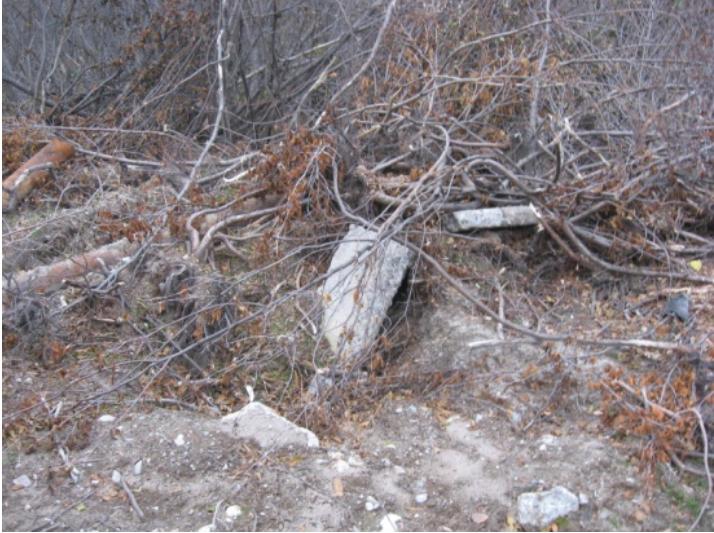
Location ID / Description	Photo(s)
<p><u>09-SD31</u></p> <p>Coordinates (NAD27) Easting: 694266 Northing: 5931178</p> <p>Description: 6 m long 200 mm diameter steel pipe (partially buried), 1 m³ of concrete debris</p> <p>Location: North of Transmitter Building site</p>

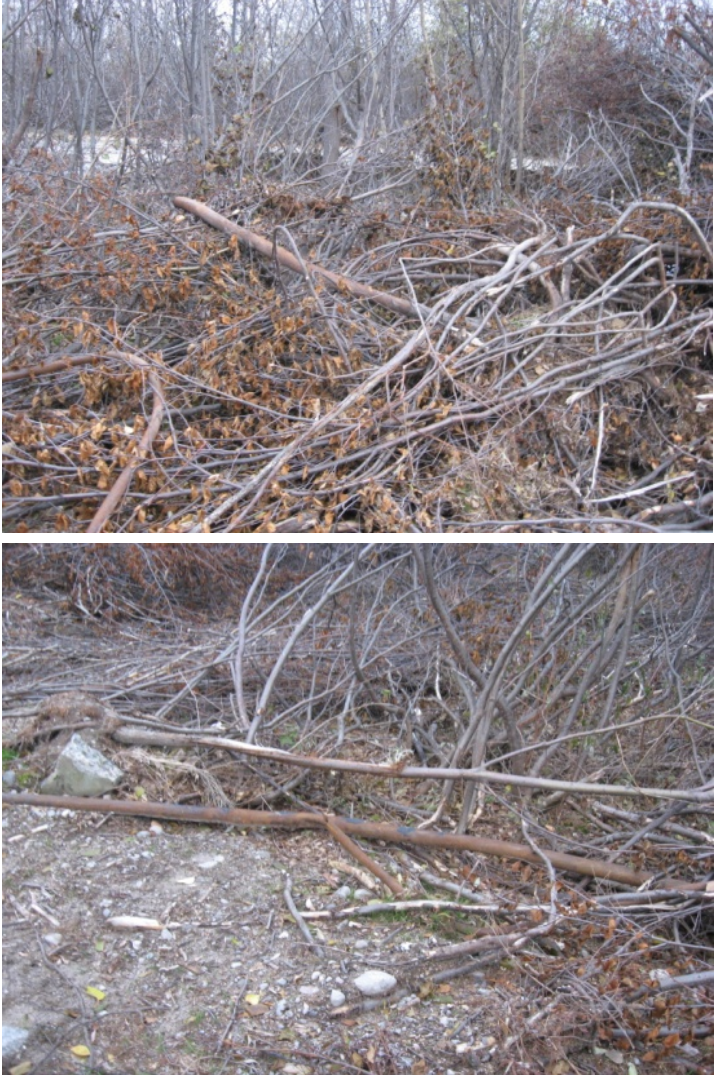
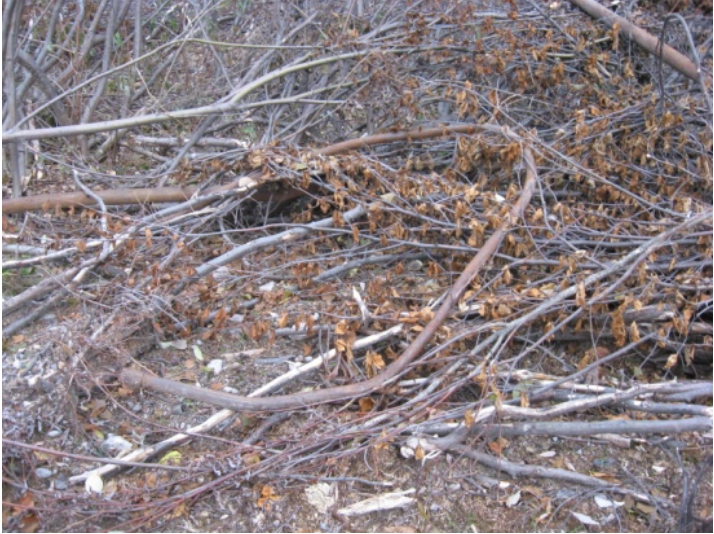
Location ID / Description	Photo(s)
<p><u>09-SD32 (continued)</u></p>

<p><u>09-SD32</u></p> <p>Coordinates (NAD27) Easting: 694142 Northing: 5931167</p> <p>Description: 10 m long 50 mm diameter steel pipe, 10 m long 25 mm conduit (partially buried)</p> <p>Location: Service Site</p>
