**Desktop Environmental
Review, Former U.S. Military
Facility, Northwest Point, NL**

Prepared for:
Newfoundland and Labrador
Department of Municipal Affairs and
Environment, 4th Floor
Confederation Building
West Block, St. John's, NL A1B 4J6

Prepared by:
Stassinu Stantec Limited
Partnership
141 Kelsey Drive
St. John's, NL A1B 0L2
Tel: (709) 576-1458
Fax: (709) 576-2126

Final Report

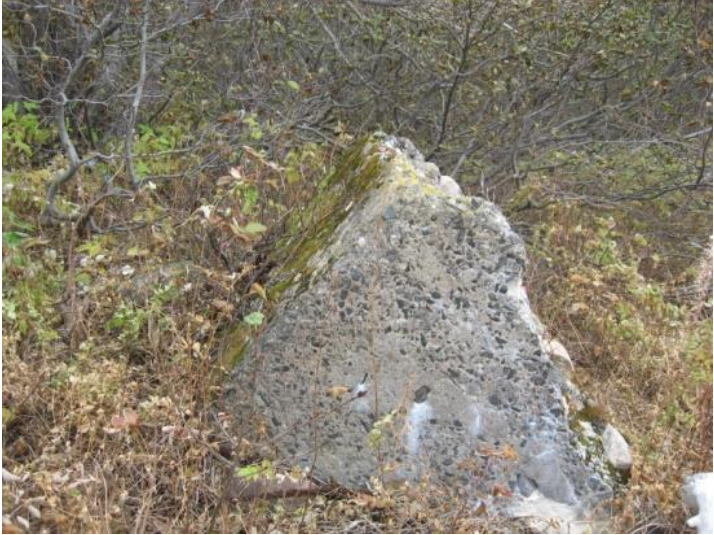
<p><u>09-SD2</u></p> <p>Coordinates (NAD27) Easting: 694715 Northing: 5932308</p> <p>Description: 1.5 m³ concrete anchor block</p> <p>Location: Lake Melville shoreline, Underground Pipeline Site</p>

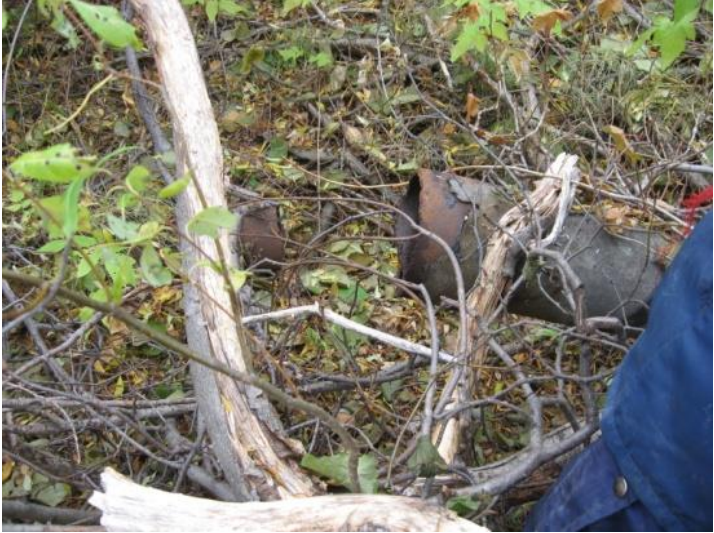
<p><u>09-SD5</u></p> <p>Coordinates (NAD27) Easting: 694737 Northing: 5932318</p> <p>Description: 10 m of steel cable</p> <p>Location: Lake Melville shoreline, Underground Pipeline Site</p>	<p>No photo taken</p>
<p><u>09-SD6</u></p> <p>Coordinates (NAD27) Easting: 694736 Northing: 5932176</p> <p>Description: 1 empty 200 L steel drum</p> <p>Location: Between Dock Road and Pipeline, east of Helicopter Pad Site</p>

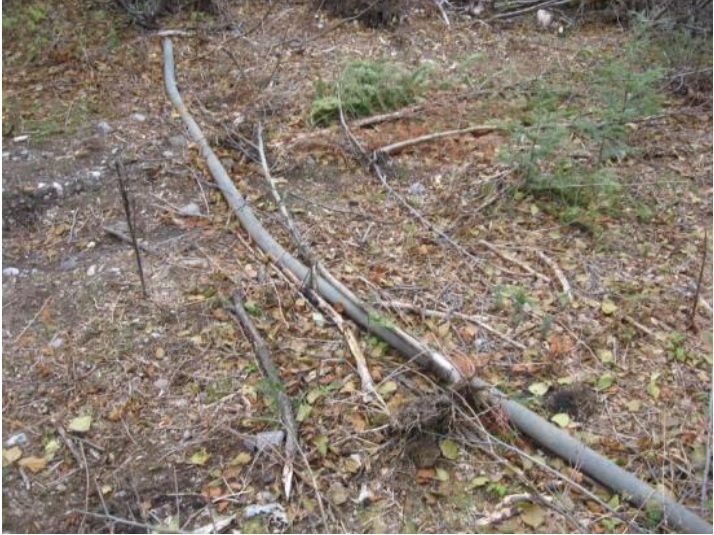
<p><u>09-SD10</u></p> <p>Coordinates (NAD27) Easting: 694787 to 694784 Northing: 5932088 to 5932116</p> <p>Description: 100 m x 30 m scattered surface and partially buried debris (plate steel, pipe, steel cable, drums, etc.)</p> <p>Location: Dock Road Drum Storage Site</p>

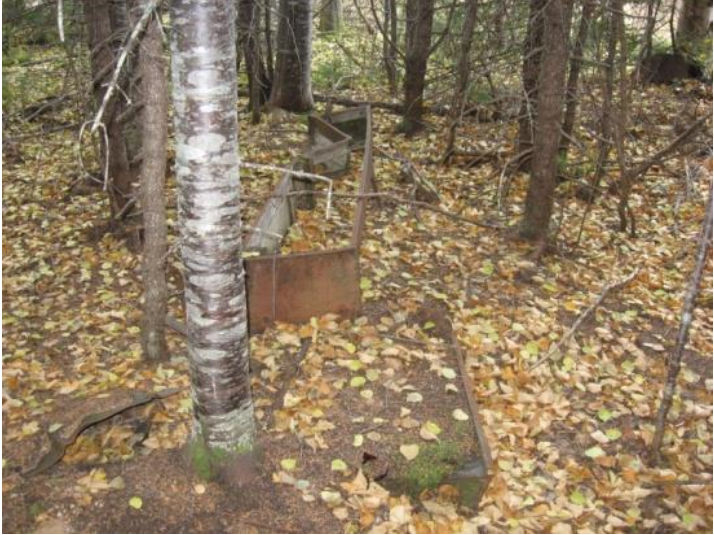
<p><u>09-SD11</u></p> <p>Coordinates (NAD27) Easting: 694762 Northing: 5932078</p> <p>Description: 20 m steel cable, 5 m long 50 mm diameter galvanized steel pipe</p> <p>Location: Dock Road Drum Storage Site</p>

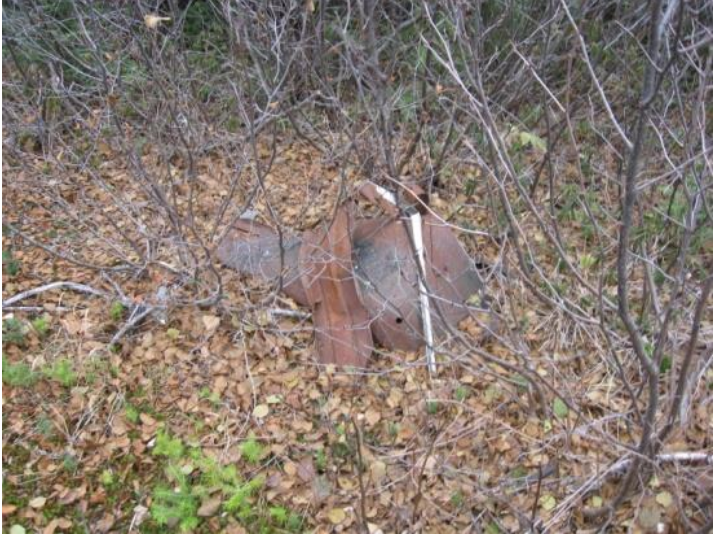
<p><u>09-SD14</u></p> <p>Coordinates (NAD27) Easting: 694763 Northing: 5932127</p> <p>Description: 2 m x 3 m tail gate</p> <p>Location: Dock Road Drum Storage Site</p>

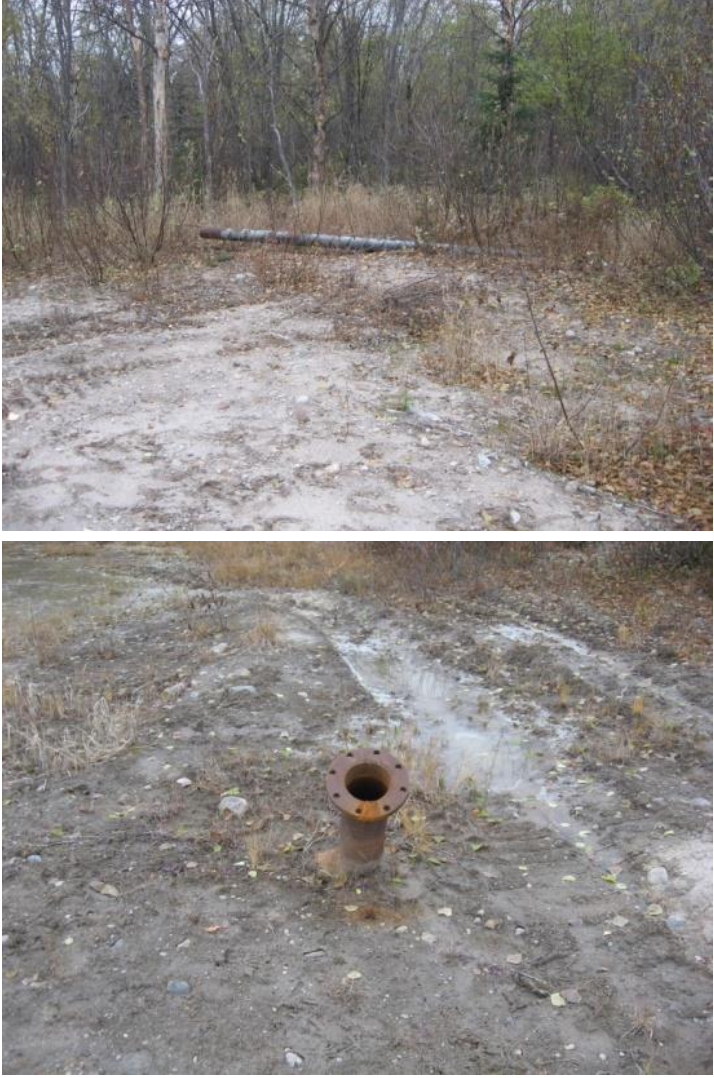
<p><u>09-SD18</u></p> <p>Coordinates (NAD27) Easting: 694317 Northing: 5931085</p> <p>Description: 0.4 m of 75 mm diameter steel pipe protruding from ground</p> <p>Location: North of VOR road, north of South Bulk Fuel Storage Site</p>

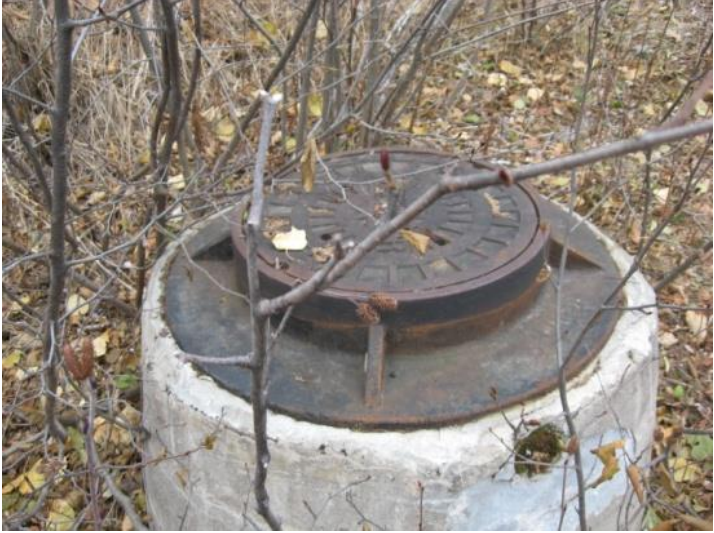
<p><u>09-SD22</u></p> <p>Coordinates (NAD27) Easting: 694294 Northing: 5931245</p> <p>Description: Sewer manhole</p> <p>Location: North of Main Access Road, along sewer line</p>

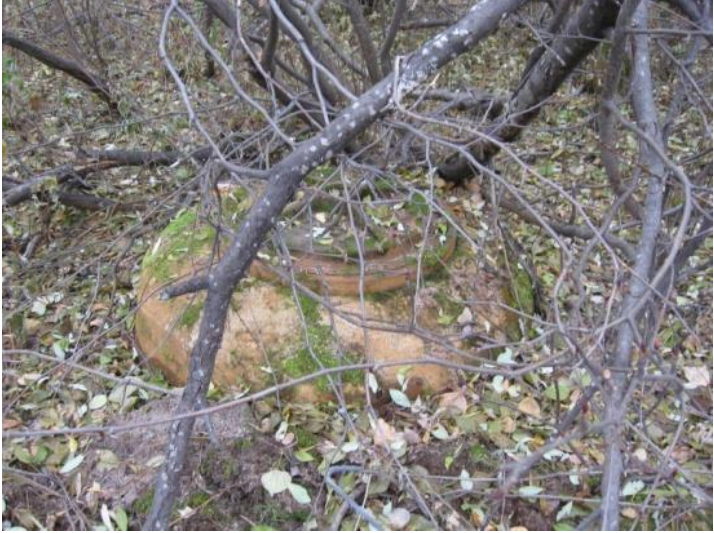
<p><u>09-SD25</u></p> <p>Coordinates (NAD27) Easting: 694254 Northing: 5931379</p> <p>Description: 12 m long 200 mm diameter steel pipe, valve</p> <p>Location: North Bulk Fuel Storage Site</p>

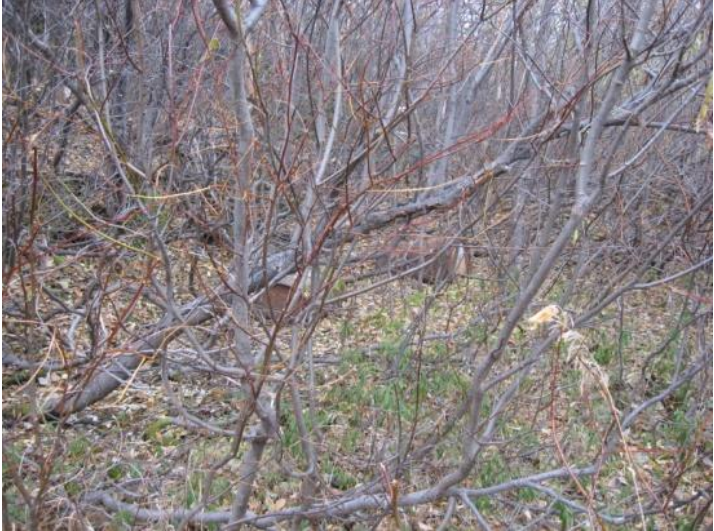
<p><u>09-SD28</u></p> <p>Coordinates (NAD27) Easting: 694288 Northing: 5931210</p> <p>Description: Steel drum, partially buried concrete debris</p> <p>Location: Sewer Site, north of Main Access Road</p>

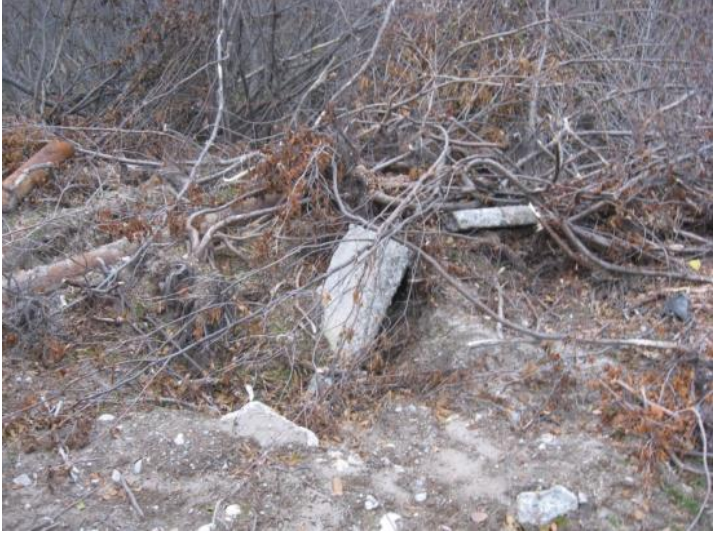
<p><u>09-SD32</u></p> <p>Coordinates (NAD27) Easting: 694142 Northing: 5931167</p> <p>Description: 10 m long 50 mm diameter steel pipe, 10 m long 25 mm conduit (partially buried)</p> <p>Location: Service Site</p>
