November, 2016

Inventory and Assessment of Dams in Eastern Newfoundland

Report Number: 1533903-01-Rev1

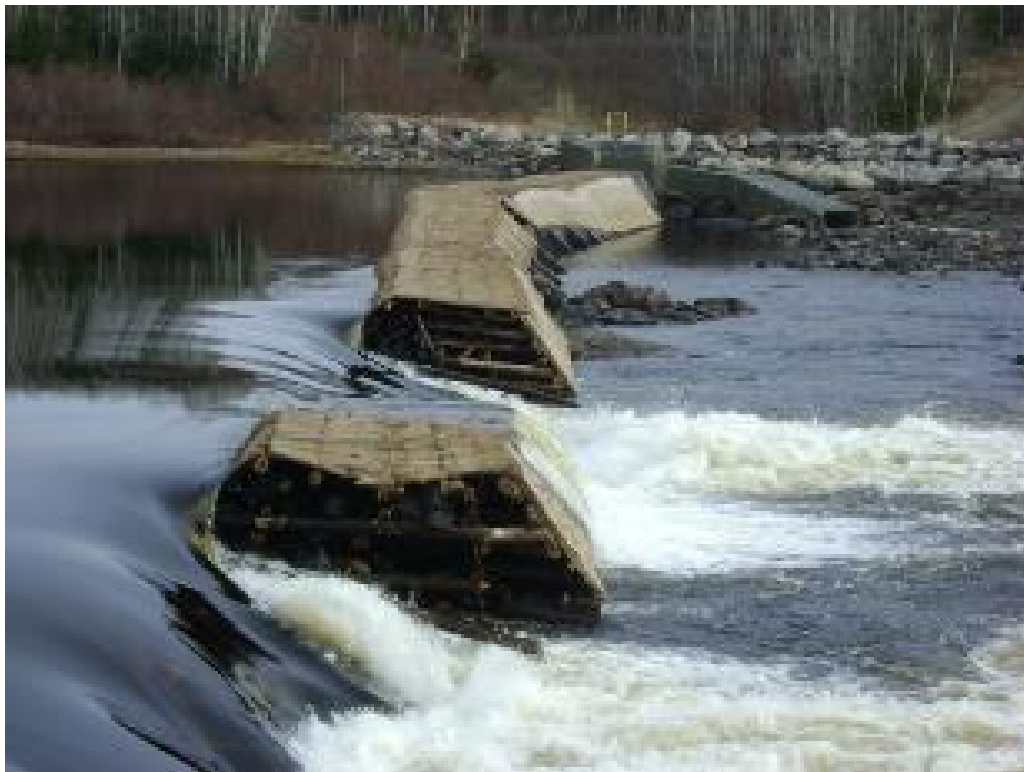
The rockfill timber crib failed in two (2) locations on the south side of Goodyear's Dam. One breach was approximately 22 m in width and the second was approximately 18 m in width. The mechanism of failure is unknown but it is suspected that the heavy rains, high flows, and large chunks of ice flowing down the river weeks prior to the identification of the failure were the cause, i.e., upstream loading.

This failure caused the water levels upstream of the dam to lower for approximately 4 to 5 km and rendered the fishways on the north and south sides of the dam inoperable. There was no effect downstream and there was no risk to public safety or loss of life. The failed dam can be seen below in Figure 1.

Figure 1: Goodyear's Dam – showing the two failed sections.

In order for repairs to take place the water level in the Exploits River would have to be significantly lowered to undertake remedial work and all emergency repairs needed to be completed prior to winter to prevent the loss of power production at the Grand Falls Hydroelectricity Facility. It is known with some confidence that emergency repairs were completed, however the details of these repairs have not been provided to Golder.

The cost to permanently repair the damages caused by the failure was estimated to be on the order of \$20 million. In April, 2016 Nalcor issued an RFP for the detailed design of the Goodyear's Dam.

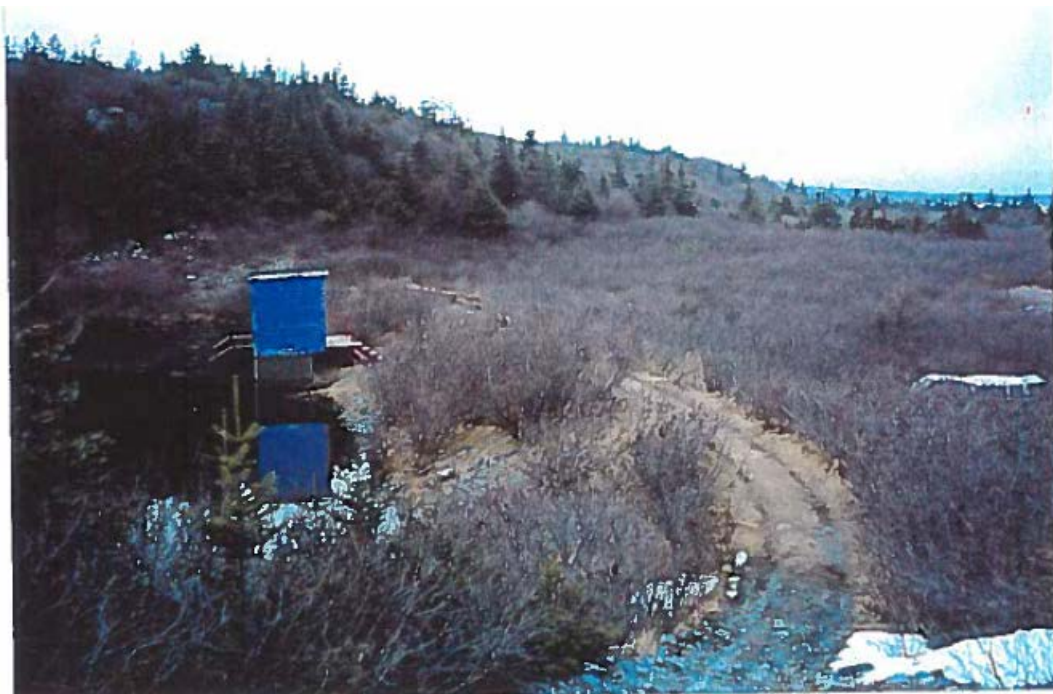
Figure 2: Dam 1 (Merrymeeting Pond) – looking along the crest.

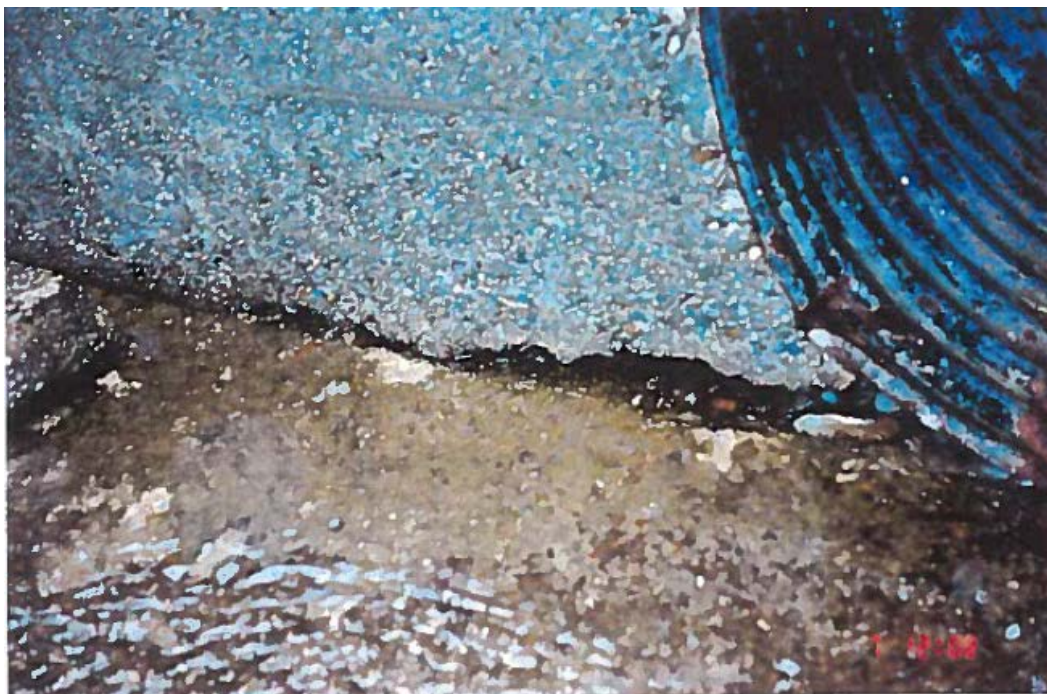
There was water seepage observed at the toe of the dam below the concrete spillway. A small gap had formed in the wall, allowing overflow water to pass through, underneath the control structure.

This seepage was considered evidence of a minor failure and was caught before anything more significant could have happened. There was minimal damage to the dam and there was no risk to public safety or loss of life. Figure 3 shows cracking in the concrete spillway.

Figure 3: Dam 1 (Merrymeeting Pond) - cracking in spillway

It is unknown if the recommended repairs were completed to the dam. The cost to repair the seepage was estimated at approximately \$21,000.

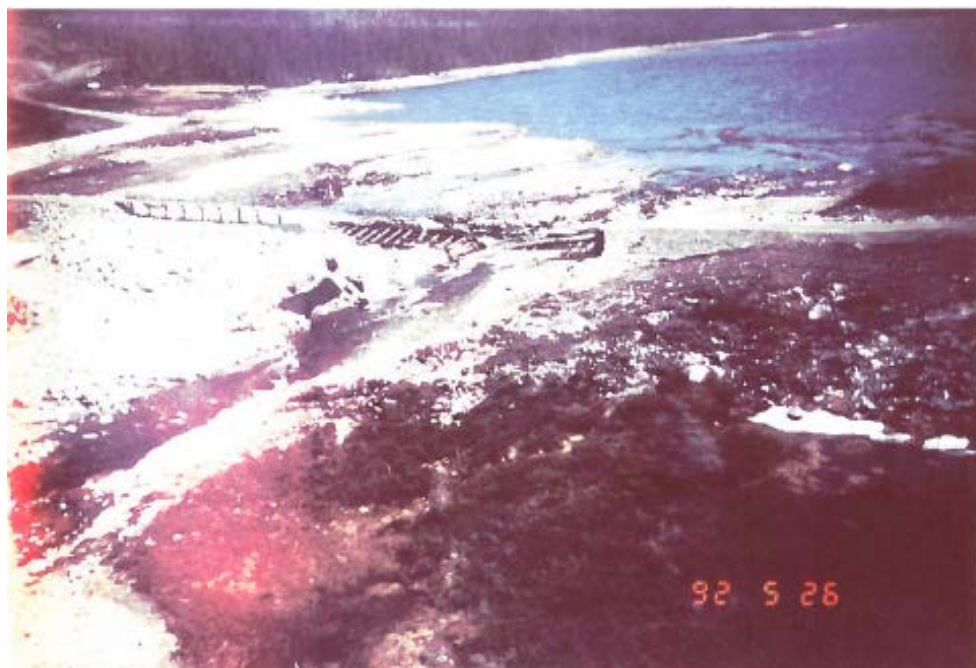
Figure 4: Joe Dennis Pond - aerial view of the dam from downstream.

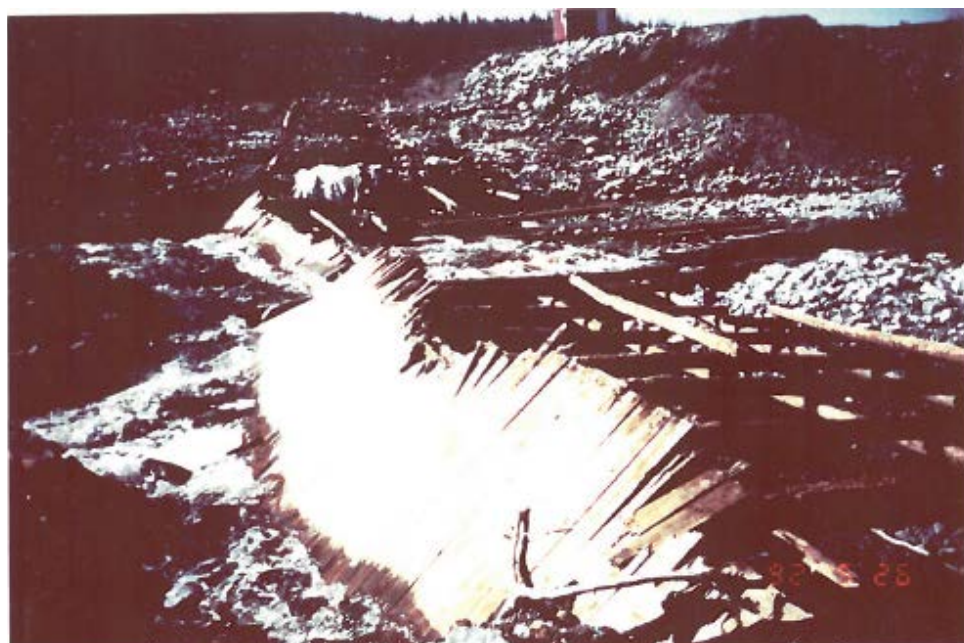
The mechanism of failure is believed to be the reoccurrence of undercutting to the upstream timber cutoff membrane of the timber cribwork outlet structure at the foundation and the subsequent washing out of the ballast.

This failure caused damage to the forebay structures, washouts and damage to a fibreglass penstock, washouts on the main access road, undermining steel penstock supports, soil washouts and infilling at the powerhouse and tailrace discharge channels. The main access road to the powerhouse was also washed out.

Figure 5: Joe Dennis Pond Dam - remains of the former dam just upstream of the new structure.

It is unknown if repairs were made to the original dam after the failure. Figure 5 shows the remnants of the old structure.

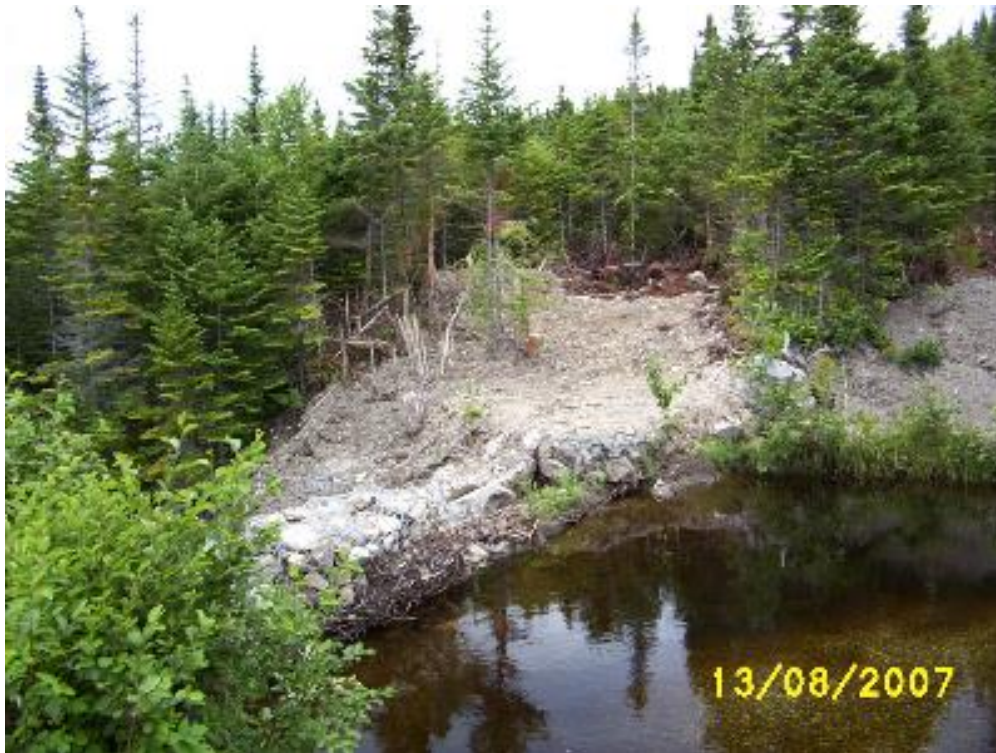
The original McIvers Reservoir Dam was constructed of gabion baskets and there were a few occurrences of minor failure prior to 2010, i.e., prior to 2010, when the water level was high in the brook, one or two of the gabion baskets would get dislodged in the dam. However, there was no damage caused by the failure and no loss of life or danger to the public. The gabion baskets in place prior to 2010 are seen below in Figure 6.

Figure 6: McIvers Reservoir Dam – showing the gabion wall

There were no chronological changes and the only repair to the dam structure was repositioning the gabion baskets prior to replacing the original dam structure in 2010 with a concrete structure. The cost of dam failure is unknown.

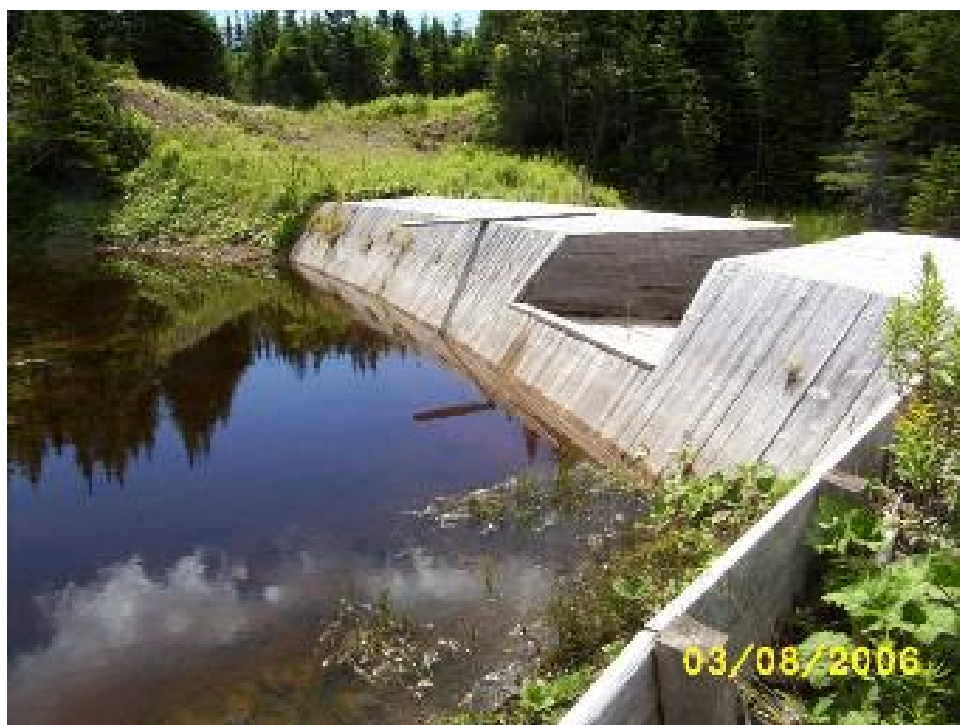
Figure 7: Sheaves Cove Dam - Showing the upstream side of the main dam.

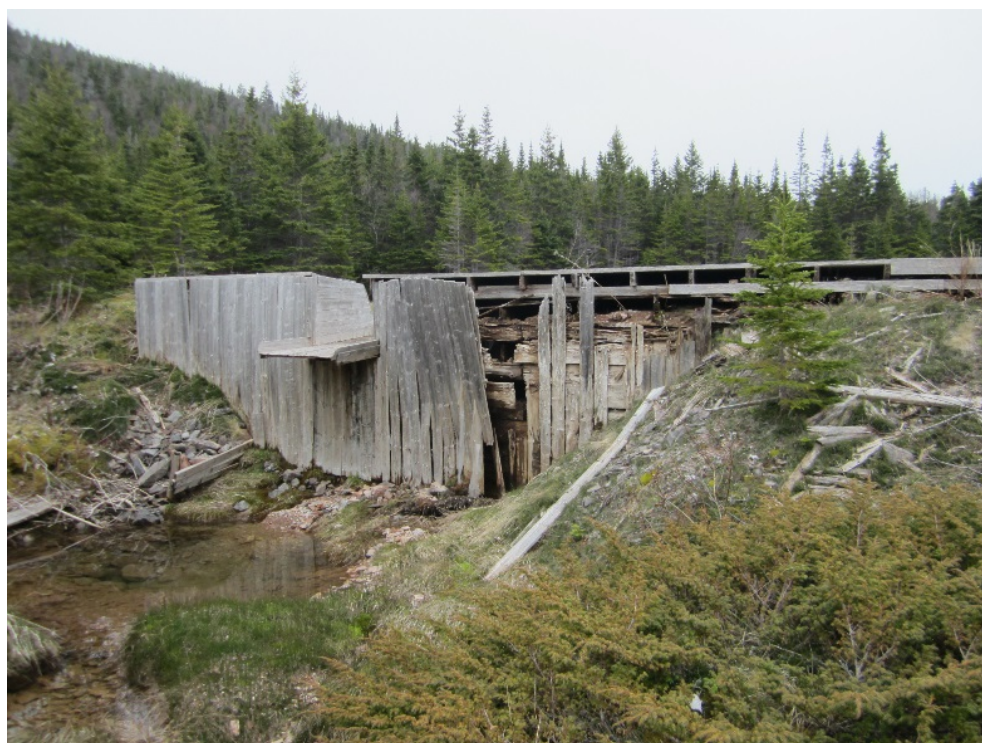
There have been no chronological changes or repairs to the dam structure and it is continuing to deteriorate.

Figure 8: Sheaves Cove Dam – showing deterioration of the downstream side of the main dam.

The cost to replace the dam would be approximately \$250,000.

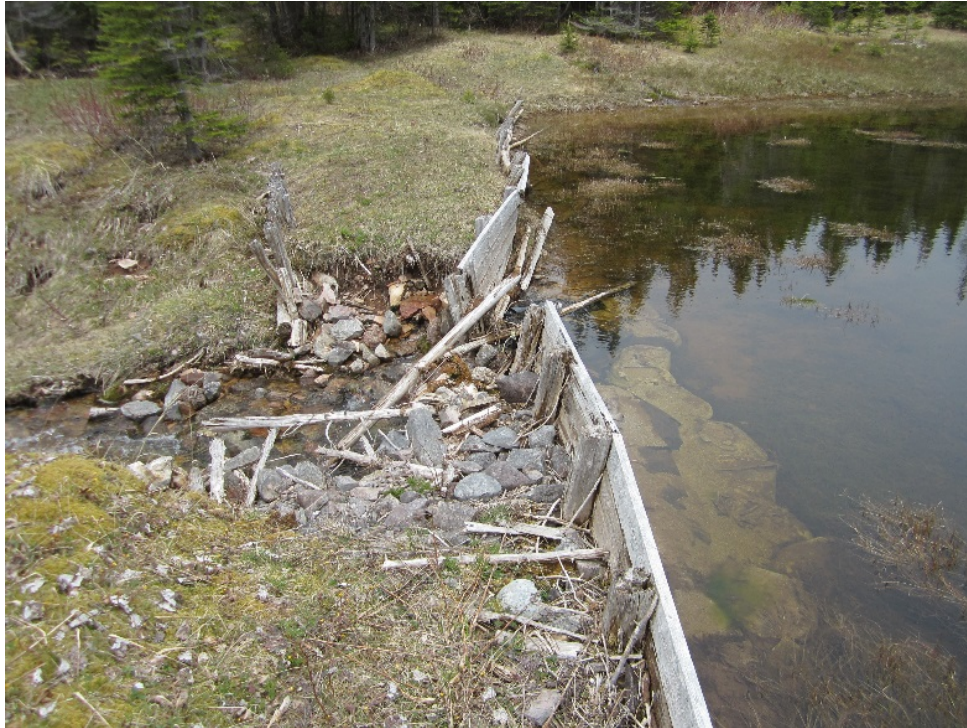
Figure 9: Sheaves Cove Dam – showing the small reserve dam and failed area.

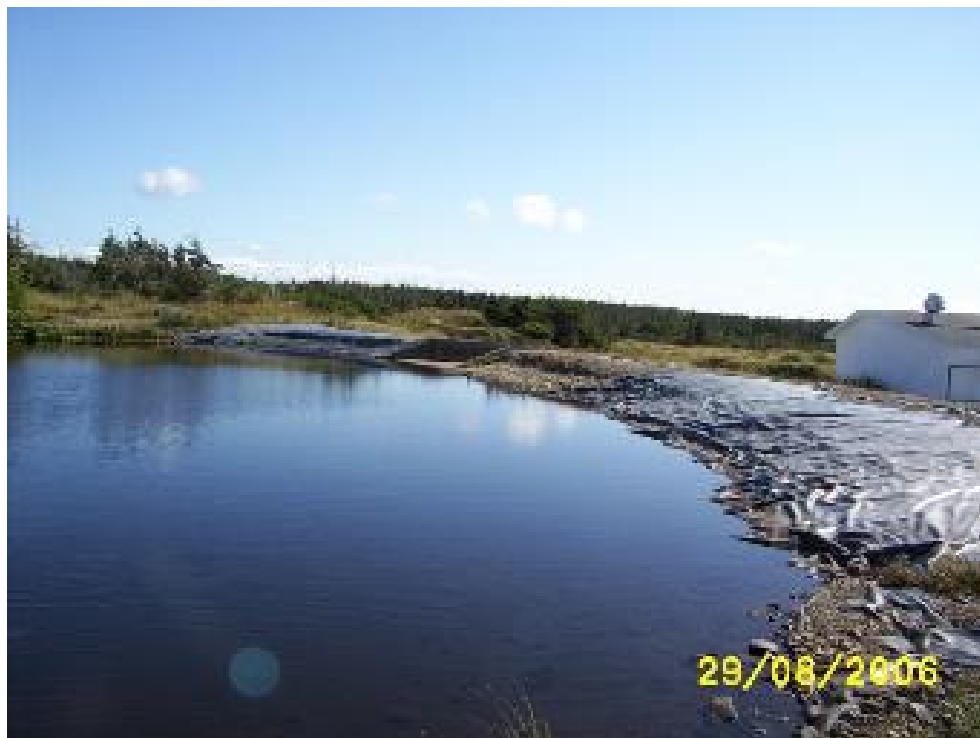
Figure 10: Well Cove Brook Dam – showing reservoir.

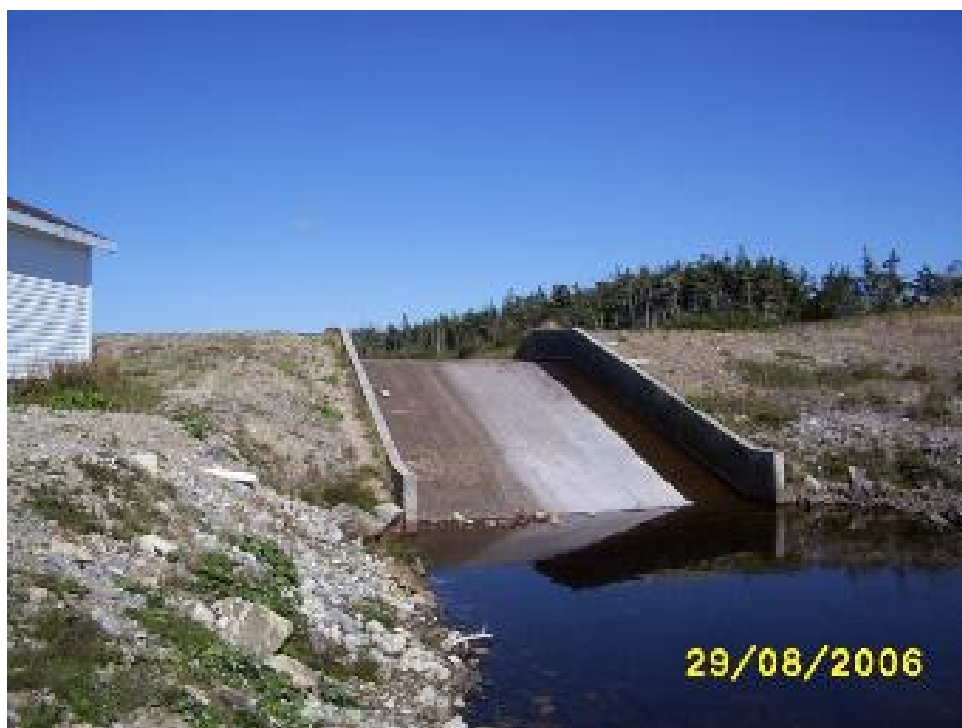
Figure 11: Well Cove Brook Dam – showing spillway (photo 1).

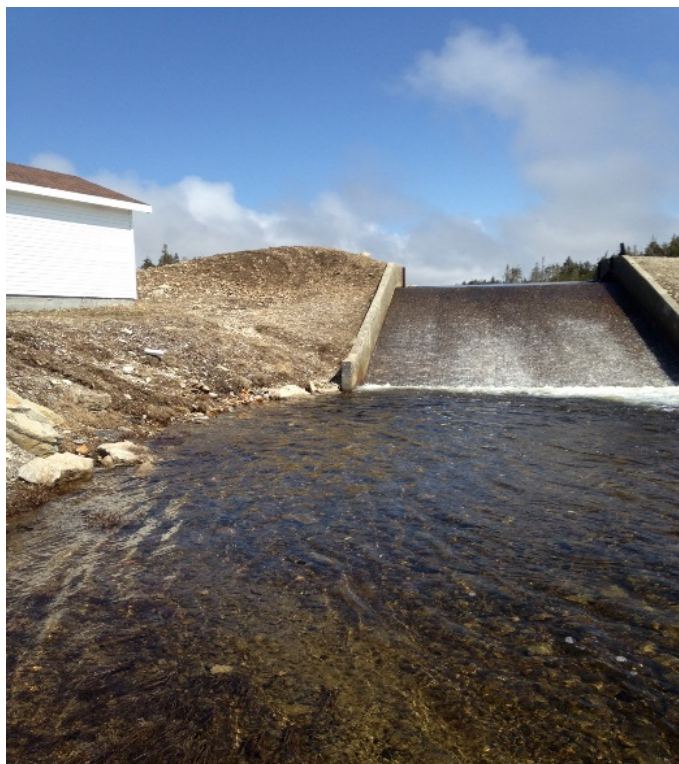
Figure 12: Well Cove Brook Dam – showing spillway (photo 2).

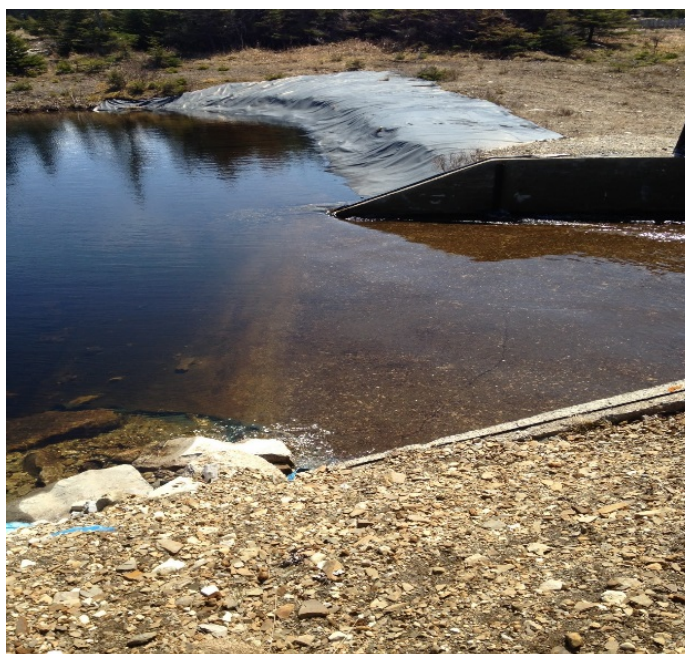
Figure 13: Well Cove Brook Dam showing spillway on the upstream side.

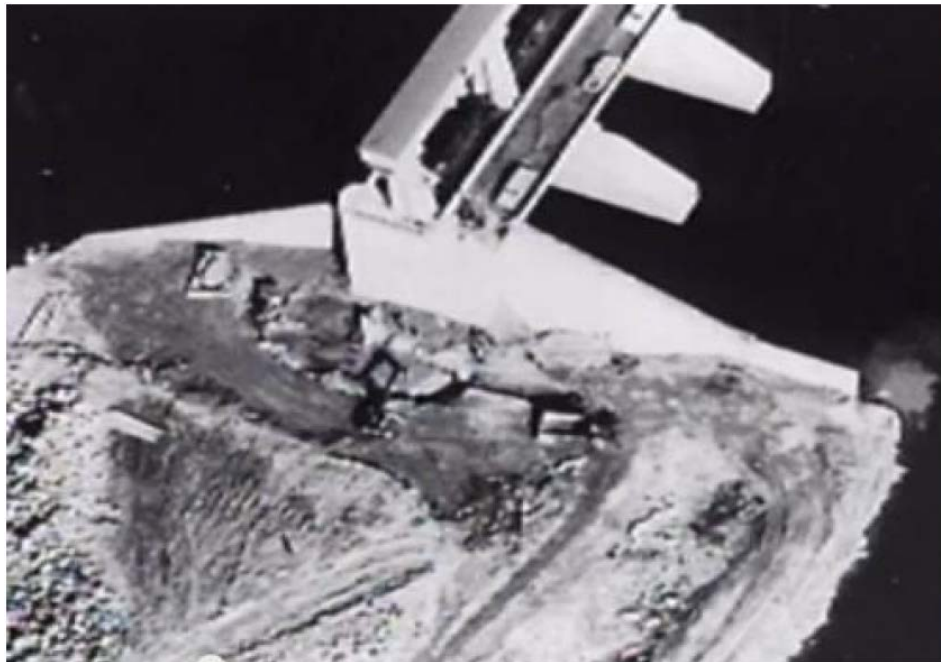
Figure 14: Dike GJ-11A – showing aftermath of the washout.

Cofferdams were constructed upstream and downstream of the area that required repairs. The dike section was excavated to bedrock which was determined to be acceptable as a foundation. A grout curtain was installed up to 12 m into the rock and was followed by reconstruction of the dike embankment. The repairs were effective and there haven't been any other issues with this dike since the project began power production in 1971.

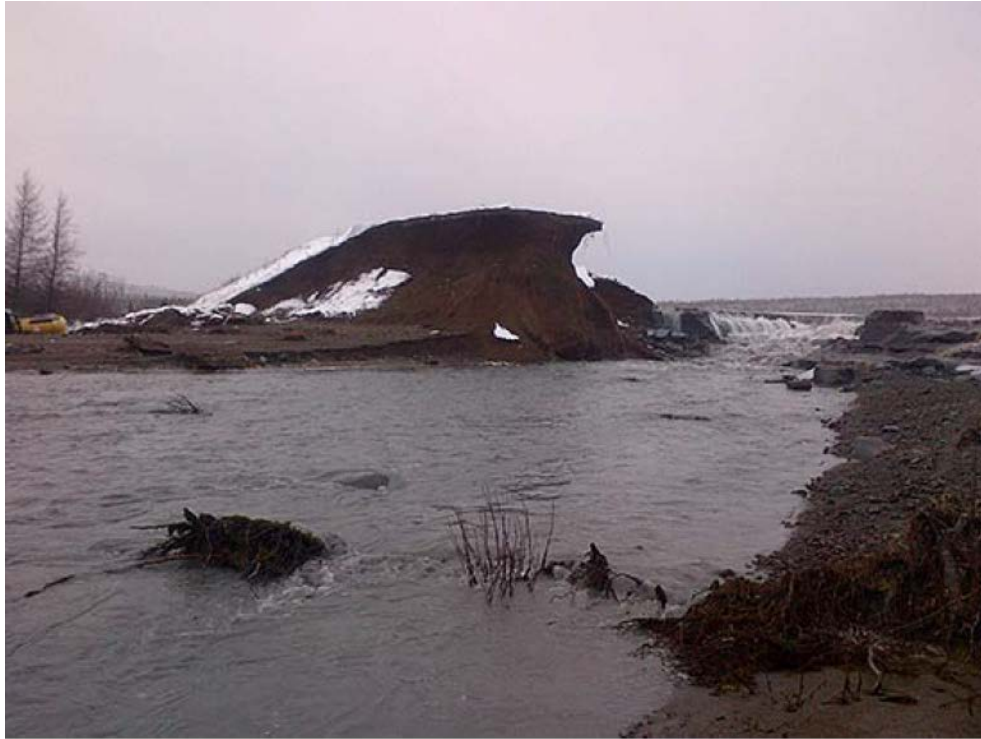
Figure 15: Gullbridge Tailings Dam – showing the breached section.

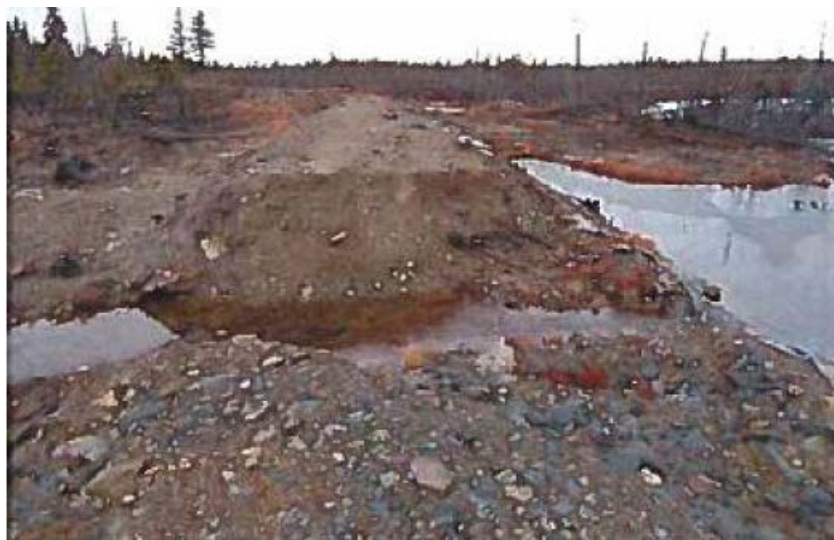
Figure 16: North Embankment Dam - circa 2010-2012, looking northwest towards the breach.

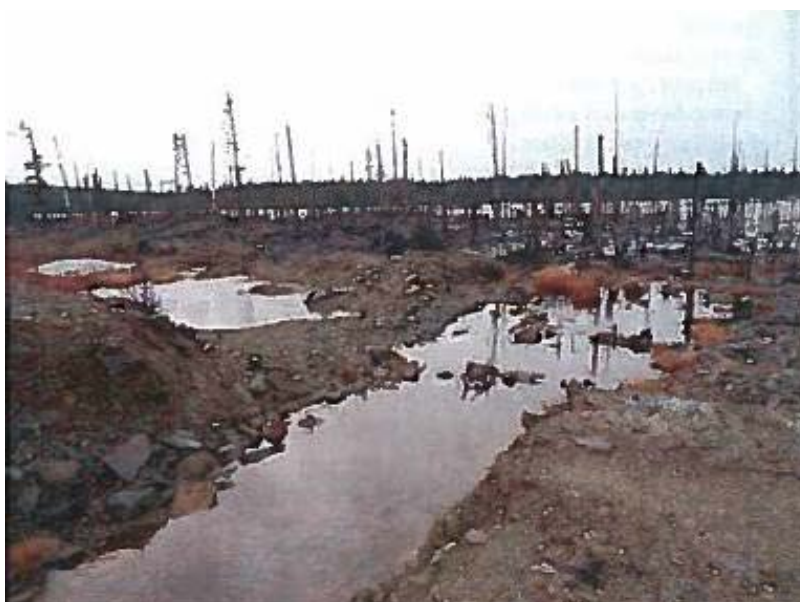
Figure 17: North Embankment Dam - circa 2010-2012, looking south towards the dam.

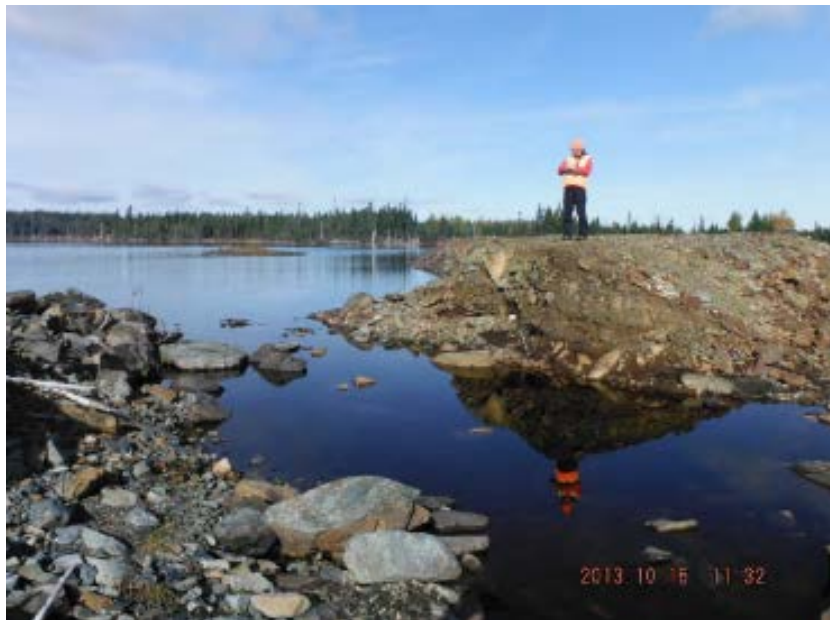
It was reported by the Department of Natural Resources that the breach in this dam at this location has occurred at least twice before and has been repaired twice, in 1995 and 1999. It is unknown if any remedial work has occurred since it was reported in 2013.

Figure 18: West Dam – showing the breached section.

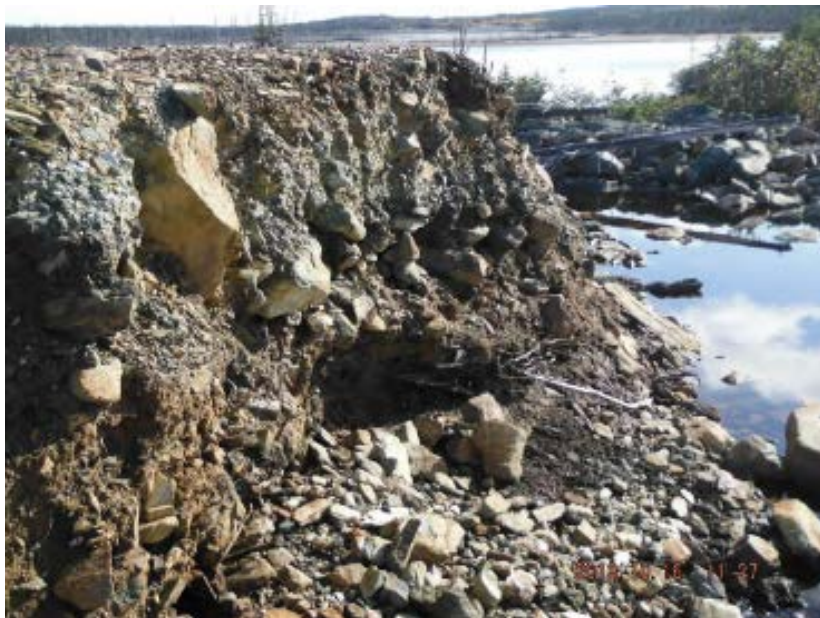
Figure 19: West Dam – showing the material within the dam.

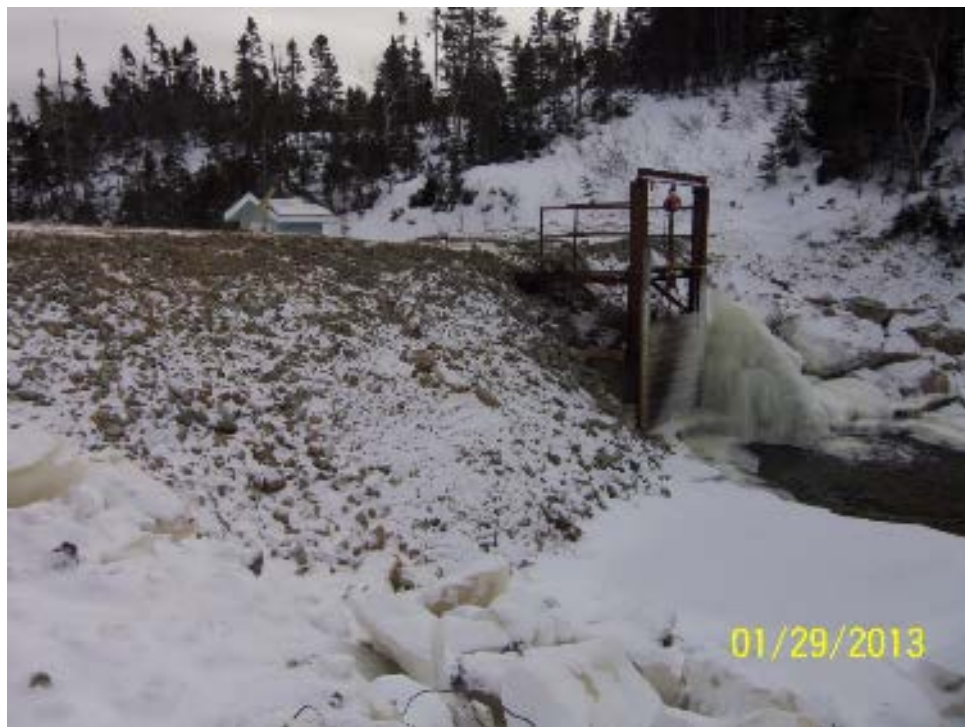
Figure 20: Nugget Pond Polishing Pond Dam – showing repairs to the dam.

The repaired dam can be seen below in Figure 20.

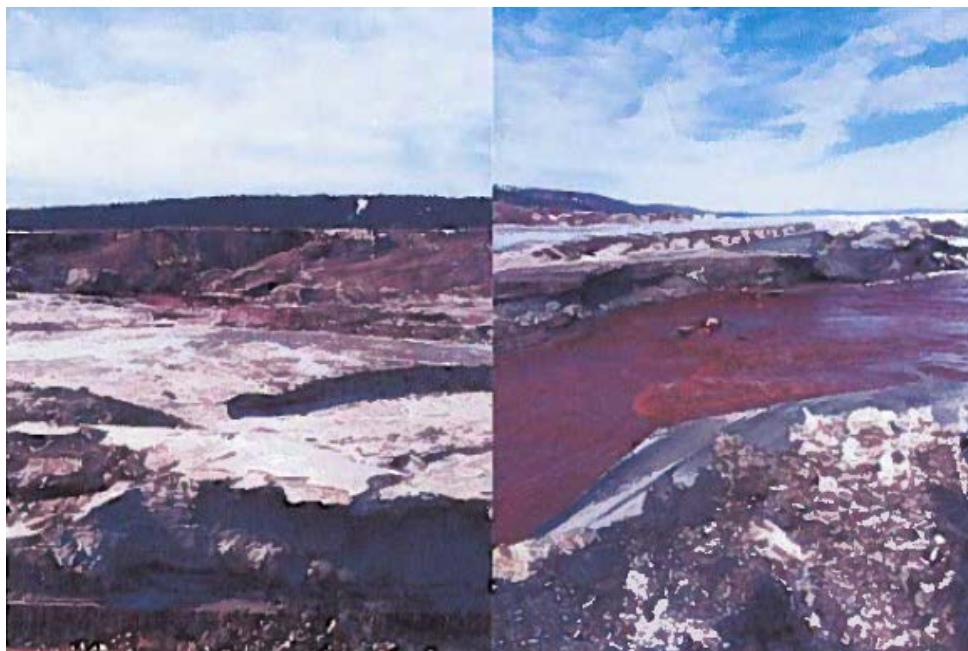
Figure 21: Central Control Dike – showing extent of the failed tailings.

Emergency repairs commenced immediately by mobilization of a local contractor. Additional height (< 2 m) and length (< 200 m) was added to the dam over a period of a few months (March to October, 2015).

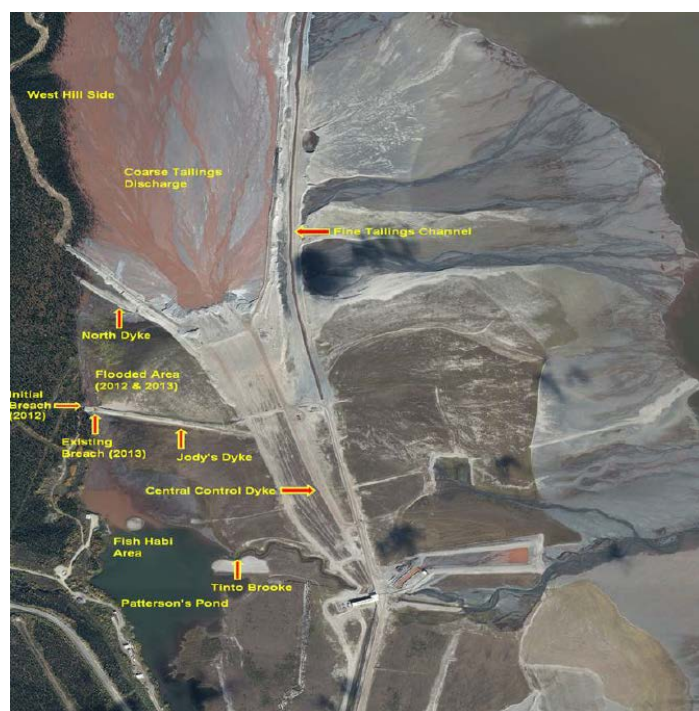
Figure 22: Jody's Dike – showing the location of the dike failure and the IOC Tailings System.

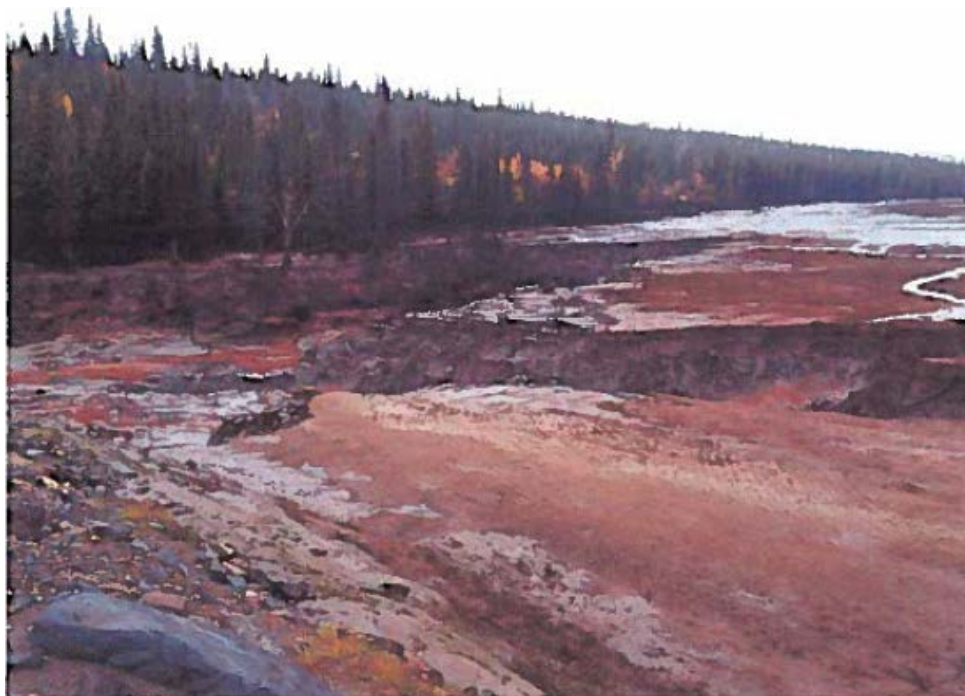
Figure 23: Jody's Dike – showing the extent of the 2012 breach.

Repairs were made to the first breach that occurred on September 30, 2012 using rock/gravel. The 2013 breach was repaired with a permanent rock-lined spillway between late August and early October of 2015. This work was performed under NL Department of Environment and Conservation, Water Resources Management division, permit number ALT7764-2014 dated Nov. 17, 2014.

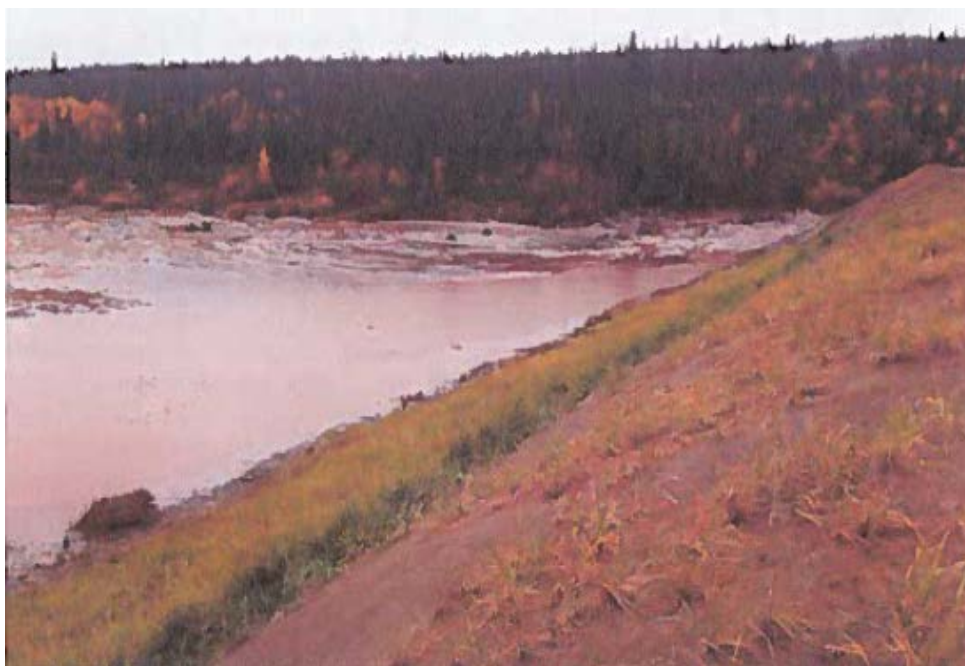
Figure 24: Jody's Dike – showing the extent of the 2013 breach.

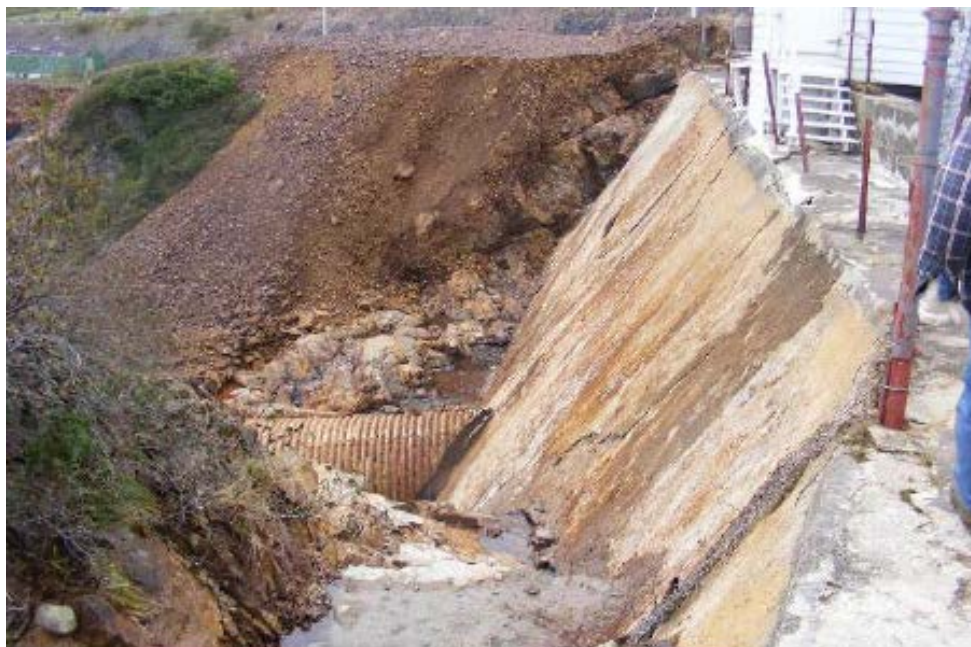
Figure 25: Lawn Forebay Dam – showing eroded abutments.

This work was planned to be completed during the summer of 2011, however it is unknown if this work was completed.

The estimated cost to repair the dam was approximately \$450,000.

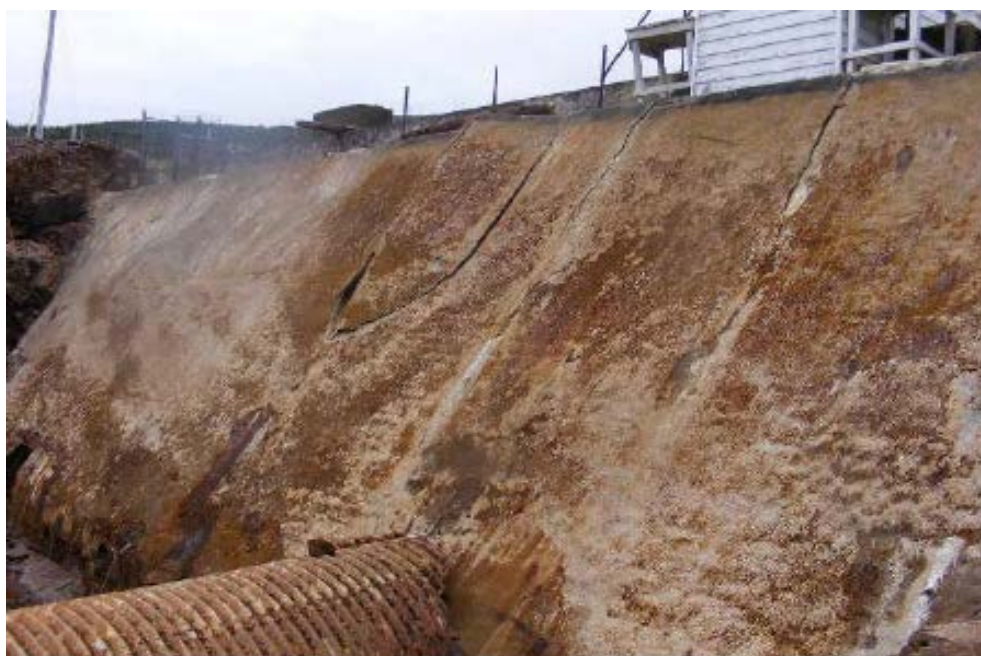
Figure 26: Lawn Forebay Dam - showing cracked and displaced concrete.

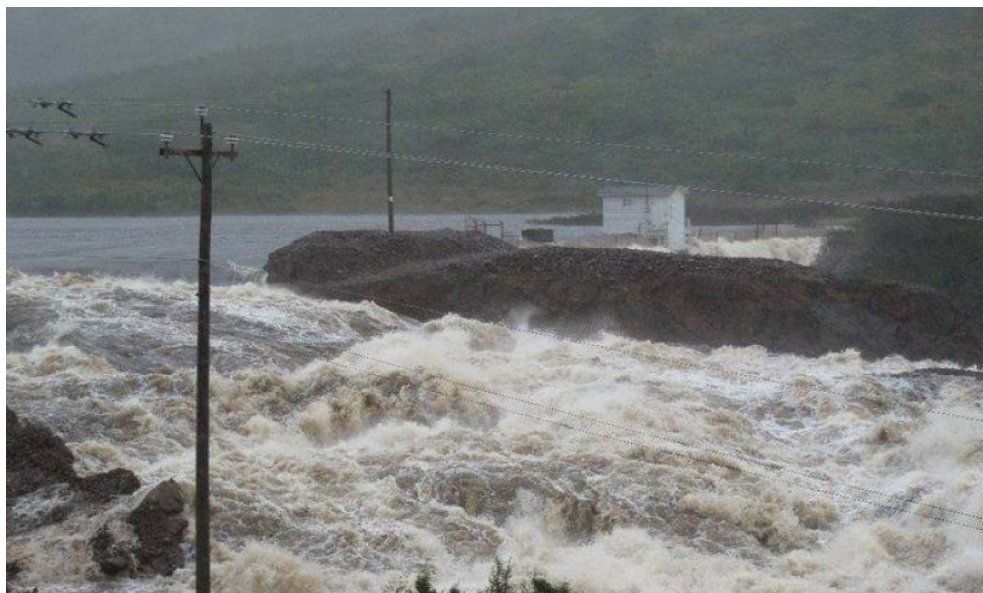
Figure 27: Flooding in Lawn caused by Hurricane Igor.

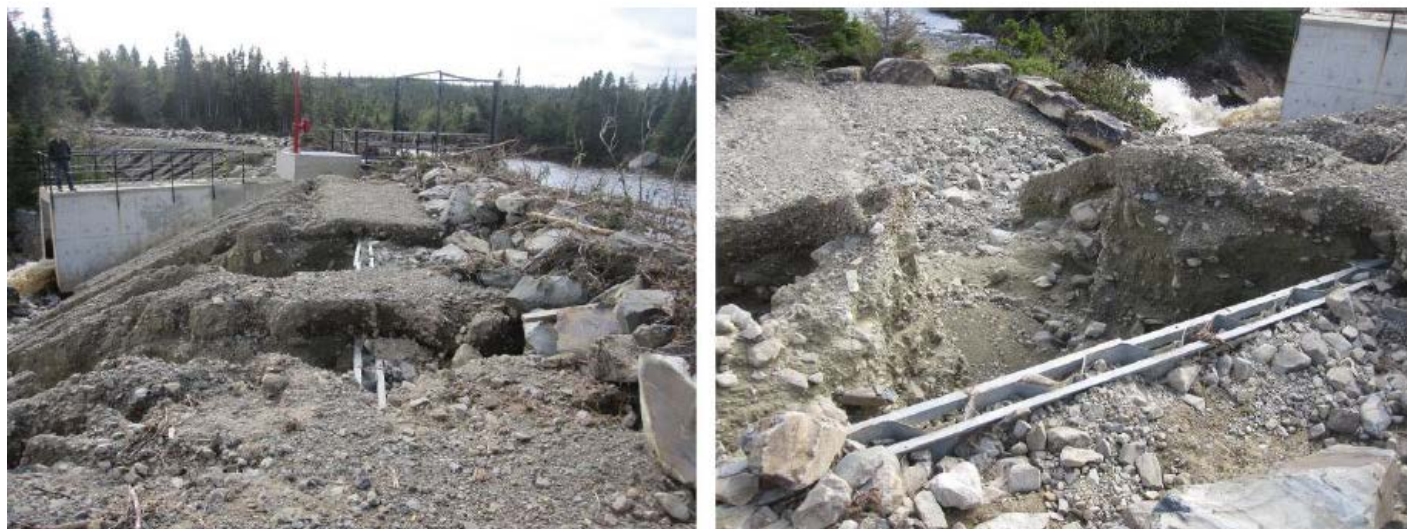
Figure 28: Port Union Hydroelectric Development - showing erosion along the dam and the dam's steel core.

Details on the repairs to the dams has not been provided, however it was mentioned in the report that this was completed as part of the hurricane clean up in 2010. The above work was planned to be completed by September 2011.

The cost of these dam failures was estimated at \$1.65 million. This includes an estimated \$320,000 that was spent in 2010 to refurbish various dams, site cleanup and securing the site for the winter.

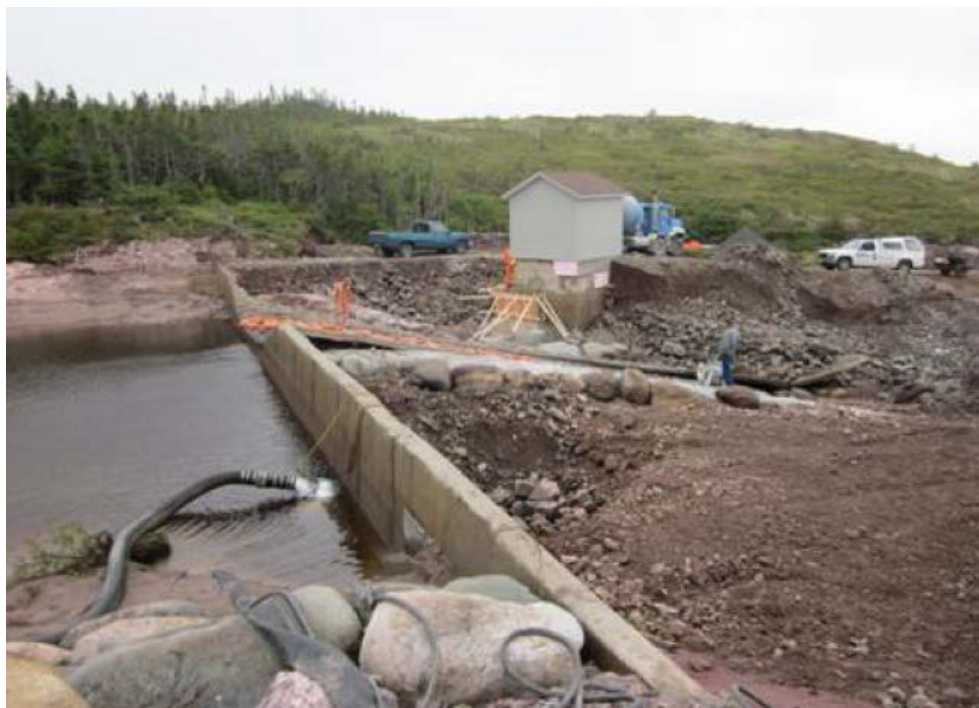
Figure 29: Sunnyside Water Supply Dam - showing damage to the dam.

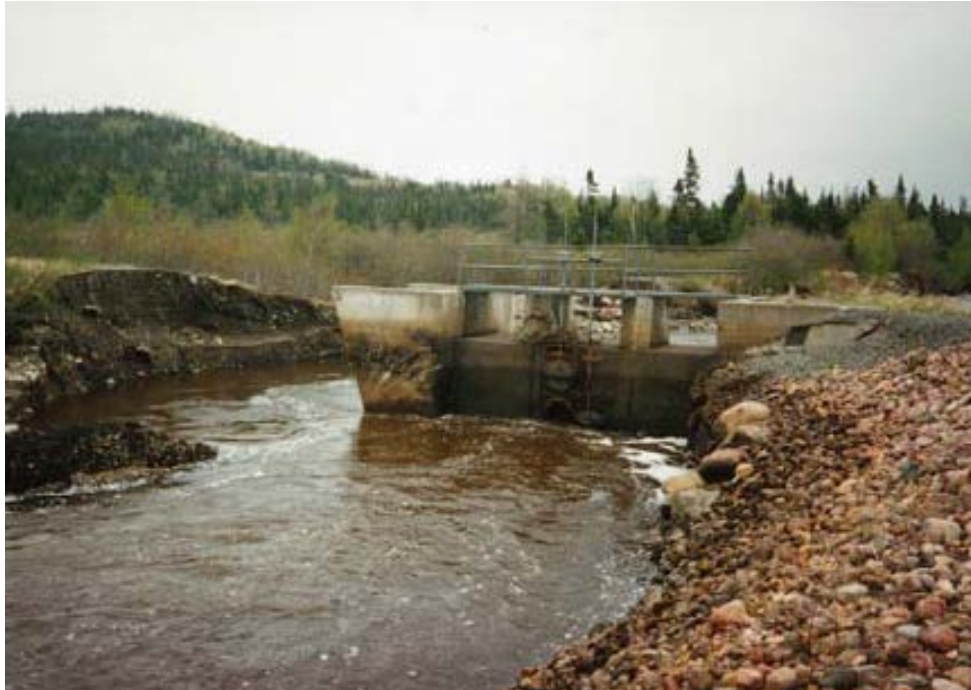
Figure 30: Bully's Pond Dam - showing the dam failure in 1995.

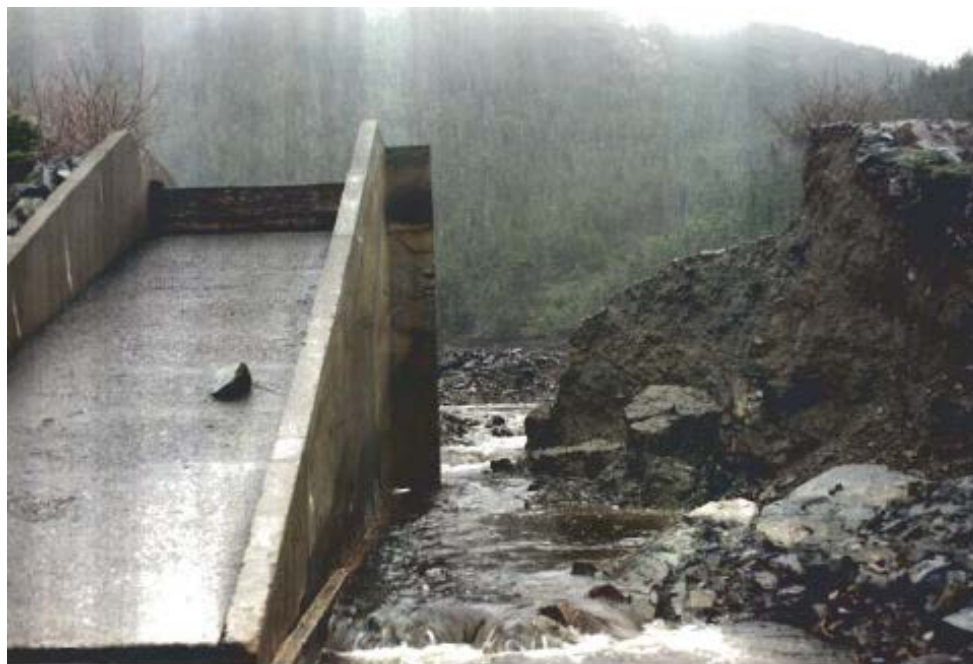
Figure 31: Granfer's Pond Dam – showing showing the dam washout and the stoplogs in the spillway.

The chronological changes or repairs to the dam are unknown. The dam was replaced then abandoned.

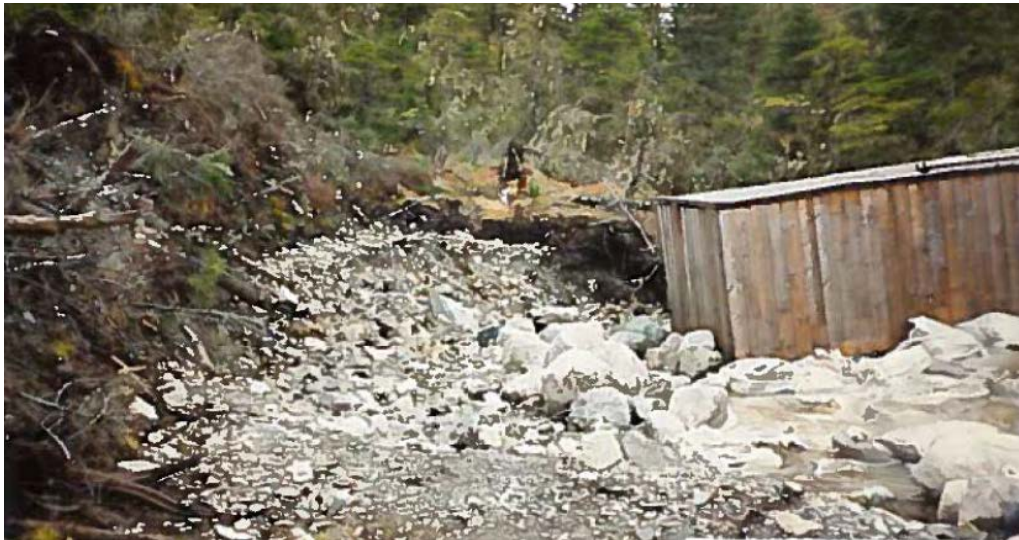
Figure 32: Hender's Brook Dam – showing dam failure in 1991.

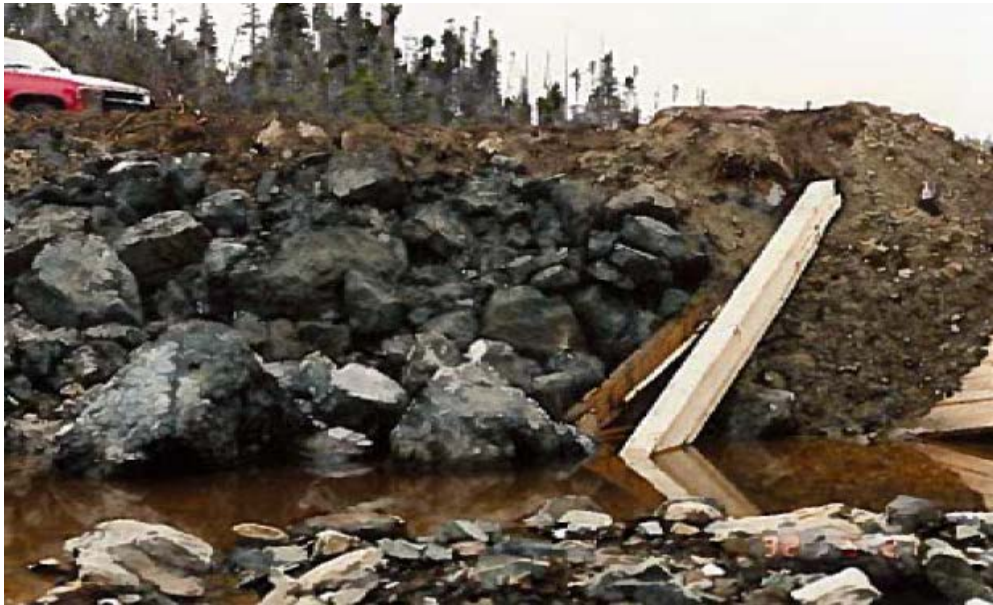
Figure 33: Terra Nova Mining Water Supply Dam – showing damage to the water supply dam.
