November, 2016

Inventory and Assessment of Dams in Eastern Newfoundland

Report Number: 1533903-01-Rev1

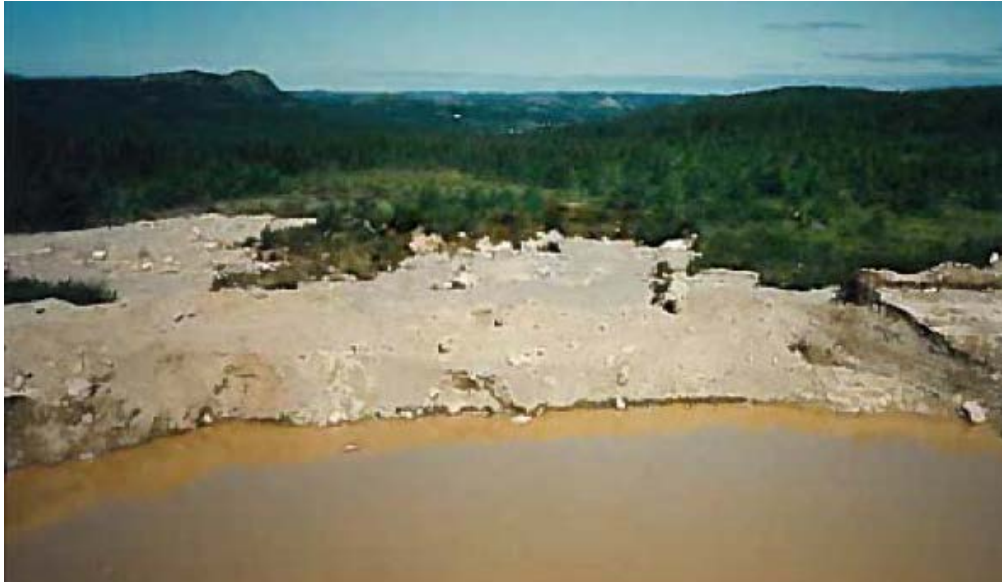
Figure 34: Concrete Products Berm – showing section of the berm that breached.

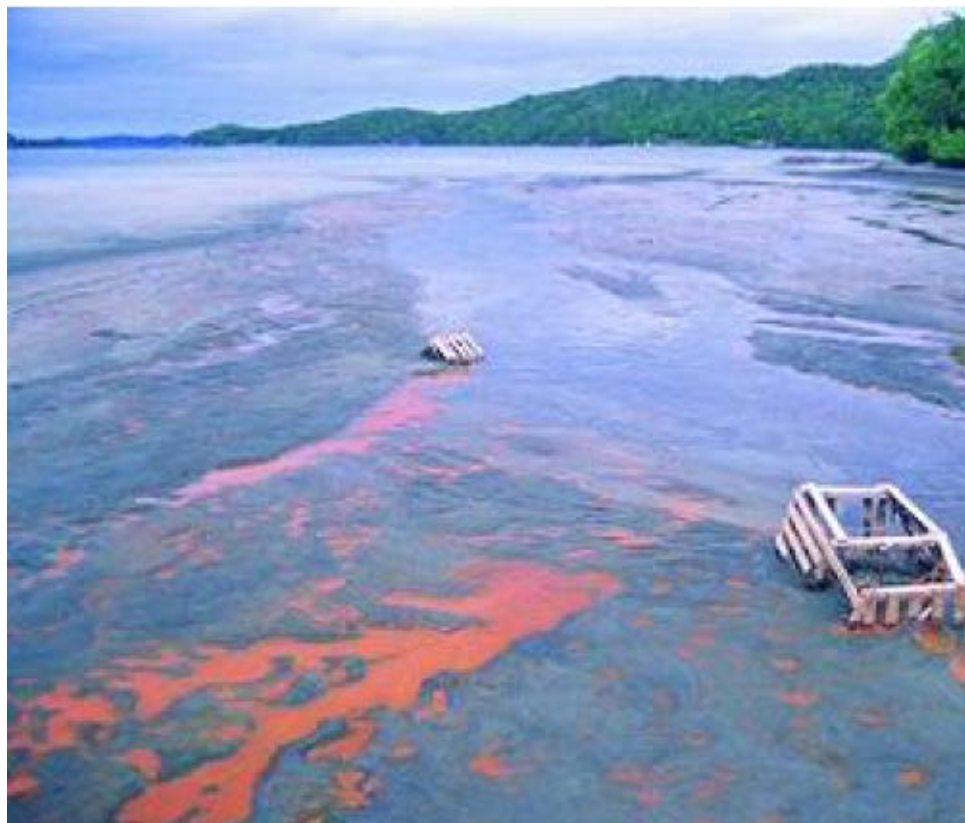
Figure 35: Little Bay Copper Mine Tailings Dam – showing tailings that were deposited due to the dam failure (Photo courtesy of DFO)

The cost to rehabilitate the site was \$500,000.
