Technical Memo: Deer Lake Seepage Issue

Prepared for: Haseen Khan, P.Eng.

Prepared by: Paula Dawe, P.Eng.
Water Resources Management Division
Department of Environment and Conservation
Copies: Department of Municipal Affairs, Town of Deer Lake
Date: June 30, 2014
File Number: 533-06

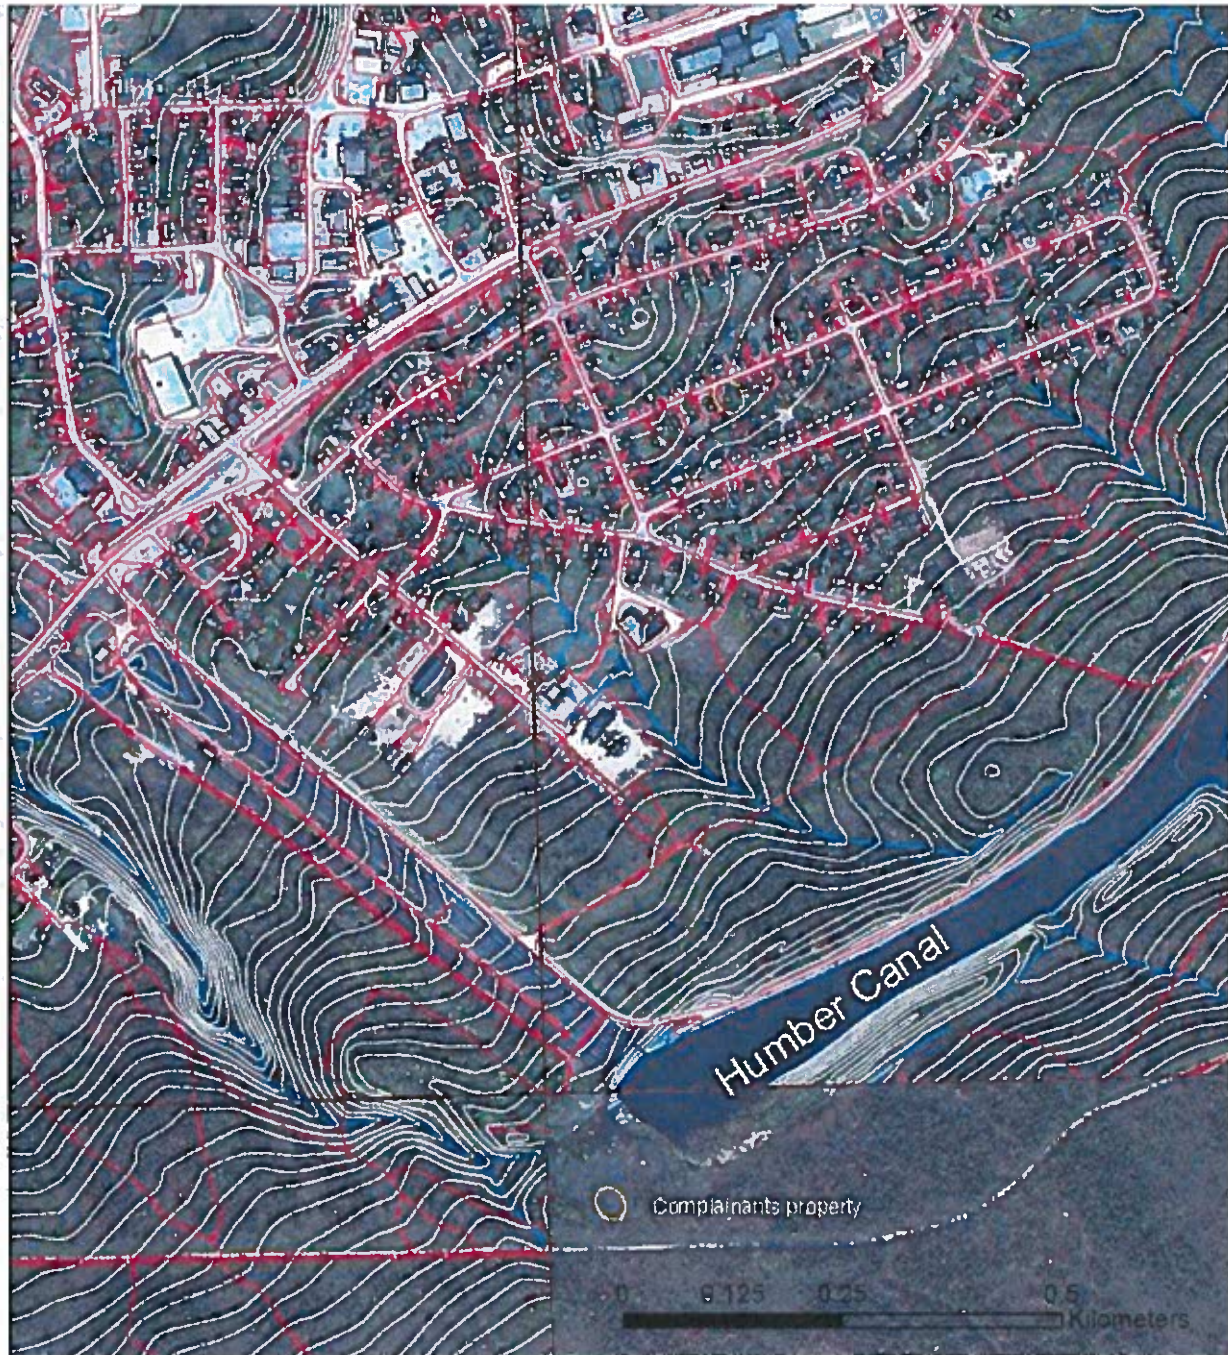
Figure 1: Deer Lake residential area downstream of Humber Canal and affected by high groundwater levels

As indicated in Figure 1 (produced by ENVC) and Figure 3 (produced by DLP), there are two surface water streams running directly through this neighbourhood. These streams appear to be the continuation of original stream channels that drained into Deer Lake prior to development of the town and canal. You can see how the Humber Canal appears to cut across these streams, interrupting the original flow pattern. As this residential area developed there were efforts to partially channelize and redirect flows from these streams through the town's stormwater system, however, it appears homes were build over or very near the original streambed. Properties in closest proximity to these original stream channels tend to be experiencing more flooding issues.

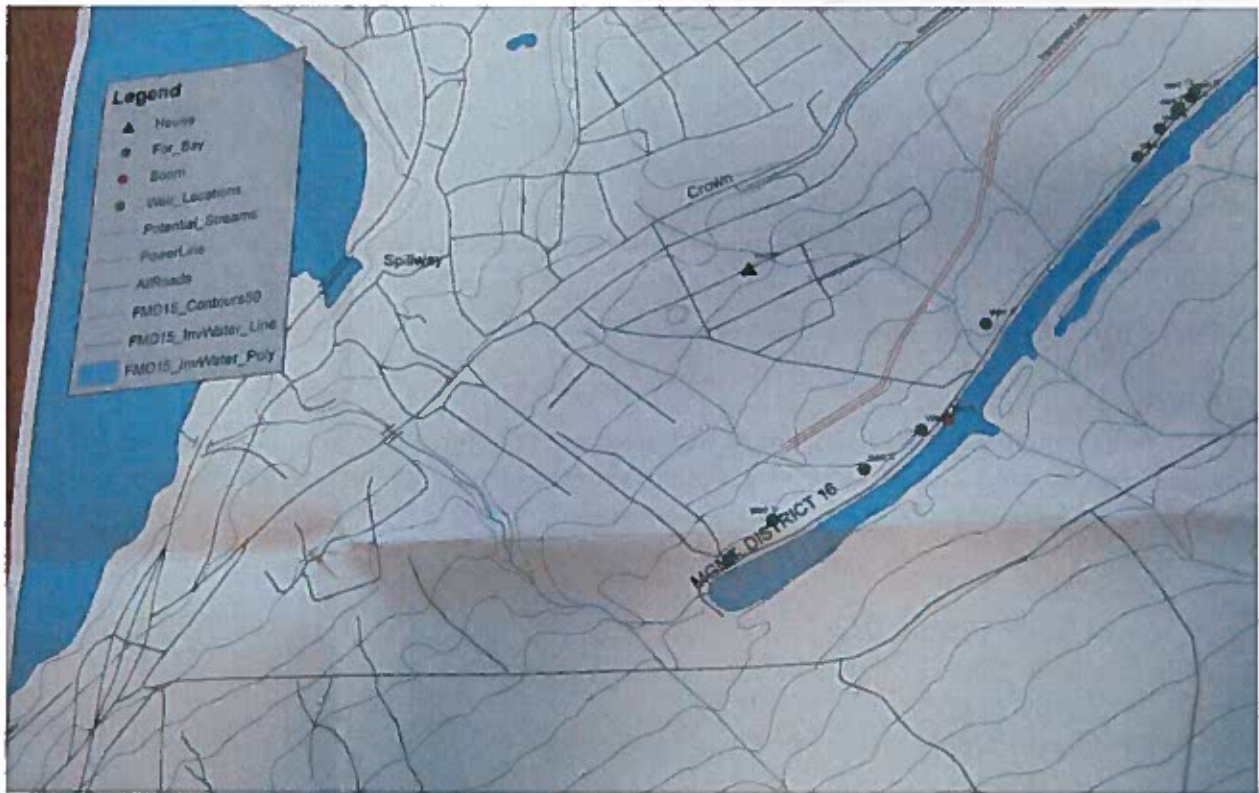
Figure 3: DLP produced map indicating seepage monitoring weirs and natural surface water drainage

There are 18 monitoring weirs located along the downstream toe of the Humber Canal to monitor seepage, as indicated in Figure 3. Figure 6 shows weir # 2 and weir # 4. The review indicated that it is wet at most locations along the downstream toe of the West Bank Dyke, immediately

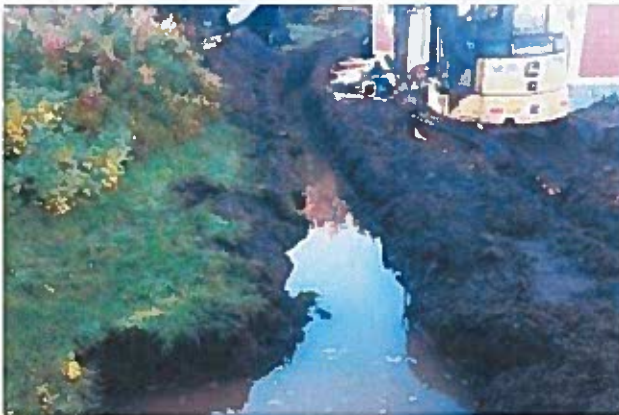
Figure 4: Western Star photo- Richard Dewey took this picture of the trench he dug in his yard to show the town how properties around the Deer Lake canal are being flooded

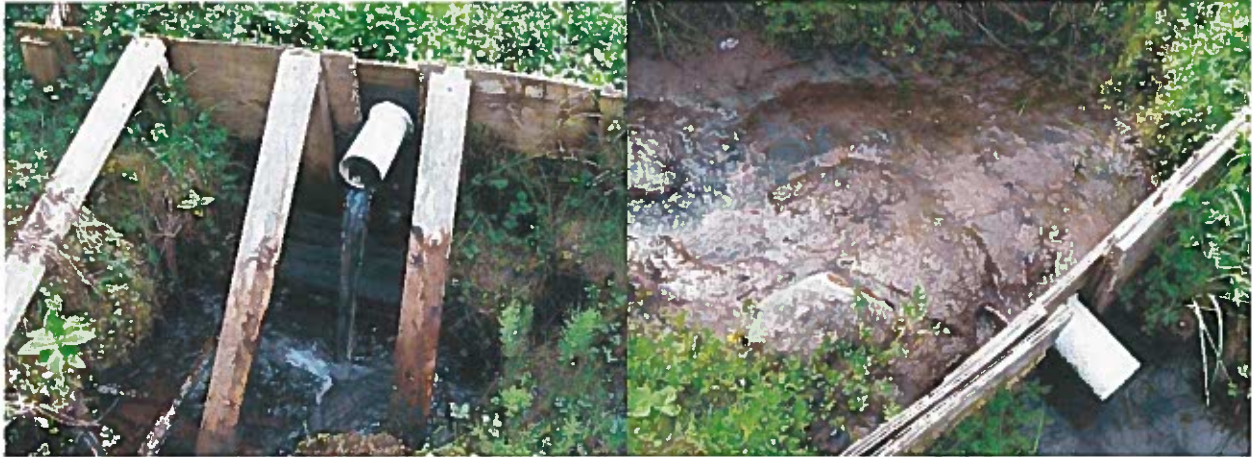
above the Town of Deer Lake. Identification of seepage, however, is impeded by the thick trees, brush and grass allowed to grow up along the downstream slope of the dyke. The downstream face of the West Bank Dyke is particularly overgrown along the section between Weirs 1 & 4. Weirs 1-4 are the closest in proximity and directly upstream of the neighbourhood of interest. Sediment was observed deposited upstream of Weirs 3 and 4.

Figure 6. Weir 2 (left) and Weir 4 with accumulated sediment (right) monitoring seepage from the toe of the West Bank Dyke

- DLP must provide flow data from weirs 1-18 to both the town and ENVC for evaluation and must continue to monitor and record this seepage information from the Humber Canal on a regular basis.
- DLP should provide a copy of the 2013 Dam Safety Review to the Town of Deer Lake.
- DLP must develop an action plan for the implementation of recommendations made in the 2013 Dam Safety Review.
- DLP must continue to work cooperatively with the Town of Deer Lake for the long-term solution to this issue.
- DLP to provide a copy of their Operation, Maintenance and Surveillance Manual to ENVC.
- DLP to fill out Dam Inventory Forms for Canal Intake Control Dam, Long Bank Dam, Deep Bank Dam, West Bank Dyke and Forebay Dam.
- DLP to include in its planning a phased approach to hydrometric station upgrades.

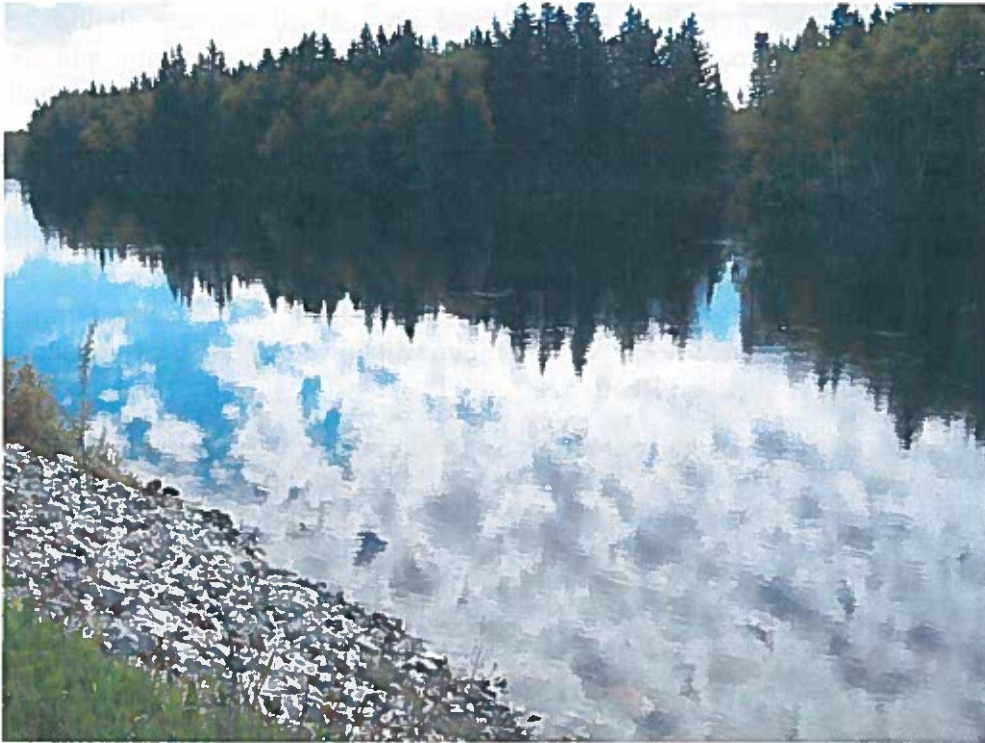
As shown in Figure 7, recent repairs to the upstream face of the West Bank Dyke were observed in a couple of locations including in the vicinity of Weirs 7 & 8. Locations of repairs coincide with the outlet of streams into the Canal from the opposite south bank. Weirs 3 & 4 also coincide with the location of stream outlets from the opposite south bank. These locations should be monitored carefully for seepage from the canal, sediment in the seepage, and any deterioration in the upstream or downstream face of the dyke. DLP lowers the water level in the Humber Canal twice a year in order to do an inspection by boat. Figure 6 shows repair work to the upstream face of the west bank dyke.

Figure 7: Repair of upstream face of West Bank Dyke opposite of natural stream in the vicinity of Weirs 7 & 8

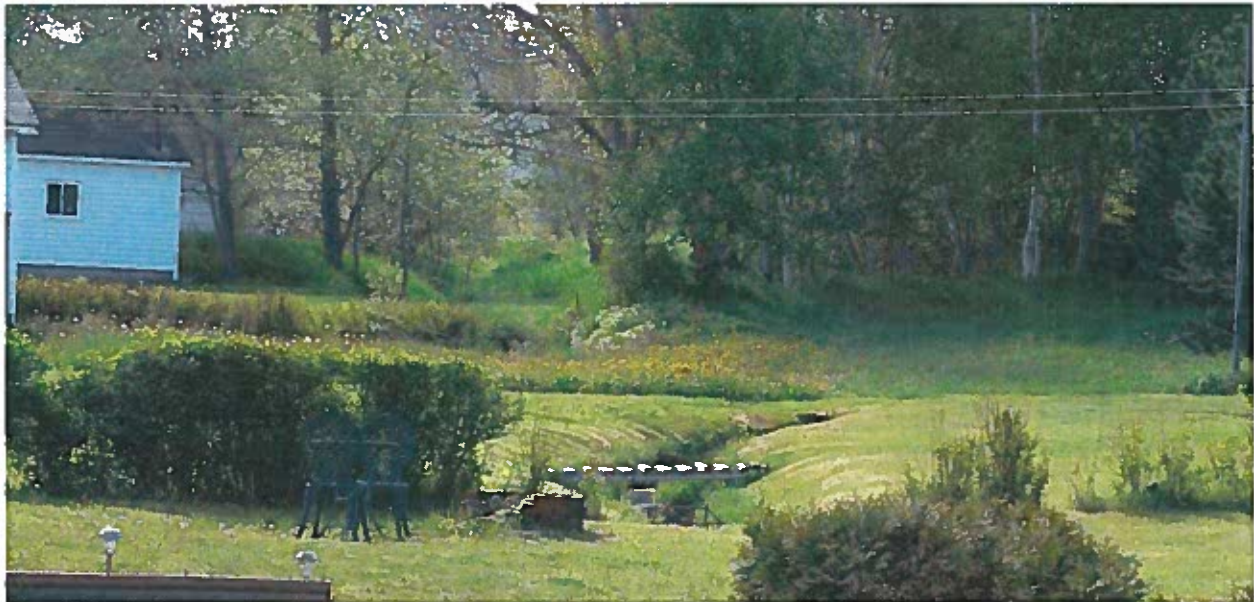
According to town officials, not all houses in the area are affected by high groundwater levels and seepage. One house may have an issue and four houses along on the same road, homeowners experience no problems. There is also unequal application of measures taken by individual homeowners to deal with drainage issues. Properties that have installed sump pumps, drainage ditches and tile drains experience fewer issues. Figure 8 shows South Stream running through backyard of homes on the Main Dam Road.

Figure 8: South stream running through backyards of homes on Main Dam Rd. before entering town's stormwater system (see extended edge of metal grate across drainage culvert)

- Provide public awareness raising information on measures residents can take to protect their property from high groundwater tables.
- The Town of Deer Lake should place a 30 m buffer zone on either side of the North and South Stream (and any other streams originating from across the canal) restricting any further future development.

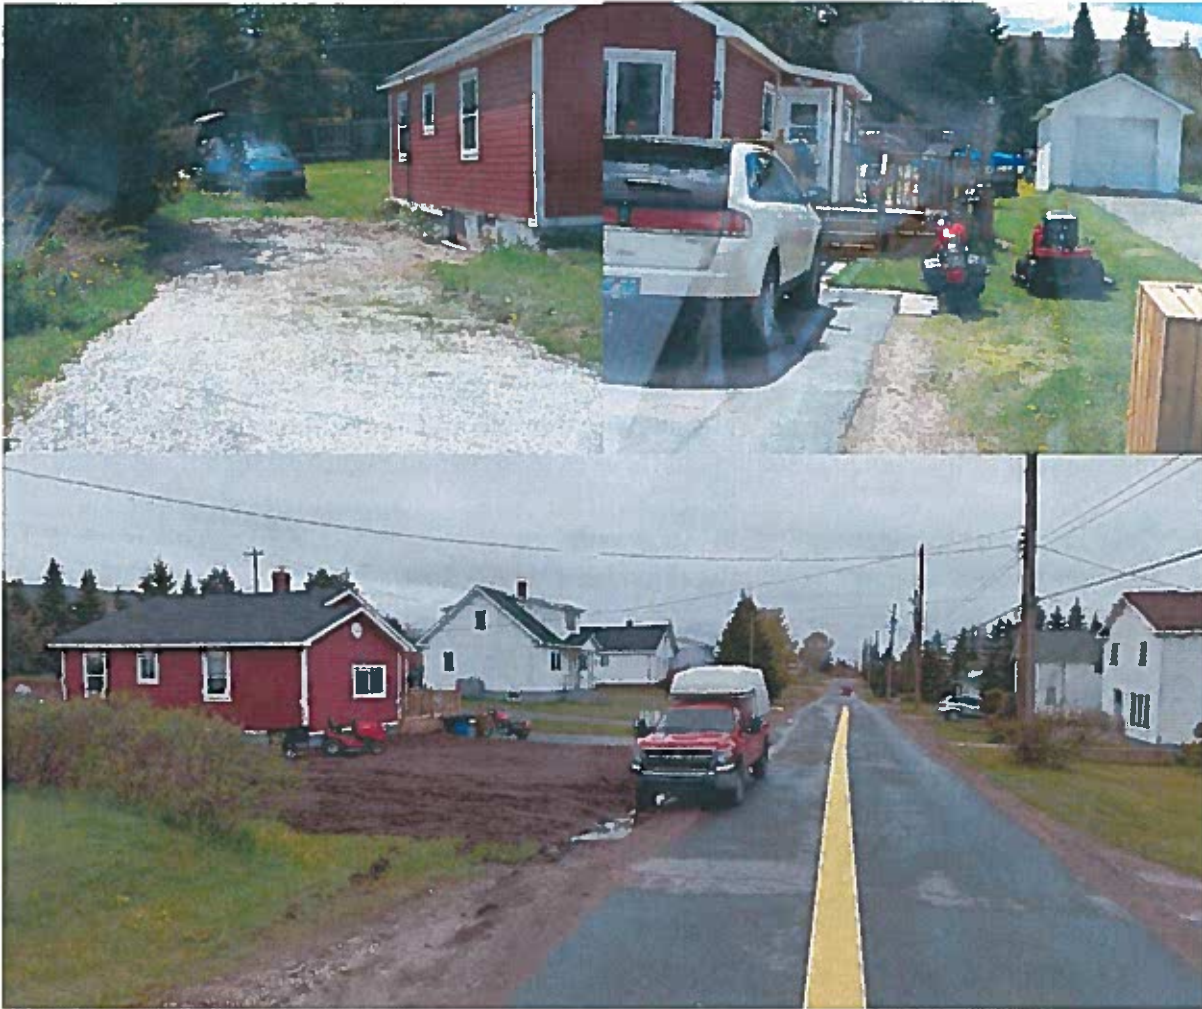
The property on Garden Rd. owned by Mr. Dewey is situated at a lower elevation than the two houses on either side of the property. There are no roof gutters and downspouts installed on the house to redirect runoff away from the home. The North stream has been redirected from its natural flow path once it hits Elizabeth Ave. where it is redirected into the town's stormwater system (a combination of ditches, culverts, storm sewer pipe and catch basins). Flow is directed west along Elizabeth Ave., then north along Edward St., and then west along Garden Rd. passing in front of Mr. Dewey's property. There is a storm drain on the east corner of Mr. Dewey's frontage on Garden Rd. It is believed the storm drain crosses Garden Rd. at this location and continues on behind properties on the other side of the road. Mr. Dewey's property is shown in Figure 9.

Figure 9: Property of Mr. Dewey on Garden Rd.

- grade yards so that surface water drains away from the house,
- soil directly around the house should be of slow permeability (i.e., not rock or gravel) so water does not penetrate near the house,
- install roof gutters and downspouts to carry the water away from the house, and
- proper maintenance of home drainage systems.

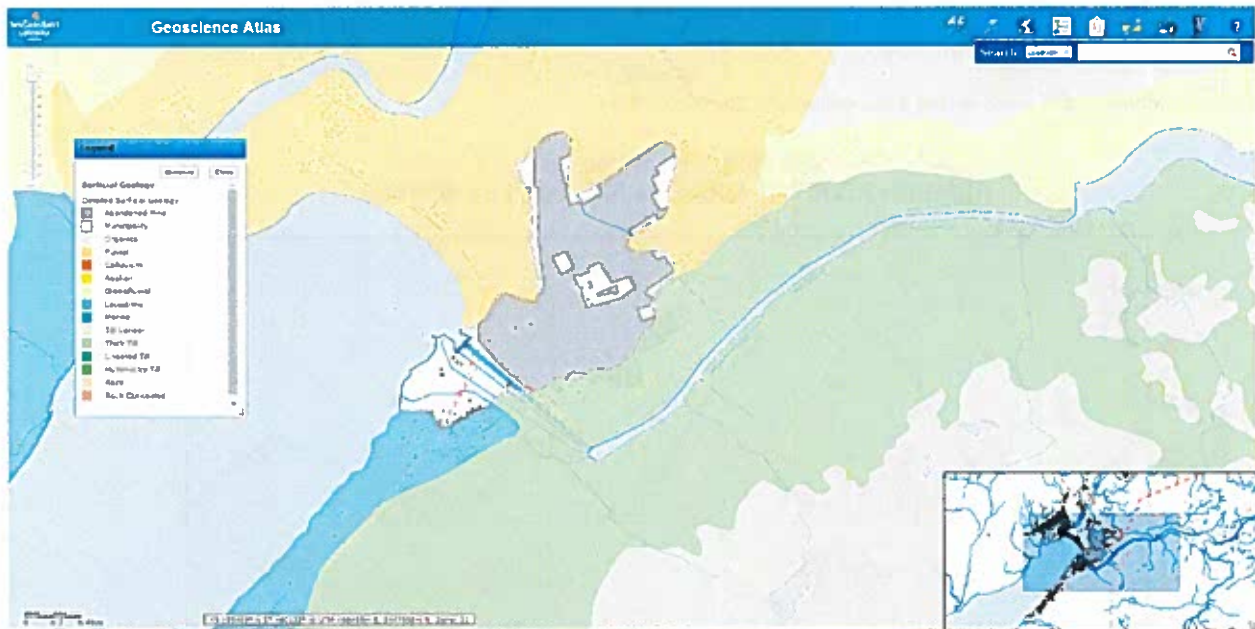
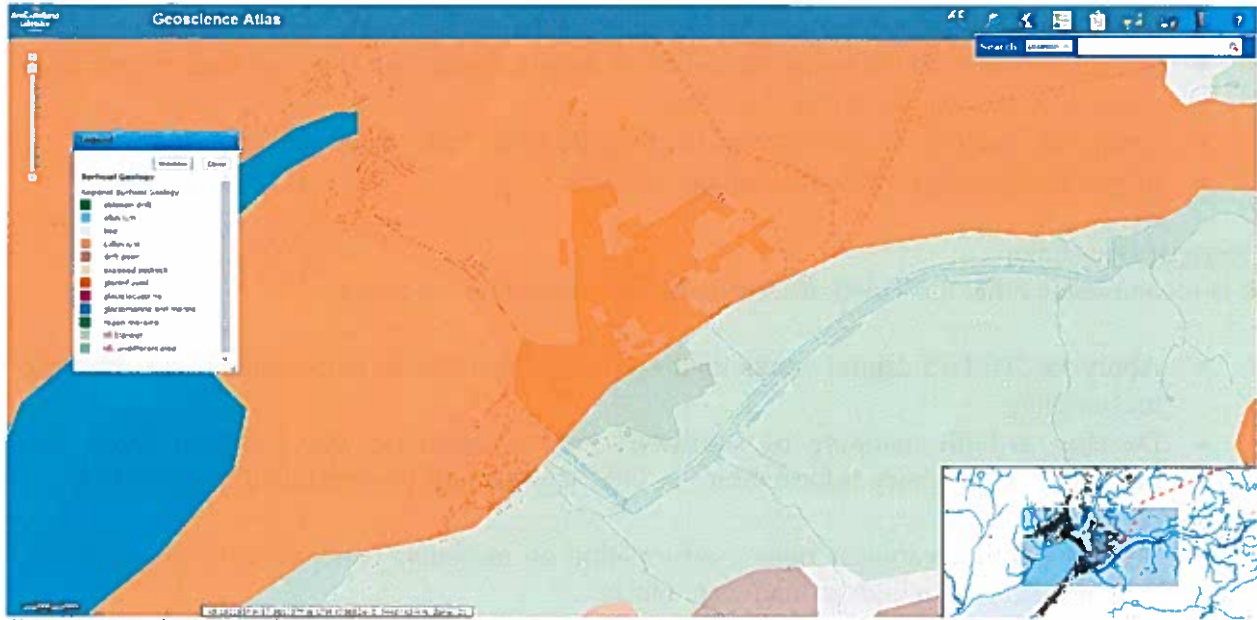
The following two maps as shown in Figures 13 and 14 show surficial geology for the Town of Deer Lake taken from the Geoscience Atlas from the Department of Natural Resources. The town is cut in half with the northern part of town comprised of glacialfluvial material comprised of well sorted sands and gravels and characterized by good drainage. The southern part of the town, extending past the canal is comprised of thick till. Till is comprised of clay interspersed with courser material that is poorly sorted and heavily comprised of fines or clay. Tills display poor drainage and can even cause the formation of perched water tables as shown in Figure 15 where a water lens forms above an impermeable or low permeability clay layer that separates it from the main groundwater table located beneath this impermeable layer. The neighbourhood in question is situated in this thick till layer which is contributing to poor drainage and the possible formation of a perched water table during periods of high runoff.
