Real-Time Water Quality Monitoring Network

Outer Cove Brook at Clovelly Golf Course - NF02ZM0365

**Audit Report
March 30th, 2015**

**Government of Newfoundland & Labrador
Department of Environment and Conservation
Water Resources Management Division**

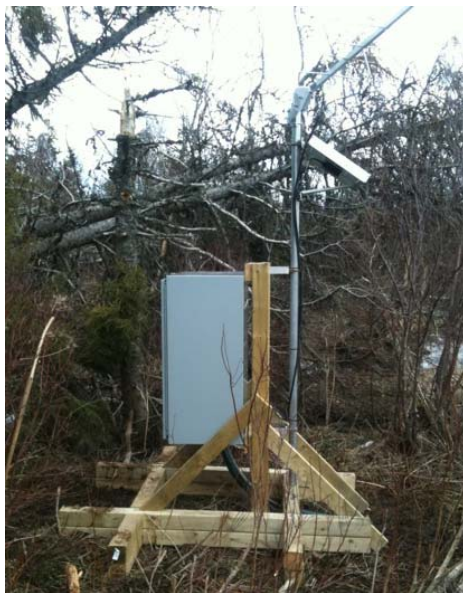
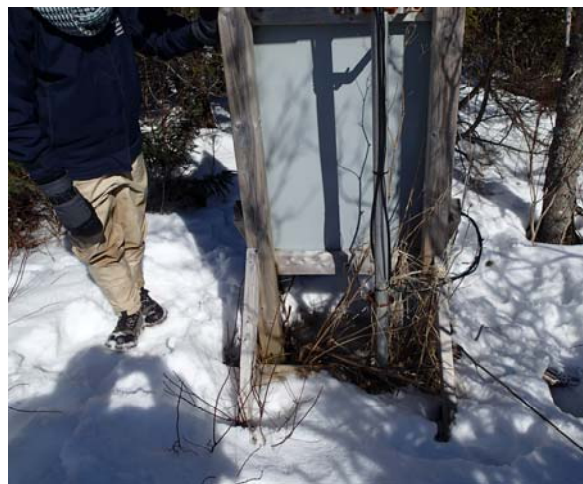
1. During the first year of installation the station has immersed into the marsh a depth of about 2ft from the initial installation height as can be seen in Figures 6 and 7.

Figure 6: April 6, 2012 Installation

Figure 7: March 30, 2015 – during audit

1. Monitor settling events and note any changes that will require stabilizing the structure.
2. In order to address the issue of rust due to moisture, the recommendation is to seal and treat the rust with a common spray from a hardware store. Once it is treated with spray, the pin holes will have to be treated with plumber's putty. A humidity indicator card should be added inside the enclosure and the desiccant that is currently depleted should be replaced. In the future when the card indicates the relative humidity is exceeded, the desiccant will need to be replaced.

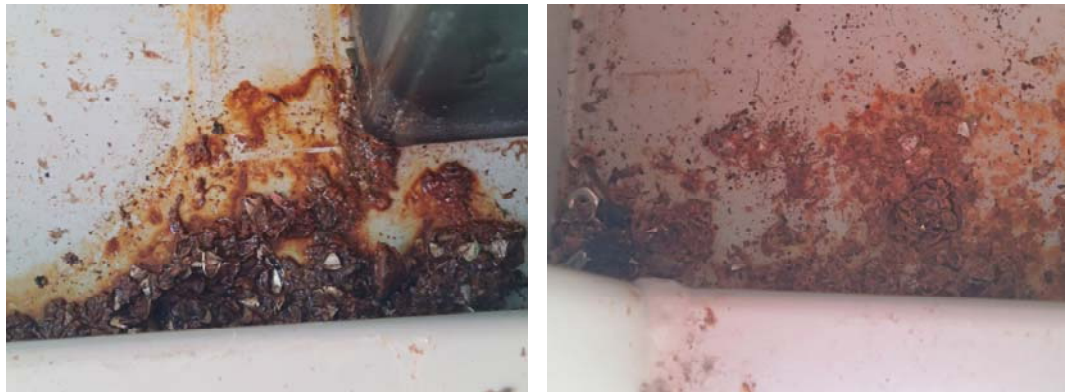
2. The station enclosure is a metal LookIn Shelter. The enclosure was originally not fully sealed from the elements which caused rust to form, resulting in pin holes in the wall and floor (See Figures 8 and 9).

Figure 8: Rust and pin holes inside of enclosure

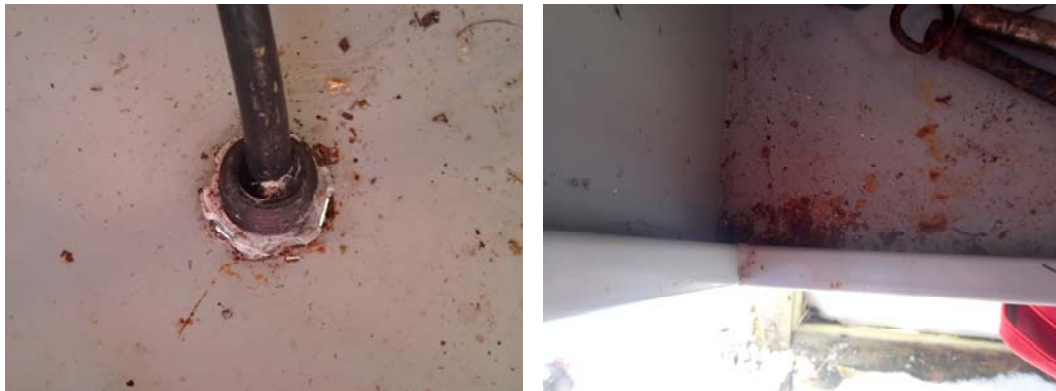
Figure 9: Rust and pin holes

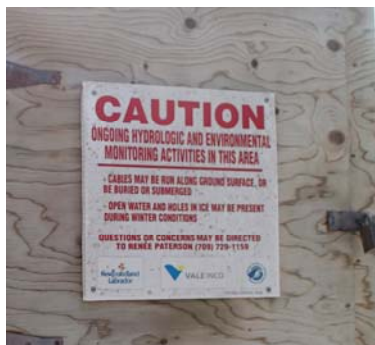
Figure 10: Real-time Station Signage Example

3. There is currently no signage on the enclosure of the station.

3. Install proper signage on the enclosure, as can be seen in Figure 10. With proper signage, the public is notified of any safety concerns and who to call for more information as needed.

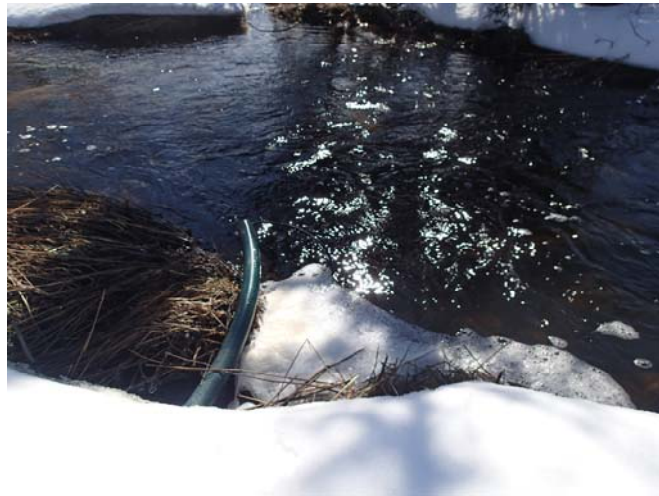
5. The water quality sonde is deployed from the shore line. The sonde itself is housed inside a four inch diameter stainless steel casing approximately 30 inches long. The cabling is housed in a flexible protective conduit to protect it from damage (Figure 11).

Figure 11: Protective conduit at Clovelly Golf Course

4. Extend the deployment pipe that houses the solar panel and antenna at least another 2-3 feet so that it is out of reach and landscape as necessary
5. Bury the flexible conduit between enclosure and riverbank for safety purposes as it is a tripping hazard and prone to vandals.

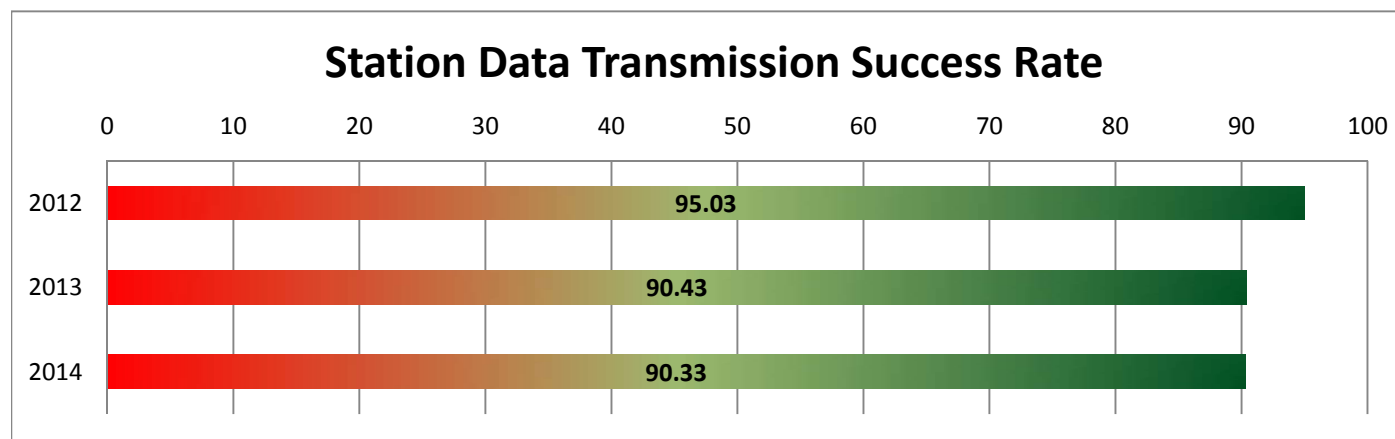
Figure 12:

The station statistics are based on the station transmissions which are hourly via GOES with measurements every 15 minutes, 365 days a year (Figure 12). Based on the statistics (refer to Appendix A), the station has over 90% successful transmissions. Maintenance and calibration days (one day per month) account for 3.29% of missed transmissions.

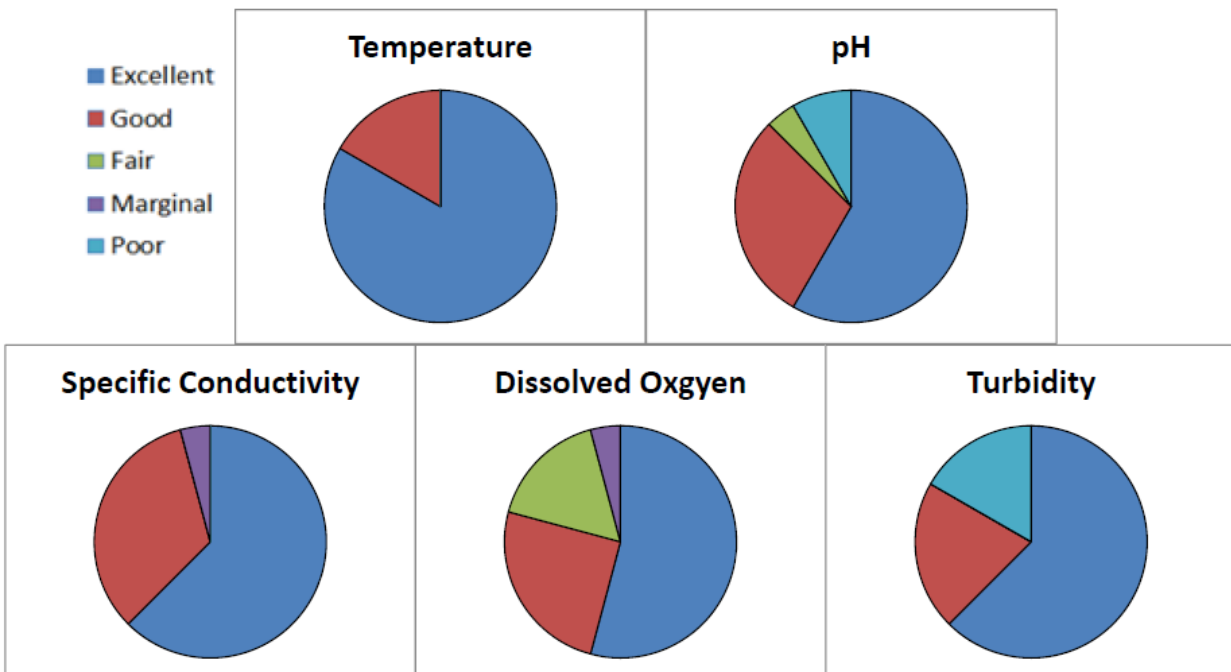
The comparison figure below is featured on the NL RTWQ field sheet and can be used as a quick reference to ensure all parameters are ideally yielding positive rankings based on the difference between the field and QAQC instrument readings (see Figure 13).

Figure 13: Station sensor comparison rankings over the 2014-15 deployment years
