Real Time Water Quality Monthly Report for Voisey's Bay Nickel Company Ltd. August 2003

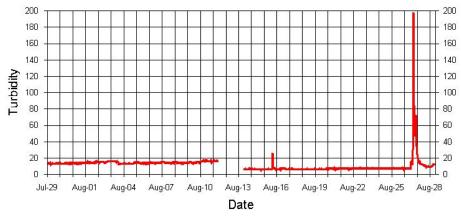
- Throughout the month of August most water quality parameters remained steady at expected background levels.
- There was a spike in turbidity in Camp Pond Brook below Camp Pond on August 26th, 2003 at approximately 6:44 AM NST whereby the turbidity levels rose to 197.9 NTU (Figure 3). The rise and fall of the turbidity levels occurred over a 12-hour time frame. Interestingly, the levels of other corresponding parameters (conductivity and TDS) also increased during this period (Figures 4 & 5). This water quality event was most likely caused by increased precipitation during this period as indicated by the stage increase in Figure 6.
