Field Inspection Report – Gullbridge Dam and South Brook Watershed

Wednesday December 19, 2012

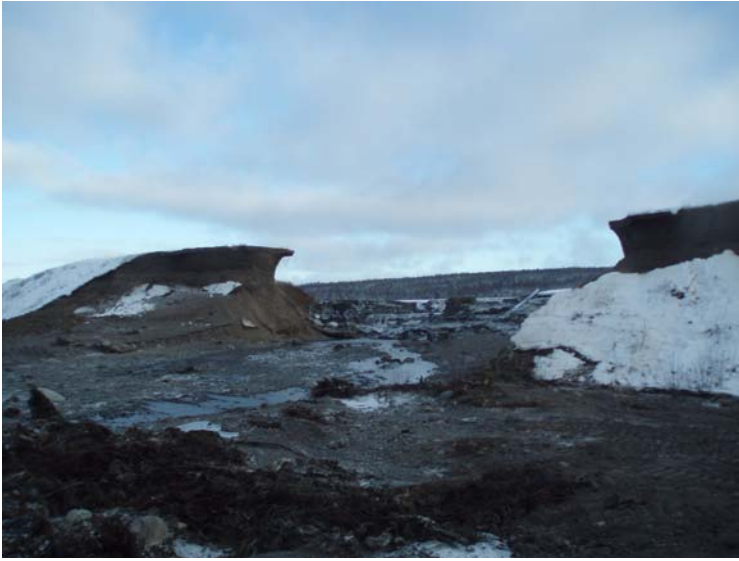
A measurement of the dam breach confirmed the width to be approximately 20m at the base. Due to overhangs it was not safe to measure the top width of the breach. However, the opening appeared to be approximately 30m wide at the top. The volume of water spilled from the breach is estimated to be in the order of 100,000m³, based on an assumed average water depth of 1m, length 1000m and average width of 100m. The tailings immediately upstream of the breach section looked to be consolidated with small channels eroded into the tailings due to the high water velocities at the breach location. The tailings at this location were estimated to be 2-2.5m high above the lowest breach elevation. Lower water velocities would occur further away from the breach area and as a result less erosion of the tailings likely occurred as you move further away from the breach area. It appears that any tailings which left the impoundment were either in small chunks from the area immediately upstream of the breach location, which likely would have settled out on the bog, or were suspended in the water at the higher velocity locations near the breach area. This would suggest that a very small fraction of tailings exited the tailings impoundment relative to the volume of water.

Picture #1: Gullbridge Breach

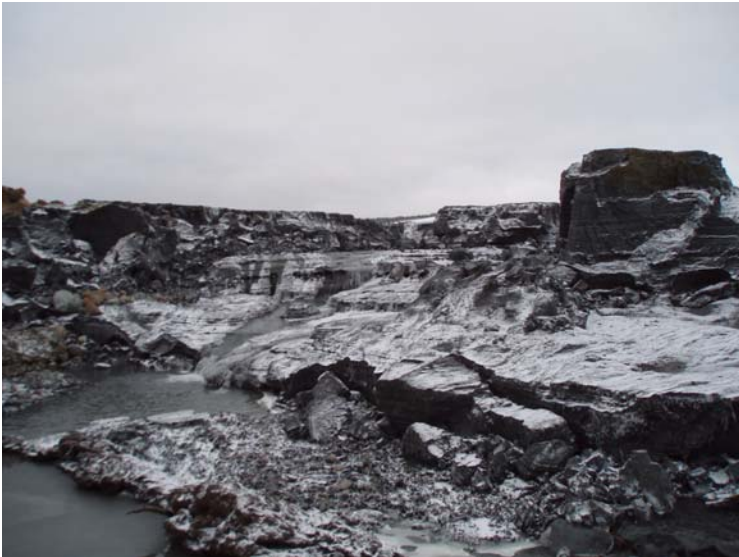
area. It was noted that the tailings look like sedimentary rock as a result of the tailings consolidating over the past 30-40 years. They also inspected the nearly finished small berm which would help form a temporary settling basin for any drainage from the tailings area.

Picture #2: Consolidated tailings at breach outlet

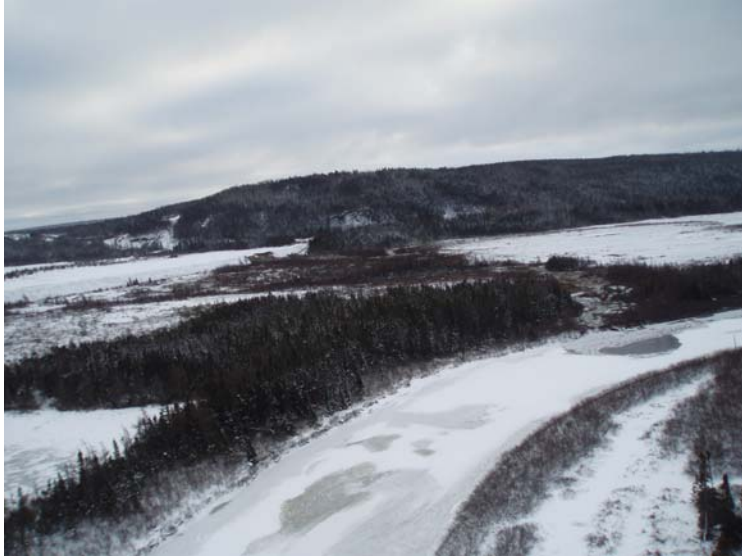
Picture #3: Breach water enters South Brook, with dam in background

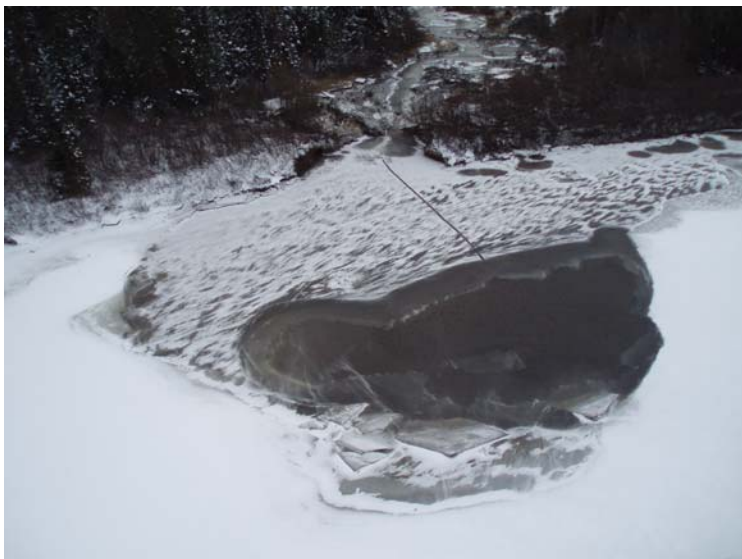
Picture #4: Breach water enter South Brook, with debris markings on ice pans

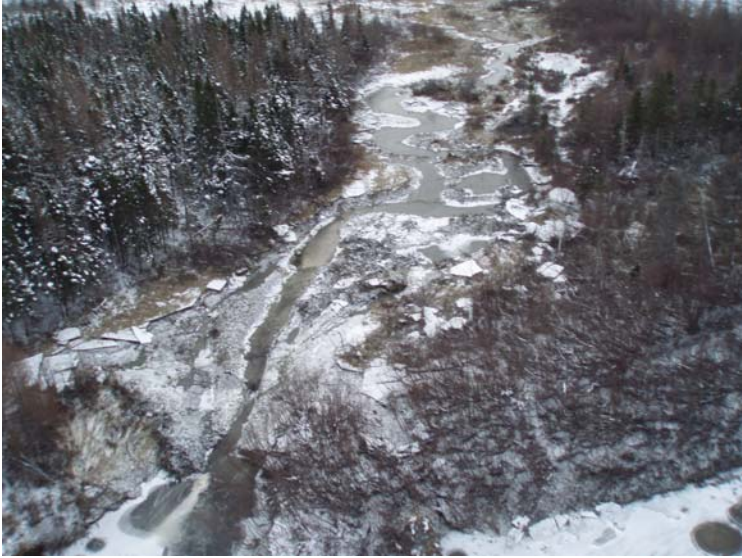
Picture #5: Section of bog close to South Brook

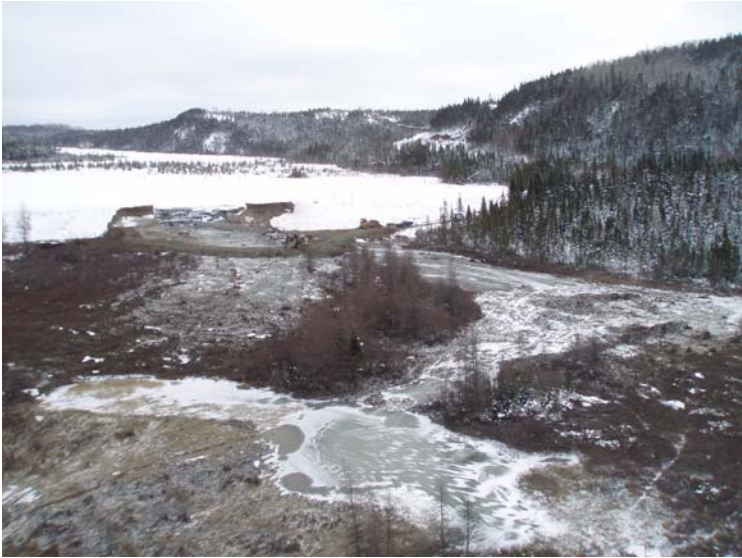
Picture #6: Section of bog halfway to South Brook

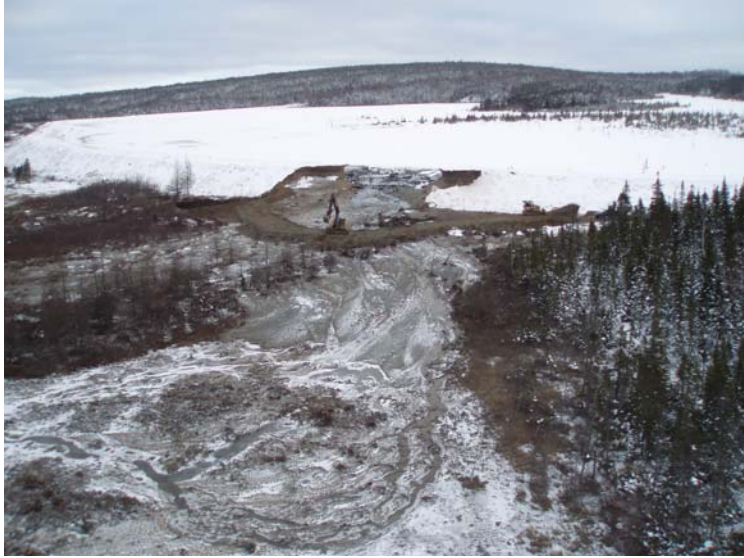
Officials from the Department of Environment and Conservation (ENVC) and the Town of South Brook conducted an aerial inspection using helicopter. They flew up South Brook from the mouth of the river looking for any changes in water appearance or markings of debris on ice/snow along the river shoreline. No debris markings, plumes or changes in water appearance were visible in South Brook or South Pond with the exception of the location on South Brook where the water entered from the Gullbridge breach. At this location there were small ice pans with dark grey debris which indicate that the tailings laden water spilled over the ice on South Brook or the ice pans came from the tailings impoundment area. Based on the thickness of the ice it appears that these ice pans came from the tailings facility during the breach. They flew over the bog toward the dam breach following the obvious markings on the bog. As they moved closer to the dam more debris was visible on the bog, with larger materials deposited just downstream of the breach area. It appears that a thin layer of gravel, sand and tailings are spread over the lower section of the bog, while close to the dam breach larger chunks of tailings and larger rocks and gravel from the dam were deposited over the bog.

Picture #7: Section of bog immediately downstream of breach

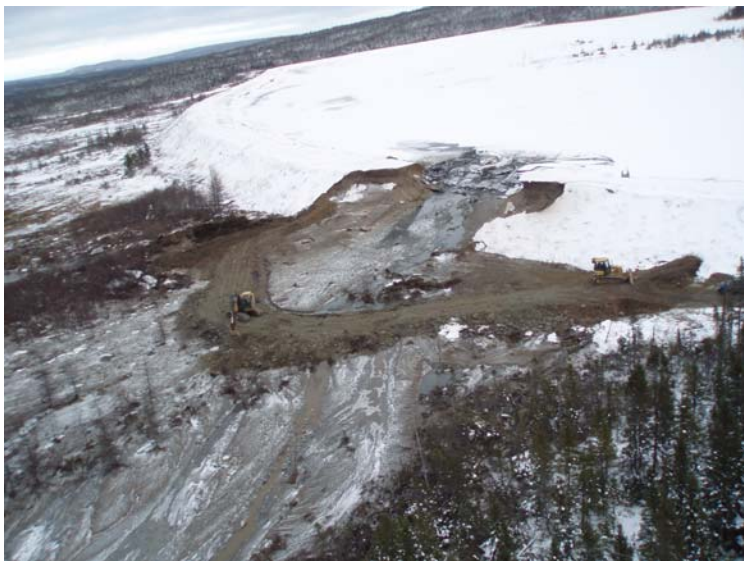
Picture #8: Construction of berm for temporary containment and settling pond

On Dec 19th, work had commenced to remove the excavator from the area and construct a small berm to create a temporary settling basin to allow any tailings to settle out from the small amount of water that continued to trickle from the tailings area.
