Weird Stuff in Water!

Department of Municipal Affairs and Environment

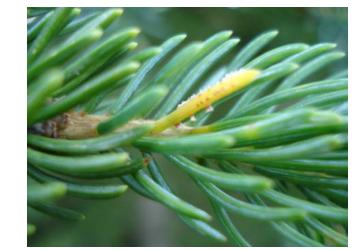
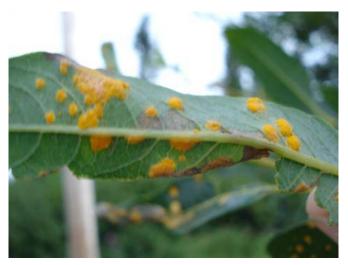
- The substance was identified as biological in nature, ruling out a mineral or chemical source
- Staff at the Biology Department were able to make a positive identification of fungus rust spores
- The spores found in the water supplies are part of the natural life cycle of the rust fungus
- Staff with Environment Canada considered that the water quality event had all the characteristics of an airborne pollen release.

Pictures taken on August 15th of surrounding vegetation indicate rust spores on spruce needles and on a green leaved tree (possibly a type of willow).

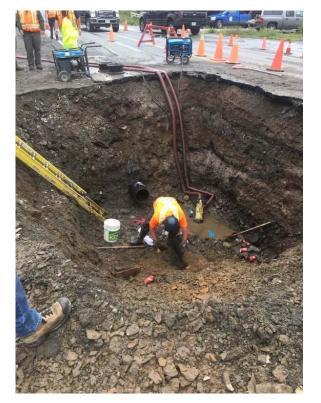
Water main repairs

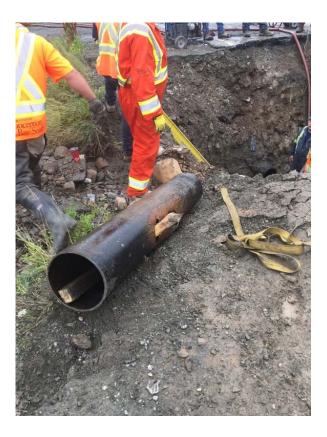
Section of 12" DI water main removed

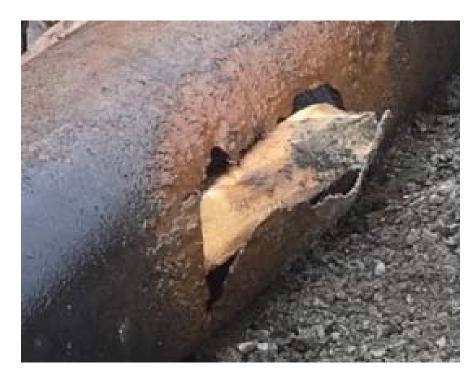
Close-up of ruptured main and piece of timber

- 12" DI water main installed in 1983.
- The piece of timber was originally a 4x4 about 5-6 feet long.
- Water pressure and flow had reduced it to about a 3x3
- Water pressure in the area 145 psi
- It was hardwood.... the same used when stacking the DI water mains during storage.
- It was assume to be already in the pipe on install. Cannot pinpoint the origin.

- During any install of water and sewer pipe, always be sure to inspect the inside of pipe before installation and remove any objects.
- Pigging and swabbing of a water main would reveal any obstructions that may be present inside the pipe.

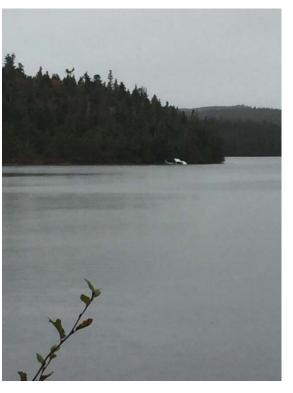
Partially submerged truck in the water supply

- October 2016 4x4 truck was driven into the Protected Pubic Water Supply Area.
- Truck was driven along the shoreline, in approximately 20inches of water, until it hit an embankment and became stuck.
- Big Pond Water Supply had adequate signage to and around the protected public water supply area
- Non-Consumption Order was issued October 31 and removed November 1 when the truck was moved to adjacent land

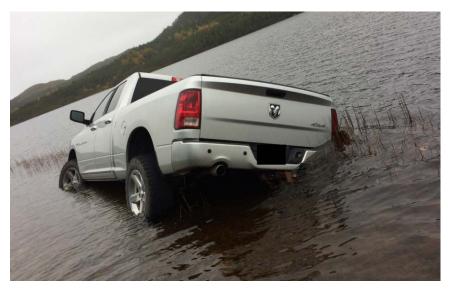
Close-up of truck in the water supply

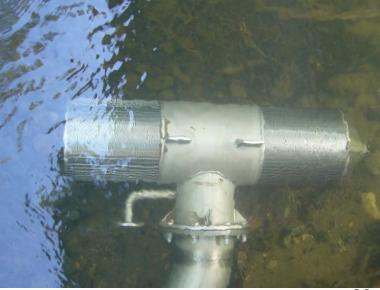
Samples of surface water source intake screen

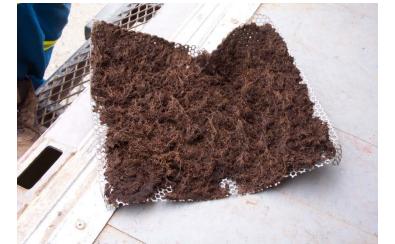
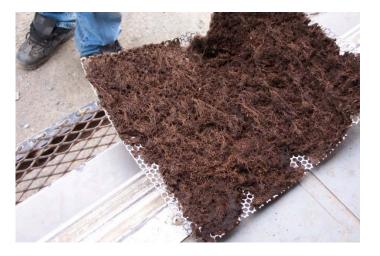
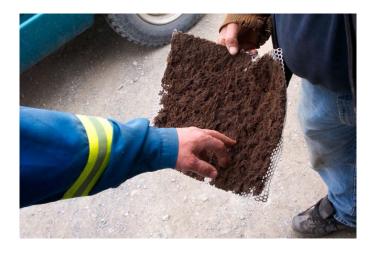
May 2005 -Intake Screen Build-up

- There was no analysis completed to pinpoint the composition of the buildup, but the elevated levels of turbidity and colour in the source water were likely a contributing factor
- It's imperative that the intake screens/screen chambers be inspected and cleaned on a regular basis
- Regular basis will be dependent on the water quality of the source. This could be semi-annually, annually, etc. based on source water quality.

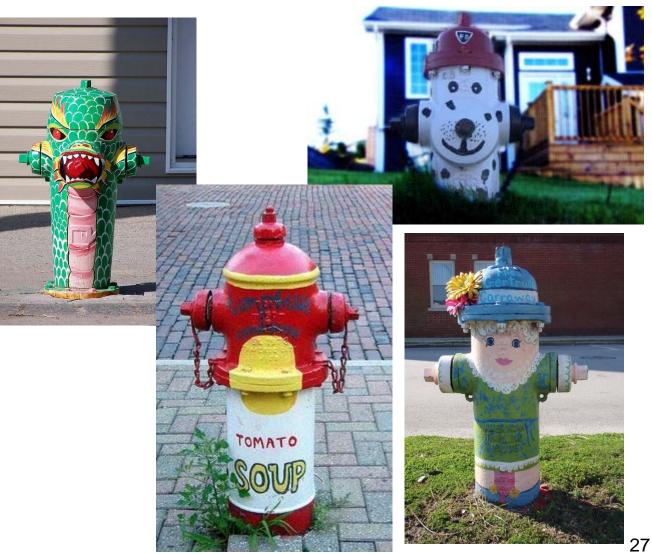
- While painting the fire hydrant body and bonnet, like in the photos we just seen, is aesthetically pleasing, it can pose problems for fire fighters and operators.
- Hydrants are usually painted in the summer by summer relief students
- In larger towns and cities hydrant bonnets are painted a certain colour to reflect system pressure in the area.
- Hydrant operating nuts are made of brass and should not be painted.

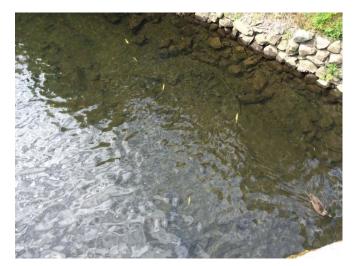
Dead Fish

- September 10, 2016 City of St. John's Parks and Open Spaces Division notified of a large number of dead fish in the Waterford River and the Bowring Park Duck Pond.
- City staff investigated and found the likely cause was a water main which expelled significant quantities of drinking water into a river that feeds into the Waterford River.
- Chorine levels in the drinking water were within the Guidelines for Canadian Drinking Water Quality
