Phase III ESA & Hazardous
Materials Assessment
Former Baie Verte Asbestos
Mine, Baie Verte, NL

NEWFOUNDLAND AND LABRADOR
DEPARTMENT OF NATURAL
RESOURCES - MINERAL
DEVELOPMENT DIVISION

REPORT NO. 1028976

February 1, 2008

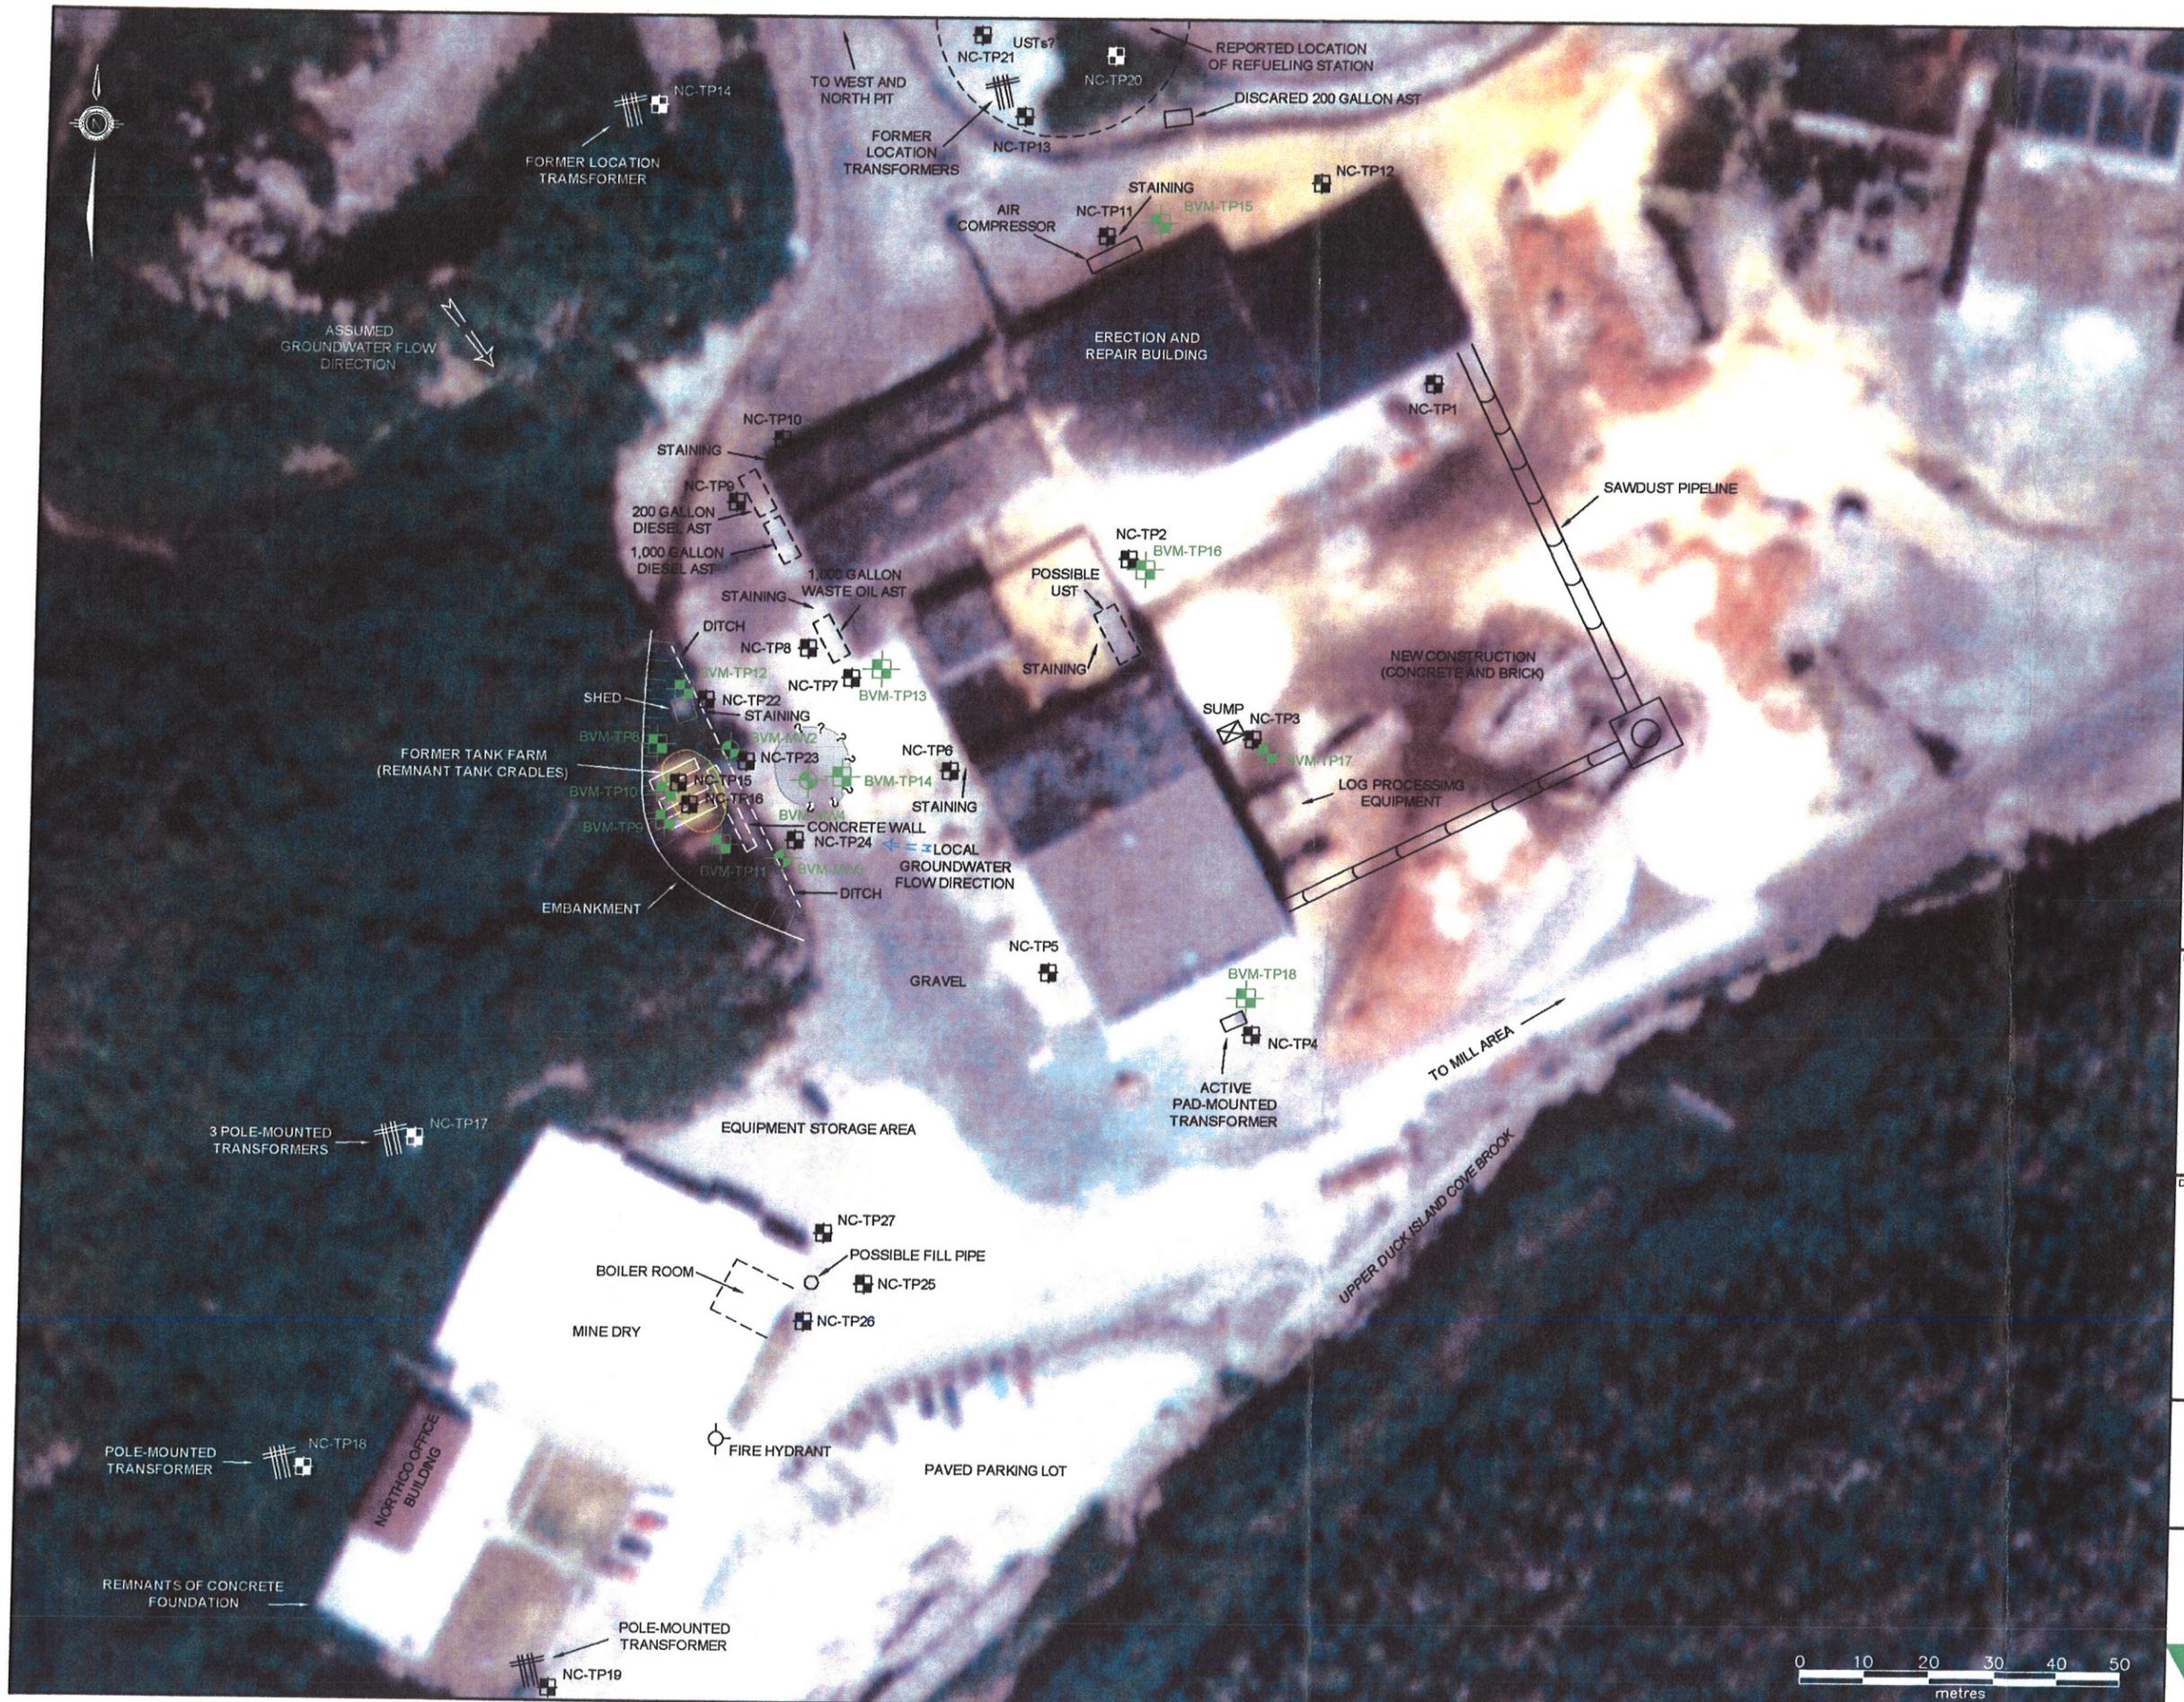
SCALE	1:1000	DATE	DEC. 7, 2007
DRAWN BY:	N.M.	CHECKED BY:	
EDITED BY:	-	REV. No.	0
DRAWING No.	1028976-EE-04		
CAD FILE:	1028976-EE-10.DWG

5. The estimated extent of the former tank farm area with TPH in soil exceeding the Tier I RBSLs for a commercial site is 100 m². Based on field evidence of impacts and the noted depth to groundwater and bedrock on the site, it is expected that approximately 100 m³ of impacted soil from this area exceeds the applicable Tier I RBSL. Field and analytical evidence indicates that petroleum hydrocarbon impacts on average are present in the upper 1 m of soil in this area. Most of the impacted soils in this area are readily accessible for removal if required. Additional delineation would be necessary to better refine these estimates.

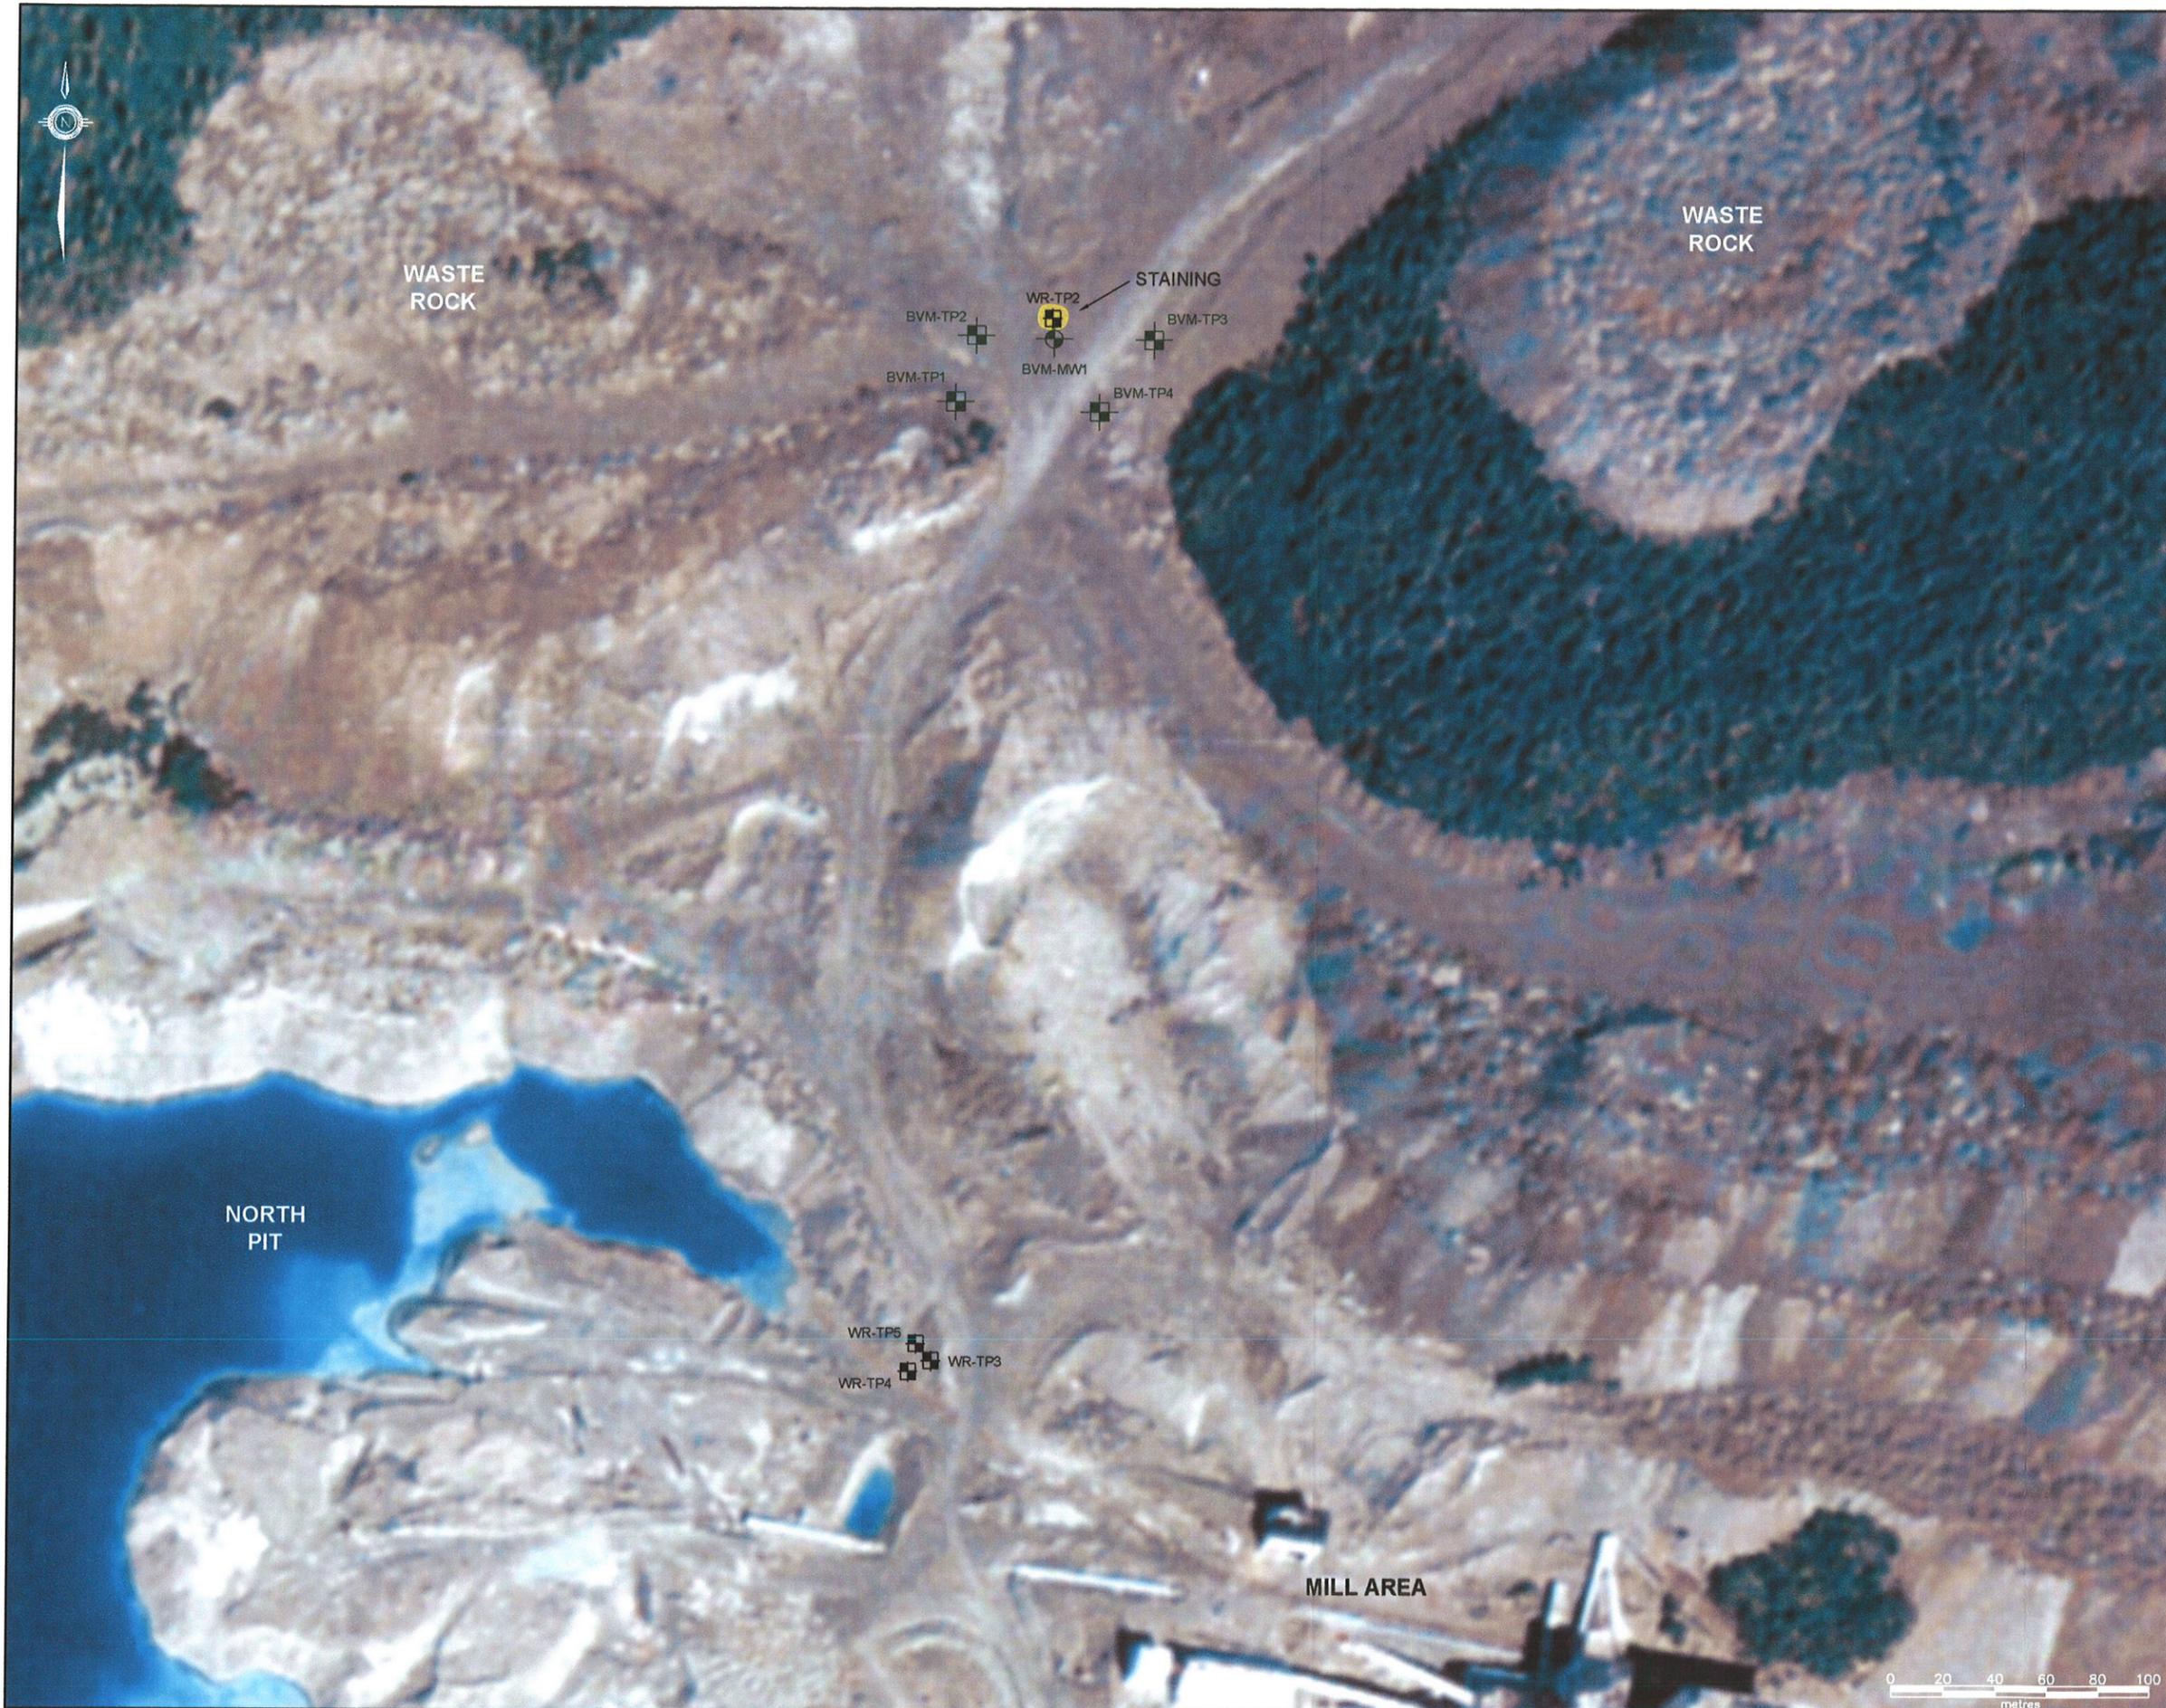
EDITED BY: -	REV. No: 0
	DRAWING No: 1028976-EE-13	
	CAD FILE: 1028976-EE-17.DWG

5. The estimated extent of TPH in soil exceeding the Tier I RBSLs for a commercial site in the vicinity of former test pit MR-TP2 is shown on Drawing No. 1028976-EE-013 in Appendix 6a. The estimated area with TPH concentrations in soil above 7,400 mg/kg in the vicinity of former test pit MR-TP2 is approximately 100 m². Based on field evidence of impacts and the noted depth to groundwater and bedrock in this area, it is expected that approximately 100 m³ of impacted soil in the vicinity of former test pit MR-TP2 exceeds the applicable Tier I RBSL. Field and analytical evidence indicates that petroleum hydrocarbon impacts are present in the upper 1 m of soil in this area. Most of the impacted soils in this area are readily accessible for removal, if required. Additional delineation would be necessary to better refine these estimates.
