MEETING IN ST. JOHN'S AND VISITS TO LOWER CHURCHILL PROJECT SITES, SEPTEMBER 15 TO 18, 2019

Prepared for: Natural Resources Canada and Nalcor Energy
IE Point of Contact: Nik Argirov
Date: November 25, 2019

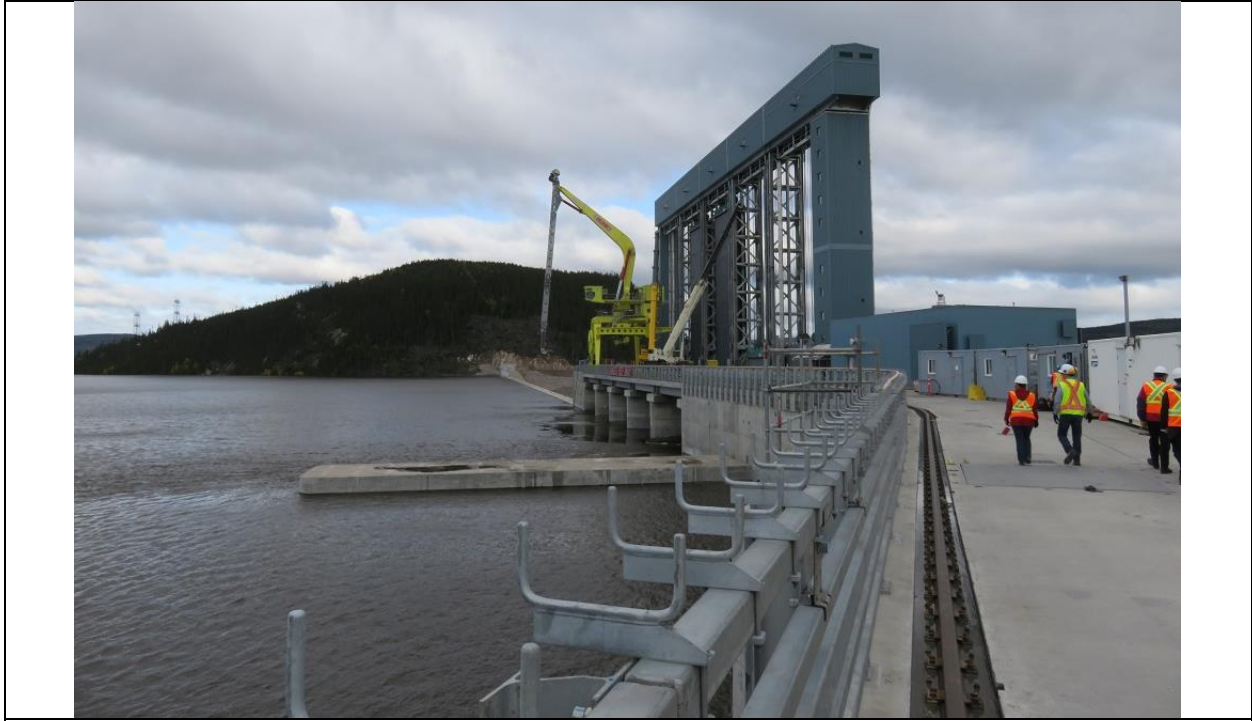
Photo A.1: Northerly view along upstream side of concrete structures with reservoir at full pool level.

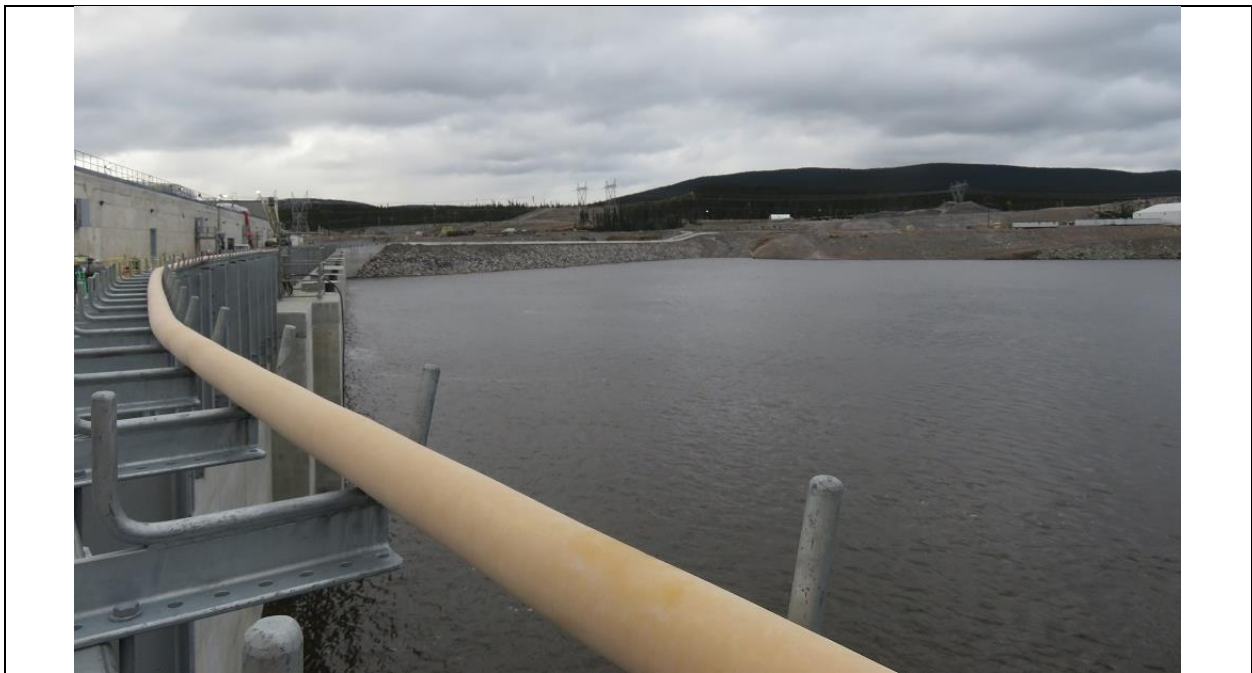
Photo A.2: Southerly view along upstream side of power intakes with south embankment dam in background.

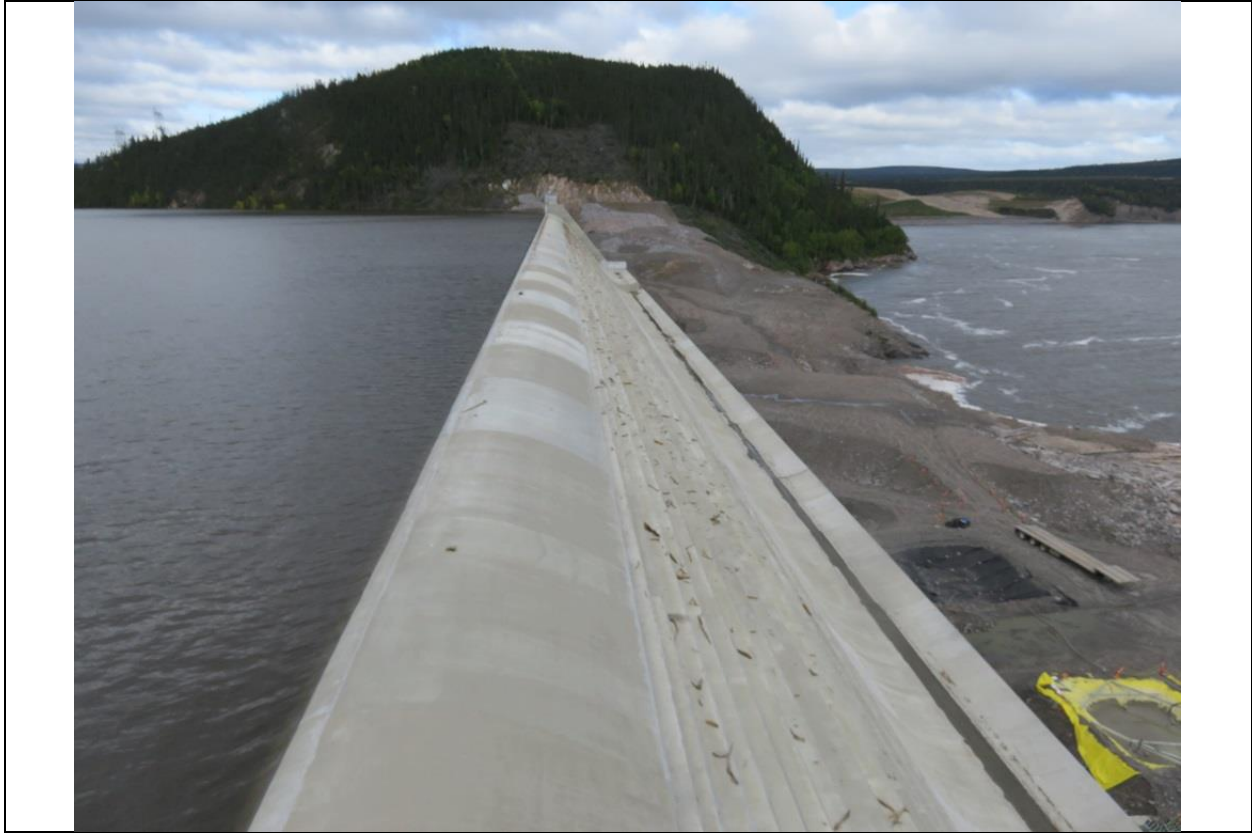
Photo A.3: Northerly view along north RCC dam.

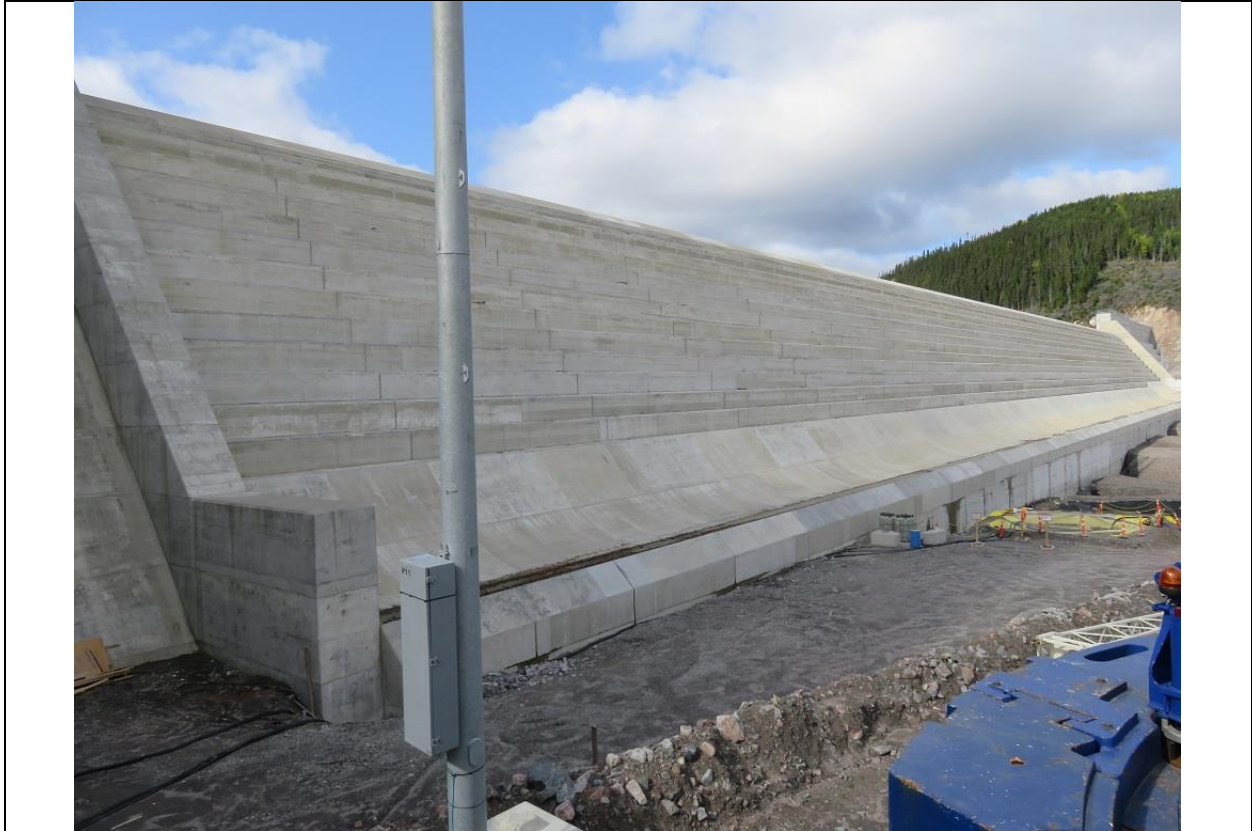
- All water retaining structures had full reservoir head on their upstream sides. No significant leakage from construction joints or lift joints was observed on the downstream sides. All structures are performing well.
- The IE continues to receive copies of weekly dam safety monitoring reports. Foundation piezometric levels and weir flows in dam galleries showed modest increases due to reservoir filling (as would be expected). There have been no anomalous responses or behaviour recorded, and no dam safety concerns have been identified.

Photo A.4: Downstream side of north RCC dam. Local areas of minor leakage along base appear to be from water ponded in the flip bucket that is draining through construction joints.

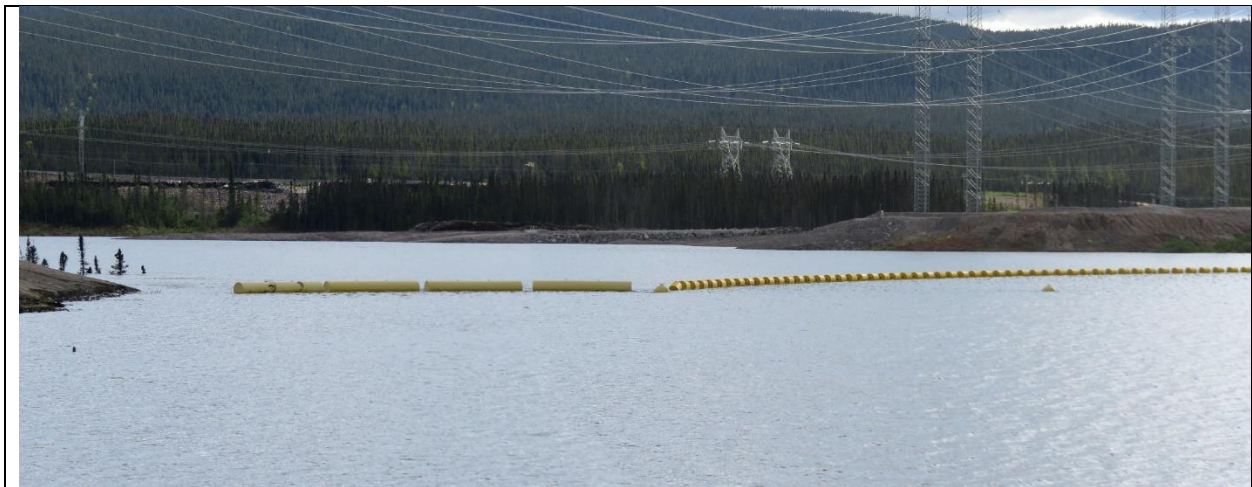
- Reservoir was at full pool level just below the overflow crest of the north RCC dam (El. 39.0 m) with water level being controlled through spillway bays 1 and 5.
- The seasonal debris boom was in place. There was no floating debris against the boom and minimal small size woody debris along the new reservoir shoreline near the dam. Several boats were being used to collect larger floating logs and trees to tow them to the North Spur where they are to be removed and hauled away.

Photo A.5: Downstream view of temporary boom, with no accumulated debris.

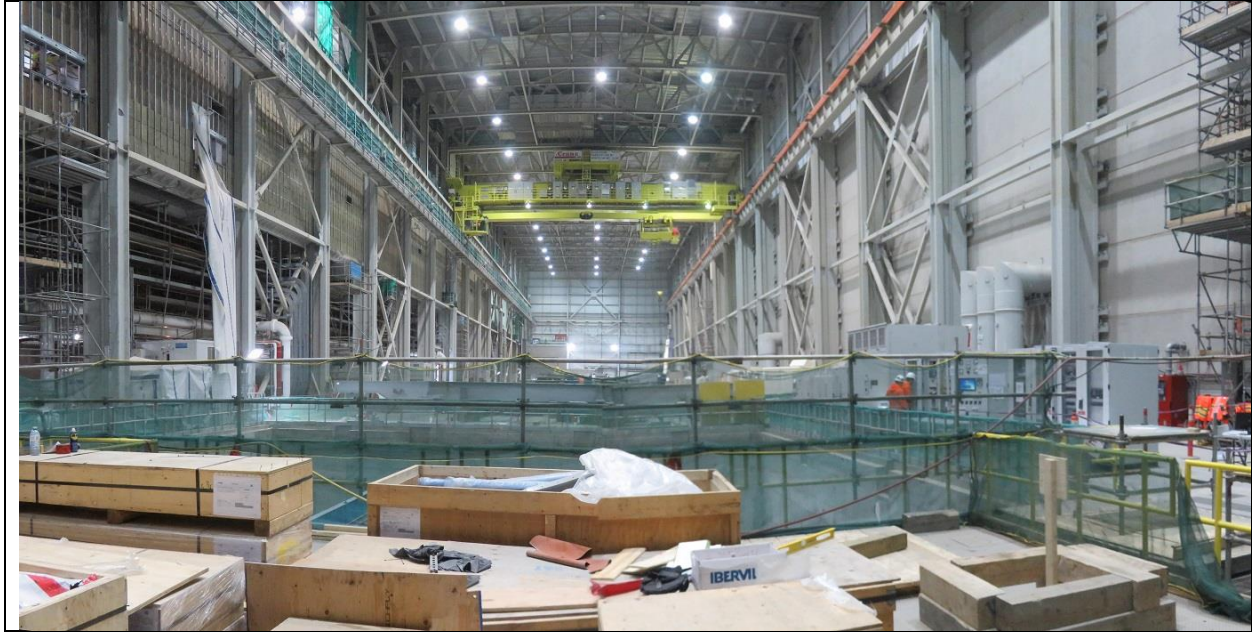
Photo B.1: Powerhouse interior, looking north from service bay. Unit controls and switchboard cabinets are being installed along right side of turbine pits.

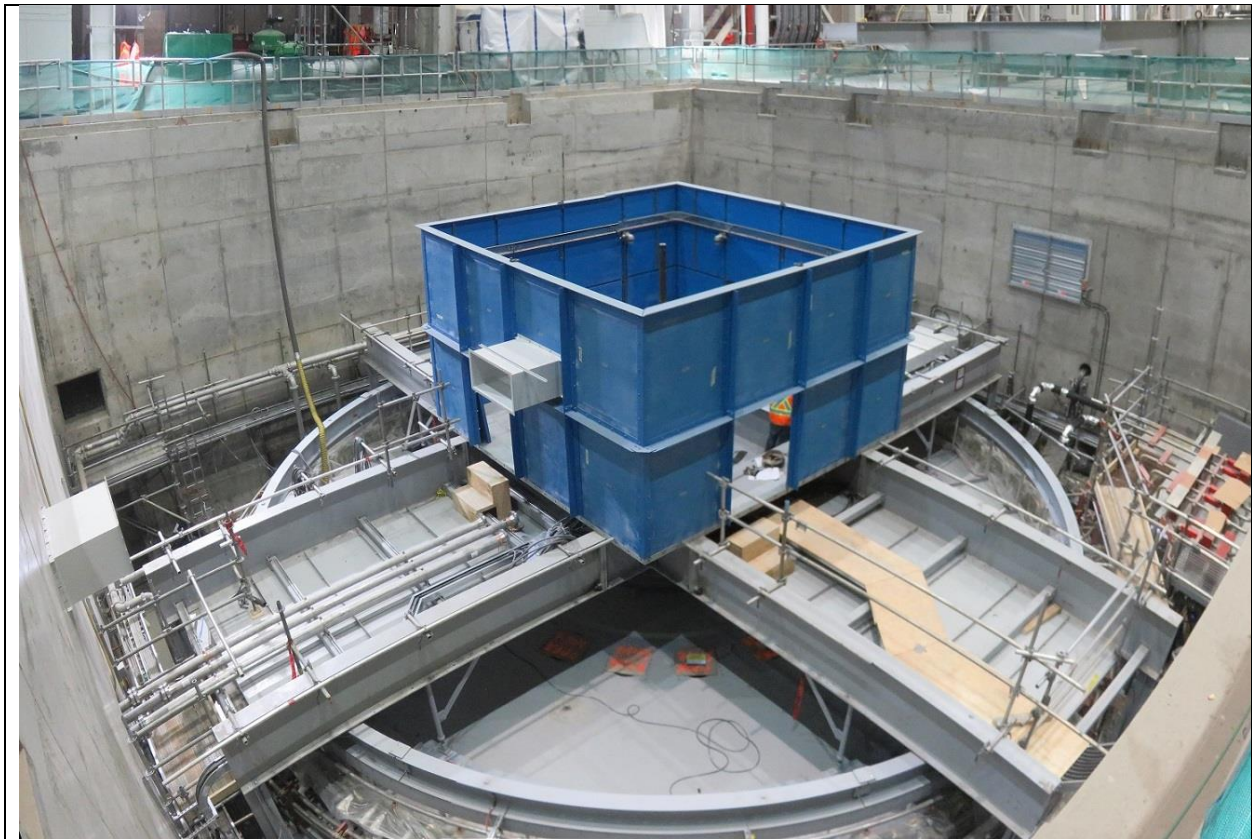
Photo B.2: Unit 1 with upper generator bracket installed.

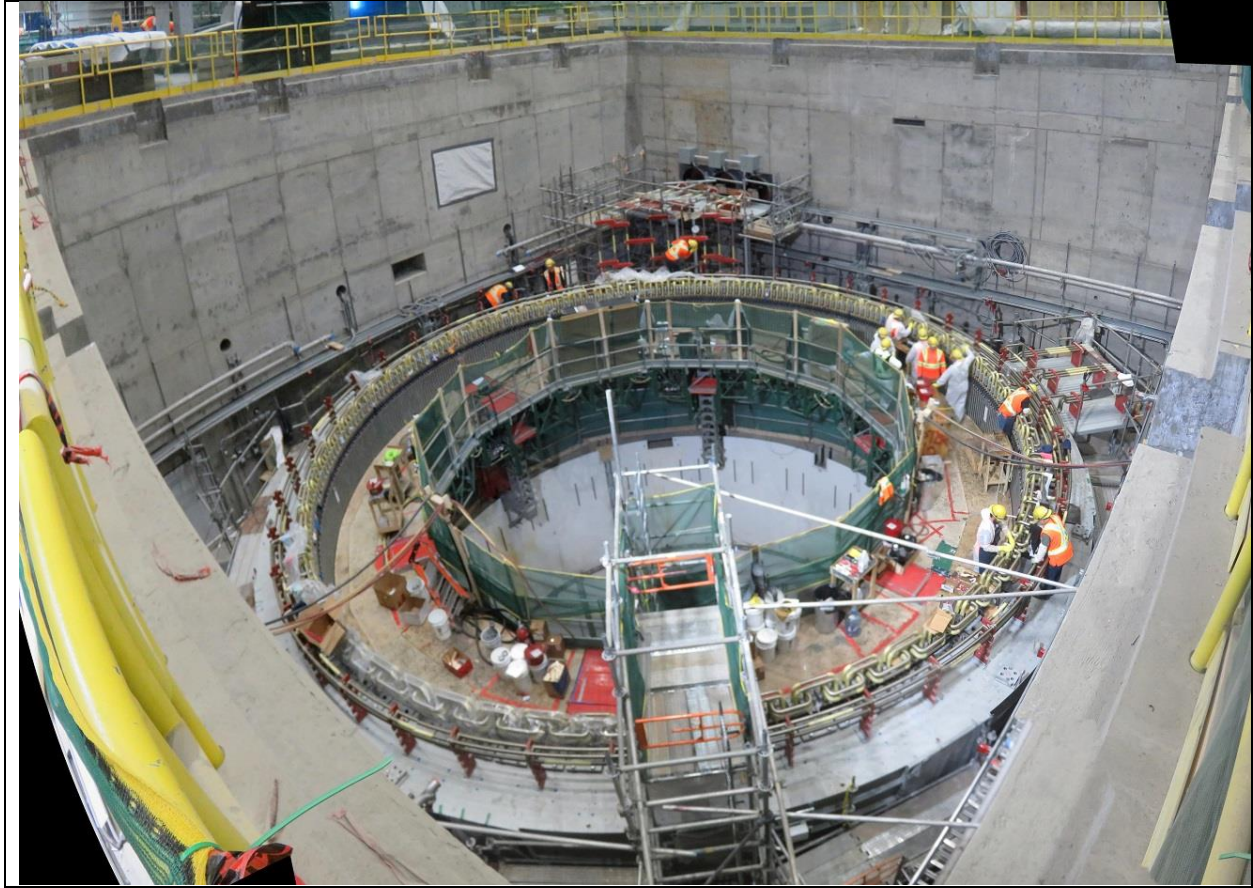
Photo B.3: Unit 2 with stator winding installation in progress.

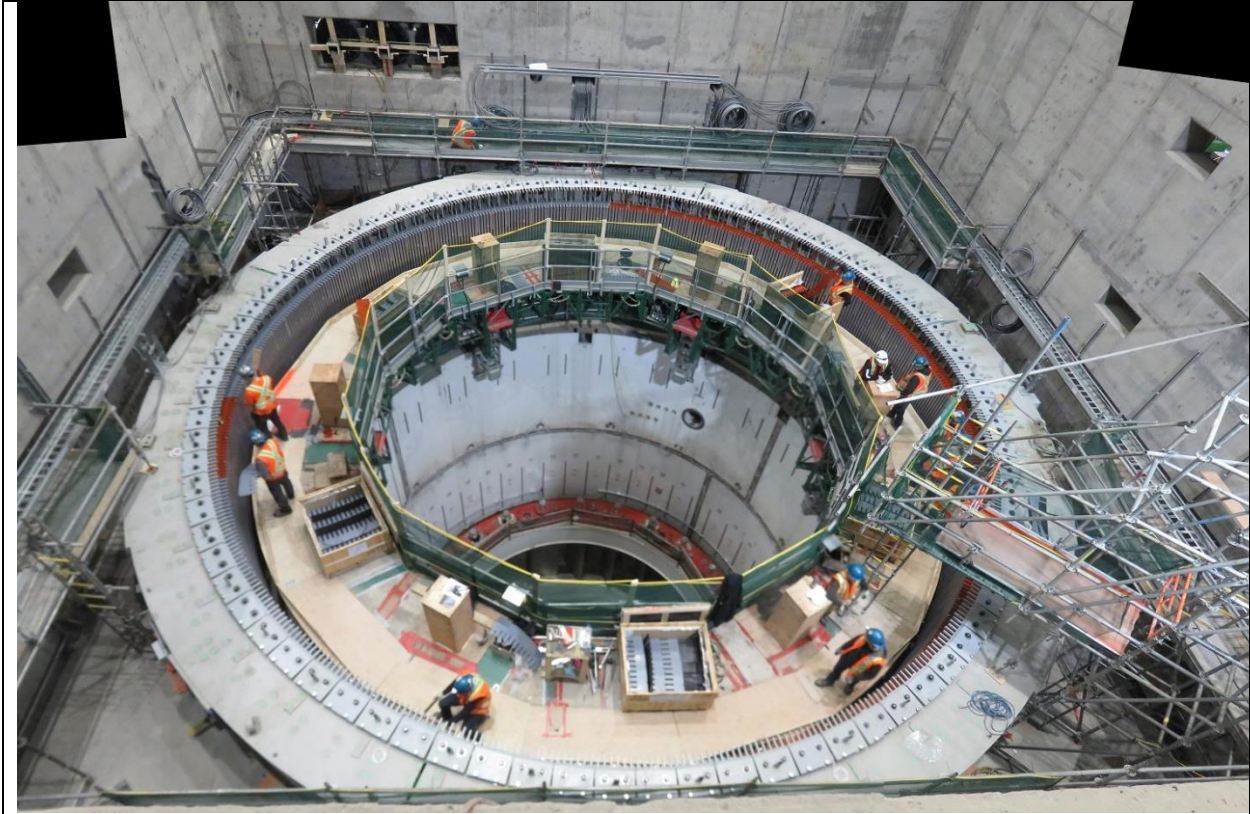
Photo B.4: Unit 3, with stator core stacking in progress.

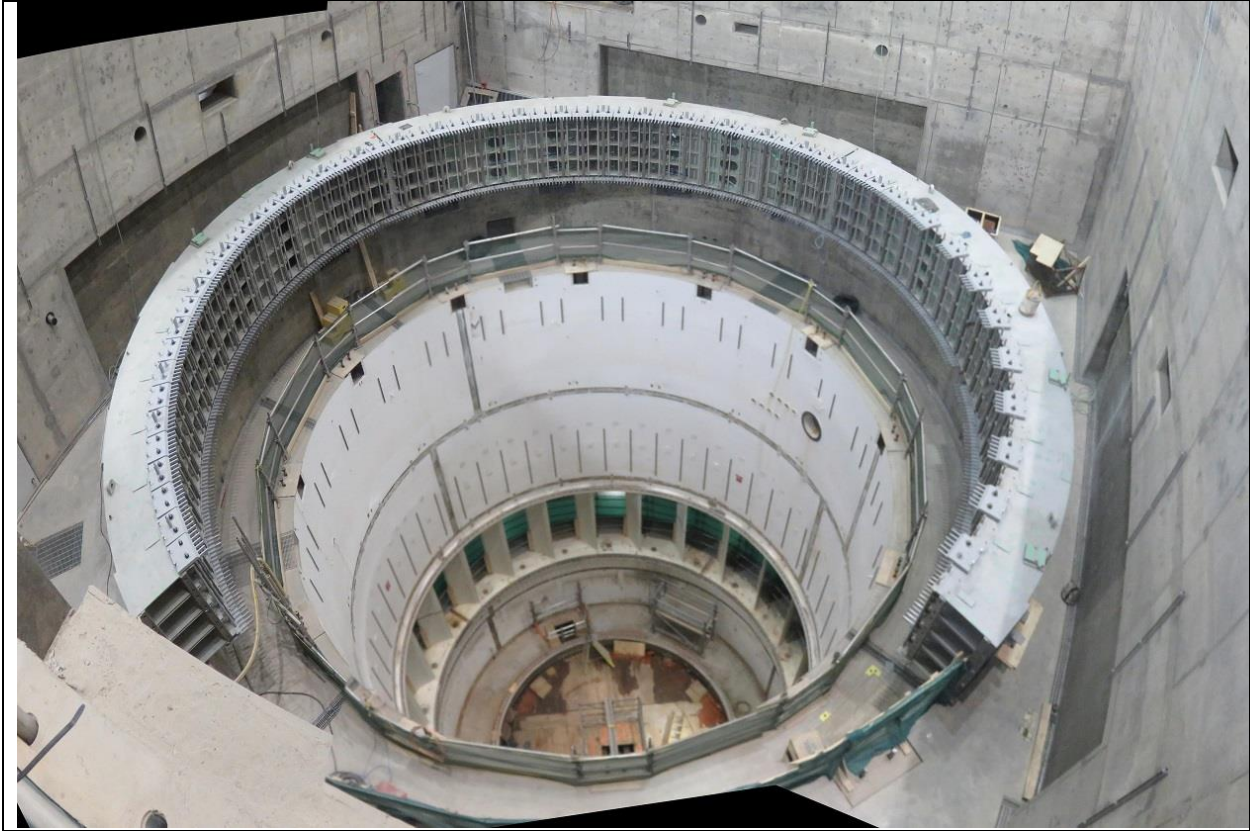
Photo B.5: Unit 4, with partially installed stator frame.

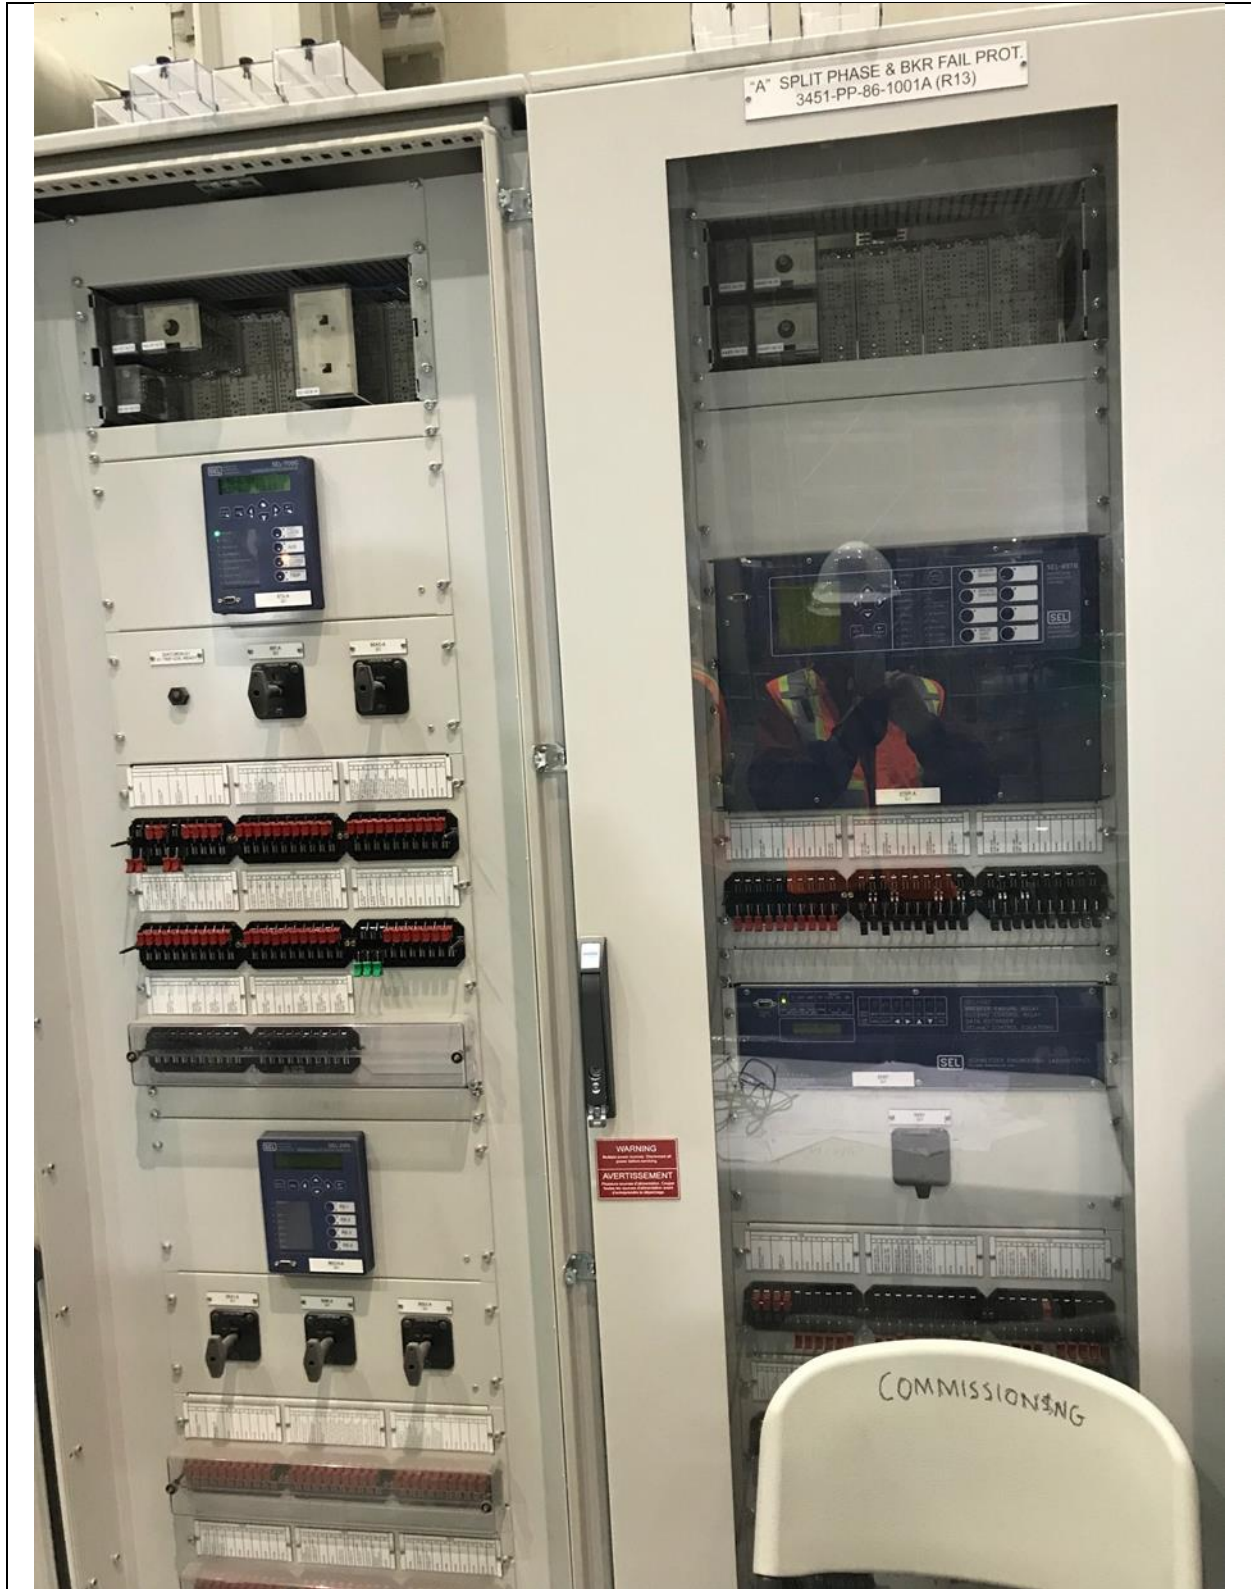
Photo B.6: Protection switchboards.

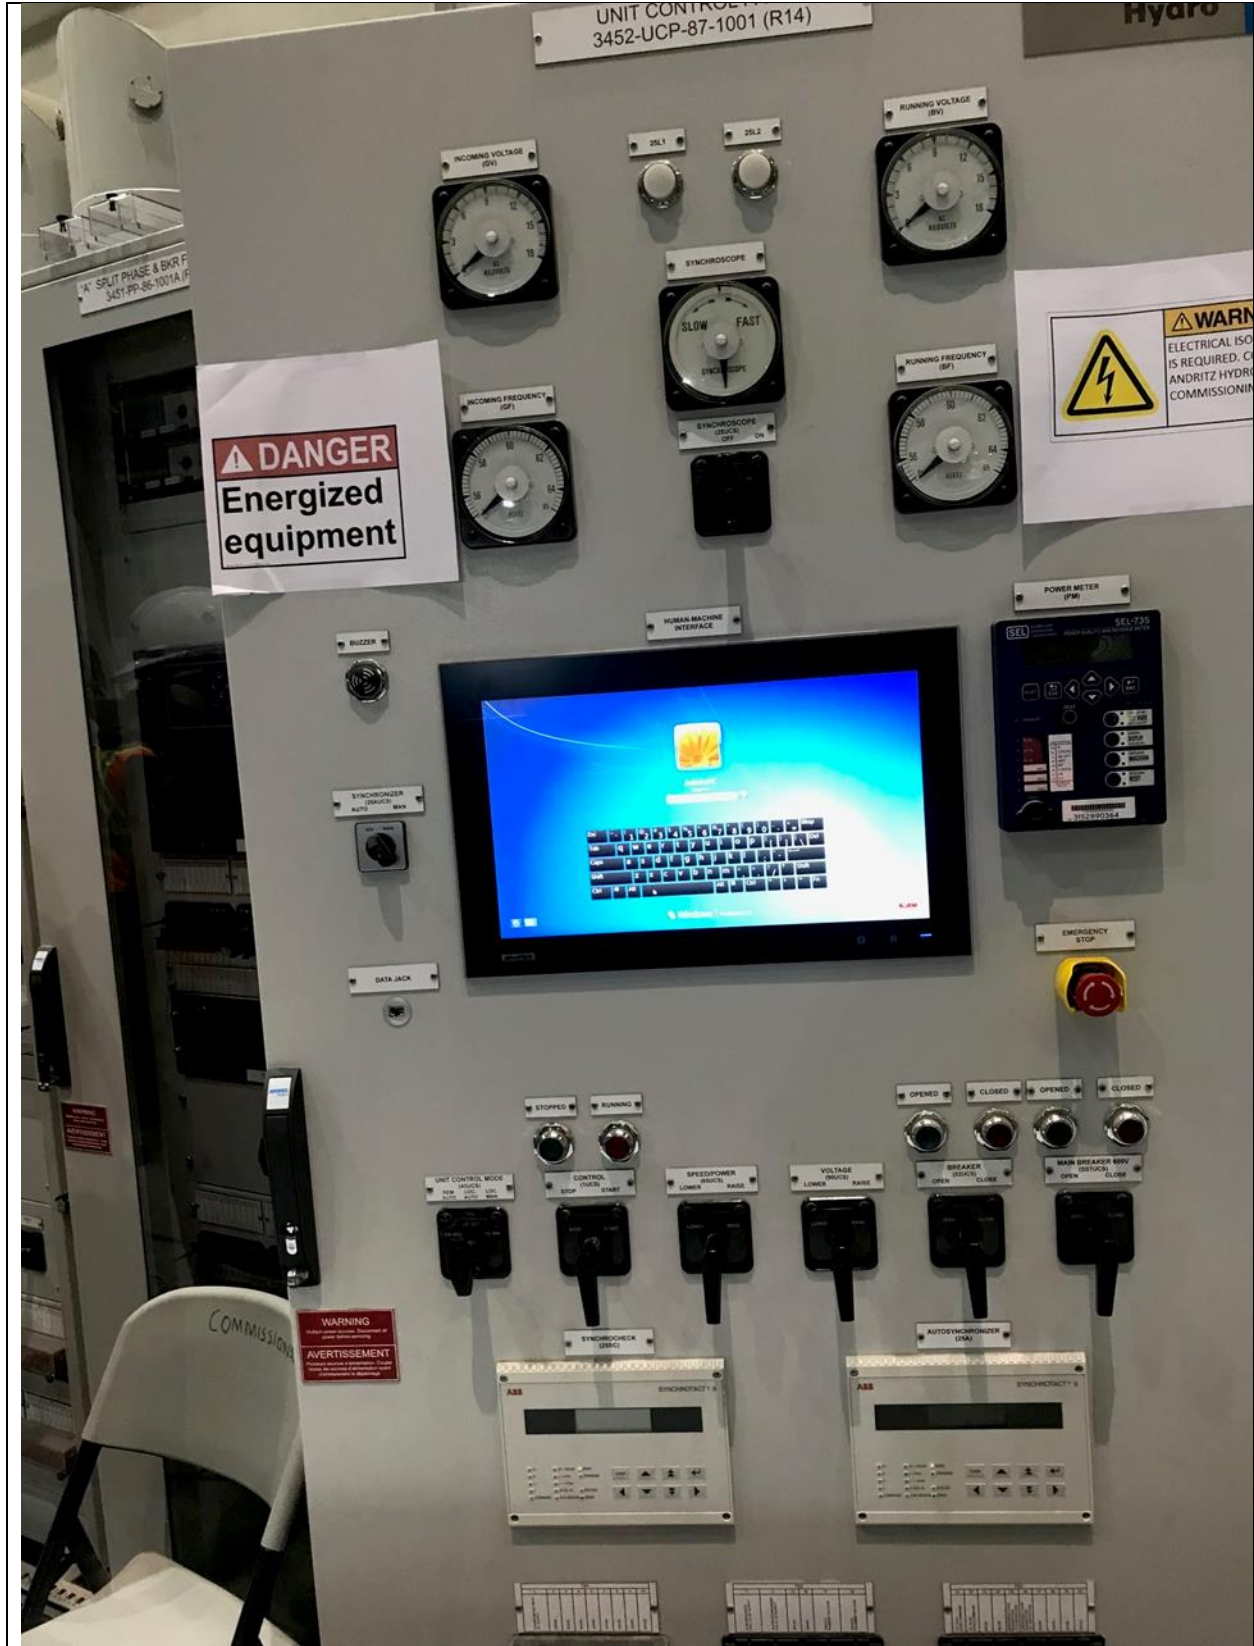
Photo B.7: Unit control board.

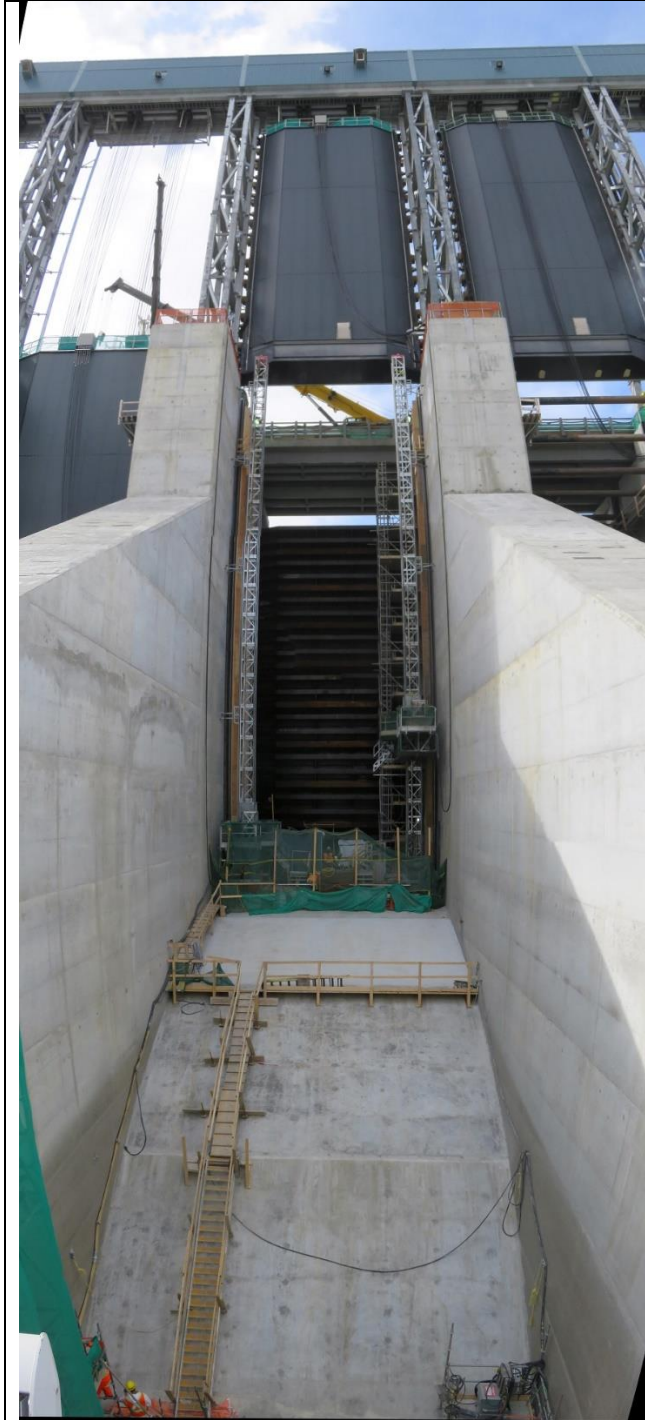
Photo C.1: Upstream view of rollway nearing completion in spillway bay 3.

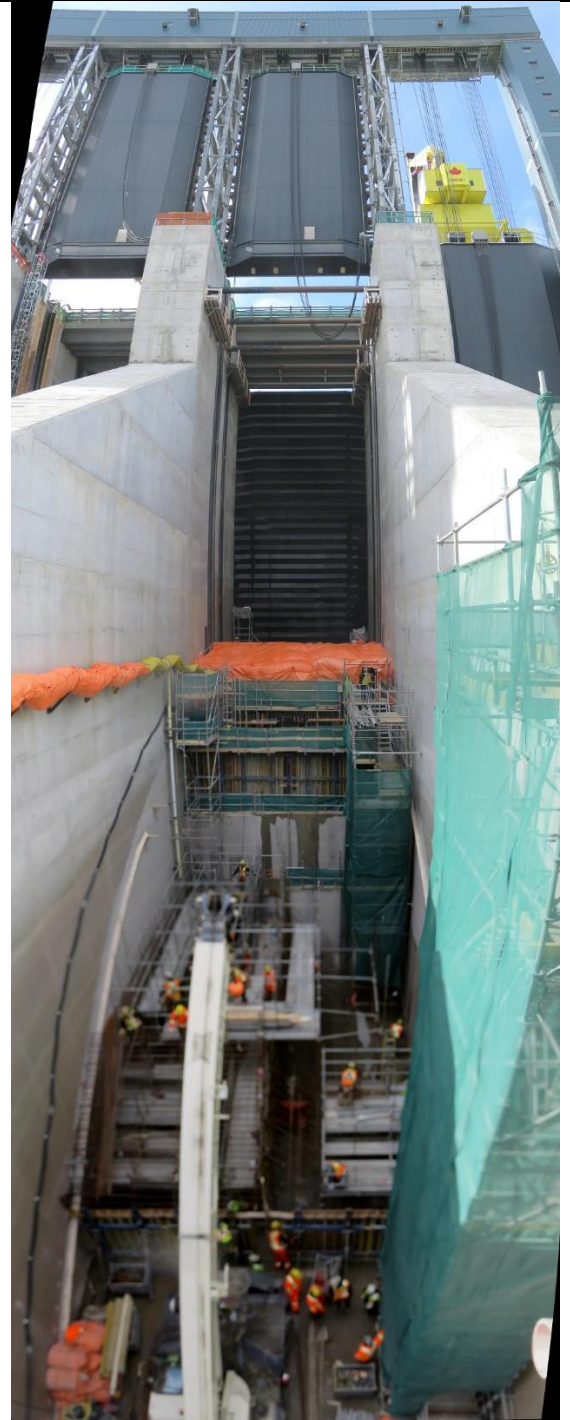
Photo C.2: Upstream view of rollway construction in spillway bay 4.

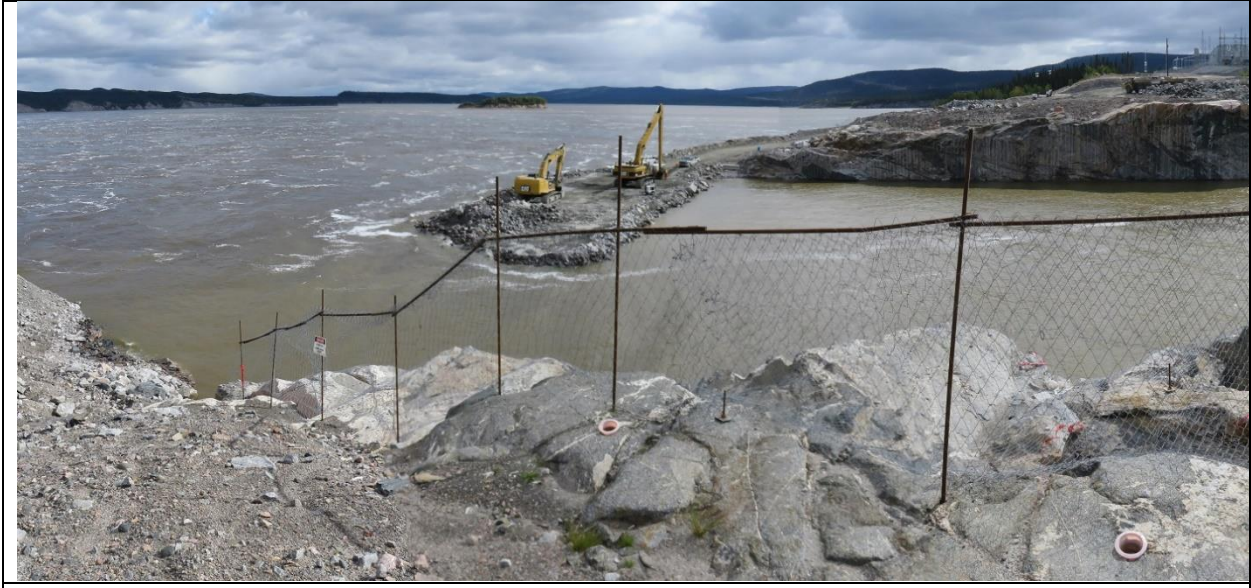
Photo C.3: Removal of tailrace rock plug in progress.

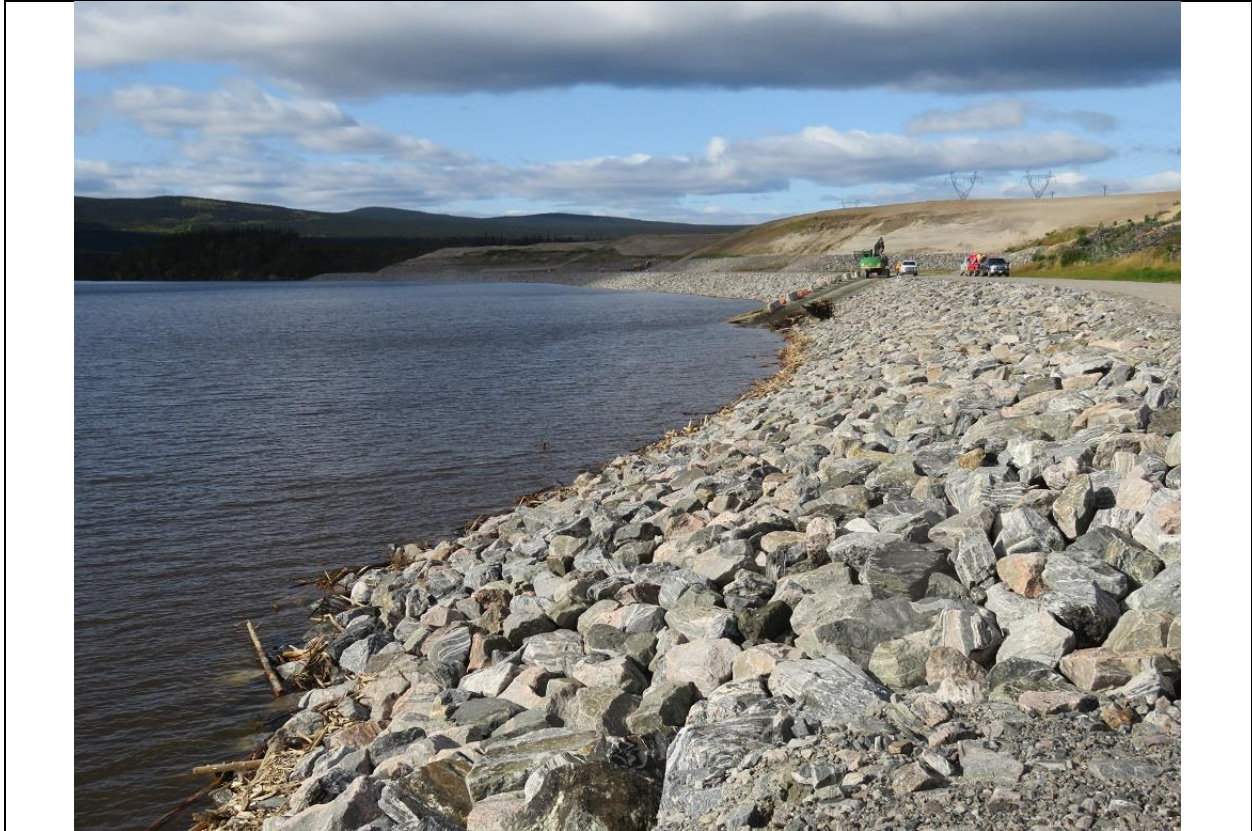
- The upstream and downstream slopes on the North Spur were stable and in good condition. There are some local areas of surficial erosion of sand by wind and surface runoff on the upper slopes which are not of concern. Nalcor has been hydroseeding and planting alders in these areas which should eventually stop such erosion.

Photo D.1: Upstream side of North Spur. Collected floating debris is removed from reservoir via the ramp near centre of photo.

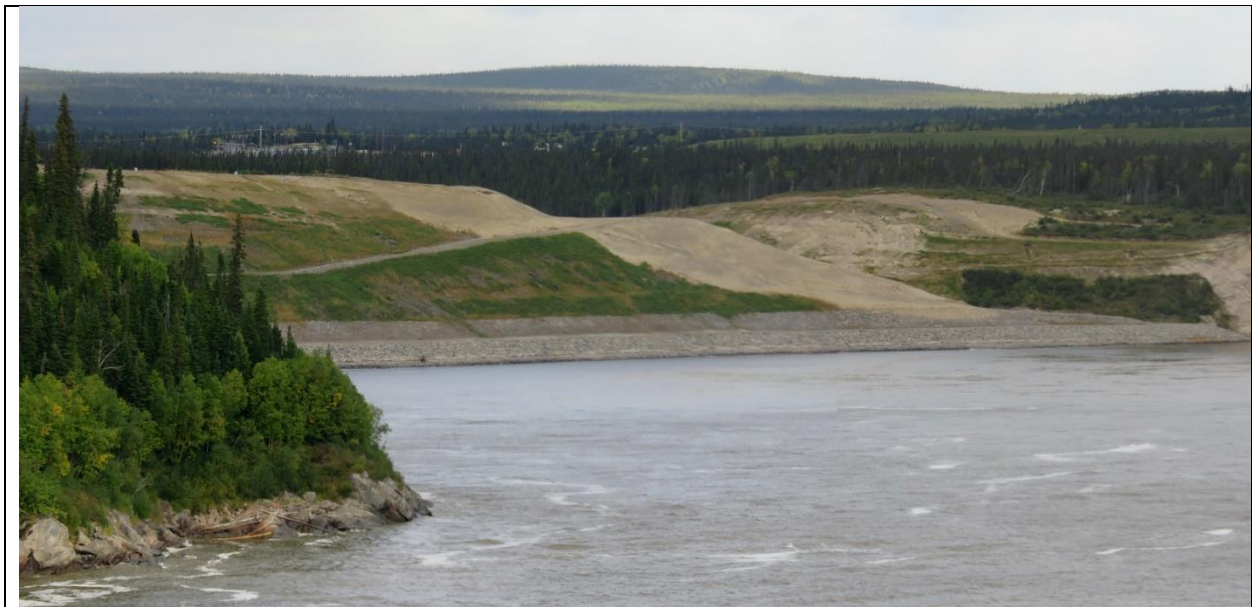
Photo D.2: Downstream side of North Spur.
