# MEETINGS IN ST. JOHN'S AND VISITS TO LOWER CHURCHILL PROJECT SITES, OCTOBER 29 TO NOVEMBER 2, 2018

Prepared for: Natural Resources Canada and Nalcor Energy  
IE Point of Contact: Nik Argirov  
Date: December 19, 2018

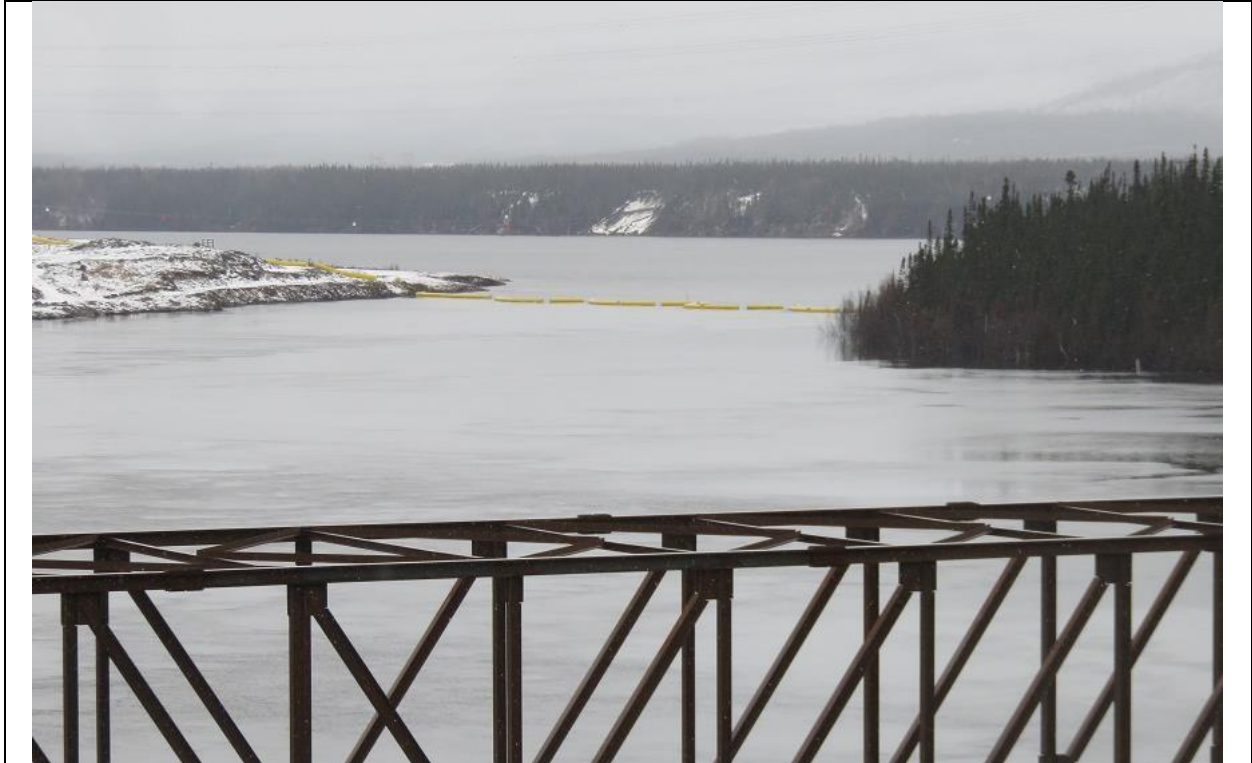
- The reservoir was at about El. 23 m at the time of the IE site visit.
- The buoy clamps of the debris/ice/safety boom have been replaced and the buoys repositioned on the boom.
- Removal of the temporary steel truss bridge across the spillway intake channel was in progress.
- See Appendix 1, Section A for photos.

Photo A.1: Upstream view of debris/ice/safety boom. Buoy clamps were replaced, and buoys repositioned along main cable.

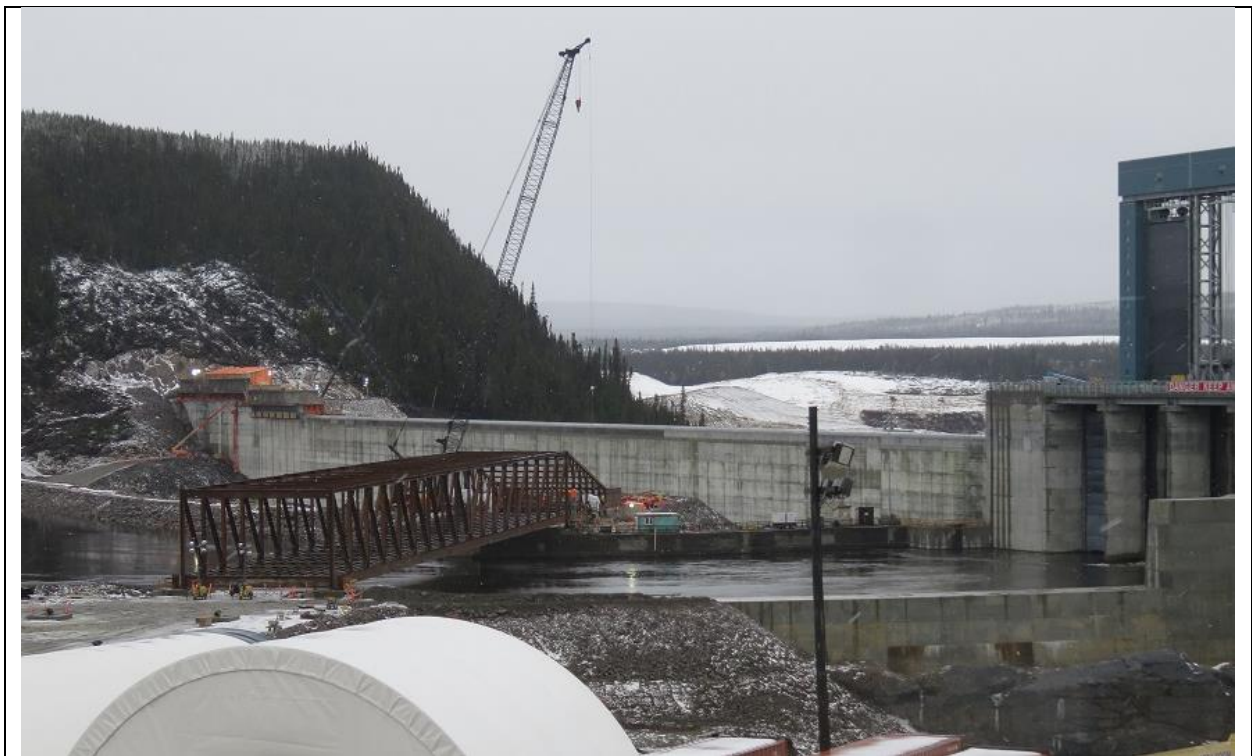
Photo A.2: Removal of temporary construction bridge in progress with completed North RCC dam in background.

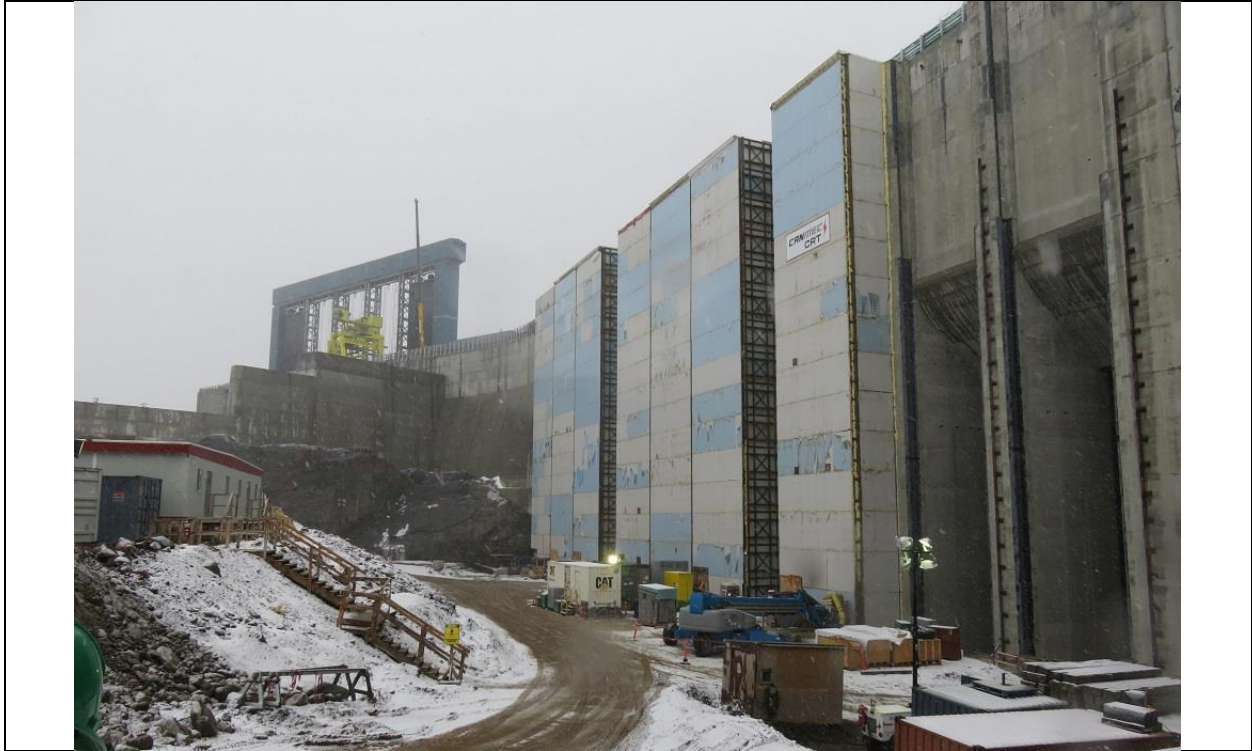
**Photo B.1:** Power intakes with temporary hoarding and heating in place for completion of second stage concrete for gate guides.

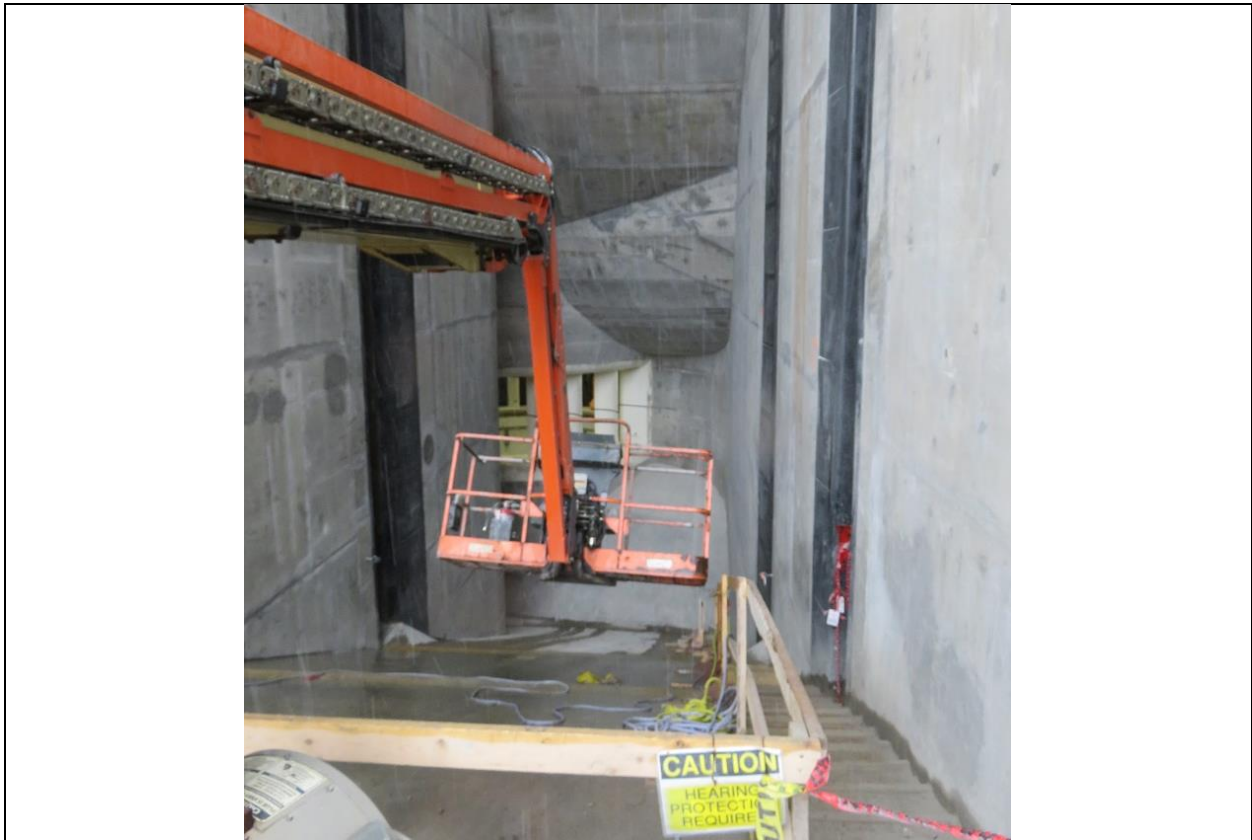
**Photo B.2:** View down one intake of Unit 1 looking along flow passage into guide vanes.

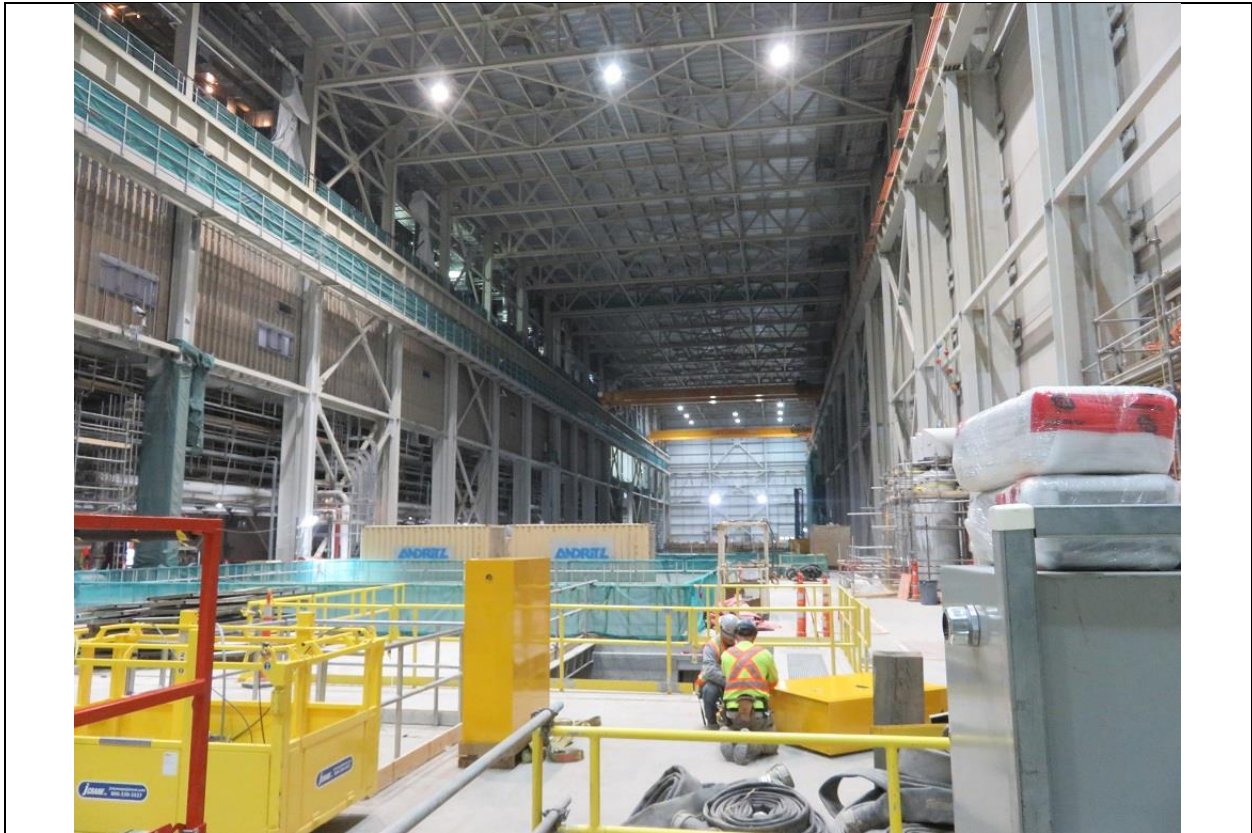
**Photo B.3:** Interior view of powerhouse from main service bay.

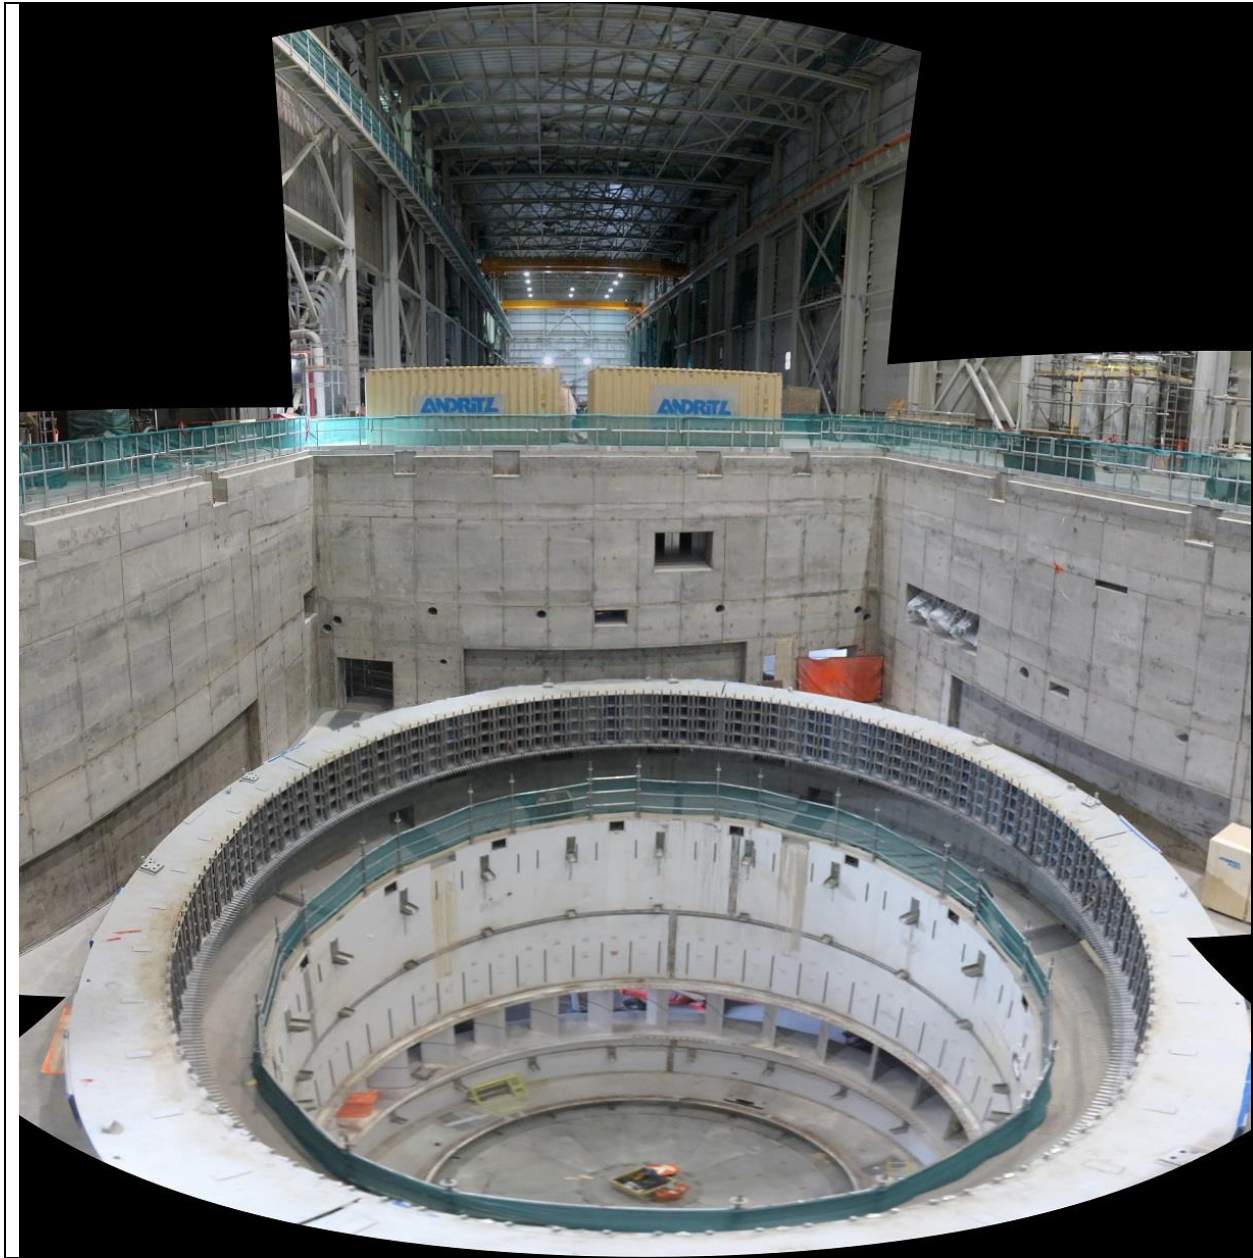
Photo B.4: Panorama view of Unit 1.

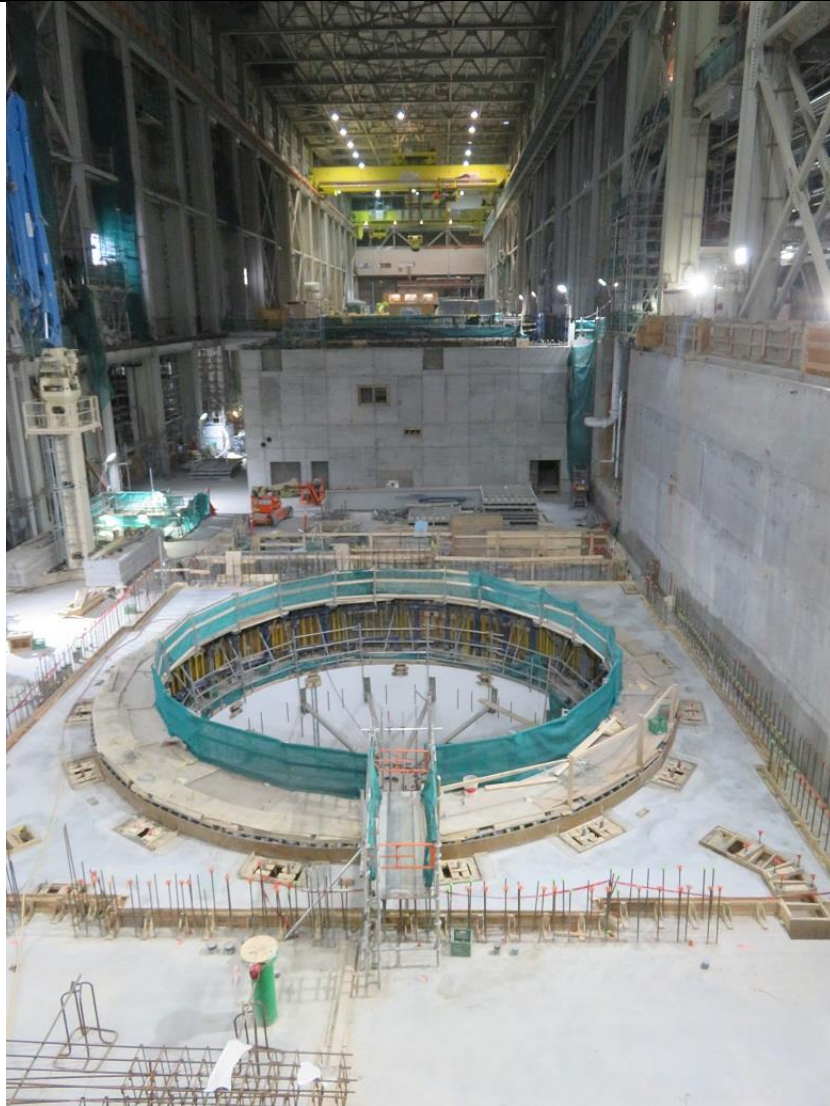
**Photo B.5:** Interior view of powerhouse from north service bay with Unit 4 in foreground.

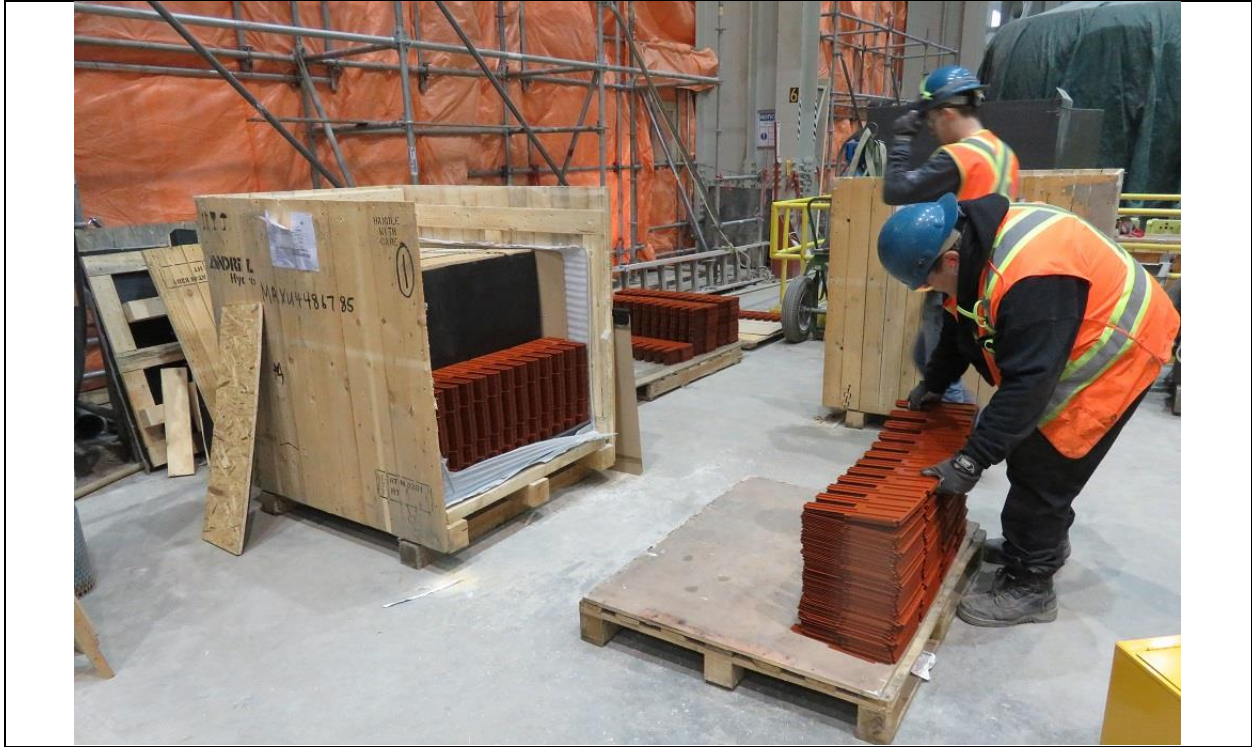
Photo B.6: Unpacking lamination plates for generator stator core.

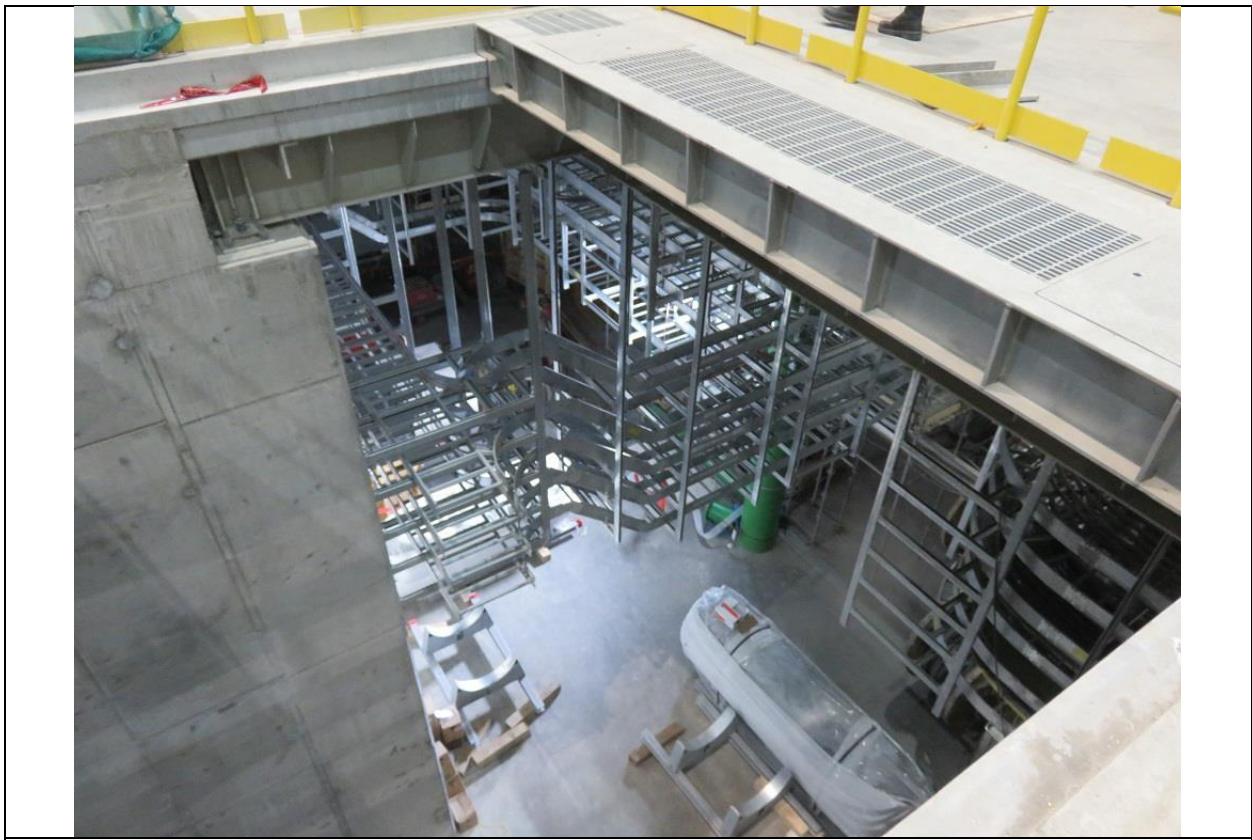
Photo B.7: Cable trays installed below generator floor.

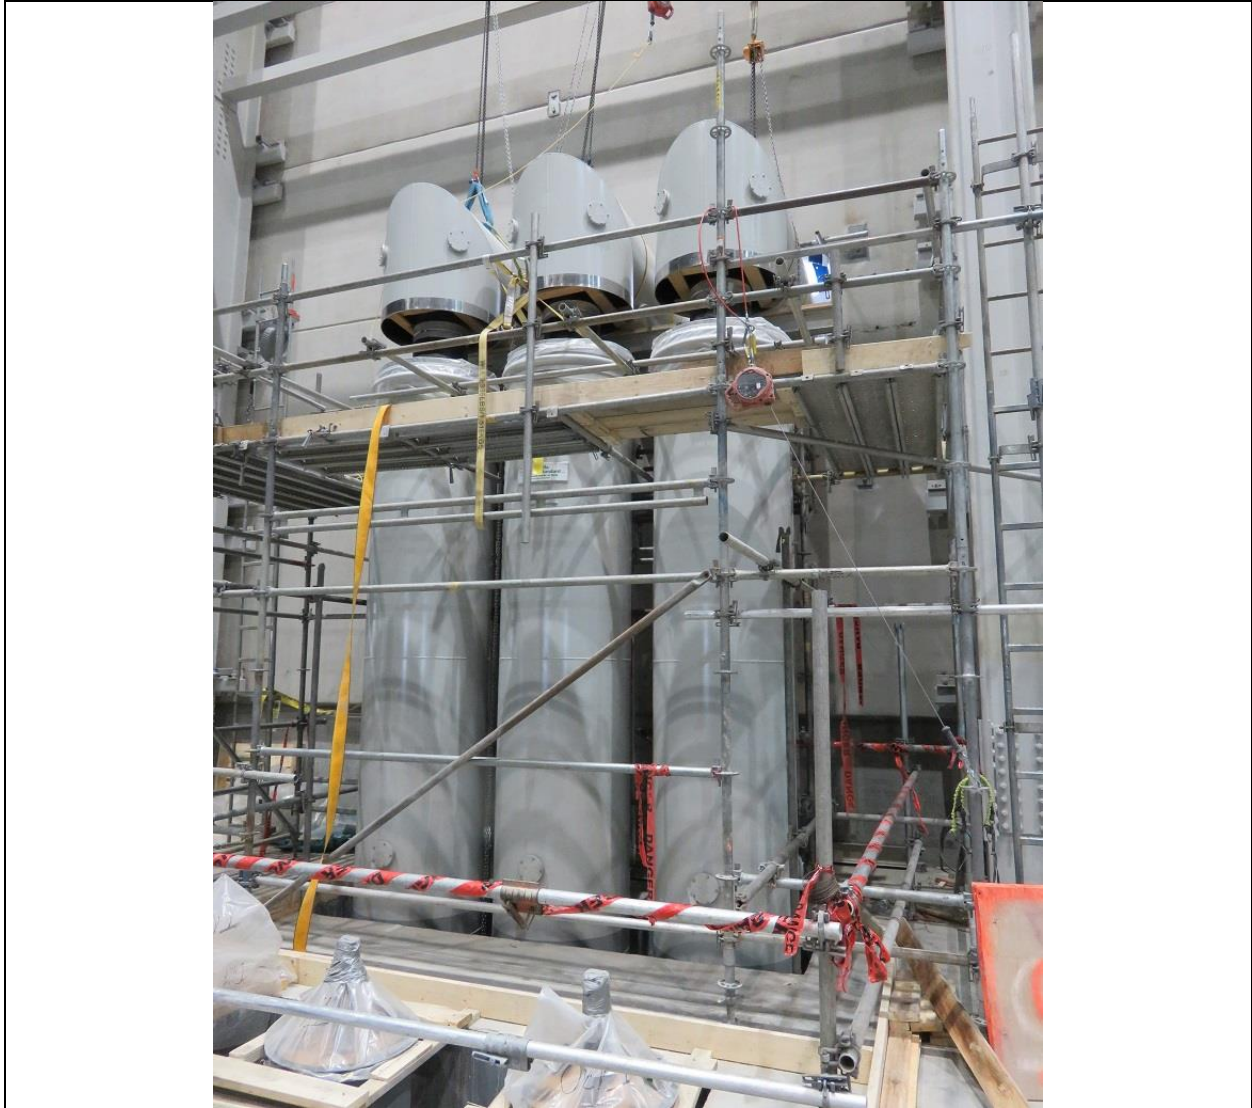
**Photo B.8:** Installation of isolated phase bus in progress.

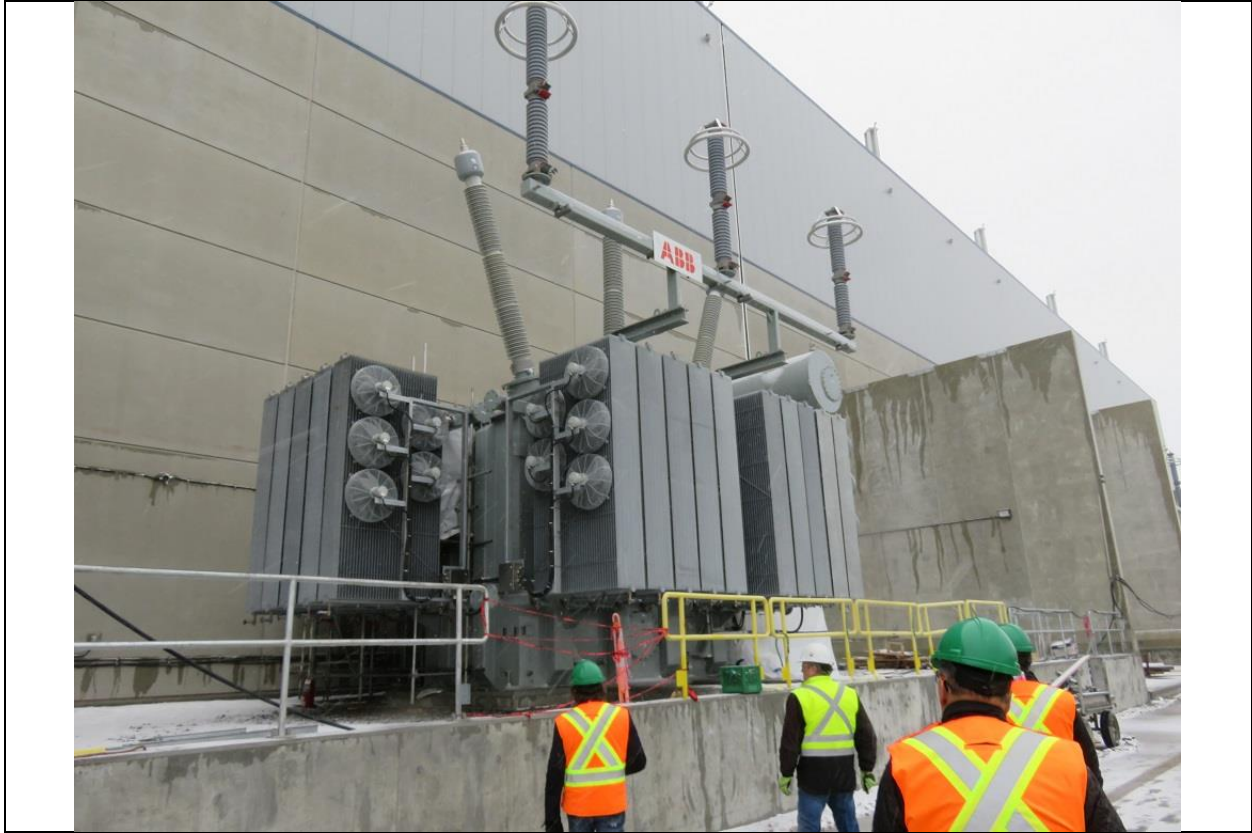
Photo B.9: Generator transformer installed on tailrace deck.

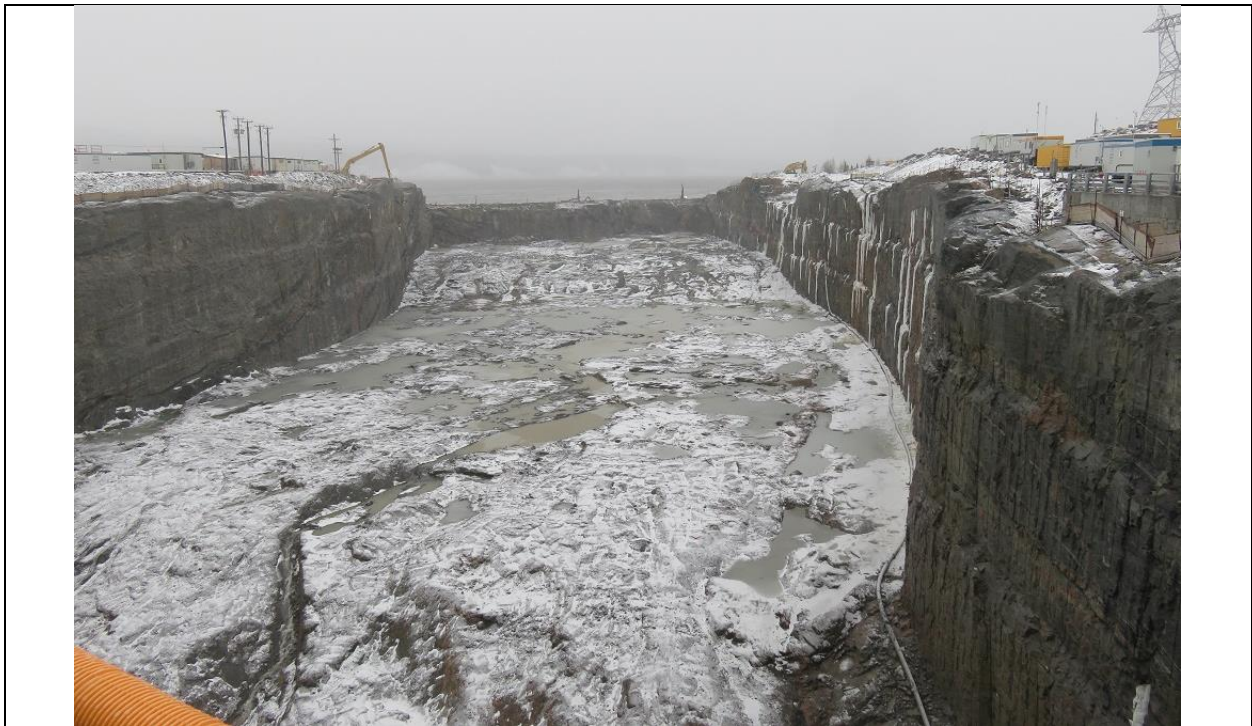
Photo B.10: Removal of rock plug at downstream end of tailrace channel is in progress.

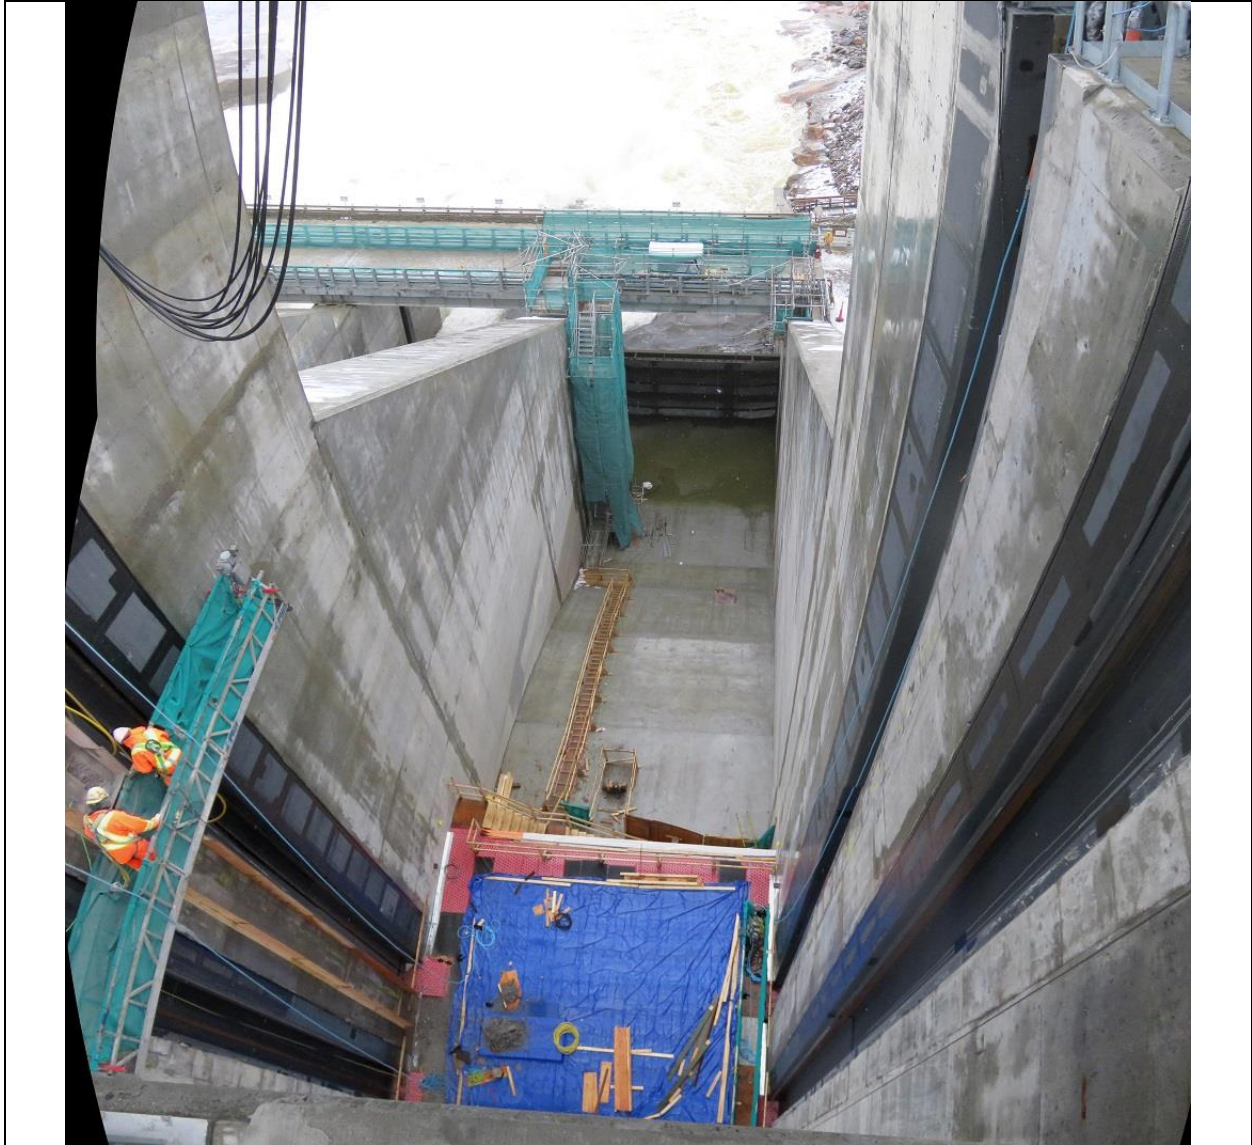
- Spillway concrete is complete except for rollways 2, 3 and 4 and minor local repairs.
- Spillway gate guides are 100% complete.
- Final commissioning of gates is underway.
- See Appendix 1, Section C for photos.

Photo C.1: Local concrete repair between gate guides in spillway bay 1.

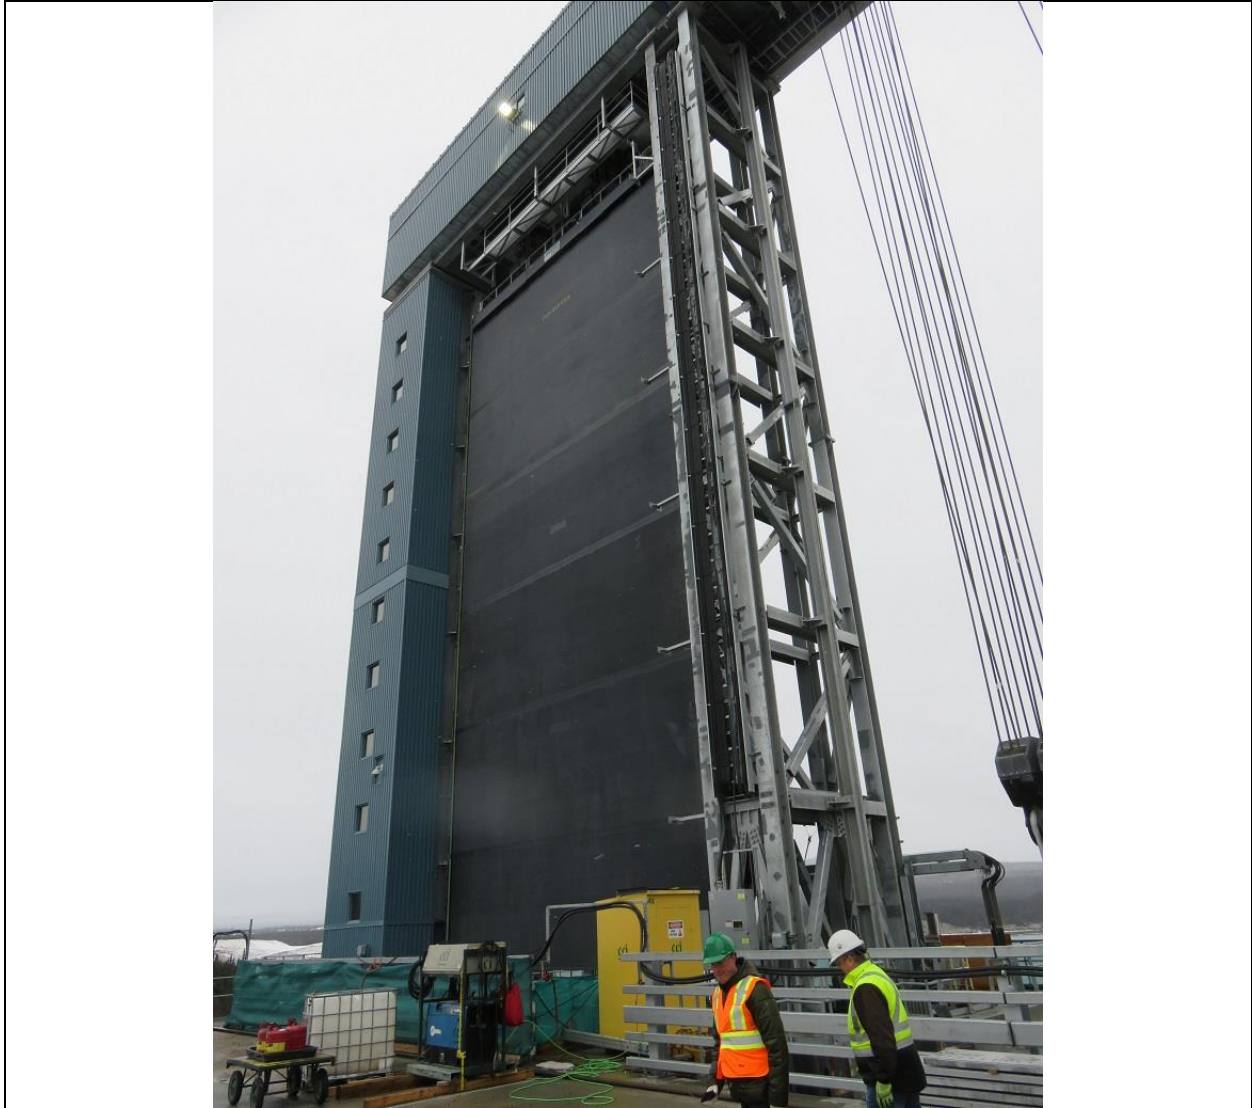
Photo C.2: Spillway gate in raised position in Bay 5.

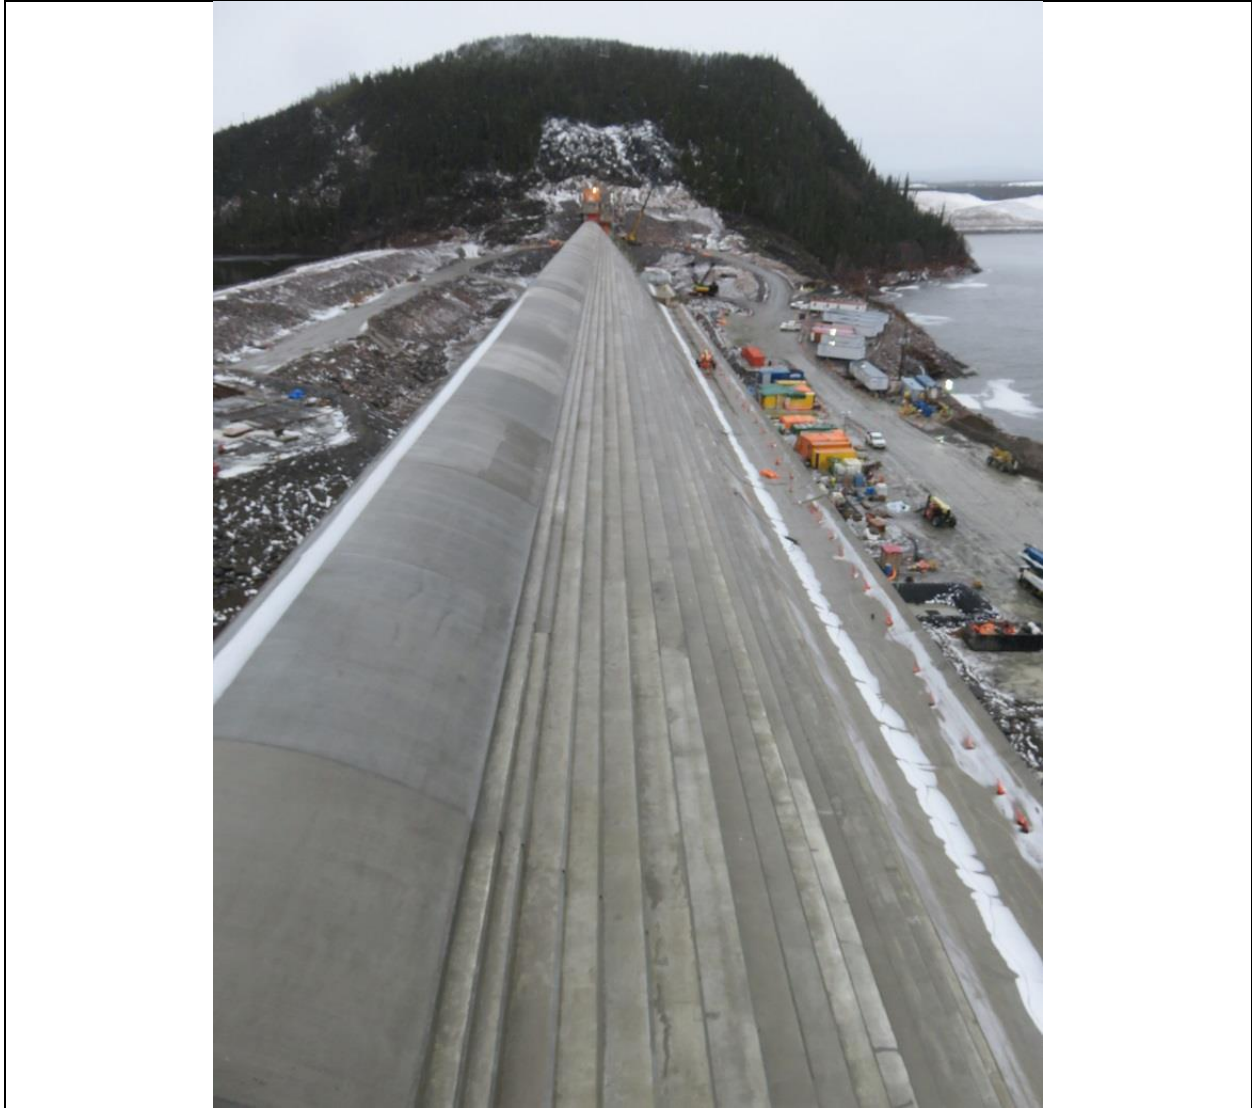
**Photo D.1:** View from north transition dam looking northerly along top of completed north RCC dam.

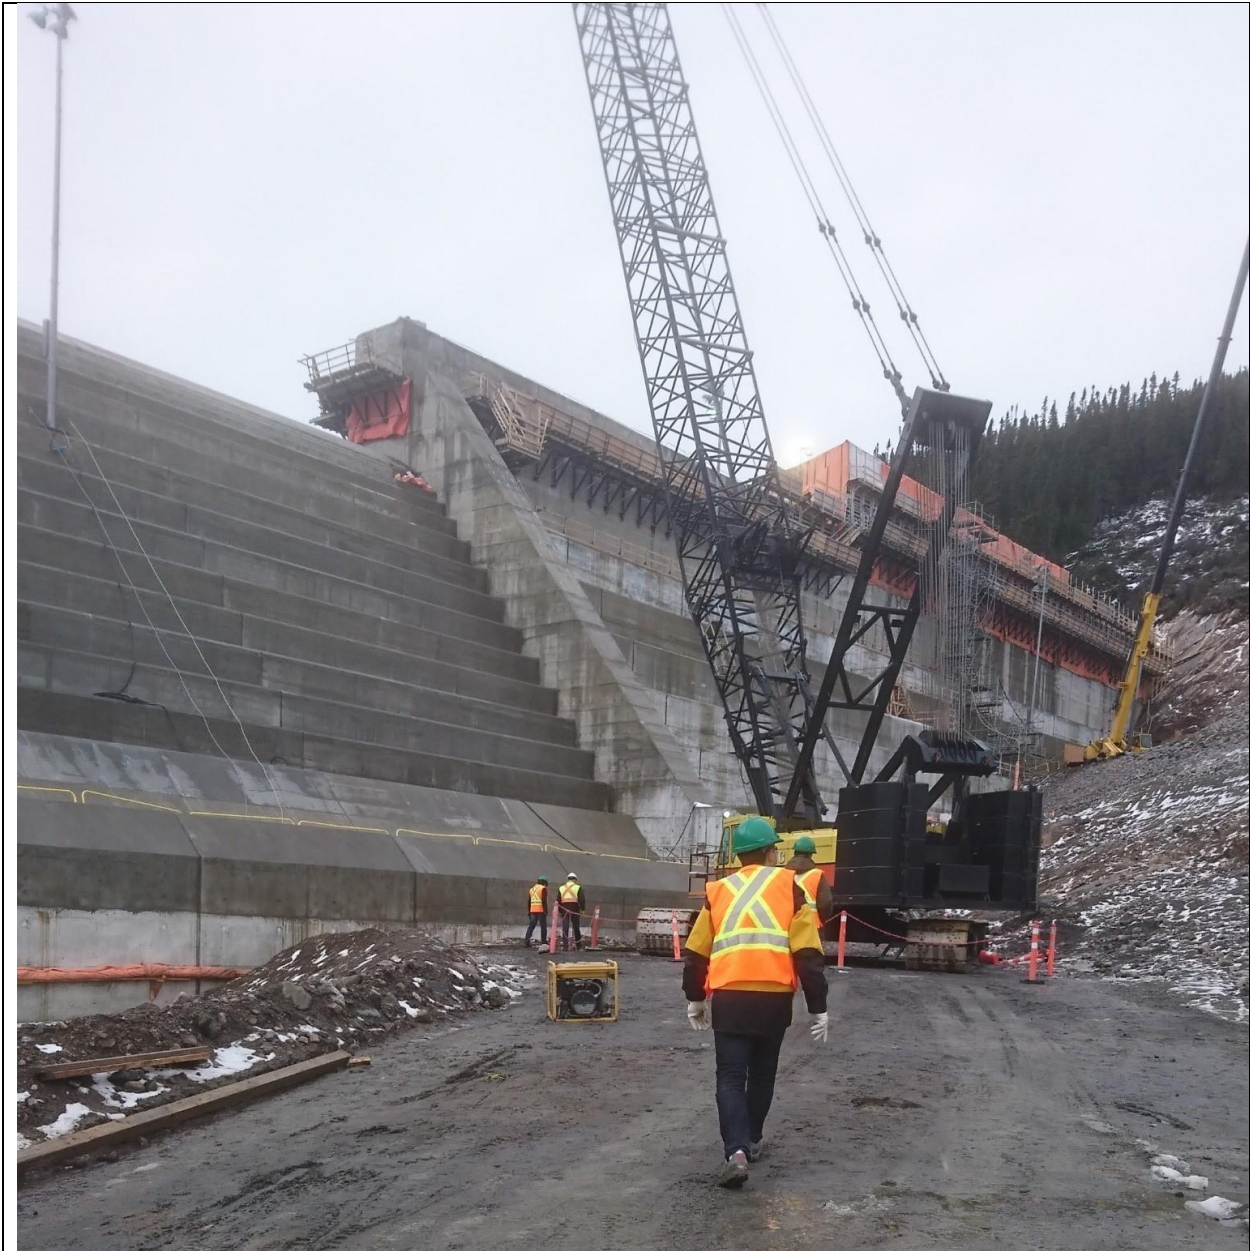
Photo D.2: Non-overflow section of north RCC dam.

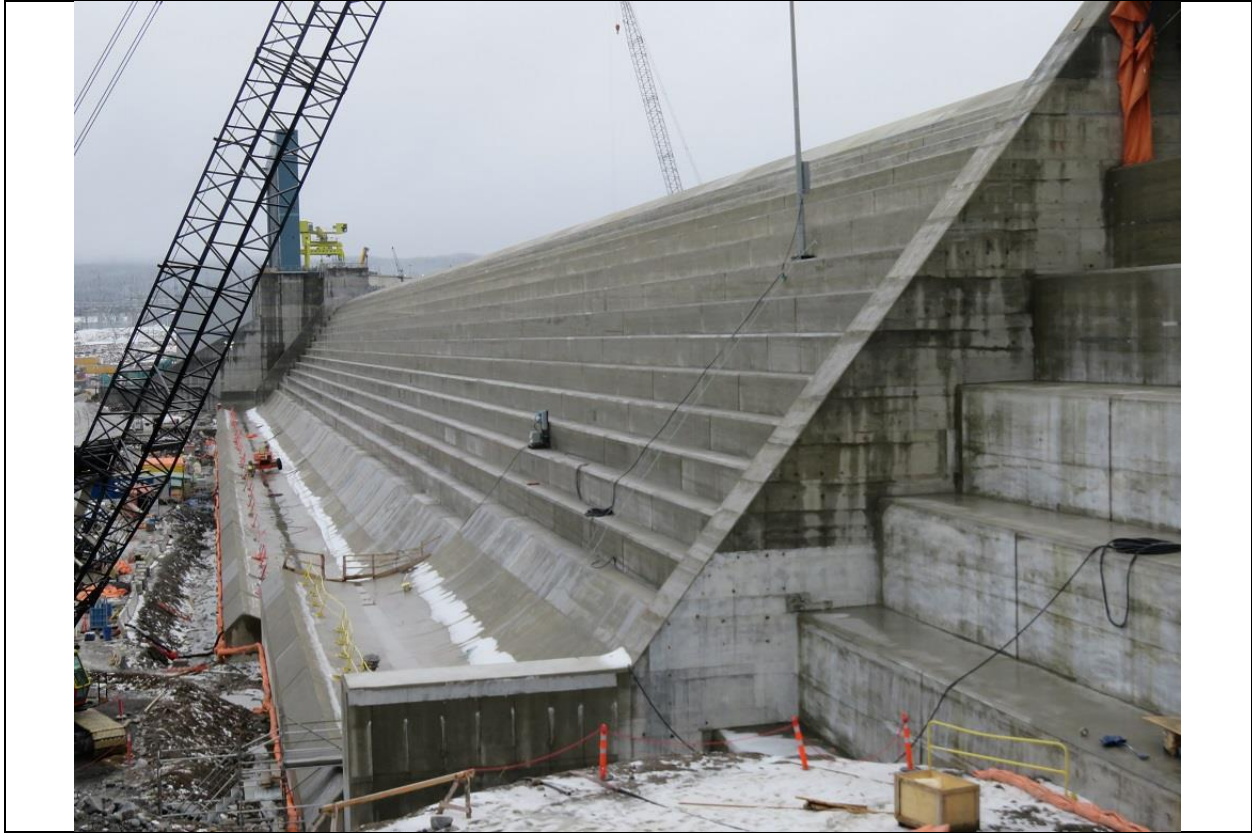
Photo D.3: Downstream side of north RCC dam.

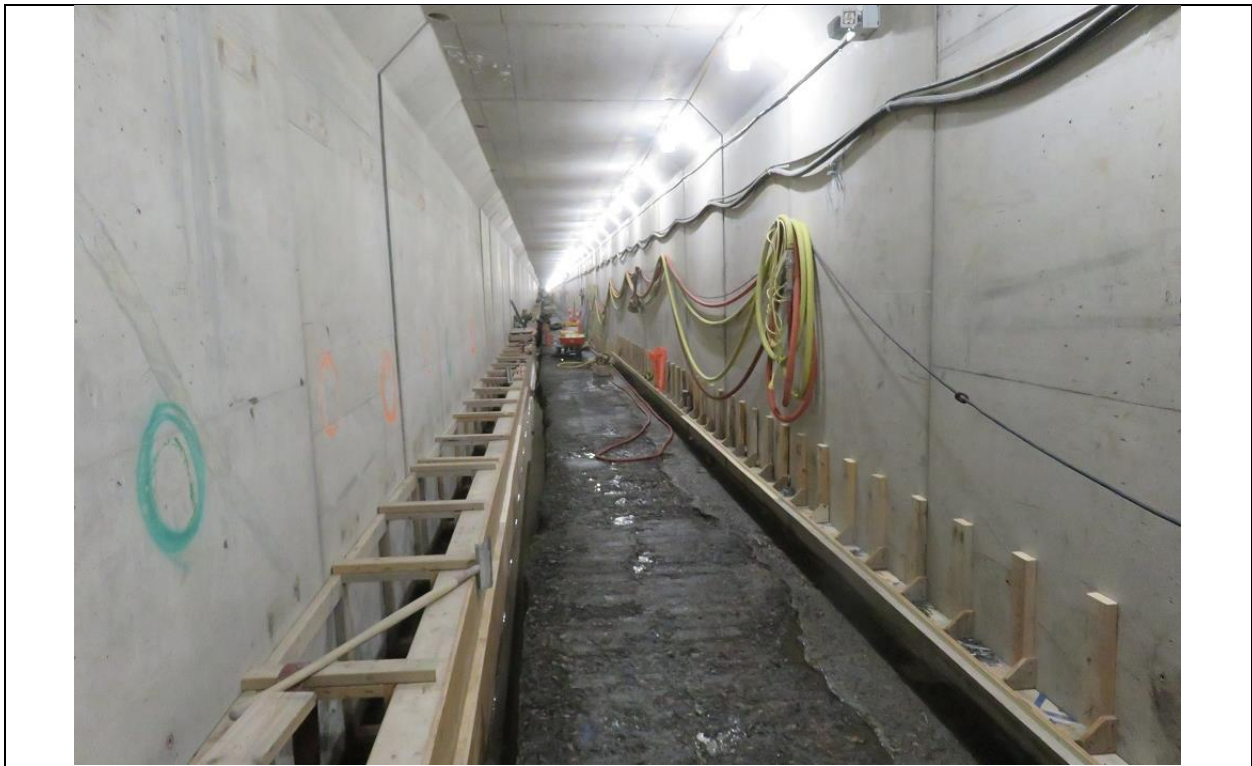
Photo D.4: Drainage gallery inside north RCC dam.

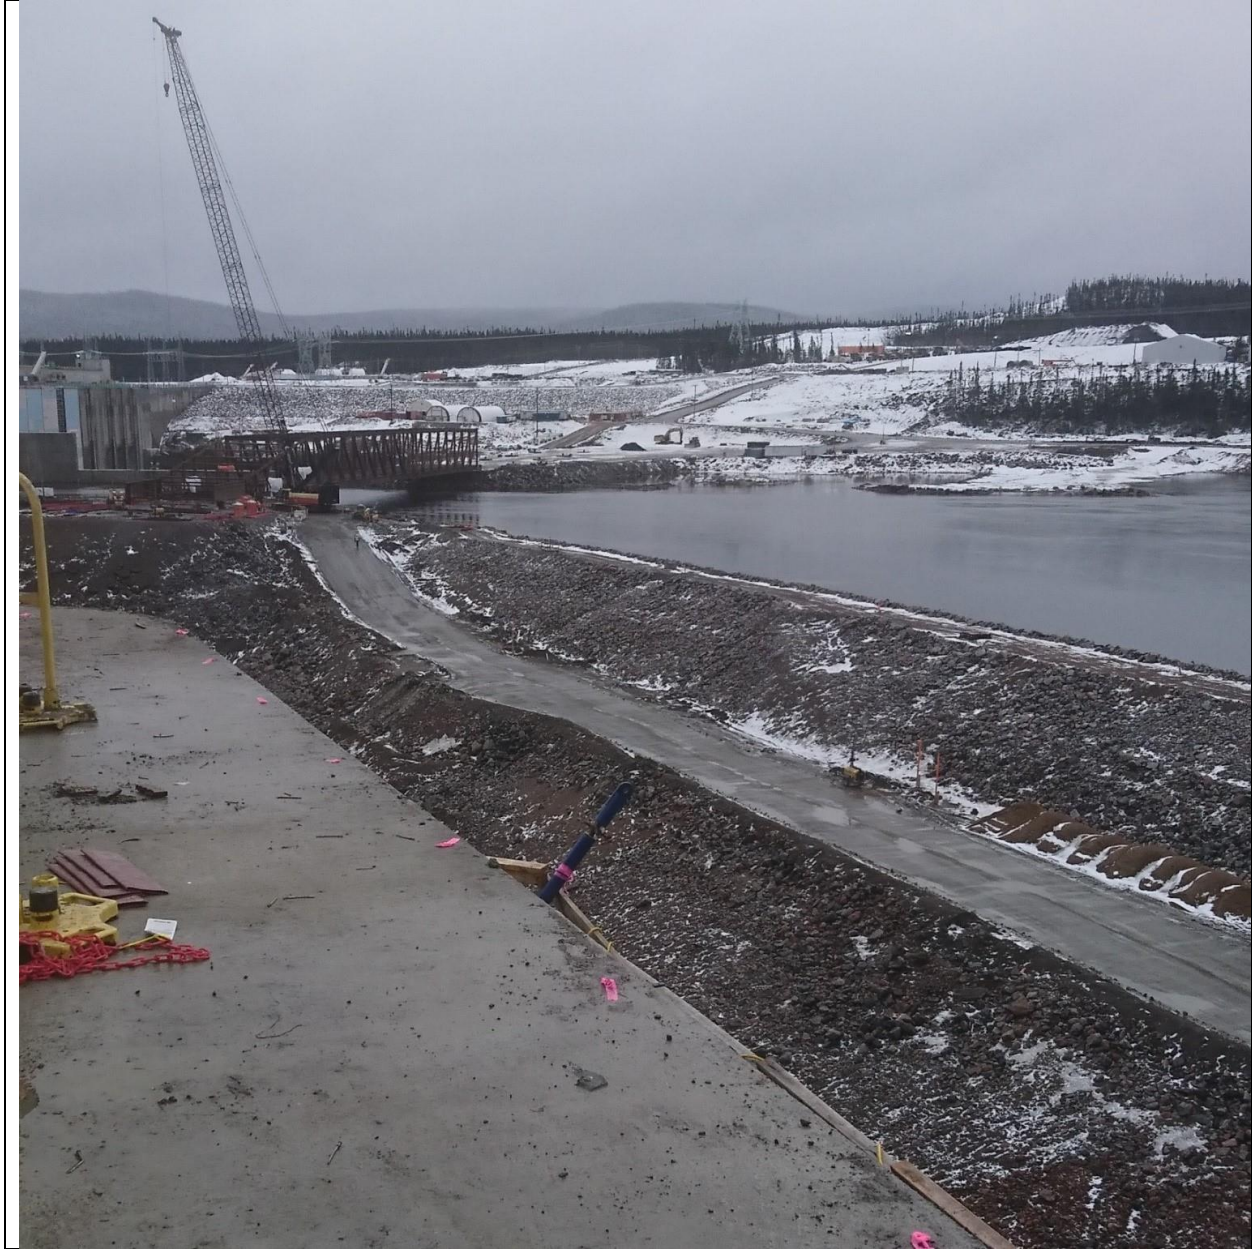
- Cofferdam will remain in place during and after final reservoir filling. A question was raised regarding if additional loading would build up on North Dam as area between cofferdam and dam fills with silt and debris over time. The answer was that such a load case is already part of the original design.
  - See Appendix 1, Section D for photos.

Photo D.5: Upstream cofferdam.

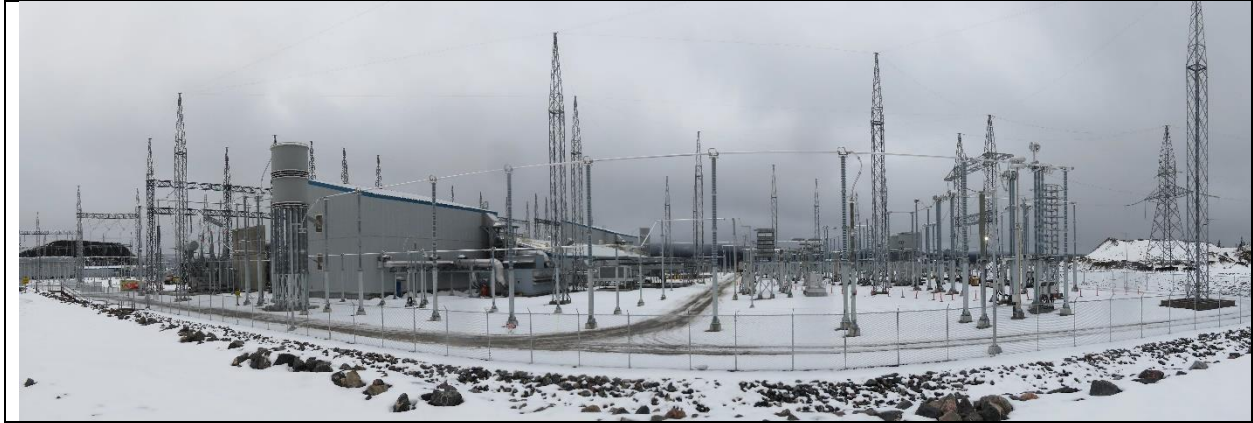
Photo E.1: GIS building and yard.
