# MEETINGS IN ST. JOHN'S AND VISITS TO LOWER CHURCHILL PROJECT SITES, OCTOBER 29 TO NOVEMBER 2, 2018

Prepared for: Natural Resources Canada and Nalcor Energy  
IE Point of Contact: Nik Argirov  
Date: December 19, 2018

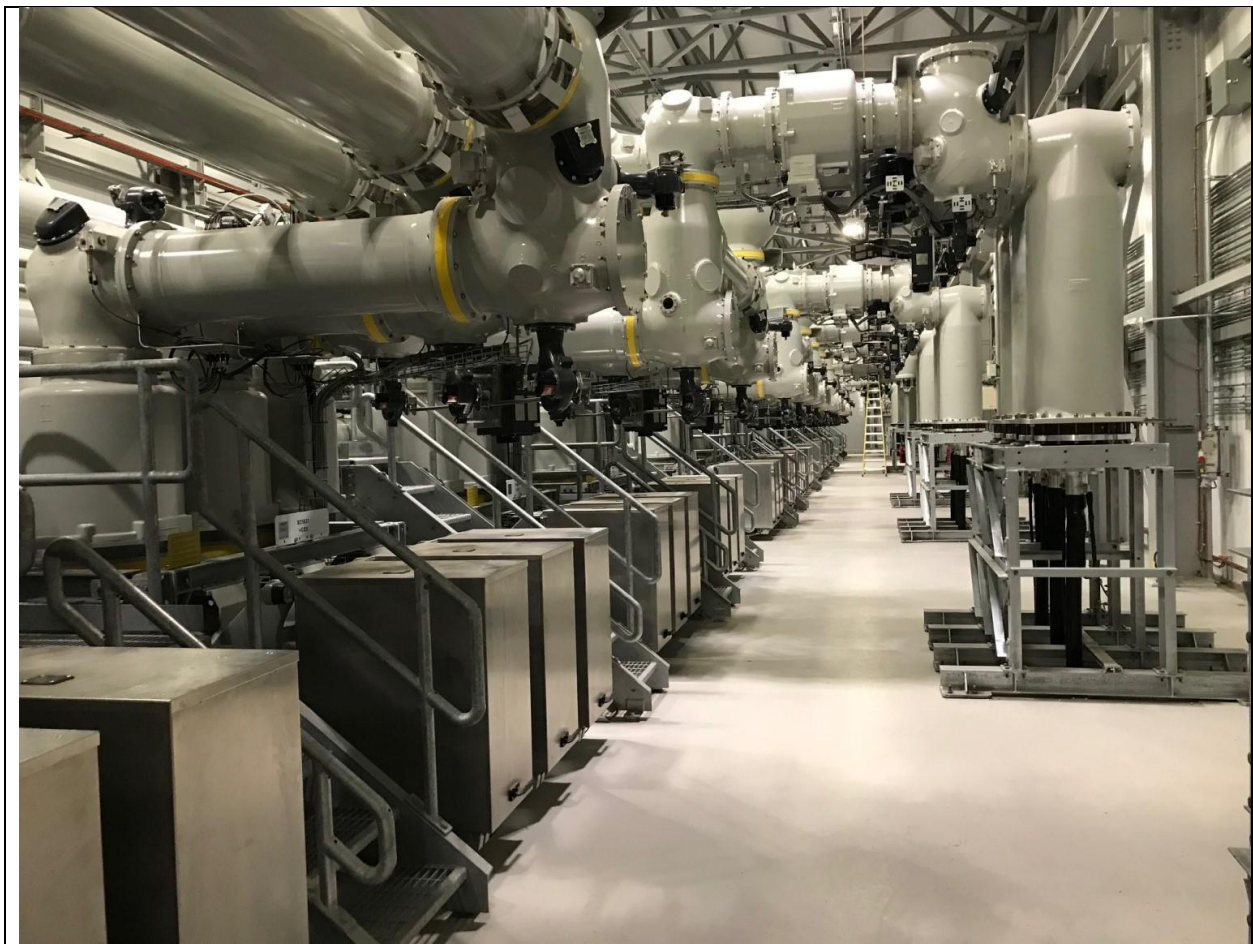
- GIS installation is complete and ready for power transfer.
- See Appendix 1, Section E for photos.

Photo E.2: GIS equipment

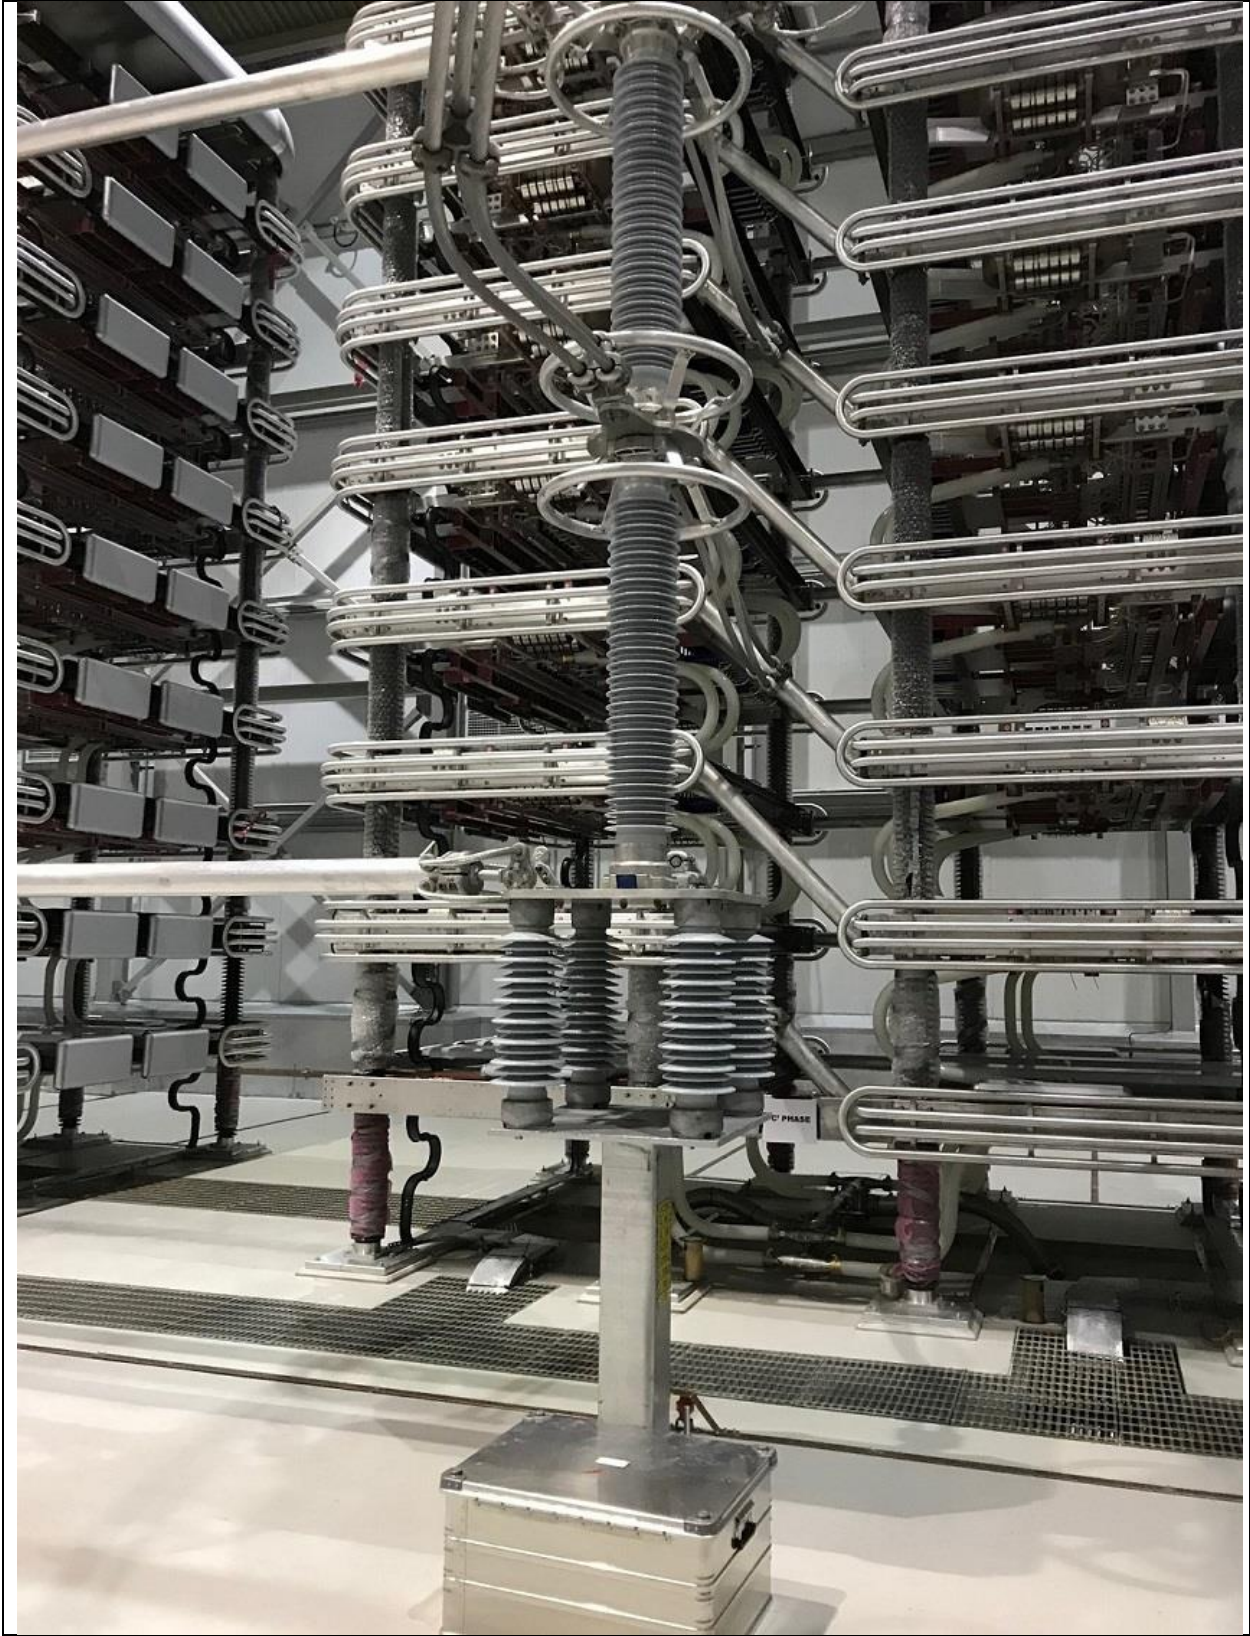
Photo E.3: HVDC valves.

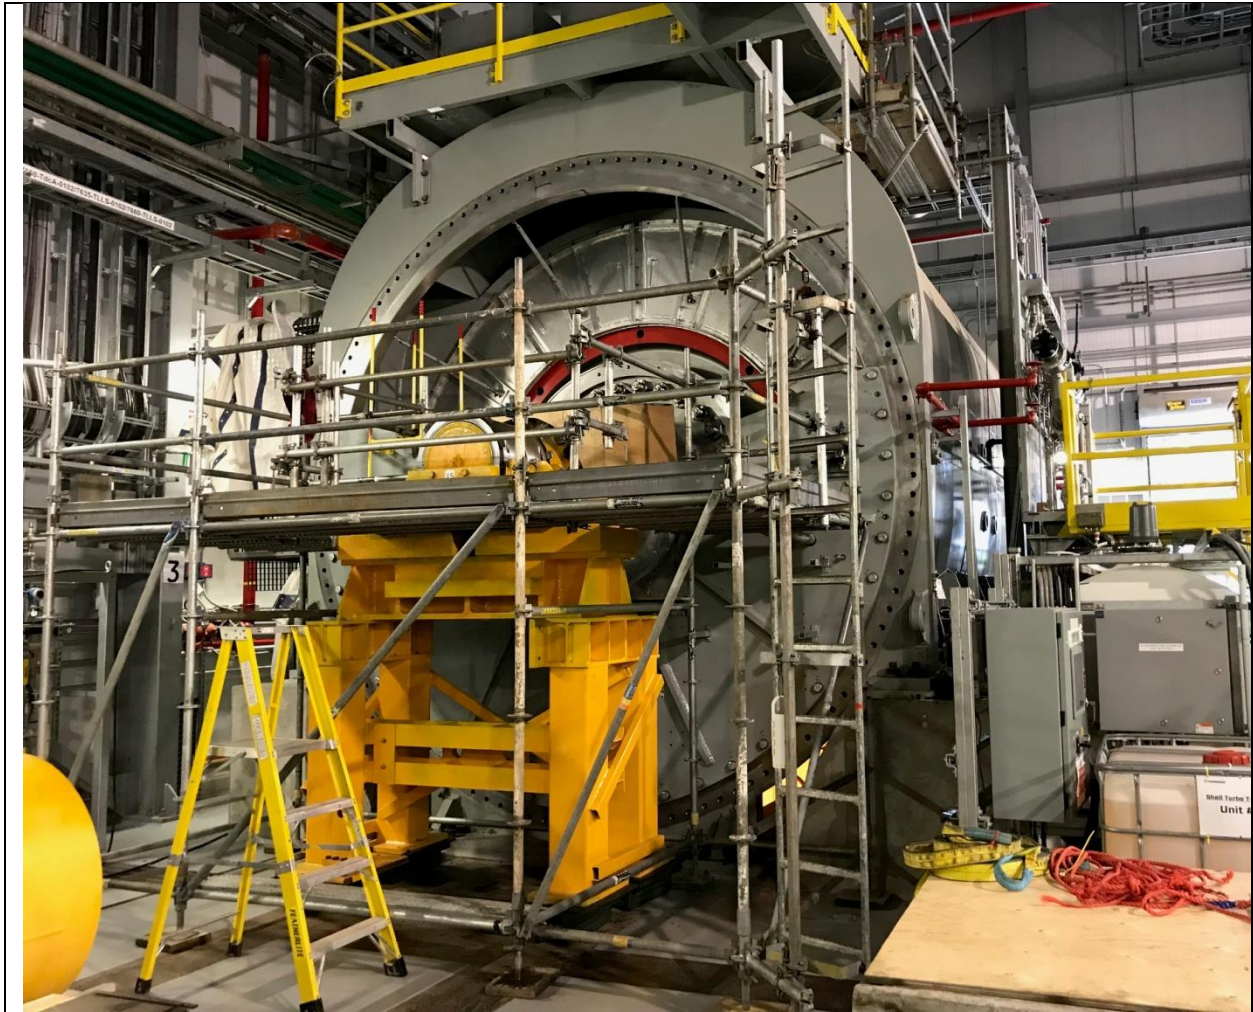
- Lubricating oil contamination was discovered in all three units during precommissioning checks. Source of the contamination is not known at this time. External consultants are assisting in the investigation and will conduct root cause analysis of the problem.
- Unit 1 rotor was jacked up, bellhousing removed and bearing shells were removed for inspection.
- See Appendix 1, Section F for photos.

Photo F.1: SOP Unit 1, bellhousing removed.

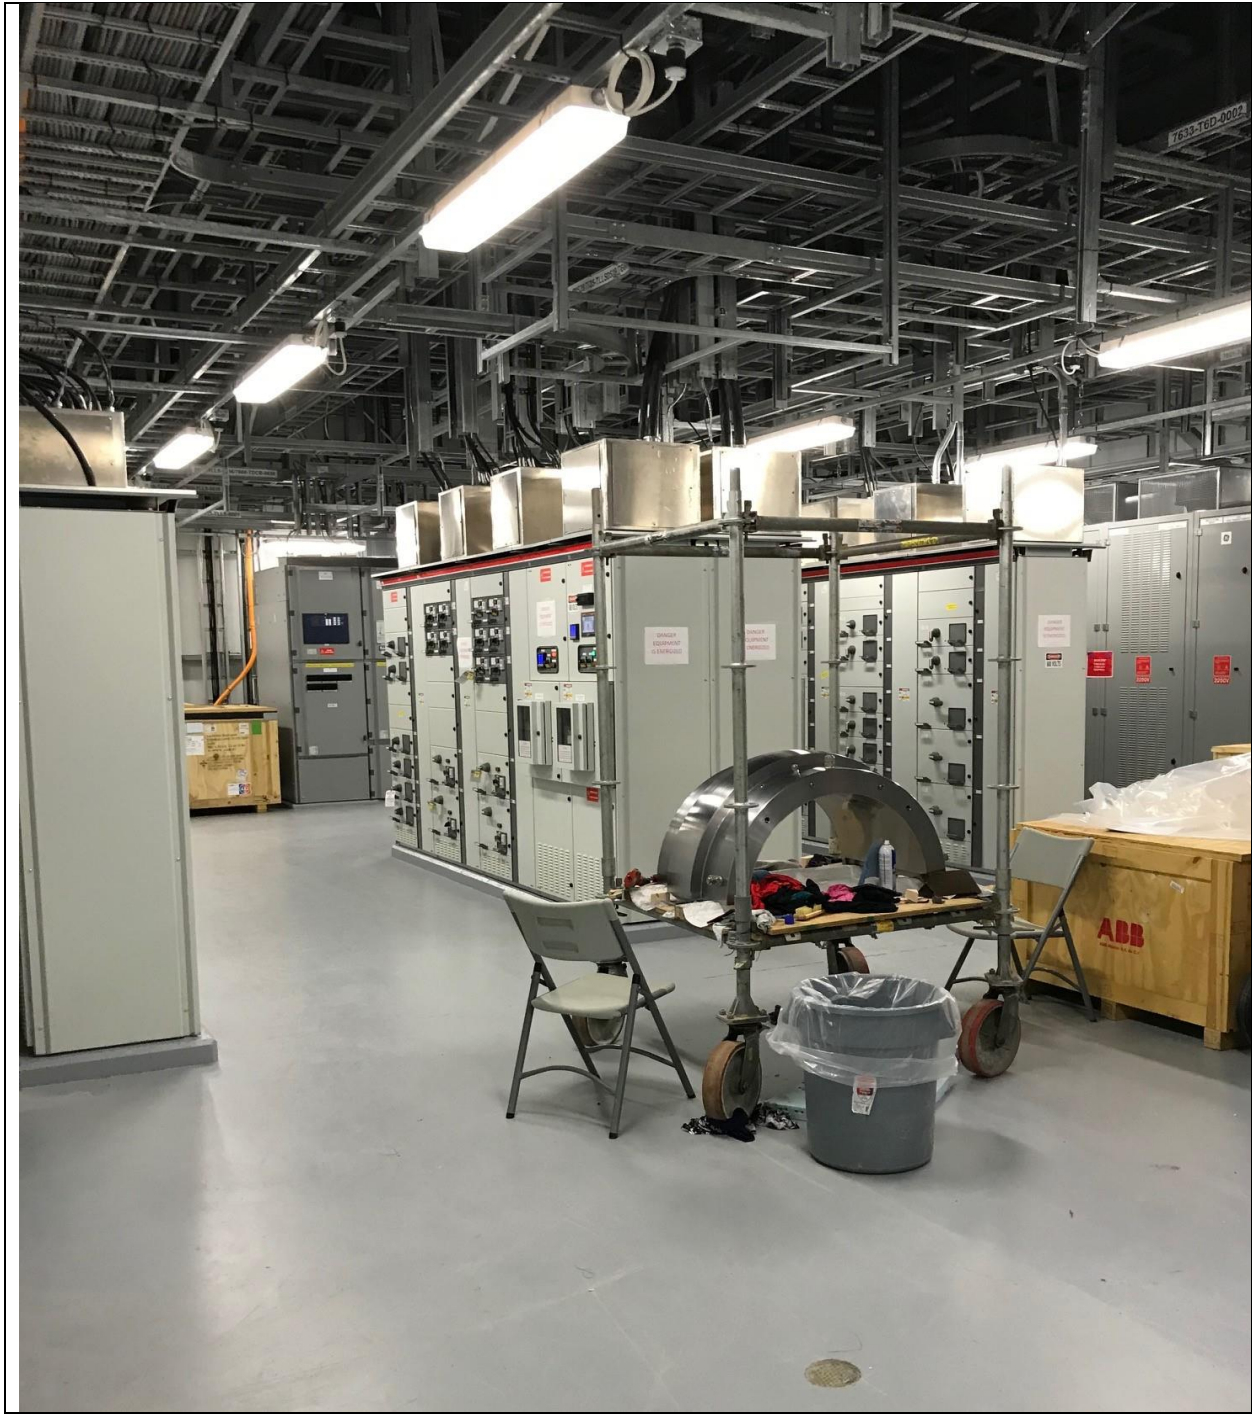
Photo F.2: . SOP Unit 1 bearing shell.
