MEETINGS IN ST. JOHN'S AND VISITS TO LOWER CHURCHILL PROJECT SITES, JULY 23 TO 28, 2017

Prepared for: Natural Resources Canada and Nalcor Energy
IE Point of Contact: Nik Argirov
Date: October 06, 2017

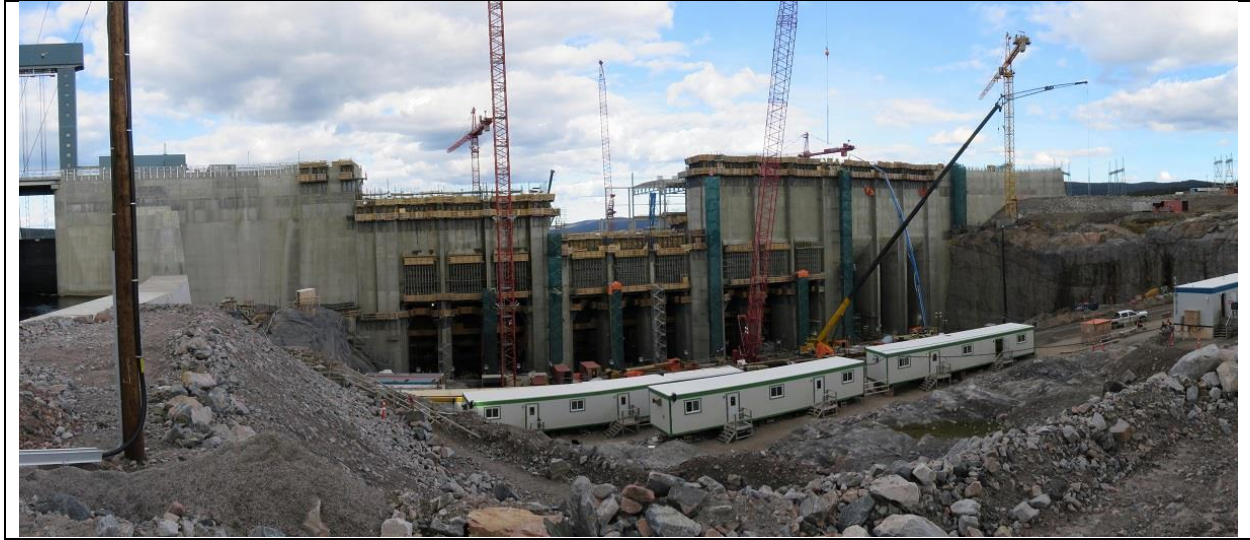
- At the time of the IE site visit, formwork, reinforcement and concrete placement activities were in progress at multiple locations of the powerhouse/intake works (Photos A.1, A.2, A.6 to A.9). Nalcor reported that about 78% of the concrete would be placed by the end of July 2017, and that substantial completion of planned concrete works for 2017 should be achieved by September. After that, the remaining concrete will be mostly second stage concrete to be placed around the generating units and steel liners.

Photo A.1: Panoramic view of upstream side of power intake structure.

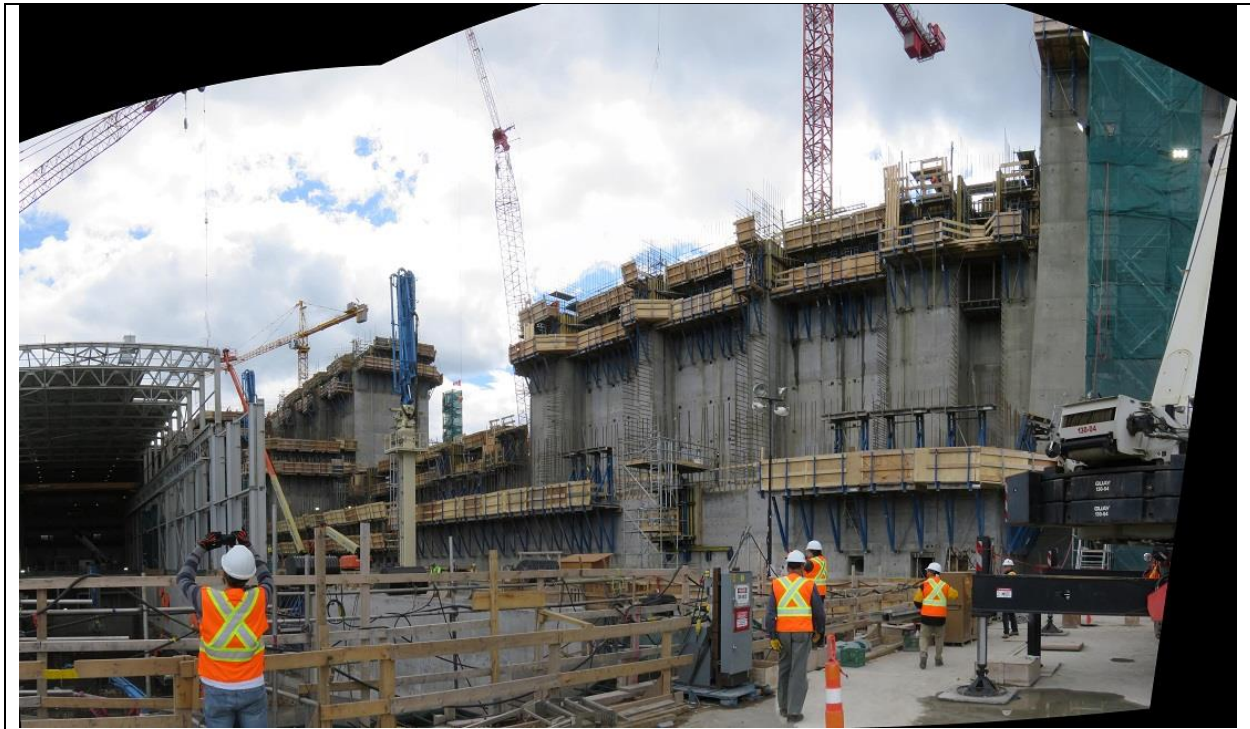
Photo A.2: Panoramic view of downstream side of power intake structure.

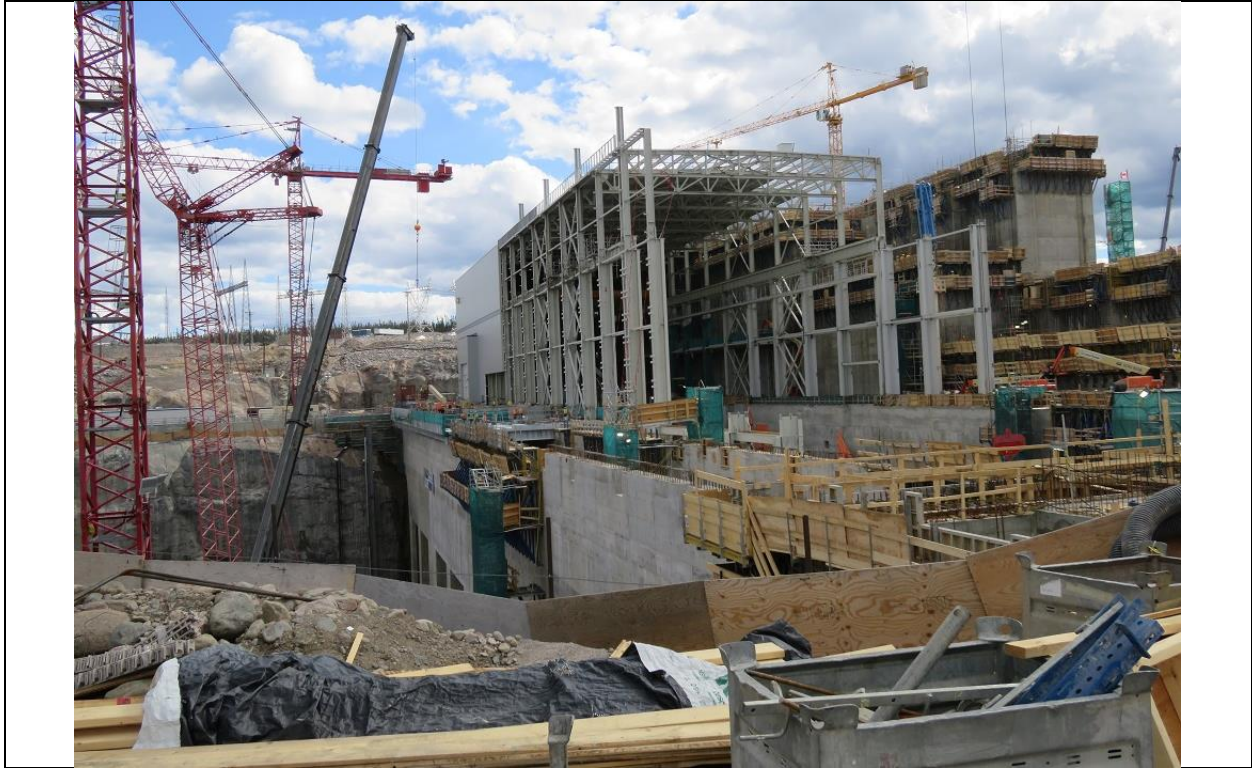
- The powerhouse steel superstructure was complete above the South Service Bay. Steel erection is advancing towards the north, and was in progress above Unit 3 (Photos A.3 and A.4).

Photo A.3: Southerly view of powerhouse steel superstructure from downstream side.

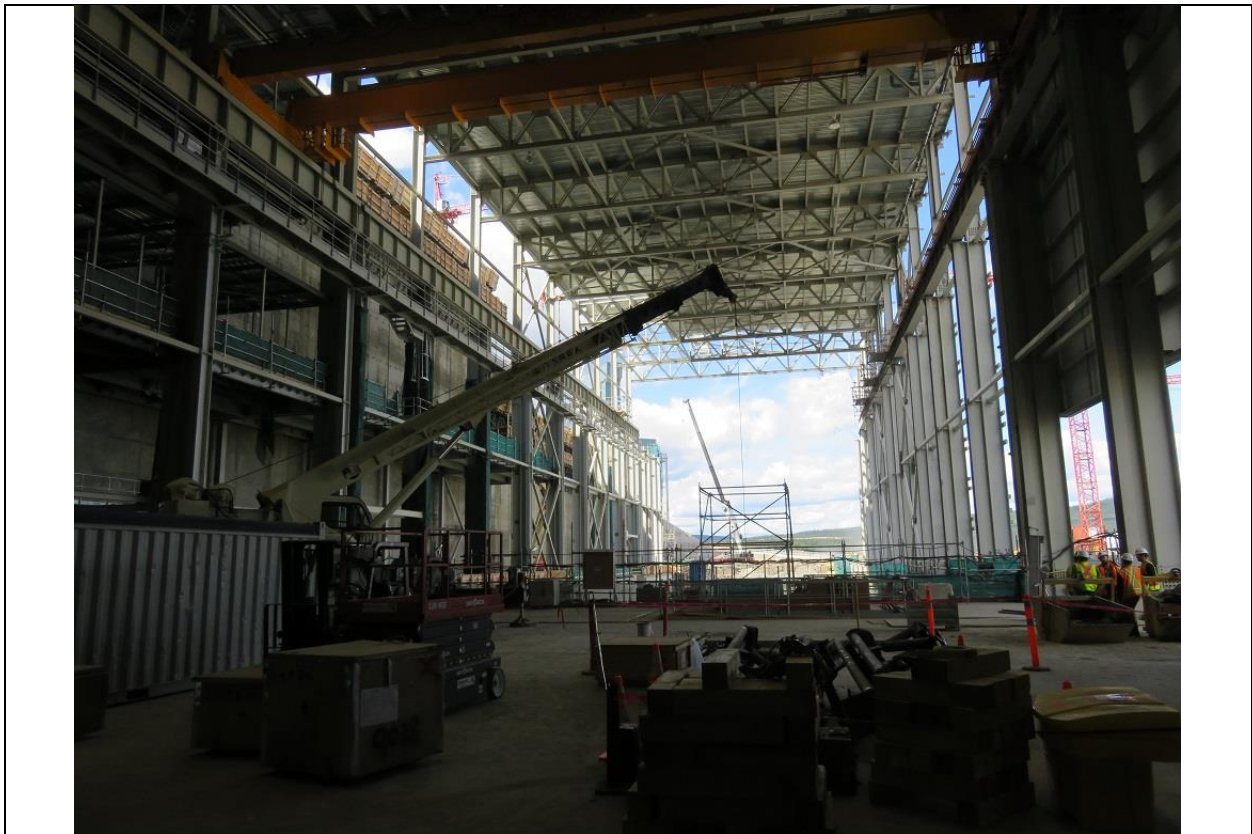
Photo A.4: Inside of powerhouse superstructure, viewed from south service bay.

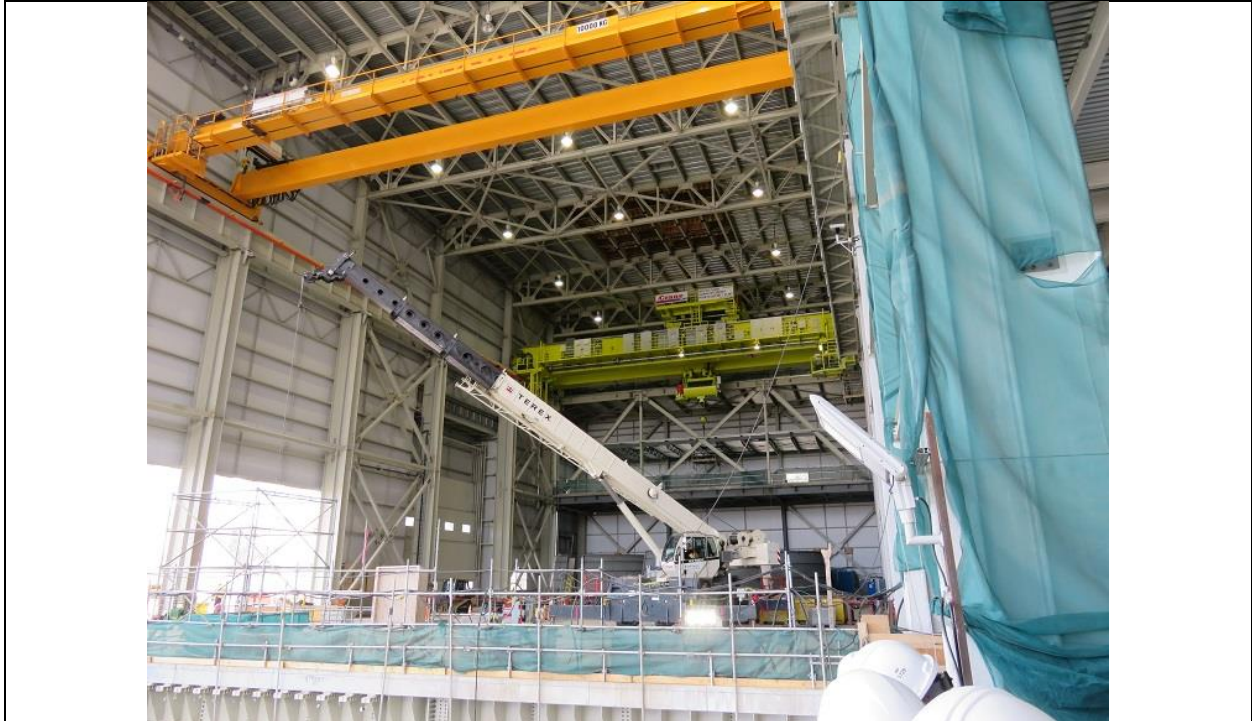
- Two overhead cranes of 10 MT and 200 MT capacity in the South Service Bay were commissioned in June 2017 and are now operational. (Photo A.5).
- Civil construction of the powerhouse drainage gallery was complete, and installation of piping was in progress (Photo A.10).

Photo A.5: South Service Bay, with overhead cranes commissioned in June 2017: 10,000 kg (orange) and 200 MT (green) capacities.

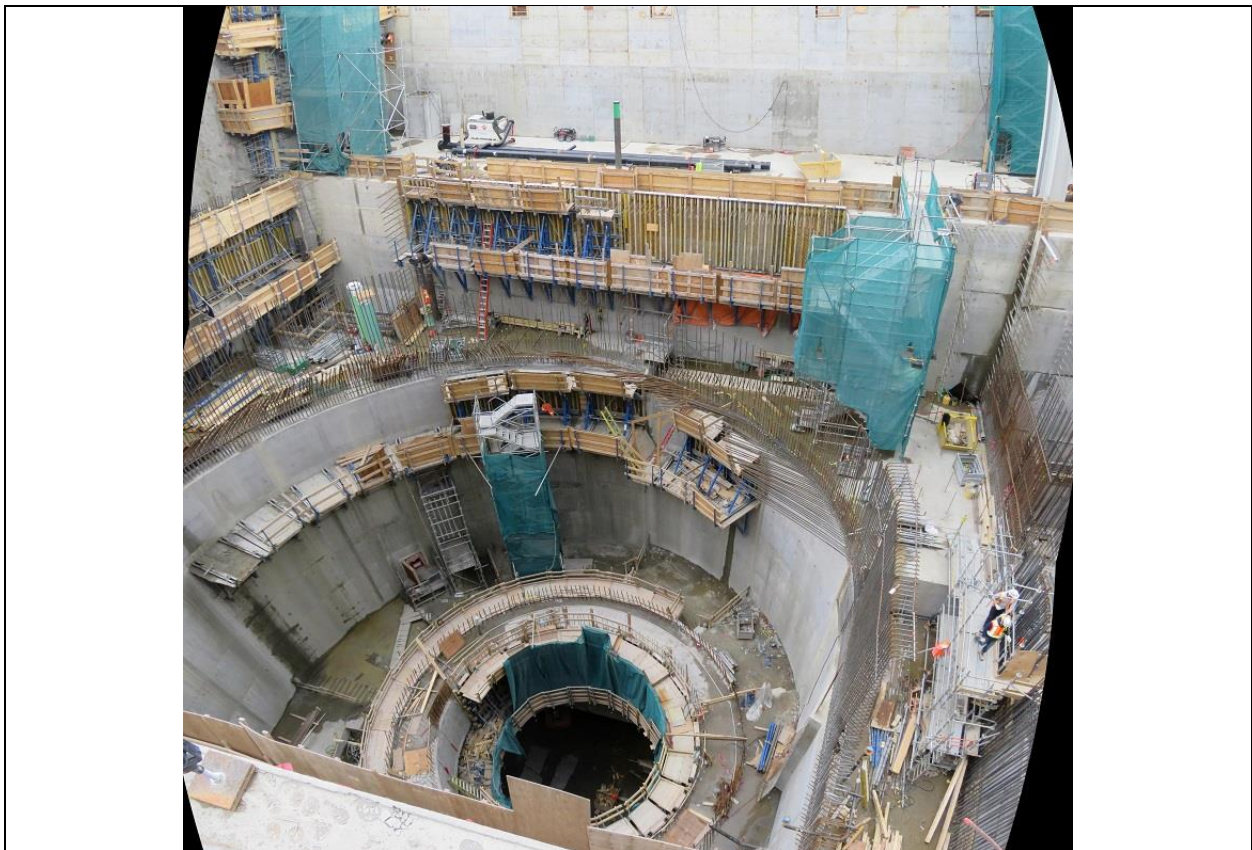
Photo A.6: First stage concrete works nearing completion in Unit 4.

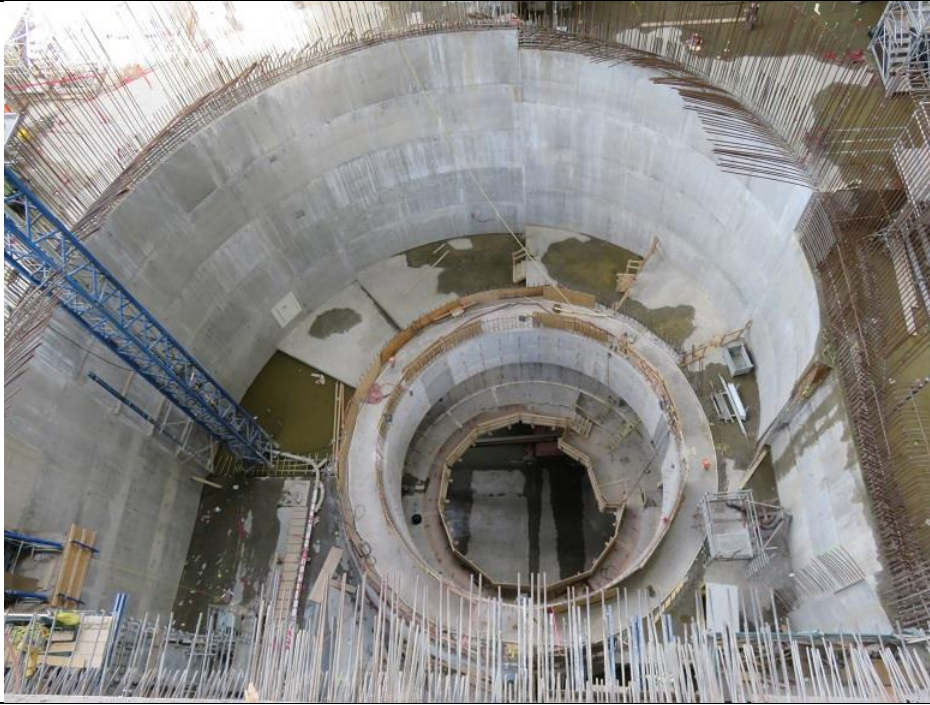
- It was reported that Unit 1 would be handed over from Astaldi to Andritz to commence turbine and generator installation by the end of July (Photos A.7 and A.8).

Photo A.7: Completed first stage concrete in Unit 1.

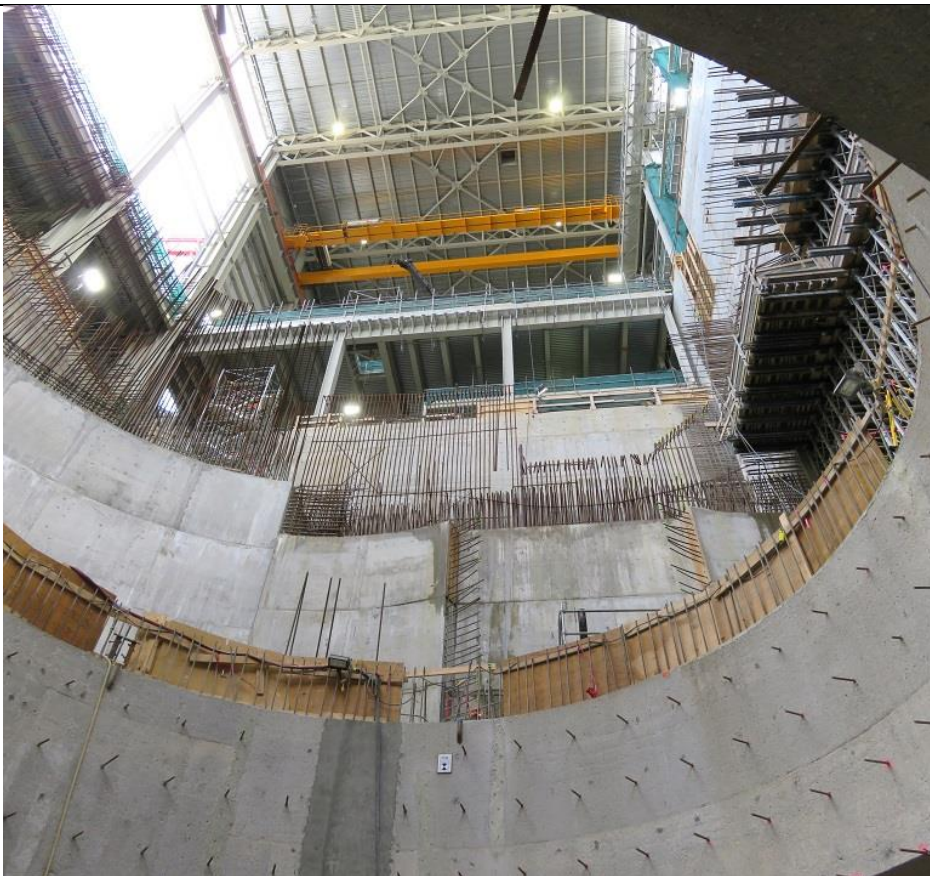
Photo A.8: View looking up from turbine level of Unit 1.

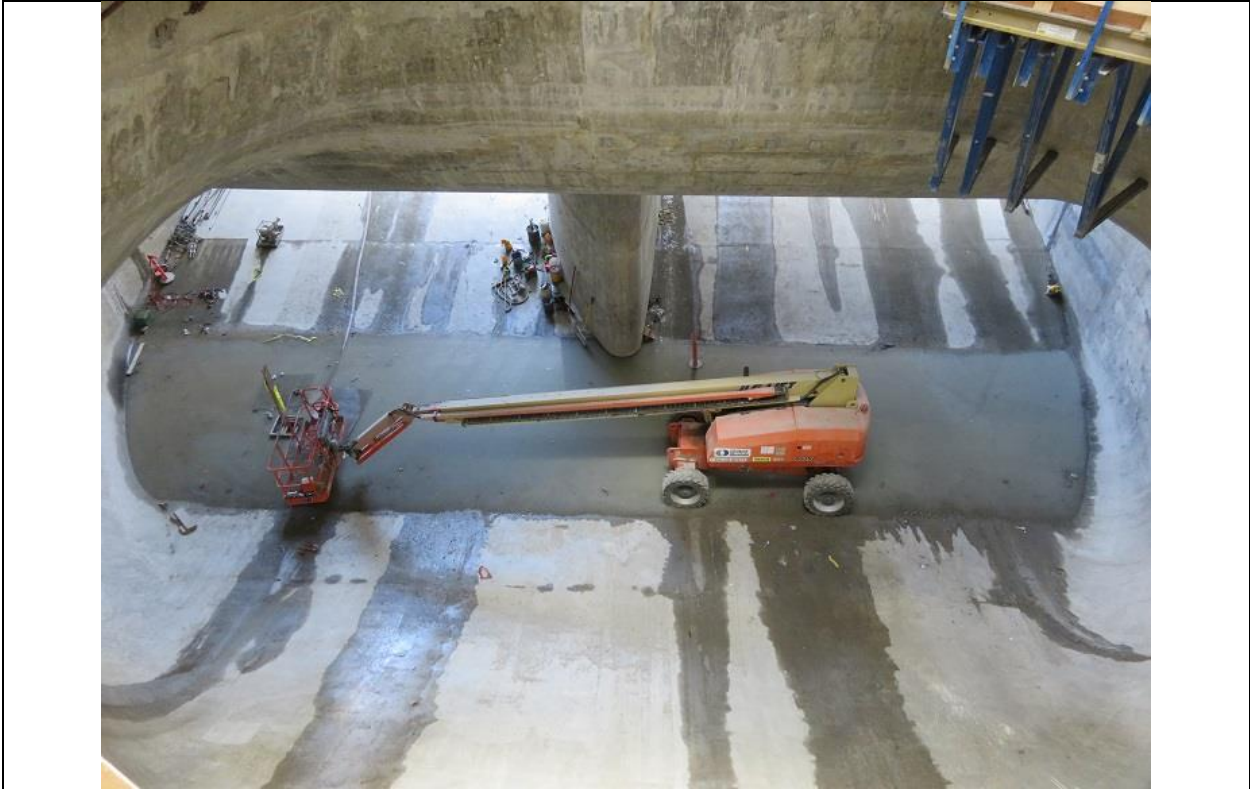
Photo A.9: Looking down into Unit 1 draft tube outlets.

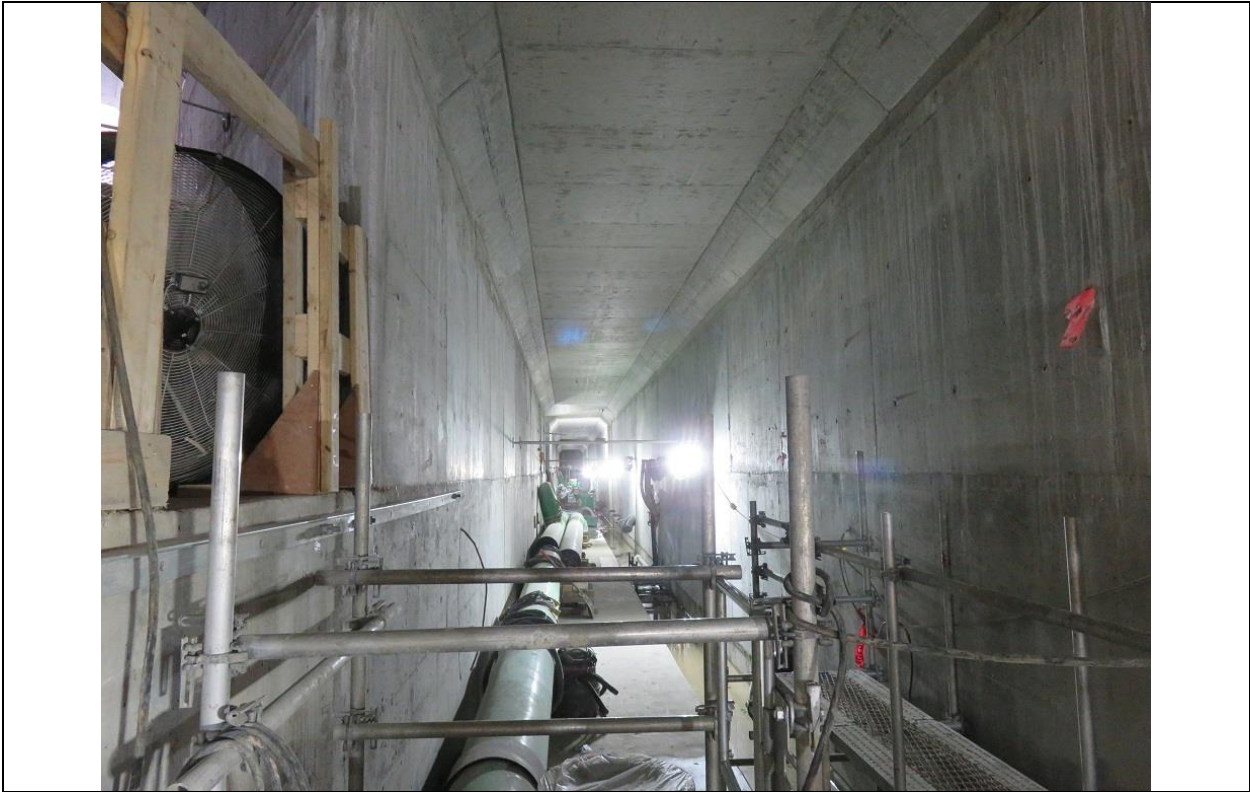
Photo A.10: Powerhouse drainage gallery.

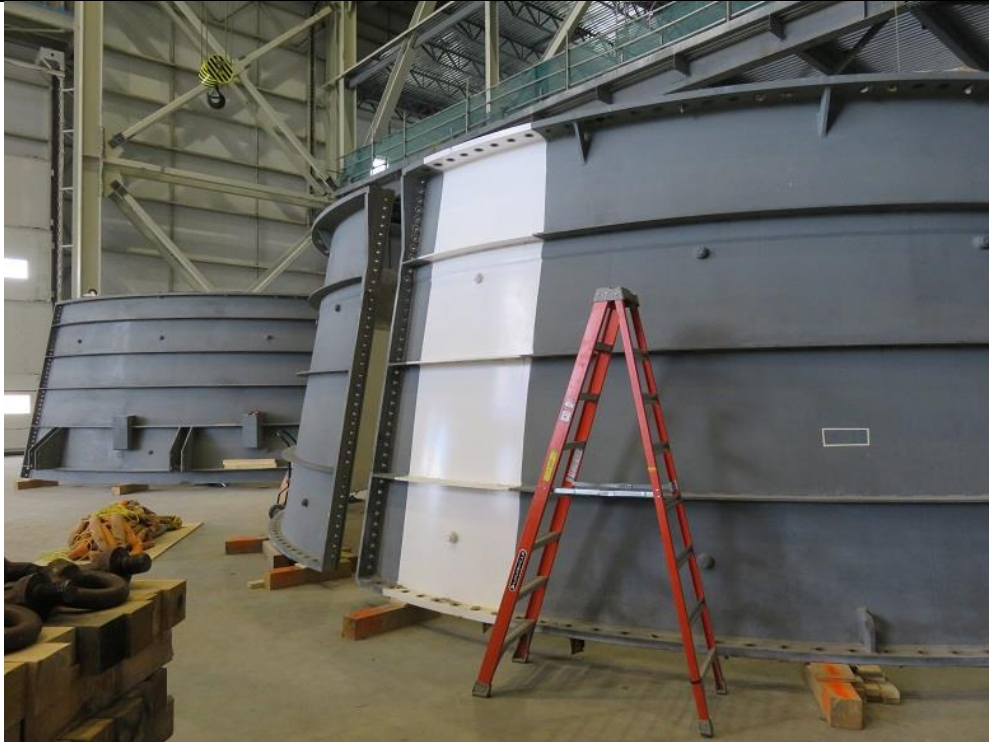
- Andritz has started assembly of the steel draft tube liner for Unit 1 in the South Service Bay (Photos A.11 and A.12).

Photo A.11: Unit 1 draft tube liner segments being assembled in South Service Bay.

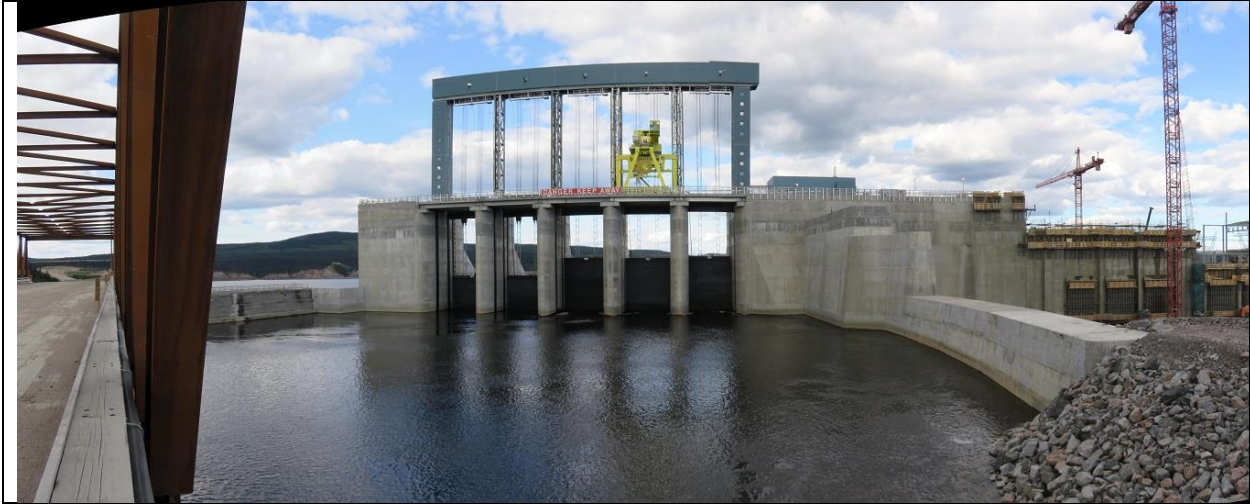
- The spillway is effectively complete and has been operational since August 2016. The adjacent north transition dam is complete and the adjacent central transition dam is almost completed (Photos B.1 and B.2).
- At the time of the IE site visit, the water in the upstream reservoir pond was at approximately El. 20.33 m.
- All five spillway gates can be operated to release river flows and manage the upstream reservoir level. Three gates were partially open at the time of the site visit (Photos B.1 and B.3).

Photo B.1: Panoramic view of upstream side of spillway structure and approach channel, viewed from south end of temporary access bridge.

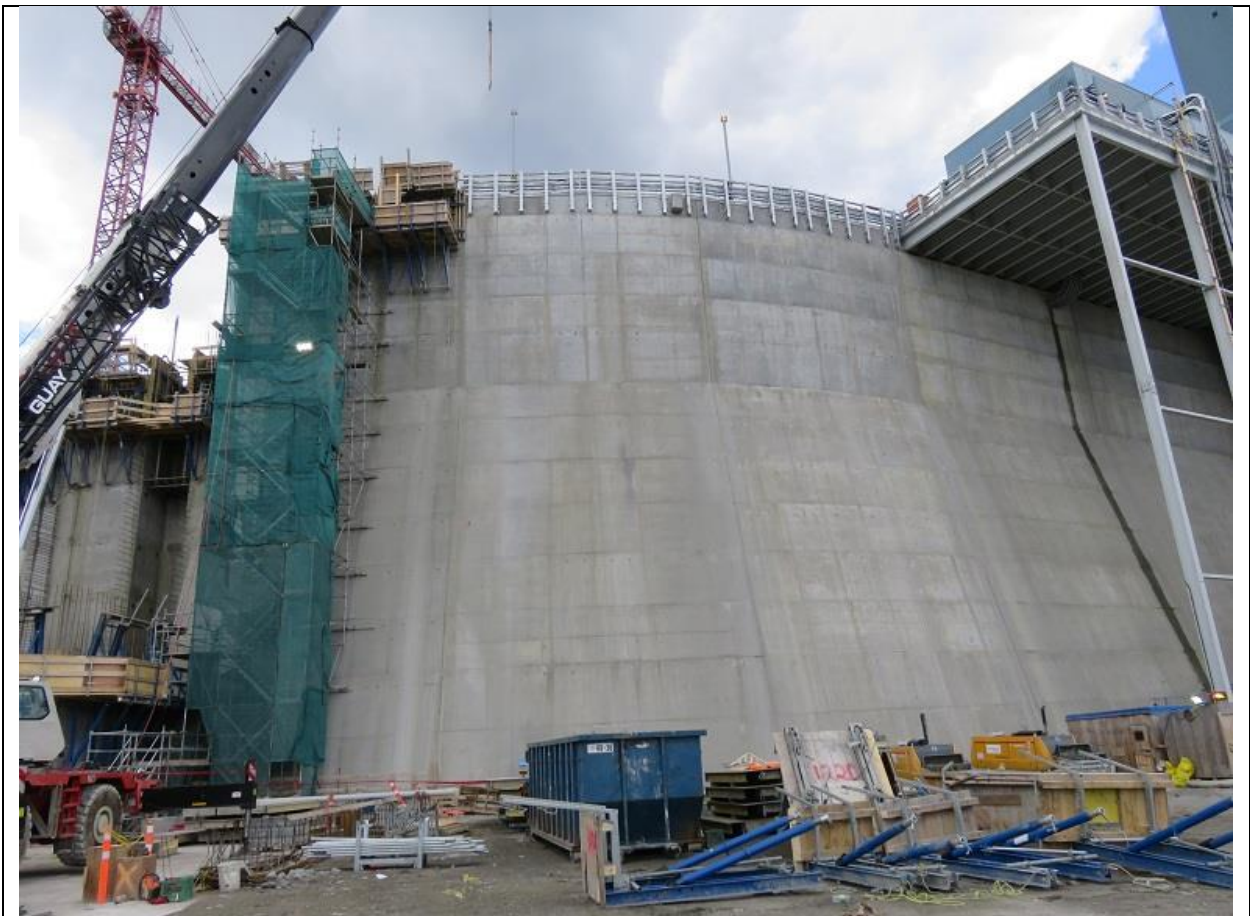
Photo B.2: Central transition dam nearing completion on south side of spillway structure.

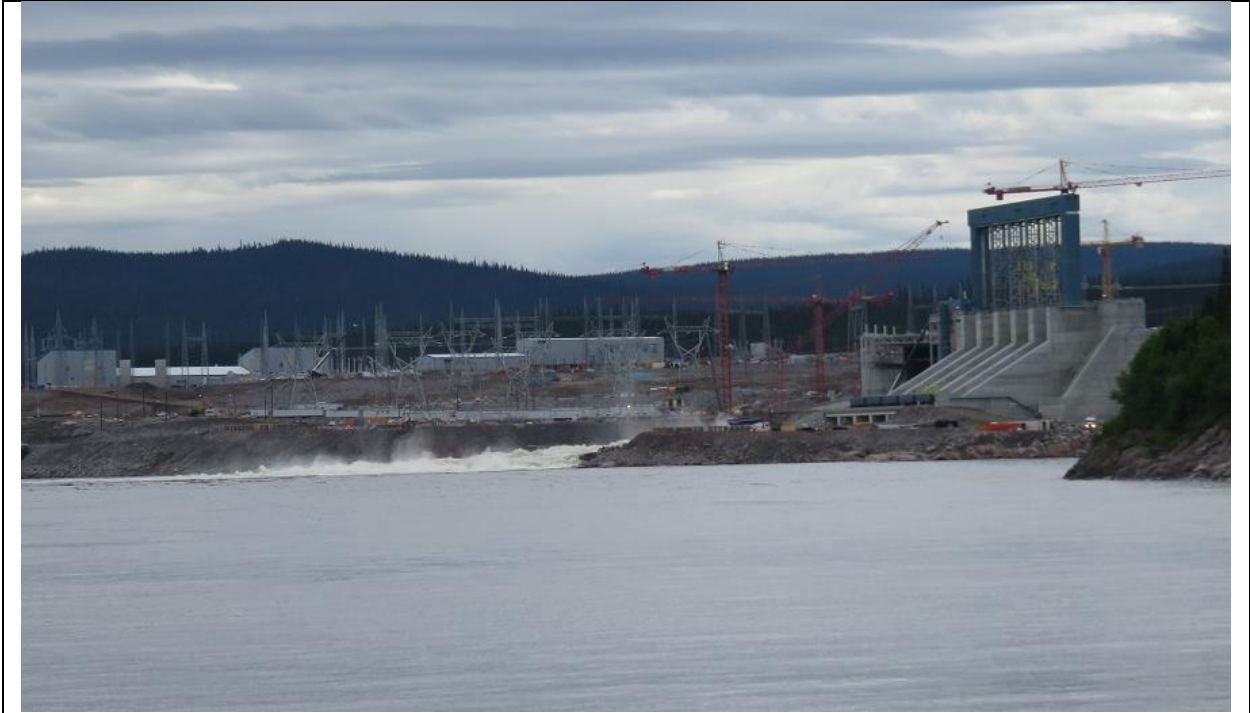
Photo B.3: Spillway release viewed from North Spur.

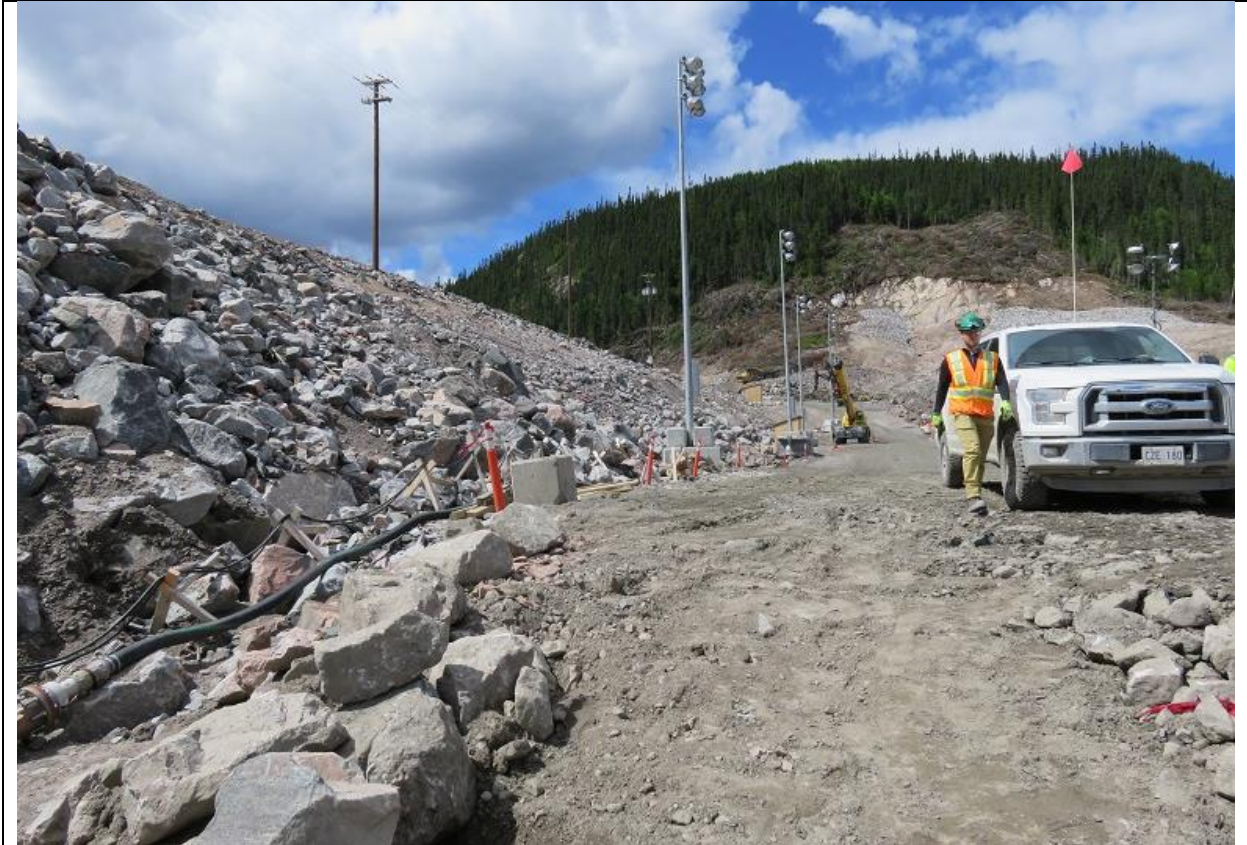
Nalcor reported that grouting repairs of the upstream cofferdam completed during the 2016-17 winter season substantially reduced leakage from about 30 m³/min to about 7 to 11 m³/min. During the site visit the leakage was about 8 m³/min, and was being readily managed by routine pumping (Photos C.1 and C.2).

Photo C.1: Northerly view along toe of upstream cofferdam.

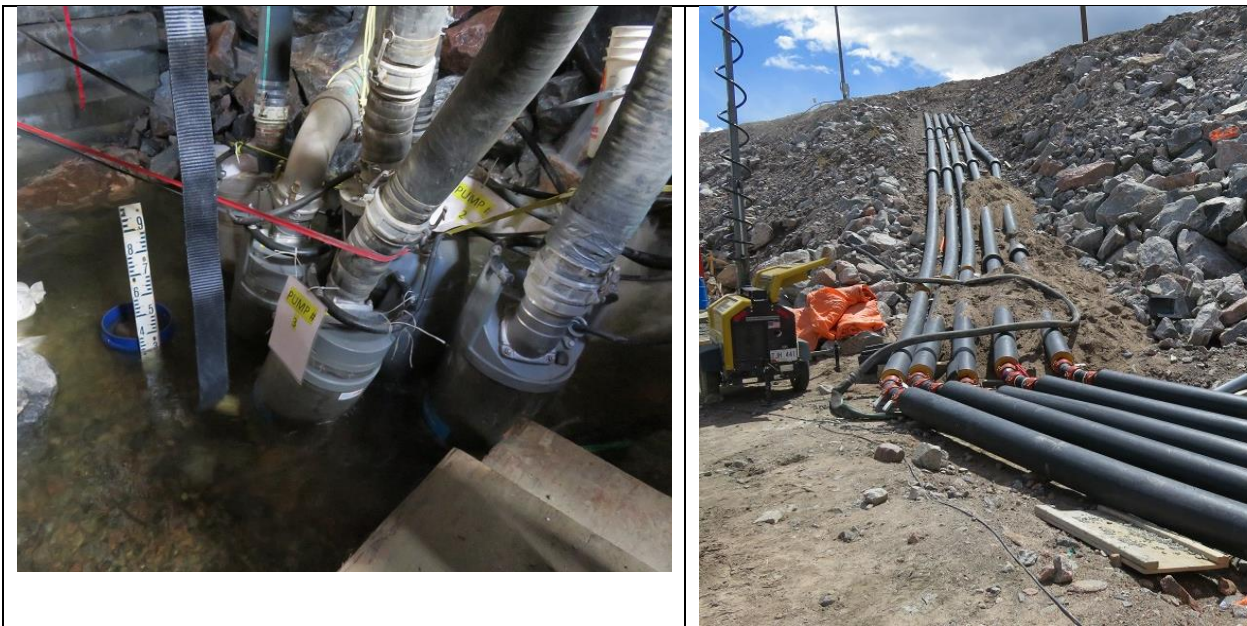
Photo C.2: Pumps and piping for upstream cofferdam dewatering system. Water is being pumped back to the reservoir.

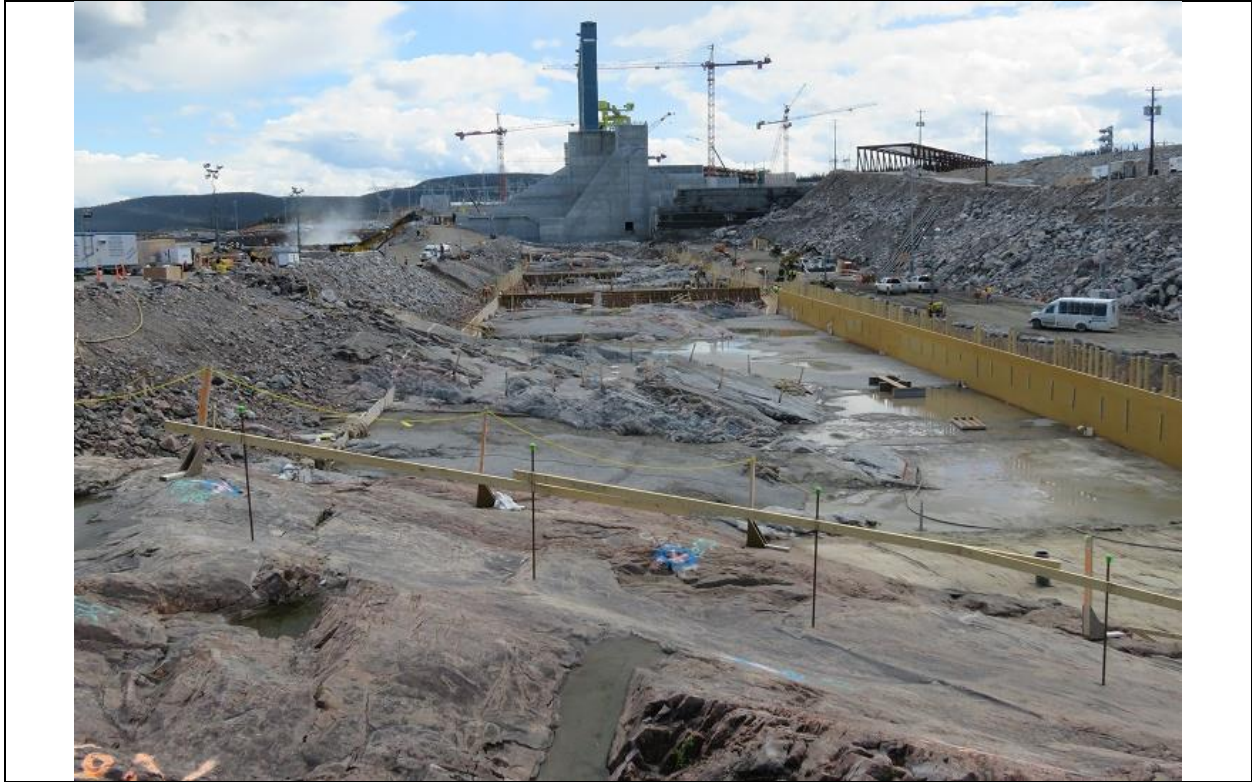
- The roller compacted concrete (RCC) dam foundation footprint has been cleaned to sound bedrock. The foundation bedrock surface is quite irregular (Photos C.3 to C.5).
- Dental concrete placement in cavities and fractures in the bedrock foundation is almost complete.
- Placement of cast-in-place concrete leveling slabs is well advanced. The concrete is being placed against wooden formwork at the upstream and downstream sides of the leveling slabs, and at upstream-downstream construction joints.

Photo C.3: Southerly view along RCC dam foundation, between downstream (left) and upstream (right) cofferdams. Formwork along sides indicates extent of dam footprint. Cast-in-place leveling concrete has been placed along upstream side.

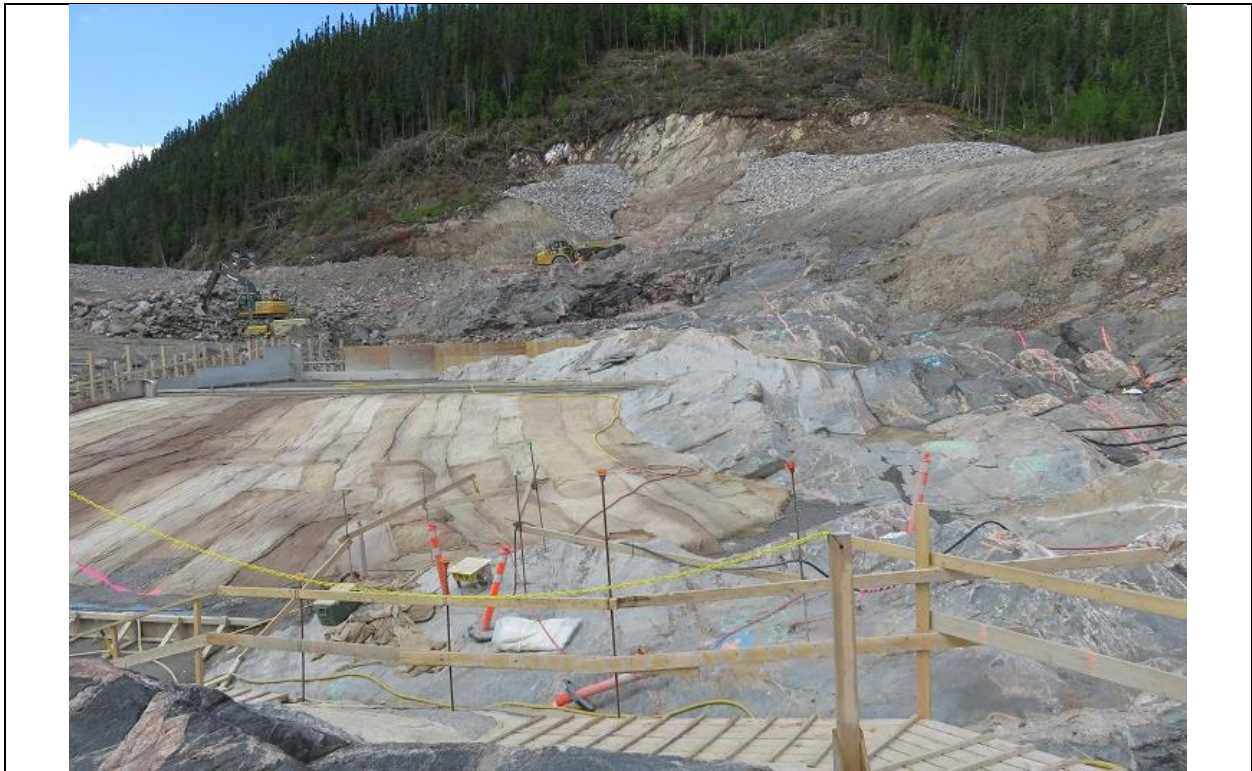
Photo C.4: Northerly view along RCC dam foundation. Area stripped to rock in background indicates future top of dam. Area at centre-left is recently-placed cast-in-place leveling concrete, covered with wet burlap for initial curing period.

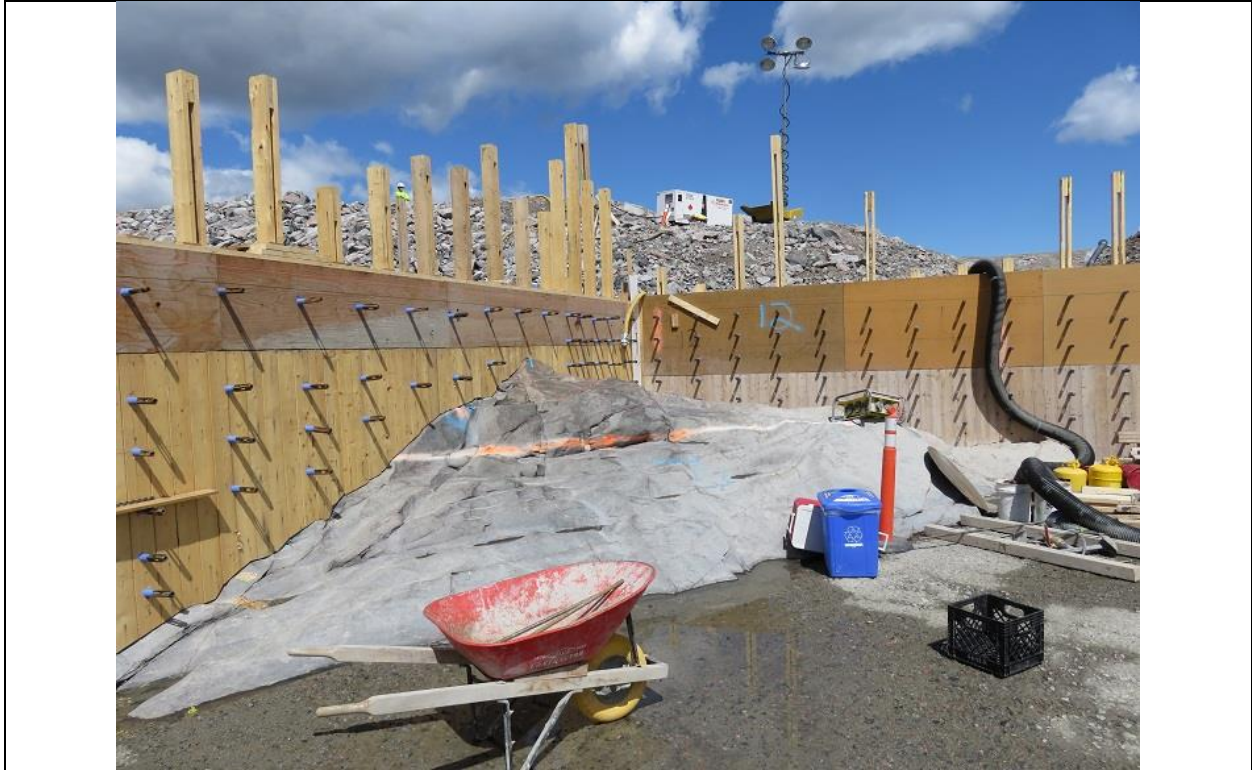
Photo C.5: Typical formwork details on irregular rock surface, with recently-placed leveling concrete in foreground.

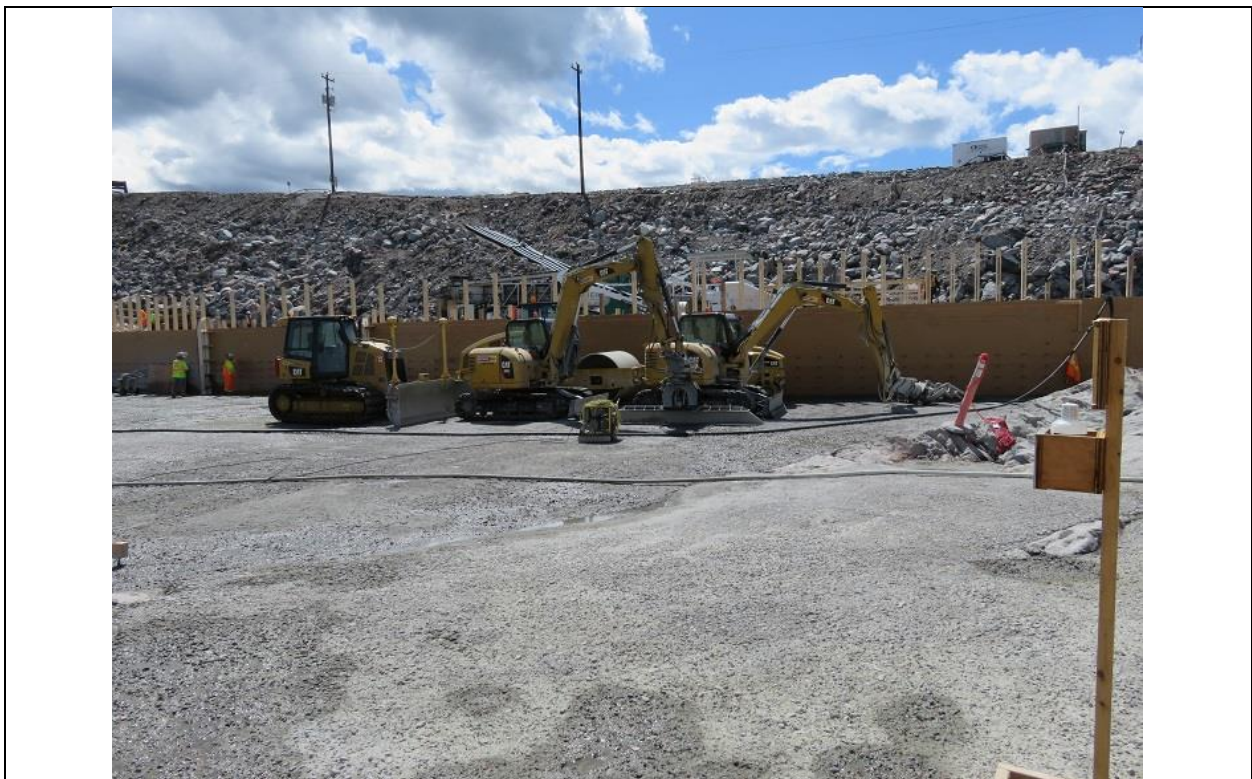
- Recently-placed leveling slabs were being green-cut with pressurized water (Photos C.6 and C.7).
- The IE observed preparations for RCC placement, and Nalcor reported that RCC placement commenced later in the week after the site visit (28 July). It is anticipated that construction of the RCC dam will extend over two seasons.

Photo C.6: Typical equipment to be used for RCC placement. Equipment is parked on cast-in-place concrete leveling slab which has been "green cut" with pressurized water.

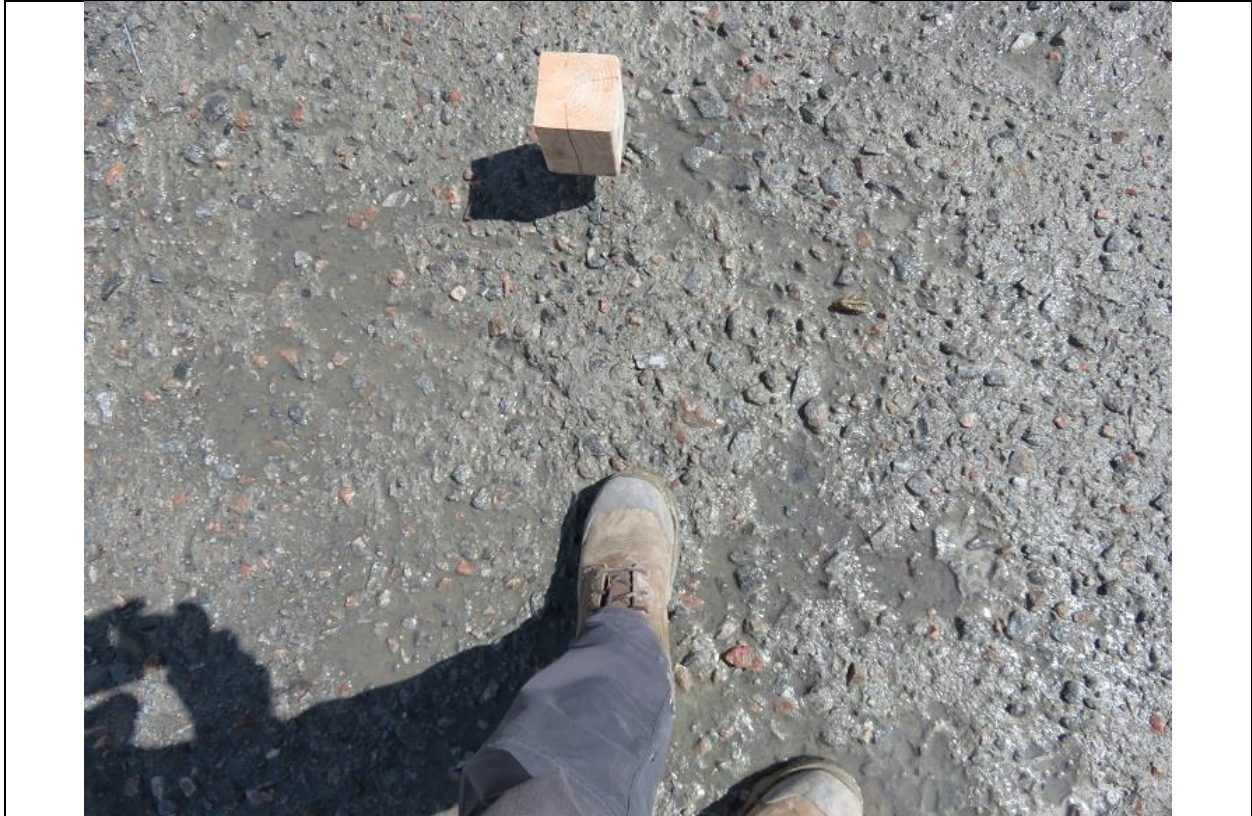
Photo C.7: Surface of leveling concrete slab after green cutting, which removes laitance and leaves exposed aggregate to provide a good bonding surface for the next layer of concrete or RCC.

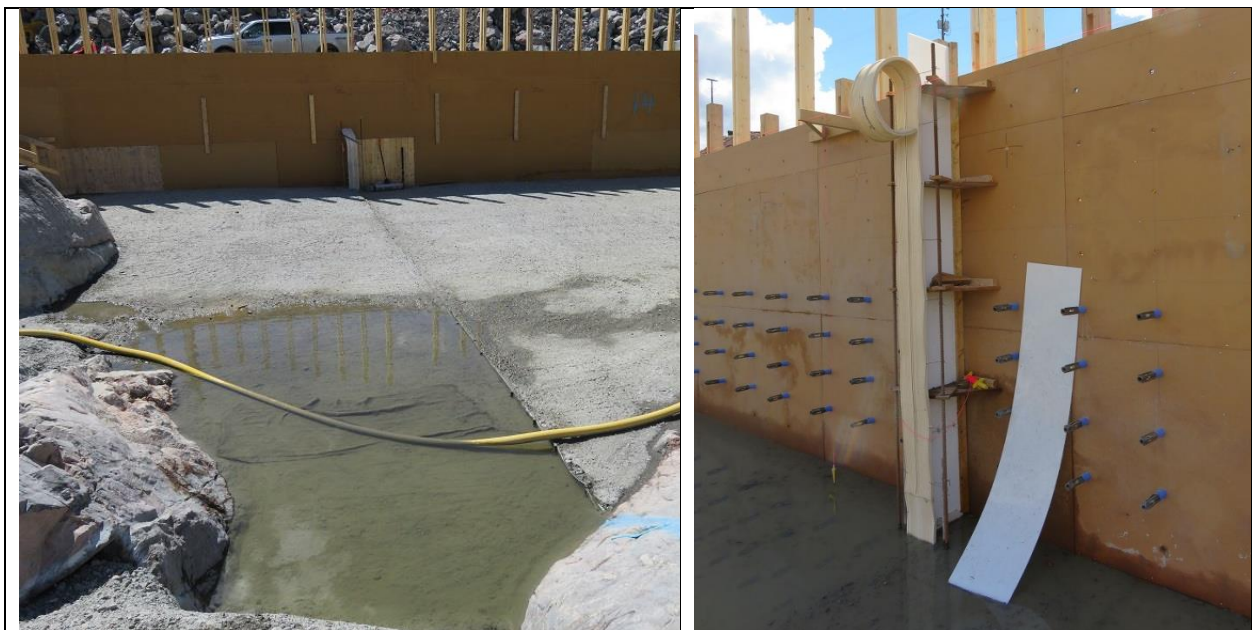
Contraction joints in the leveling slabs are created with embedded “Stayforms” which are thin rigid panels of expanded steel mesh. PVC waterstops are installed at the upstream ends of construction and contraction joints (Photos C.3 to C.6, C.8, C.9).

Photo C.8: Typical contraction joint in leveling slab, created with embedded “Stayform”, with waterstop at upstream end of joint (left photo). Details of typical waterstop at upstream side of a contraction joint (right photo).

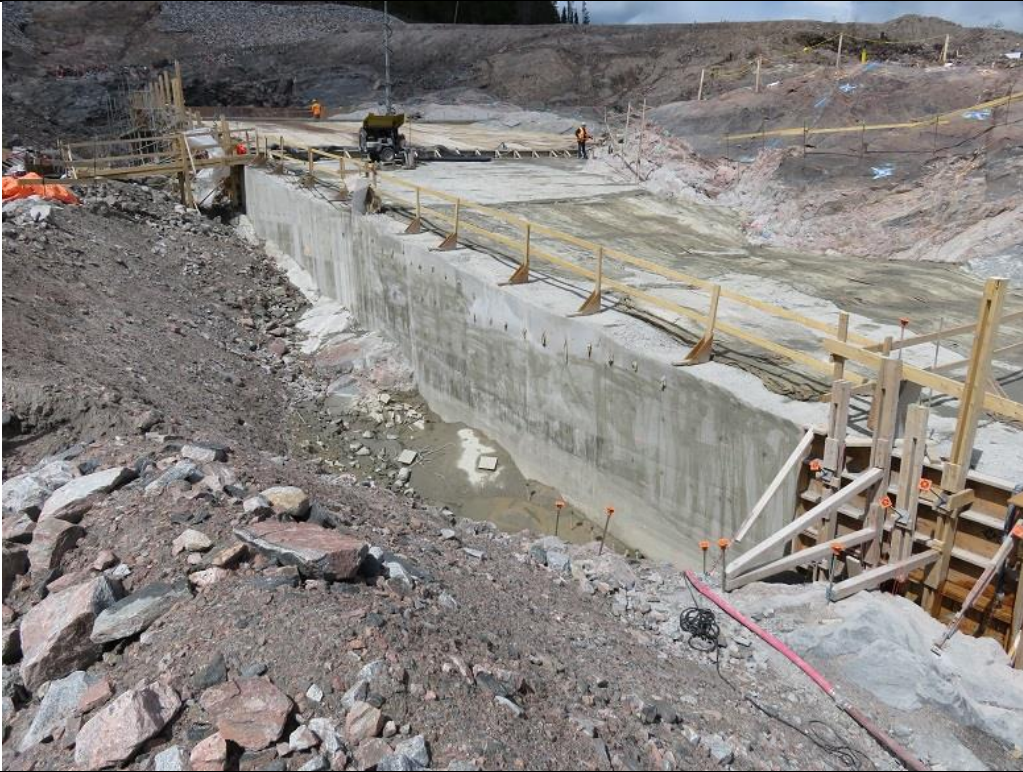
Photo C.9: Upstream side of levelling concrete after formwork removal, showing good contact with bedrock and good compaction of concrete.
