MEETINGS IN ST. JOHN'S AND VISITS TO LOWER CHURCHILL PROJECT SITES, JULY 23 TO 28, 2017

Prepared for: Natural Resources Canada and Nalcor Energy
IE Point of Contact: Nik Argirov
Date: October 06, 2017

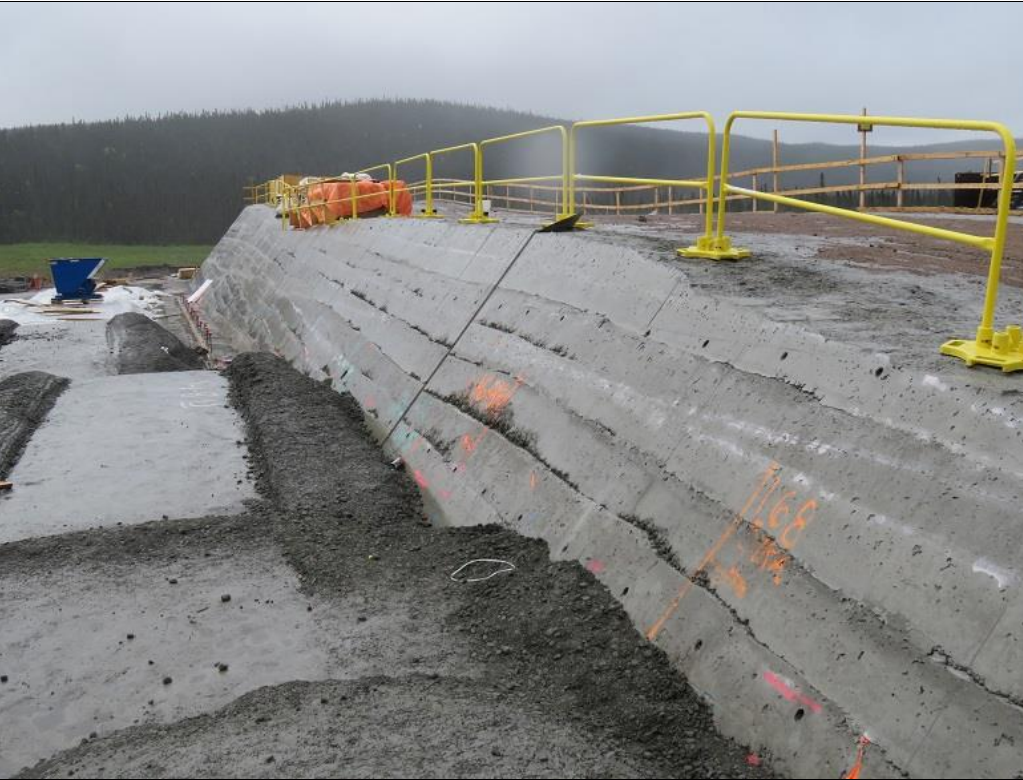
- The downstream side of the RCC dam above El. 12 m will have a stepped or sloping face. RCC trials completed in 2016 included a trial placement with sloping formwork on one side to model this configuration. At the downstream sloping face of the trial section, there was poor bonding along horizontal lift joints and honeycombing due to insufficient compaction (Photo C.10). Another trial placement with a similar formwork configuration and modified placement techniques was recently carried out. The IE viewed the completed trial placement, but the formwork had not yet been stripped and the results of the trial were not known at the time of the site visit (Photo C.11).

Photo C.10: Initial 2016 RCC trial placement, showing poor bonding along horizontal lift joints and honeycombing due to insufficient compaction at downstream sloping face.

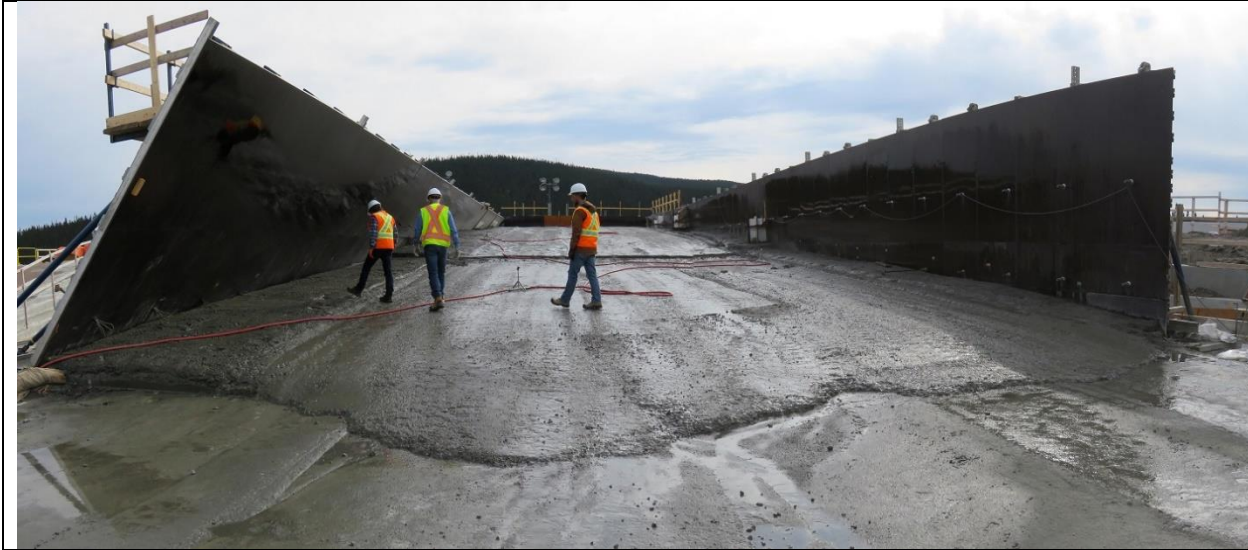
Photo C.11: Recently-placed 2017 RCC trial.

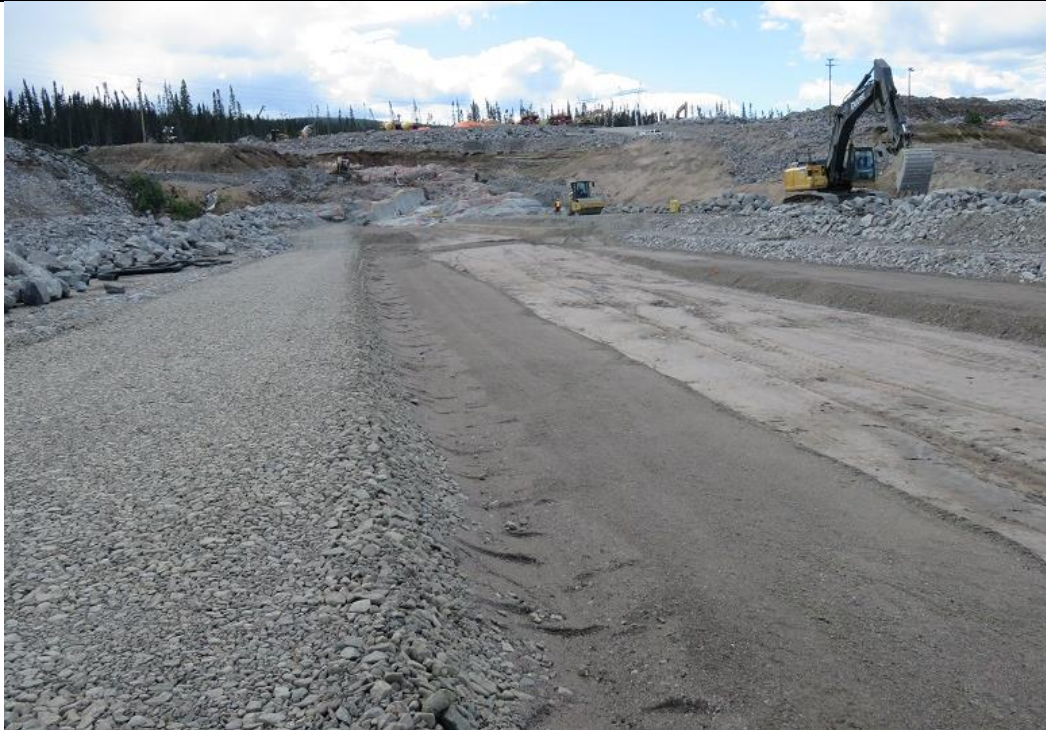
- Nalcor reported that 44% of the south embankment dam fills were placed in 2016 prior to the winter shutdown. Approximately 60% of the fills had been placed by the time of the IE site visit, and construction of the dam is forecast to be completed in September 2017.
- The top of the fill was at about El. 36 m at the time of the IE site visit (Photos D.1 and D.2).
- The right (south) abutment will be entirely founded on bedrock. Final cleanup of the bedrock abutment was in progress. It was observed that the bedrock surface was being well cleaned (Photos D.3 and D.4).
- It was also observed that there appeared to be good control to maintain zone widths and boundaries during fill placement (Photos D.1, D.2, D.5).

Photo D.1: Southerly view along south embankment dam towards right abutment.

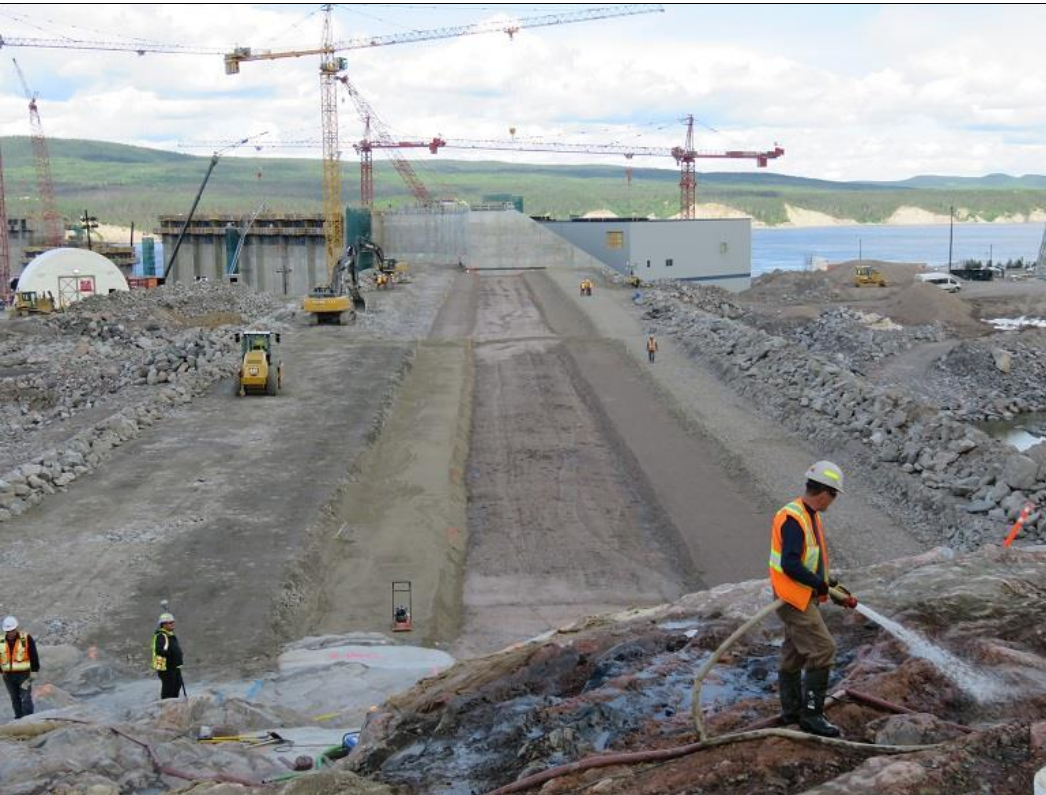
Photo D.2: Northerly view along south embankment dam towards south transition dam which forms the left abutment. Boundaries between zones of different materials are well-defined.

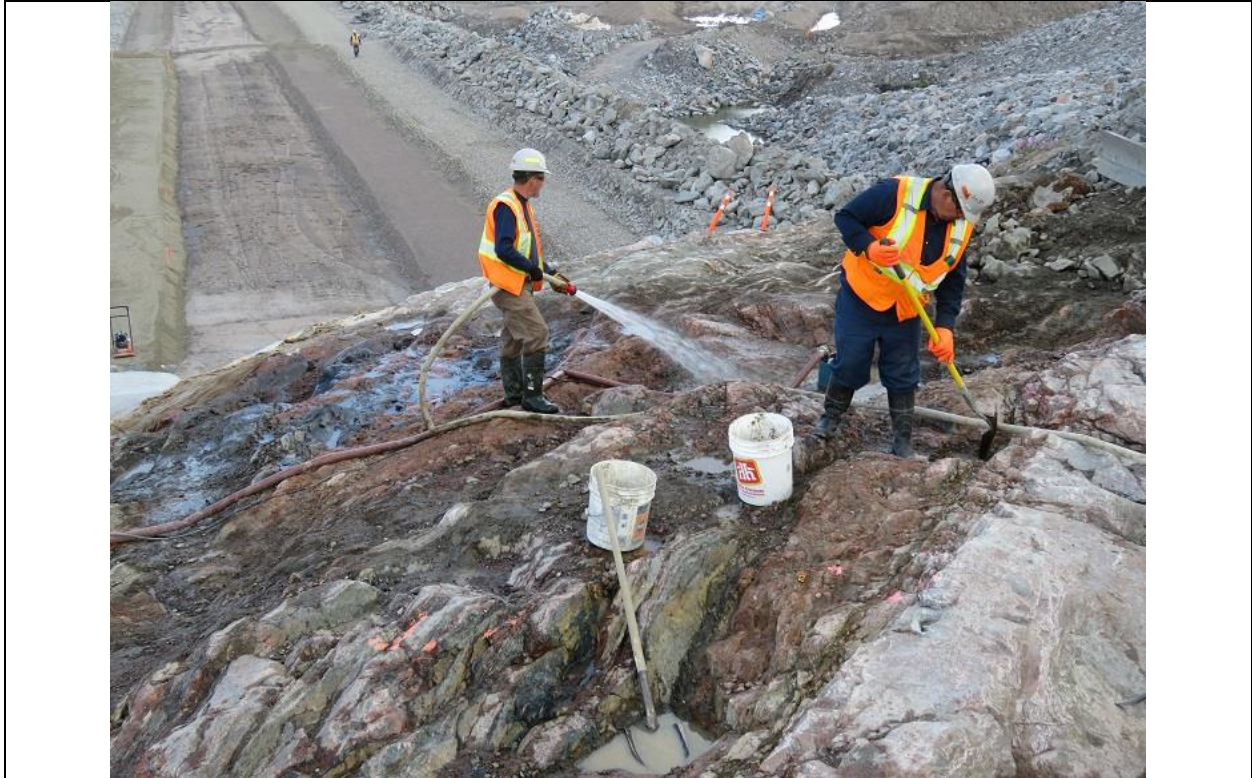
Photo D.3: Final cleanup of foundation bedrock surface by hand methods at right abutment of south embankment dam.

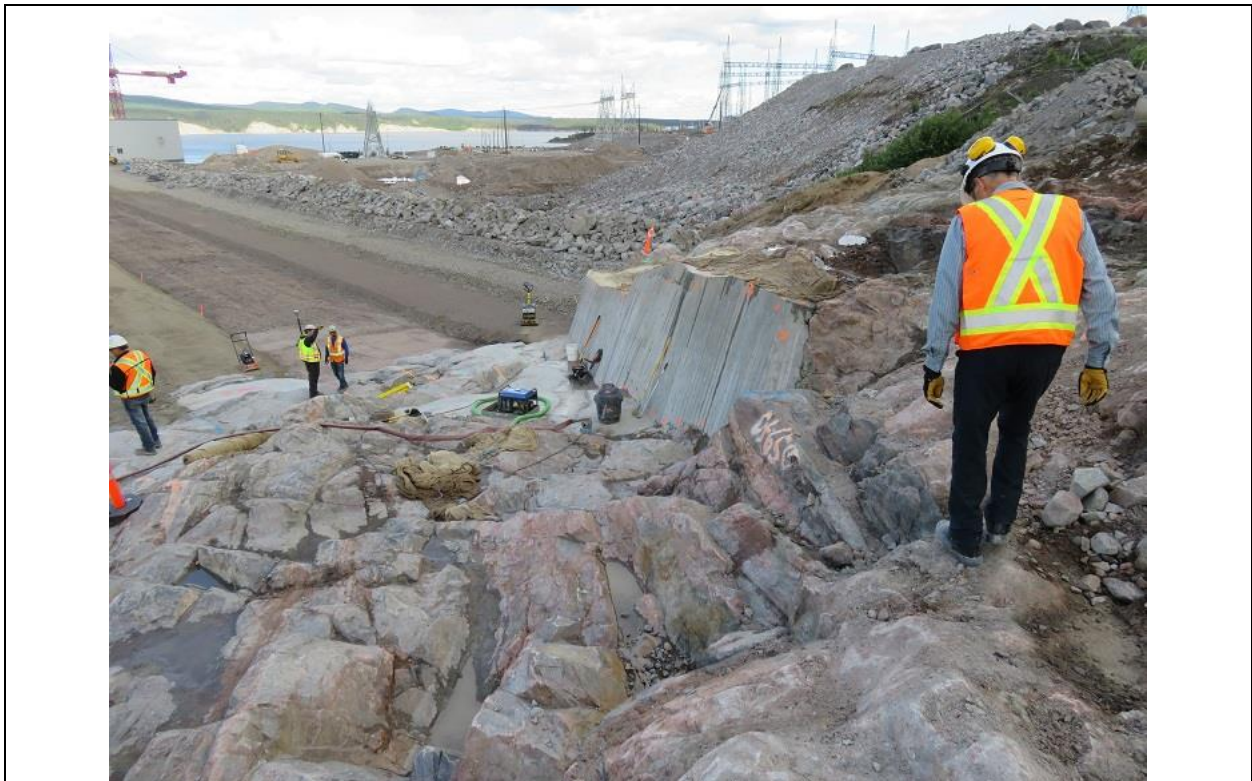
Photo D.4: Cleaned bedrock surface on lower right abutment, ready for dental concrete. Note concrete infill for local shaping of core contact zone in centre of photo.

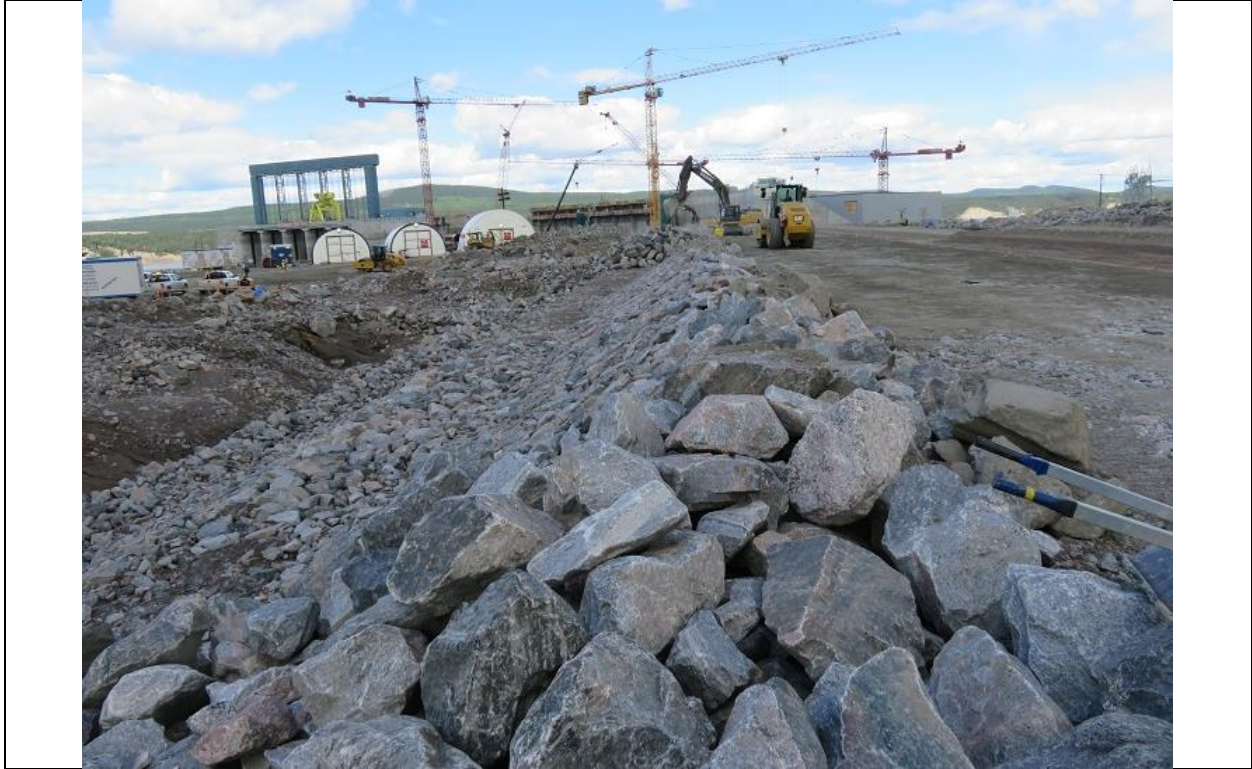
Photo D.5: Neatly-placed riprap along upstream side of south embankment dam.

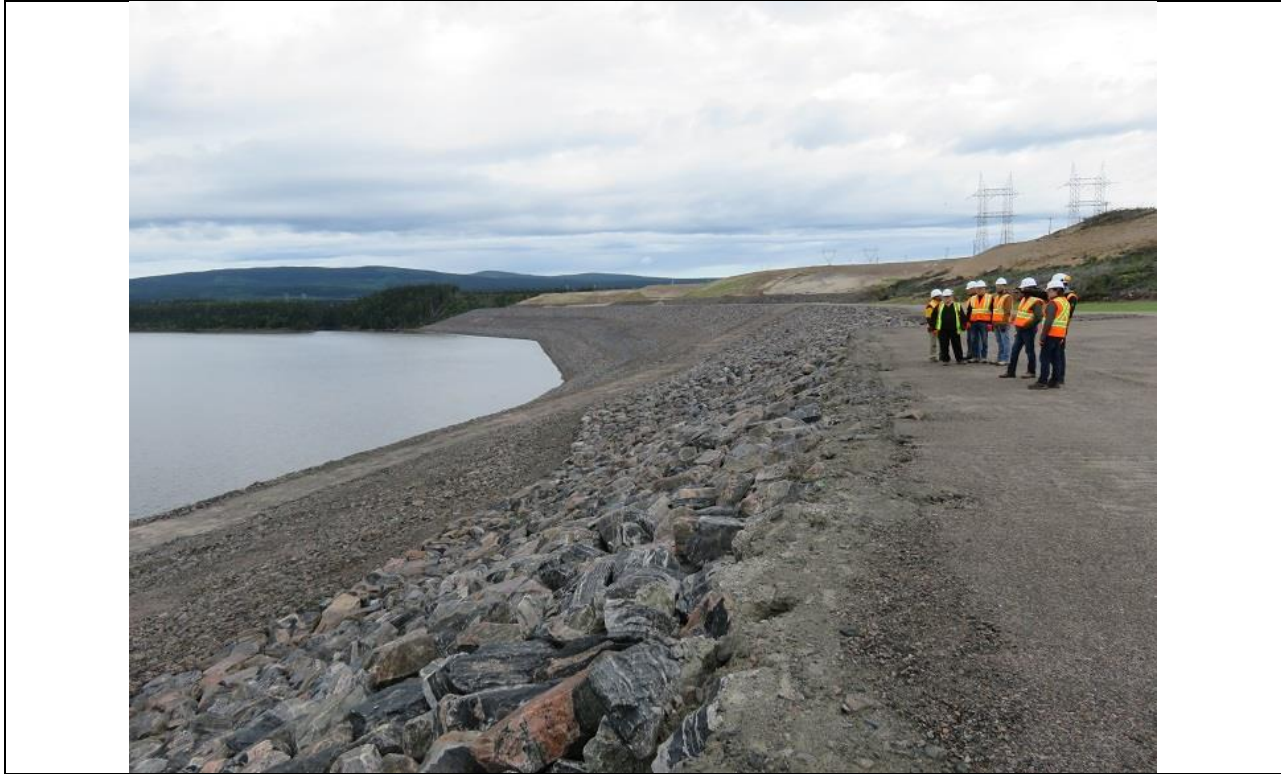
- Fine-grained soil slopes were hydroseeded earlier in the summer and grass was starting to grow (Photos E.1 to E.8). Local erosion from surface runoff was observed in several locations of the upper slopes where vegetation cover was not fully established; local maintenance and repair of these areas may be required in future.

Photo E.1: Northerly view along upstream side of North Spur slope stabilization works. Group is standing on maintenance road at El. 43 m.

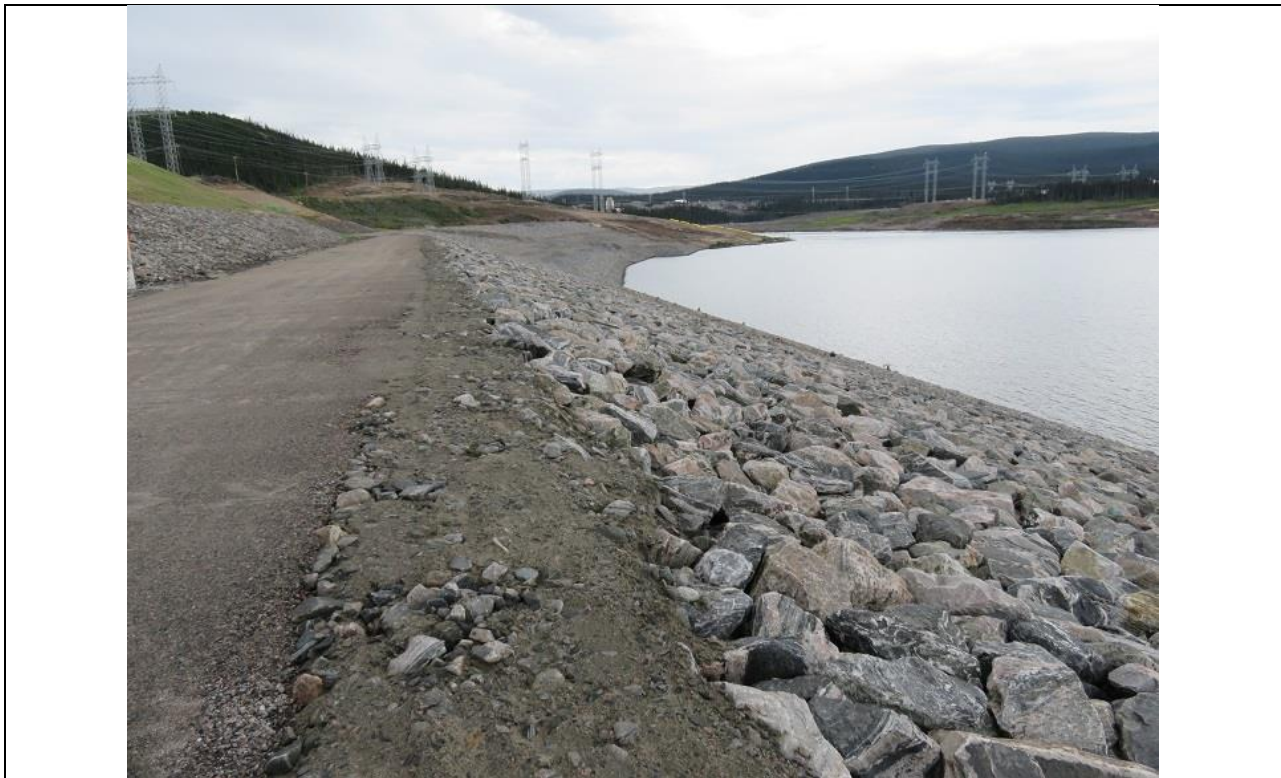
Photo E.2: Southerly view along upstream side of North Spur slope stabilization works.

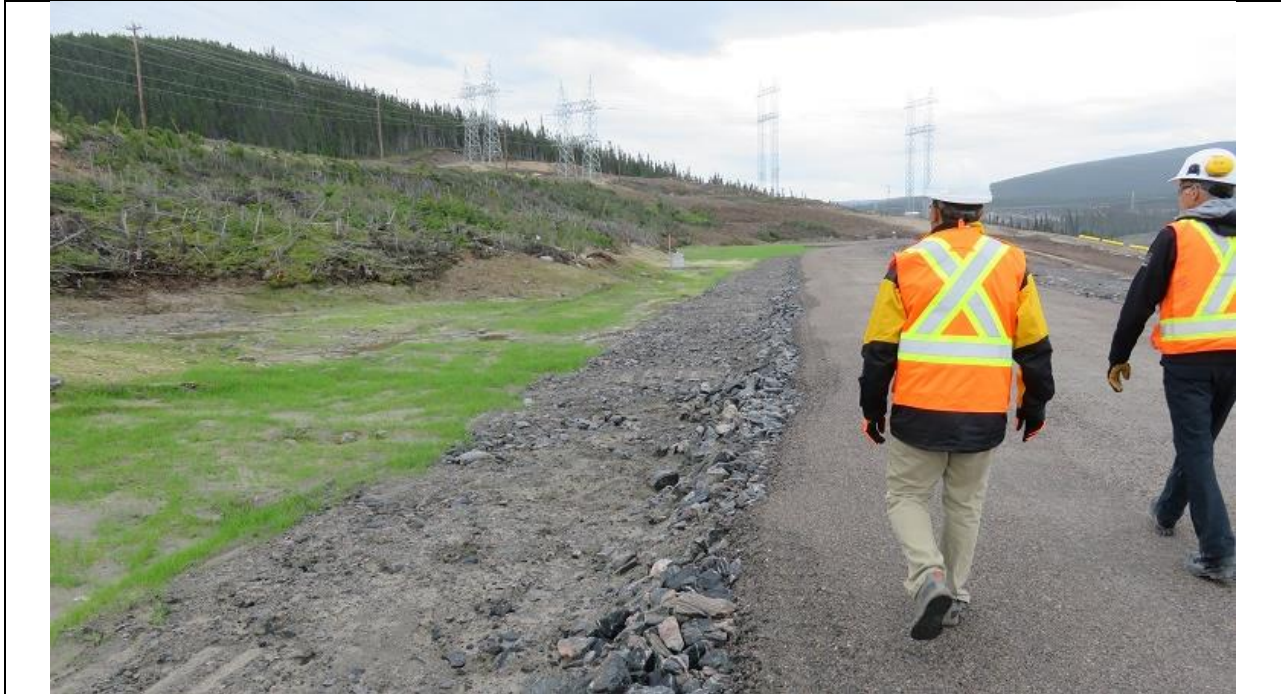
Photo E.3: Southerly view along maintenance road on upstream side of North Spur slope stabilization works. The top of the till blanket is just below the recently-seeded ditch on the inside of the road.

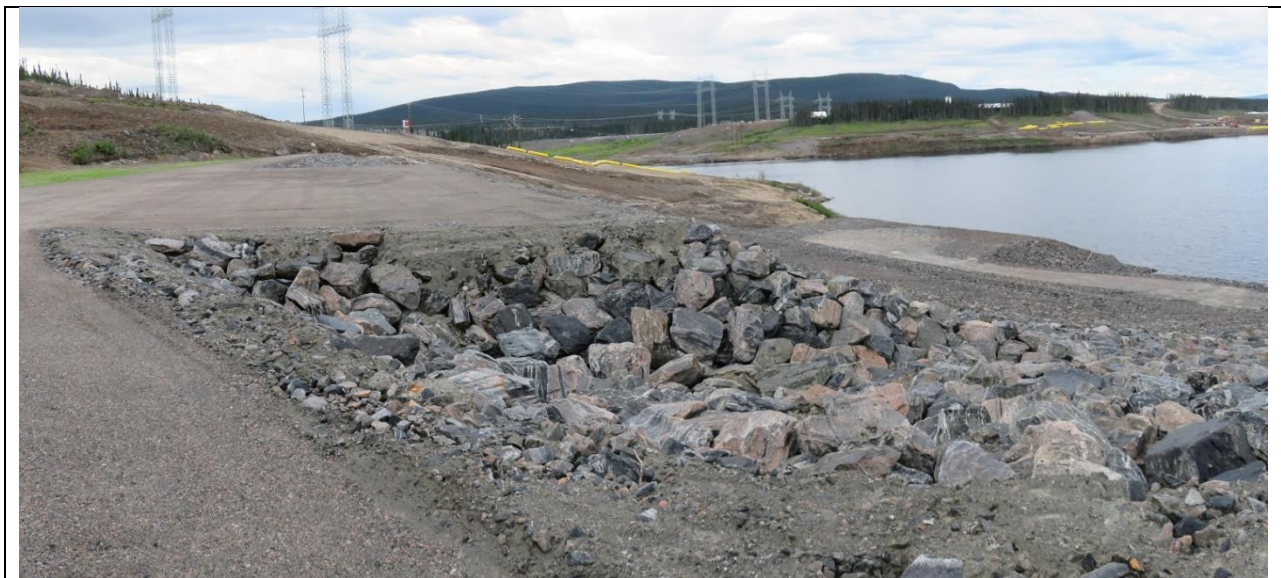
Photo E.4: Southerly view showing log boom platforms at El. 43 m and E. 27 m. Reservoir level is El. 20.33 m. Yellow log boom sections are visible on shore in upper centre and upper right of photo.

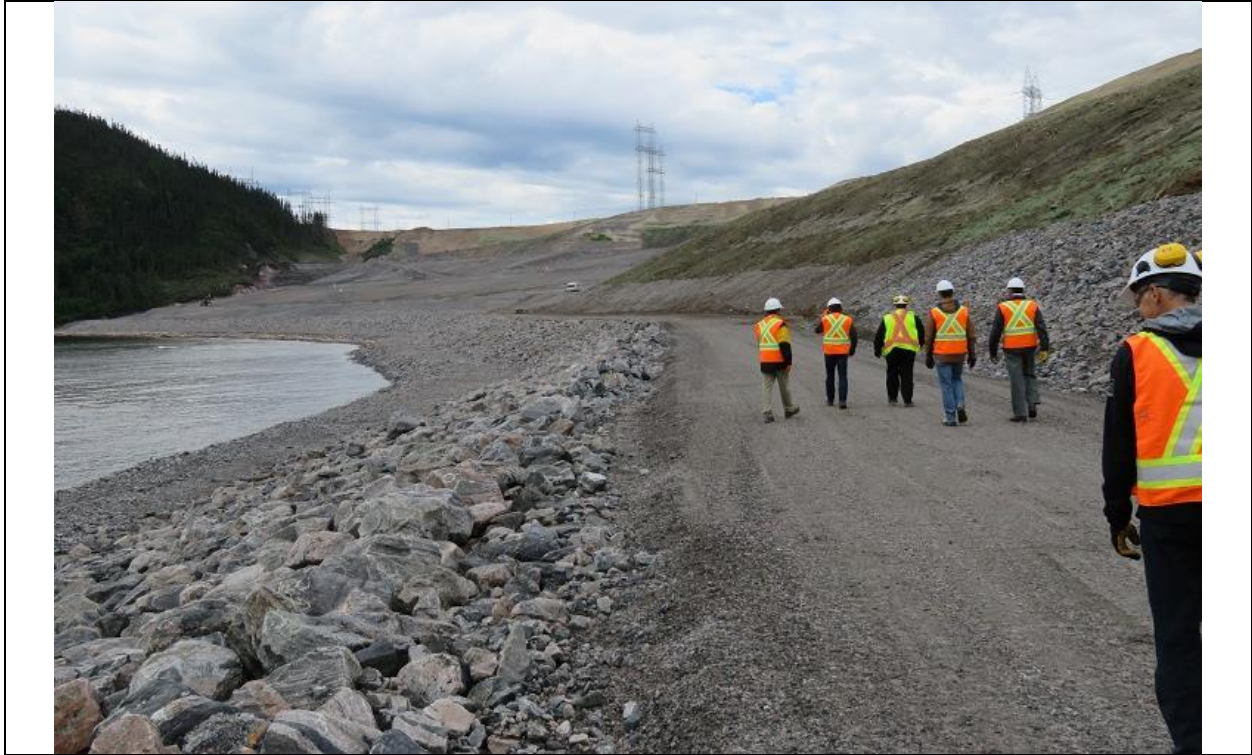
- Construction of the North Spur slope stabilization measures was substantially completed (98%) in late 2016. By the time of the IE site visit, work on the upstream side of the Spur was completed (Photos E.1 to E.4). On the downstream side, the contractor was in the final stages of finishing and grading roads and local finishing of slope cover (Photos E.5 to E.8).

Photo E.8: Southerly view along access road at toe of downstream side of North Spur slope stabilization works.

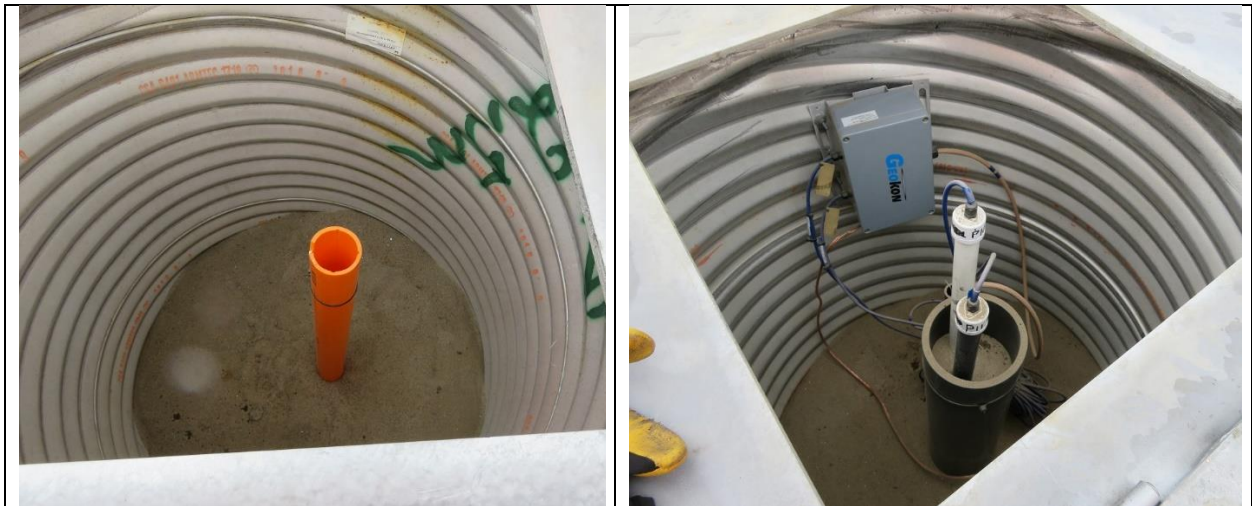
- The North Spur is monitored with piezometers, inclinometers and seepage measuring devices. Inclinometers are read manually, and other instruments are monitored with dataloggers that are downloaded daily. The IE viewed several typical instrument installations, which are well-protected with sturdy, locked housings (Photo E.9).

Photo E.9: Typical instrument installations installed inside protective CMP collars with locked steel lids. Inclinator at left and dual vibrating wire piezometers with remote readout system at right.

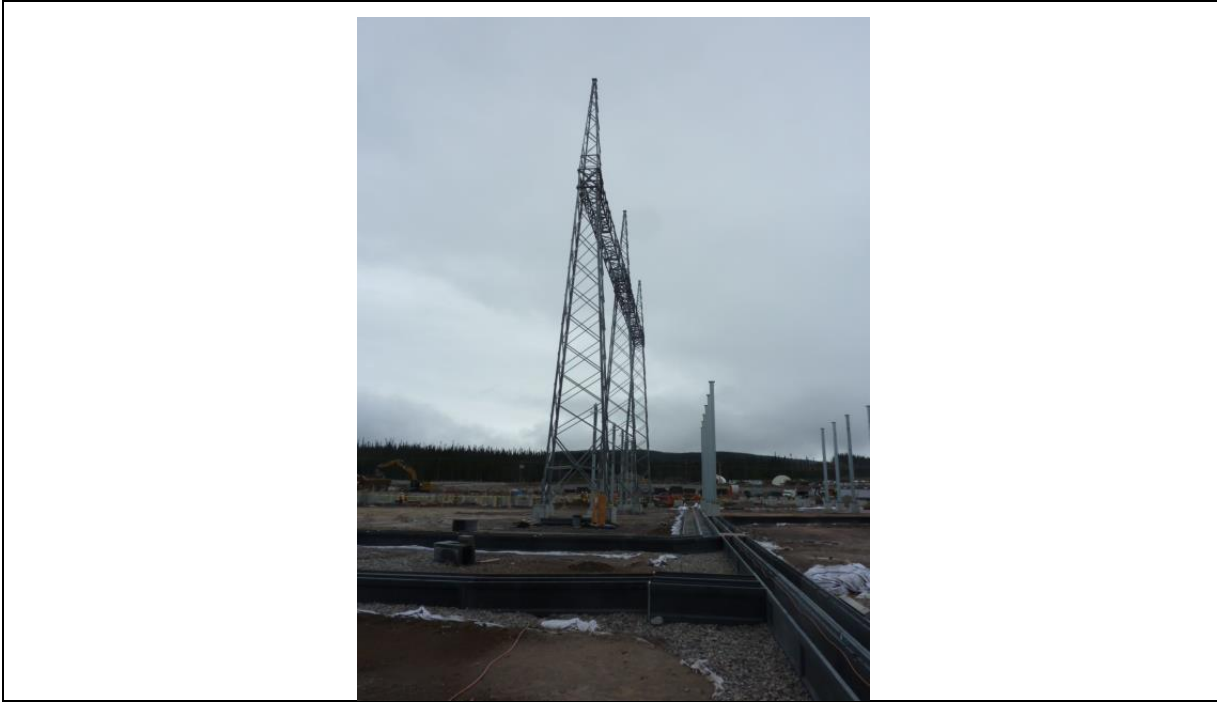
- Ground grid, cable ducts and concrete pads are in place (Photos F.1 and F.2).
- Power apparatus and the structures are in the construction stage.
- 315kV Churchill Falls Transmission line and four powerhouse collector feeder towers have been erected (Photos F.3 and F.4).

Photo F1: AC yard

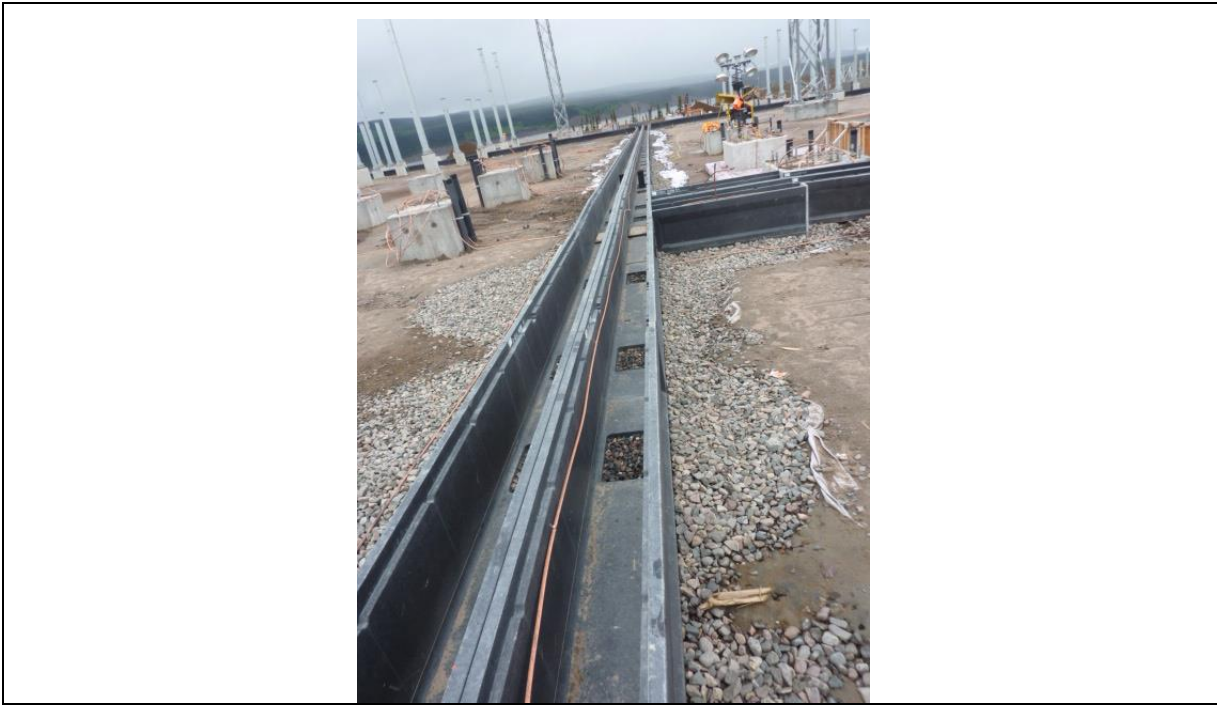
Photo F2: AC yard precast cable ducts and grounding detail

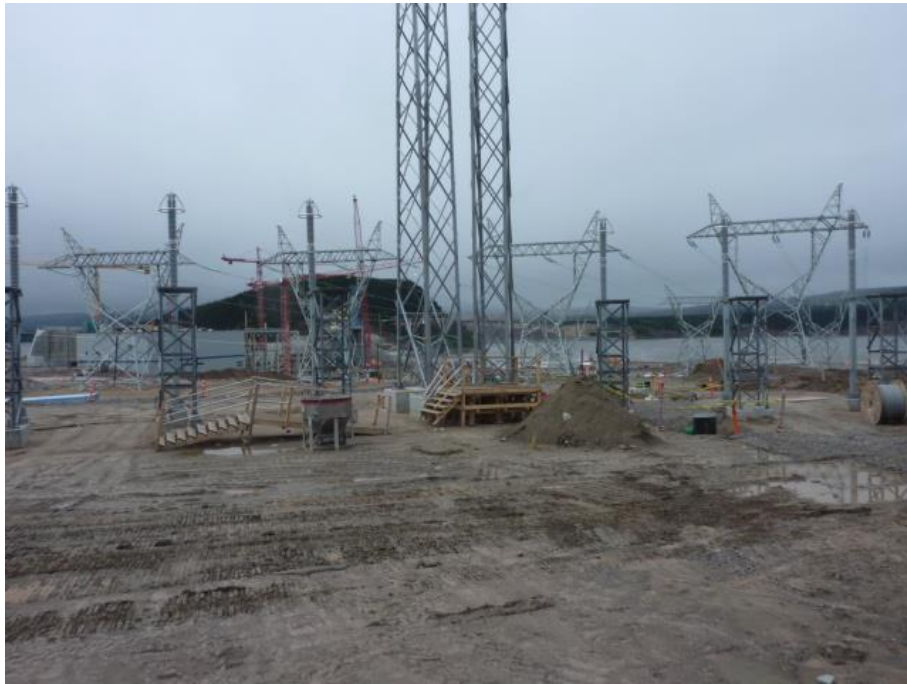
Photo F.3: Powerhouse to GIS building collector feeder lines

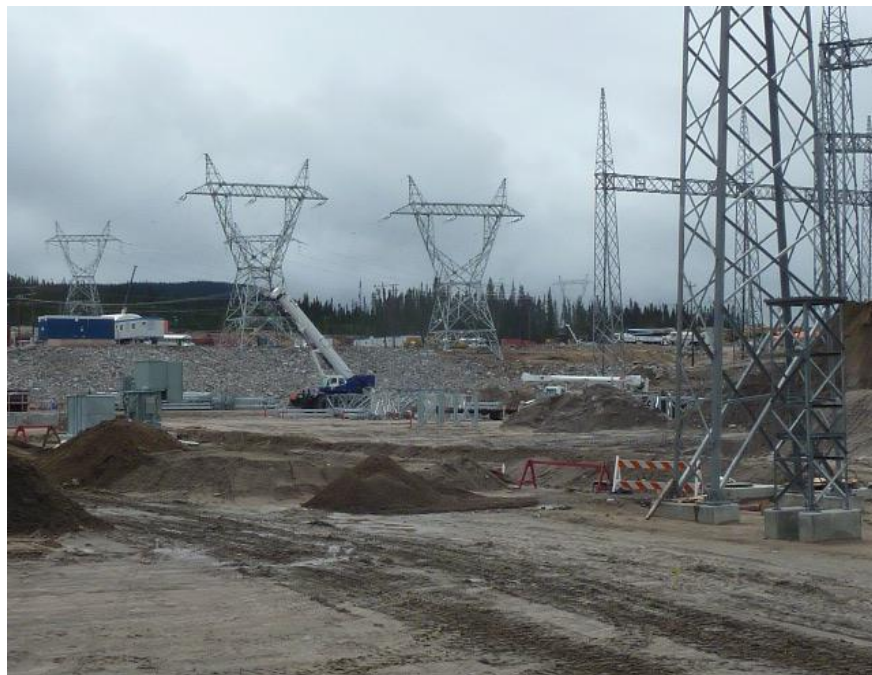
Photo F.4: Incoming Churchill Falls 315 kV AC Transmission Lines

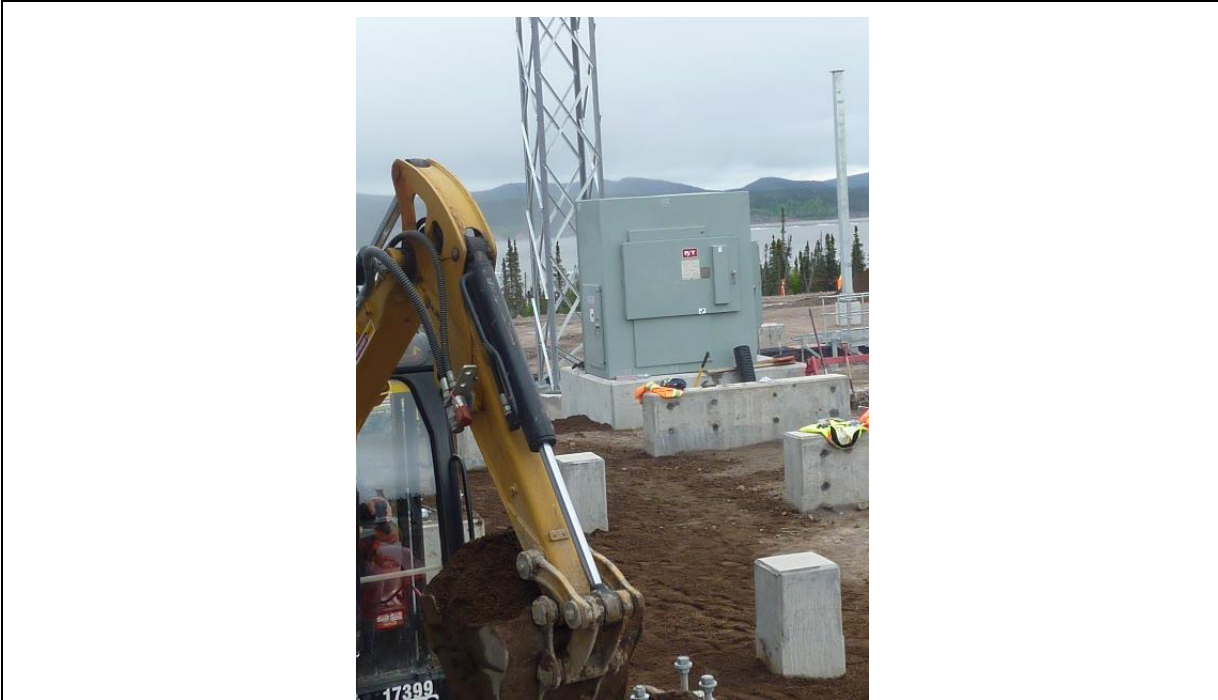
- Transformer bays are complete awaiting arrival of the converter transformers.
- Power equipment concrete pads, ground grid and insulating fill are partially complete.
- Station Service transformers have been installed on their pads (Photo F.5).

Photo F.5: Station Service Transformer with power connections led underground.

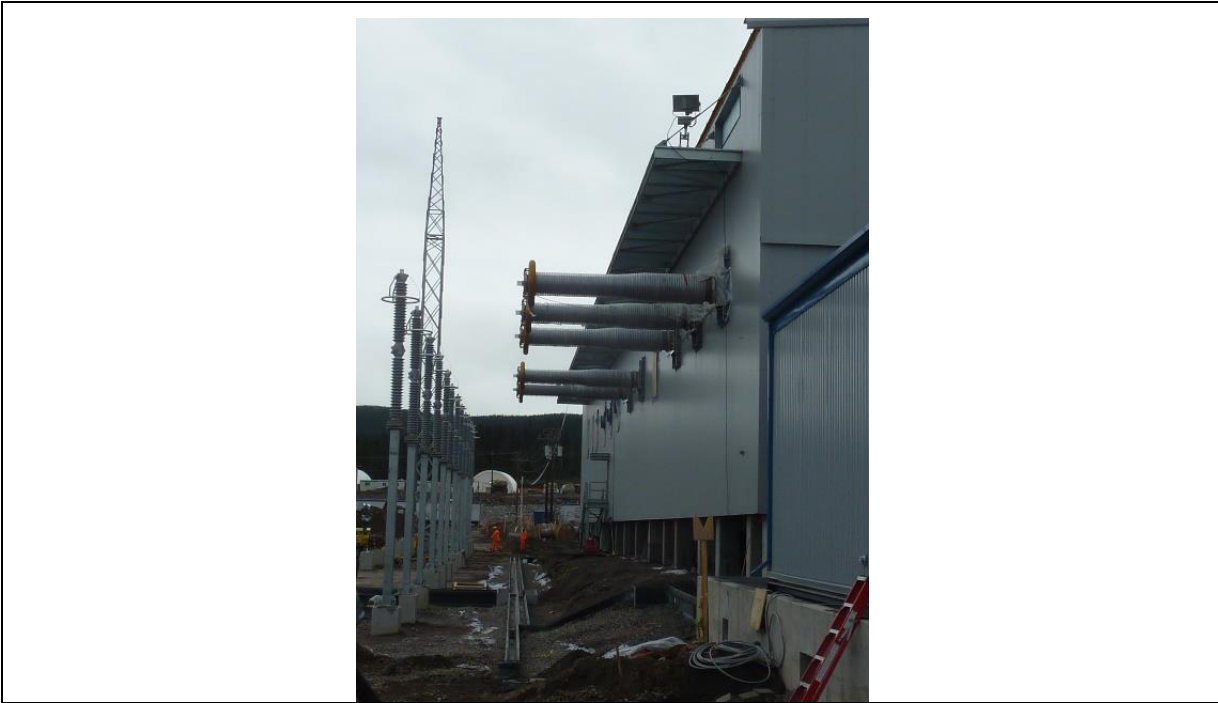
- Wall bushings and collector cable facilities are in the construction stage (Photos F.6 and F.7).
- GIS equipment and Local Control cabinets have been installed, low voltage cables have been pulled in and are being connected (Photo F.8 and F.9).
- Converter transformer pads are complete. The transformers are expected to arrive by end of August.

Photo F.6: GIS Building - Wall bushings

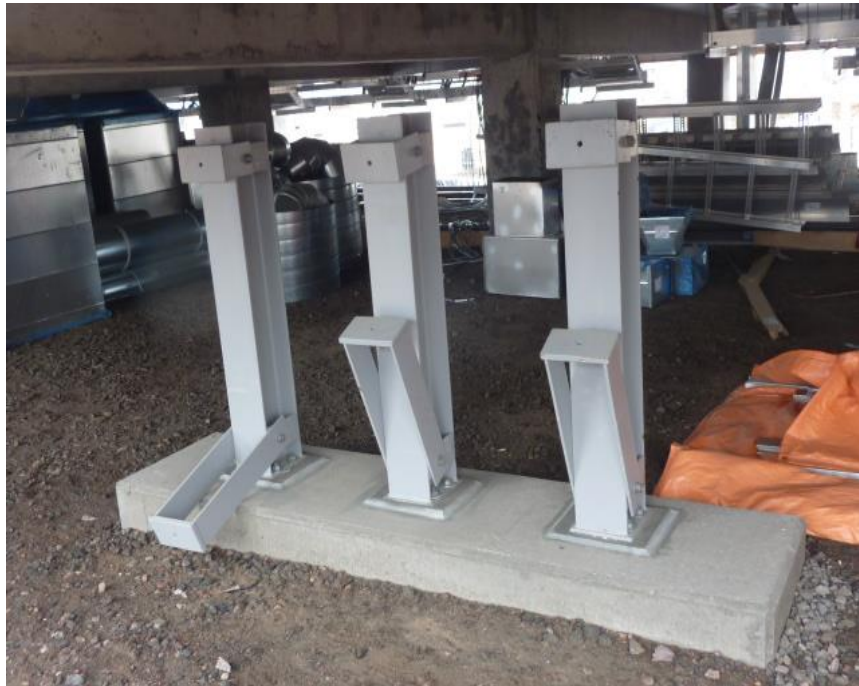
Photo F.7: GIS Building - Powerhouse collector feeder cable supports

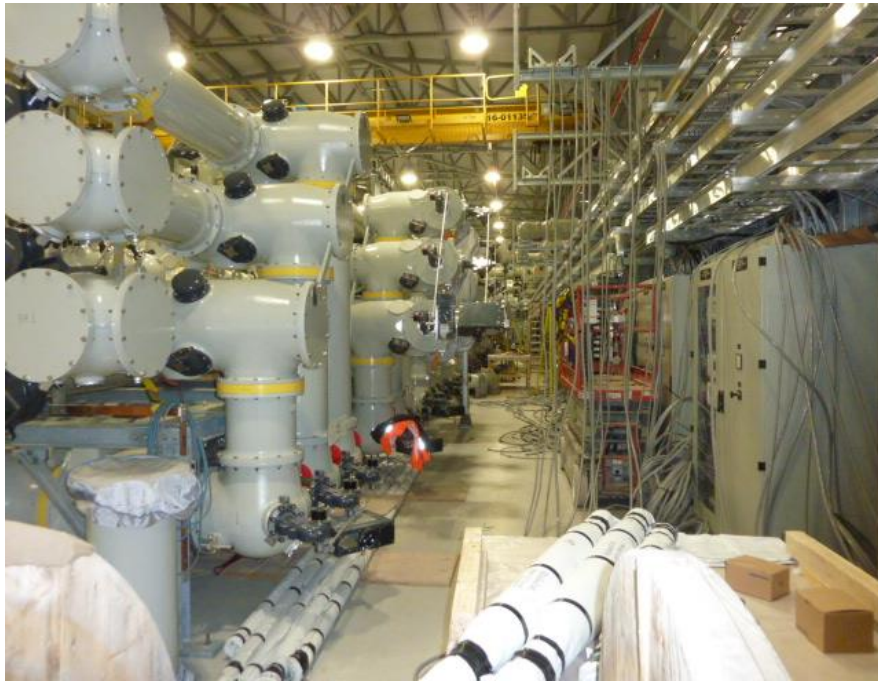
Photo F.8: GIS Equipment and control cabinets installation

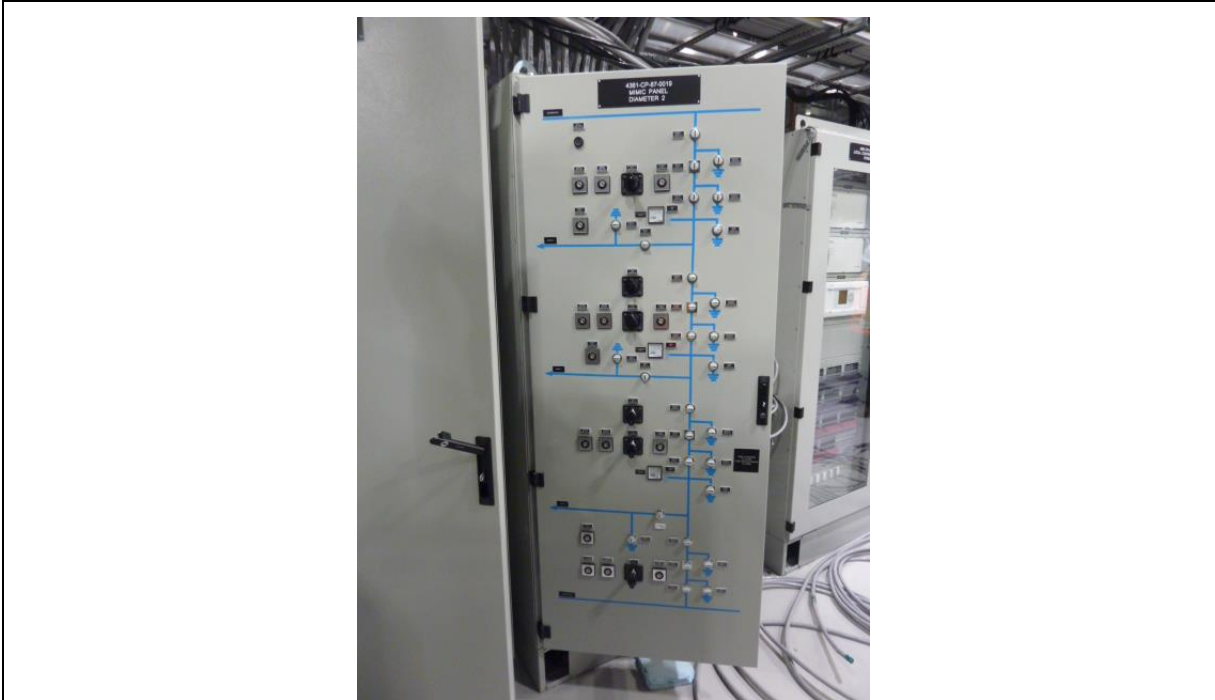
Photo F.9: GIS Equipment - Local Control Cabinets.

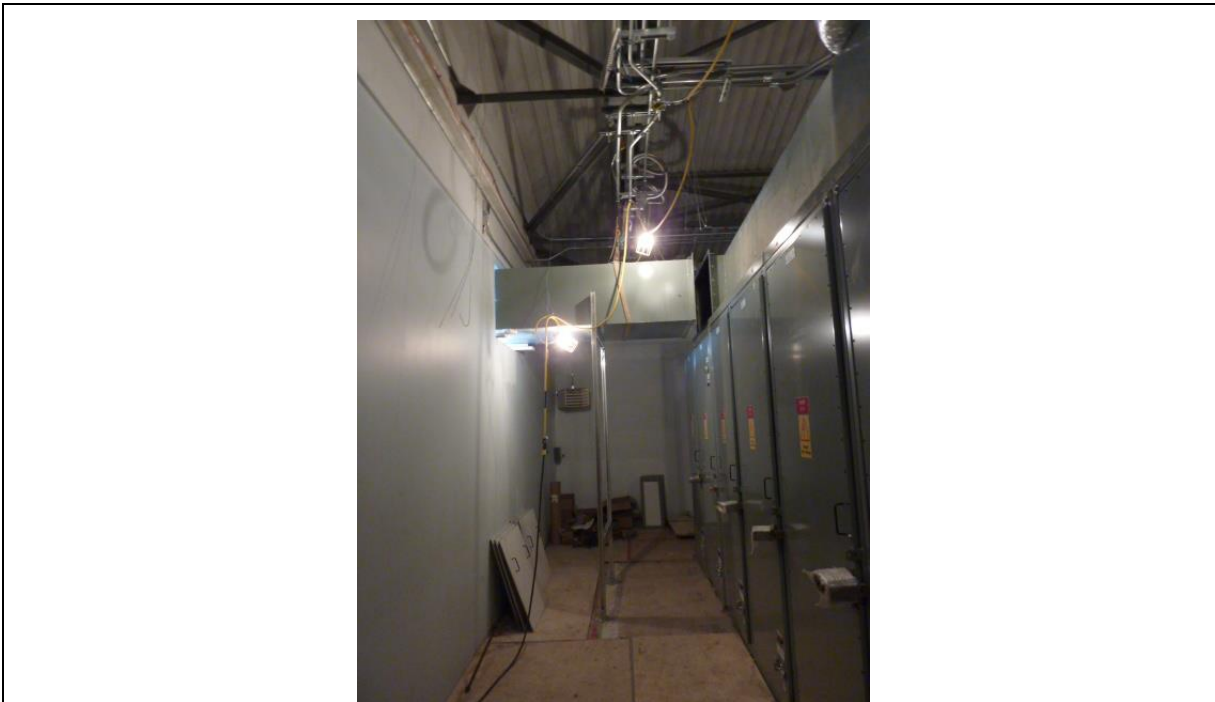
Photo F.10: AC Substation 25kV switchgear arc flash vent detail.

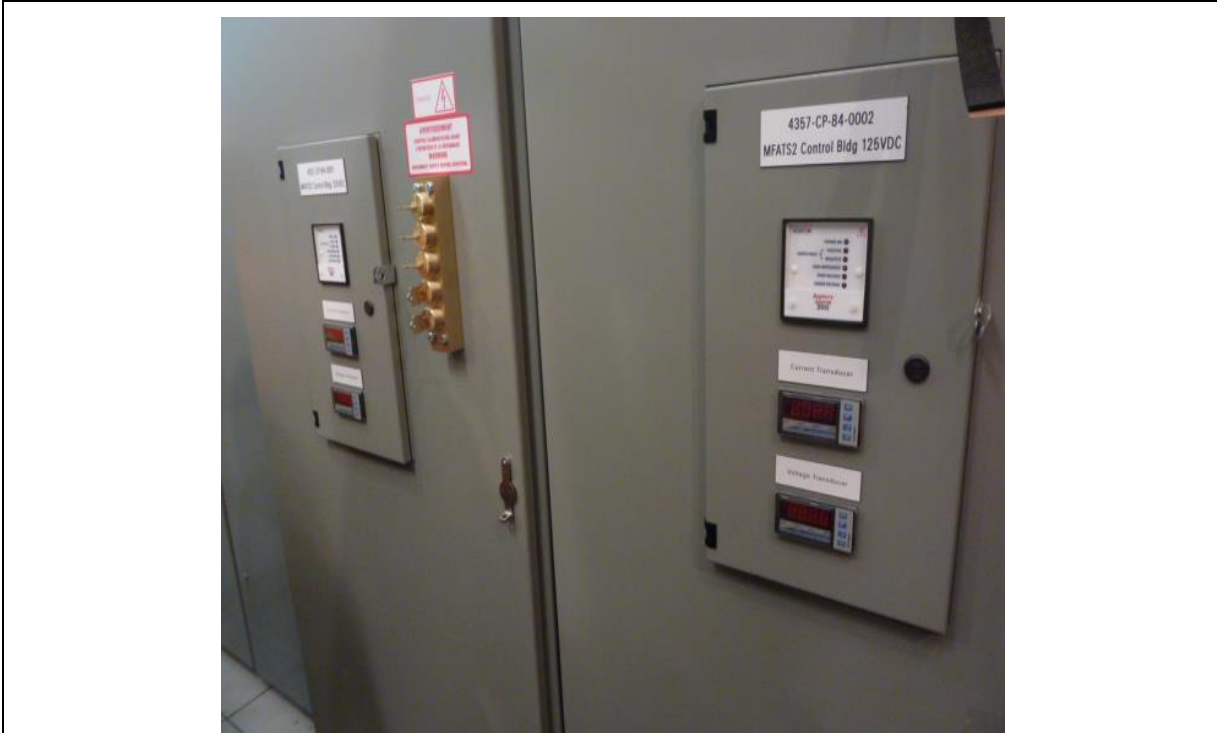
- AC Substation building was completed. Equipment installation is in progress.
- Protection panels have been moved into their position and cabling is prepared for installation.
- 25kV section is nearing completion (Photo F.10).
- 125VDC batteries, chargers and their controls have been installed. Batteries were under charge and the battery rooms could not be accessed at this time (Photo F.11).

Photo F.11: 125 VDC controls and monitoring detail

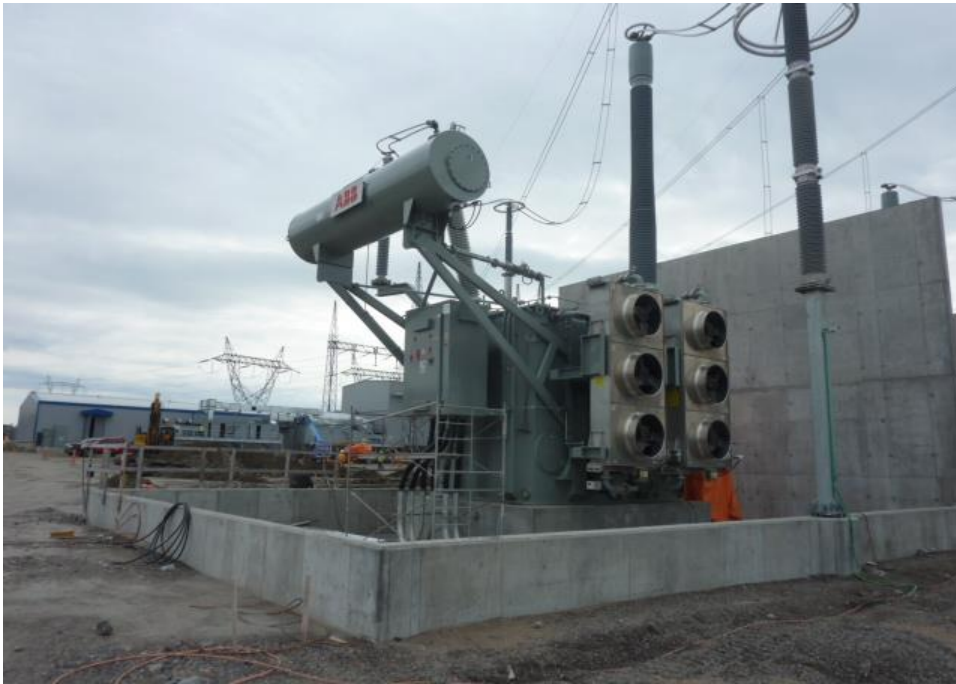
- 1st bus will be energized by end of July.
- Switchyard equipment is completely installed and commissioning is in progress (Photo G.1, G.2 and G.3).
- Substation P&C, auxiliary room, communication room wiring is in progress.
- Switchyard extension is essentially complete and will be energized by early August (Photo G.4).

Photo G.1: CF Single Phase Transformer

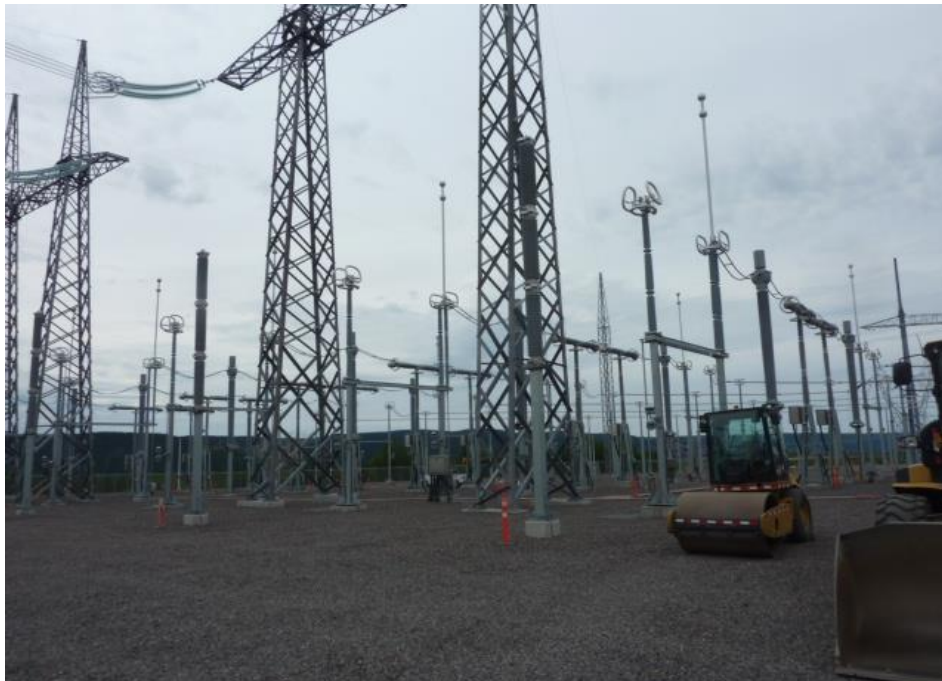
Photo G.2: CF Switchyard - grade completion
