MEETINGS IN ST. JOHN'S AND VISITS TO LOWER CHURCHILL PROJECT SITES, JULY 23 TO 28, 2017

Prepared for: Natural Resources Canada and Nalcor Energy
IE Point of Contact: Nik Argirov
Date: October 06, 2017

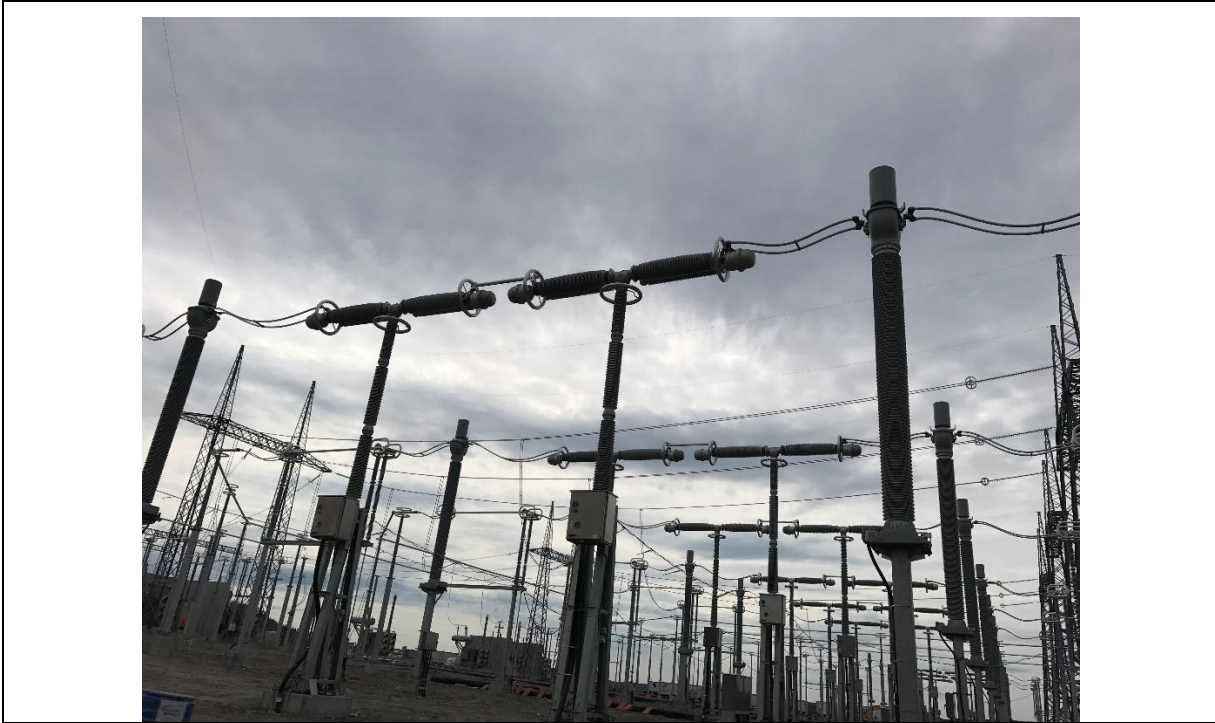
- 1st bus will be energized by end of July.
- Switchyard equipment is completely installed and commissioning is in progress (Photo G.1, G.2 and G.3).
- Substation P&C, auxiliary room, communication room wiring is in progress.
- Switchyard extension is essentially complete and will be energized by early August (Photo G.4).

Photo G.3: CF Switchyard equipment installation completed.

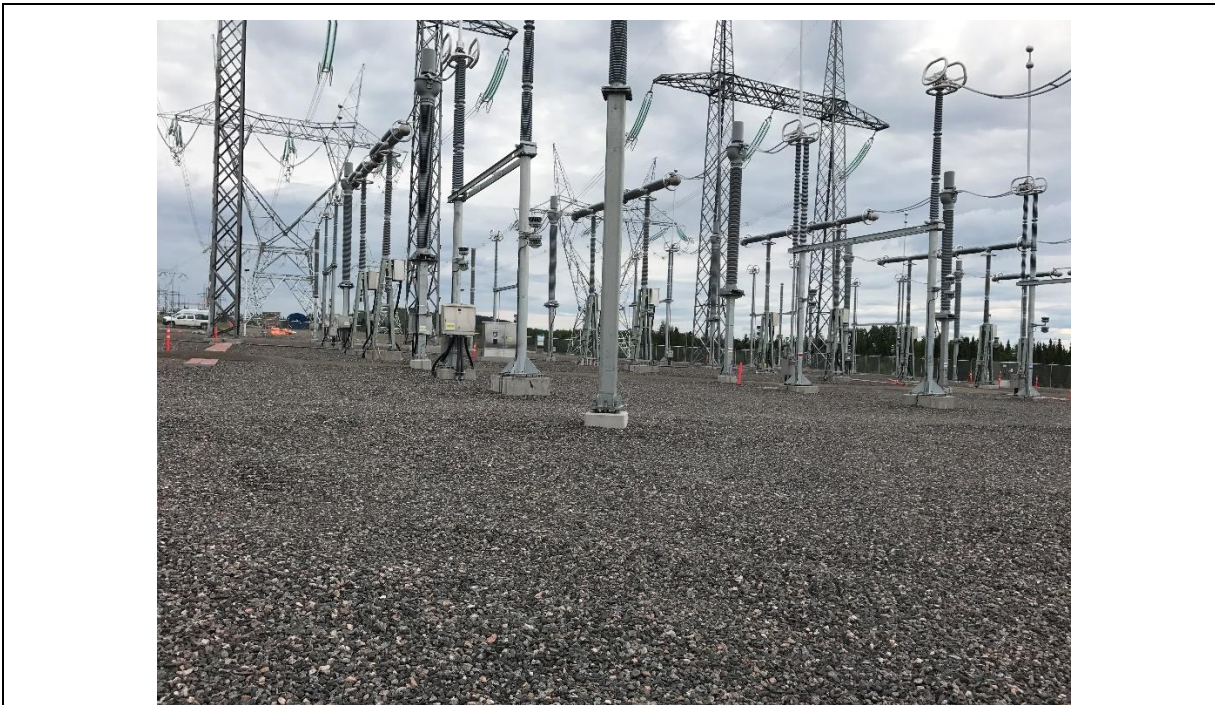
Photo G.4: CF Switchyard Extension essentially completed.

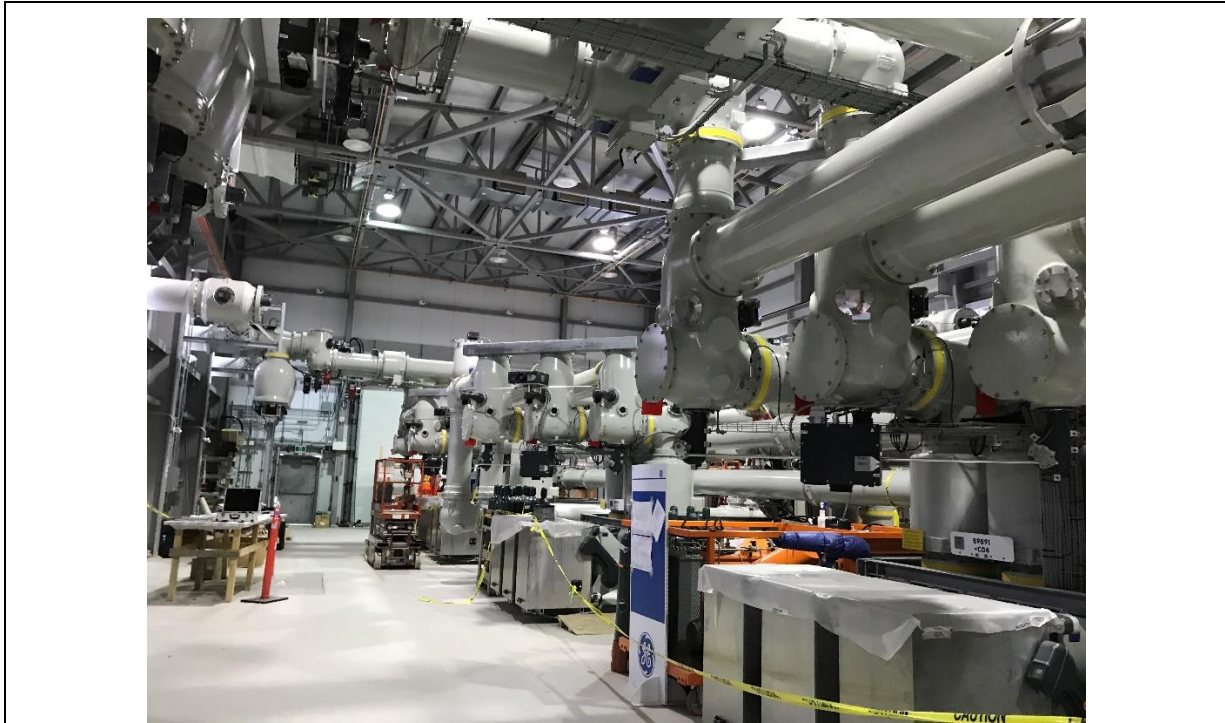
- The SF6 ducting and power apparatus have been installed (Photo G.5).
- Most of the low voltage cables appear to have been pulled in and are being connected to the equipment control cabinets.

Photo G.5: CF GIS equipment installed. Cable terminations ongoing.

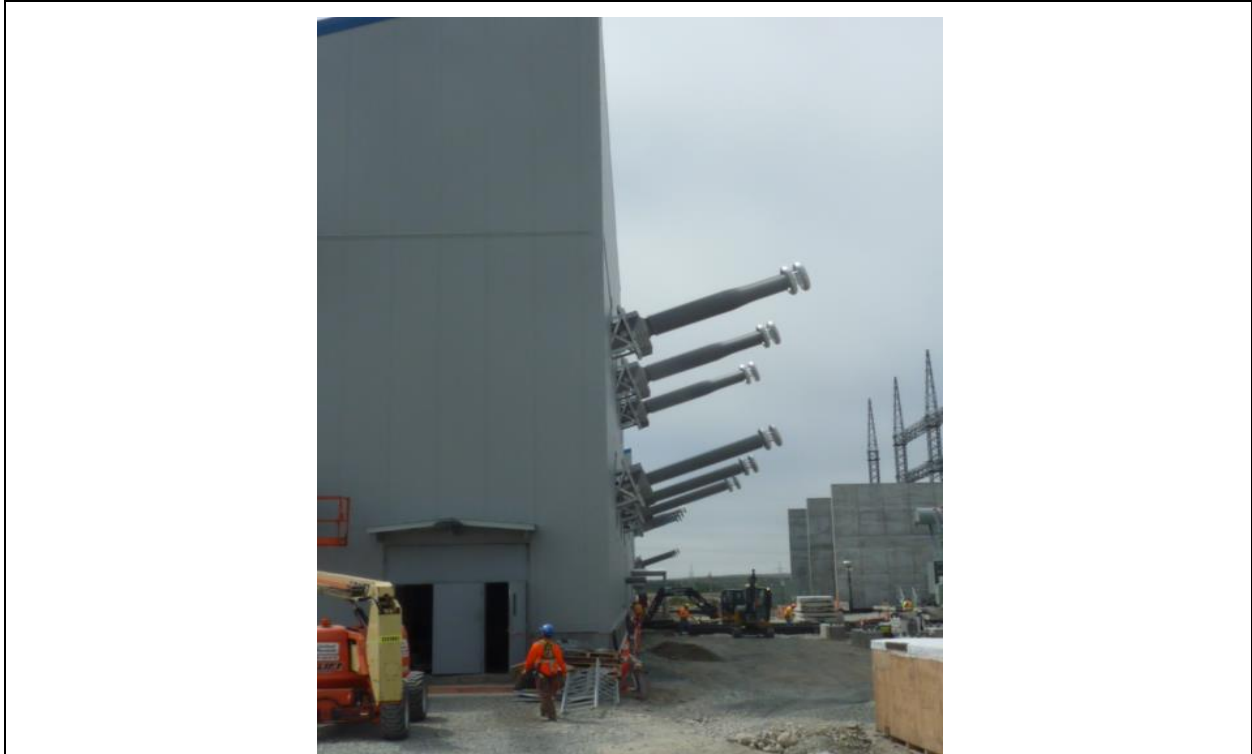
- AC and DC wall bushings (WB) have been installed (Photos H.1 and H.2).
- Valve cooling equipment is being installed, main supply pipes and pumps are in situ in the Pole 1 section (Photos H.4 and H.5).
- Cooling Control cabinets are in place and being connected (Photo H.6).
- Floors have been epoxy sealed and building is ready for equipment installation (Photo H.7 and H.8).
- Pole 1 module installation can commence in 3 weeks.

Photo H.1: Converter Station AC Wall Bushings.

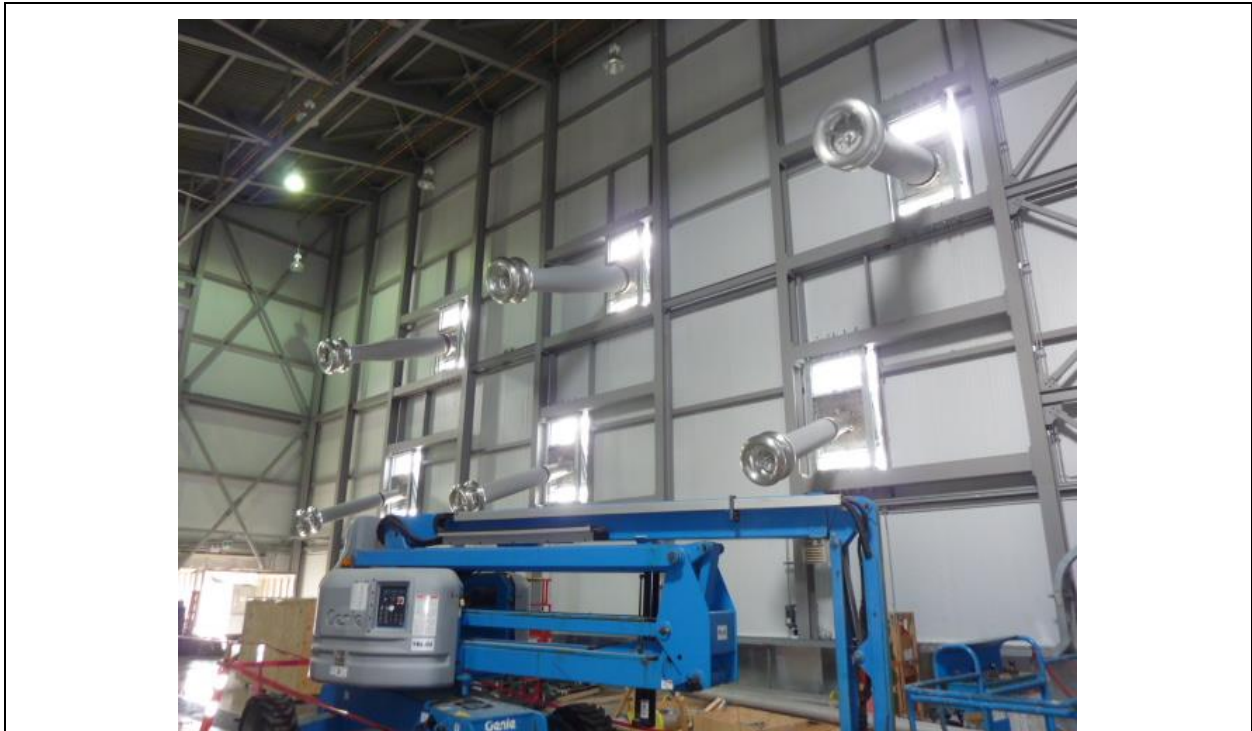
Photo H.2: Converter Station AC Wall Bushings inside Valve Hall.

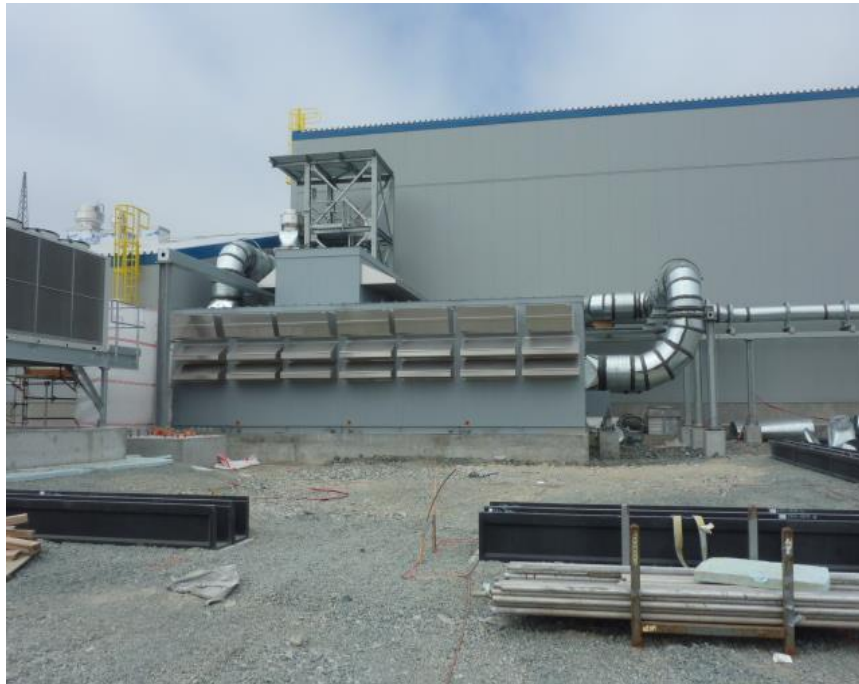
- Ground grid and concrete pads have been installed (Photo H.9).
- Valve cooling heat exchangers have been erected (Photo H.3).
- Converter transformers are on their pads, Pole 1 and the Spare have their bushings installed and have been oiled (Photo H.10).

Photo H.3: Converter Station Cooling Equipment – Heat Exchangers.

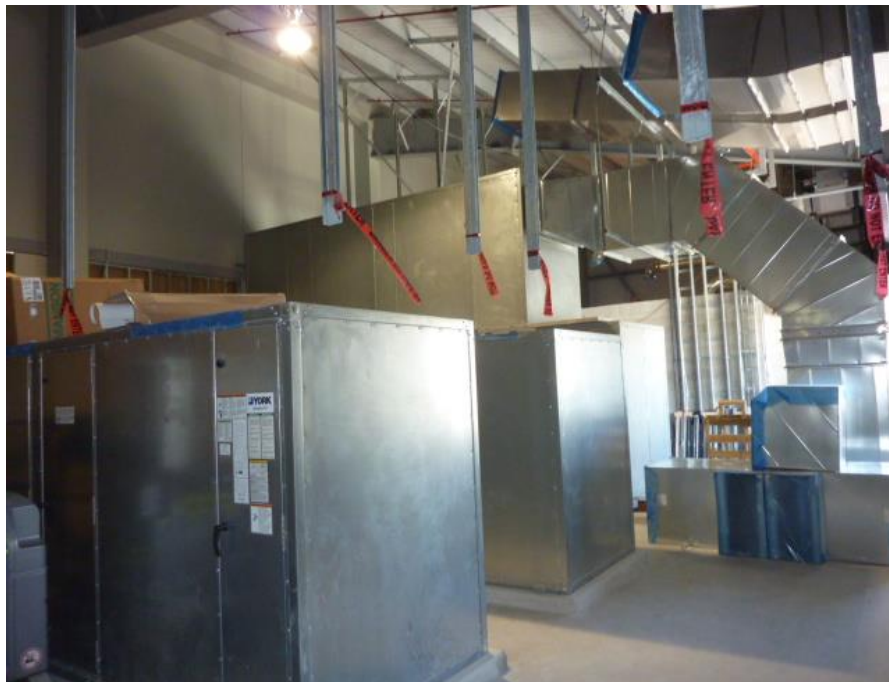
Photo H.4: Converter Station Valve Cooling - Interior Ducting.

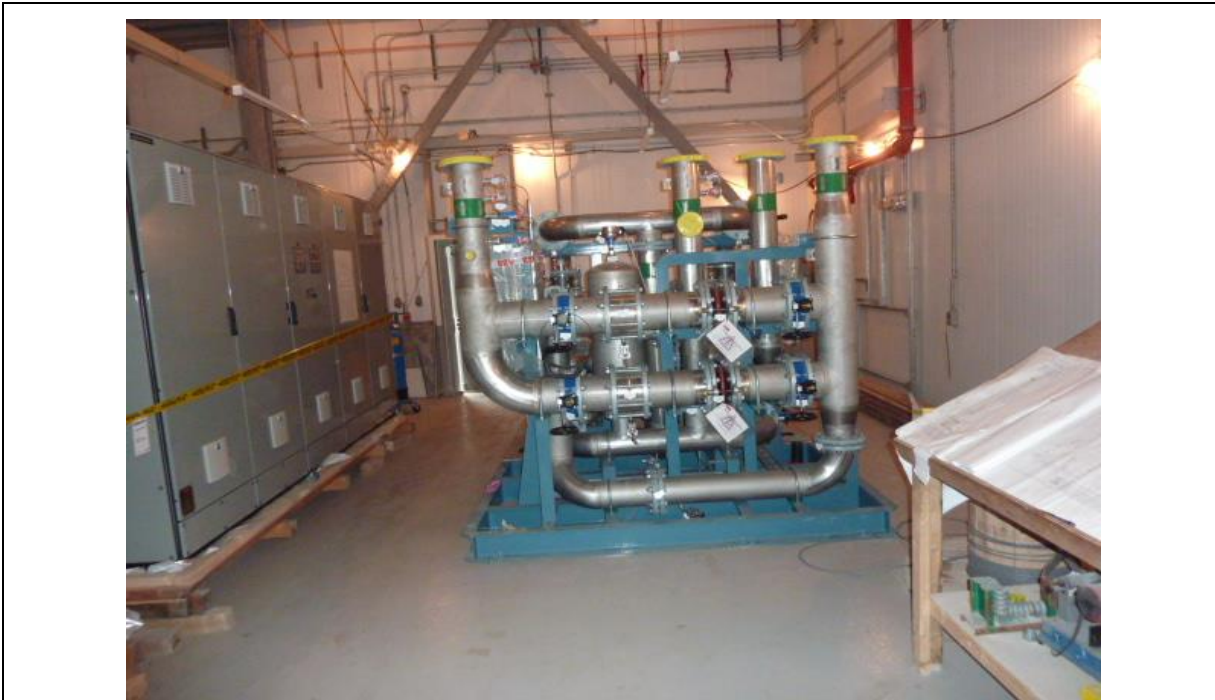
Photo H.5: Converter Station Valve Cooling - Cooling Pumps.

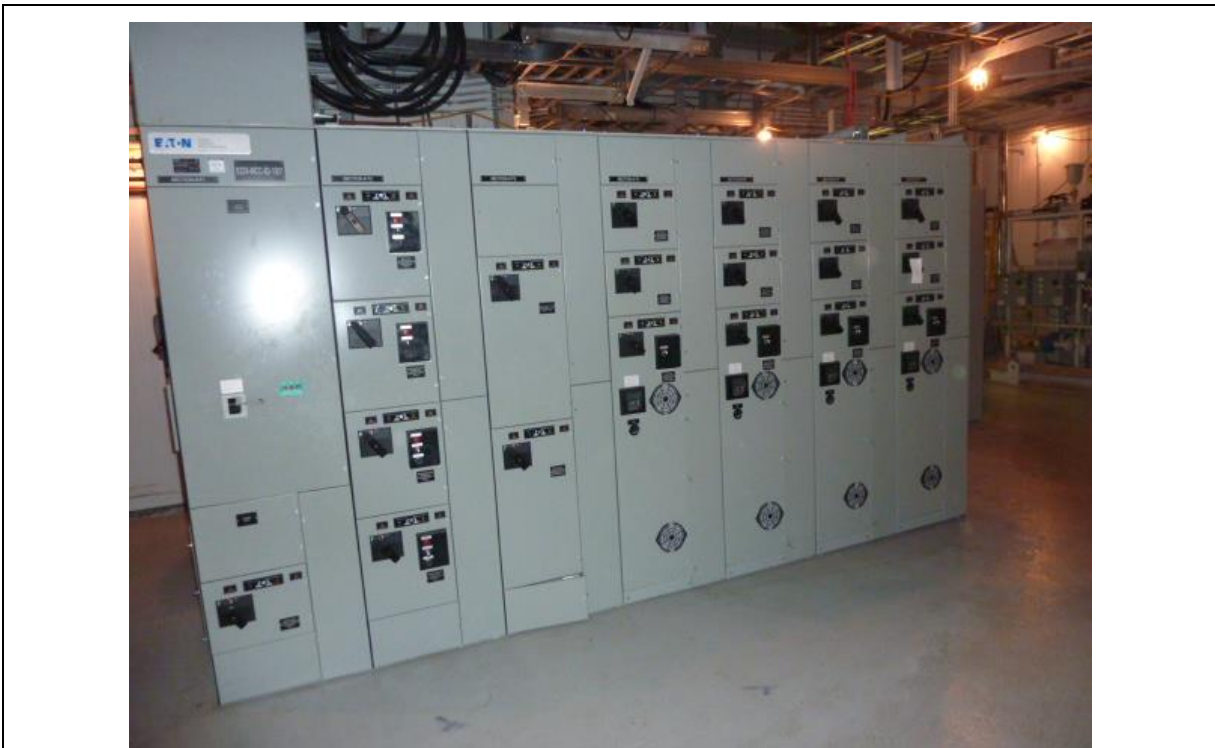
Photo H.6: Converter Station Valve Cooling - Motor Control Centre.

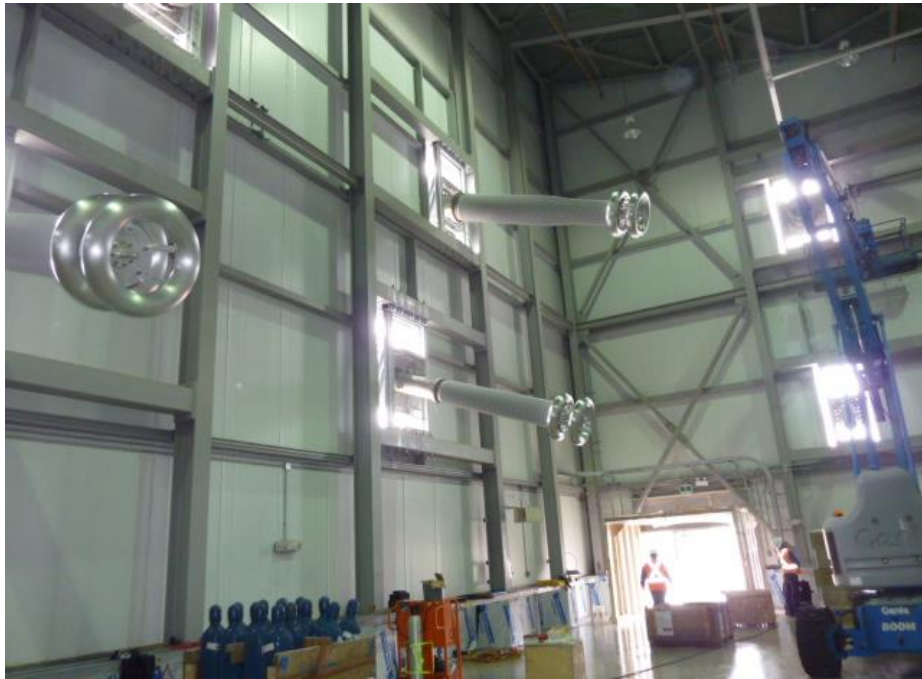
Photo H.7: Converter Station Valve Hall - Sealed floors and DC Wall Bushings are ready for equipment installation.

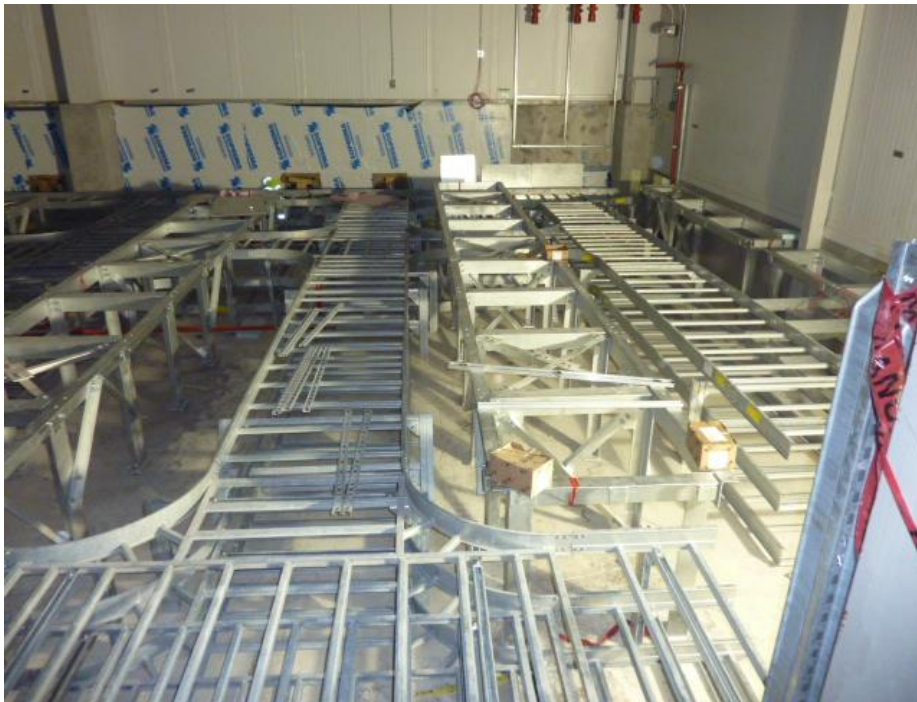
Photo H.8: Converter Station - suspended floor support and cable trays.

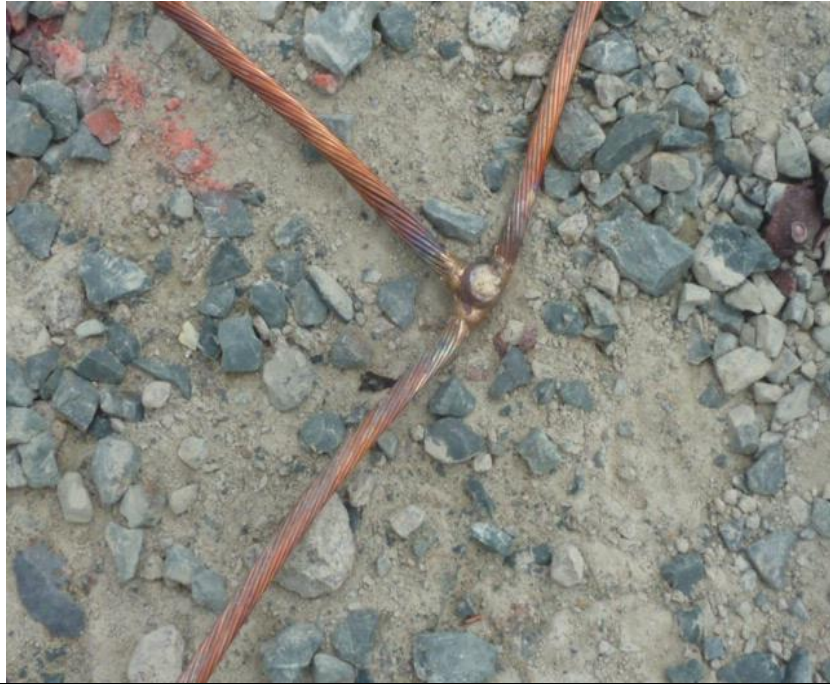
Photo H.9: Converter Station DC Yard - Ground grid cad-weld joint detail.

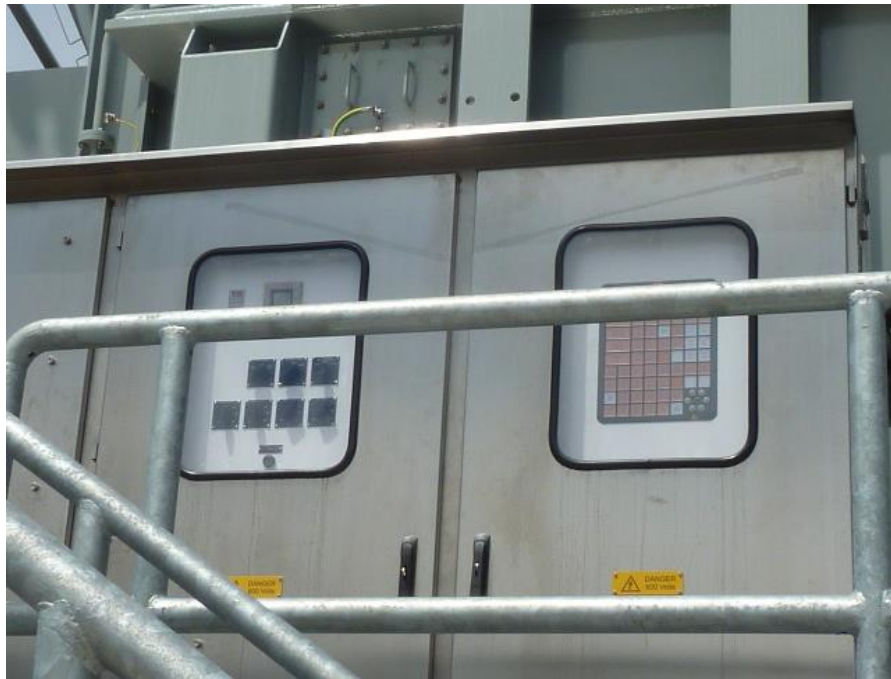
Photo H.10: Converter transformer annunciator and control panel detail.

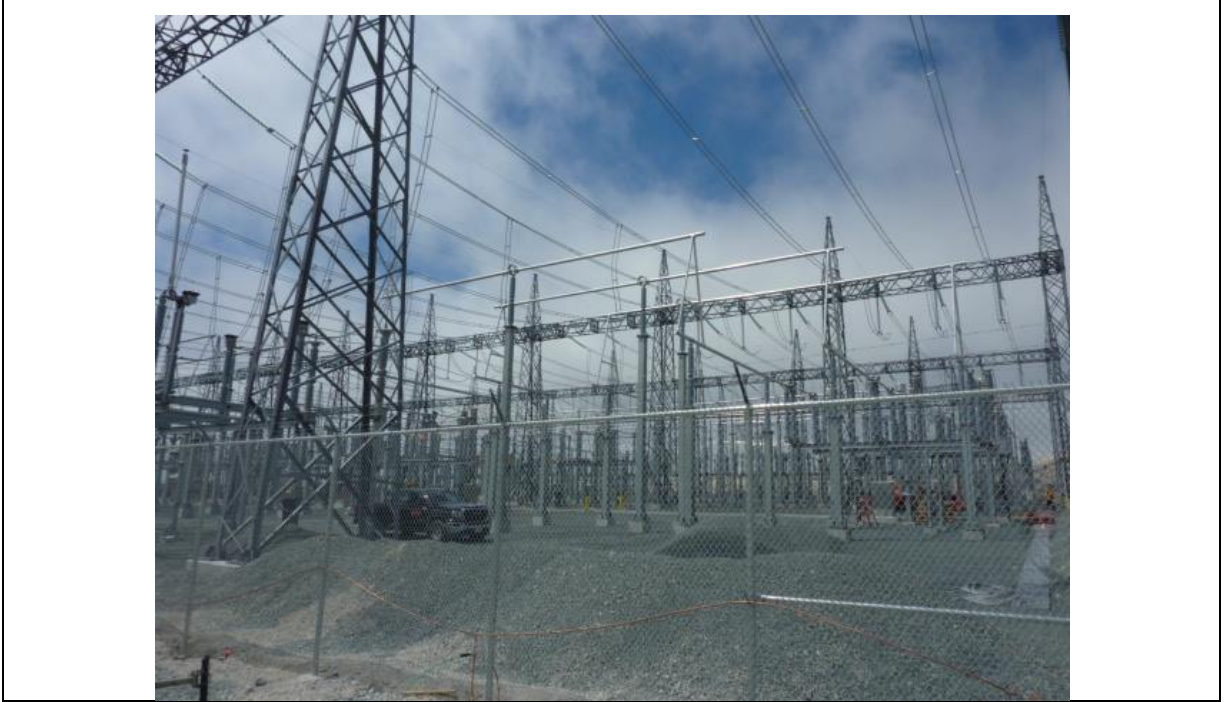
- AC Substation works are nearing 100 percent completion. Equipment testing was ongoing (Photo H.11).
- Auxiliary room has been completed, it is test energized and under test permit. No access was possible at this time.
- Protection panels are in place and wired in. Relay testing is in progress (Photo H.12).
- Communication room panels are in place being wired. Communication battery was not inspected due to construction activities taking place.
- Battery 1 and Battery 2 are installed in their racks, main cables are ready for the final connections (Photo H.13).

Photo H.11: AC Substation construction has been completed with testing in progress.

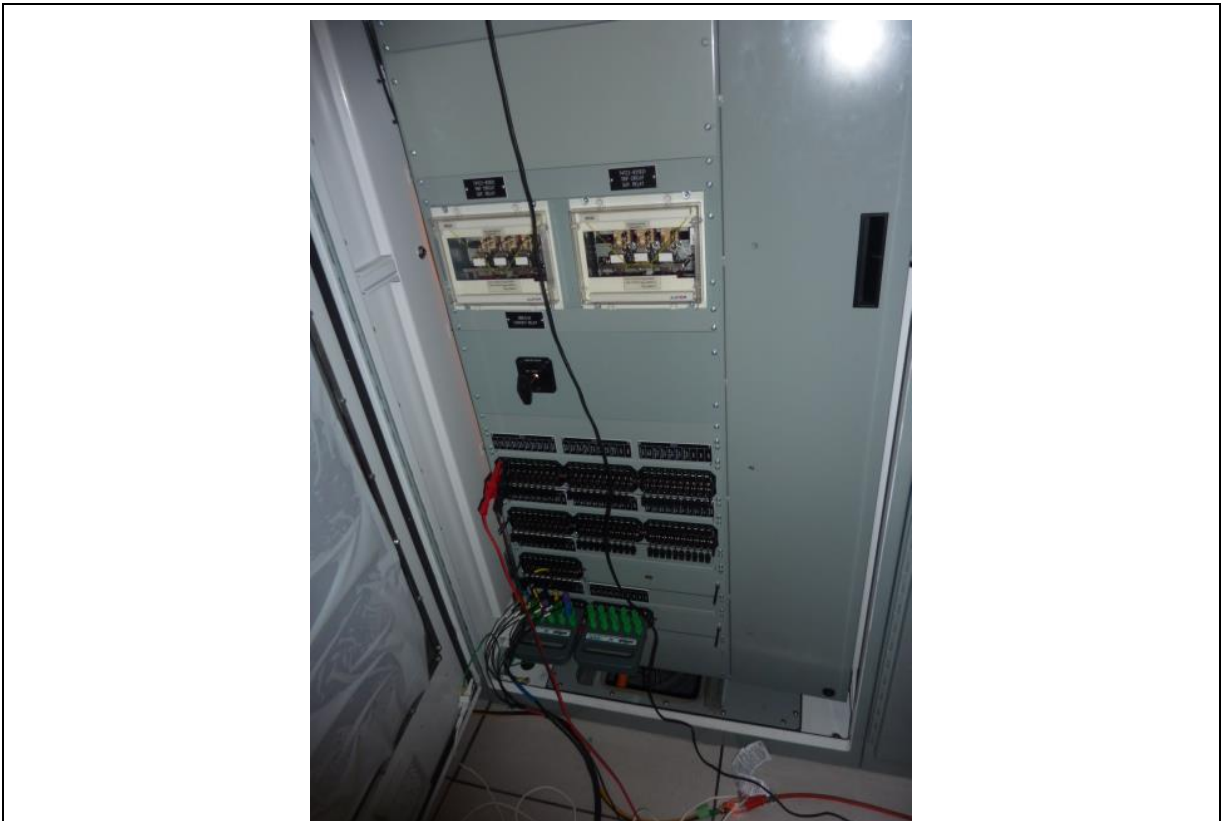
Photo H.12: AC Substation Control Building - relay panels in place undergoing testing.

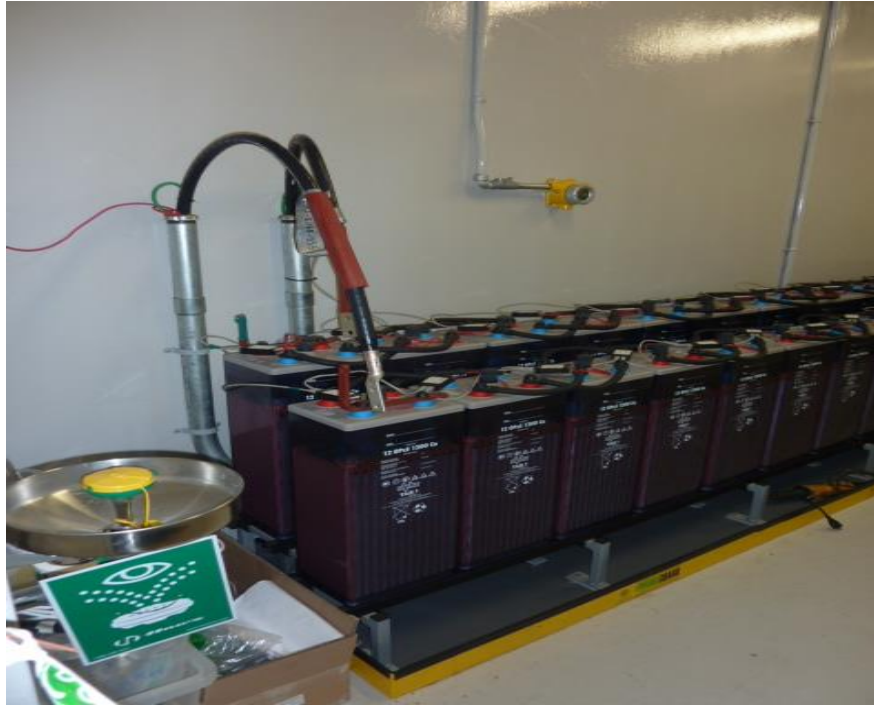
Photo H.13: AC Substation Control Building - Battery #2 Cabling.

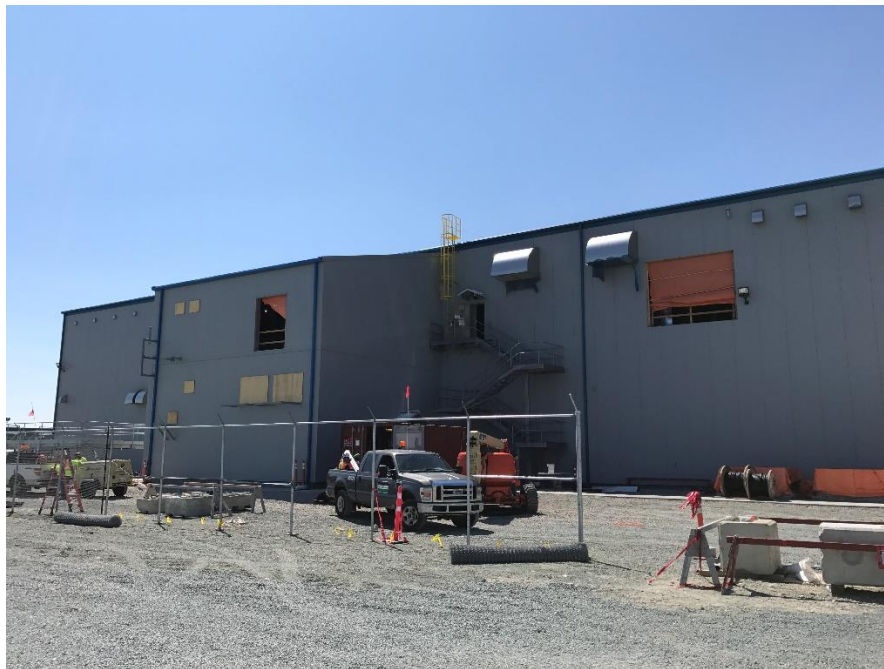
- UPS building extension completed (Photo H.14).
- Unit 1, 2 and 3 are on their pedestals. Installation of all rotors is complete, with bearing installation ongoing (Photos H.15 and H.16).
- Some of the cooling equipment has been installed (Photo H.17).
- Synchronous Condenser Power and Exciter Transformers are on their pads (Photo H.18).

Photo H.14: Synchronous Condensers Power and Exciter Transformers.

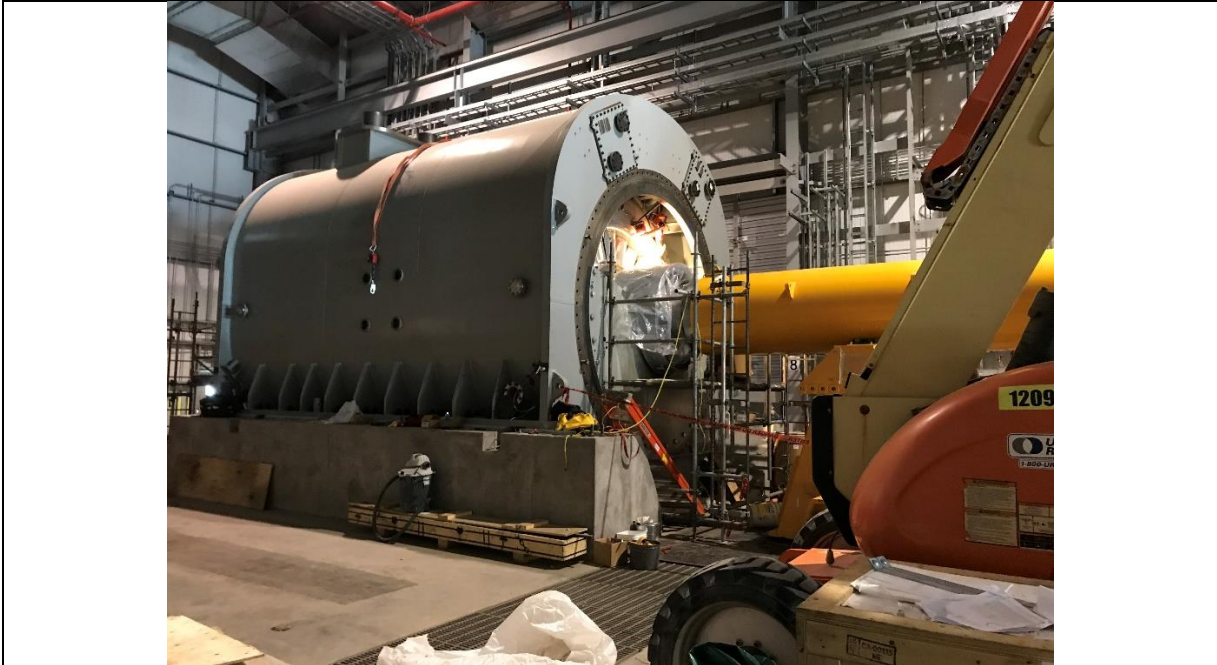
Photo H.15: Synchronous Condenser Unit 1 fully installed on concrete pedestals.

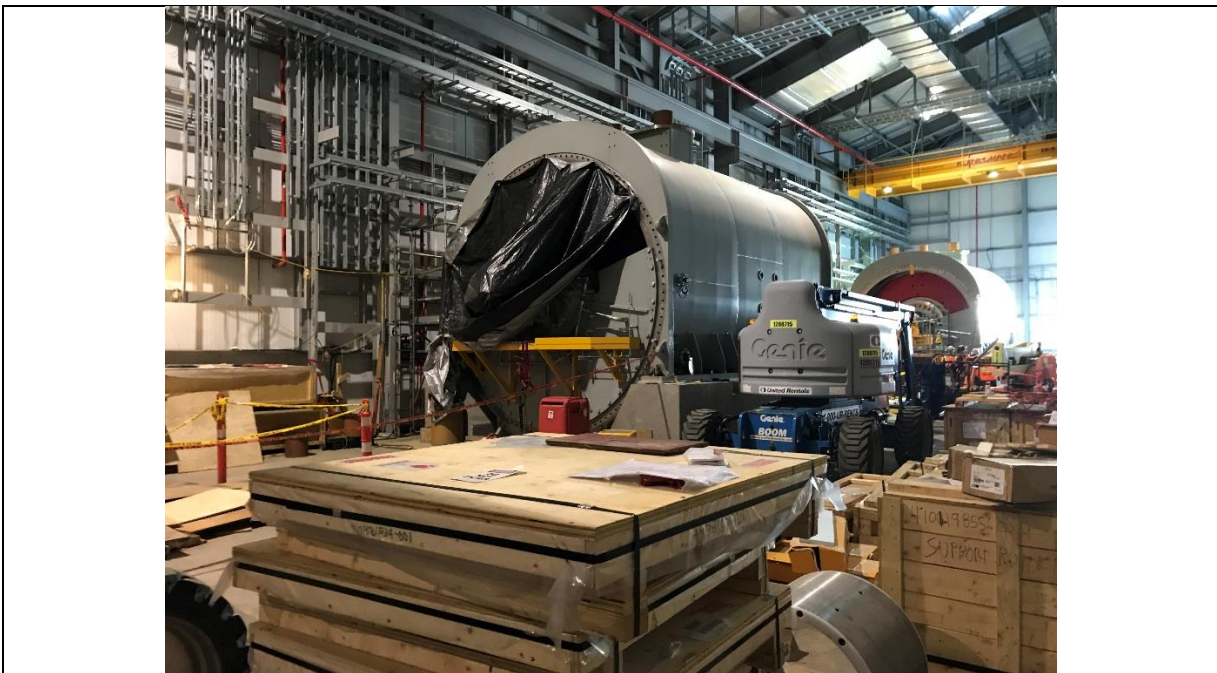
Photo H.16: Synchronous Condensers Units 2 and 3 installed on their pedestals.

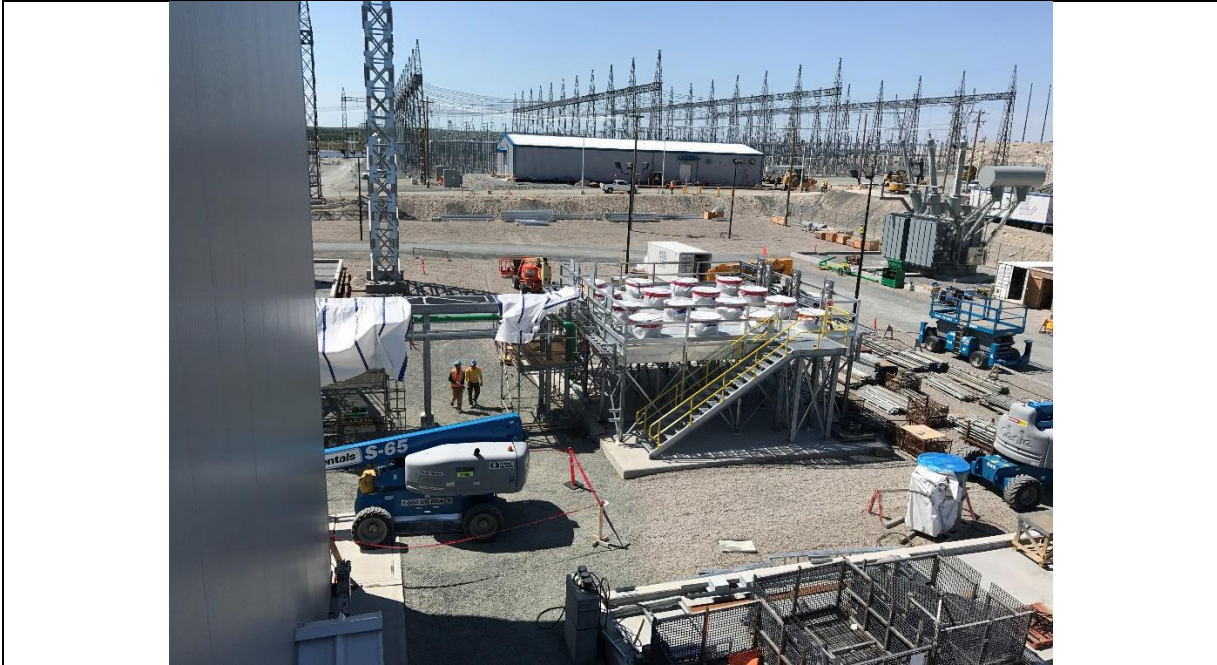
Photo H.17: Synchronous Condensers Cooling System - exterior heat exchangers

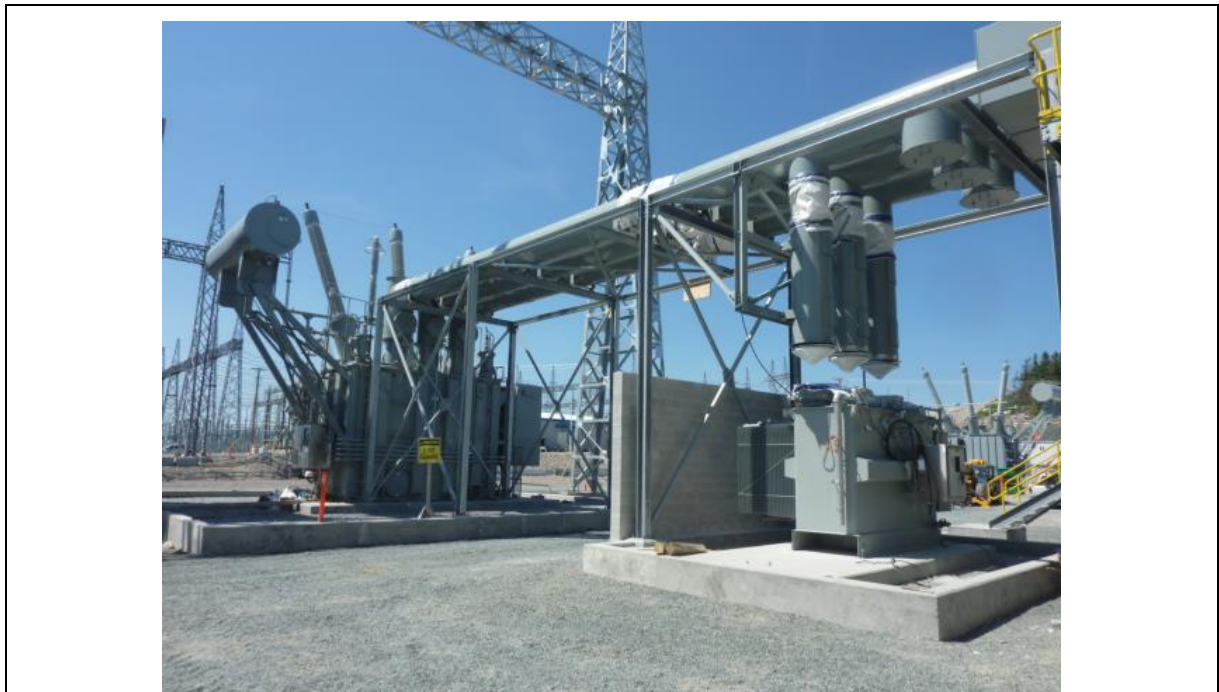
Photo H.18: Synchronous Condensers Power and Exciter Transformers.
