MEETINGS IN ST. JOHN'S AND VISITS TO LOWER CHURCHILL PROJECT SITES, JUNE 26 TO 29, 2018

Prepared for: Natural Resources Canada and Nalcor Energy
IE Point of Contact: Nik Argirov
Date: August 14, 2018

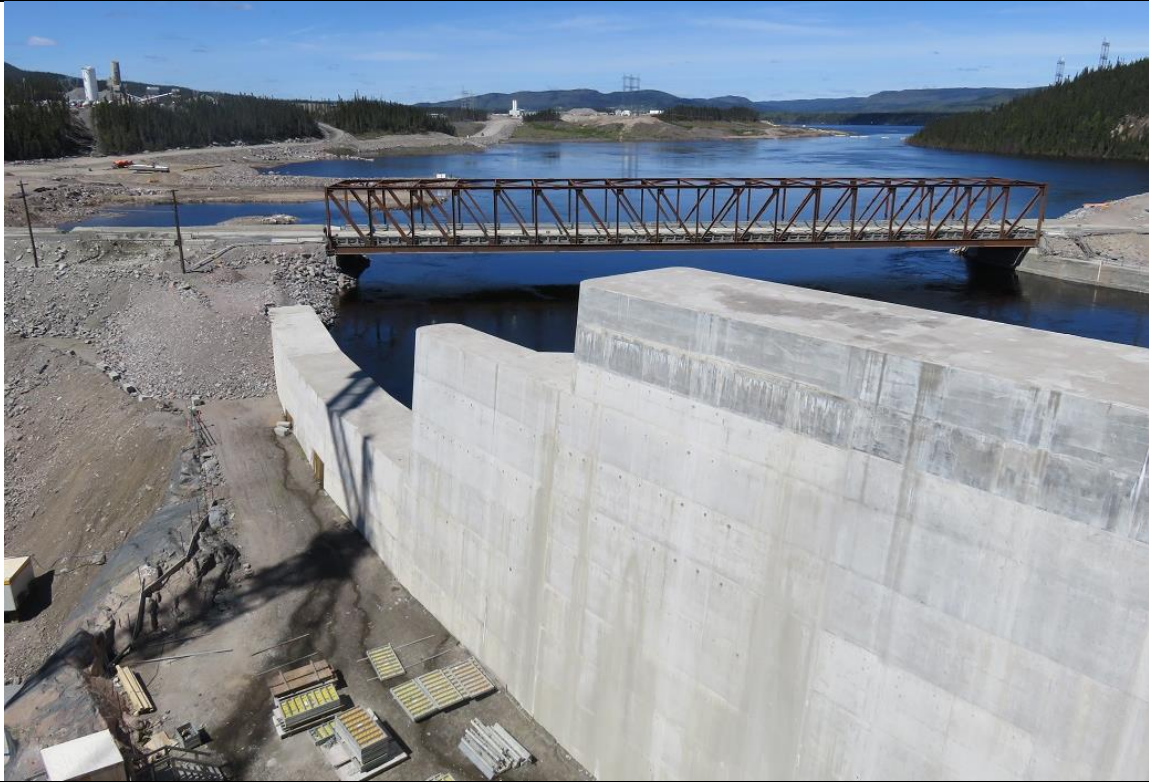
The reservoir was at about El. 23 m at the time of the IE site visit.

Photo A.1: Upstream view of spillway approach channel and lower reservoir.

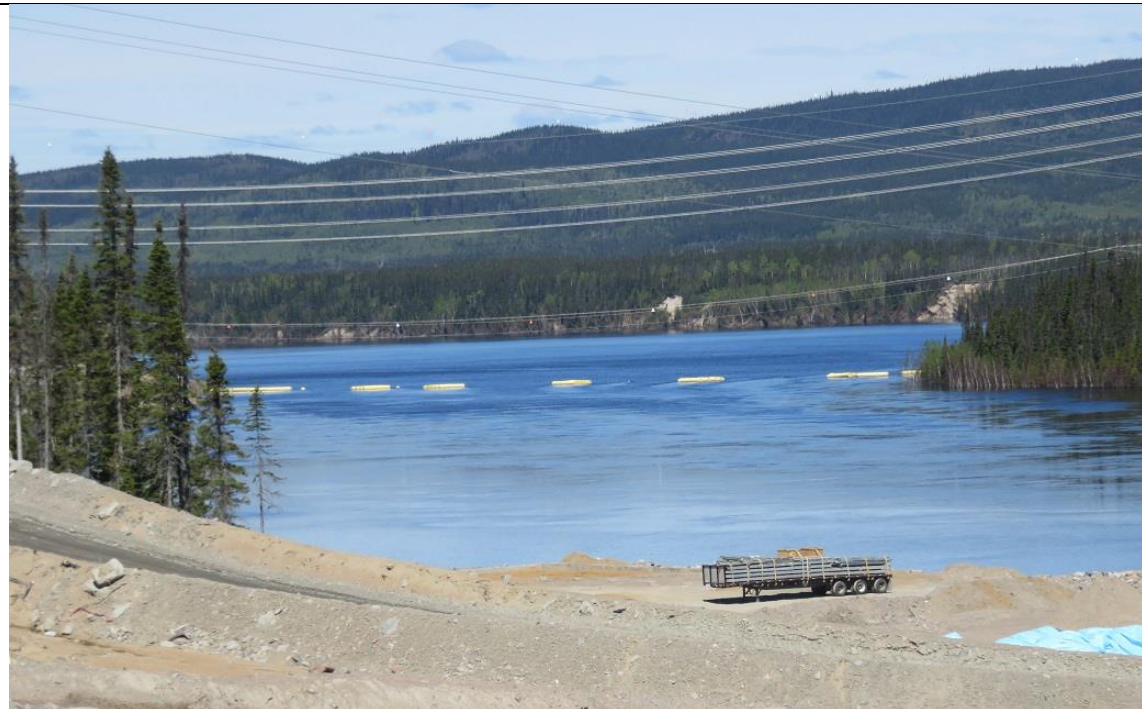
Since the debris/ice/safety boom was installed in 2017, the positions of some of the boom buoys have shifted due to slippage of holding clamps. Nalcor plans to replace the clamps with an improved device this year. Nalcor reported that it will maintain a

Photo A.2: Upstream view of debris boom, showing irregular spacing of buoys due to slippage of clamps.

24-hour safety watch of the upstream area until the buoys are repositioned and the clamps replaced in order to avoid potential public access.

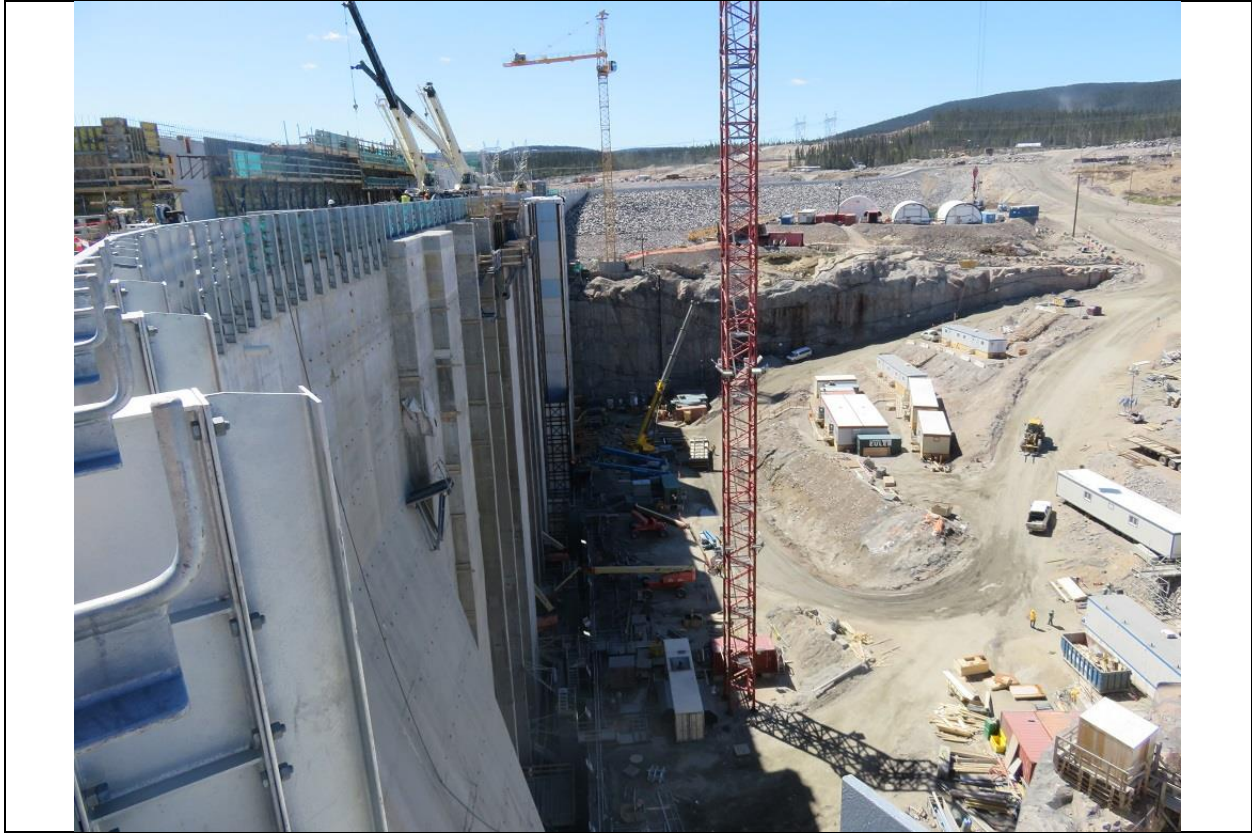
Photo B.1: Power intakes and intake channel, with south embankment dam in background.

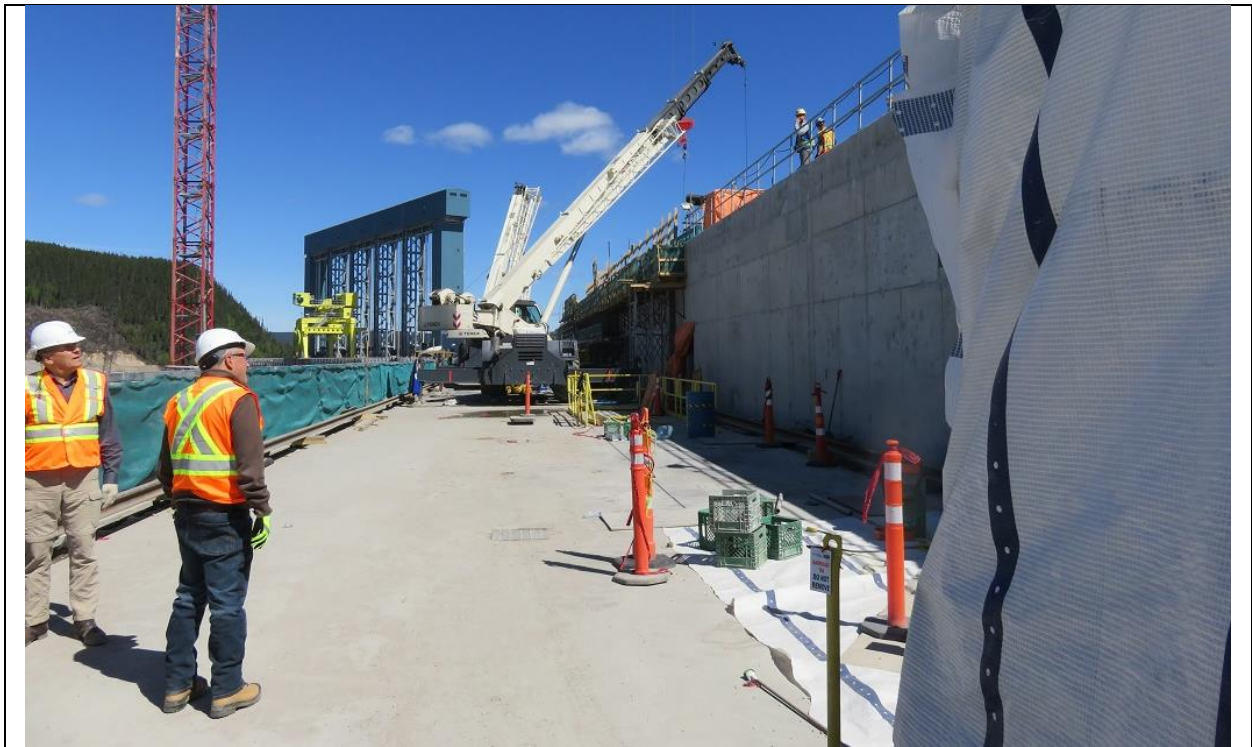
Photo B.2: Power intakes deck.

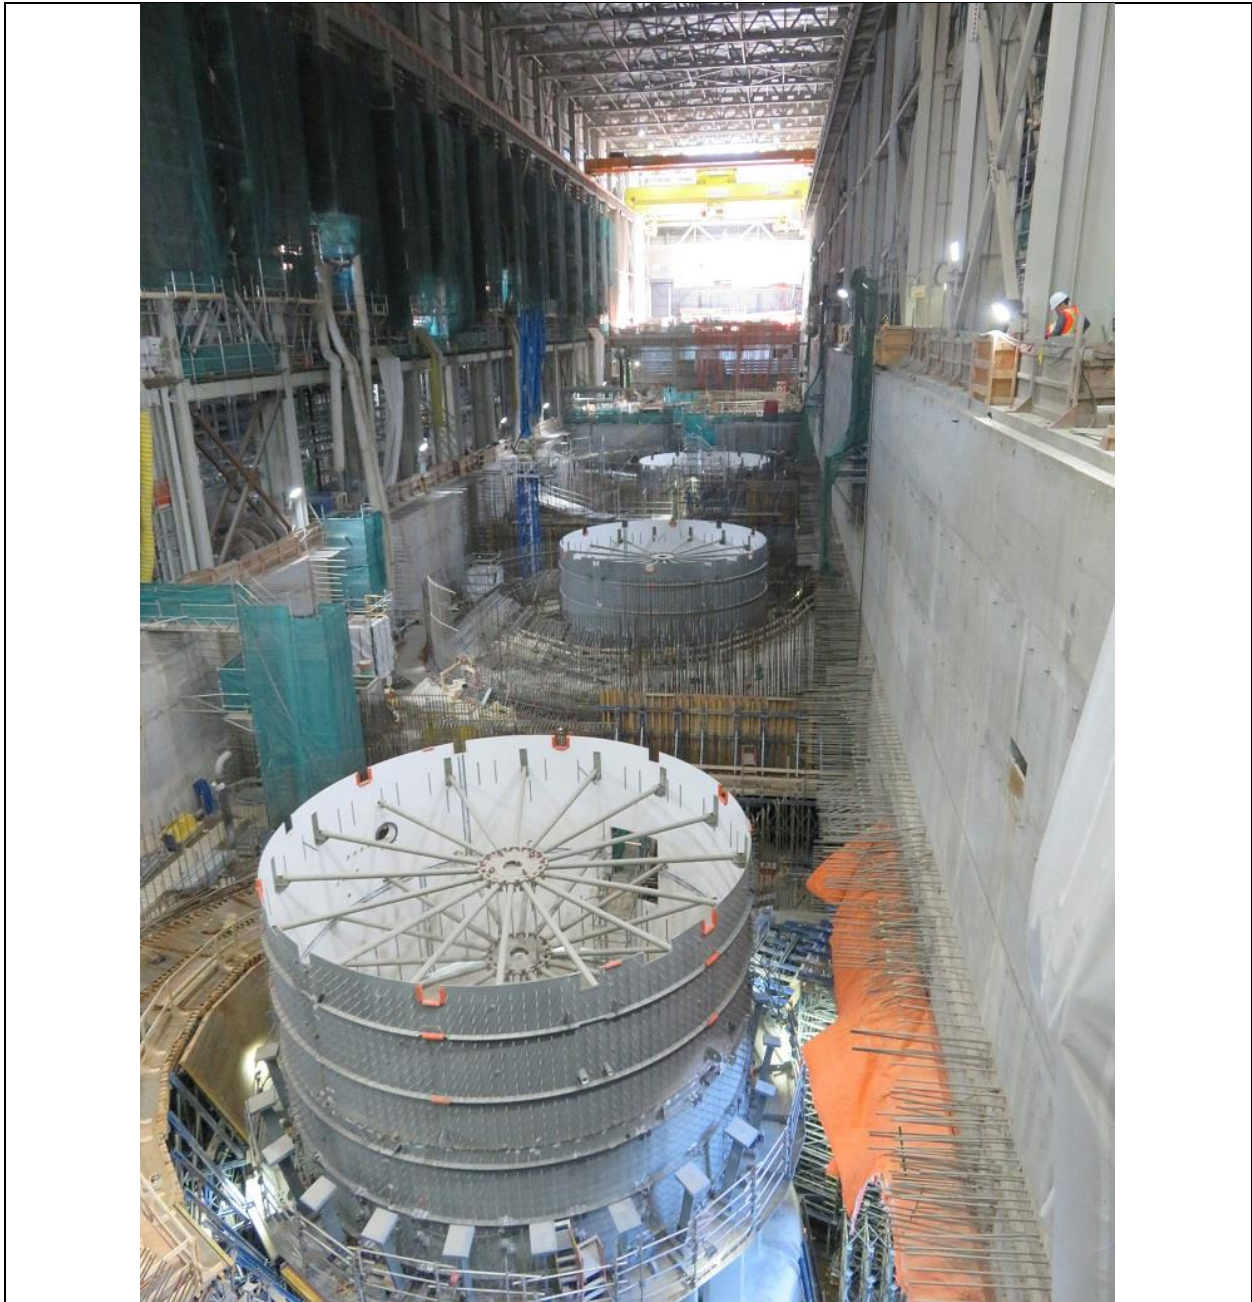
Overall construction of the powerhouse was reported to be about 79% complete at the time of the site visit. Most of the remaining work is related to installation of turbines, generators and balance of plant works. The turbine pit steel liners are in place for all four generating units, with second stage concrete at various stages of completion.

Photo B.3: Interior view of powerhouse from North Service Bay (generator floor level), with Unit 4 in foreground.

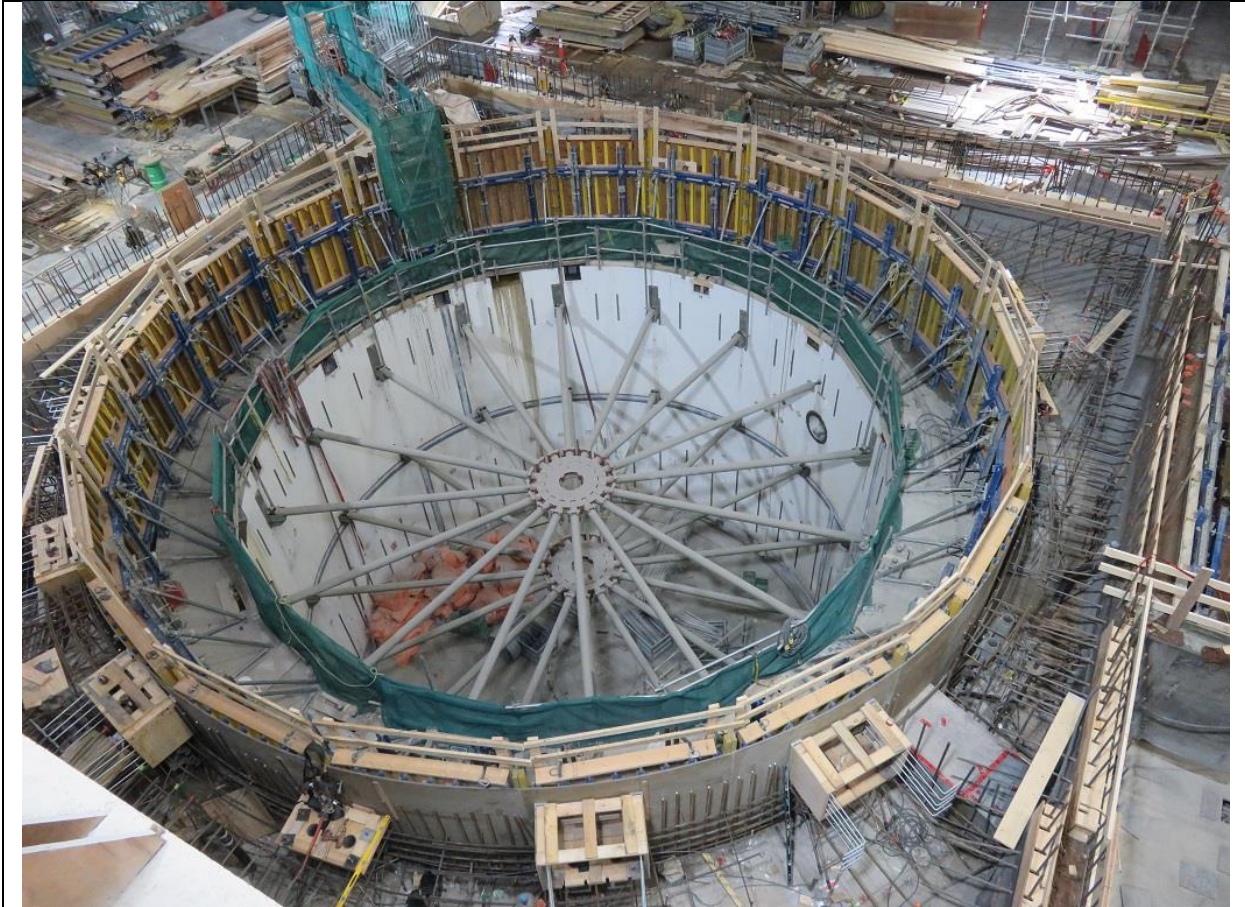
Photo B.4: Second stage concrete around pit liner nearing completion in Unit 1.

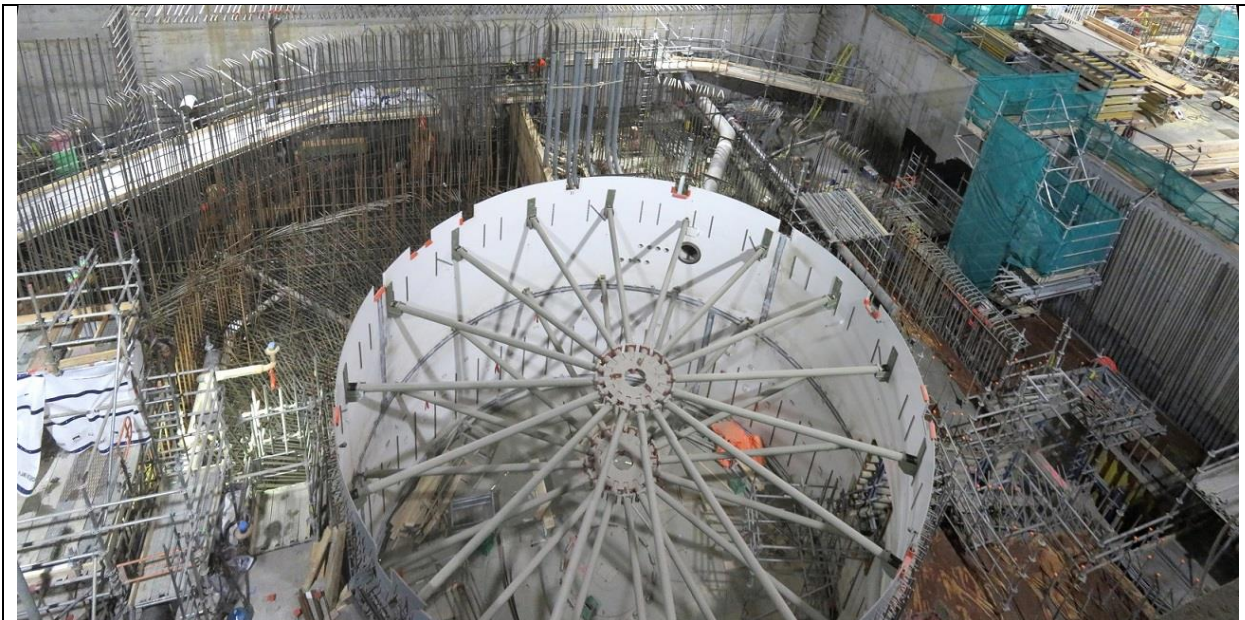
Photo B.5: Installation of reinforcing steel and embedded piping in preparation for second stage concrete around pit liner in Unit 2.

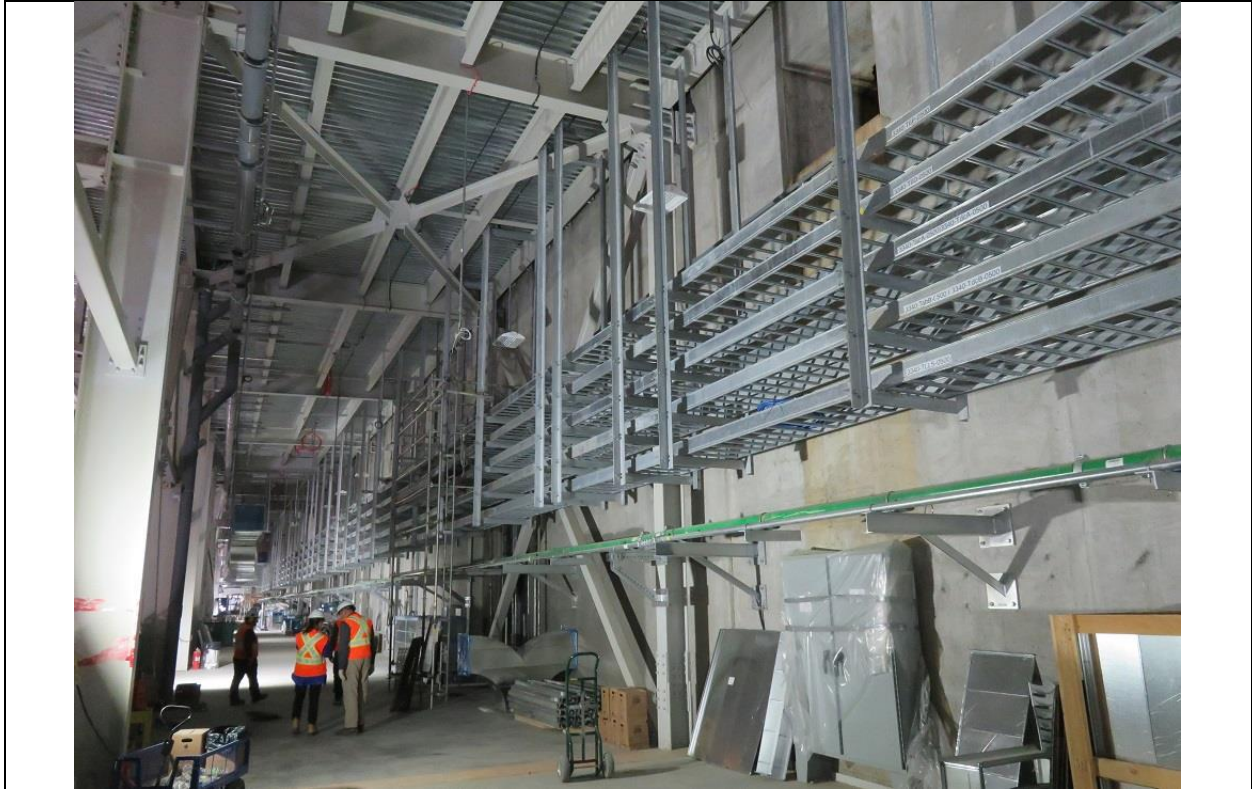
Photo B.6: Mezzanine floor.

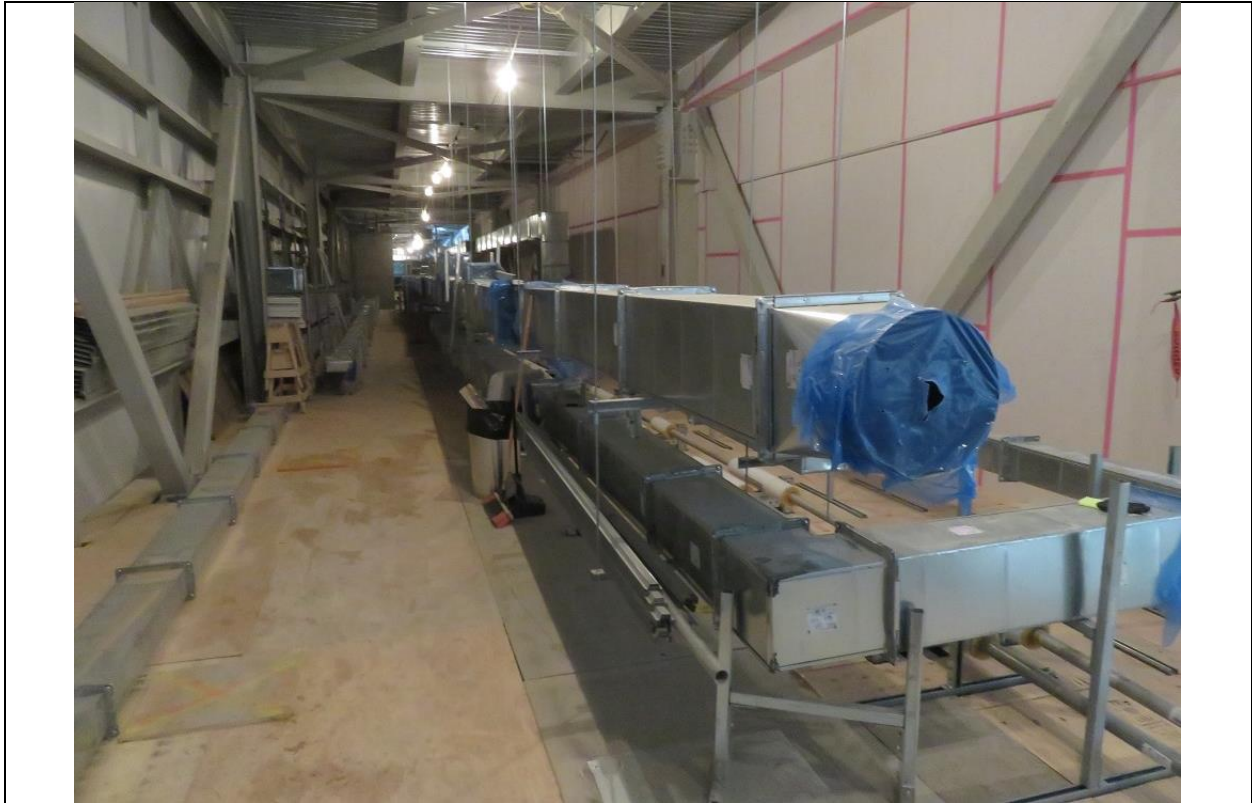
Installation of cable trays and cabling, piping systems and heating ventilation and air conditioning (HVAC) systems were in progress in various areas of the powerhouse. Construction of concrete walls between generator transformer bays on the tailrace deck was in progress.

Photo B.7: Powerhouse HVAC works in progress.

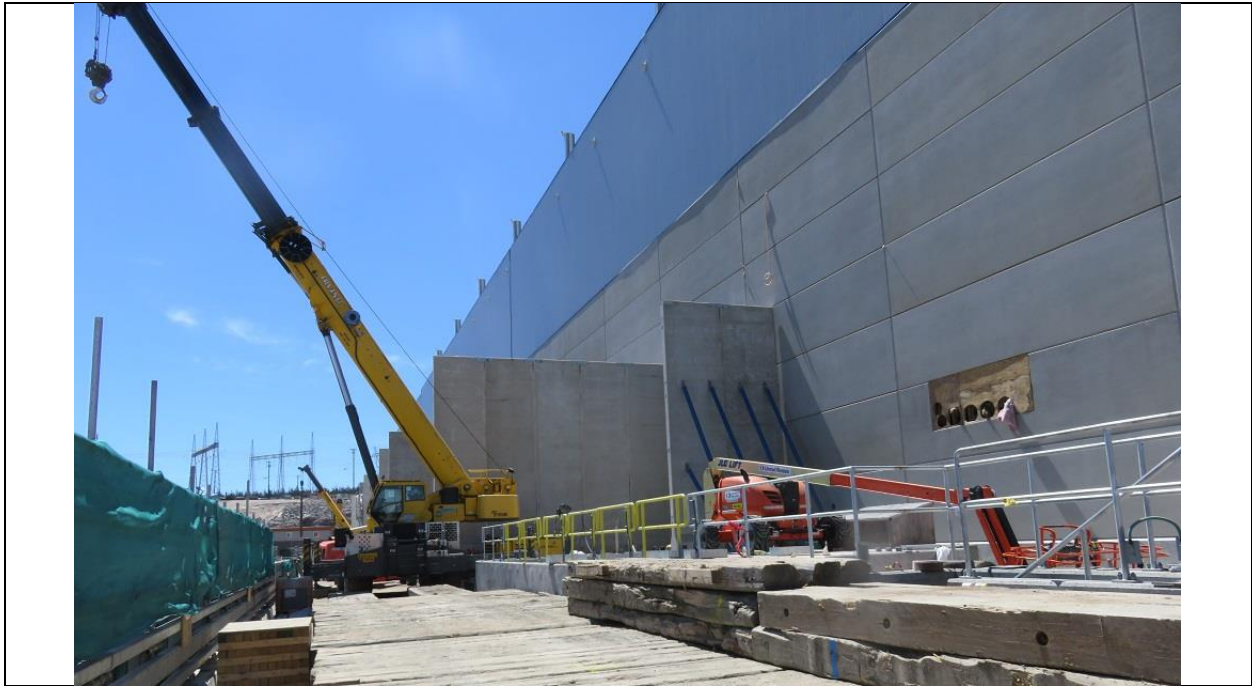
Photo B.9: Transformer bays on tailrace deck.

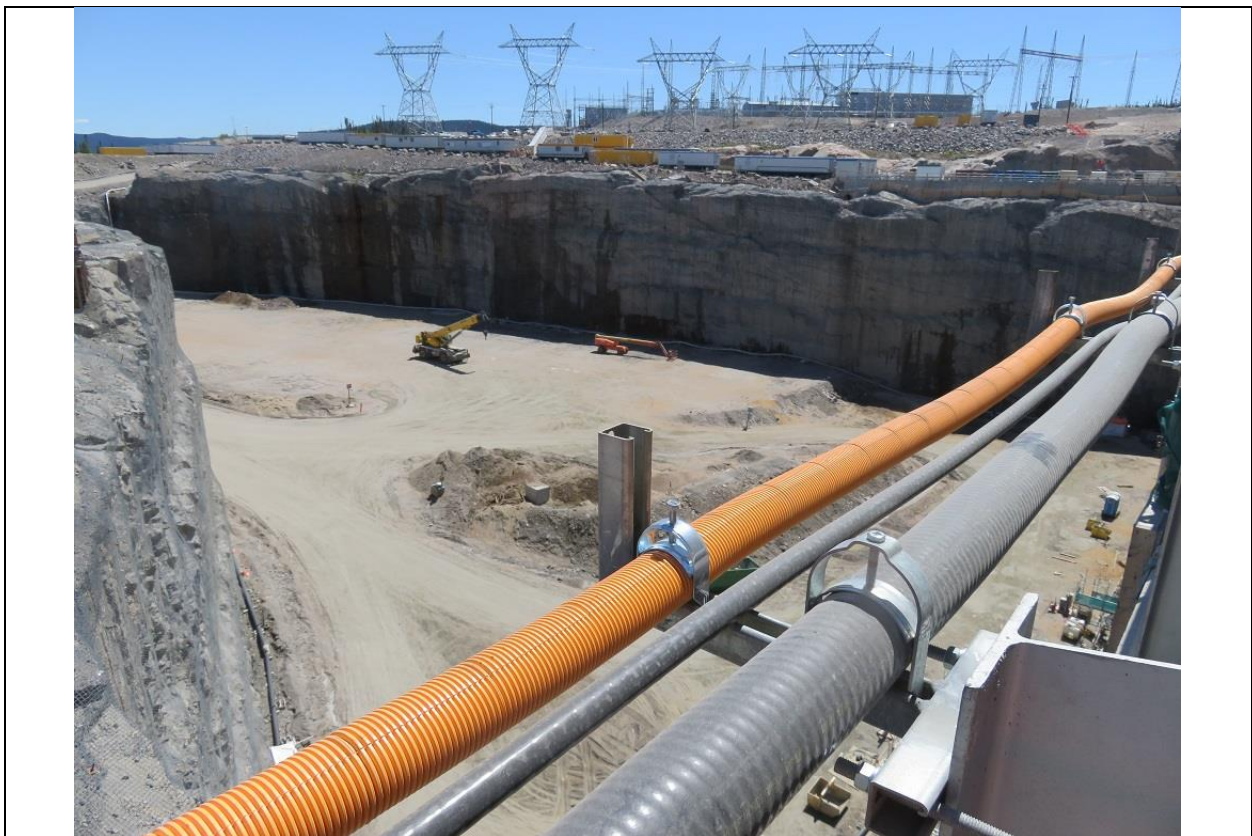
Most temporary construction facilities have been removed from the tailrace channel. Removal of the overburden portion of the tailrace plug has started, the bedrock portion will remain in place until the construction access road across the top of the plug can be decommissioned.

Photo B.10: Tailrace channel.

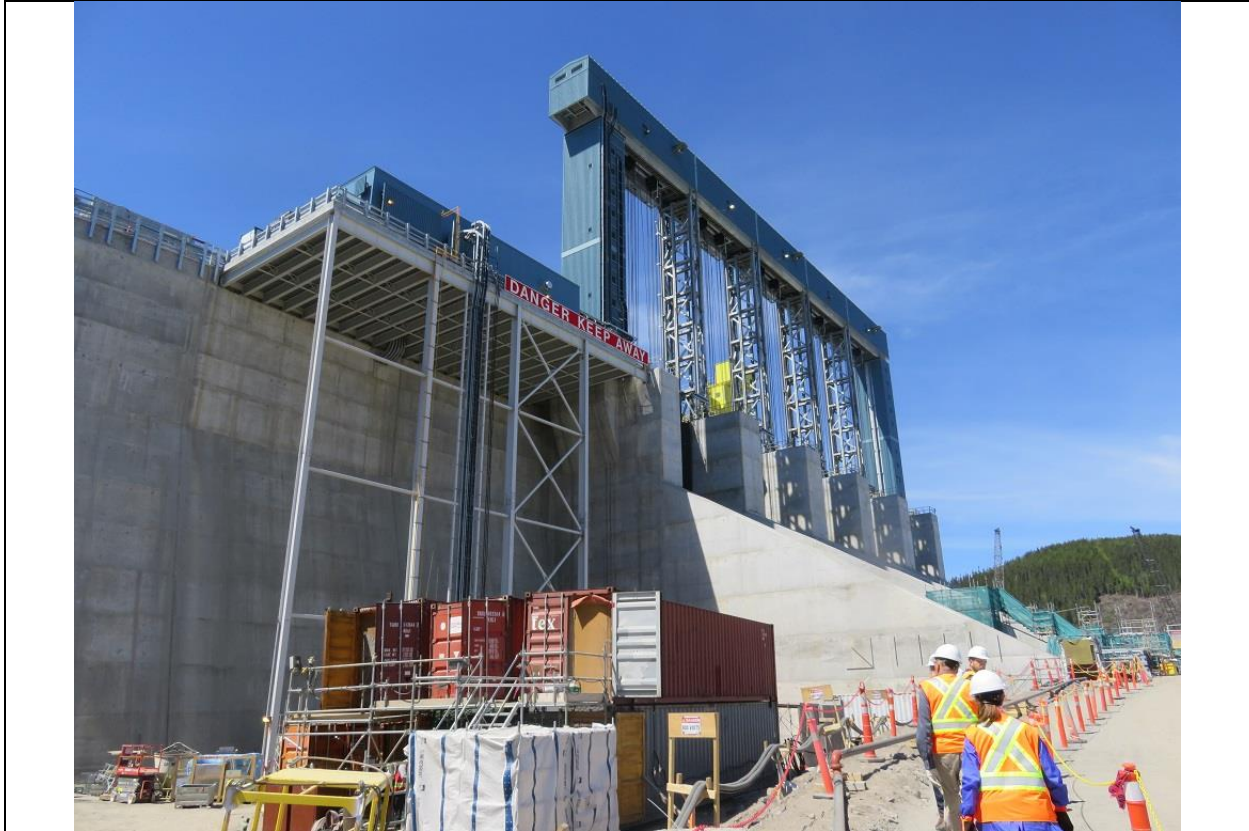
Photo C.1: Spillway with centre transition dam at left.

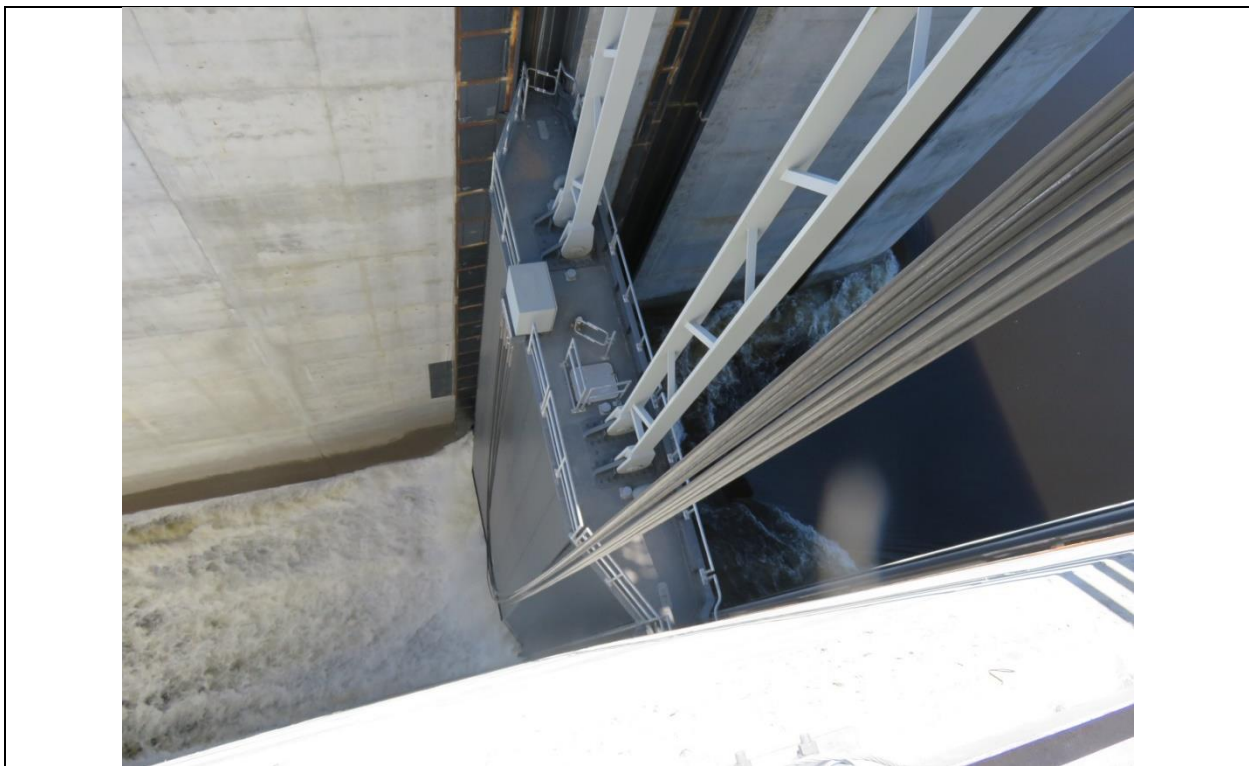
Photo C.2: Looking down at partially-open spillway service gate. Flow is right to left.

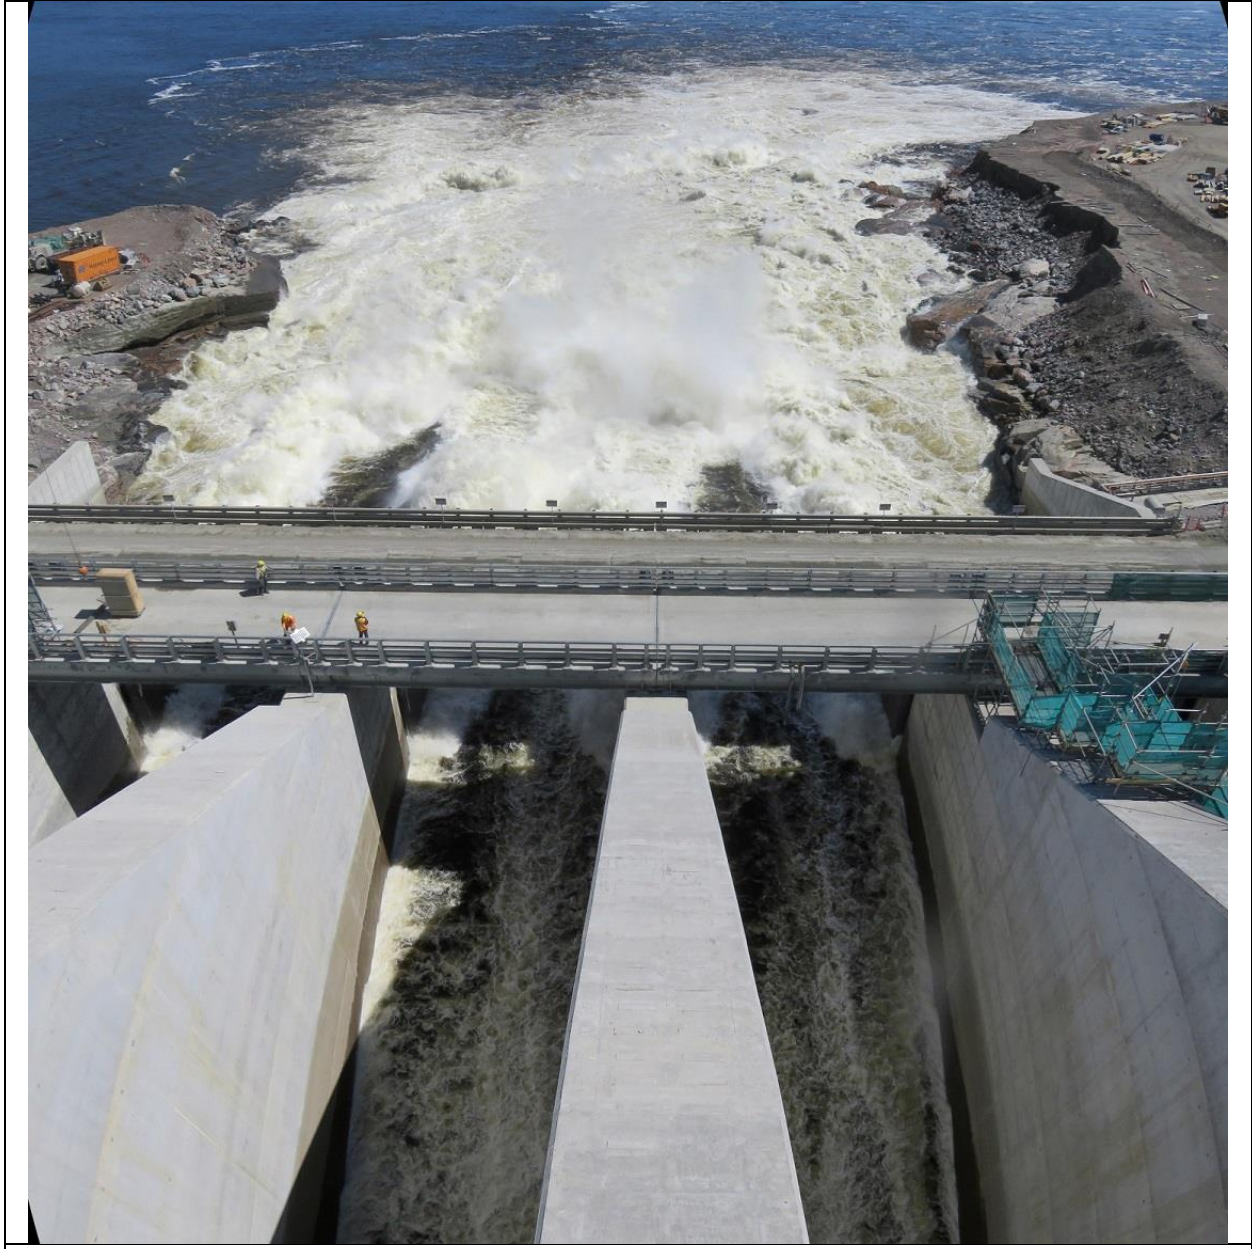
Spillway bays 1 and 5 are closed for construction of concrete rollways and the reservoir is being controlled by the three central gates.

Photo C.3: Spillway outlet channel with central three gates partially open. Bays 1 and 5 are closed for rollway construction.

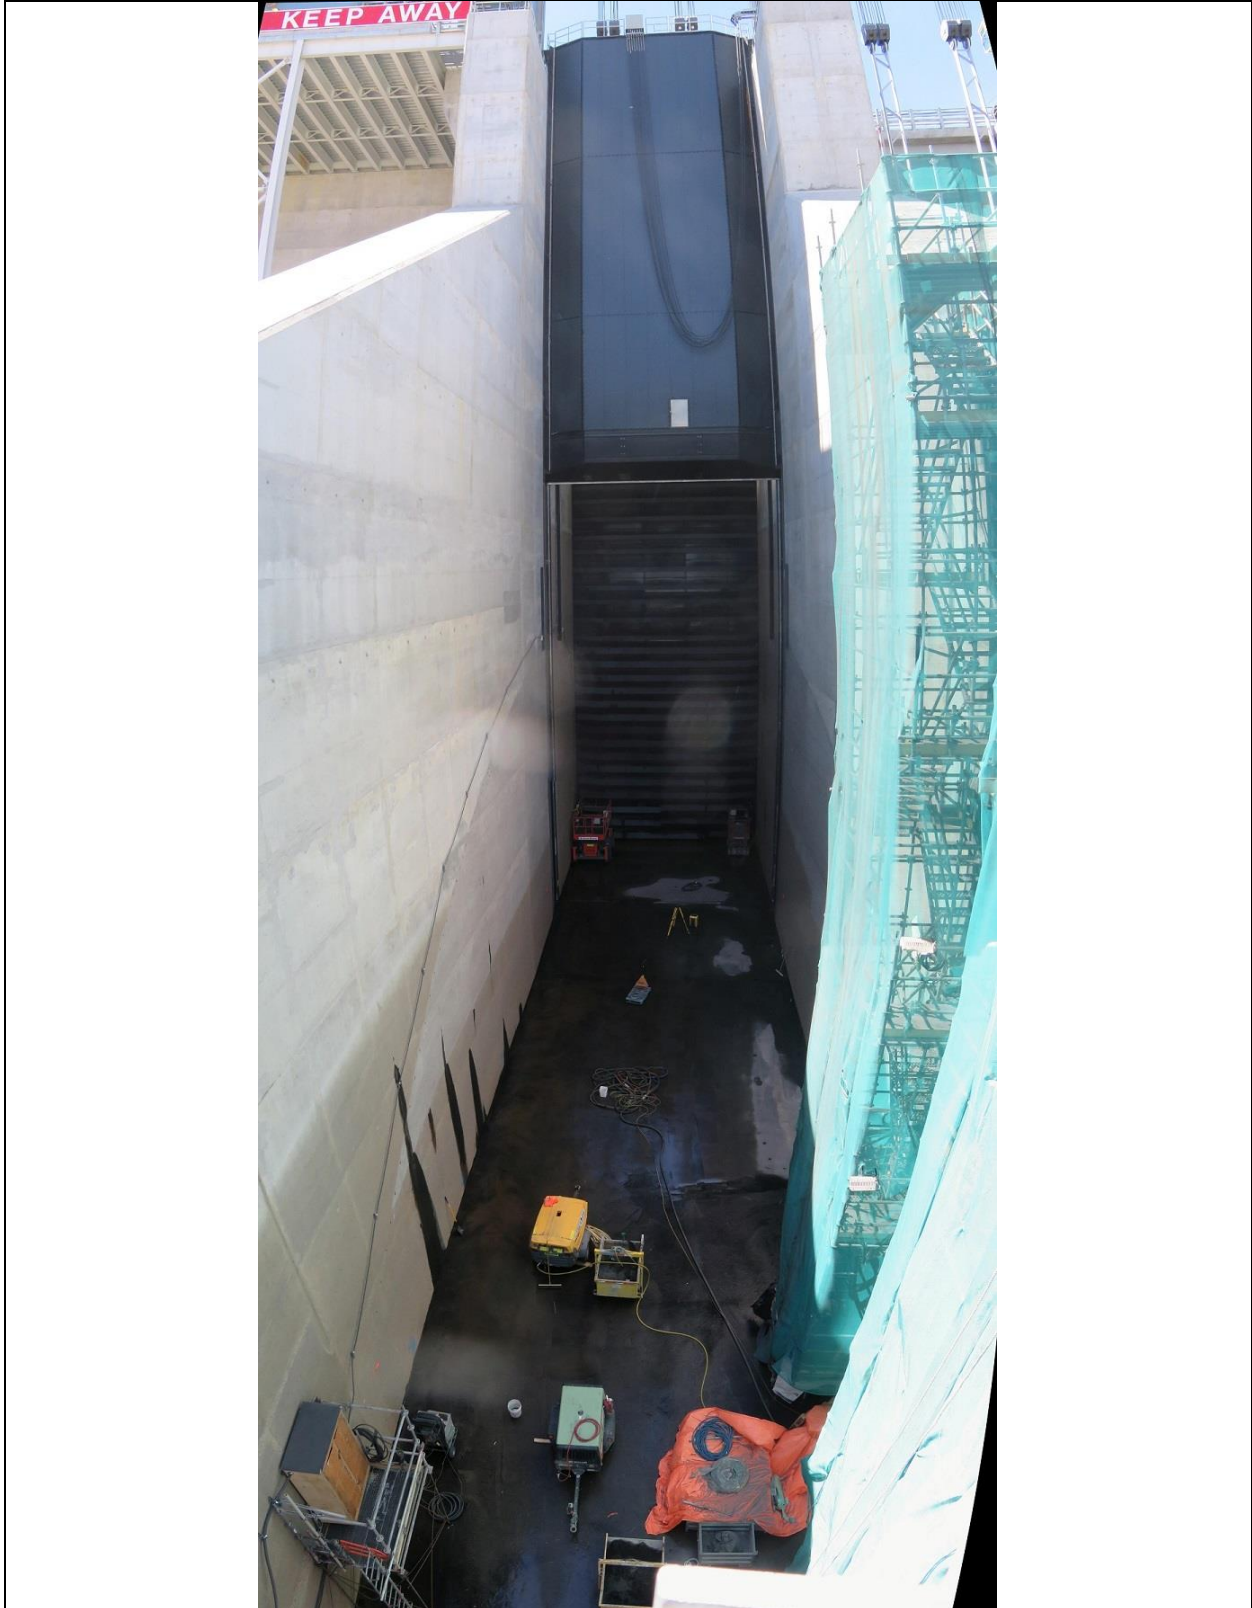
Photo C.4: Looking upstream in spillway bay 1 where rollway construction works are starting. Service gate is in raised position at top of photo with stoplogs (visible below) closing the bay.

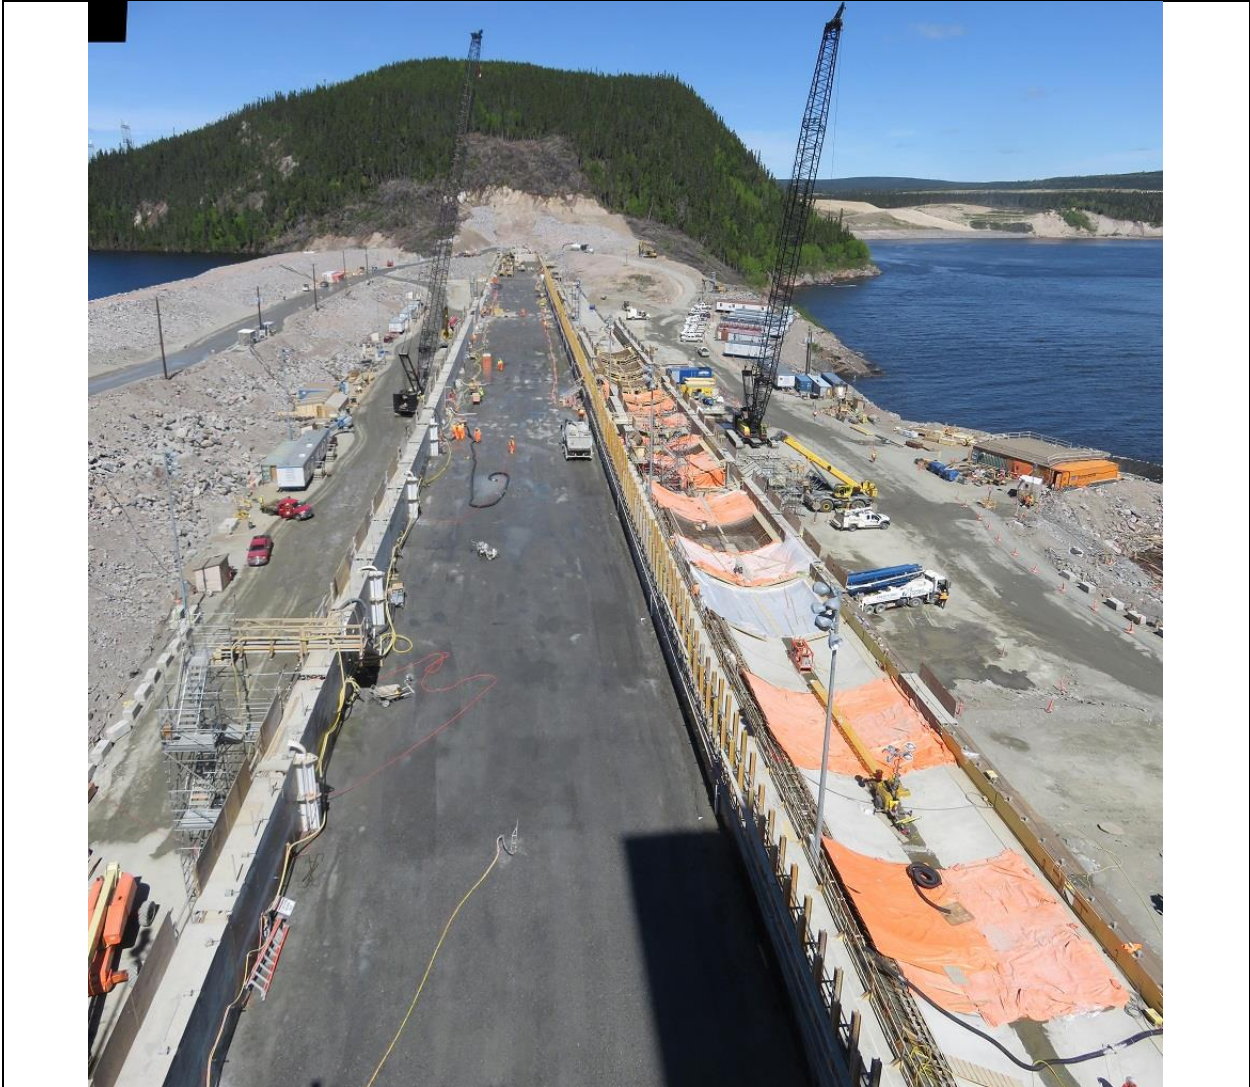
The downstream face is being constructed with steps formed with conventional concrete on the outer surfaces. The flip bucket at the toe of the dam is also being constructed with conventional reinforced concrete.

Photo D.1: View from north transition dam looking northerly along top of RCC dam. Spillway flip bucket, being constructed with conventional cast-in-place concrete, is along right (downstream) side; upstream cofferdam is to left.

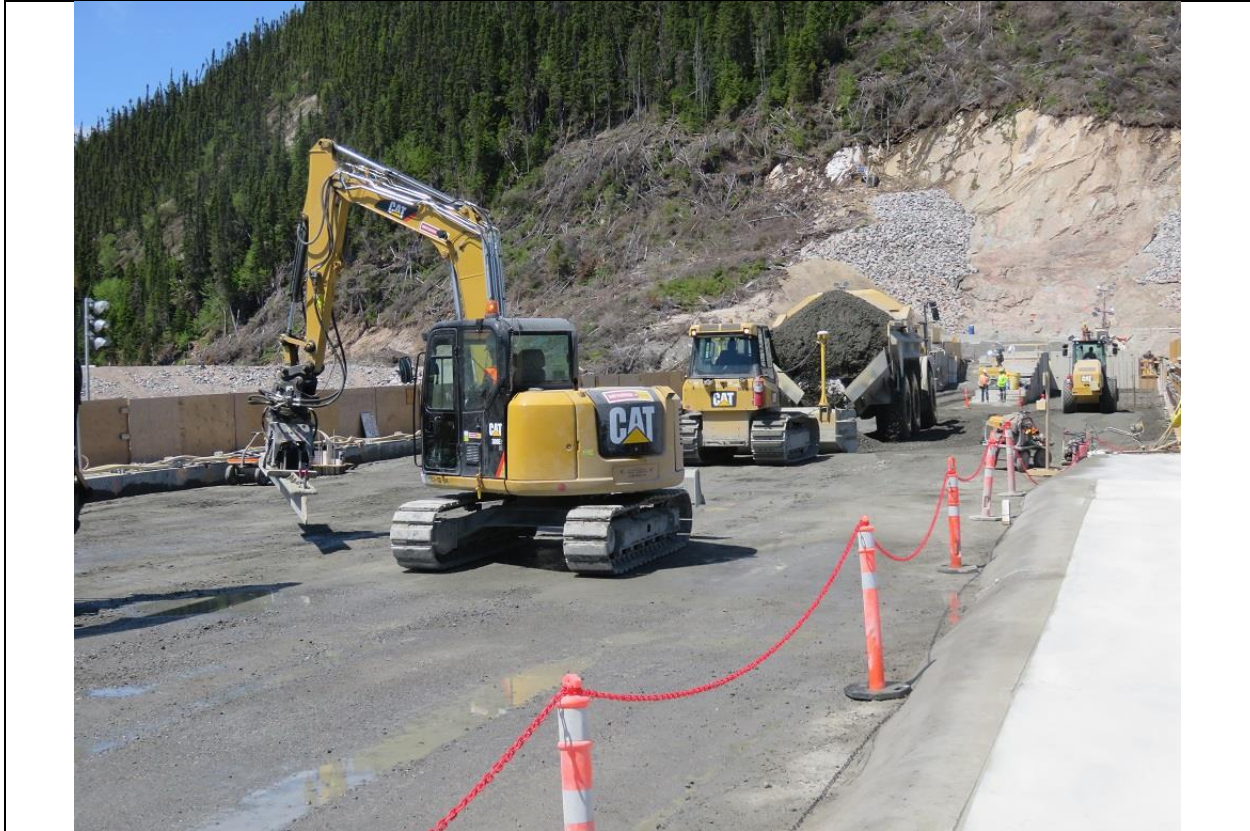
RCC placement continues to be with the slope layer method, with layers currently sloping at 40H:1V. It was reported that placement rates this season had been sufficient to achieve mostly hot joints between RCC lifts.

Photo D.2: RCC placement in progress at north end of RCC dam. Smooth concrete at right is conventional concrete that forms one of the steps on the downstream side of the dam.

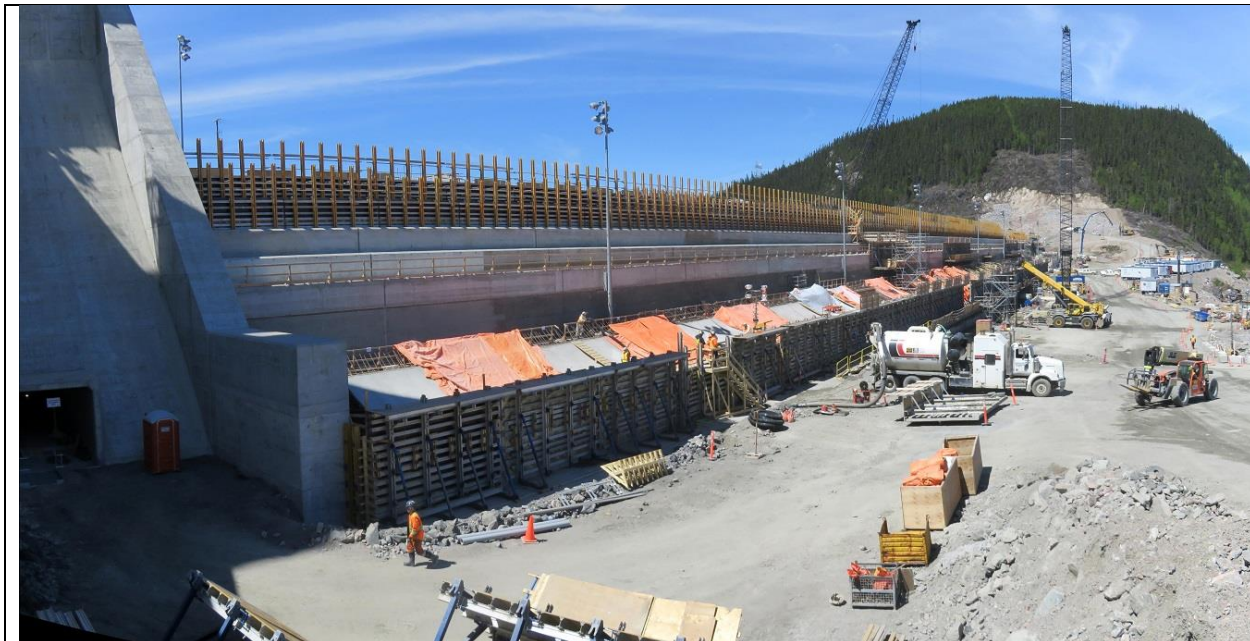
Photo D.3: Downstream side of RCC dam, with north transition dam at left.

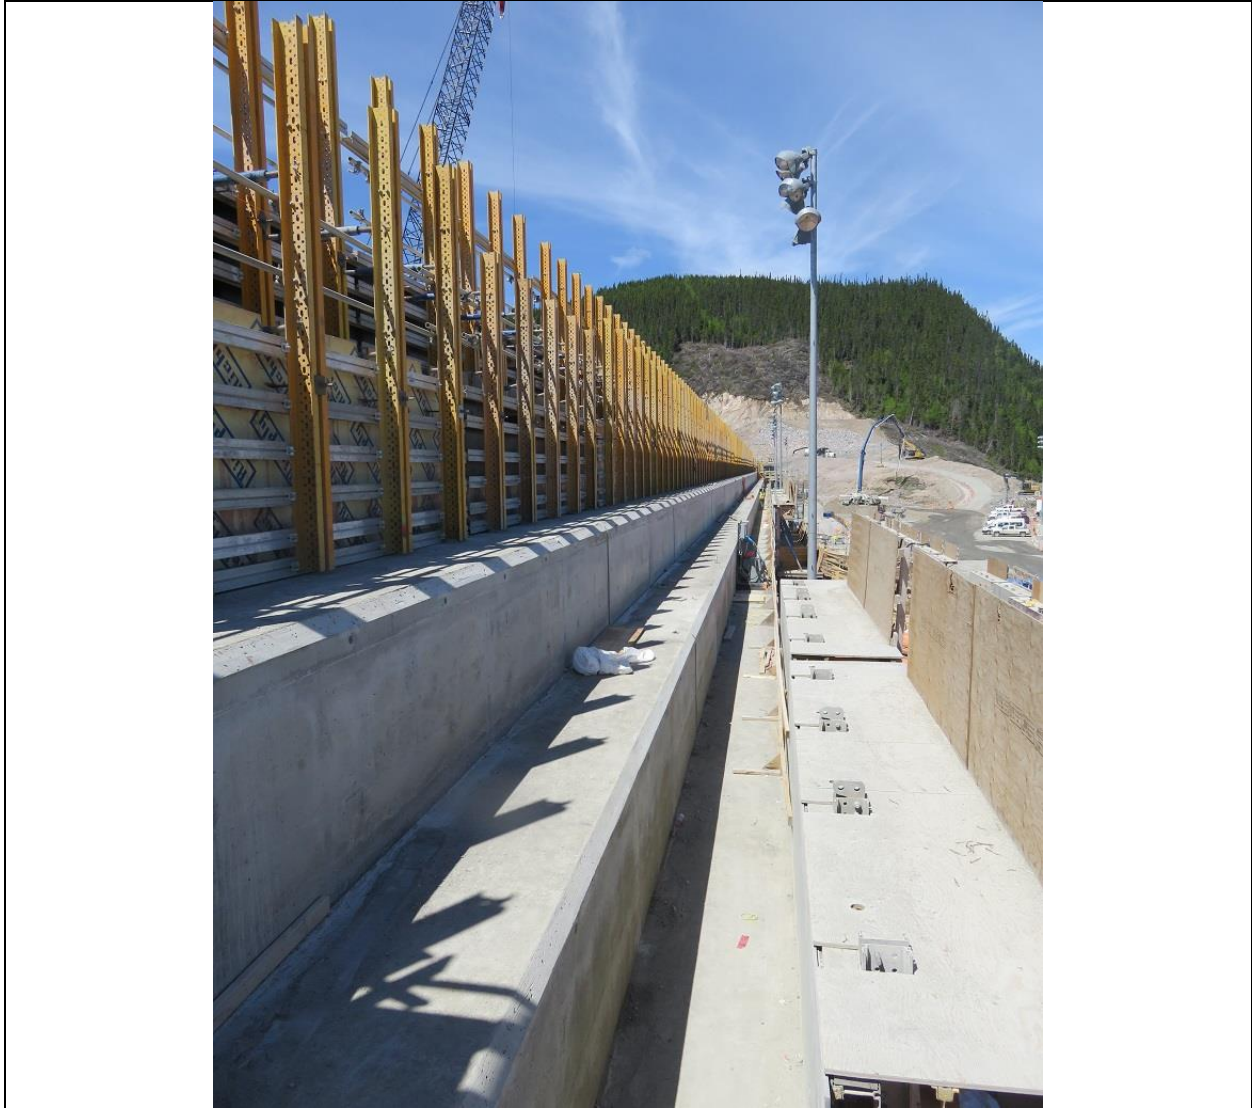
Photo D.4: Stepped downstream side of RCC dam, constructed with RCC and facial conventional concrete.

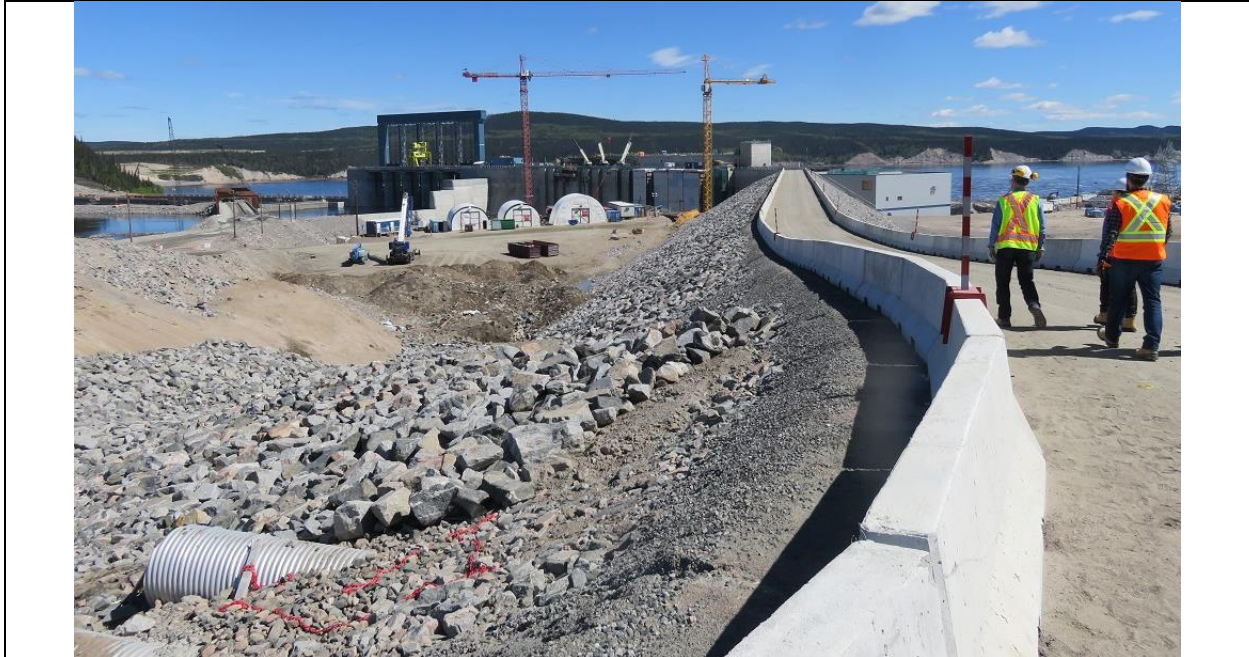
Photo E.1: Upstream side of south embankment dam, with spillway and intakes in background at left.
