MEETINGS IN ST. JOHN'S AND VISITS TO LOWER CHURCHILL PROJECT SITES, JUNE 26 TO 29, 2018

Prepared for: Natural Resources Canada and Nalcor Energy
IE Point of Contact: Nik Argirov
Date: August 14, 2018

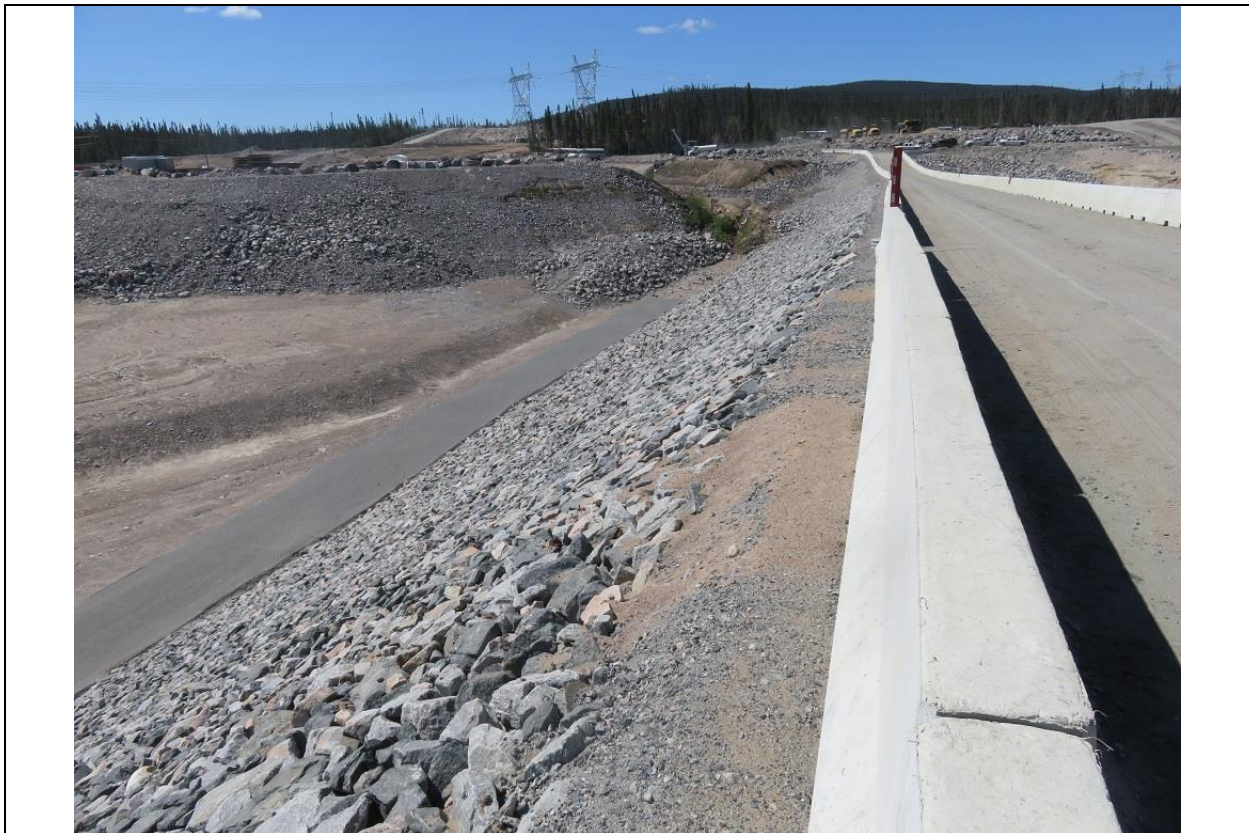
During the site visit, the IE team noted that the outer slopes of the dam were finished with neatly-placed riprap, and a compacted granular road surface with no-post concrete side barriers constructed along the top of the dam.

Photo E.2: Southerly view along downstream side of south embankment showing neatly-finished riprap cover.

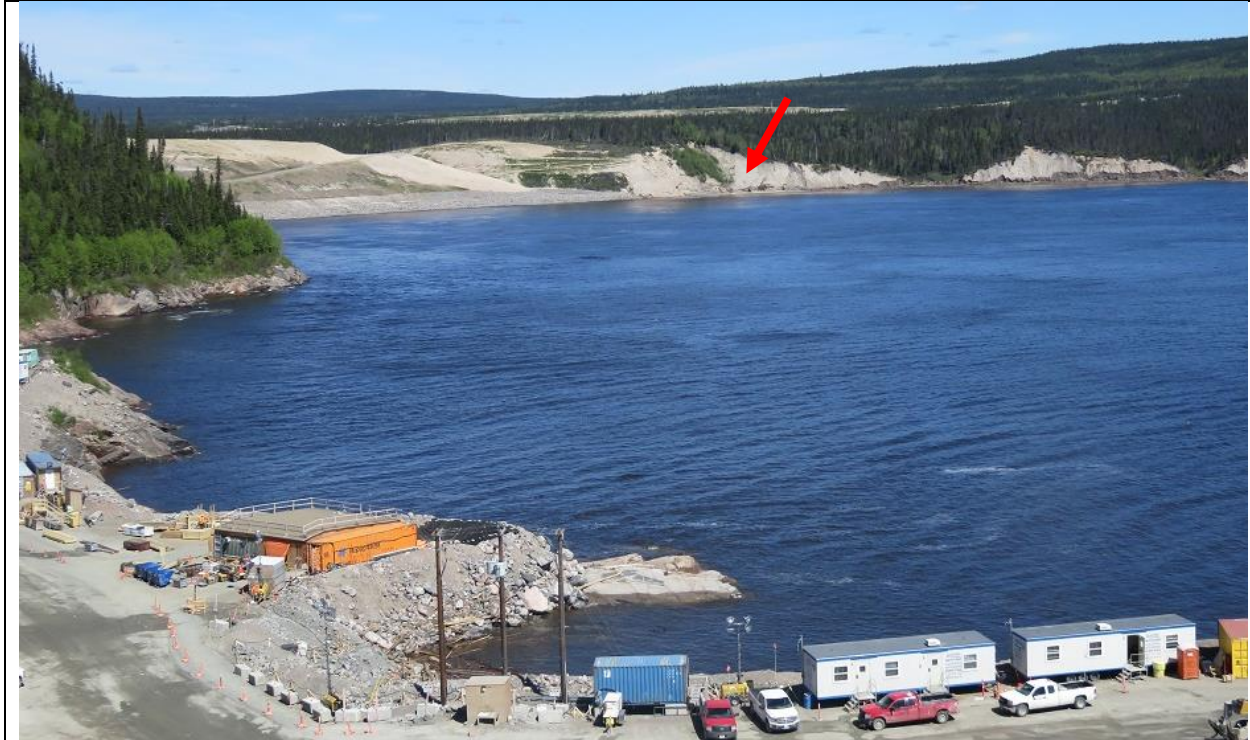
The location of a local surficial slide that occurred downstream of the North Spur in early February was pointed out to the IE team. The slide occurred within the limits of a pre-existing erosional slope above the riverbank. Several kilometers of the north riverbank are visible from the dam site, and much of that slope shows similar natural erosion, including recent erosion along the toe of the slope.

Photo F.1: North river bank downstream of North Spur. Arrow indicates approximate location of local surficial slide reported in early February 2018, within a pre-existing erosional slope. Dark area just above river level to downstream indicates extent of ongoing recent erosion along toe of other similar slopes.

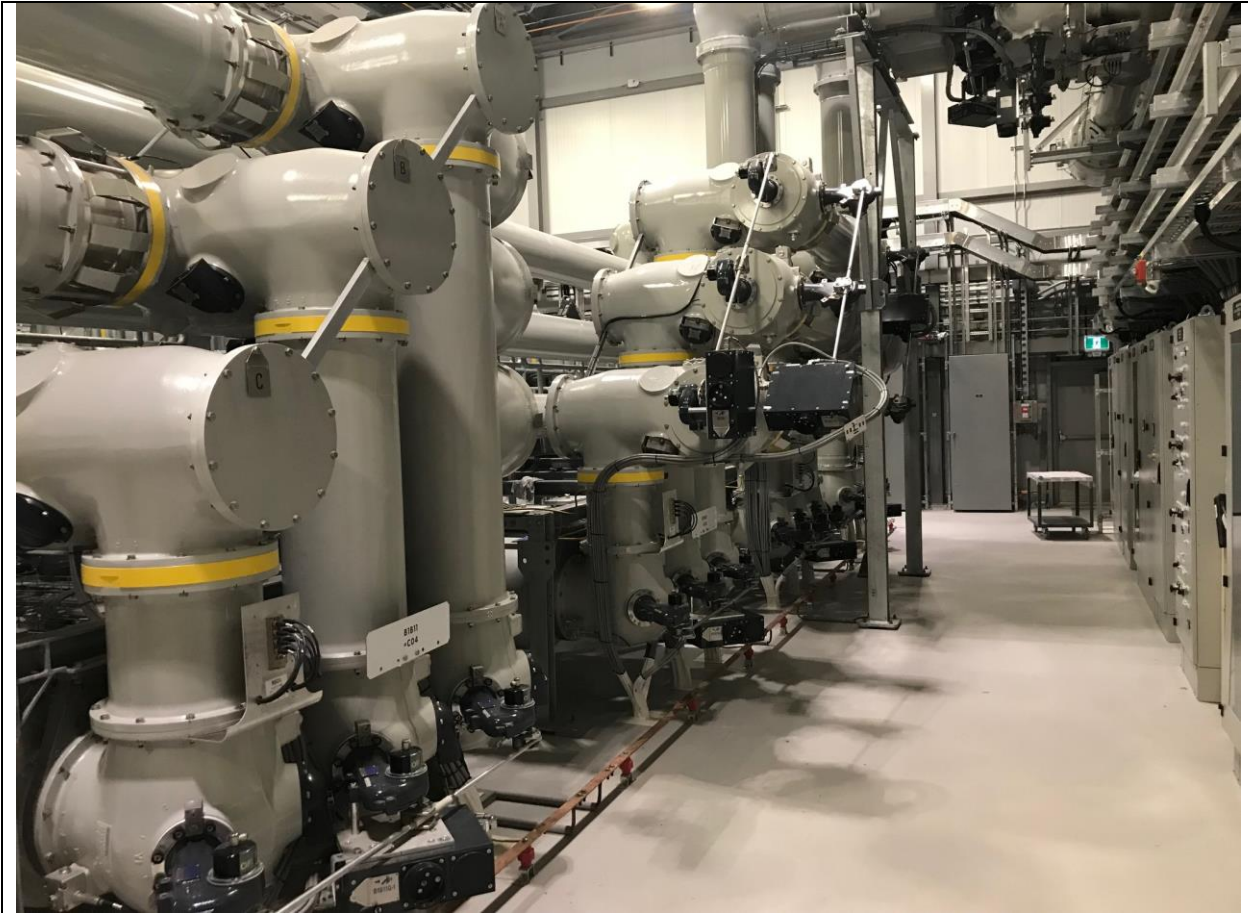
Photo G.1: Muskrat Falls -.GIS equipment energized.

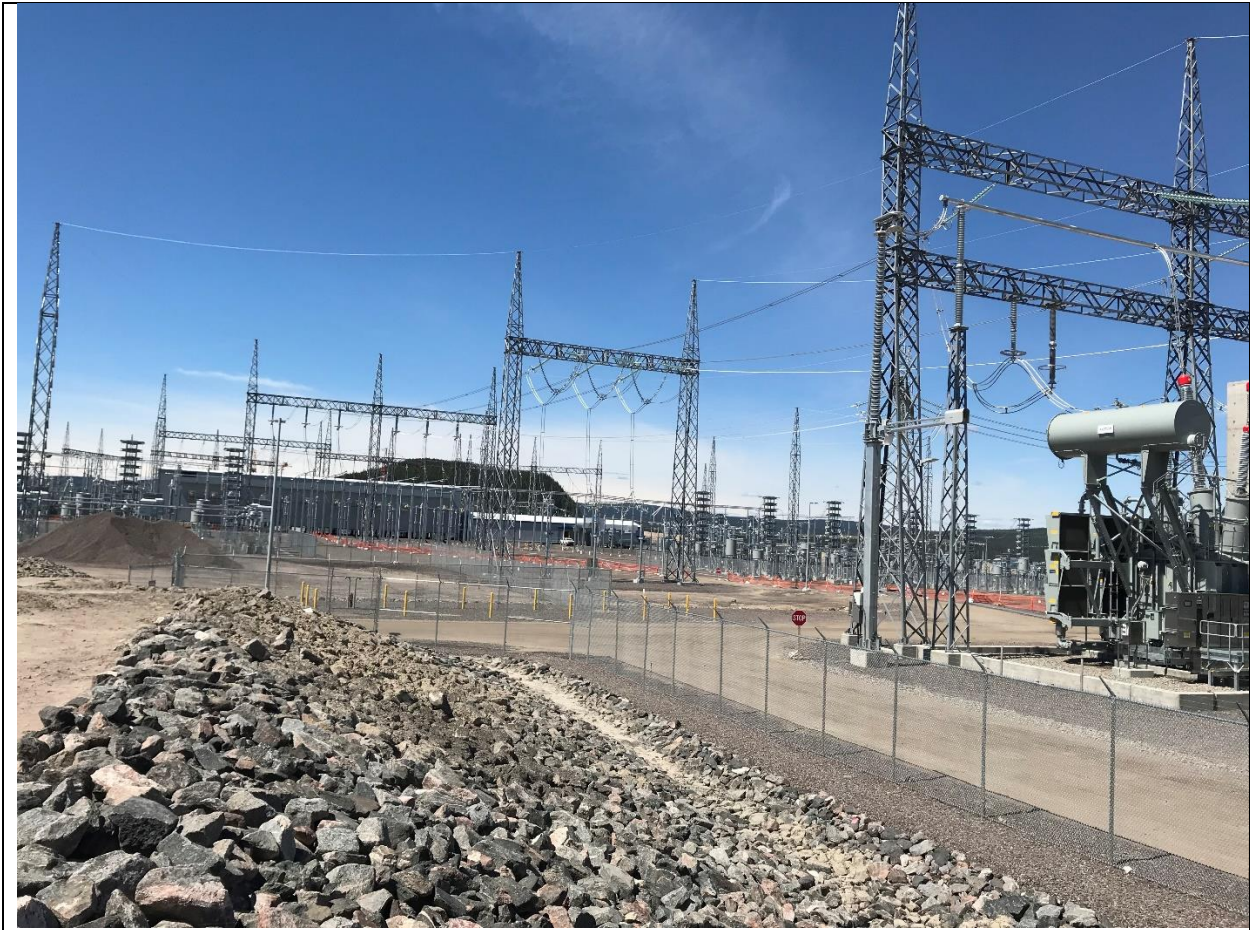
Photo G 2: AC Switchyard with GIC and Control buildings on the background.

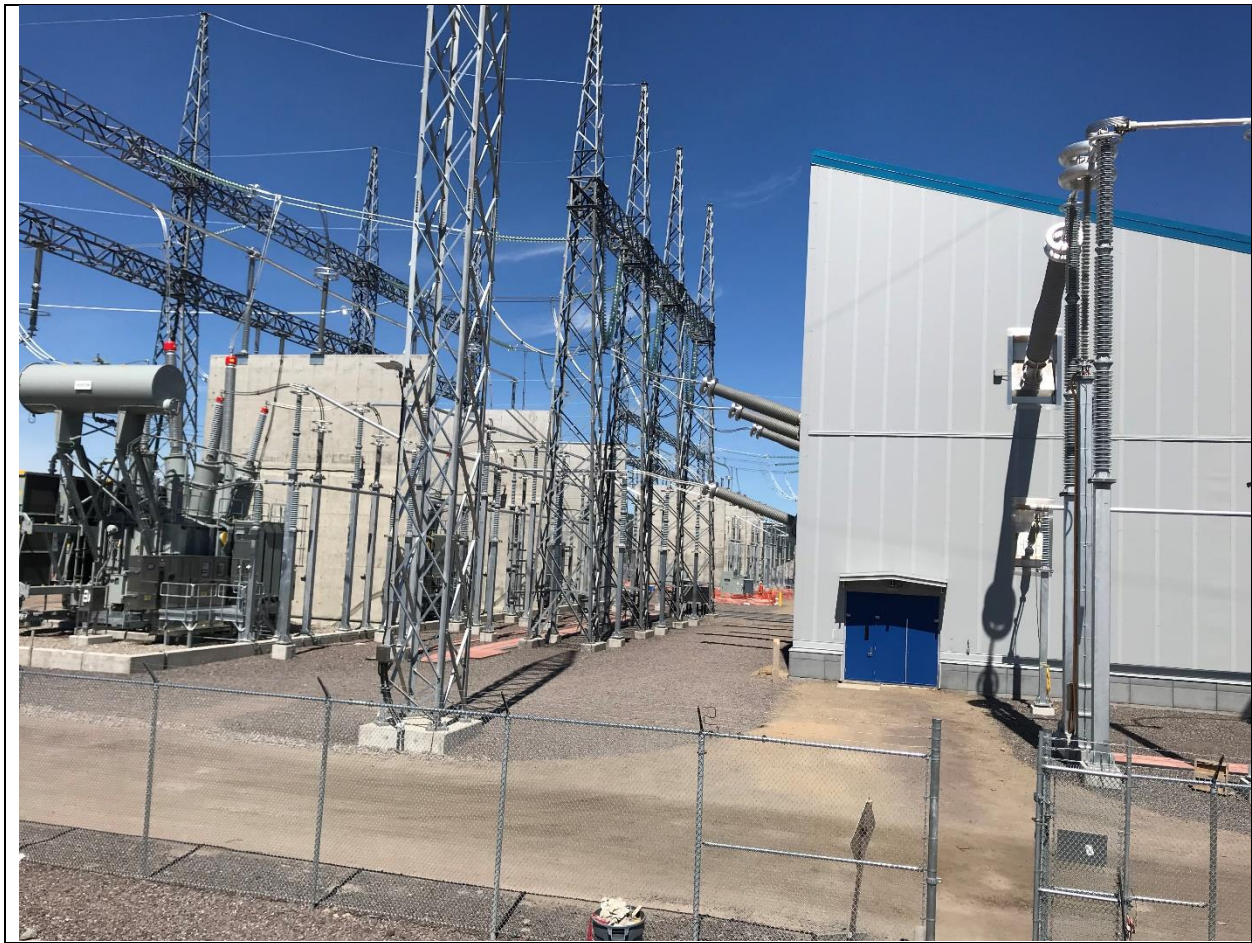
Photo G.3: Converter Station Transformers – fully dressed with Pole 1 (on the opposite side) energized.

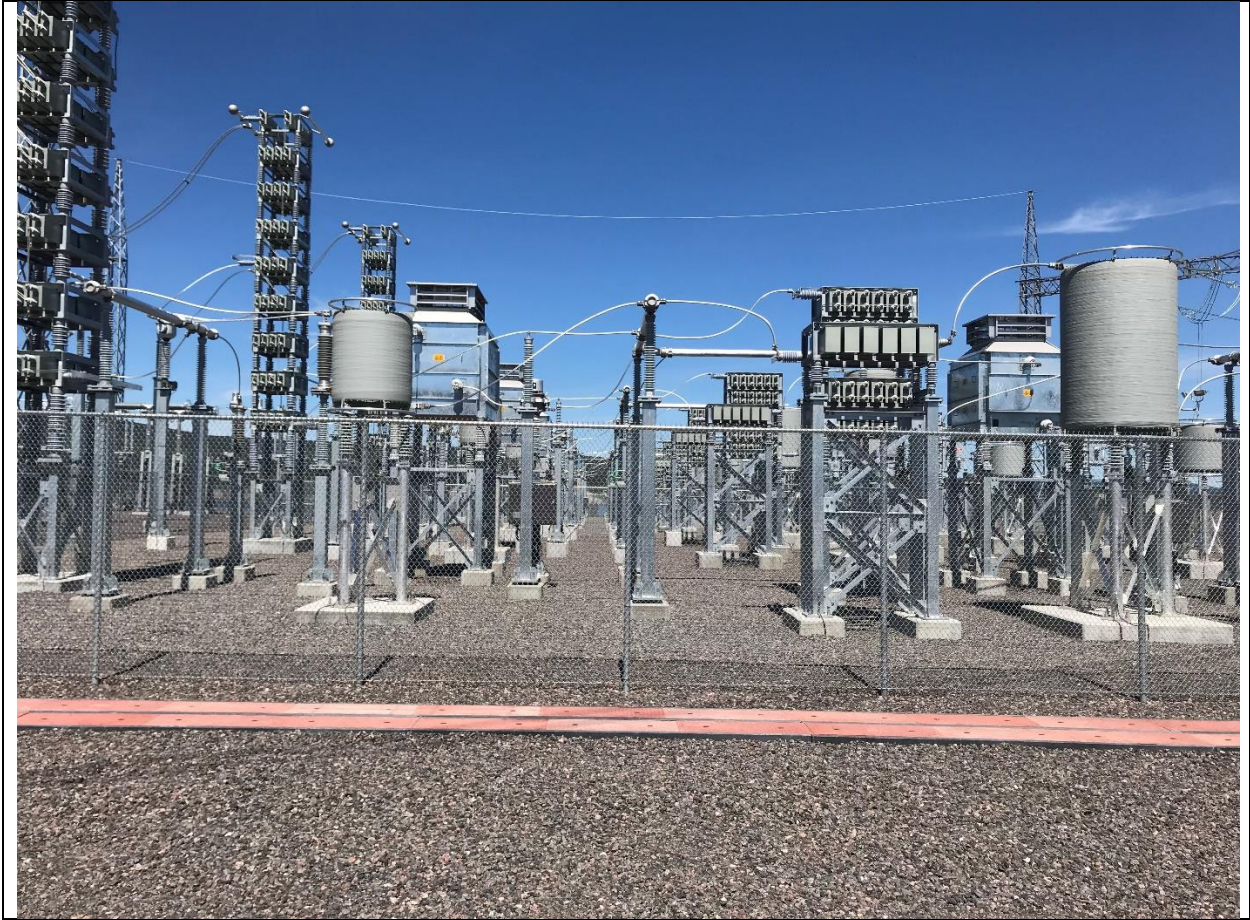
Photo G.4: Converter Station AC filters yard.

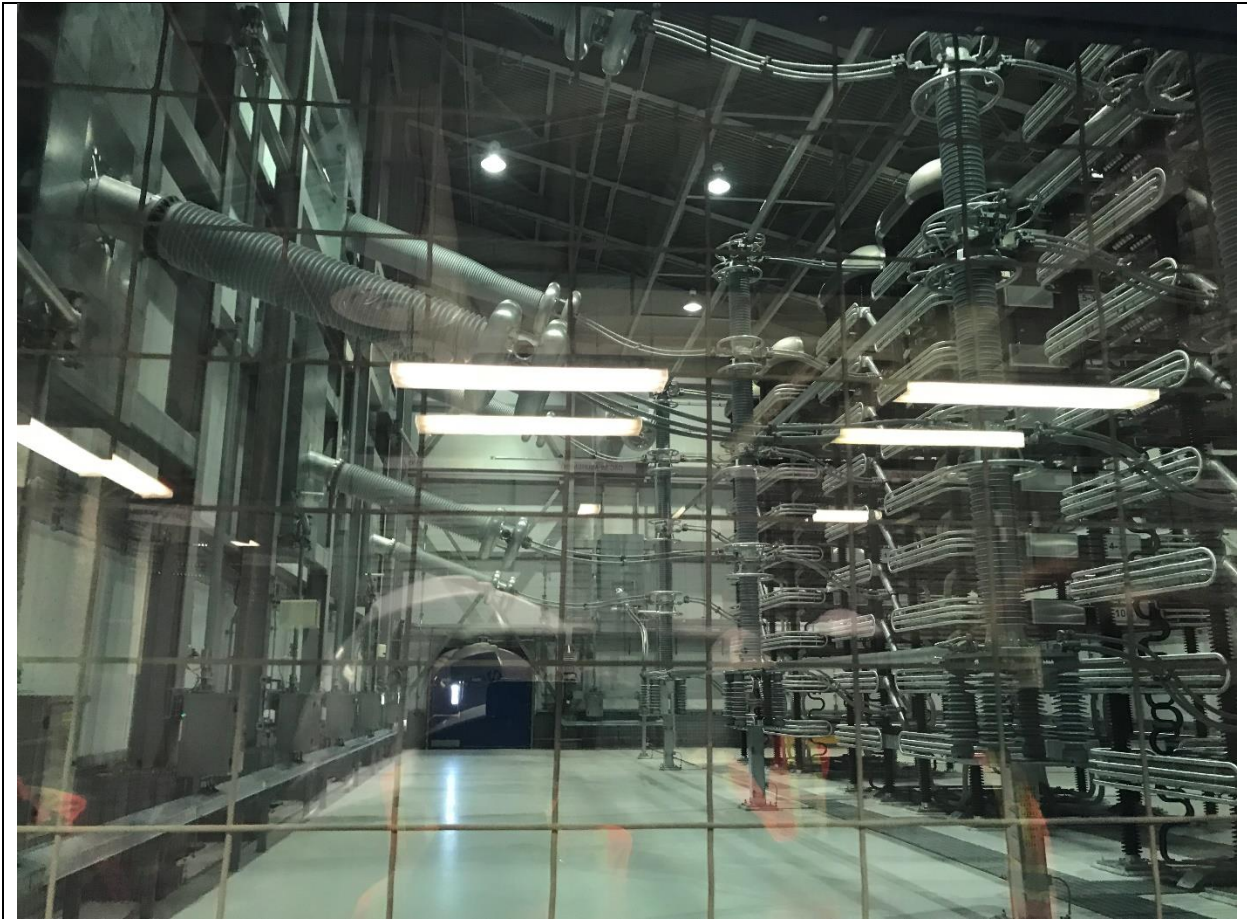
Photo G.5: Muskrat Falls – Converter Valve 1 energized.

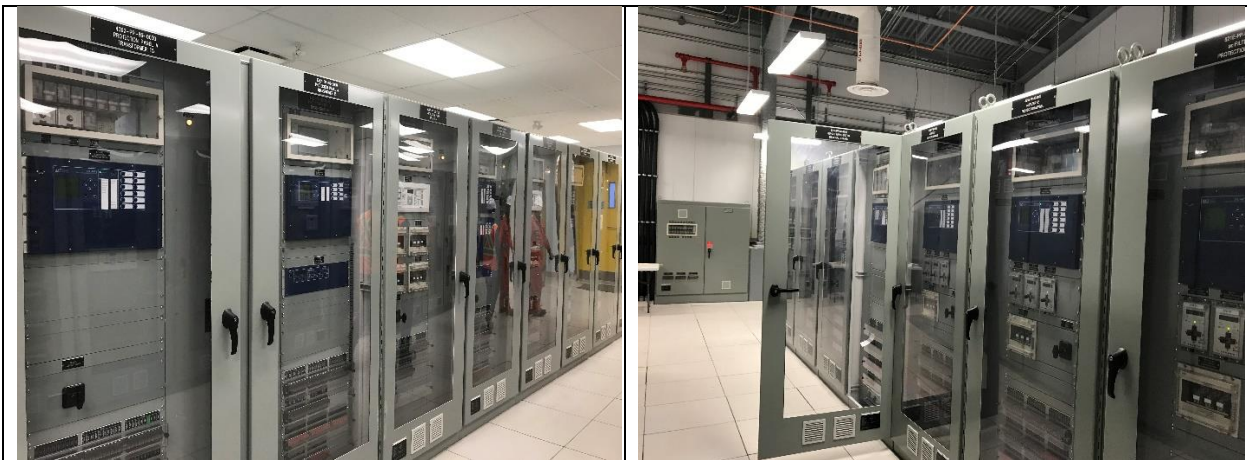
Photo G.6: Muskrat Falls Converter Station - protection panels

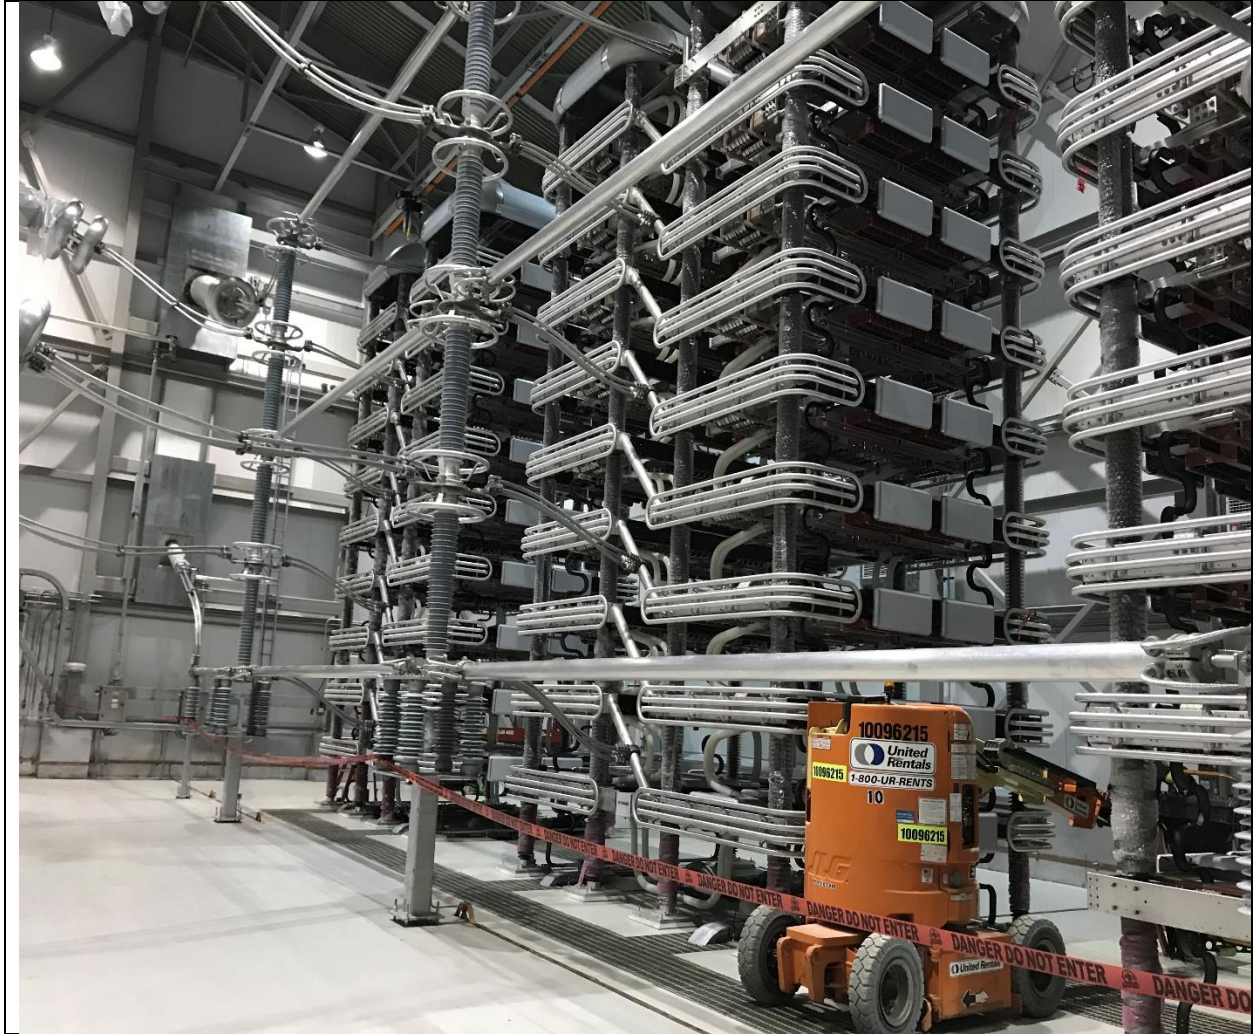
Photo H.1: Converter Station - Valve hall 2.

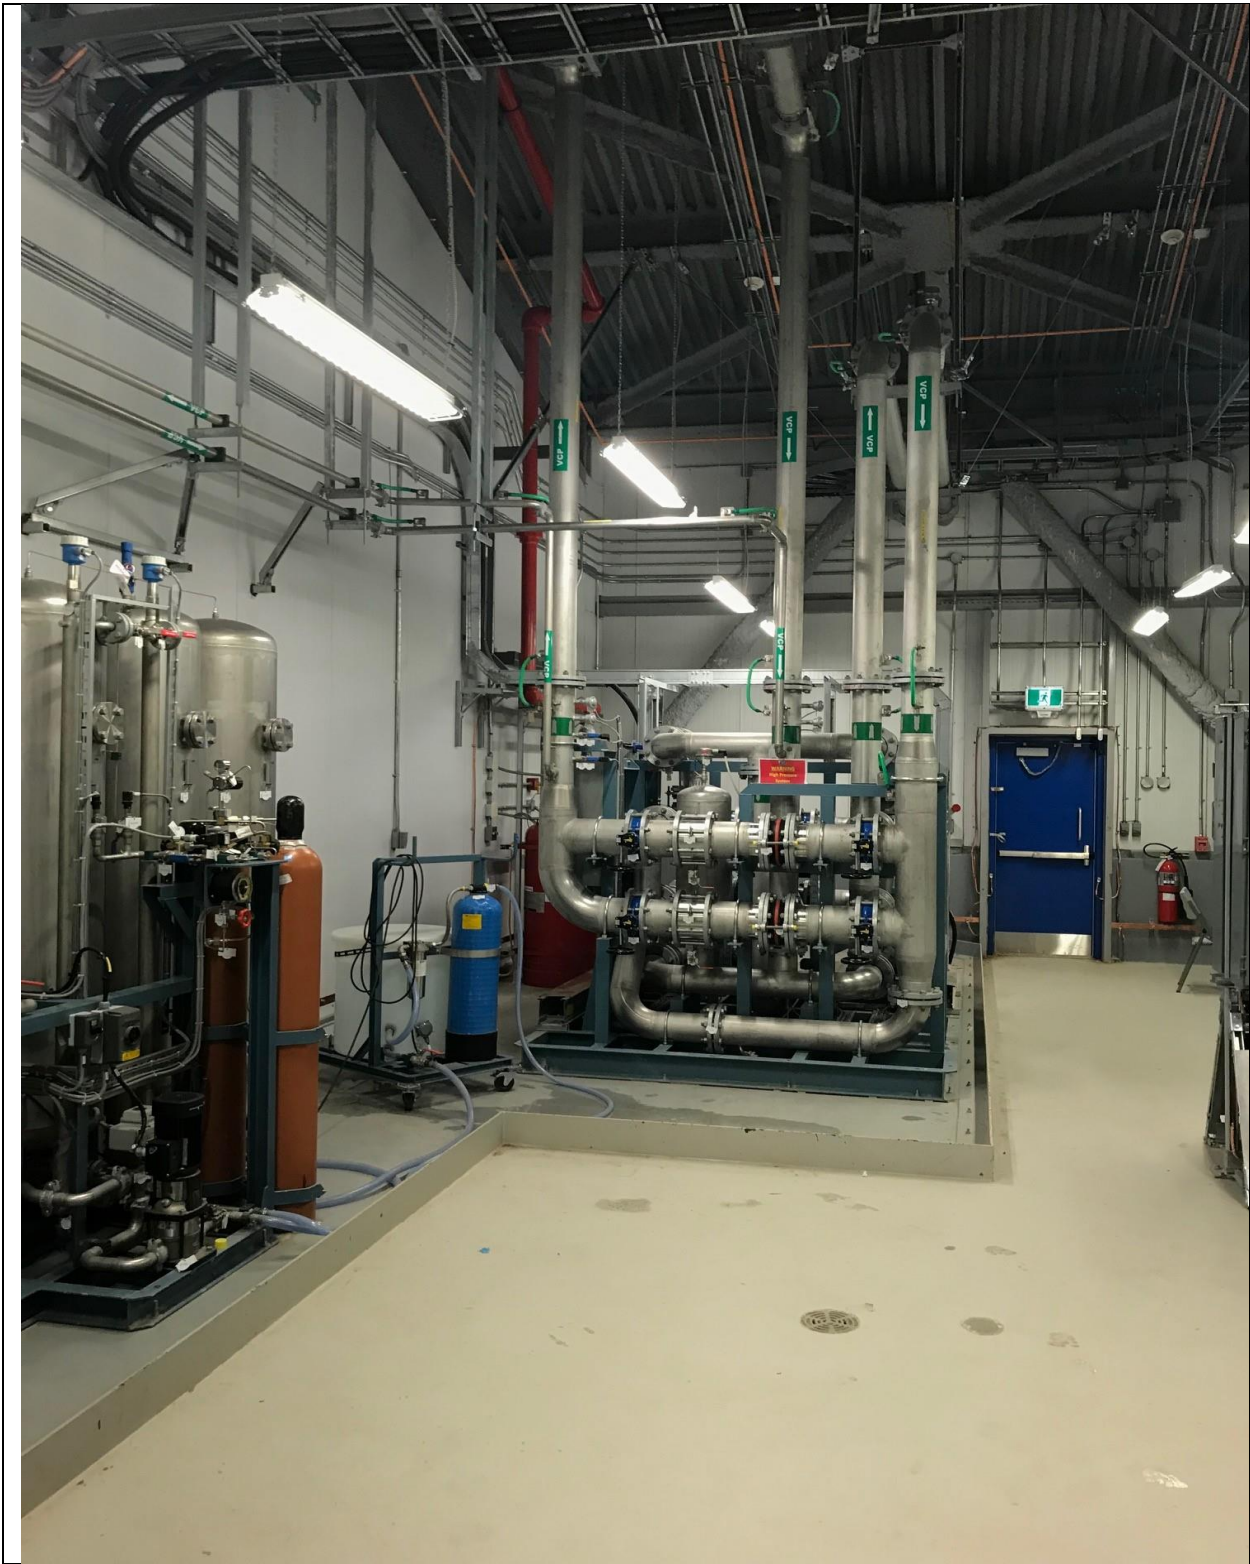
Photo H.2: Converter Station - Valve cooling system.

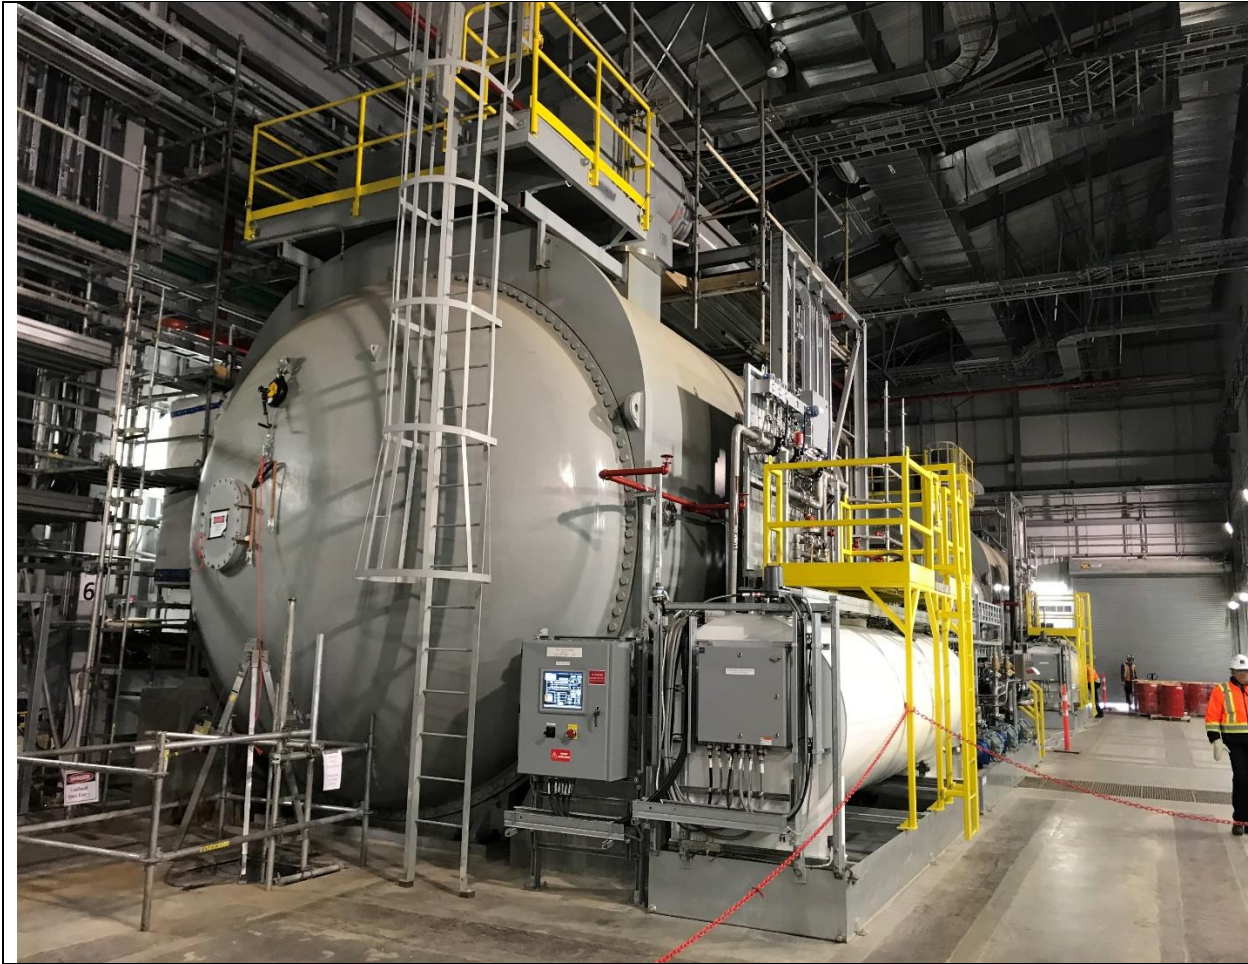
With the load limited to 45MW, SOP synchronous condensers (SC's) are not required and have not yet been commissioned into service. During this interim period the required reactive power is supplied from the grid and by one A-Type filter at MFA and one B-Type filter at SOP.

Photo H.3: Synchronous Condensers.

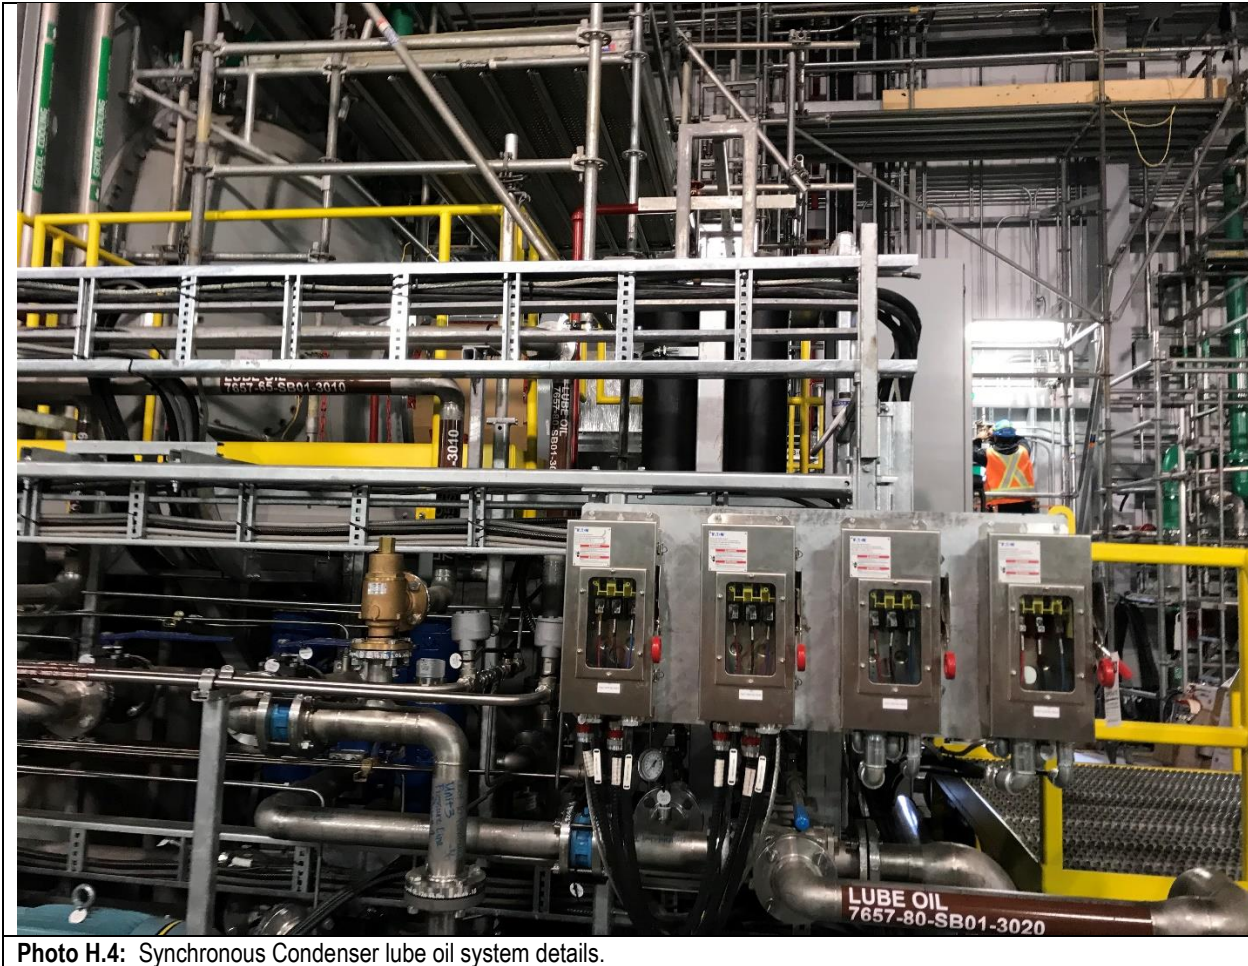
Photo H.4: Synchronous Condenser lube oil system details.
