MEETINGS IN ST. JOHN'S AND VISITS TO LOWER CHURCHILL PROJECT SITES, NOVEMBER 27 TO DECEMBER 01, 2017

Prepared for: Natural Resources Canada and Nalcor Energy
IE Point of Contact: Nik Argirov
Date: January 22, 2018

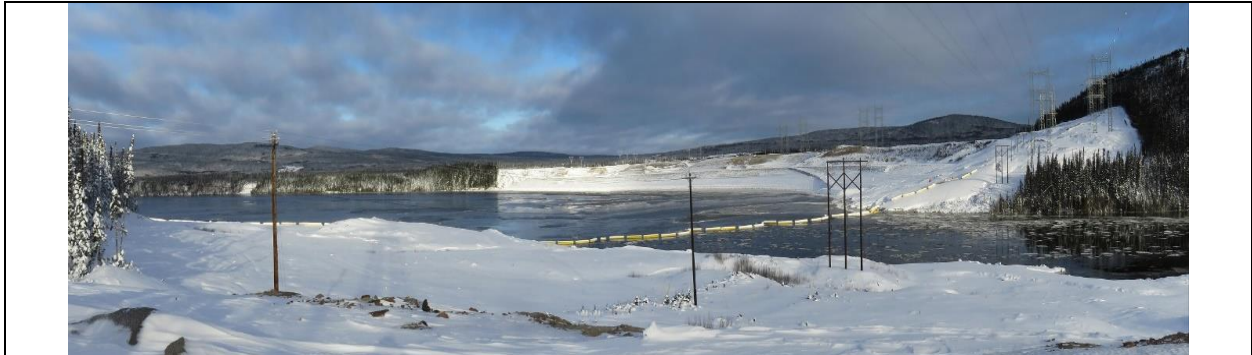
- The reservoir level was at about El. 22 m at the time of the IE site visit.
- The debris/ice/safety boom is now installed. Small pans of ice were floating downstream but the ice had not yet formed a continuous cover at the boom. Some ice pans were migrating downstream between the boom sections (Photos A.1 and A.2).
- Later in the week, Nalcor reported that a helicopter inspection found that substantial ice cover has formed in the upper reservoir.

Photo A.1: Upstream view of lower reservoir, with debris/ice/safety boom installed. Reservoir level is about El. 22 m. Snow-covered area in background is upstream side of North Spur.

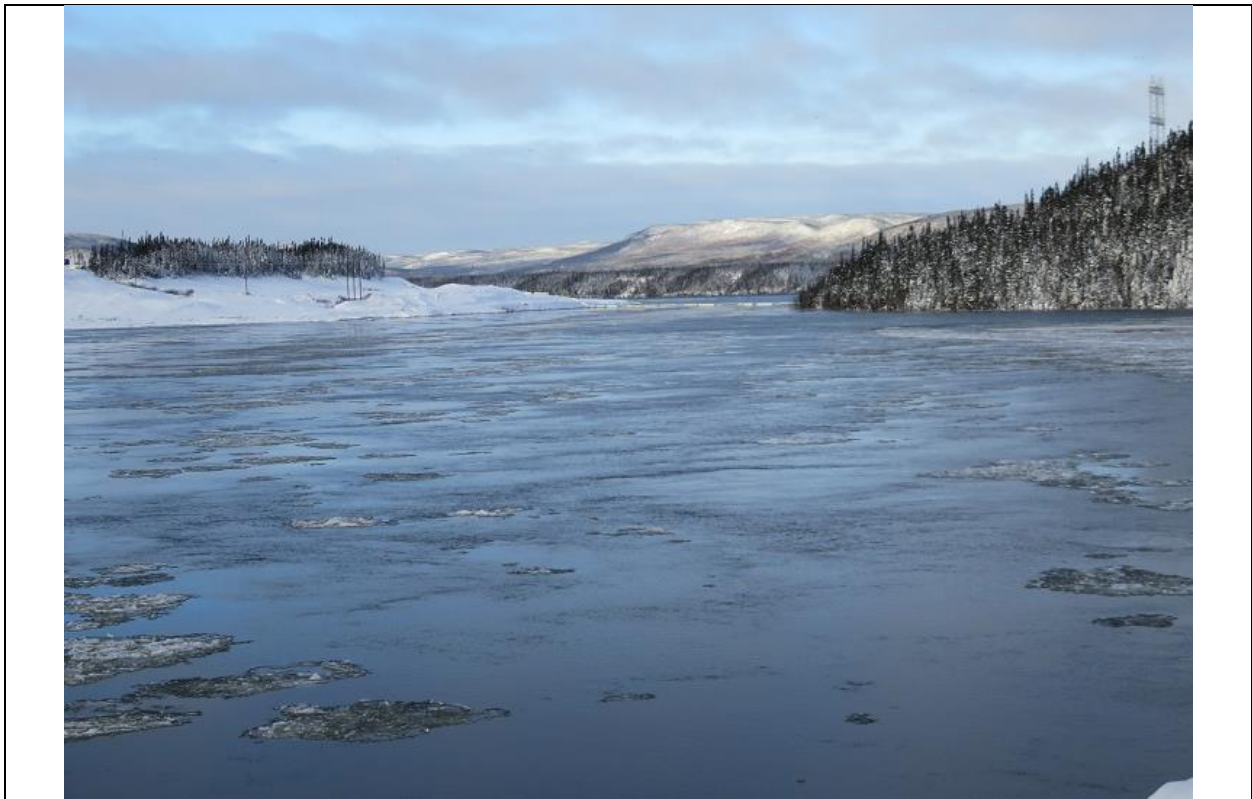
Photo A.2: Small ice pans just upstream of spillway approach channel.

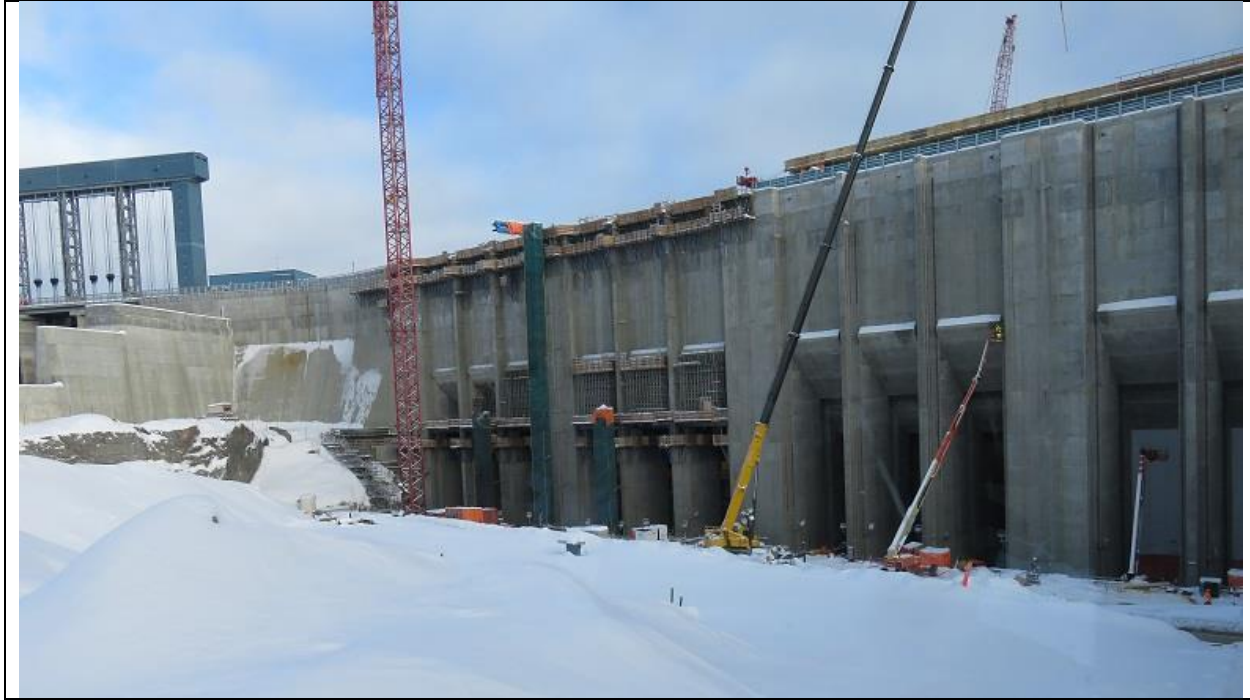
- The powerhouse superstructure is fully erected and enclosed and mezzanine floors are installed. Primary concrete placement by Astaldi for the powerhouse and intakes is complete (Photos B.1 to B.4).
- Units 1 to 3 have been handed over from Astaldi to Andritz for turbine and generator installation.
- Installations of circular passage and draft tube steel liners are in progress in Units 1 to 3. Liner components are being assembled in the service bay, then moved into position using the overhead crane. Once each liner is aligned and anchor welding is completed, second stage concrete is placed between the liner and the first stage concrete (Photos B.3, B.6, B.7).
- The Unit 1 stay ring is in the service bay, being prepared for installation (Photo B.5).

Photo B.1: Upstream side of power intake structure with Unit 4 intake at left (3 intake bays per unit).

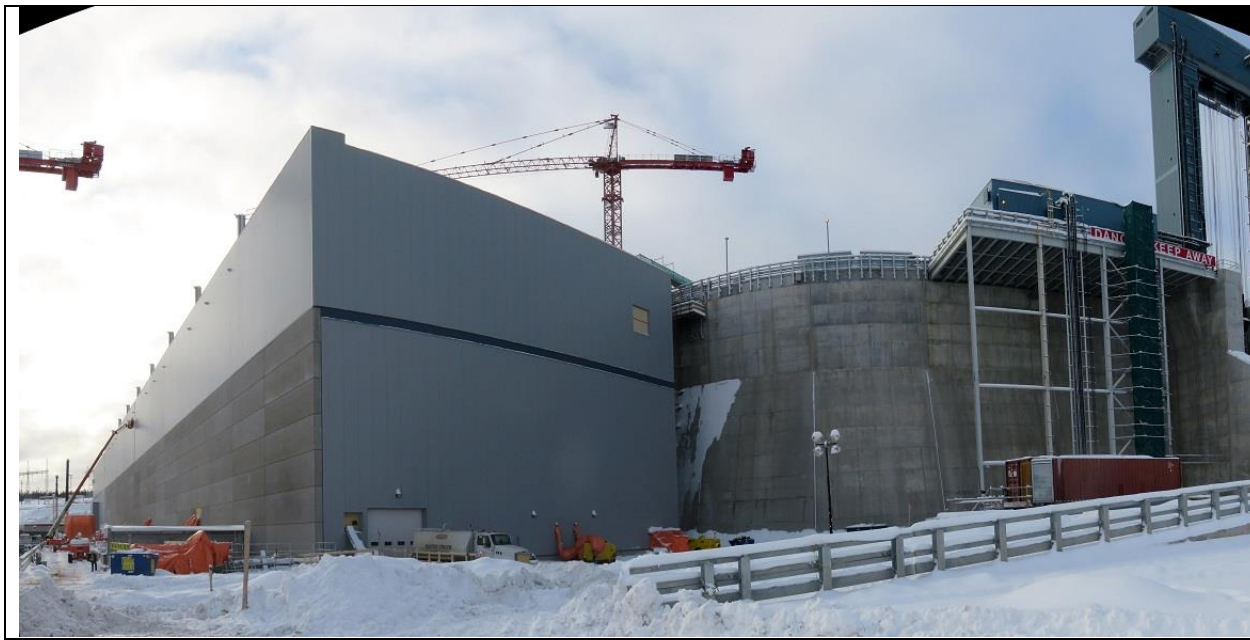
Photo B.2: Panorama view of powerhouse building and centre transition dam.

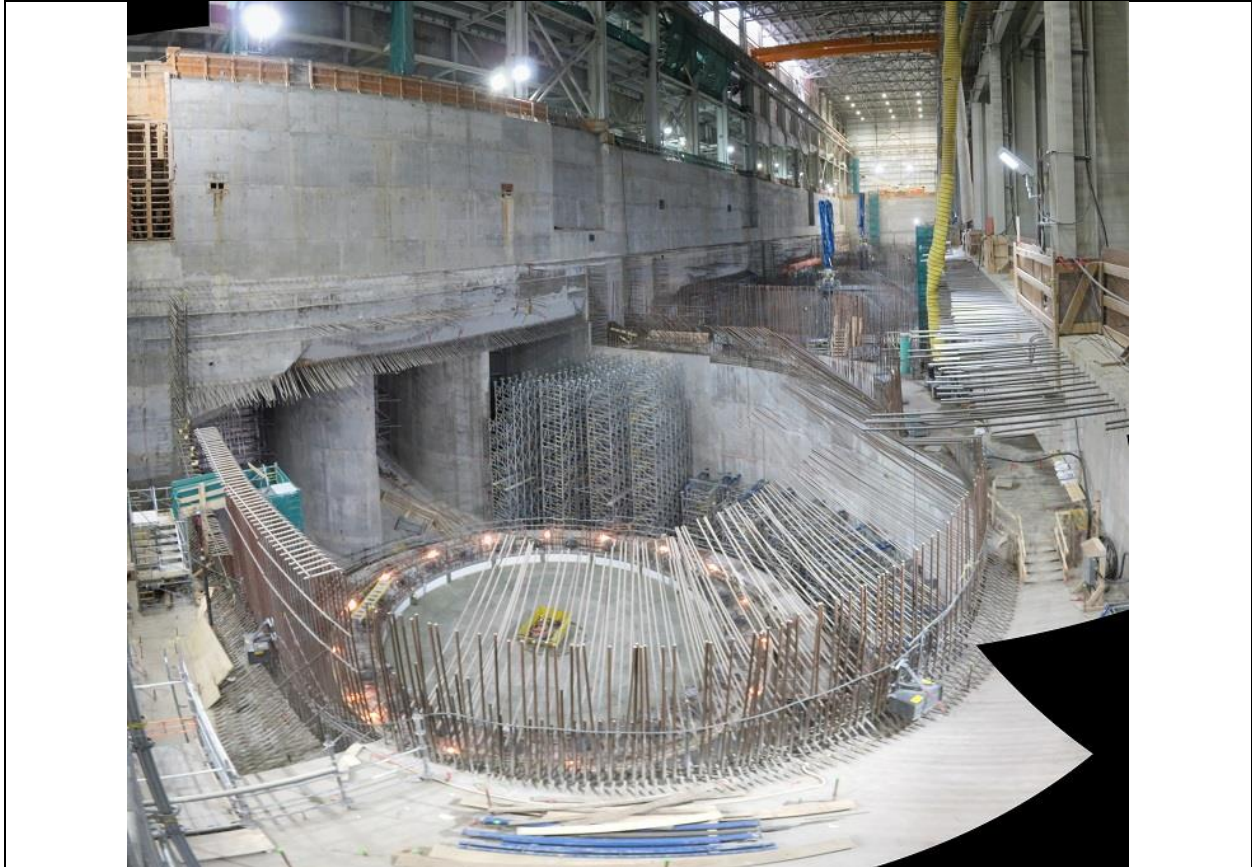
Photo B.3: Interior of powerhouse, with Unit 1 draft tube in foreground and Unit 1 intakes at centre left.

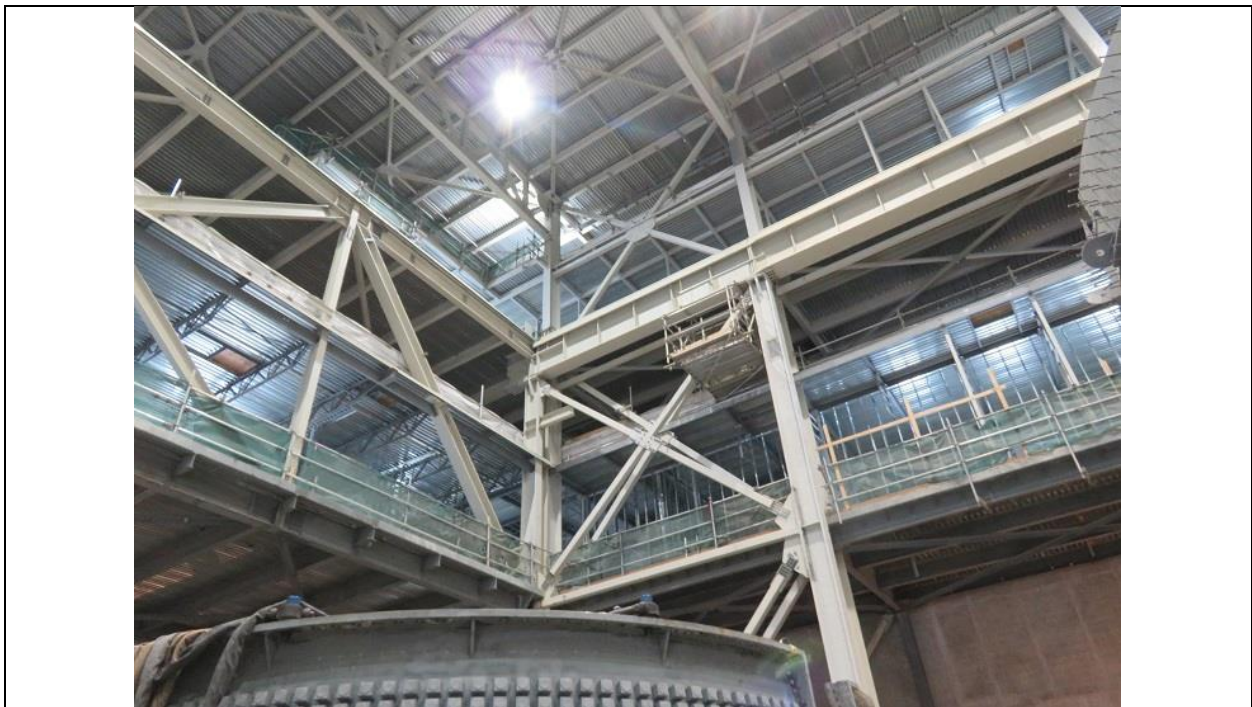
Photo B.4: Mezzanine floors inside powerhouse (above service bay).

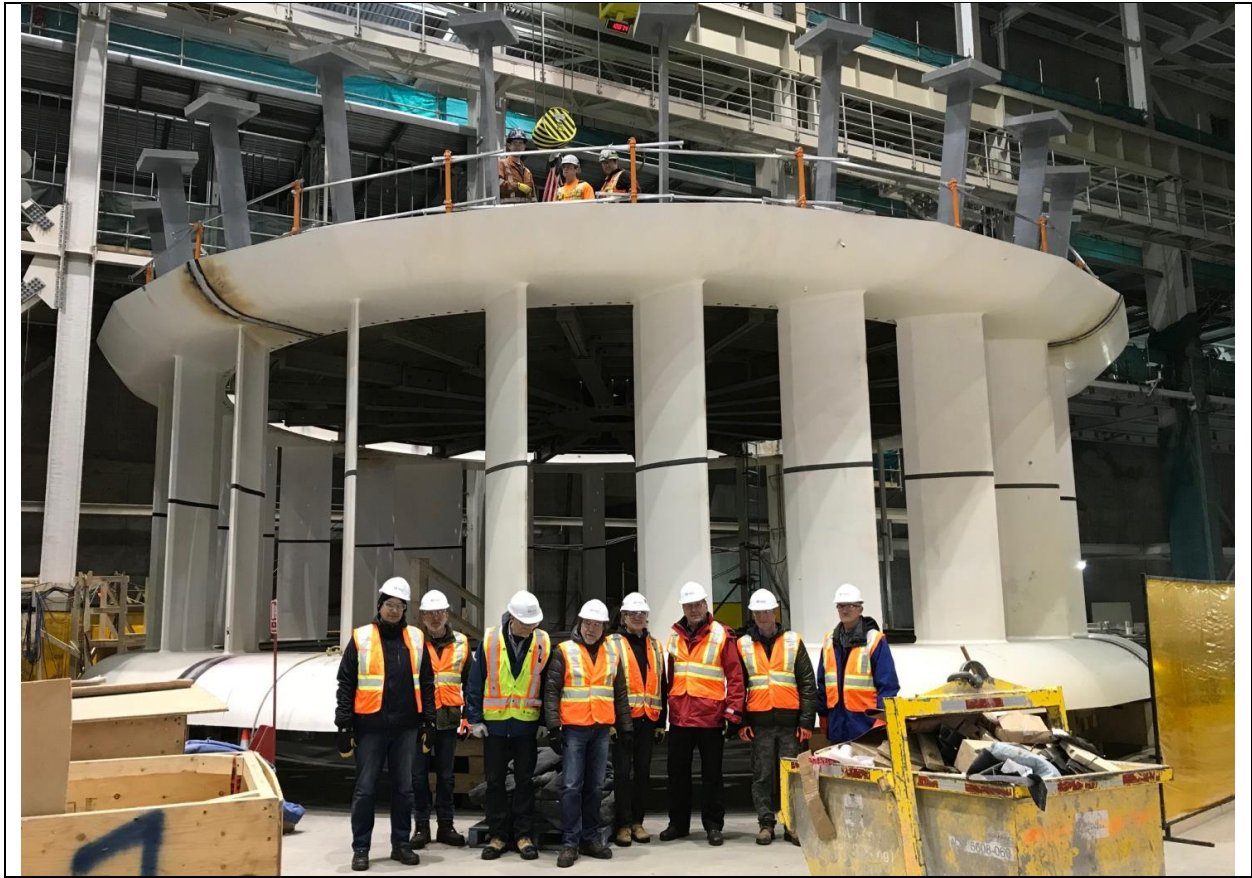
Photo B.5: Unit 1 turbine stay ring.

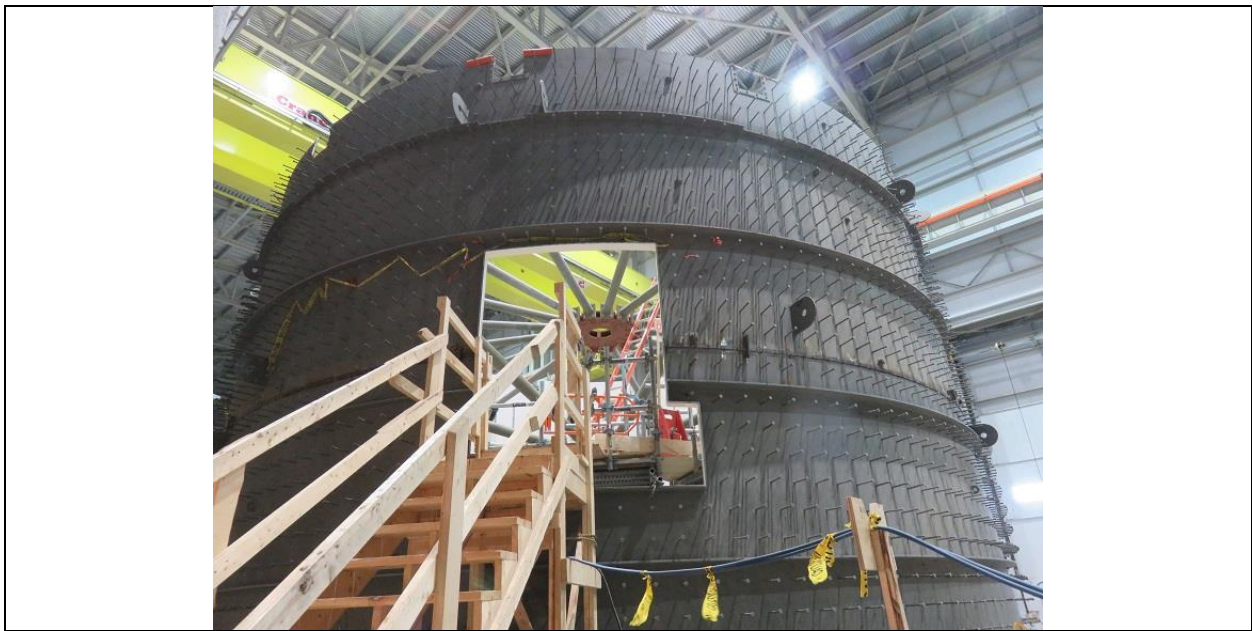
Photo B.6: Turbine pit liner with external Nelson stud anchors that will be embedded in second stage concrete.

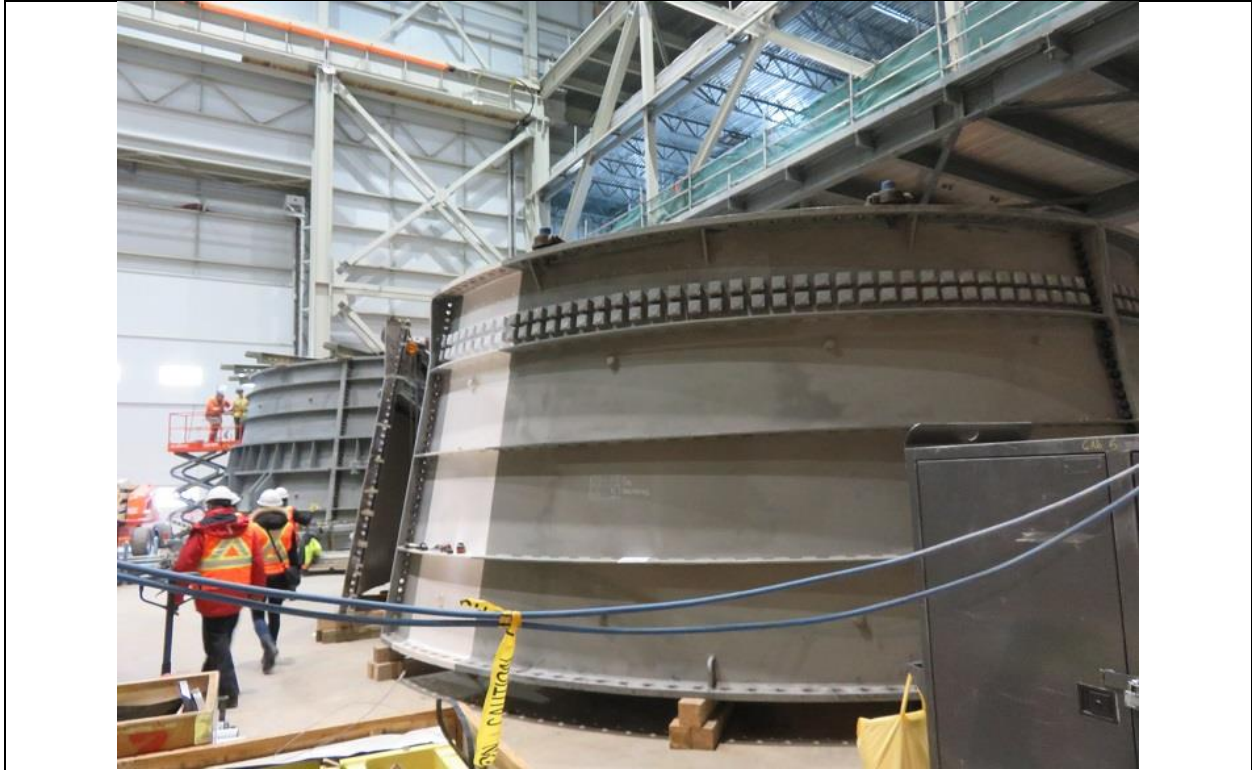
Photo B.7: Draft tube liner.

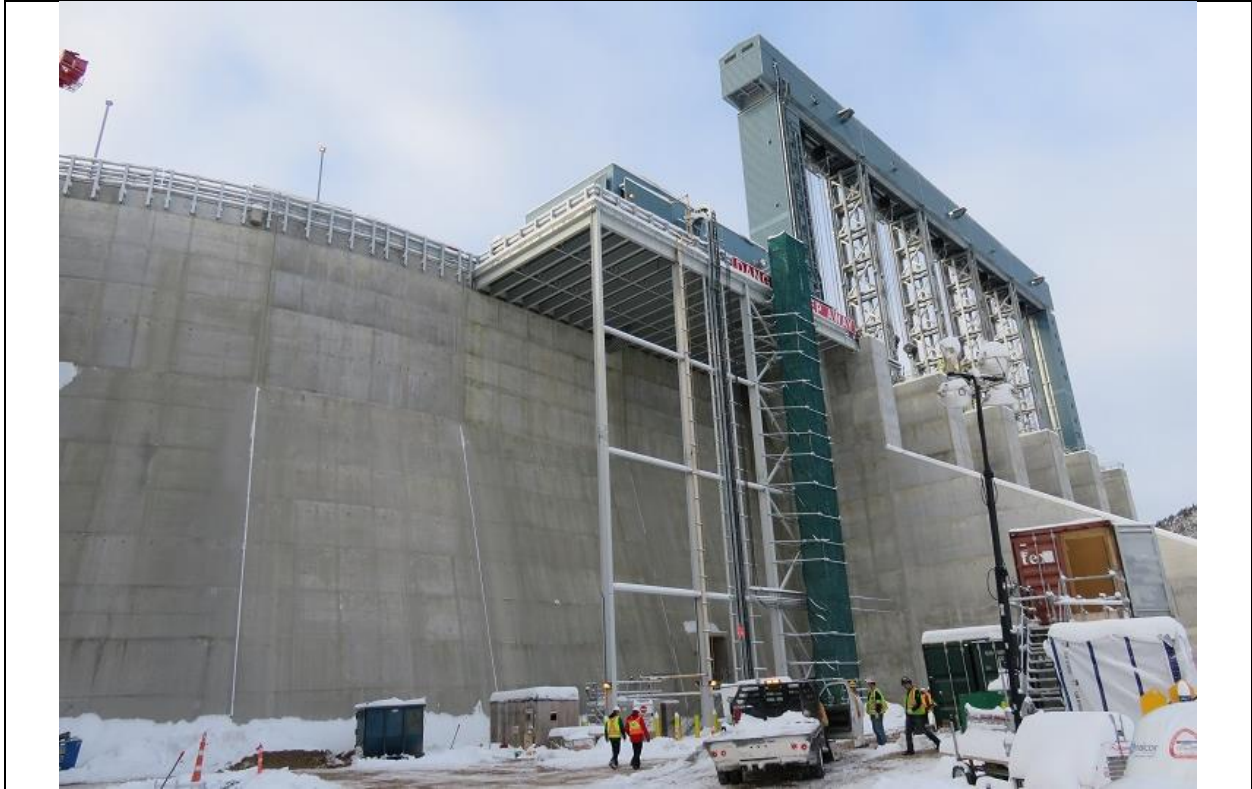
- The spillway is fully functional. At the time of the IE site visit, two spill gates were open to maintain the reservoir level and the Churchill River flow.
- Small ice pans were being easily passed through the open spill bays (Photos C.1 to C.4).

Photo C.1: Centre transition dam and spillway.

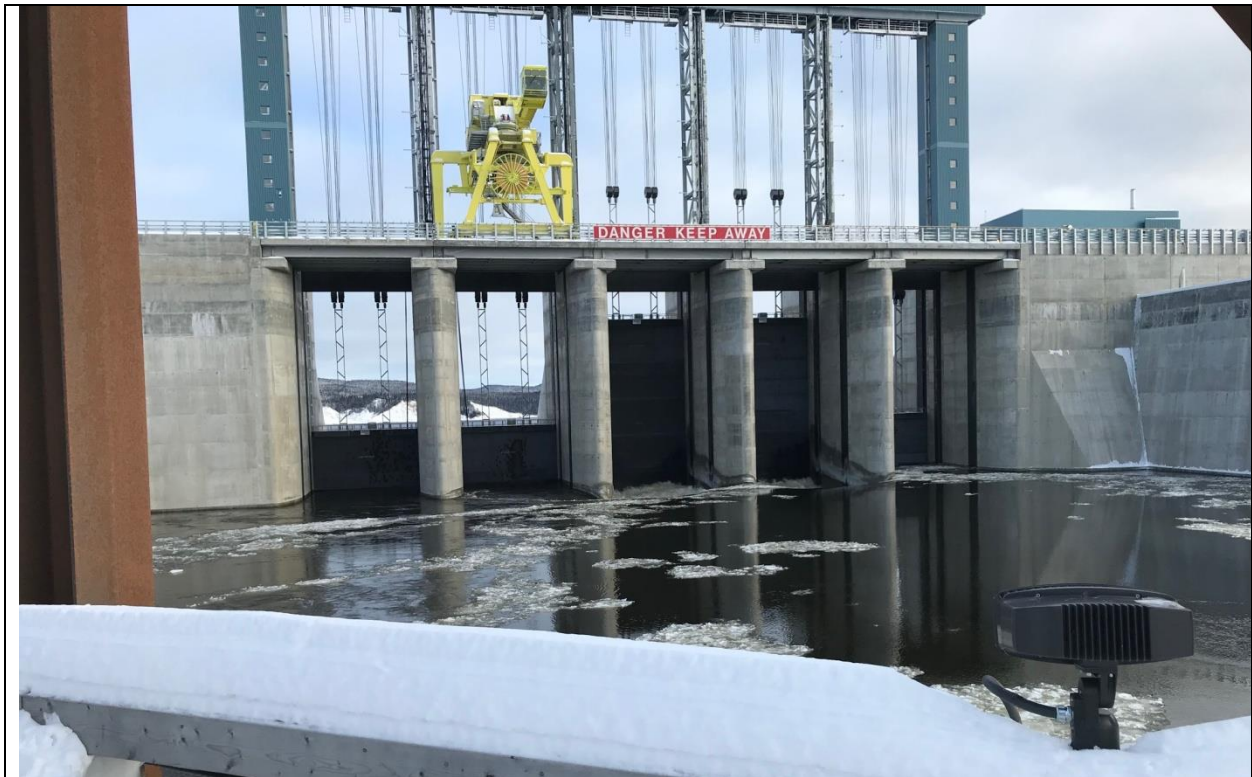
Photo C.2: Upstream side of spillway with two gates open.

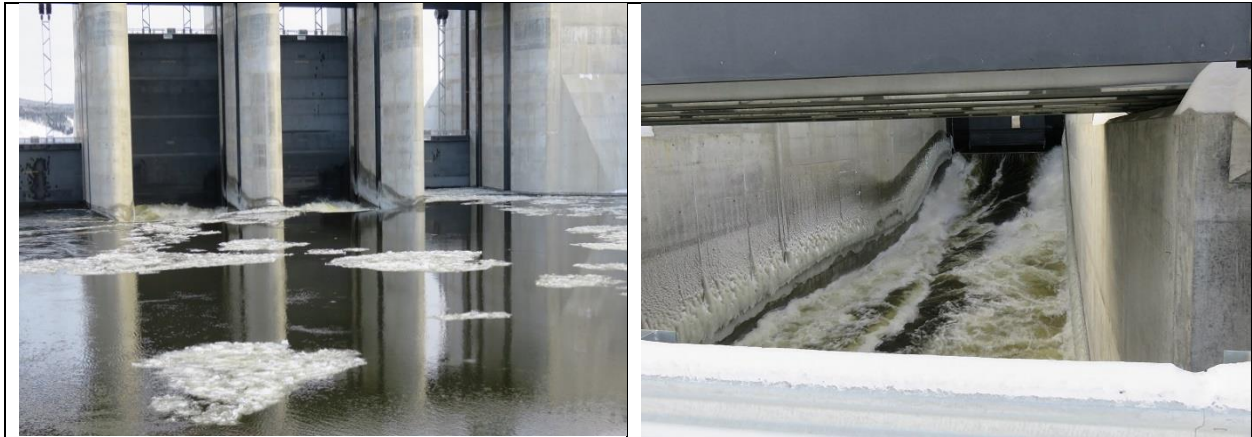
Photo C.3: Open spillway gates showing entrance flow conditions (left) and exit flow conditions (right).

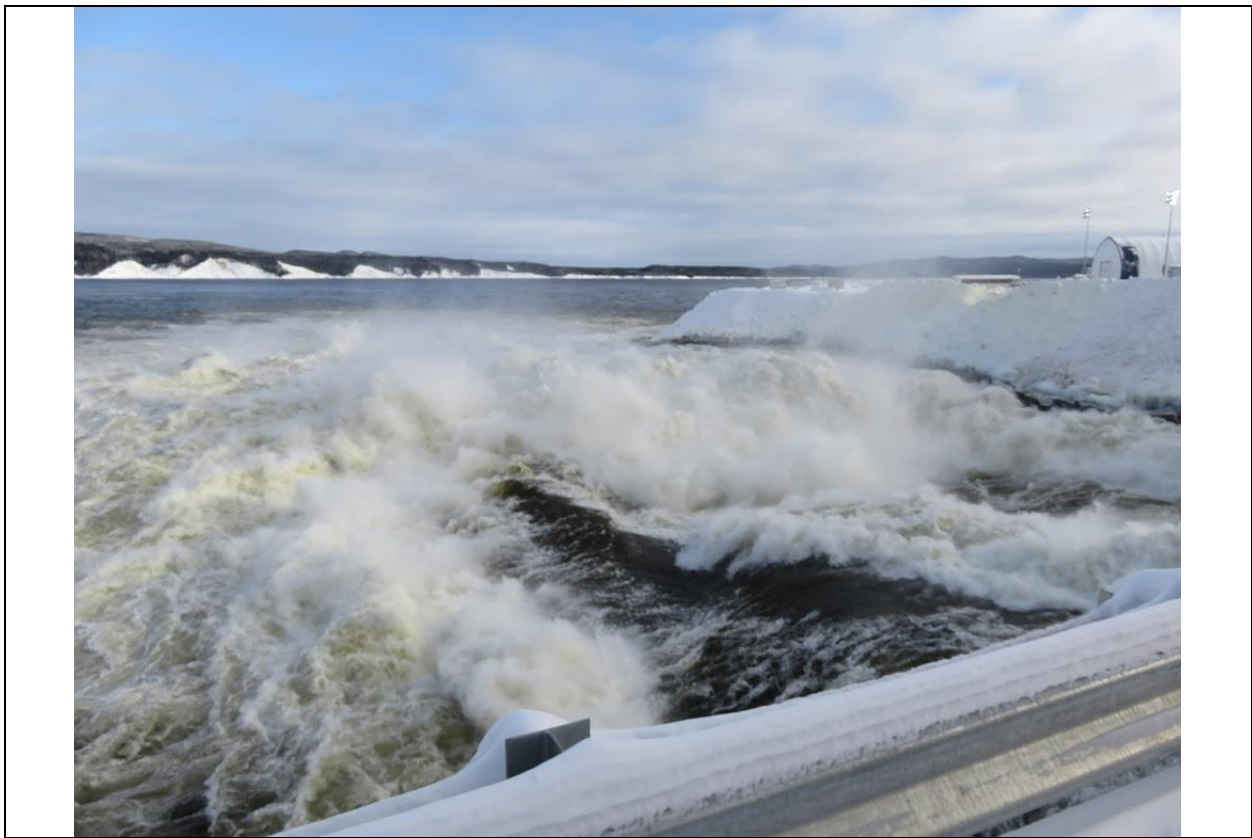
Photo C.4: Spillway discharge entering river.

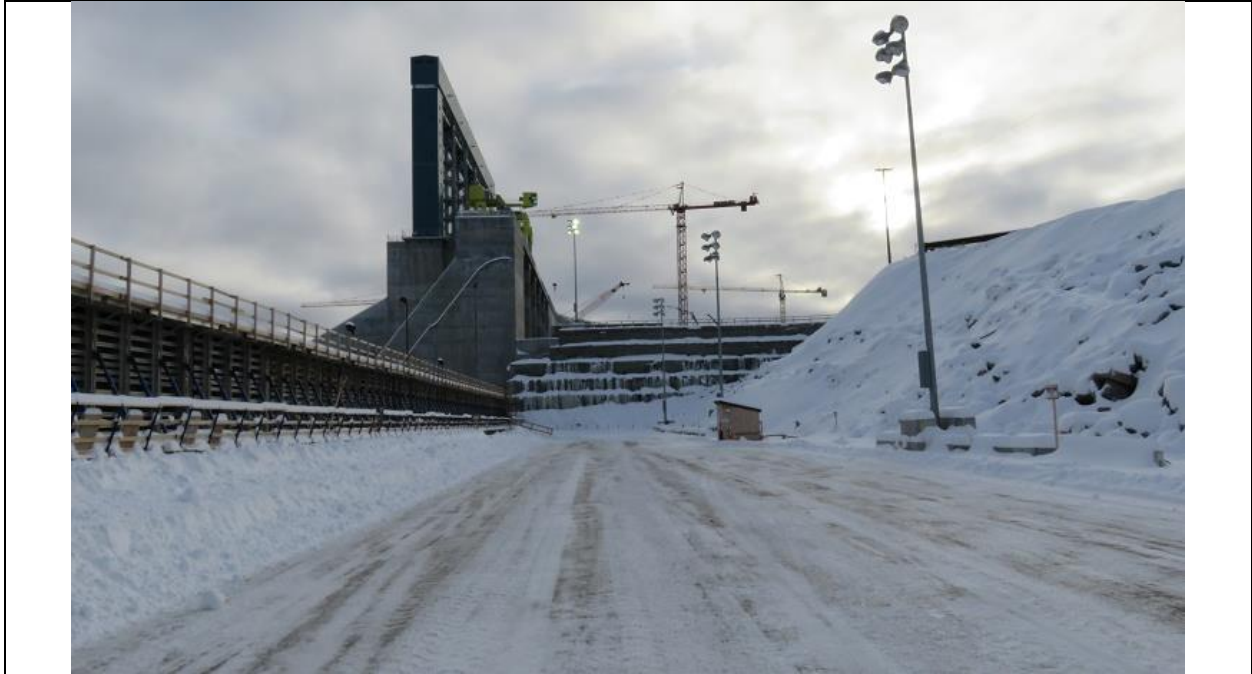
- The RCC dam has been insulated for the winter, based on the results of a thermal analysis. On the upstream side and upper downstream side of the dam, the vertical formwork has been left in place for the winter; the formwork was temporarily separated from the concrete and tarps were inserted to provide adequate insulation. Other exposed surfaces were covered with tarps. RCC temperatures are being monitored with thermocouples (Photos D.1 to D.3).
- Backfill was placed and the water level between the upstream cofferdam and the RCC dam was raised to El. 9 m at the end of October, which reduces the differential head through the dam. Seepage flows dropped from about 10 m³/min to about 6.5 m³/min, and have remained stable (Photo D.4).
- Nalcor informed the IE that the downstream face of the RCC dam will be stepped, and the steps will be constructed using formwork in 2018.

Photo D.1: Southerly view between RCC dam (left) and upstream cofferdam (right). RCC formwork is being left in place through the winter for insulation purposes.

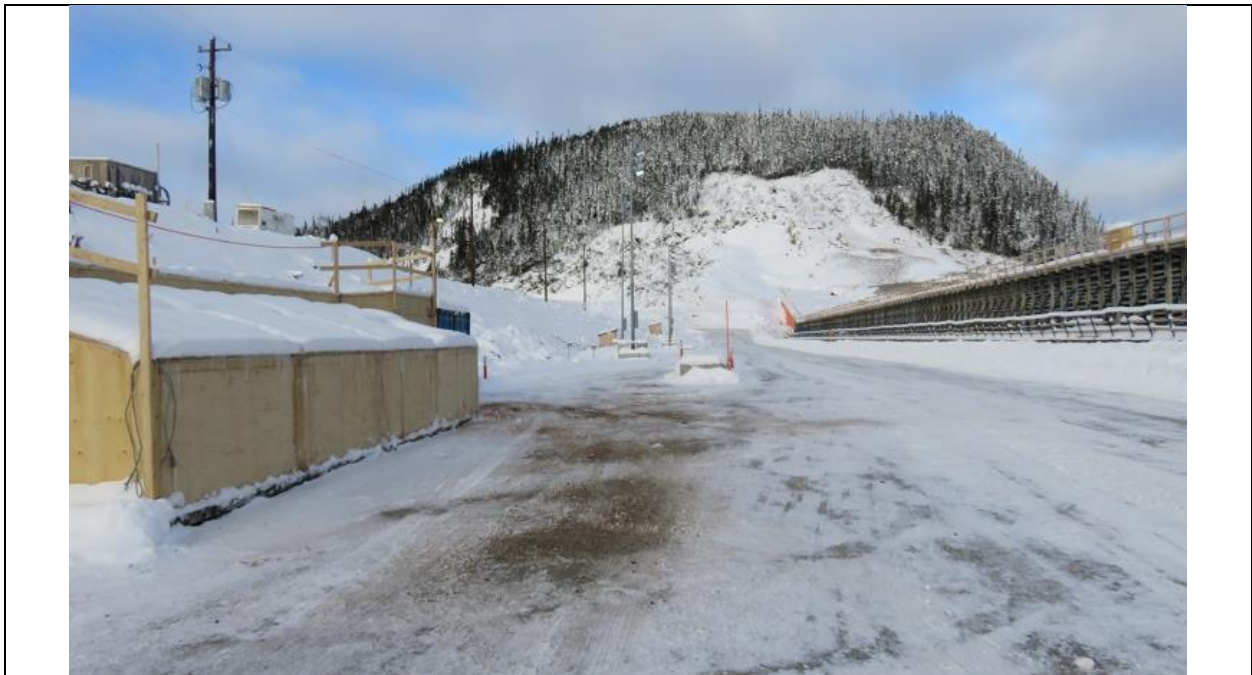
Photo D.2: Northerly view between upstream cofferdam (left) and RCC dam (right). Wooden structure at left houses the cofferdam dewatering system.

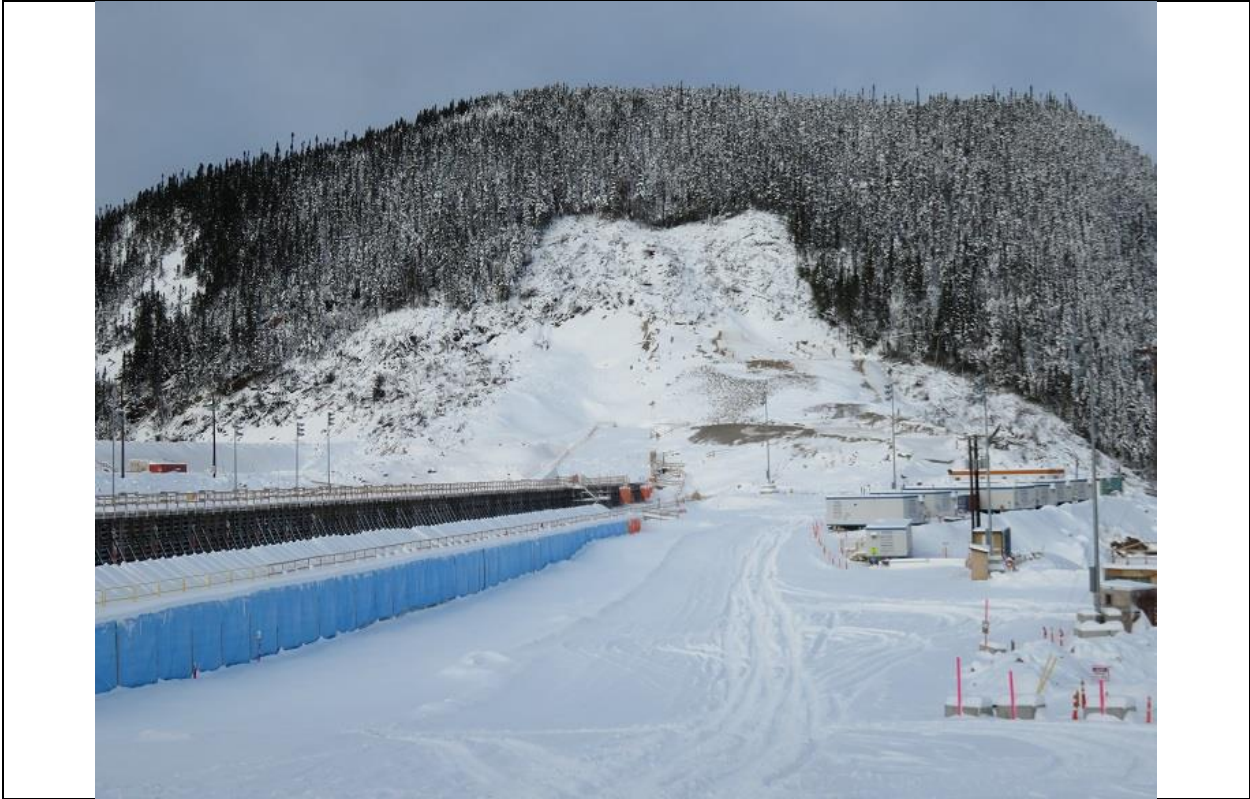
Photo D.3: Northerly view along downstream side of RCC dam. Formwork remains in place on the upper part of the dam and the lower part has been covered with blue tarps for winter insulation.

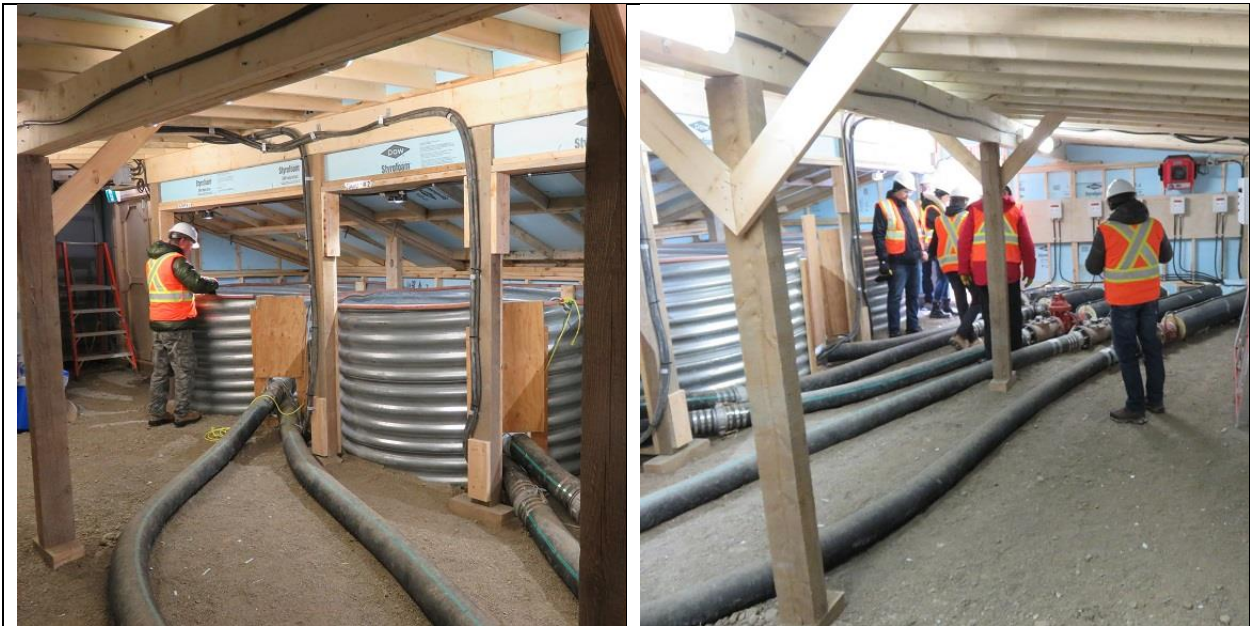
Photo D.4: Upstream cofferdam dewatering system housed inside insulated temporary structure. Inside each vertical corrugated metal pipe is a seepage collection sump with a pump. Pumped flows are measured by flow meters and returned to the reservoir.

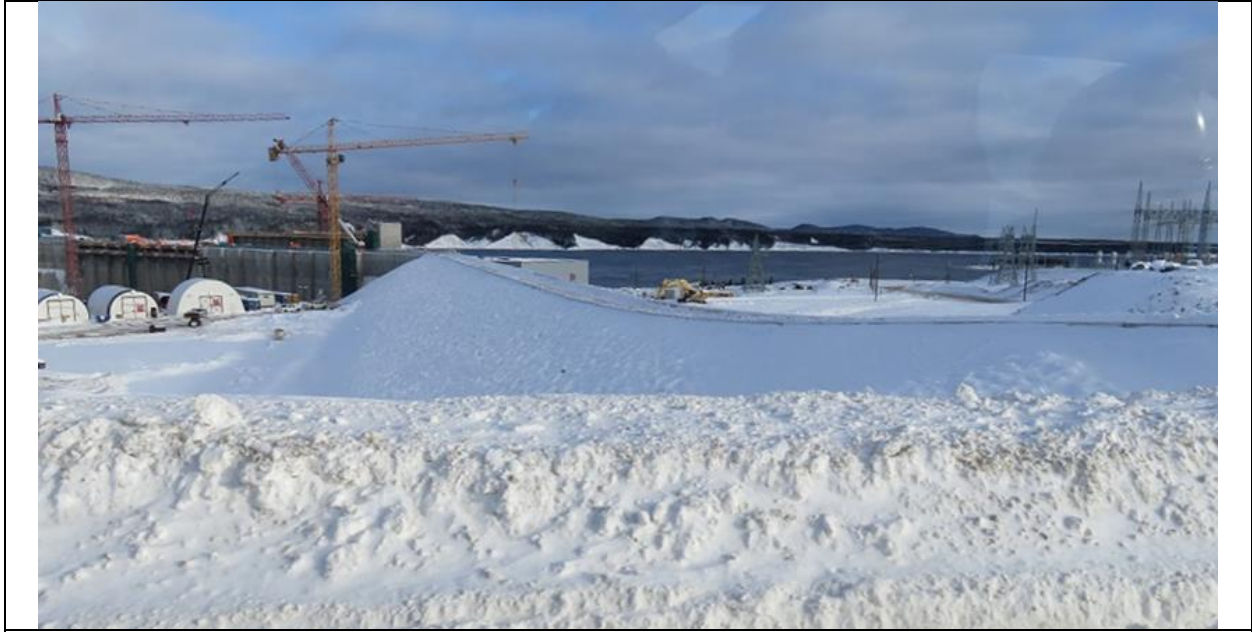
Construction of the south embankment dam was completed in Fall 2017 (Photos E.1 to E.3).

Photo E.1: Upstream side of completed south embankment dam.

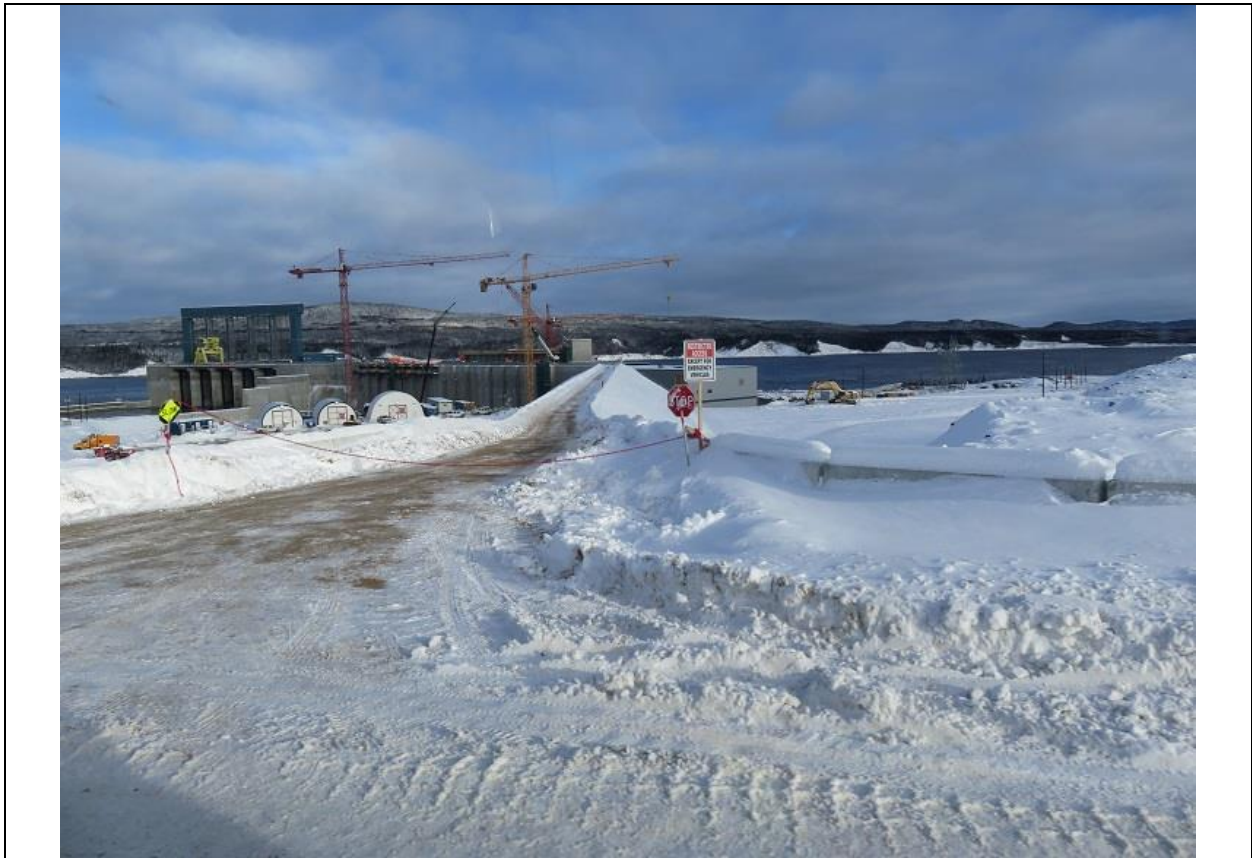
Photo E.2: View along crest of completed south embankment dam.

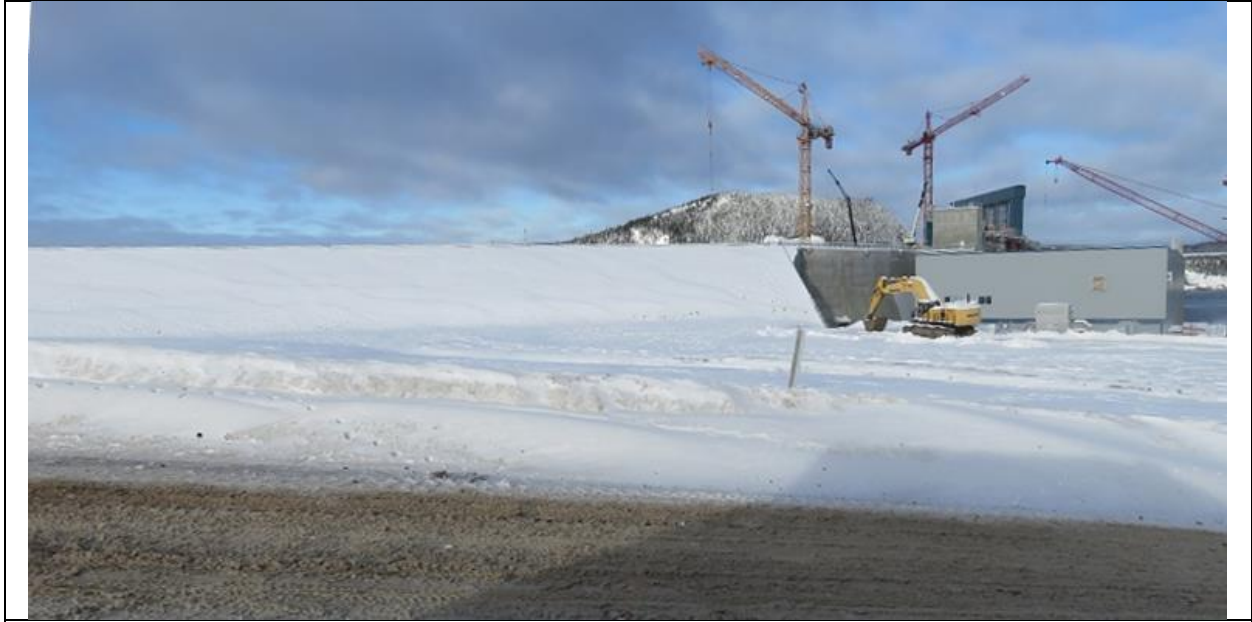
Photo E.3: Downstream side of south embankment dam and contact with south transition dam.

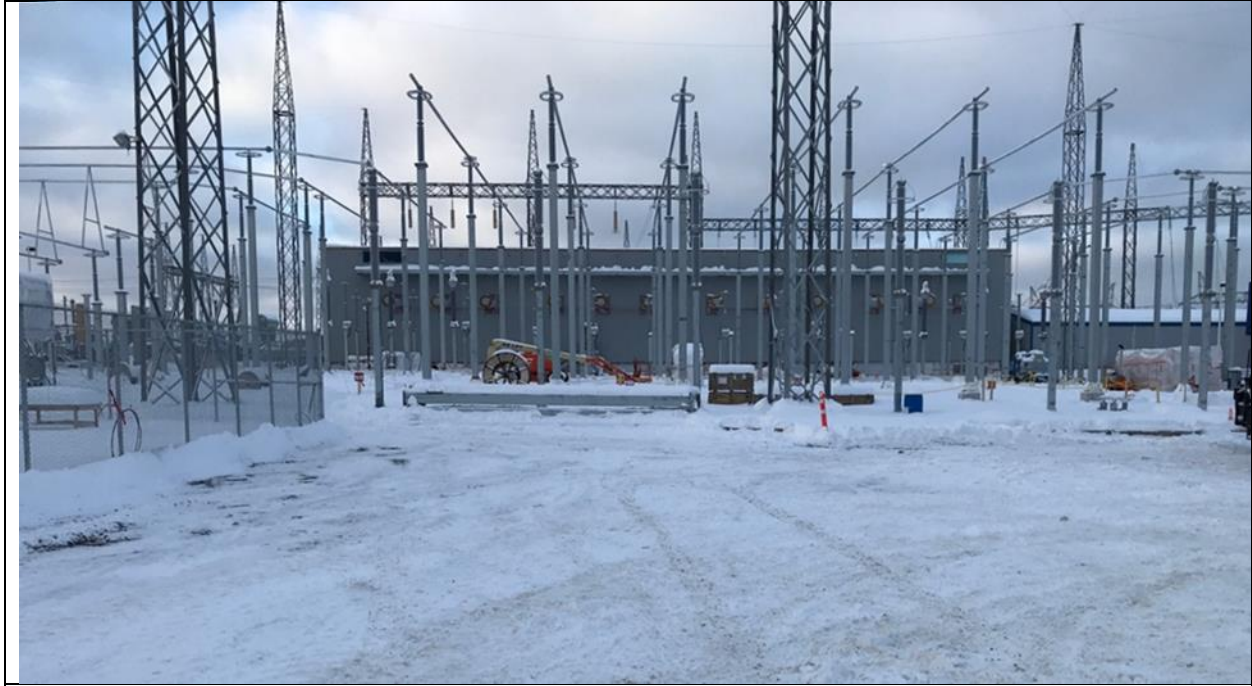
- Power apparatus and the structures have been installed and are in final commissioning stages.
- 315kV Churchill Falls Transmission line and four powerhouse collector feeder towers have been erected and connected.

Photo F.1: Muskrat Falls DC switchyard.

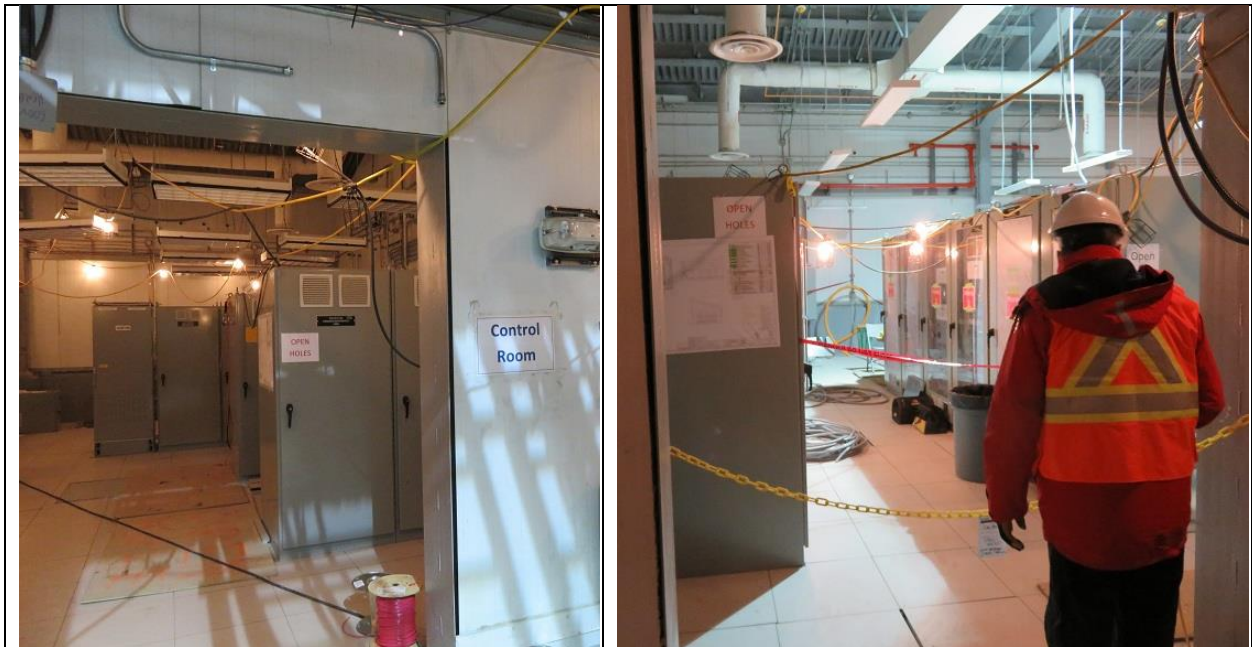
- Converter building is in final stages of completion (Photo F.2).
- Converter transformers have been installed on their pads.
- HVDC Valves have been installed, cooling system is being tested (Photo F.3).
- Fibre optic cables will be installed following the tests and clean up (Photo F.2).

Photo F.2: Muskrat Falls converter building control room (left) and P&C room (right).

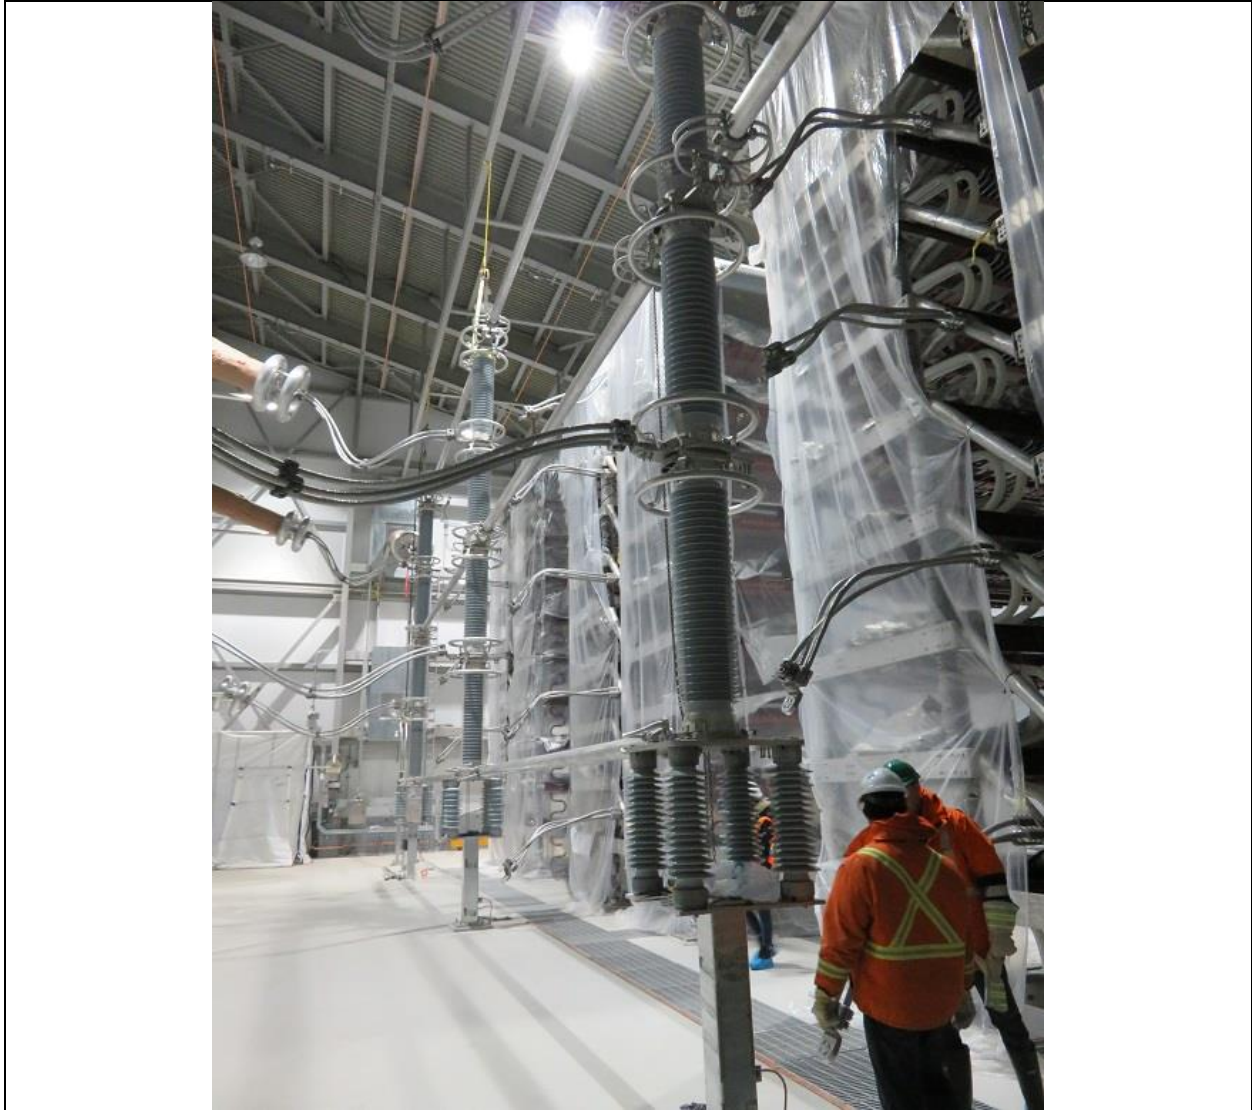
Photo F.3: Muskrat Falls converter building valve hall.
