MEETINGS IN ST. JOHN'S AND VISITS TO LOWER CHURCHILL PROJECT SITES, NOVEMBER 27 TO DECEMBER 01, 2017

Prepared for: Natural Resources Canada and Nalcor Energy
IE Point of Contact: Nik Argirov
Date: January 22, 2018

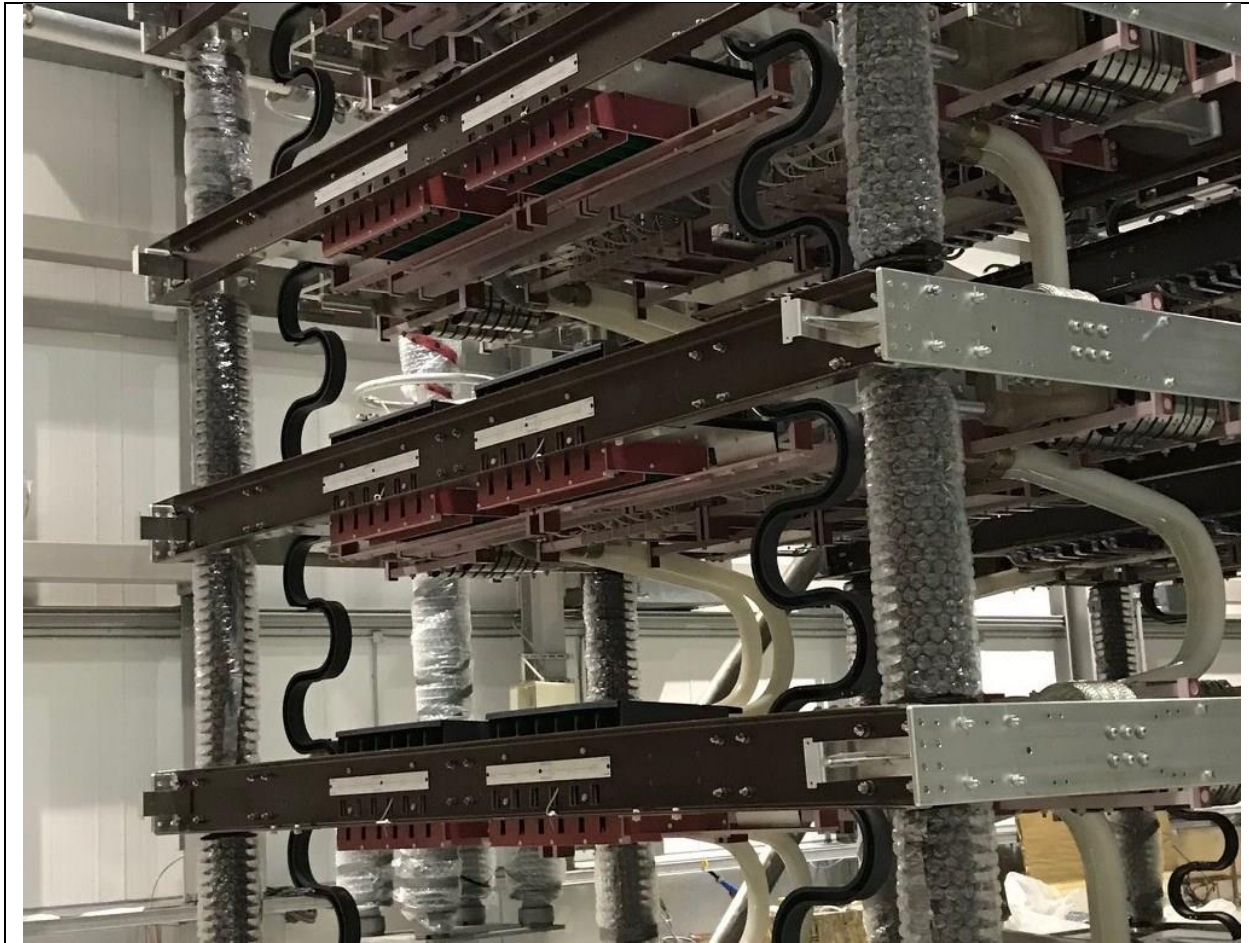
Photo F.4: Valve cooling detail.

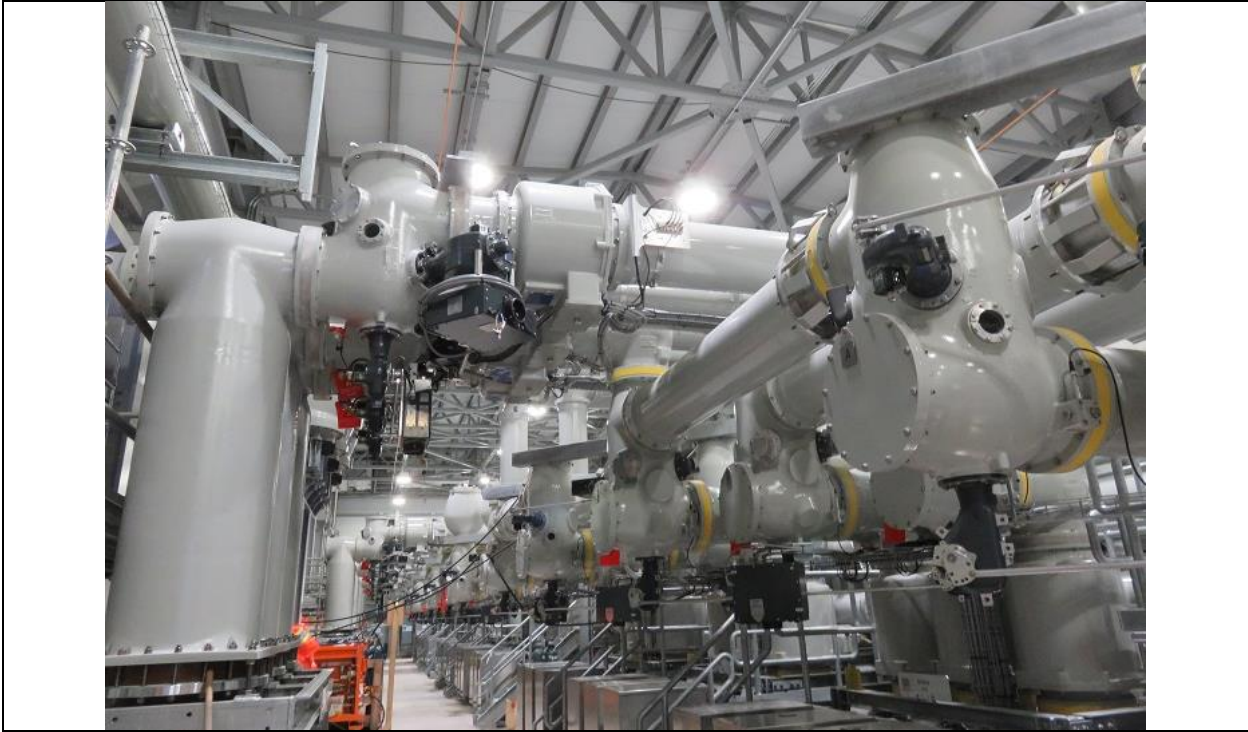
- GIS equipment and Local Control cabinets have been installed, low voltage cables have been pulled in and the building is in final stages of construction (Photos F.5 and F.6).

Photo F.5: GIS equipment.

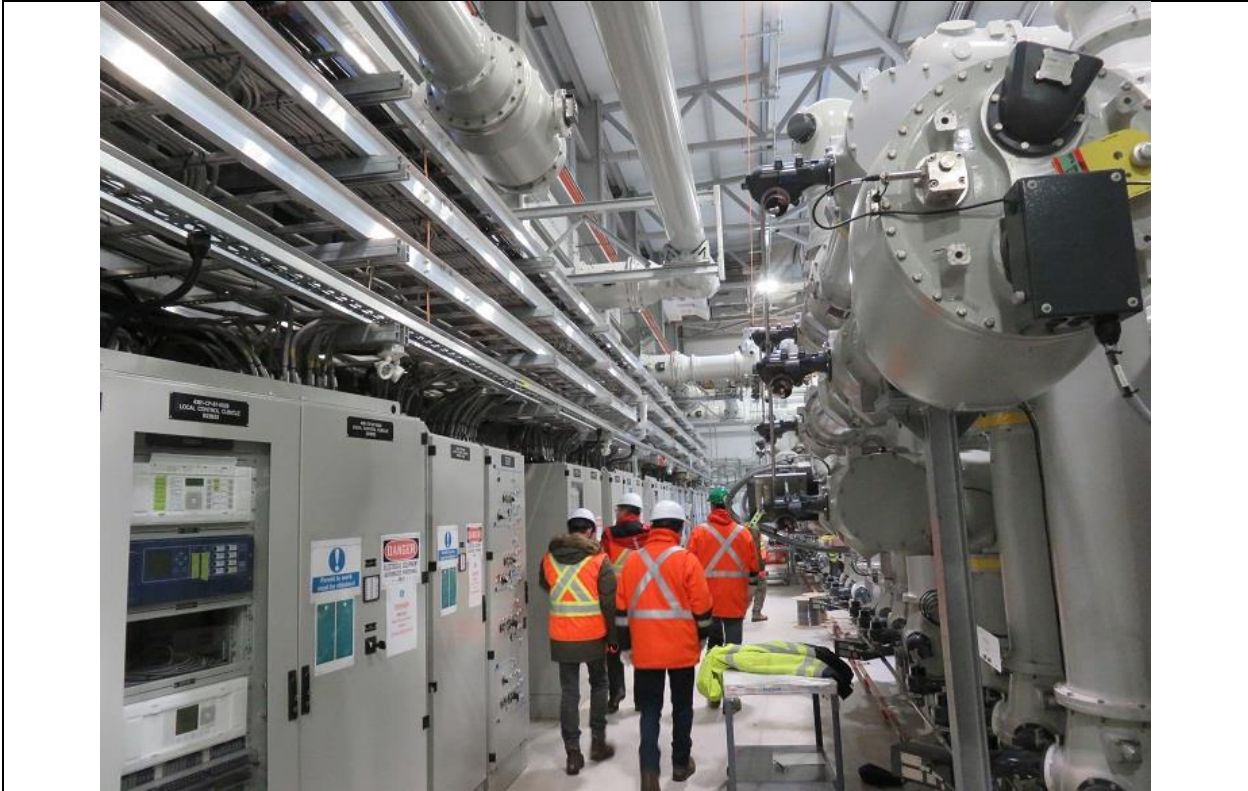
Photo F.6: GIS equipment, cable trays and control cabinets.

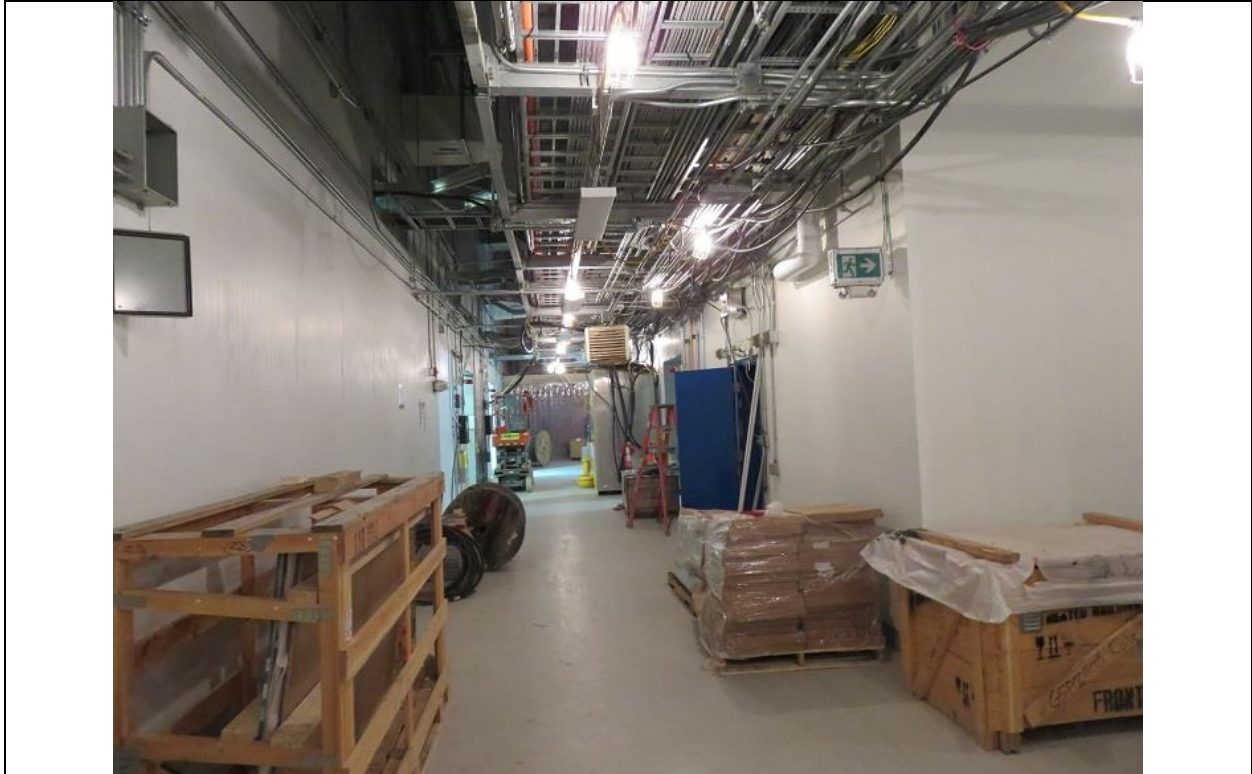
- At the time of the IE site visit the construction work is nearing the final stages (Photos G.1 to G.3). Completion work is in phase with the Muskrat Falls site.

Photo G.1: Soldier's Pond converter building interior works nearing completion.

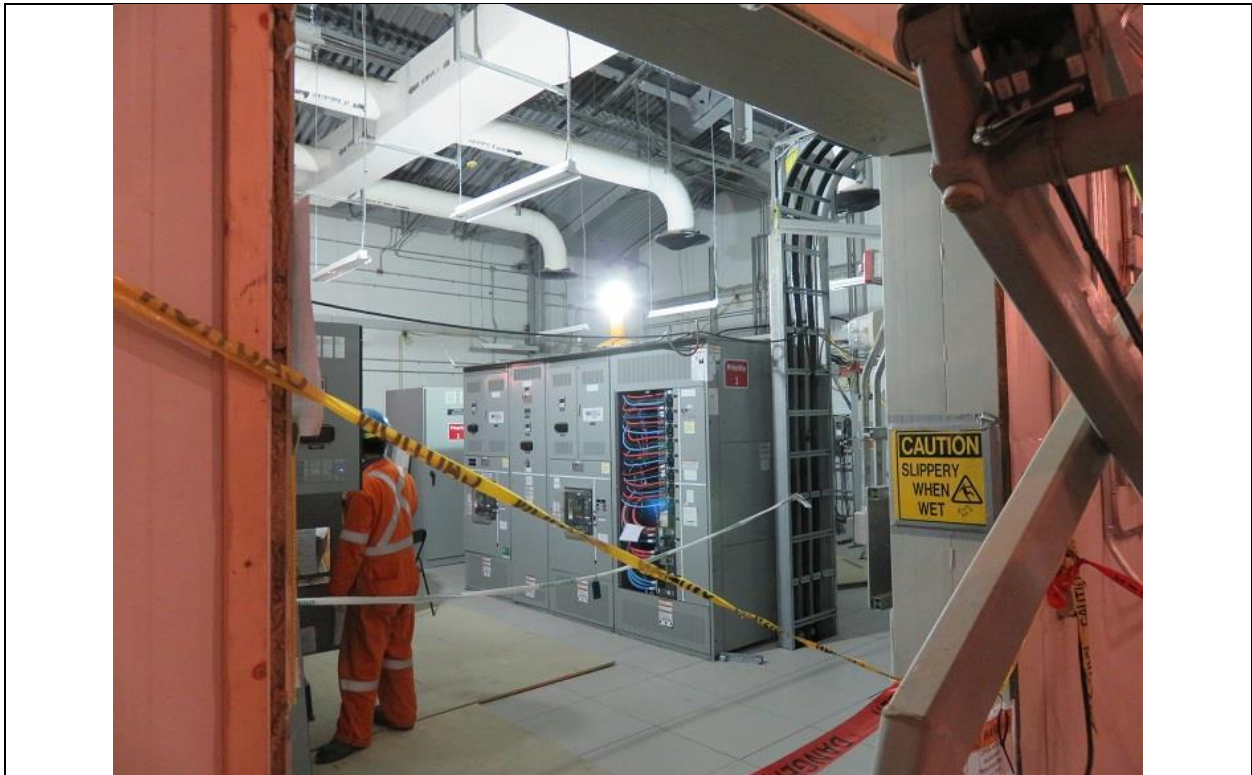
Photo G.2: Control cabinets wiring completion and testing in progress.

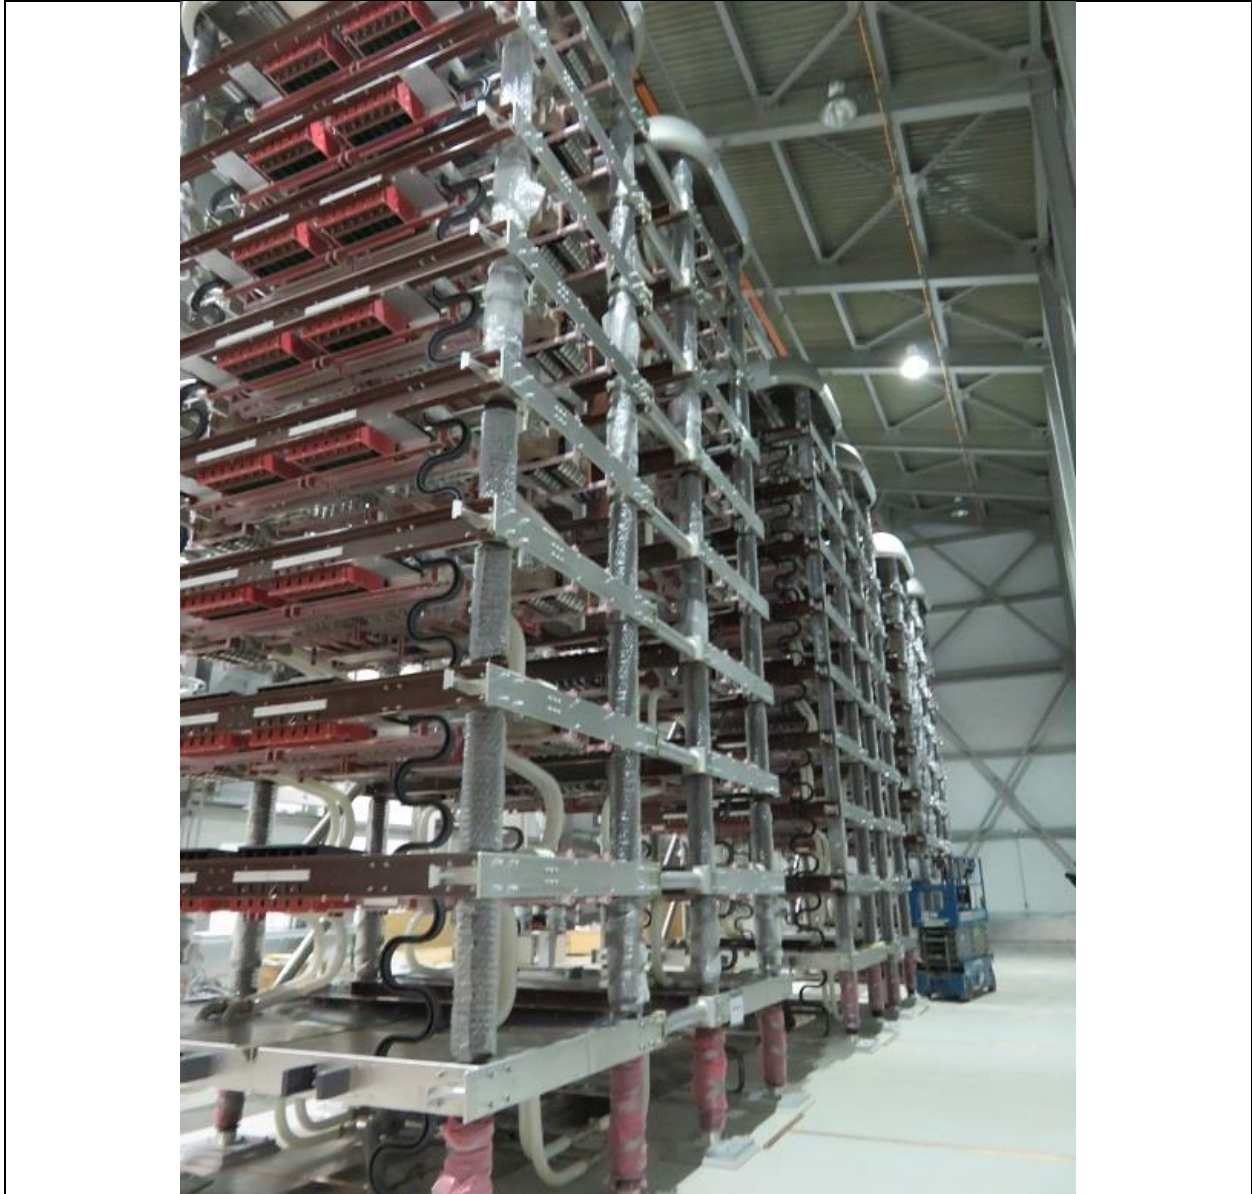
Photo G.3: Soldier's Pond converter building valve hall.

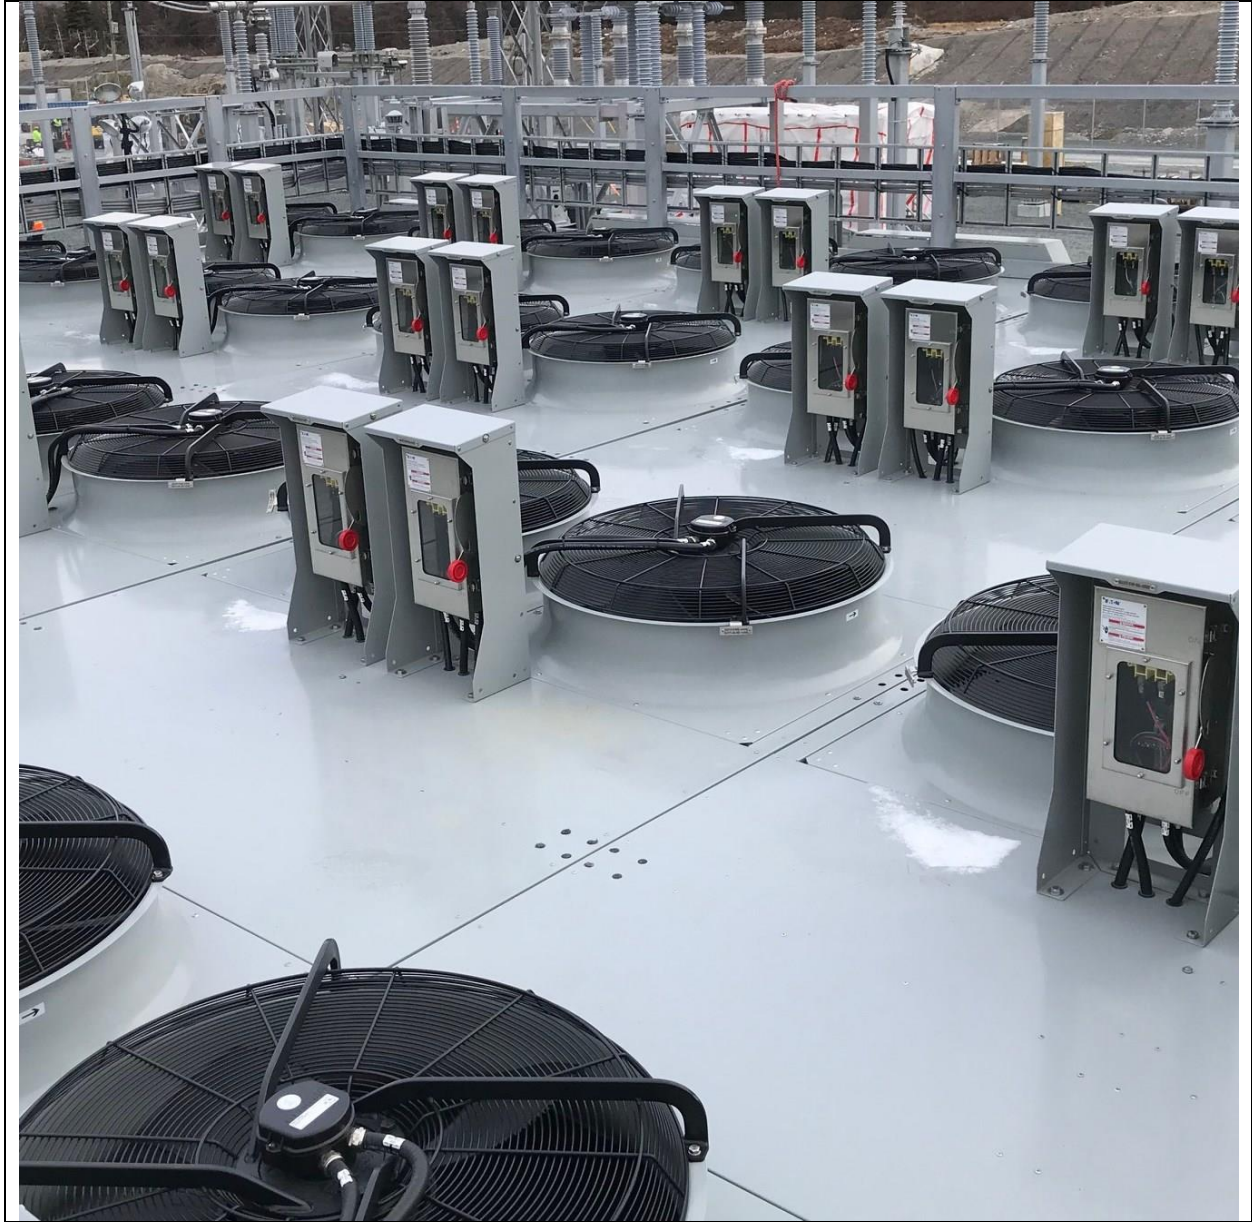
- Valve cooling heat exchangers have been completed (Photo G.4).
- Converter transformers are on their pads and have been oil filled.

Photo G.4: Valve cooling heat exchangers.

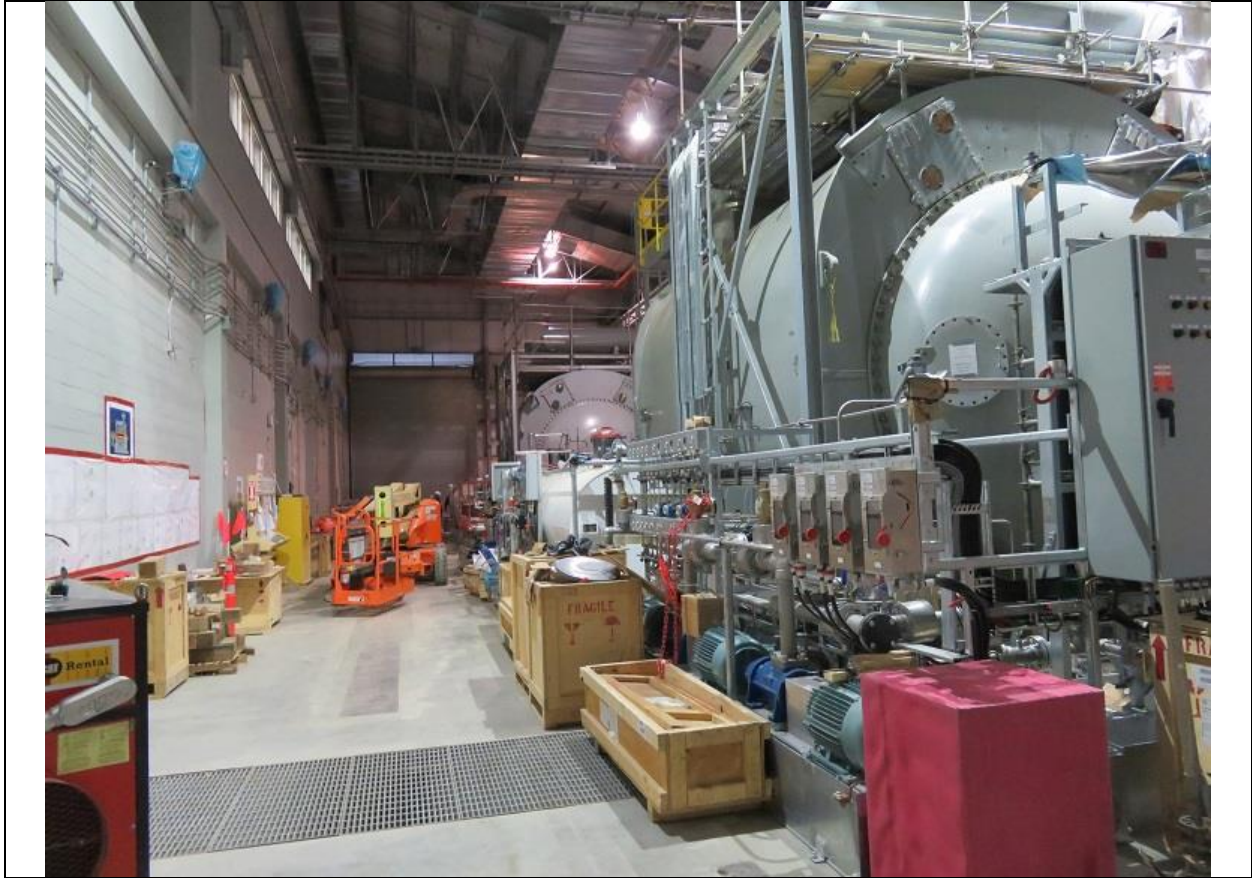
- Unit 1, 2 and 3 are on their pads, and rotors and stators are assembled (Photo G.5).
- Exciter, switchgear and Protection cubicles have been installed (Photo G.6).
- Synchronous Condenser Power and Exciter Transformers are on their pads.

Photo G.5: Synchronous condensers.

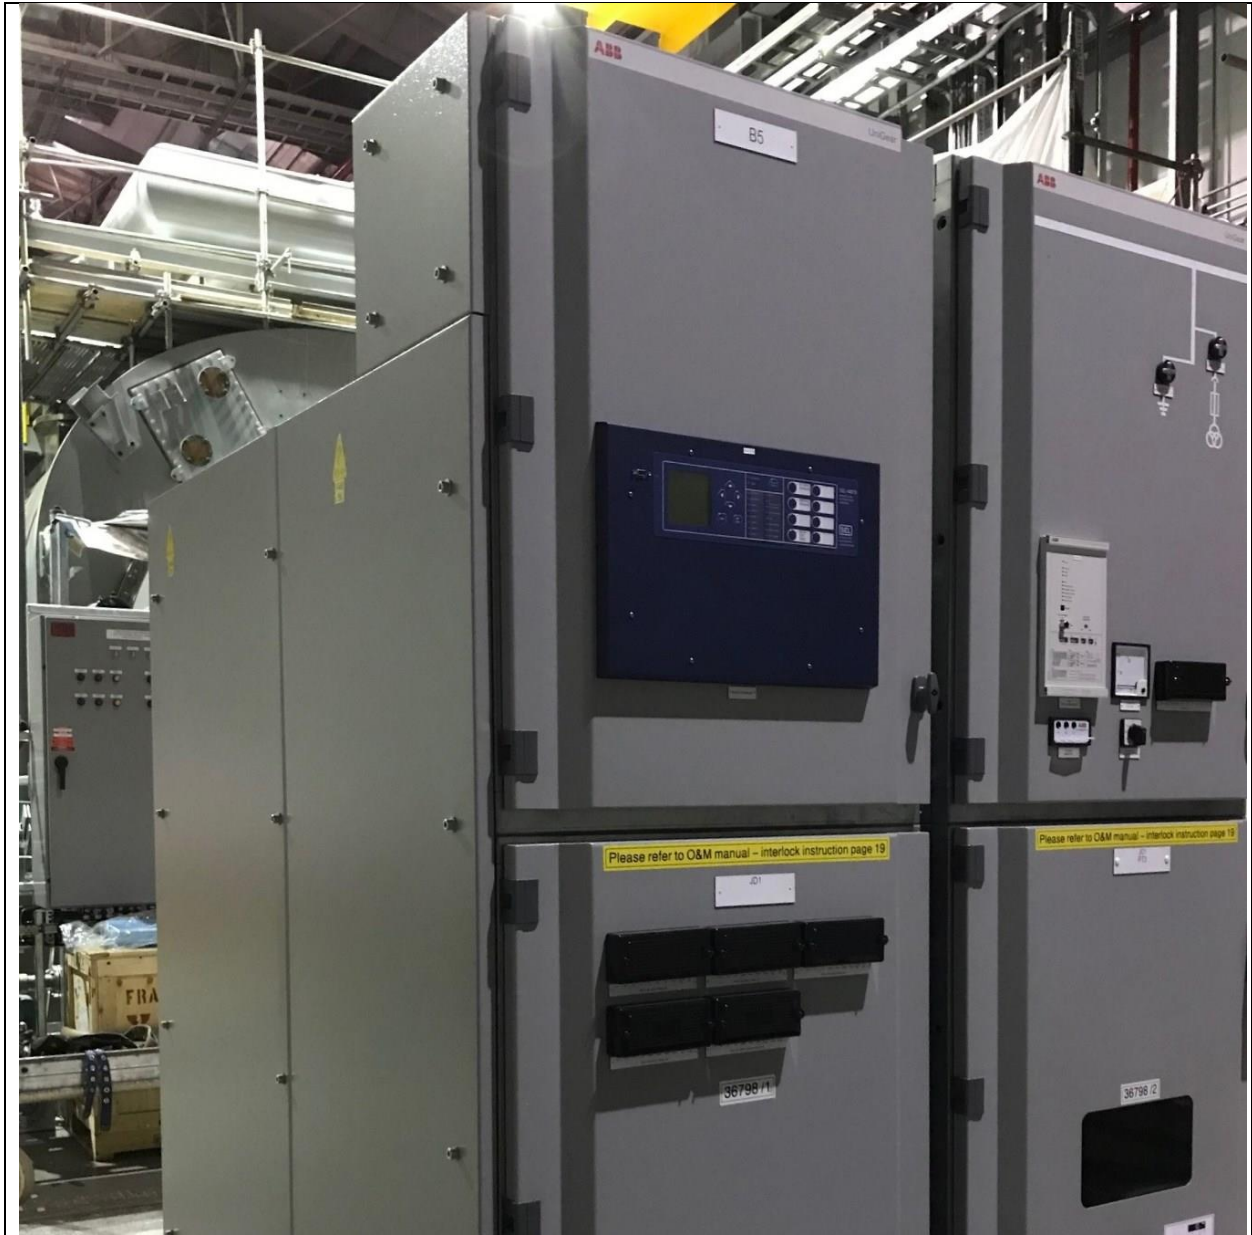
Photo G.6: Synchronous condenser control cabinets.

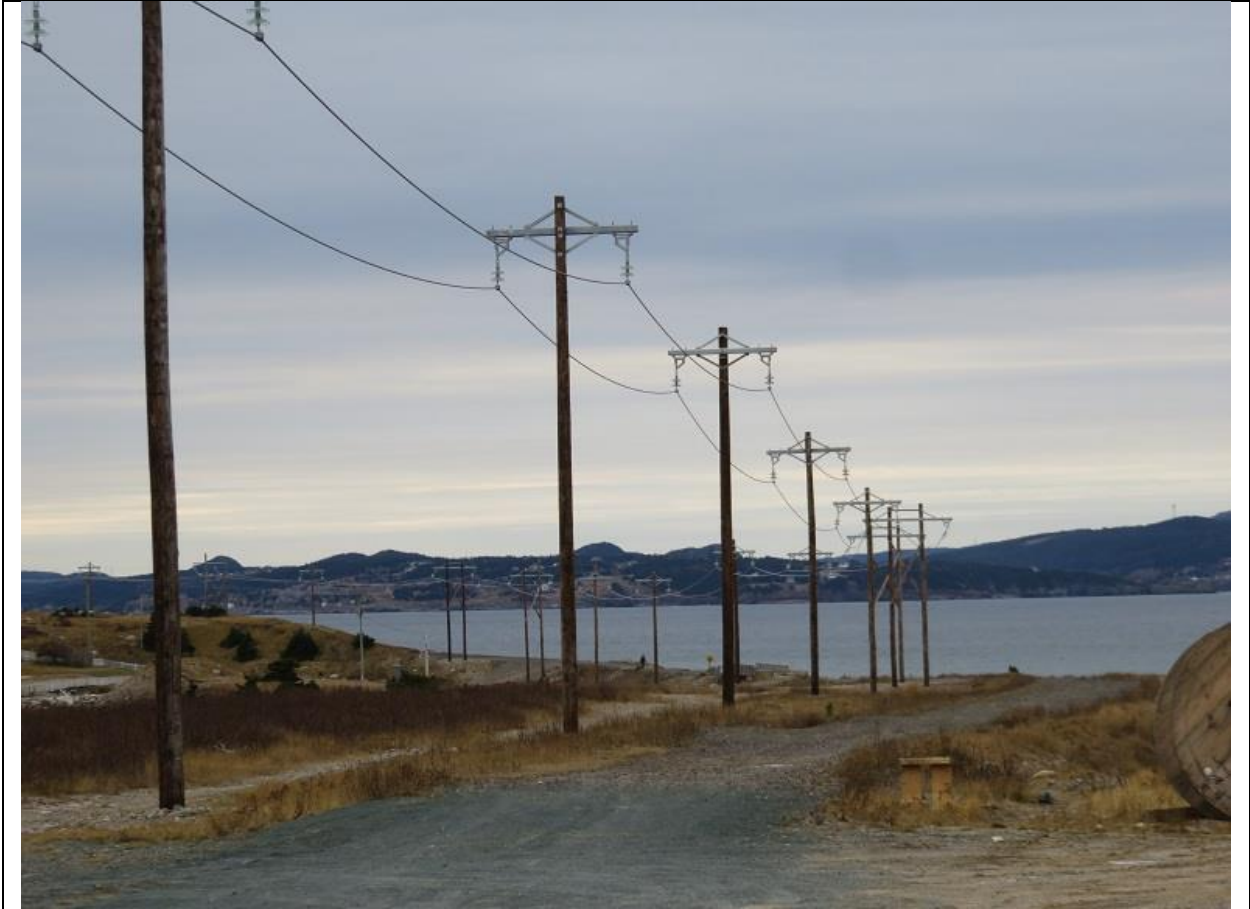
- Construction is nearing completion, electrode wells and their instrumentation are in place (Photos H.1 to H.3).
- Site is awaiting shipment of harmonic filters for the fault locating equipment.

Photo H.1: Grounding line on west side of Dowden’s Point site.

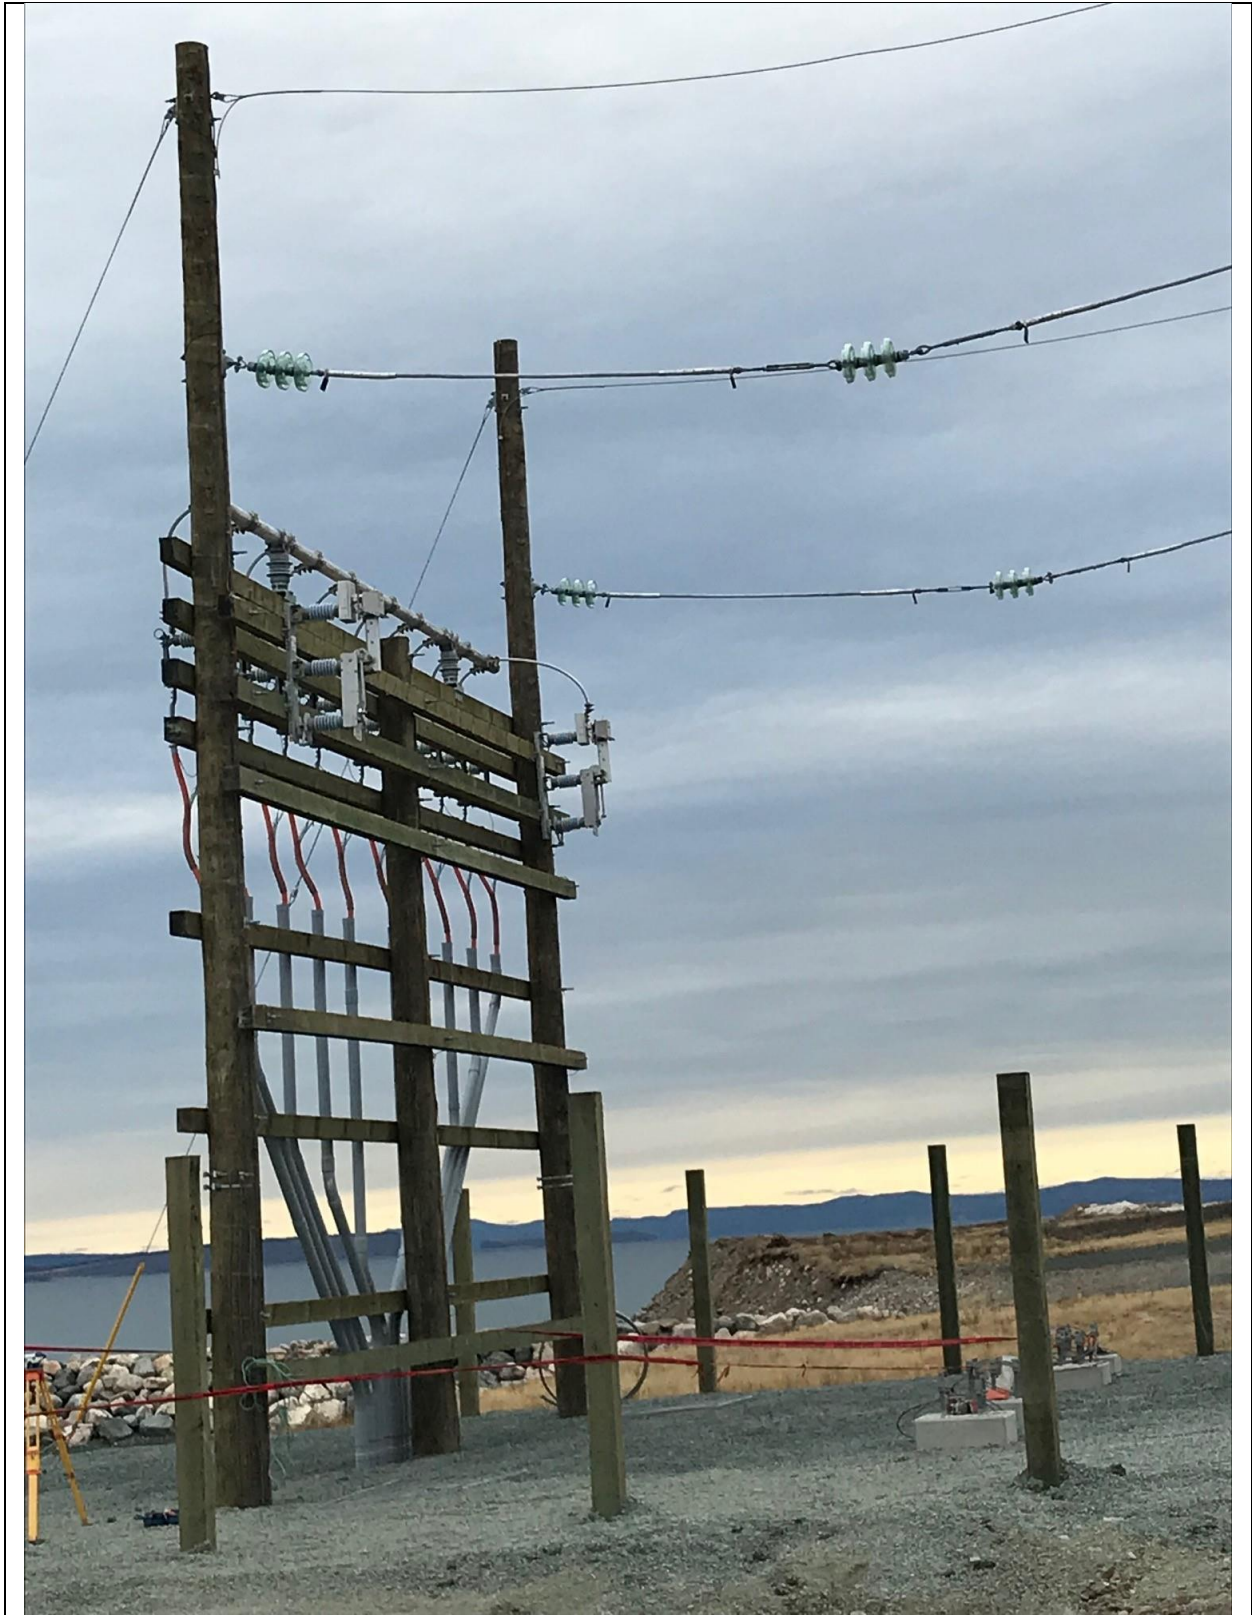
Photo H.2: Dowden's Point grounding lines terminations.

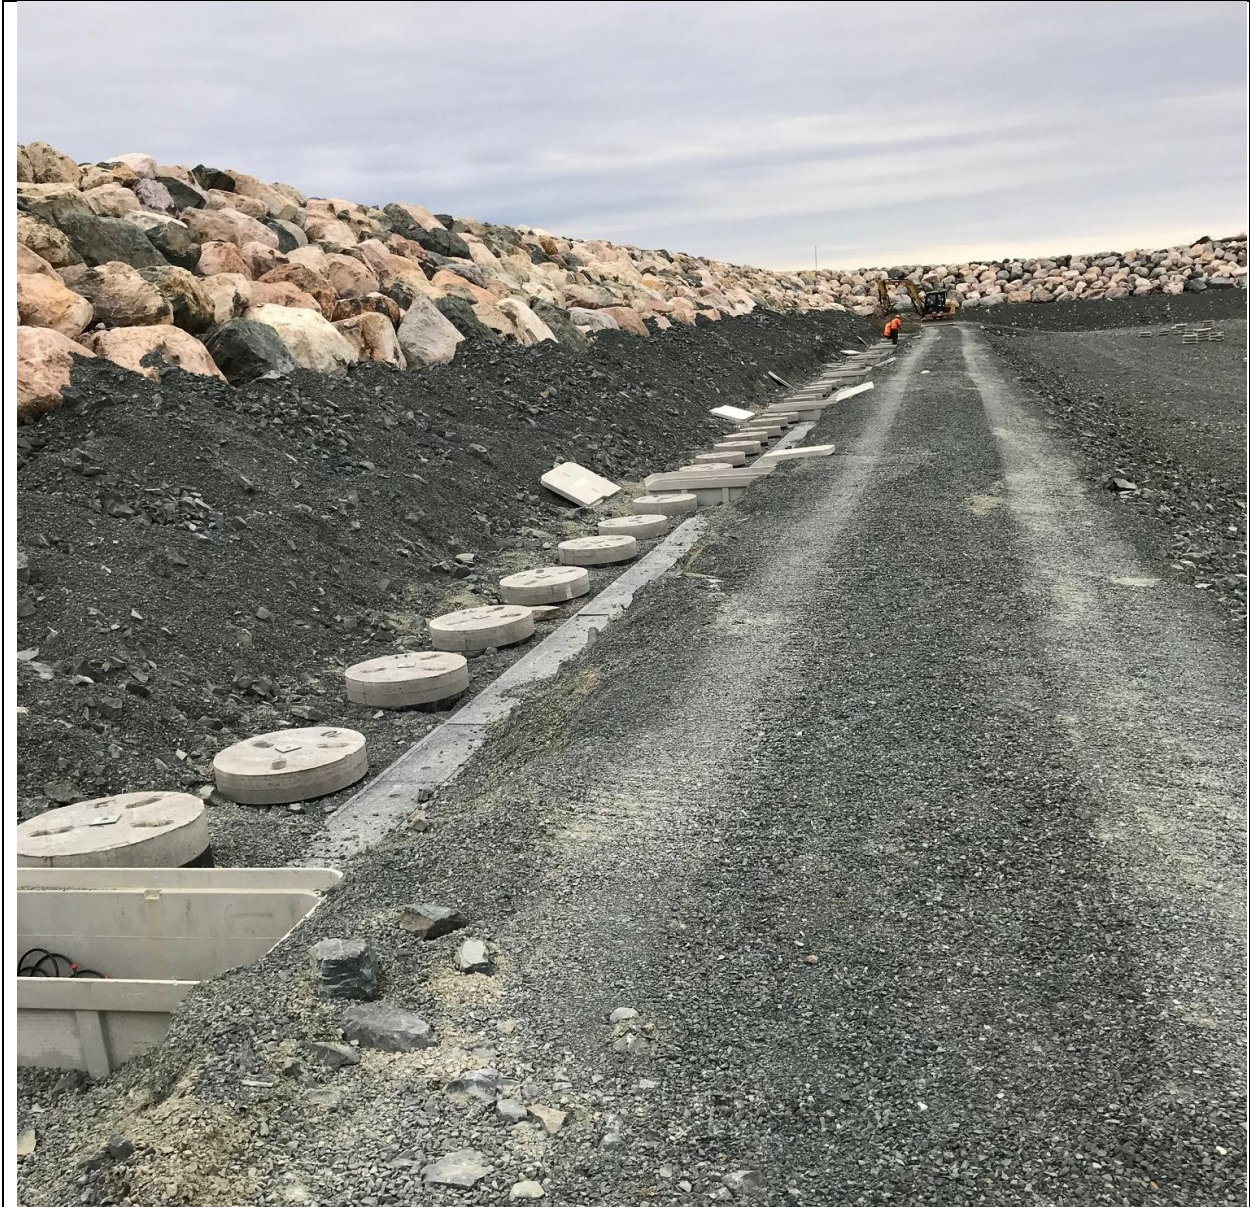
Photo H.3: Dowden's Point electrode wells.
