MEETING IN ST JOHN'S AND VISIT TO MUSKRAT FALLS - SEPTEMBER 21-23, 2015

Prepared for: Nalcor Energy
 IE Point of Contact: Nik Argirov
 Date: November 21, 2015

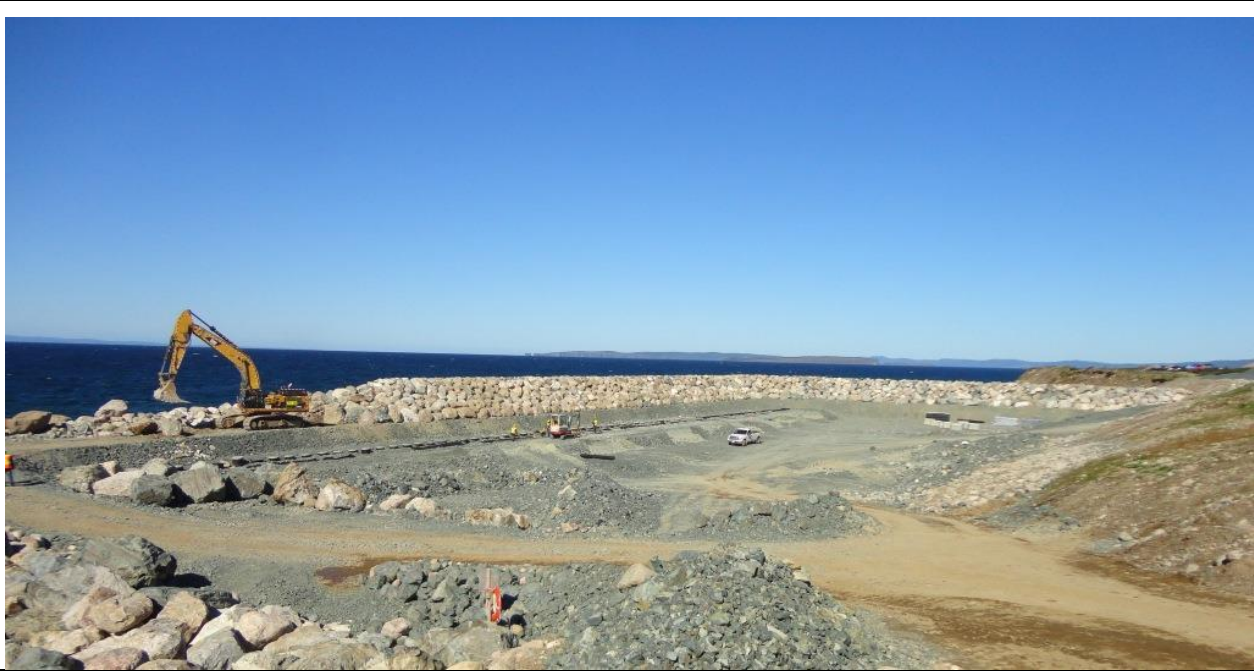
- The shoreline dyke is at an advanced stage of construction (Photo 1.1). The eastern end (Photo 1.2) and central areas are completed. Work was progressing on the western end (Photo 1.3) of the dyke at the time of the site visit.

Photo 1.1: Dowden's Point dyke. Note the line of electrode wells at the base of the dyke.

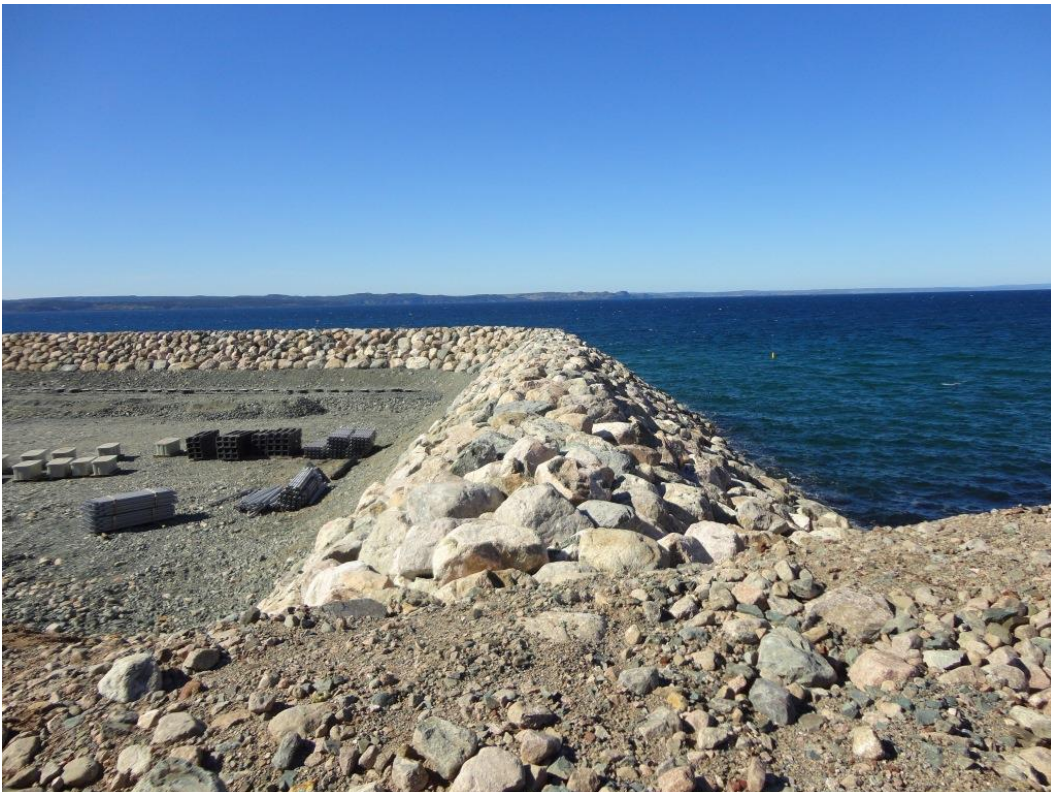
Photo 1.2: East end of the dyke

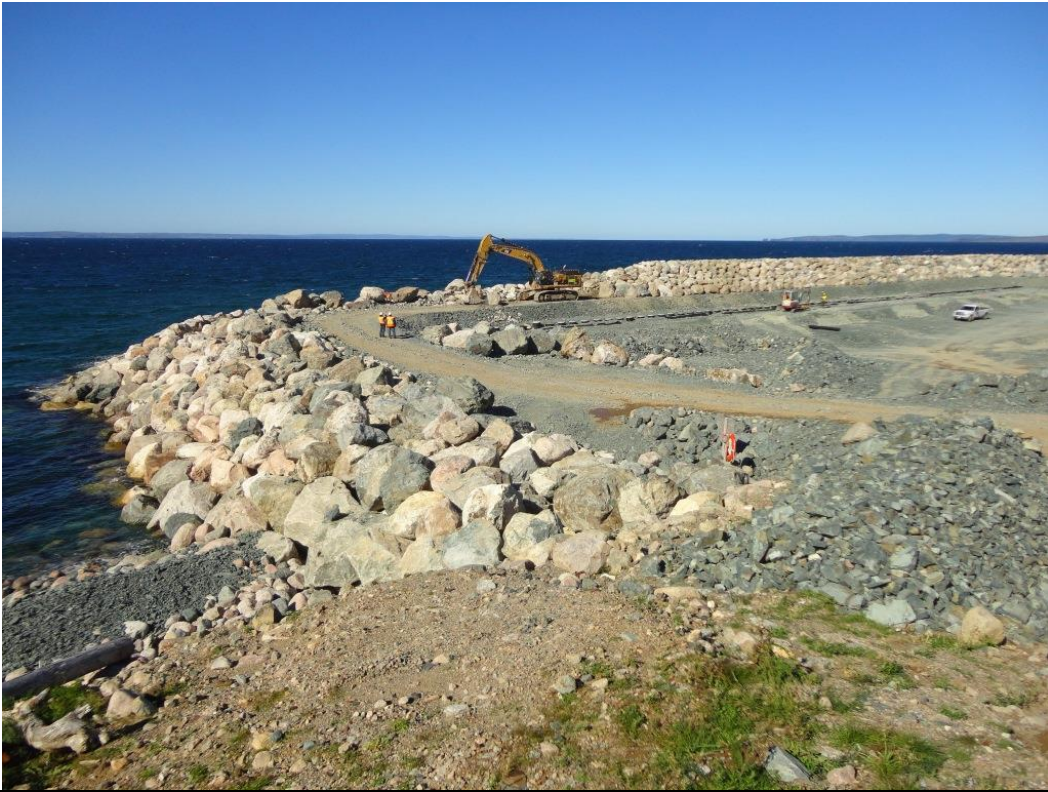
Photo 1.3: West end of the Dowden's Point dyke. Note the ongoing armour stone placement work.

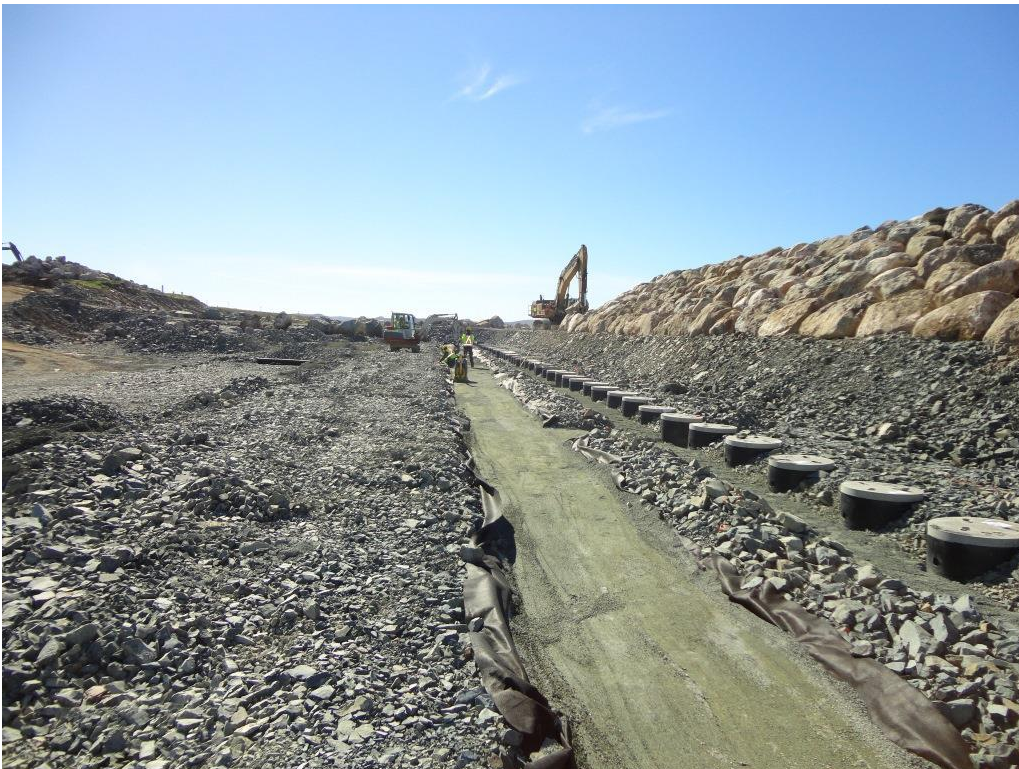
- The electrode wells have been installed adjacent to the inner toe of the dyke (Photo 1.4 and 1.5) and work on the conductor bedding trench was progressing (Photos 1.4 and 1.6).

Photo 1.4: Looking west along the line of electrode wells and the conductor bedding trench.

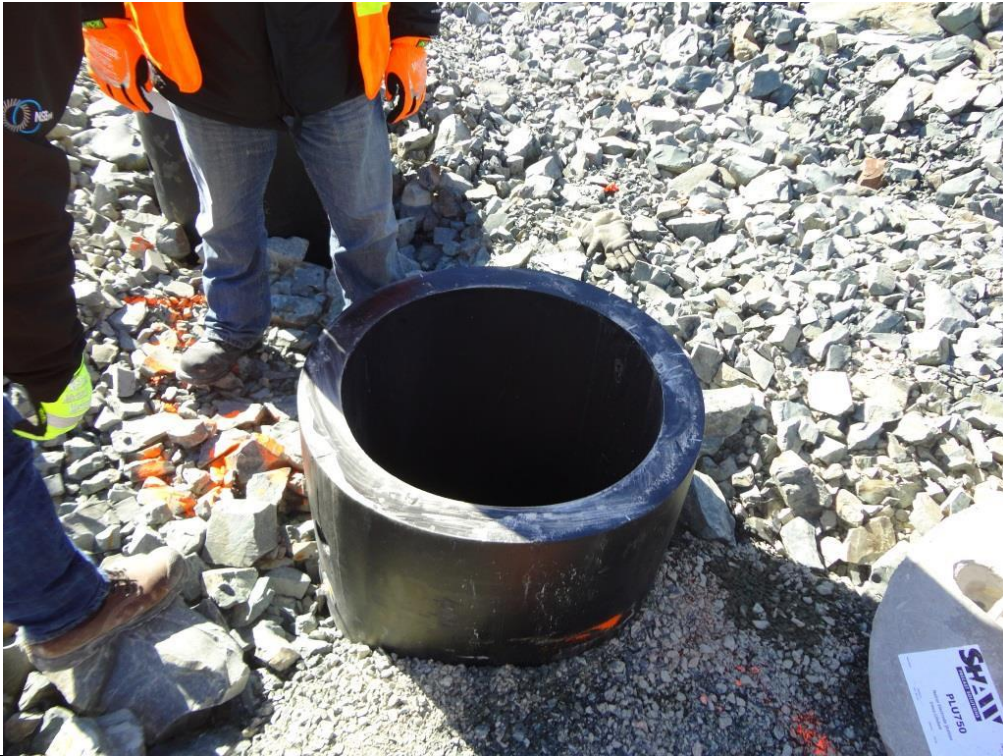
Photo 1.5: Electrode well casing installation

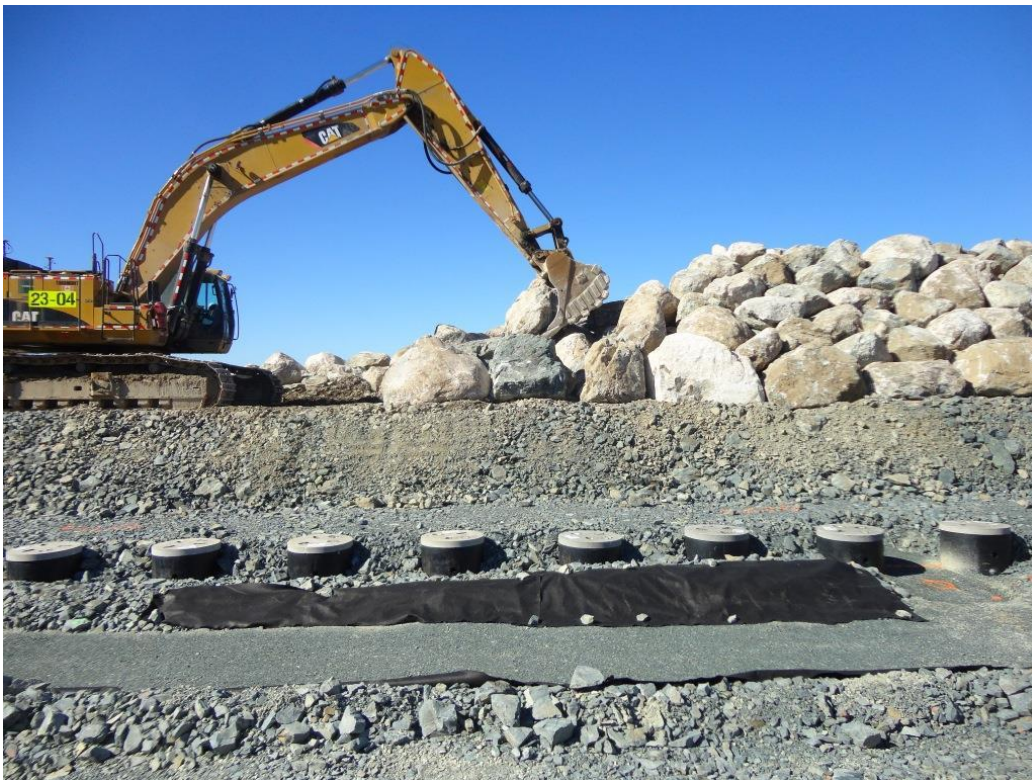
- The upper inner slope, crest and full height outer slope of the dyke are covered by armour stone erosion protection (Photos 1.6 and 1.7). The armour stone consists of equidimensional blocks of very strong granitic rock and Precambrian siltstone. This material was obtained from various off-site sources and is stockpiled at Dowden's Point. Approximately 80% of the armour stone has been placed and 100% has been delivered to the site. In general the rock is of very good quality although a few of the metamorphosed siltstone blocks had numerous tight incipient cracks that could cause some spalling and breakdown over time.

- All of the work on excavations, well installations and fill placement is high quality and in keeping with accepted standards. In particular the armour stone placement works (Photo 1.6 and 1.7) are of exceptionally high quality, generally better than the norm for breakwater installations.

Photo 1.6: Placing and dressing the armour stone at the west end of the dyke. Electrode wells visible in foreground.

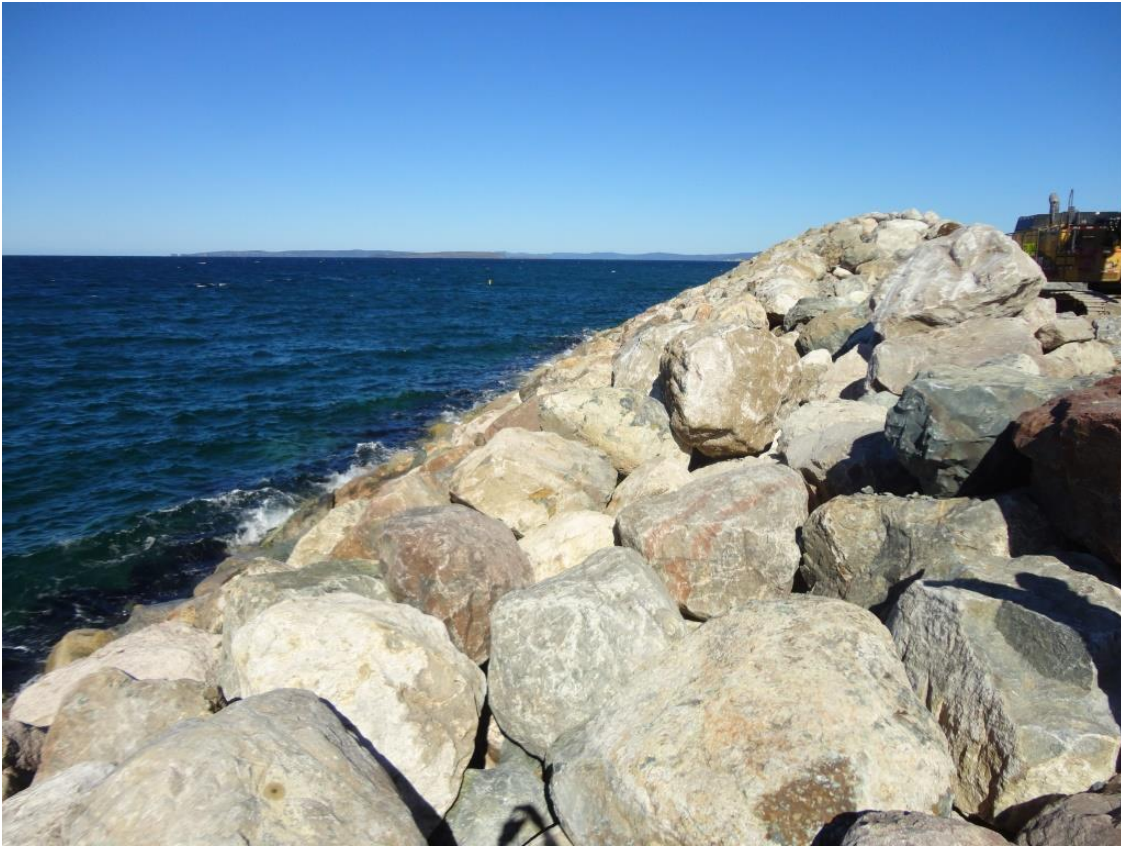
Photo 1.7: Armour stone blanket on the outer slope.

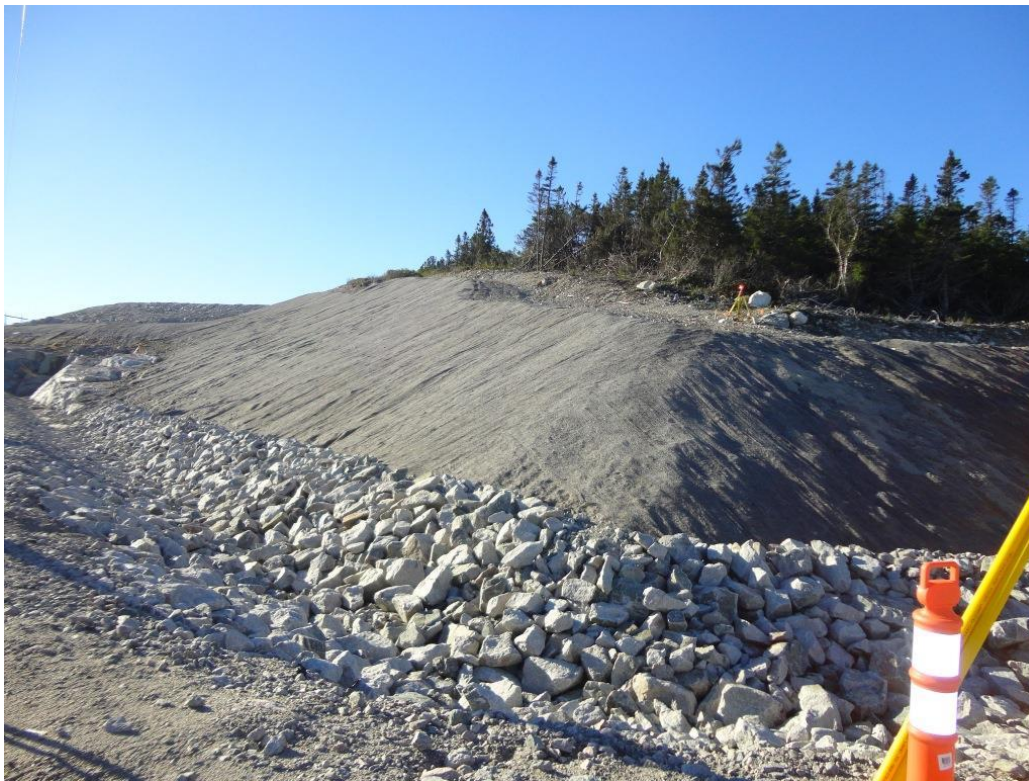
- Virtually all site preparation, including site grading excavations and fill placements has been completed.
- The cut slopes at various locations around the perimeter of the complex have been excavated and are generally of good quality. Photo 2.2 shows the slope at the western side. At this location upper slope is covered by porous coconut/wire mesh slope protection. No seeding has been done and this mat has deteriorated in many places. Rip rap layer is placed on the lower slope.

Photo 2.2: Cut slope in glacial moraine at west end of the facility. The upper slope is covered by porous coconut/wire mesh slope protection. No seeding has been done and this mat has deteriorated in many places. Rip rap layer in place on the lower slope.

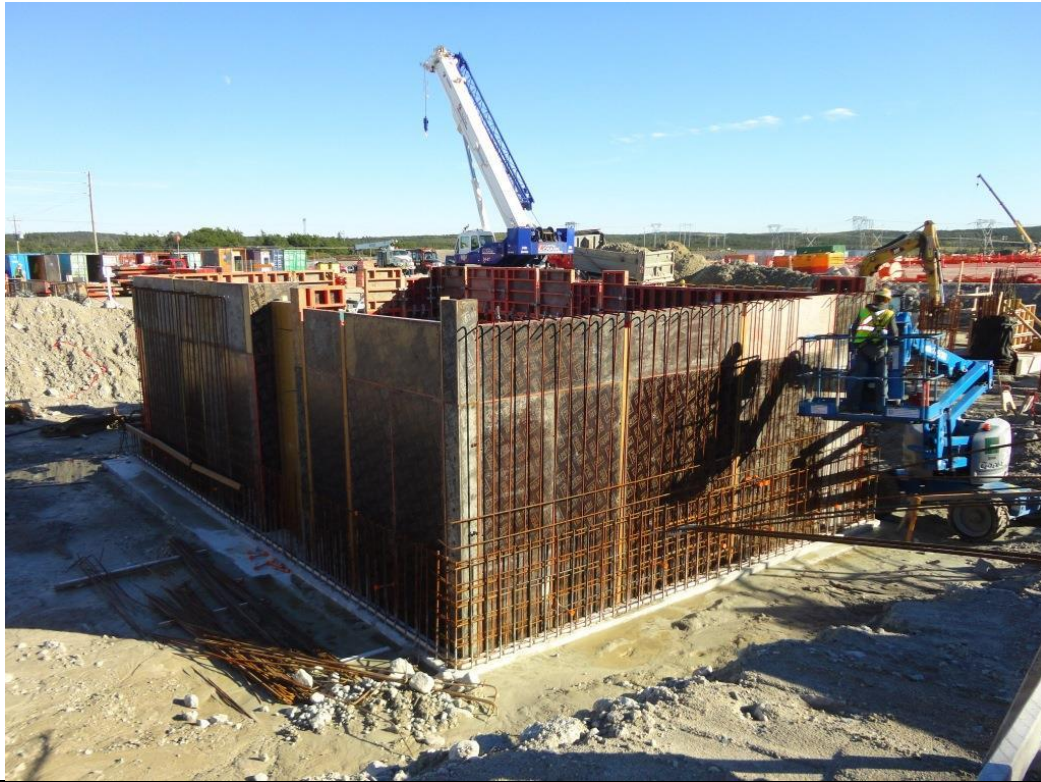
- Formwork has been erected for the sides of the water tank at the converter transformers location (Photo 2.3).
- Erection of the steel framework of the synchronous condenser building is at an advanced stage (Photo 2.5).

Photo 2.3: Formwork and rebar installation for water tank for synchronous condenser facility

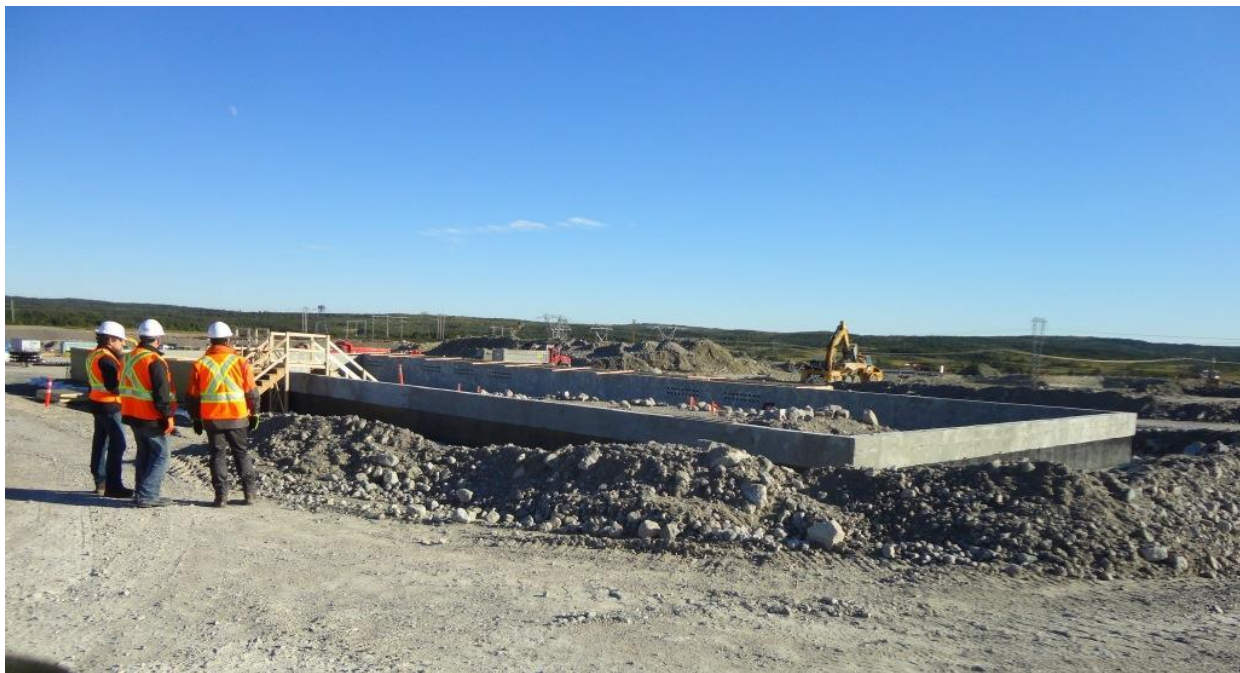
- The footings of the AC substation control building (Photo 2.4) and the base slab of the oil/water separator for the converter facility (Photo 2.6) at the western end of the site have been completed.

Photo 2.4: AC Substation Control Building foundation

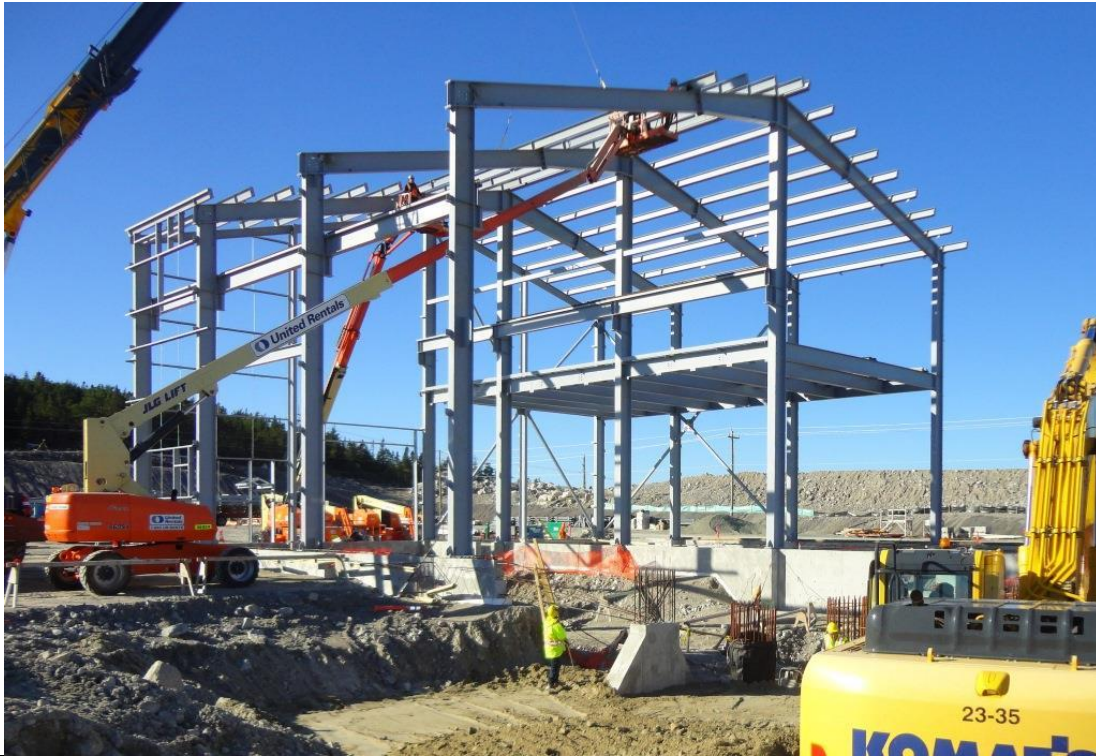
Photo 2.5: Synchronous condenser building

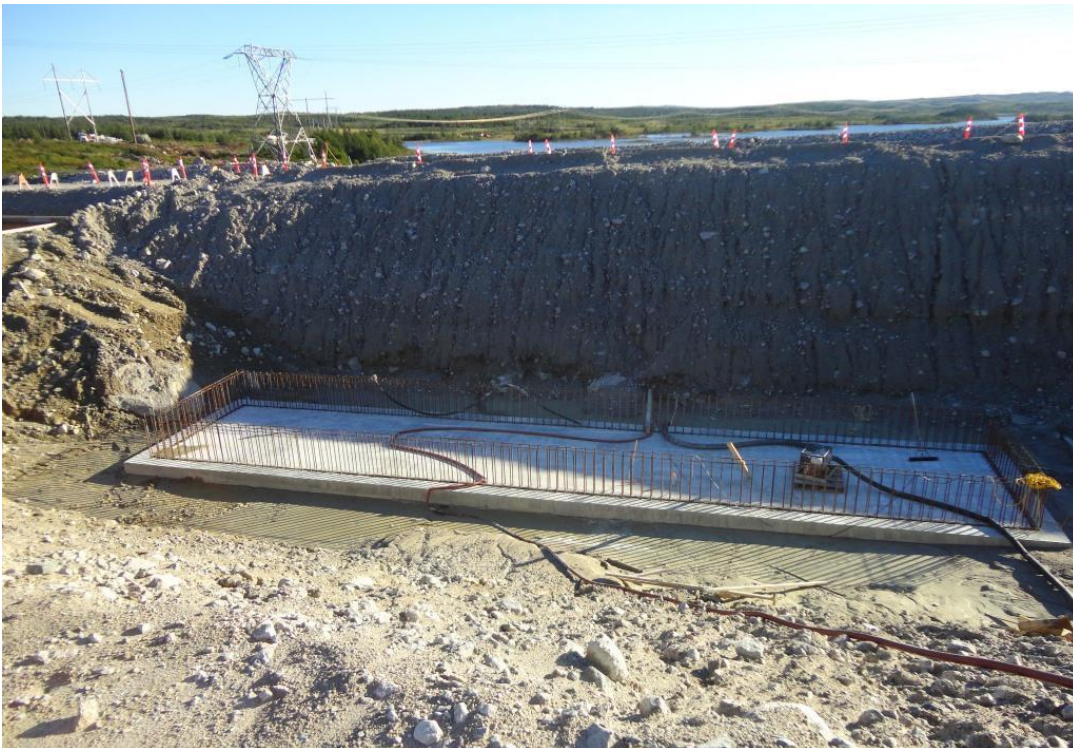
Photo 2.6: Base slab for oil/water separator

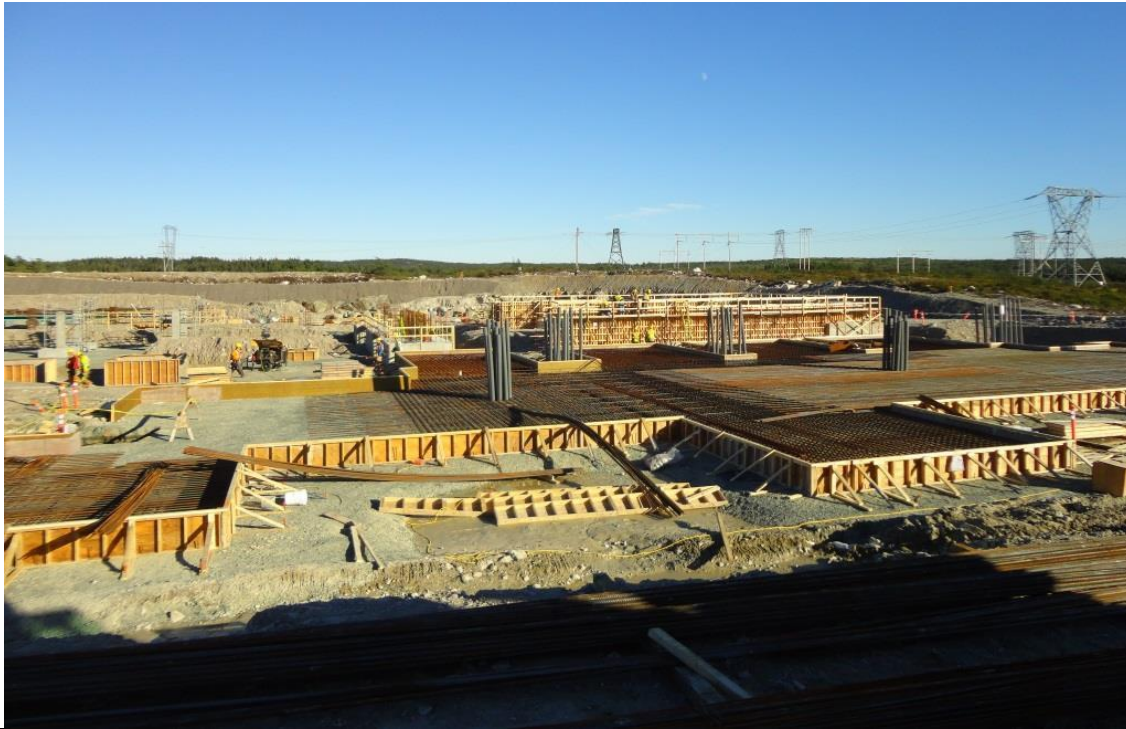
- In general, most of the ongoing work is focused on foundation construction for many major facilities. Foundation footings and/or base slabs are being constructed for the converter building (Photo 2.1), gantries for the AC substation (Photo 2.8), and the converter transformer (Photos 2.9 and 2.10). The footings of the converter facility are at an advanced stage of completion at the south side of this facility (Photo 2.9) and in the very initial stages of construction at the north side (Photo 2.10).

Photo 2.9: DC transformer foundation pads, southern area

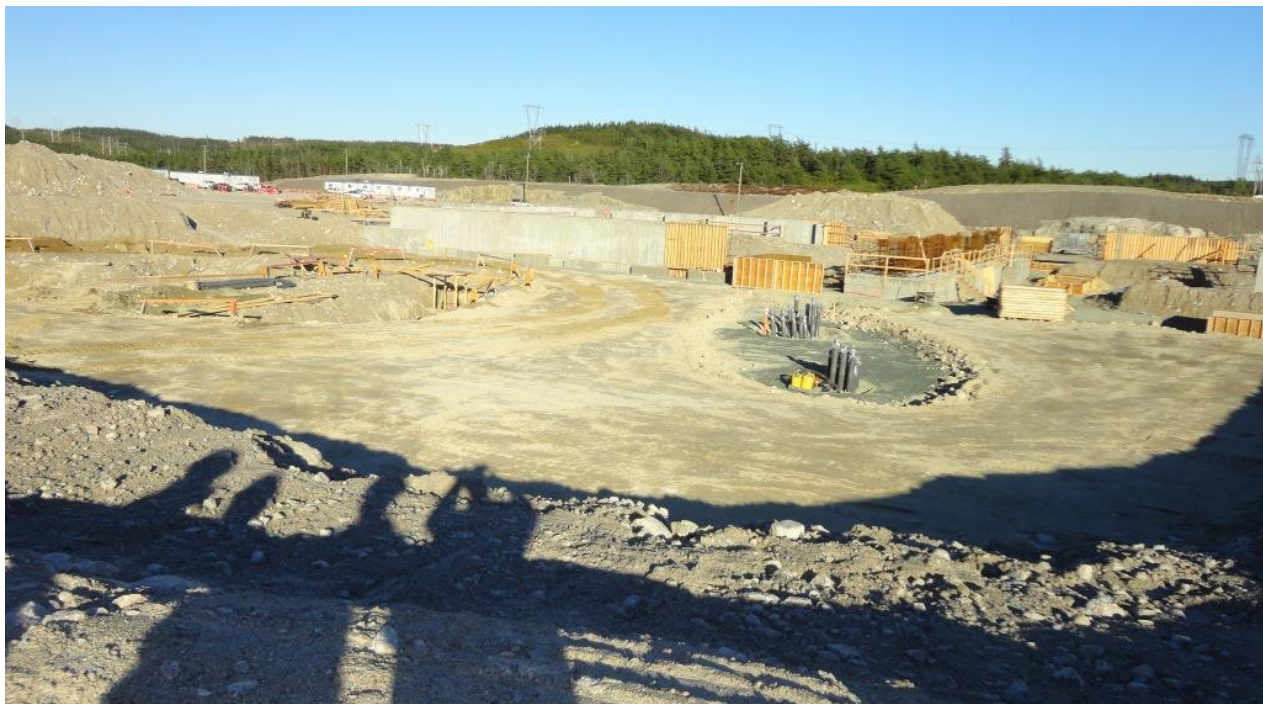
Photo 2.10: DC transformer foundation southern area

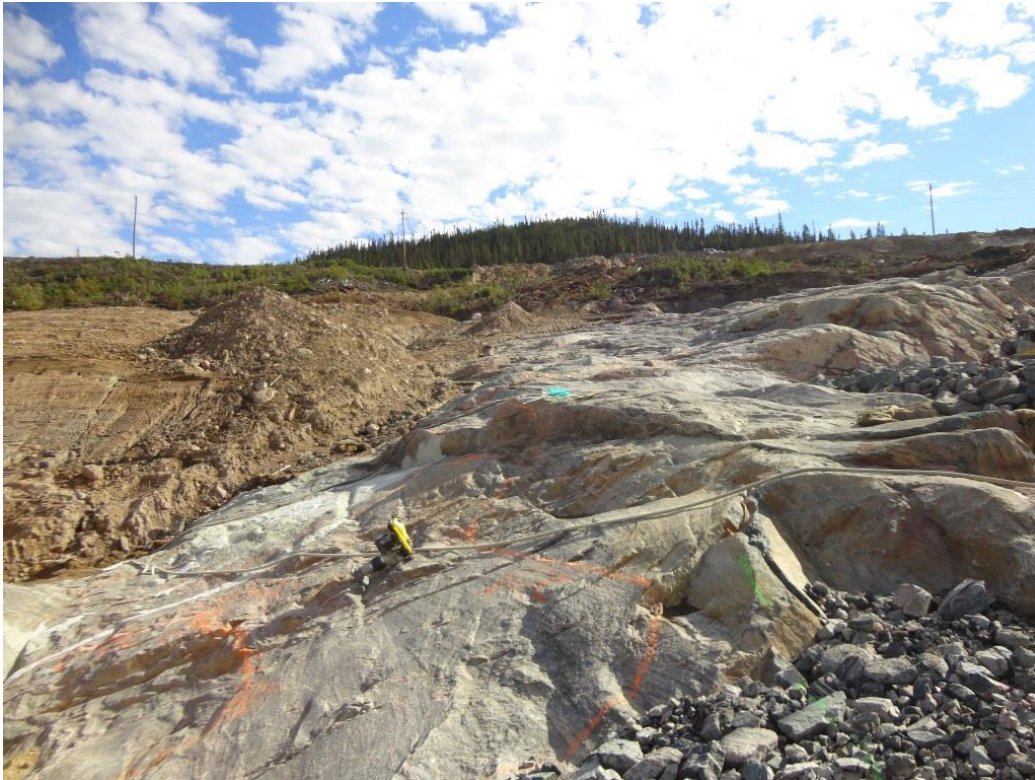
- Bedrock is exposed adjacent to the cutoff near the rock knoll at the south end of the North Spur (Photos 3.11 and 3.12). This is a competent granitic rock. The surface of the rock has been cleaned to an acceptable standard and locally forms the base of the impervious till blanket above el 20m.

Photo 3.11: Upstream slope. Granitic bedrock exposed at the periphery of the rock knoll at the south end of the upstream slope.

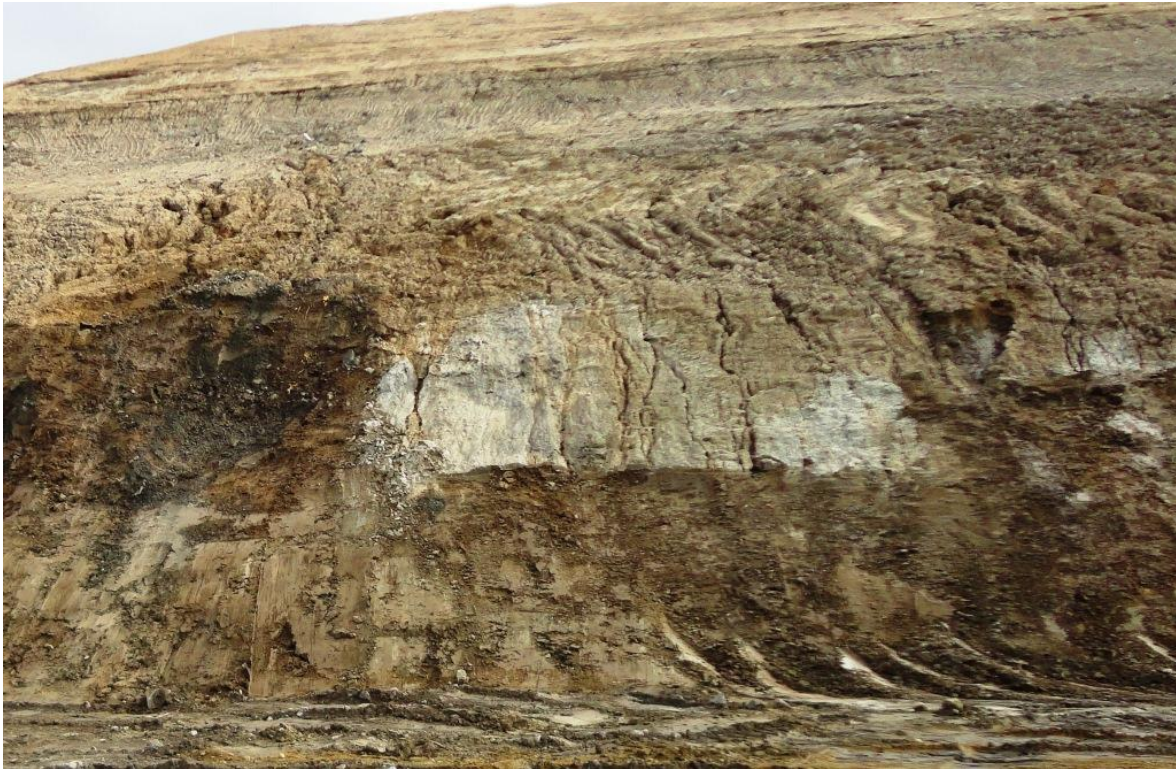
- The Upper Sand and Upper Clay are exposed in the upstream slope above el 20m. Site geotechnical engineer report that the material is most interlayered sand and silt (Photos 3.13 and 3.14). Most of the laying is discontinuous and most layers pinch out horizontally.

Photo 3.13: Upstream slope- Excavated slope in the upper clay and sand. Note the erosion runnels in the sand/silt at mid height.

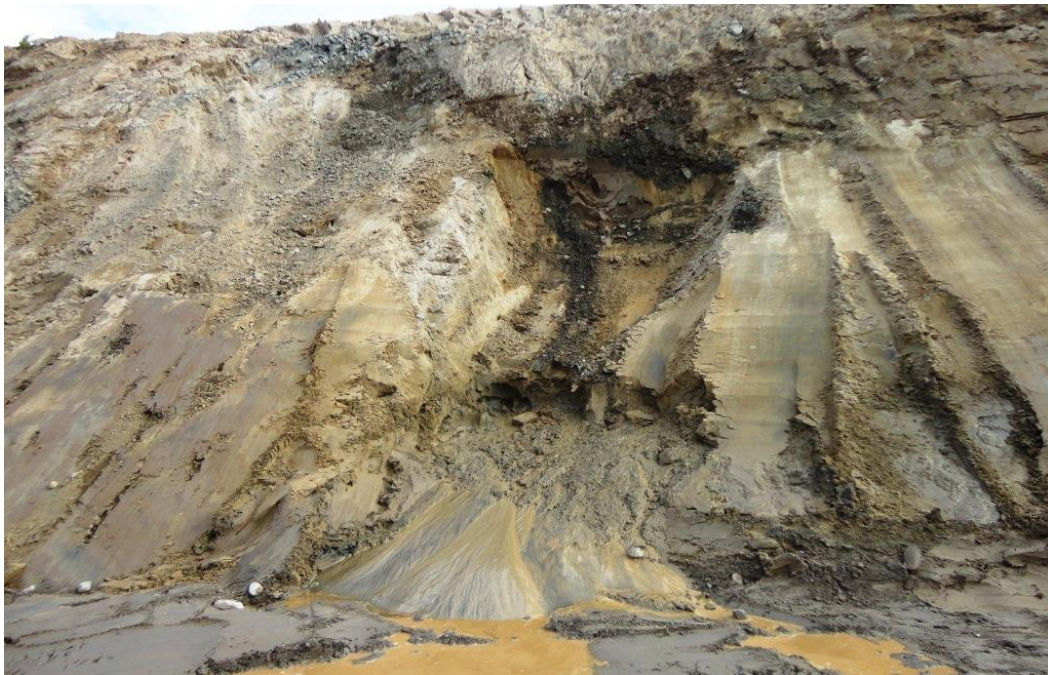
- There are numerous water seepages from sand layers in the excavated faces (Photo 3.14). This causes minor localized washouts but has not caused any significant geotechnical issues. It was noted that temporary slopes in the sands and silts are very susceptible to erosion but once again this is not a problem since the slopes are temporary and will later be covered and protected.

Photo 3.14: Upstream slope, layered Upper Clay/Sand zone. Note the water seepage from sand layers at lower and upper slope levels. This has caused localized washout of materials.

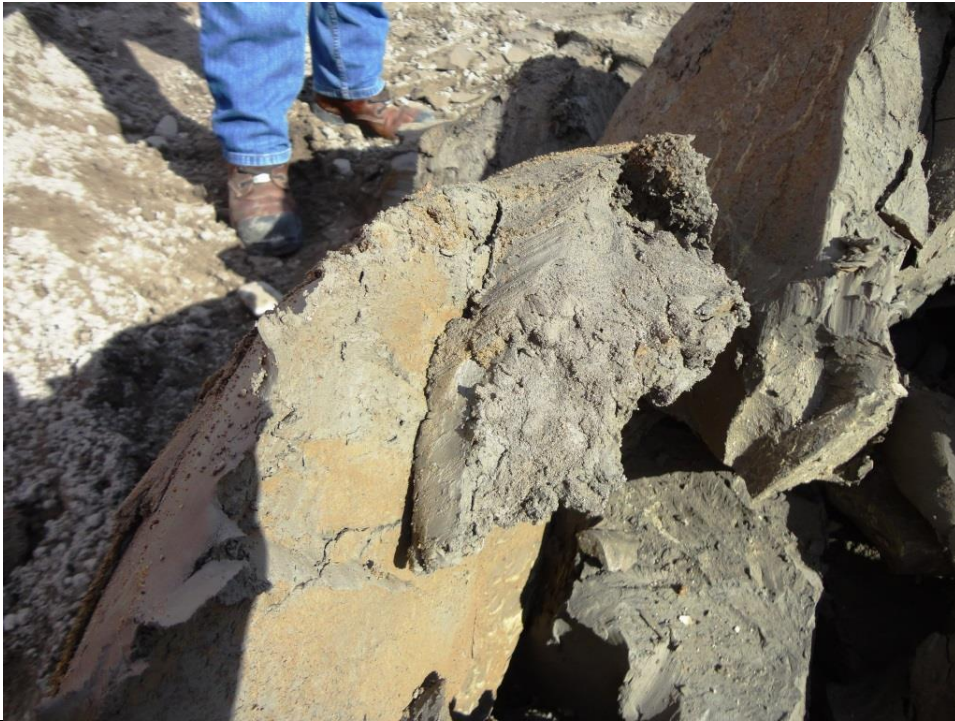
- The lower clay rises to high levels at the south end of the North Spur. Recently excavated material was examined during the September 23 site visit (Photo 3.15). This material which was examined could be seen to be very different

from the upper sand and silt/cay. It is dark greenish grey, firm and plastic with no tendency for liquefaction behaviour when disturbed.

Photo 3.15: Upstream slope- Excavated greenish grey “lower clay” from the south end of the cut-off. The lower clay is a firm, plastic clay with low sensitivity. This material is at approximate el 20m along most of the upstream face and is the impervious material that the base of the cut-off wall is seated in.

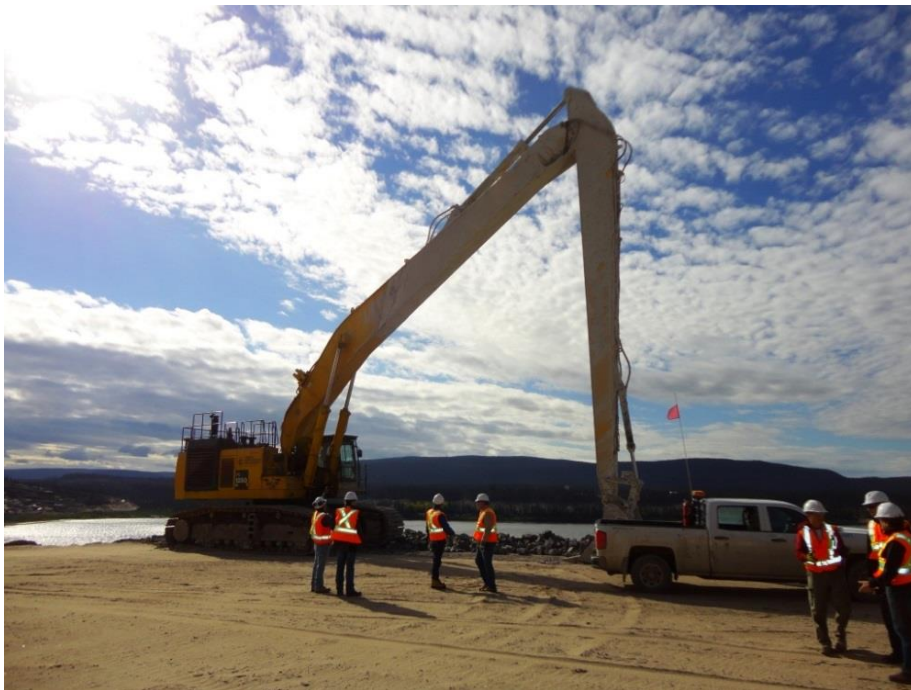
- To date, the wall was excavated with a long-stick backhoe (Photo 3.16). This excavator can dig to depth of just below 17m. Bentonite/cement slurry was mixed on site (Photo 3.18) and delivered to trench by pipe. The slurry is a plastic bentonite/cement mixture with a 28 day strength of 300 to 400 KPa. Batching quantities are as follows

Photo 3.16: Upstream slope- Long stick backhoe excavator used to excavate most of the upstream slope cut-off wall to depths of about 15m

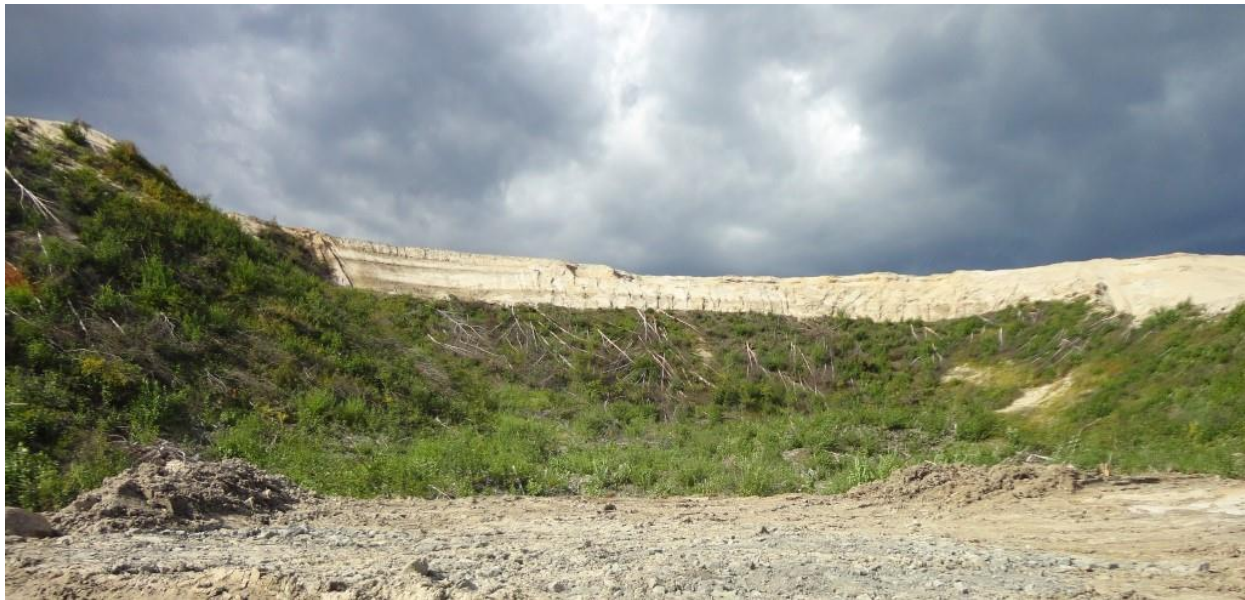
- Brush clearing is complete in the area and various features are now more visible than was the case in earlier site visits. Photo 3.19 shows the back scarp of the 1978 landslide. Slide debris from that event can still be seen in some areas.

Photo 3.19: Downstream slope. View of the scarp of the 1978 landslide.

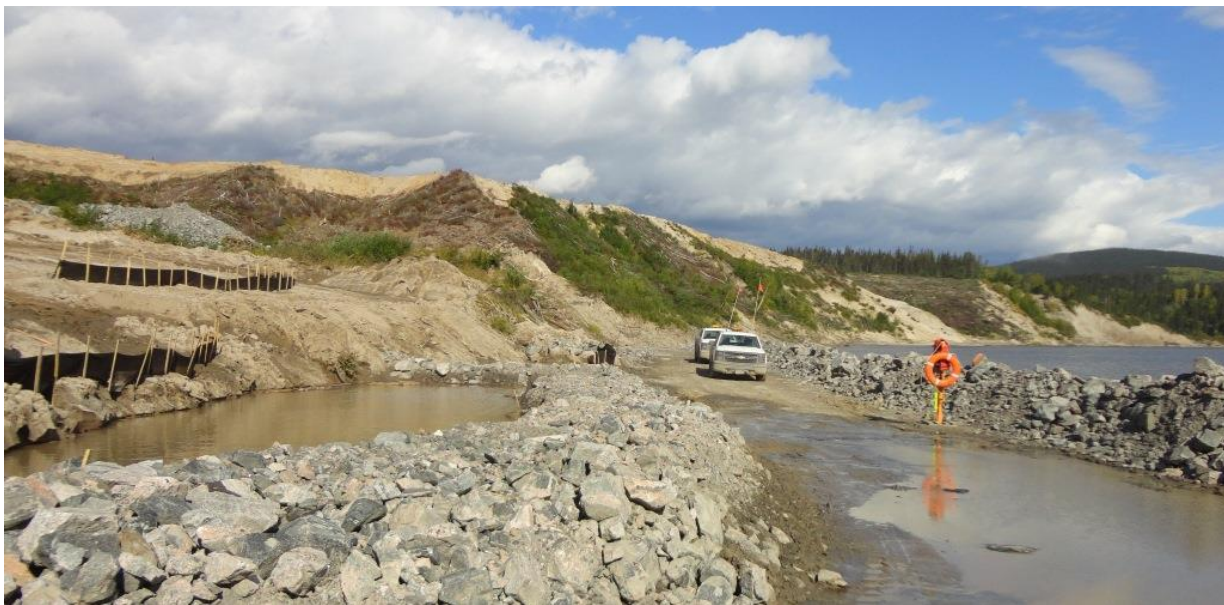
- A toe berm has been excavated and some slope trimming has been done in the lower slope (Photo 3.20).
- Water collection ditches and berms have been constructed at the toe of the slope (Photos 3.20 and 3.21).

Photo 3.20: Downstream slope; water collection and silt fences at toe of slope. Some slope trimming has been done in the lower slope. Some debris from the 1978 slide are visible in the background (upslope from the white pick-up trucks).

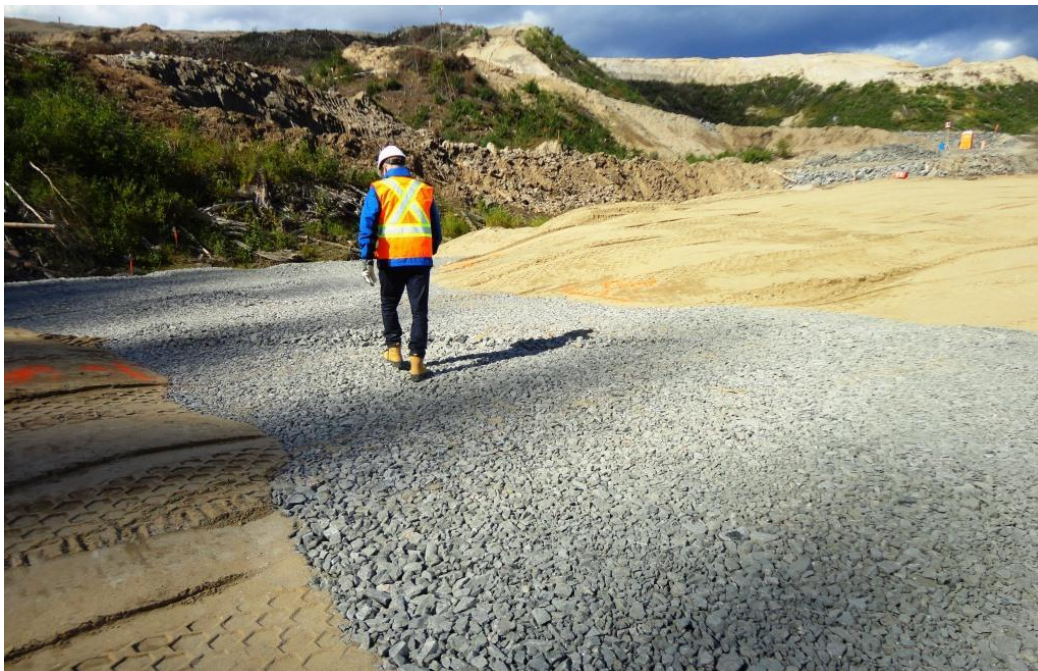
- Work on the southernmost finger drain is at an advanced stage (Photo 3.22). The finger drain will be embedded within the fill that will form the lower slope in this area. These drains are part of the water control measures designed to depress the water table in the slope.

Photo 3.22: Downstream slope; finger drain near the toe of the slope. The finger drain filters extend across the slope.

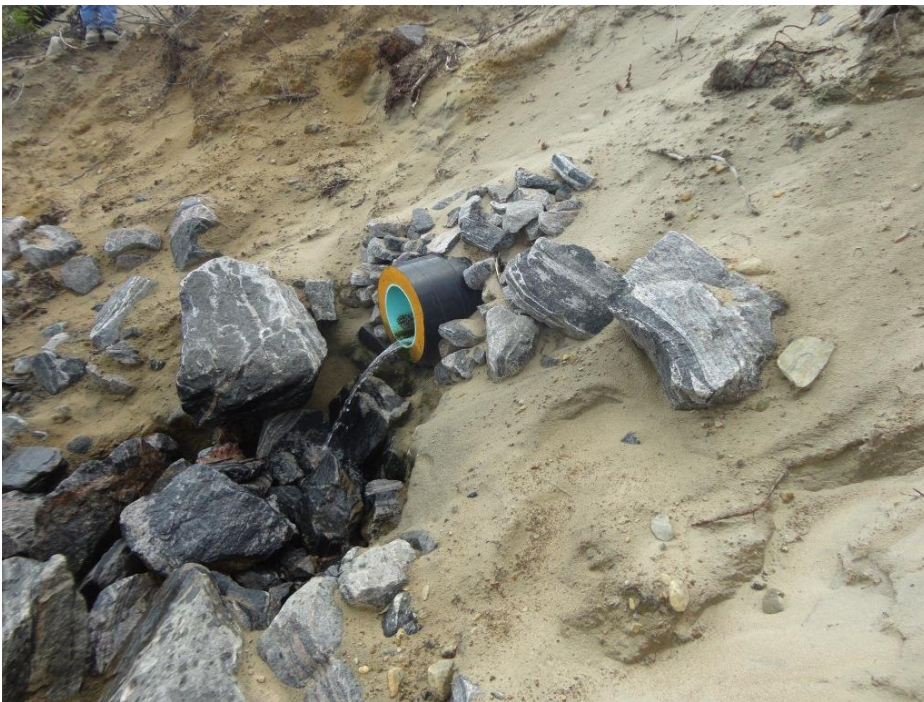
- Rip rap, underlain by a granular transition zone, has been placed on the permanent slope below the toe berm.
- The Kettle lakes outlet gully (Photo 3.25) and the outlet drain of the dewatering wells (Photo 3.26) were inspected. As can be seen on Photo 3.26, the wells were discharging a small continuous flow, estimated to be less than 10 l/min at the time of the site visit.

Photo 3.26: Pumped wells outlet pipe in the ravine downstream of the kettle lakes.

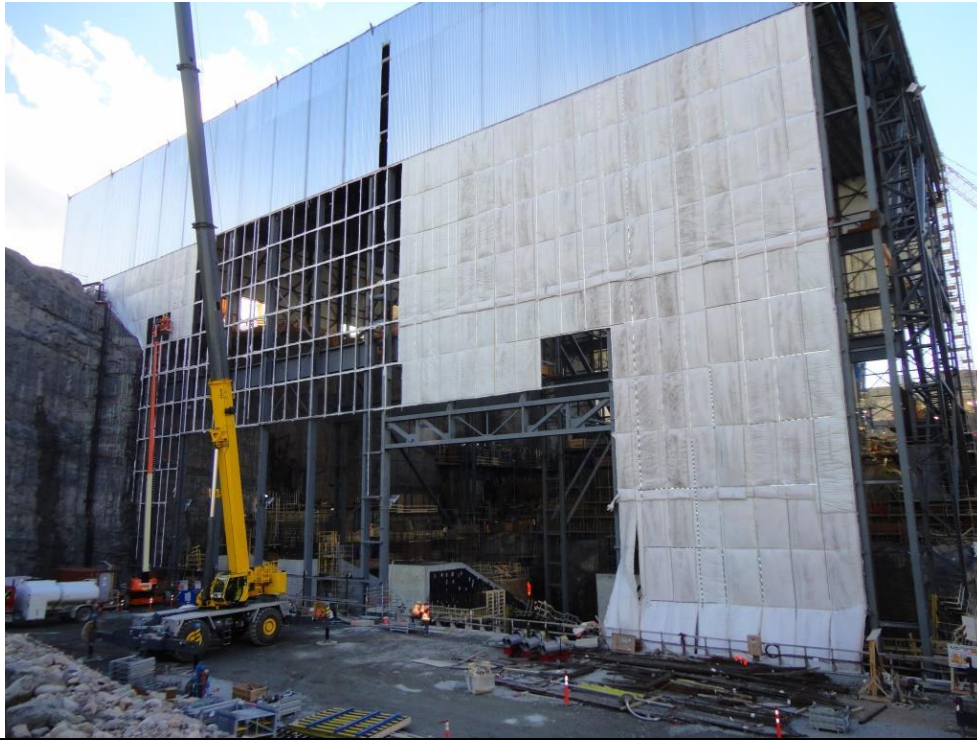
- The partially completed ICS (Integrated Cover System) shelter, which was covering Units 1 and 2, is currently being dismantled to allow better over head access for two new cranes to be installed. (Photos 4.7 and 4.8). Winter shelter for various works will be provided by local heated shelters, similar to those used for the spillway works.

Photo 4.7: Powerhouse – ICS shelter structure over units 1 and 2 is currently being dismantled.

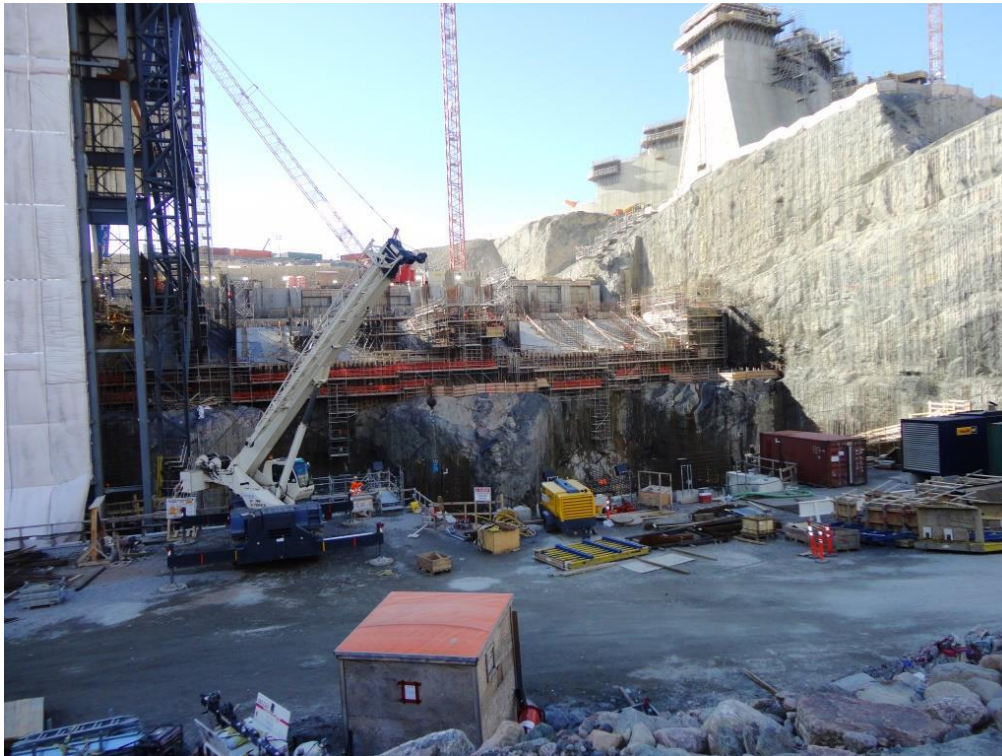
Photo 4.8: Powerhouse. Rock excavations for Units 3 and 4 are visible in the centre of the photo..The concrete transition dam is visible at the upper right side of the photograph.

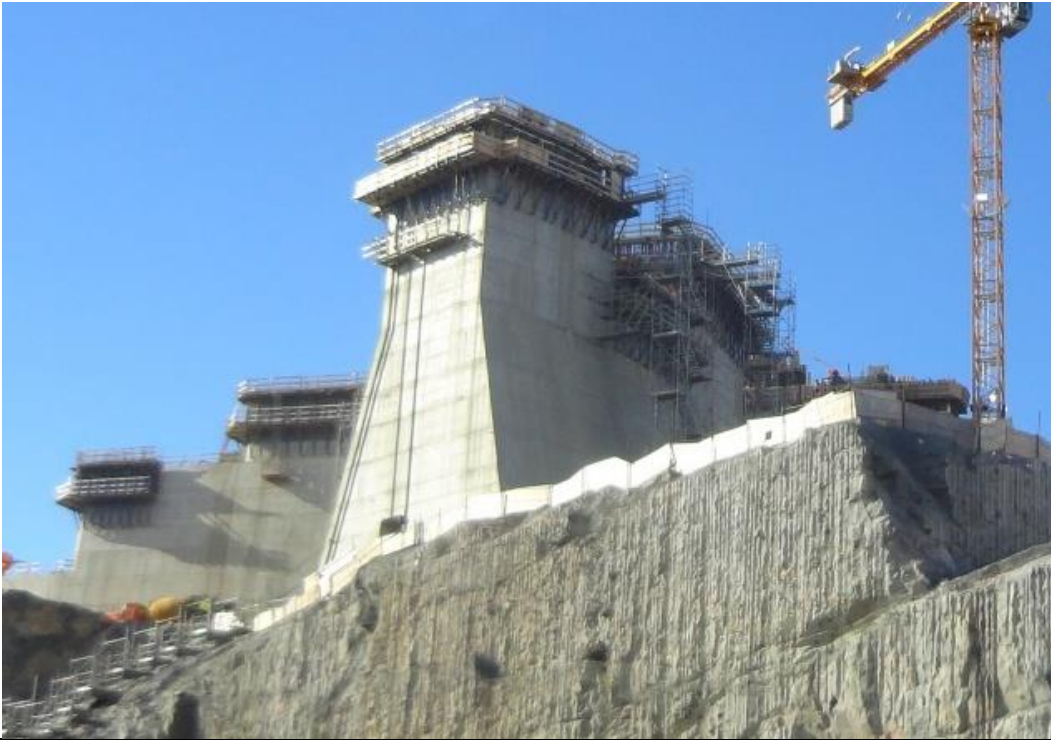
- The concrete dam between the powerhouse and spillway is at an advanced stage of construction (Photo 4.9).
- Formwork construction for the scroll cases at Units 1 and 2 (Photos 4.10, 4.11 and 4.12) is at an advanced state. At the time of the site visit no similar formwork was in place at Units 3 and 4 (Photos 4.13 and 4.14).

Photo 4.9: Concrete transition dam between the powerhouse and the spillway
