MEETING IN ST JOHN'S AND VISIT TO MUSKRAT FALLS - SEPTEMBER 21-23, 2015

Prepared for: Nalcor Energy
 IE Point of Contact: Nik Argirov
 Date: November 21, 2015

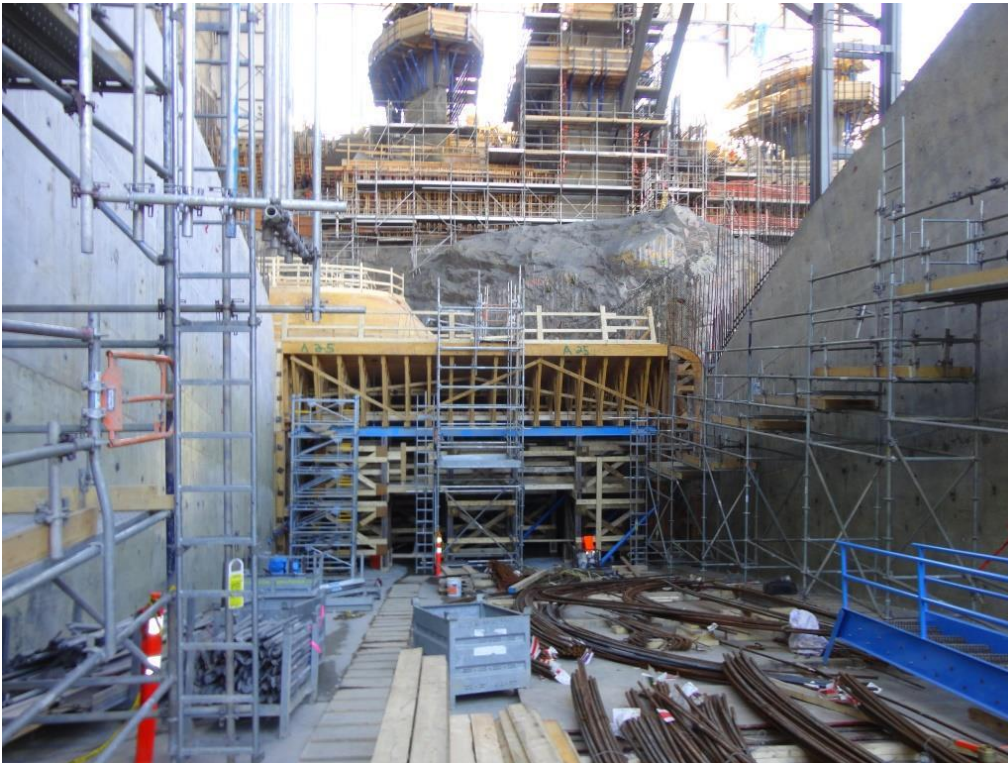
- The concrete dam between the powerhouse and spillway is at an advanced stage of construction (Photo 4.9).
- Formwork construction for the scroll cases at Units 1 and 2 (Photos 4.10, 4.11 and 4.12) is at an advanced state. At the time of the site visit no similar formwork was in place at Units 3 and 4 (Photos 4.13 and 4.14).

Photo 4.10: Powerhouse, Unit 1. Formwork for the scroll case is visible
