MINERAL DEVELOPMENT DIVISION - REHABILITATION PROJECTS

LA MANCHE MINE, PLACENTIA BAY

VISUAL OBSERVATION SUBSIDENCE AT THE FORMER TERRA NOVA MINE

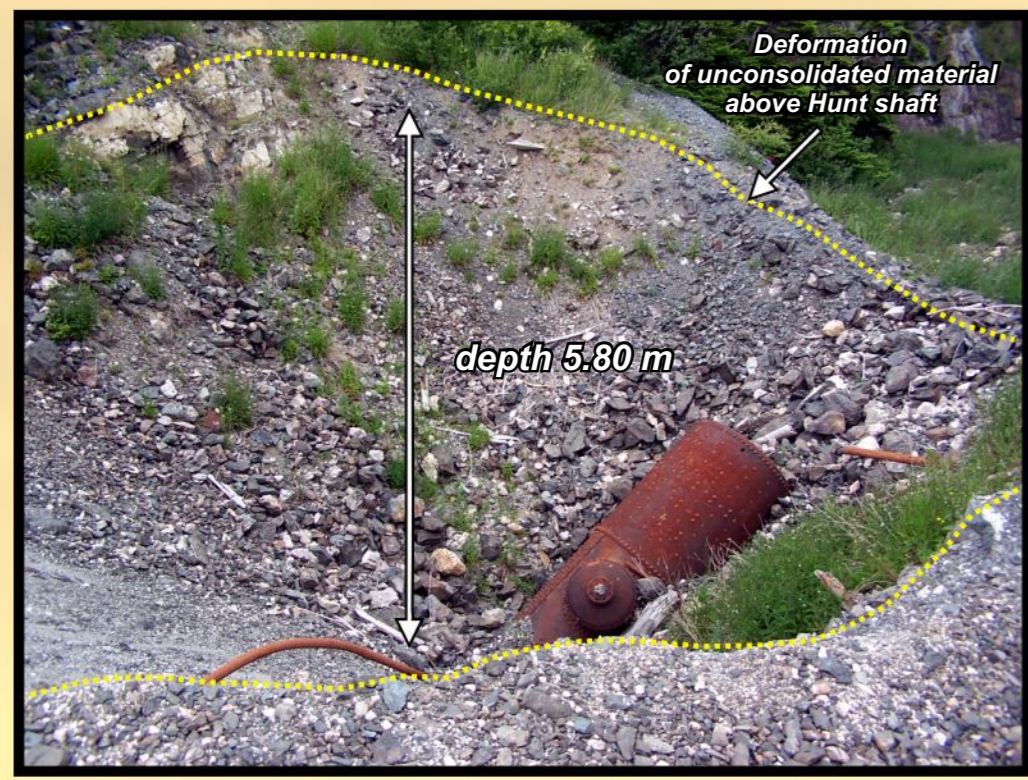
View of Hunt shaft before rehabilitation

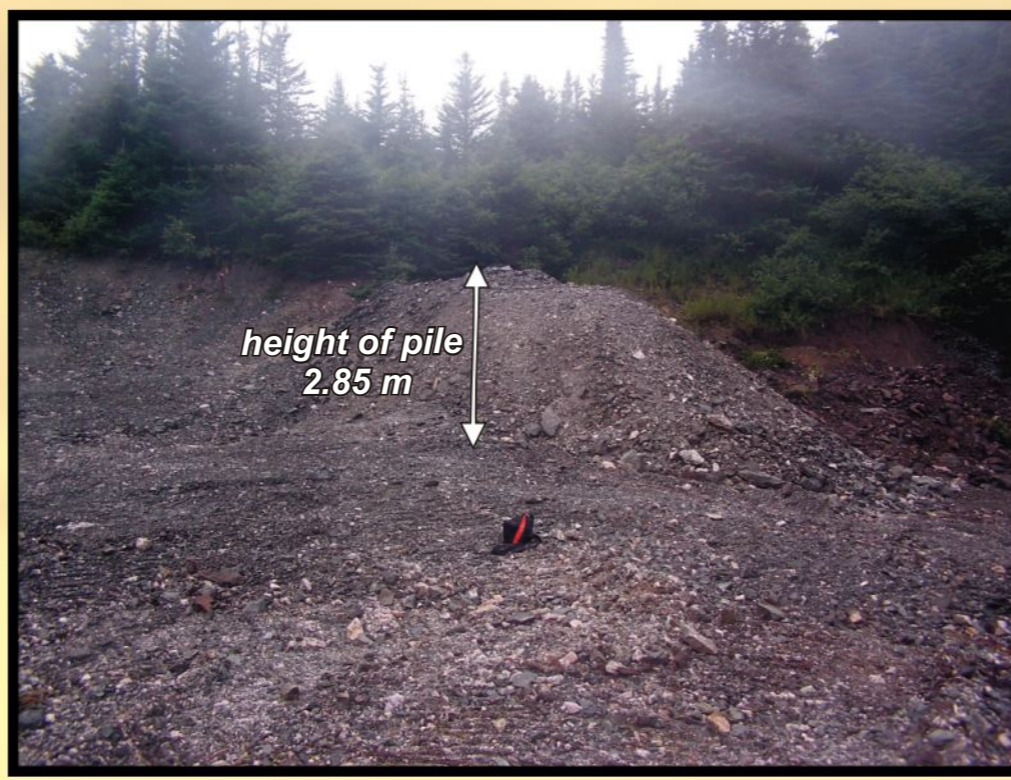
View of Hunt shaft after rehabilitation

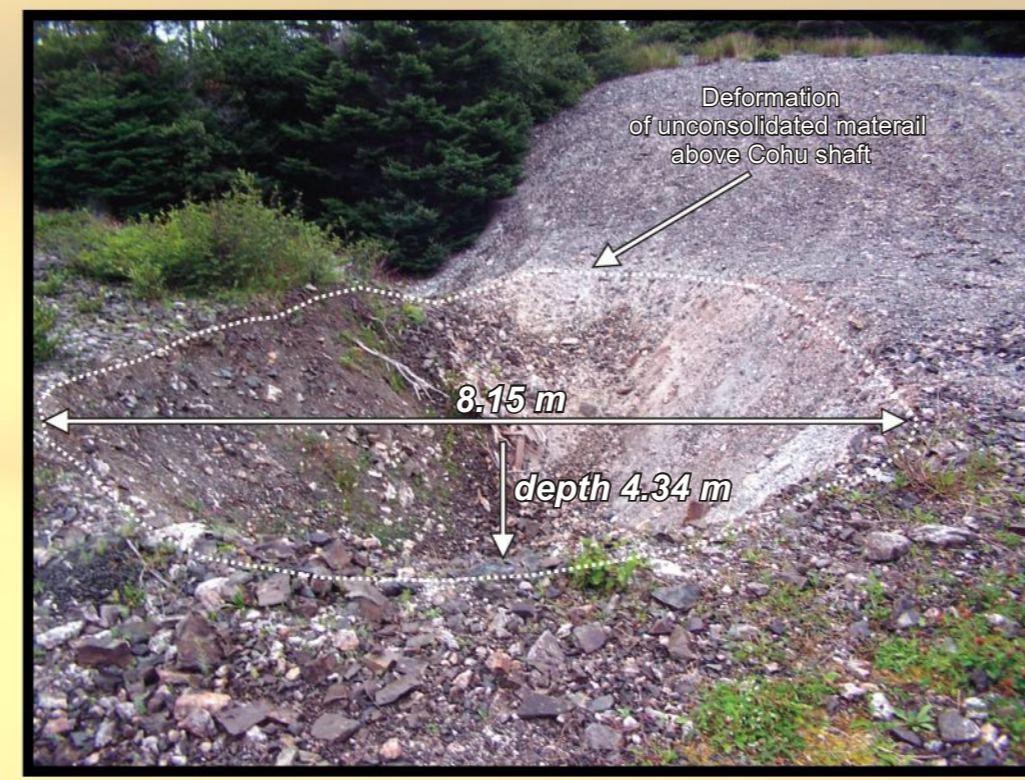
View of Cohu shaft before and after rehabilitation

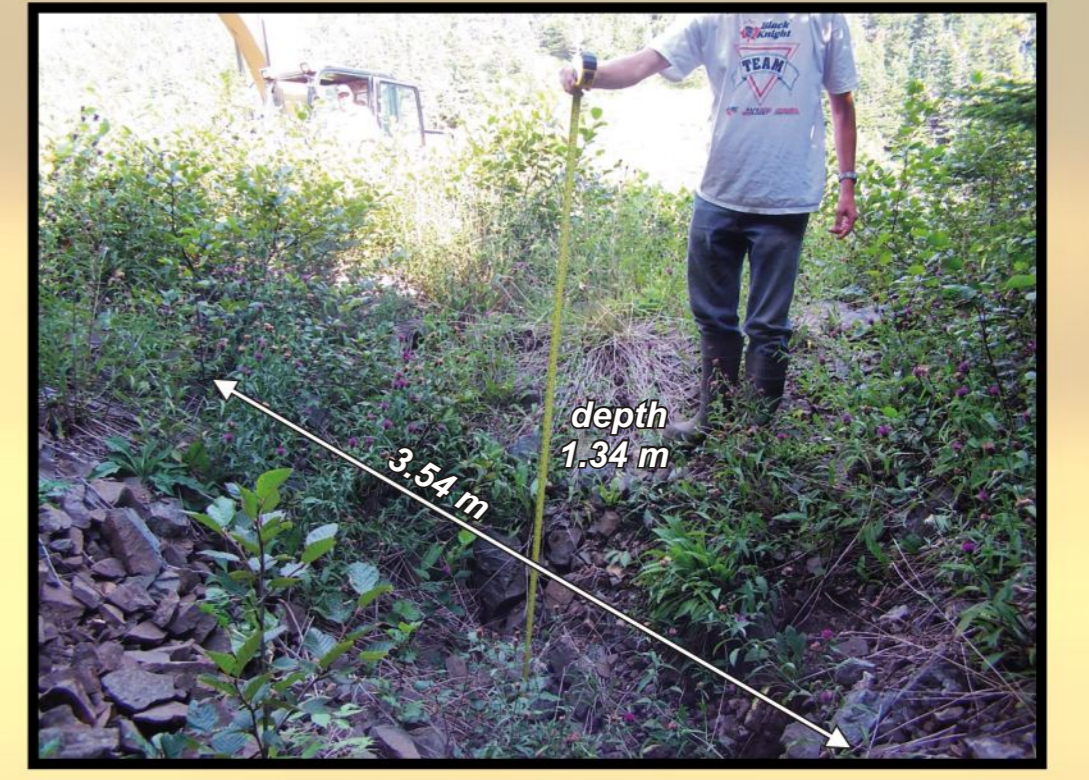
View of McConachie shaft before and after rehabilitation

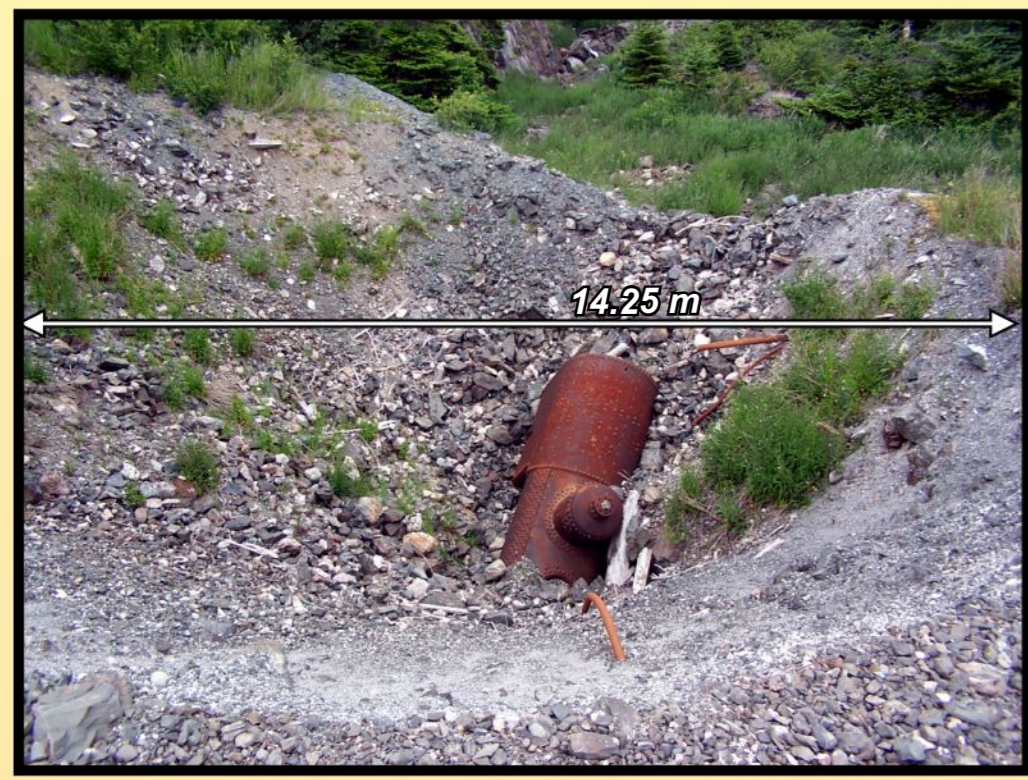
View of Hunt shaft before rehabilitation

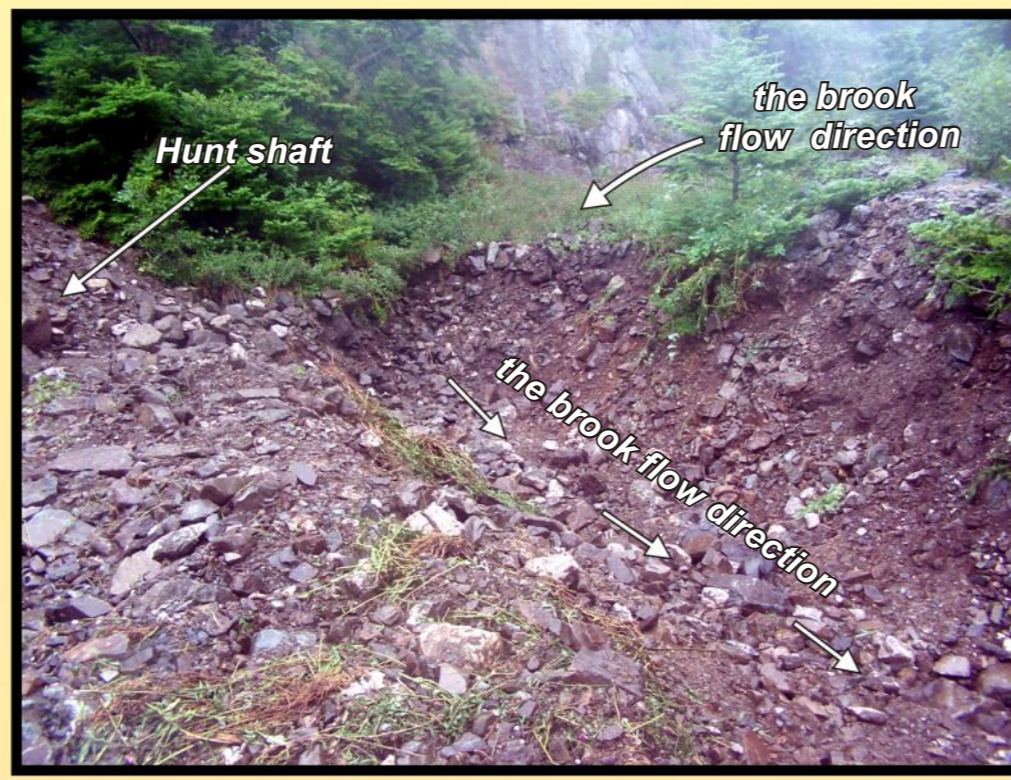
View of excavated ditch around Hunt shaft.

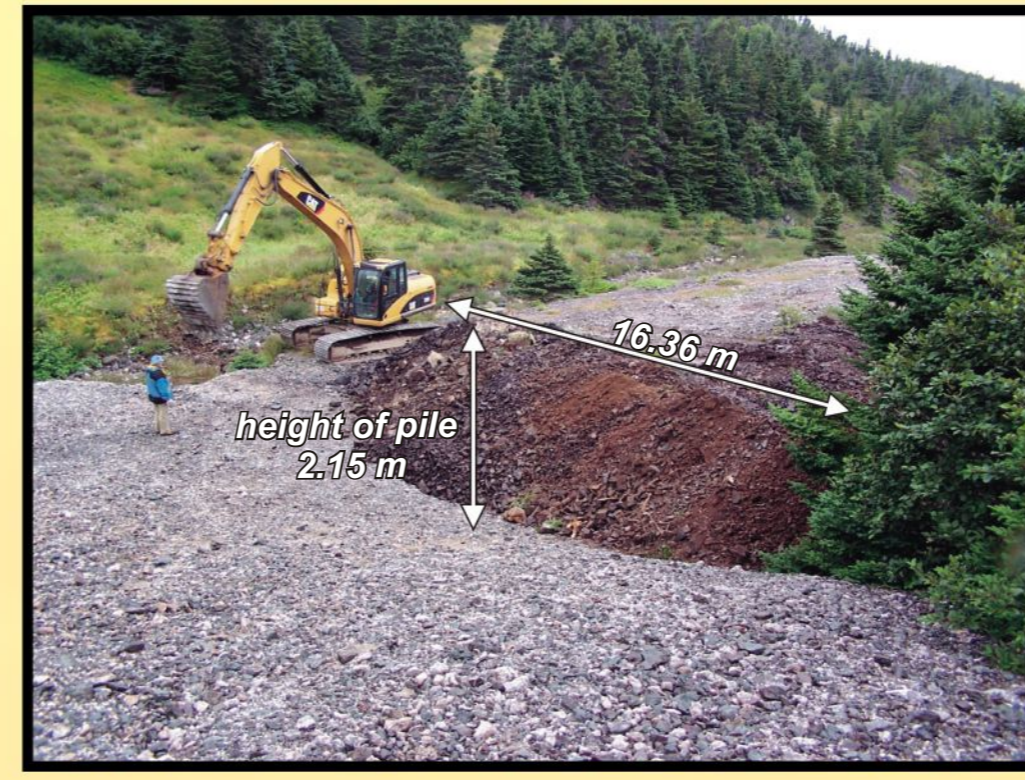
View of Cohu shaft before and after rehabilitation

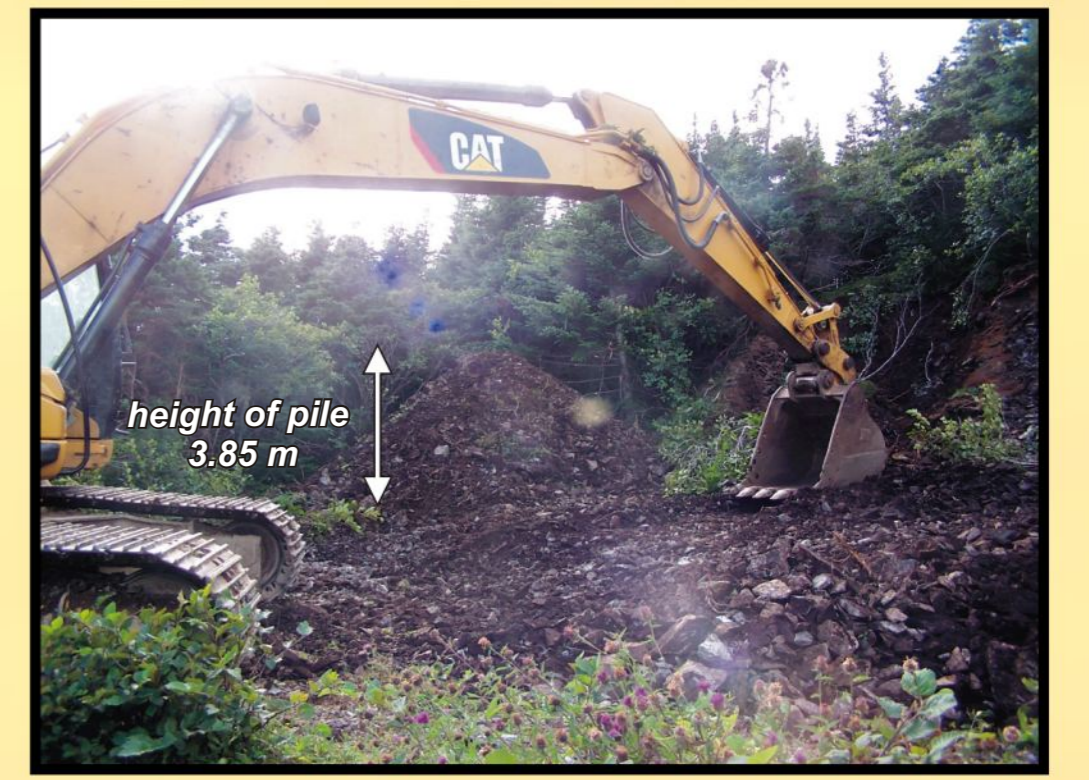
View of McConachie shaft before and after rehabilitation

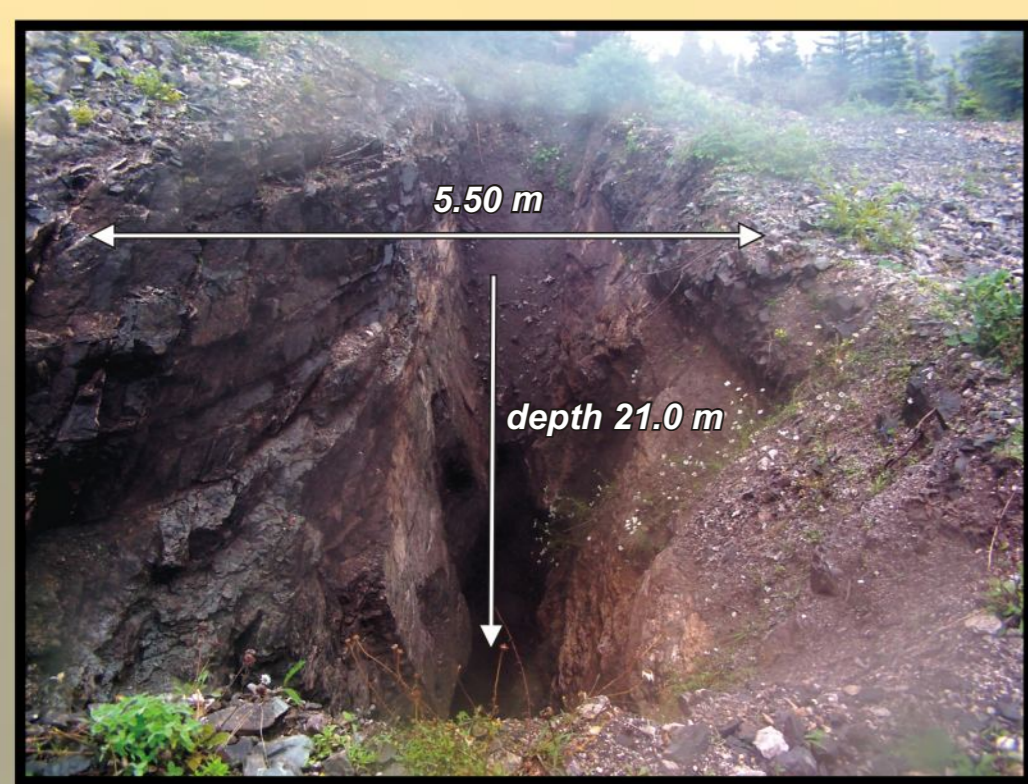
View of Cooper shaft and surface pillar collapsed before and after rehabilitation

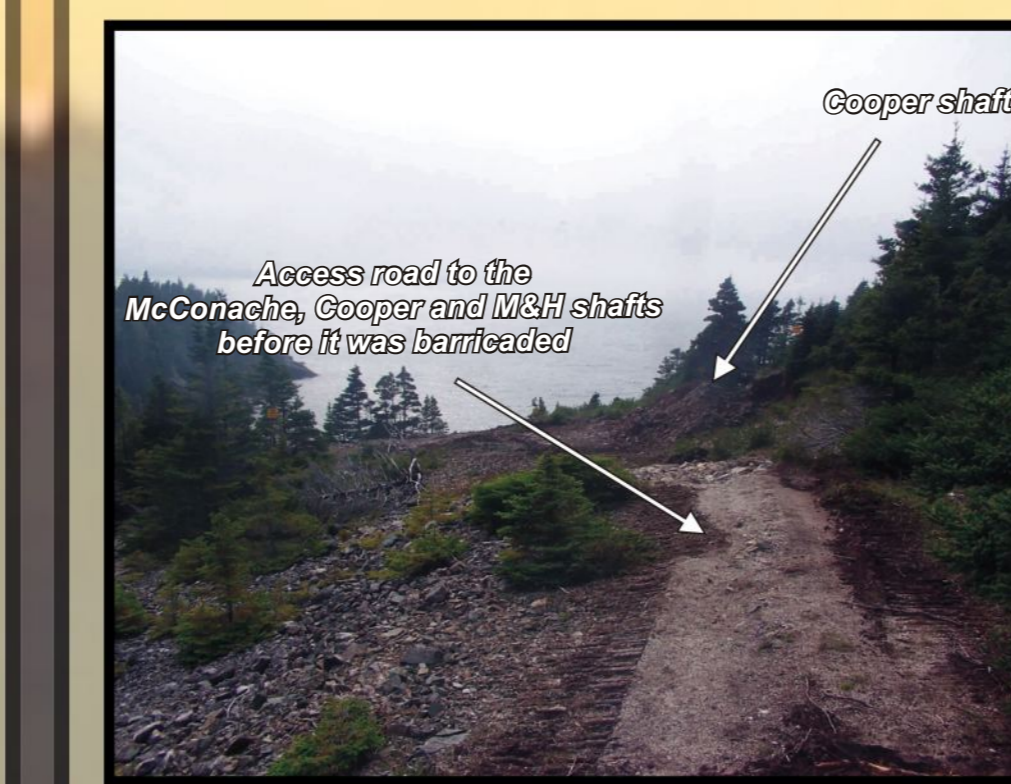
Access road to the McConachie, Cooper and M&H shafts before it was barricaded

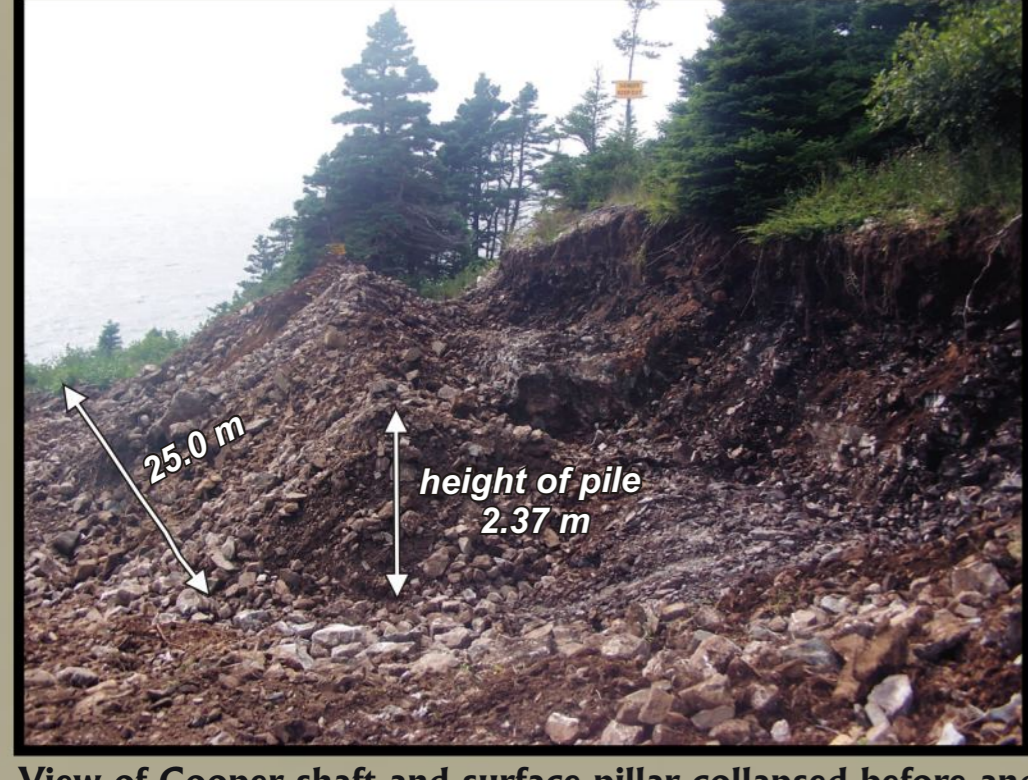
View of Cooper shaft and surface pillar collapsed before and after rehabilitation

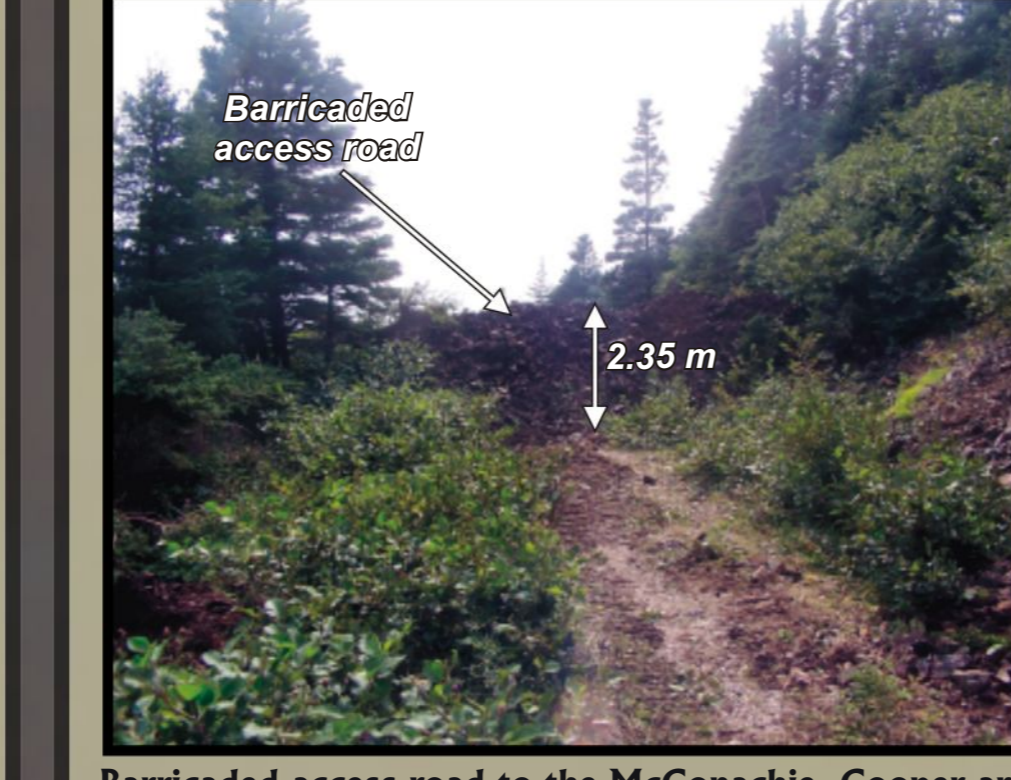
Barricaded access road

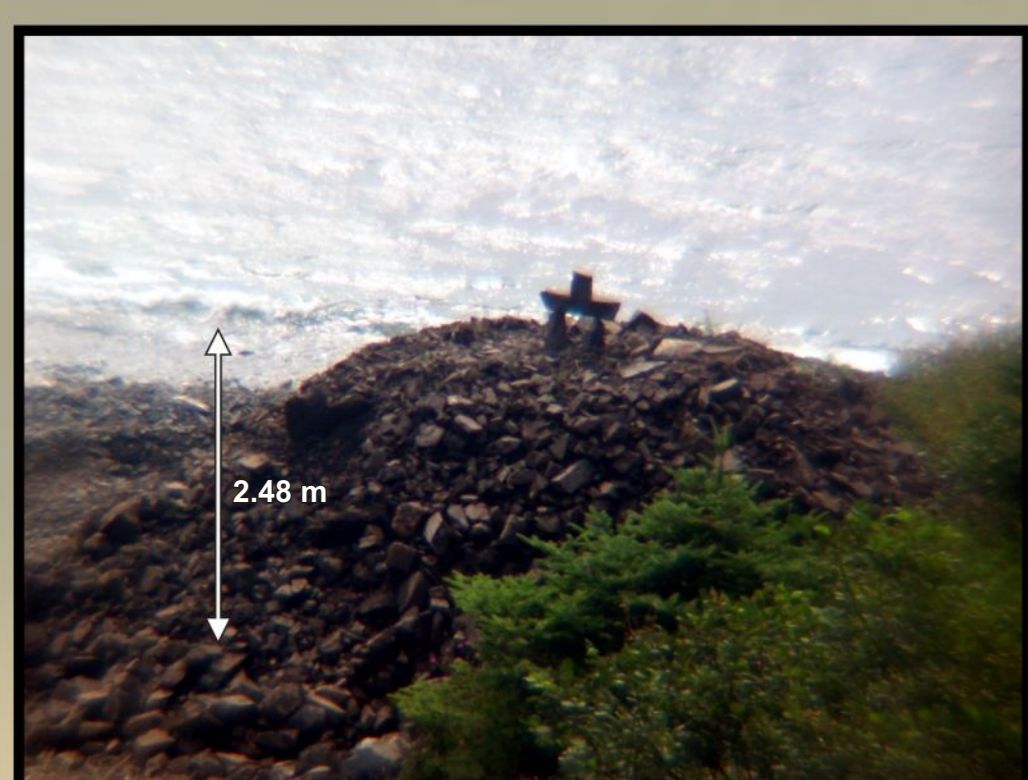
View of M&H shaft after rehabilitation

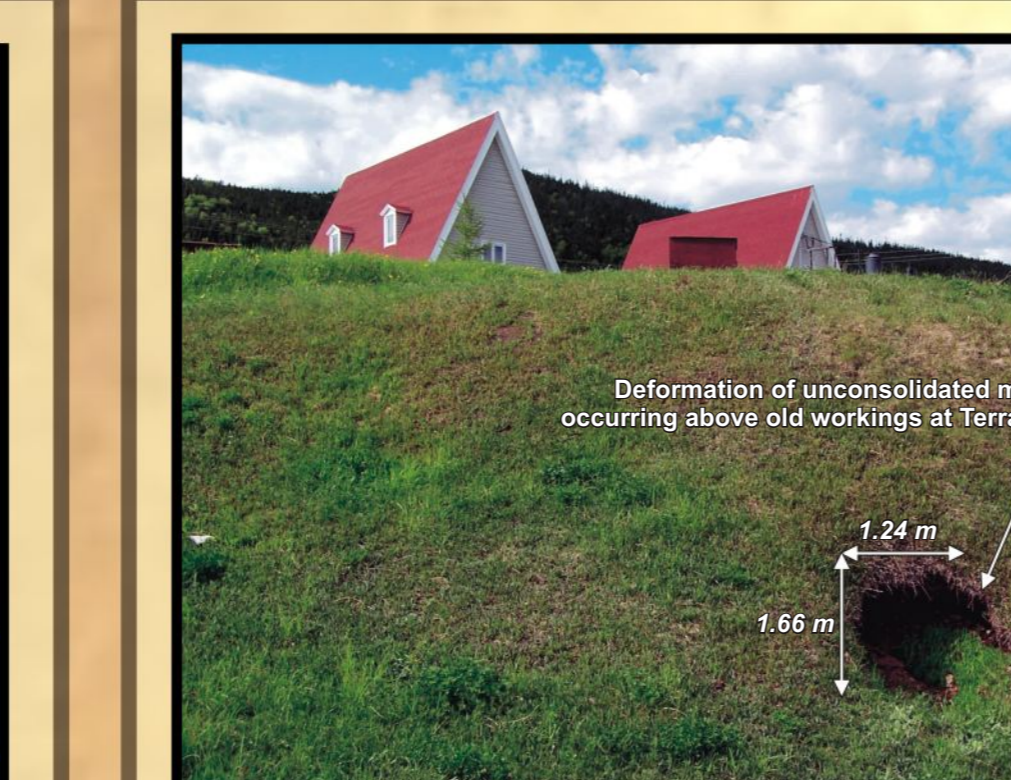
View of the surface deformation and depression

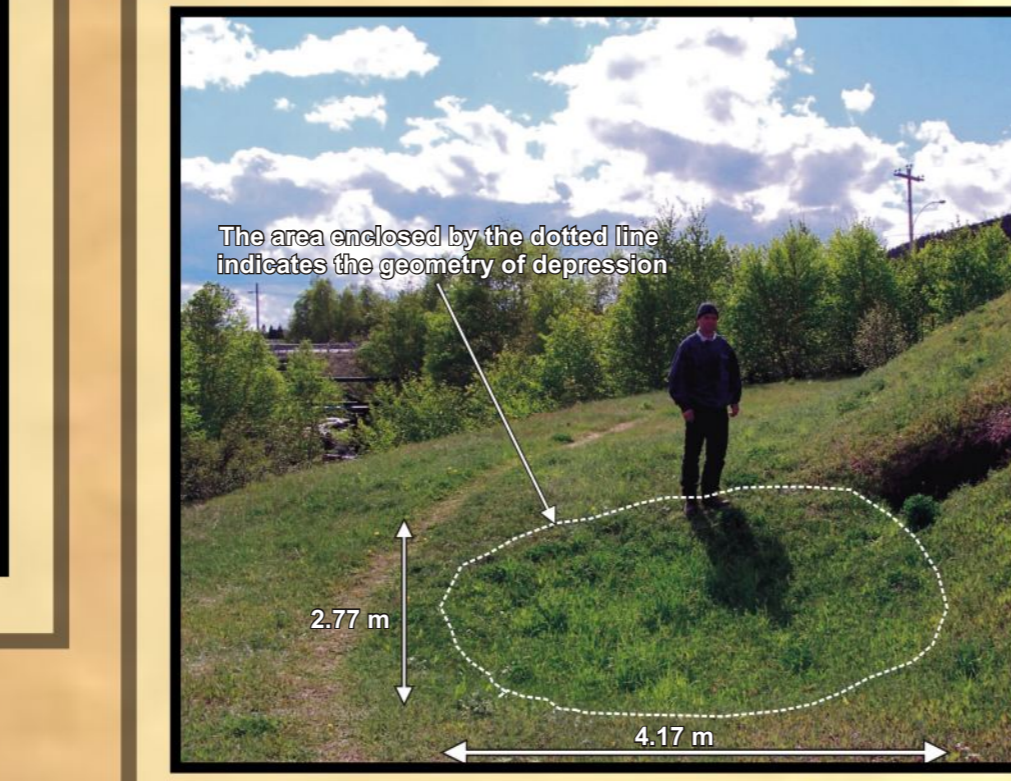
View of the surface deformation and depression

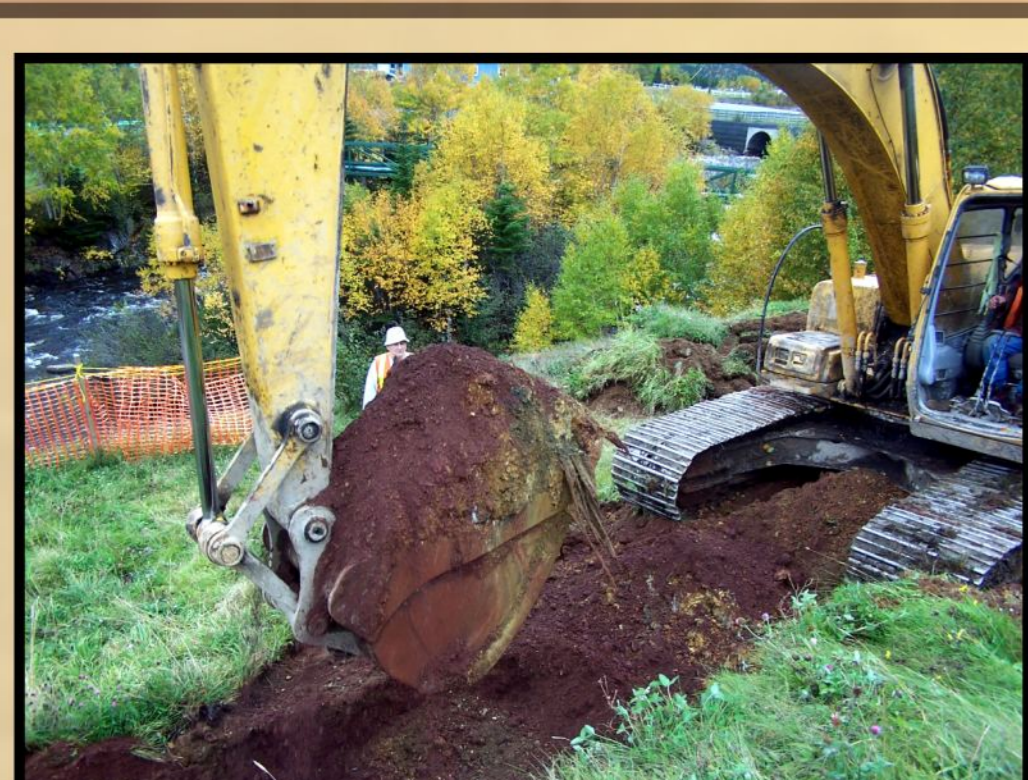
Excavator removing materials above the surface depression.

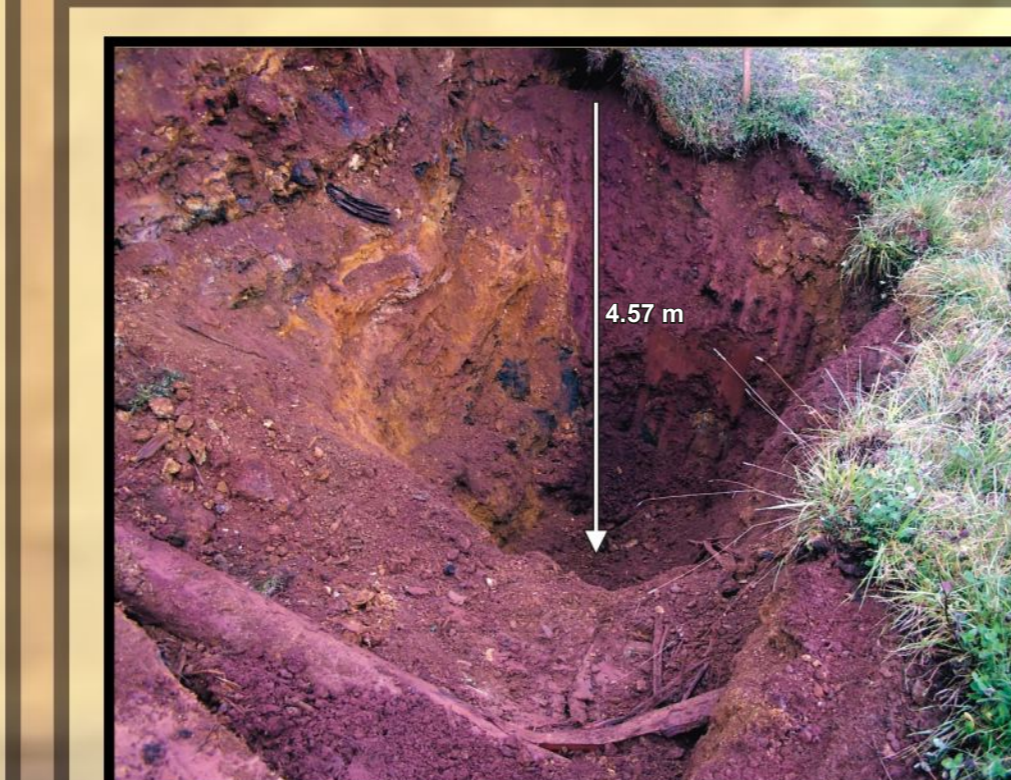
View of the sink hole above depression

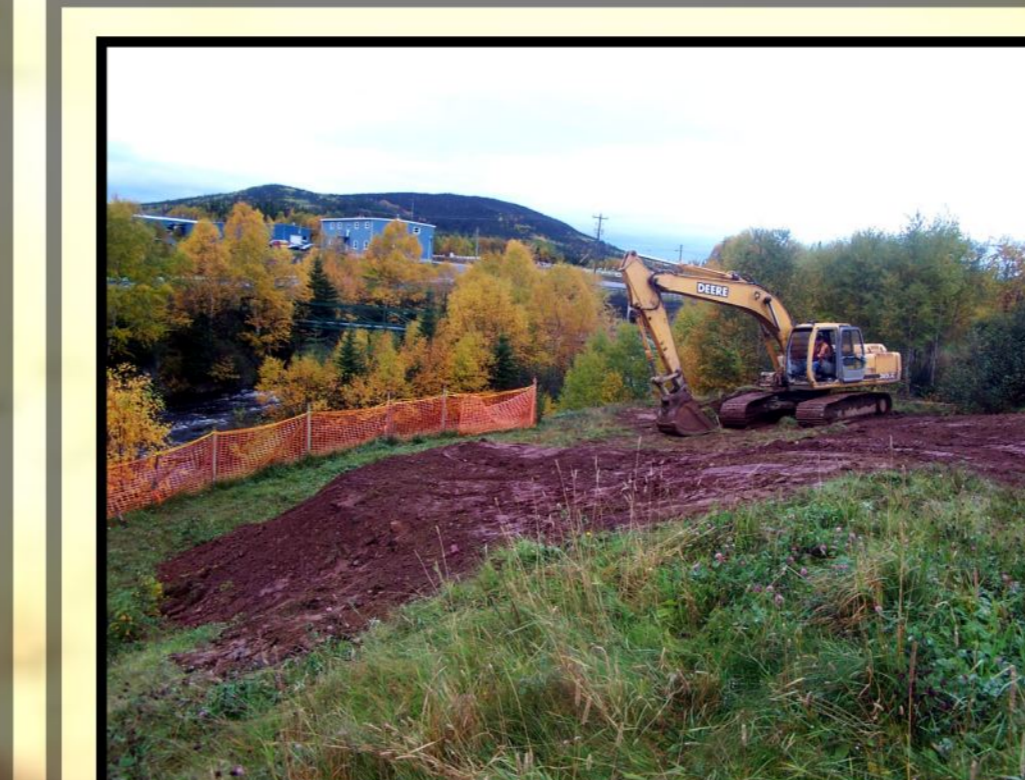
Removed top soil and grass were restored

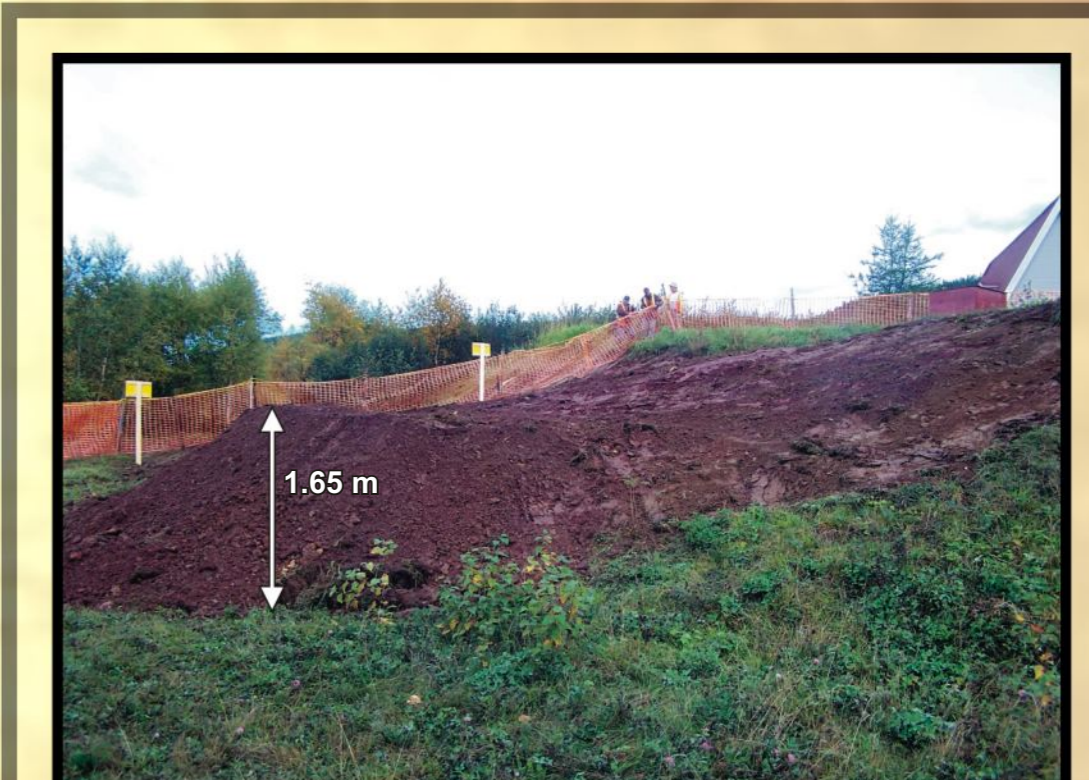
View of the site after rehabilitation completed

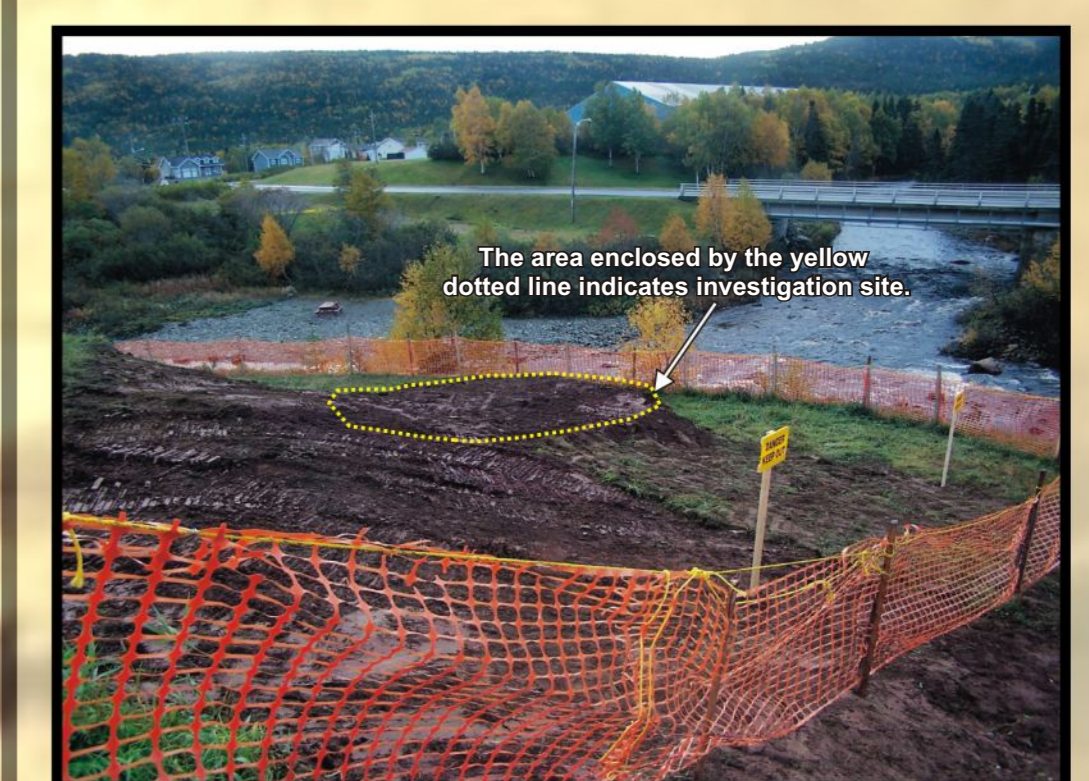
View of the site after rehabilitation completed
