**Supplementary Report
Dam Safety Review (DSR)
Gullbridge Mine, Newfoundland**

Project No. 121613065.100
December 12, 2012

Stantec	Supplementary Hydrotechnical Assessment Former Gullbridge Mine Tailings Dam	Page 1 of 21
	TECHNICAL MEMORANDUM

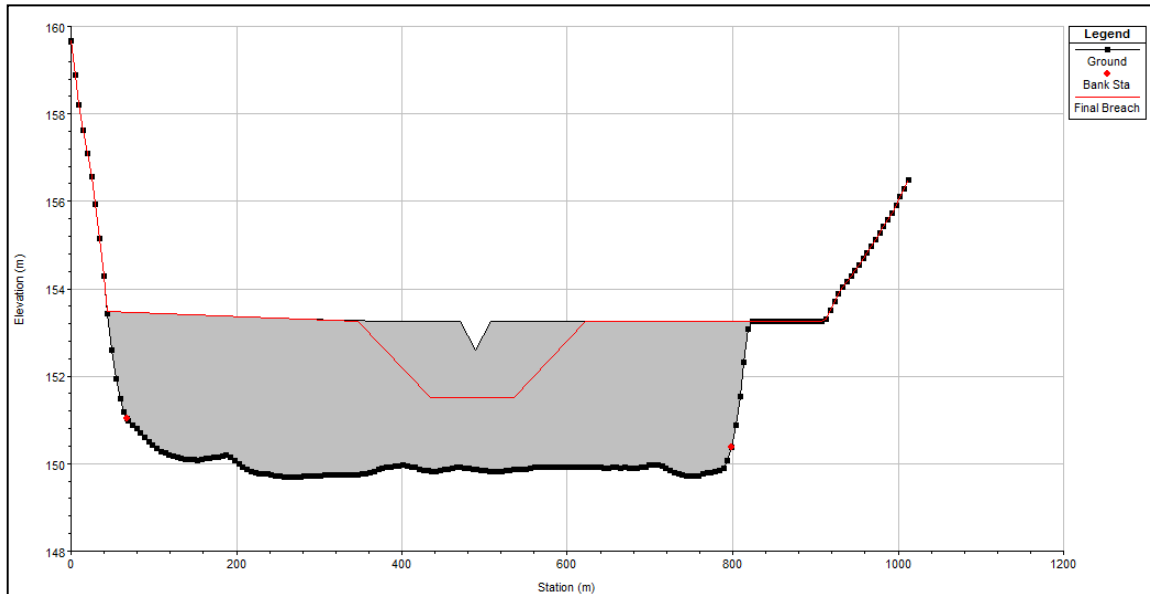
Figure 5 Breach Geometry of the Gullbridge Tailings Dam

Additionally, the geometry of the dam breach geometry was selected based on geotechnical parameters and what is considered as a feasible catastrophic breach condition. The breach geometry was set with a width at the base of 100 m and at the top of 275 m and a total height of 1.75 m. The time for the progression of the breach to reach a full opening was set at 0.5 hours and the assumed failure mechanism was selected to be overtopping, all failures were set at a fixed time when storm effects are maximized (i.e. during the passage of the peak flow). The breach geometry is shown in Figure 5.

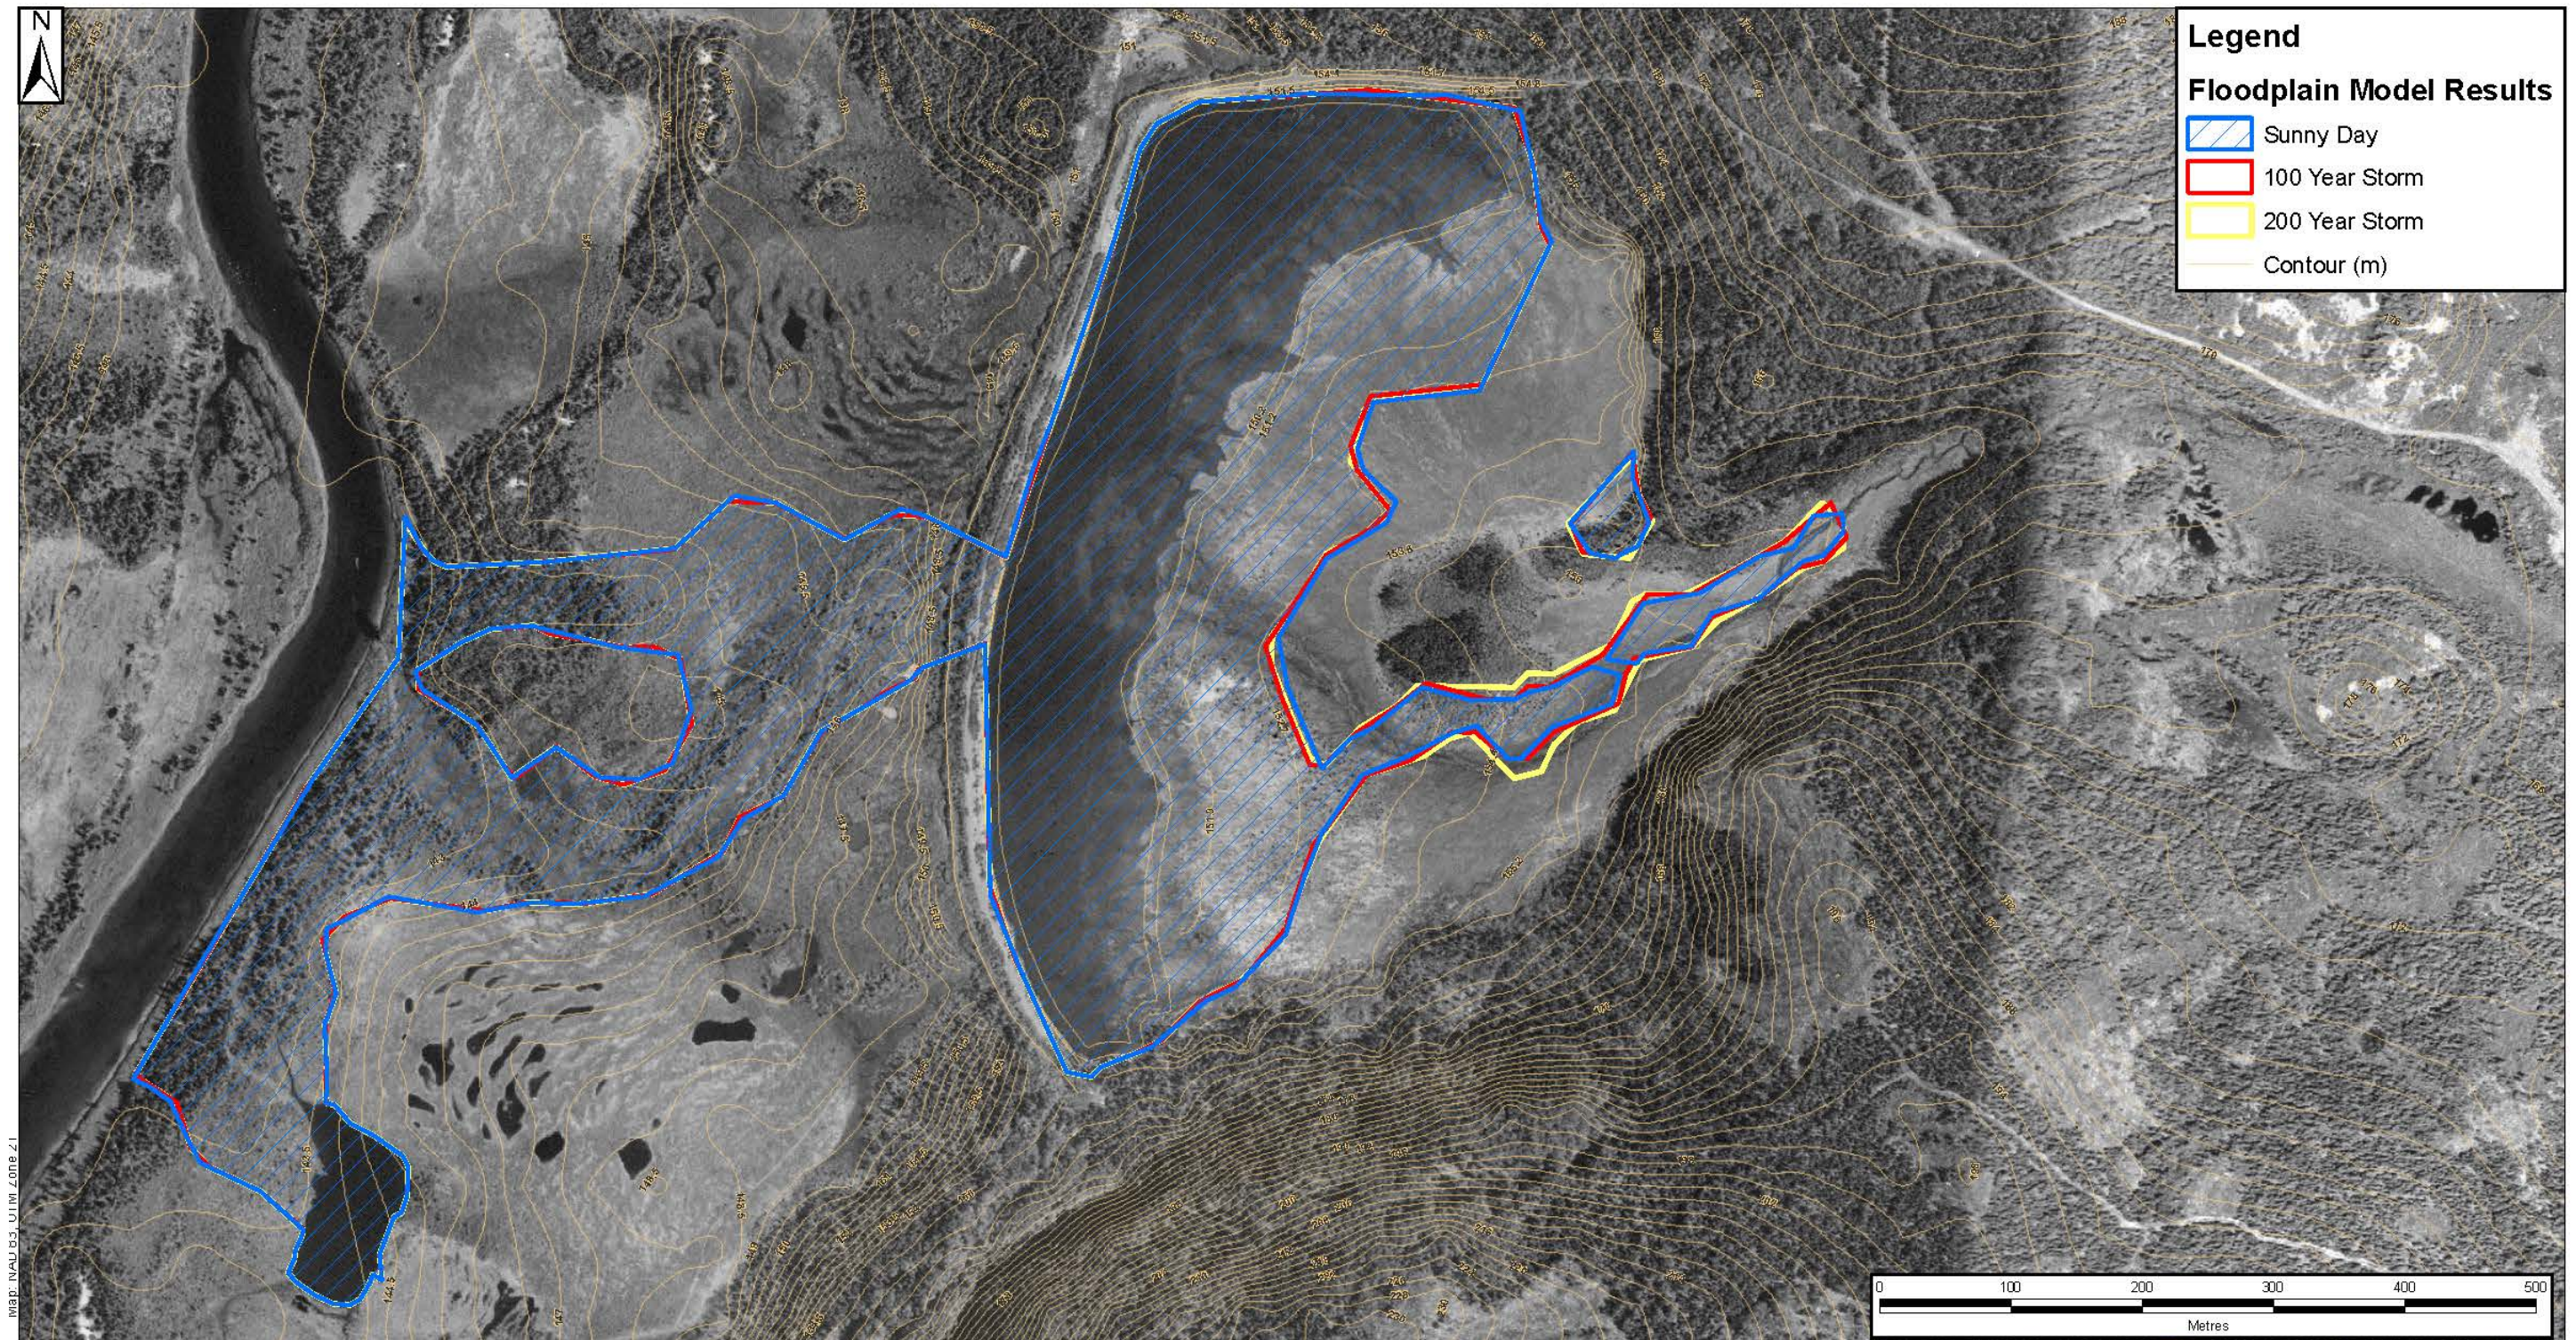
Figure 6 Floodplain Model Results

For the cases considered it was noted that the floodplain delineation boundaries have negligible increase with increasing storm magnitude, therefore the Inflow Design Flood (IDF) was selected to be the 1:100 year event, however, due to a reassessment of potential effects the dam hazard classification was upgraded from Low to Significant.

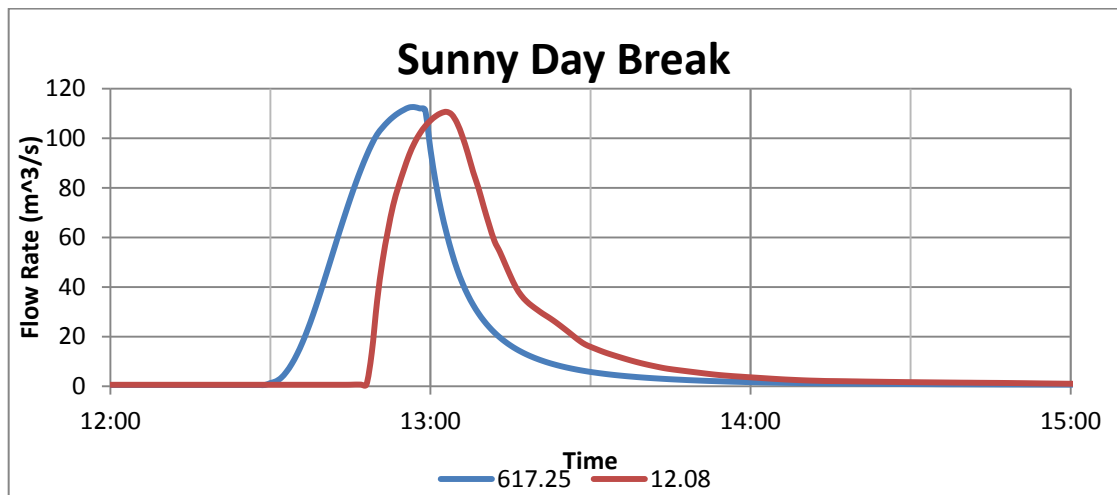
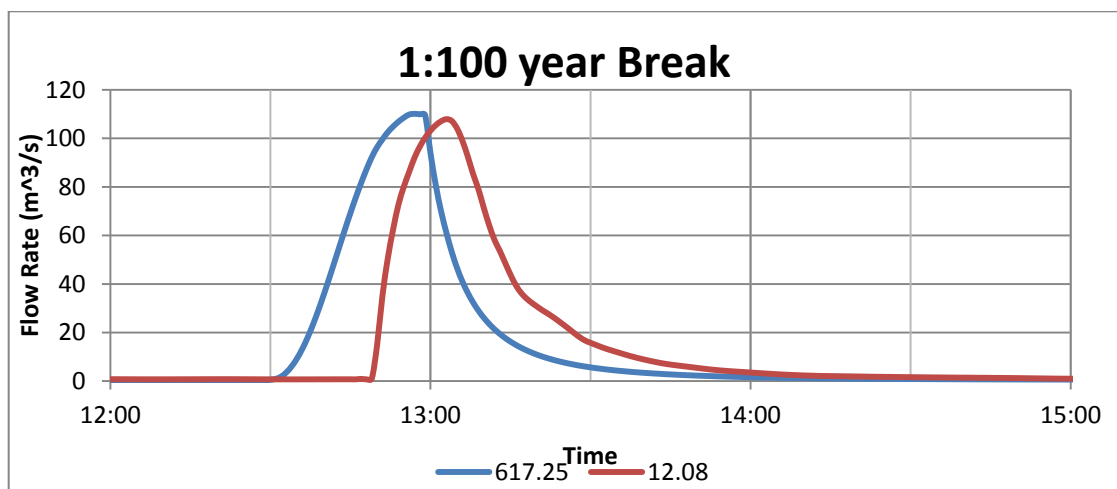
Figures 7 a & b Flow Hydrographs during dam break for different event magnitudes

The peak flow hydrographs at cross sections located in the upstream and downstream reaches of the floodplain (Cross sections 617.25, and 12.08) are shown in Figure 7.a, and 7.b for the sunny day and the 1:100 year storms with dam breach respectively. Cross section 617.25 is located just downstream of the tailings dam and cross section 12.08 is located just upstream of South Brook. The flow hydrographs indicate that the floodplain storage capacity between the dam and South Brook is negligible, and therefore the flow rate associated with the transient wave that reaches South Brook has no attenuation.

The model results also indicate that the dam breach and release of tailings pond water govern peak flow rates with a small contribution from the wet weather events.

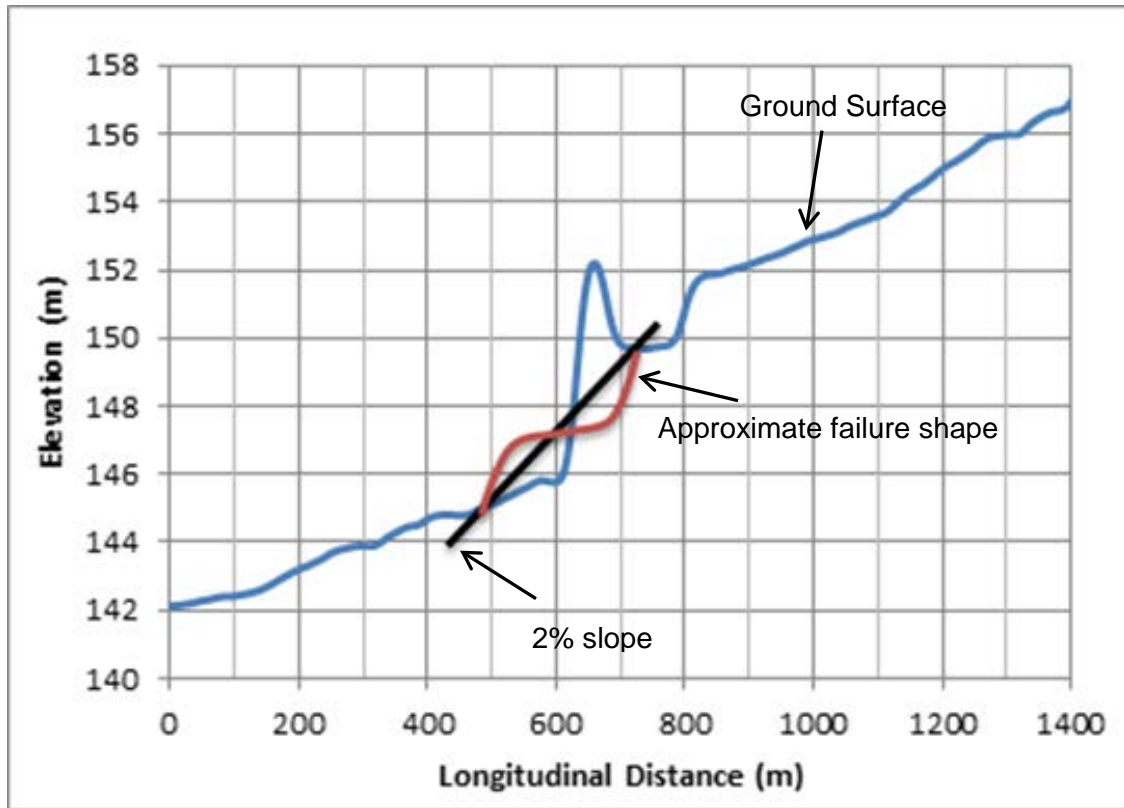
Figure 8 Estimated extent of tailings migration

The results indicate that the expected travel distance of the tailings is approximately 120 m downstream of the tailings dam toe and 440 m upstream of South Brook. Therefore, it can be concluded that the coarser portion of the tailings material will not reach South Brook under any of the scenarios considered in this assessment.
