**PHASE I ENVIRONMENTAL SITE ASSESSMENT
FORMER RAMBLER MINE PROPERTY
BAIE VERTE, NEWFOUNDLAND**

SUMMARY

Davis Engineering & Associates Ltd. (DEAL) was commissioned by the Provincial Department of Natural Resources (DNR) to conduct a Phase I Environmental Site Assessment of the Former Rambler Mines Property in Baie Verte, Newfoundland and Labrador. Based on a review of information supplied by the Client as well as observations made during the site investigation, the property assessment has revealed the following:

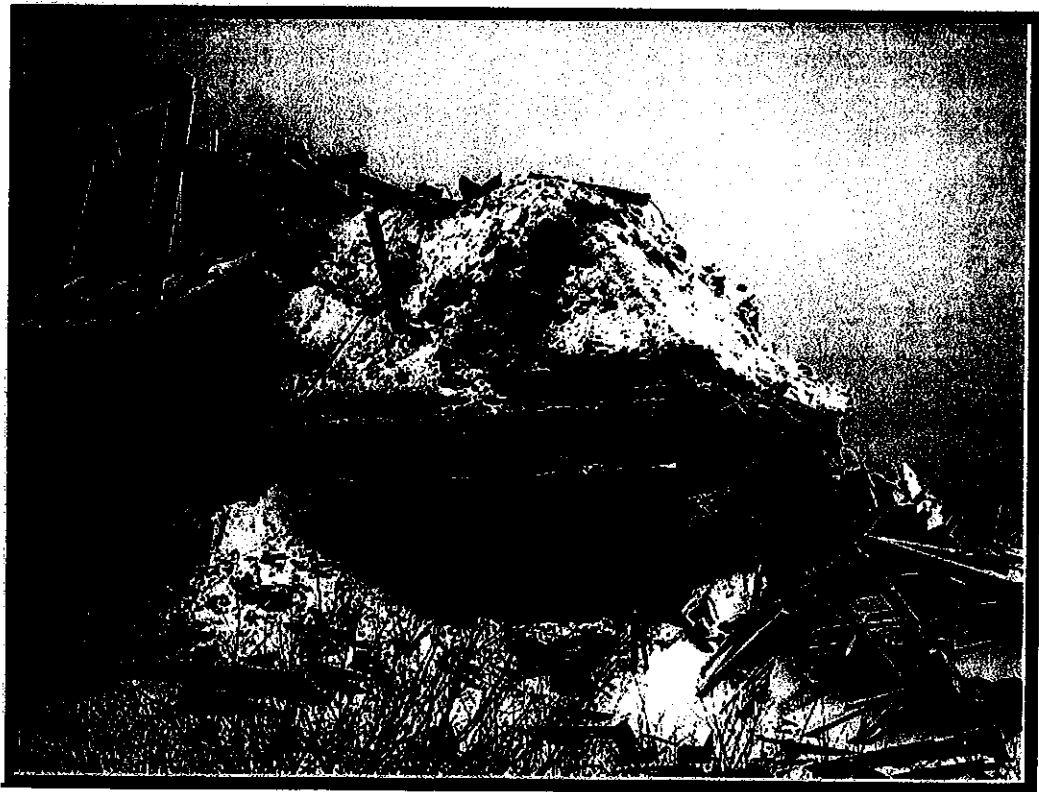
Photograph 10: Mined Ore left on screening equipment, Building #1 – East Mine

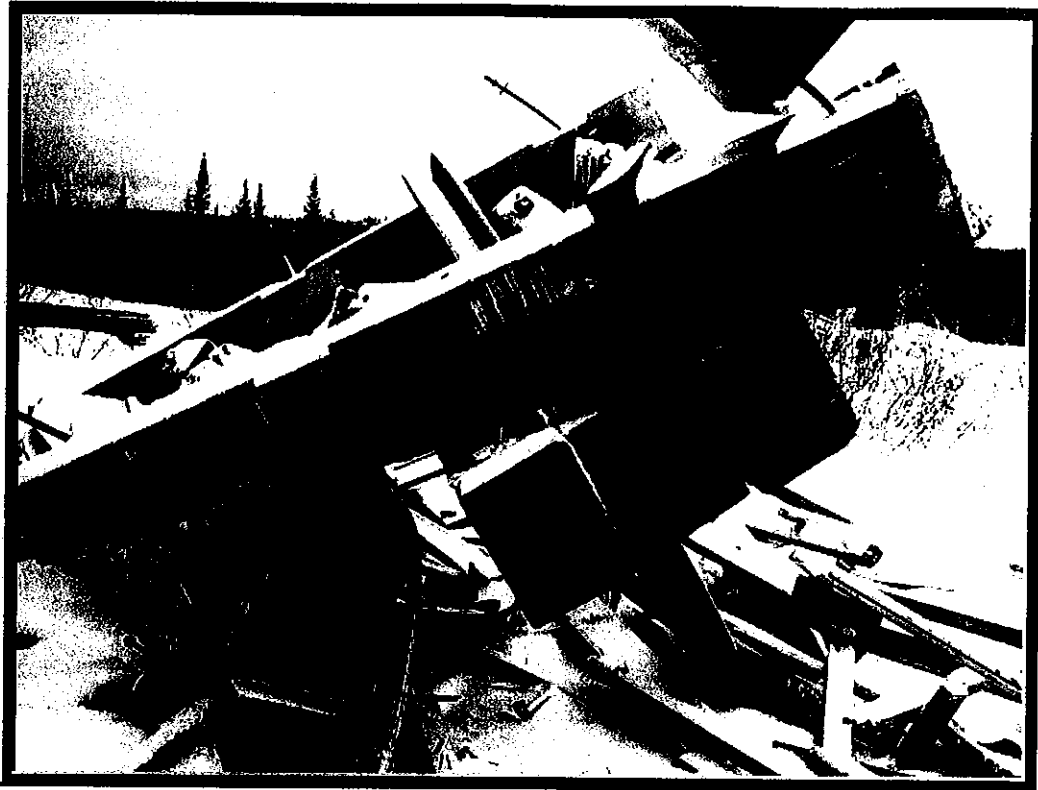
Photograph 11: Creosote Timber near Building #1 – East Mine

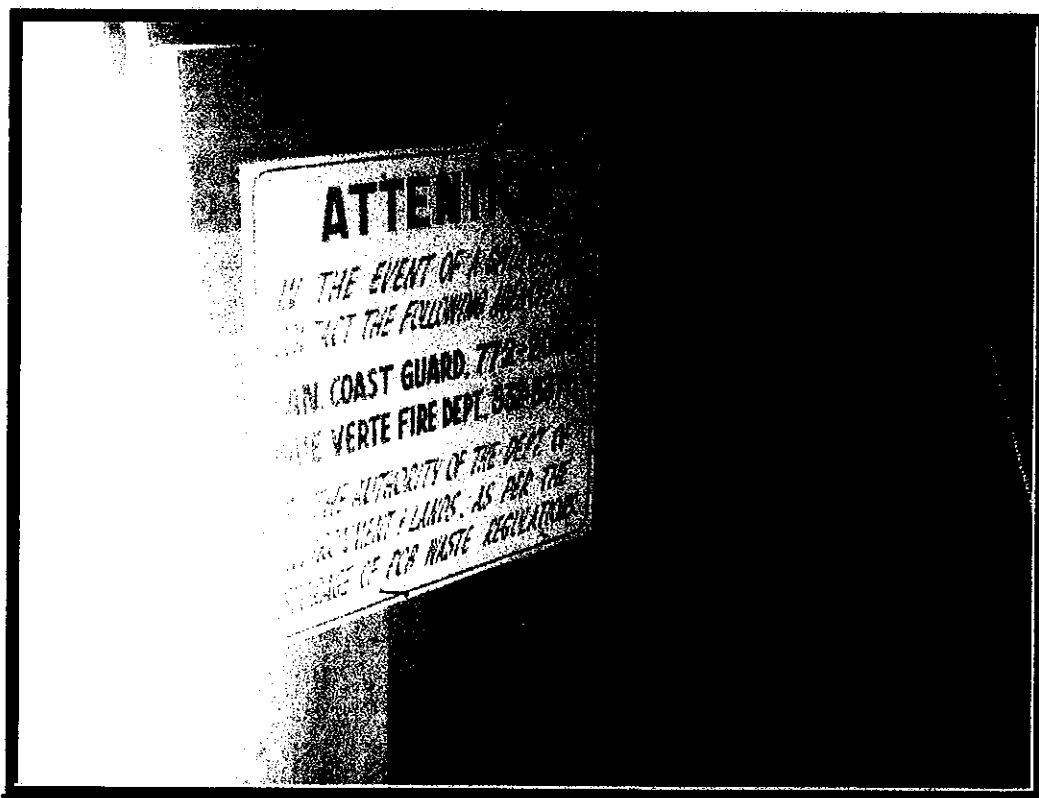
- A sampling program implemented by Jacques Whitford Environmental Limited (JWEL) in 2003 indicated areas of soil around Building #2 at the East Mine site impacted by PCBs (exceeding CCME criteria). Also, several swabs taken from the PCB Storage Area inside Building #2 indicated impacts to the floor and walls. To date, there is no knowledge of additional soil/water /swab/concrete core samples being taken or completion of contamination delineation as recommended by JWEL.

- Staining was noted in both buildings at the East Mine site, however staining on the exterior of the buildings was not ascertained due to the snow cover. Stains found in the PCB storage area (Building #2) have been tested in previous studies and indicate concentrations of PCBs above applicable guidelines.

Photograph 14: PCB Storage Area, Building #2 – East Mine

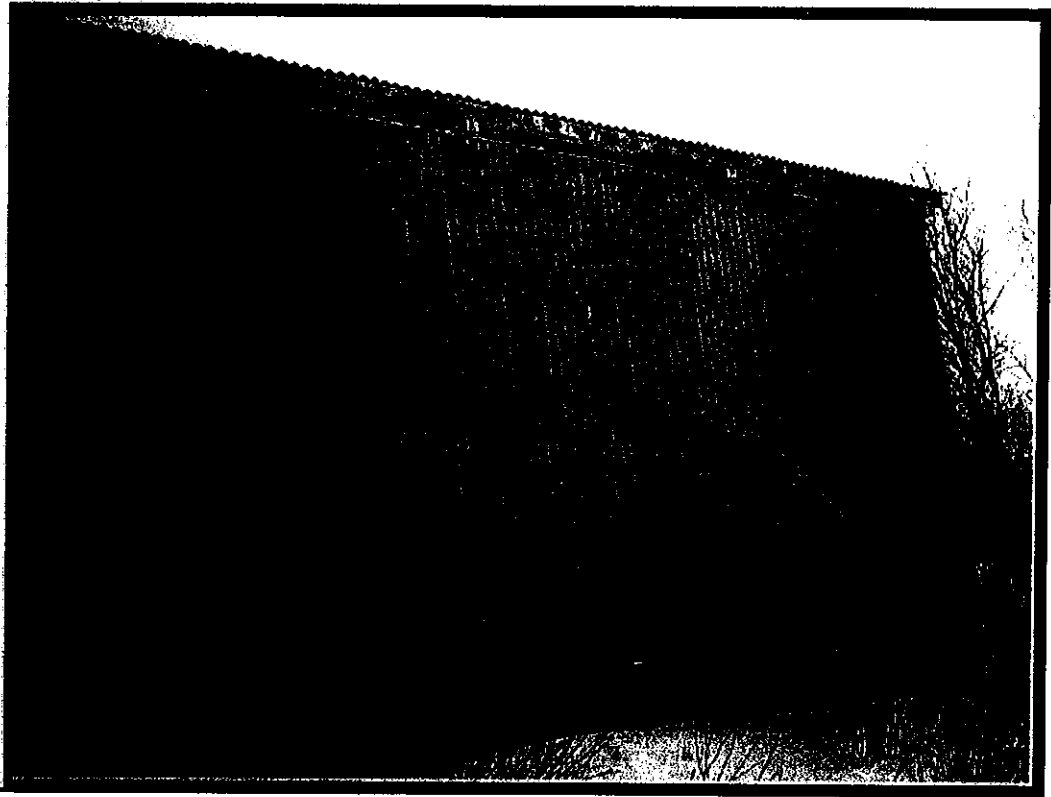
- Potential asbestos siding was noted on Building #2 on the East Mine site. Potential asbestos based piping and elbows was noted at the Raymo Processing Facility. Appropriate precautions should be taken when removing and disposing of any potential asbestos containing materials.

Photograph 15: Potential Asbestos Siding on Building #2 – East Mine

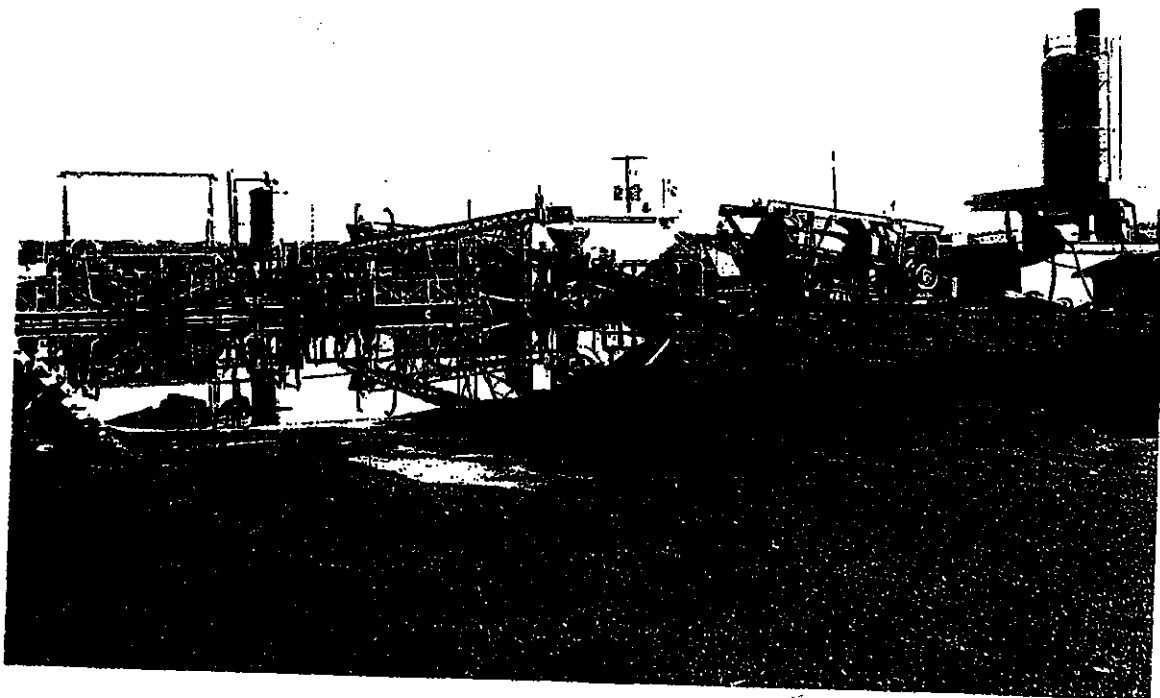
Photograph 2

Equipment associated with pelletizing and vat leaching of tailings.

Dismantling, salvaging, and sale of equipment to defray costs. Leveling, landscaping and revegetation of site.

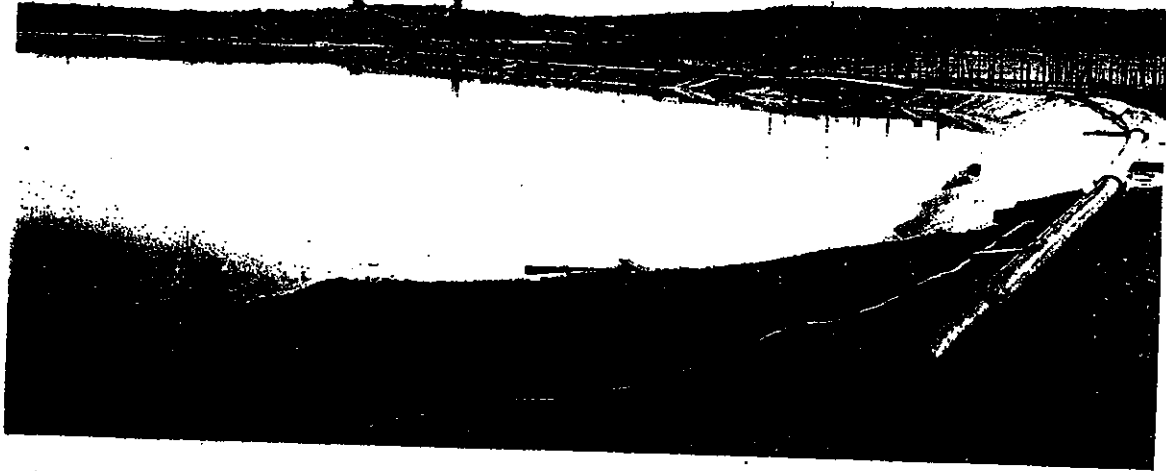
Photograph 3
Rubber lined pond associated with reprocessing operation.

Problem
Pond contains acid generating materials. Rubber lining damaged

- Draining and neutralization of supernatant
- Folding inwards of edges of residual rubber pond ensuring that remaining contained solids
- Covering of pond with soil, relandscaping to fit in with surrounding

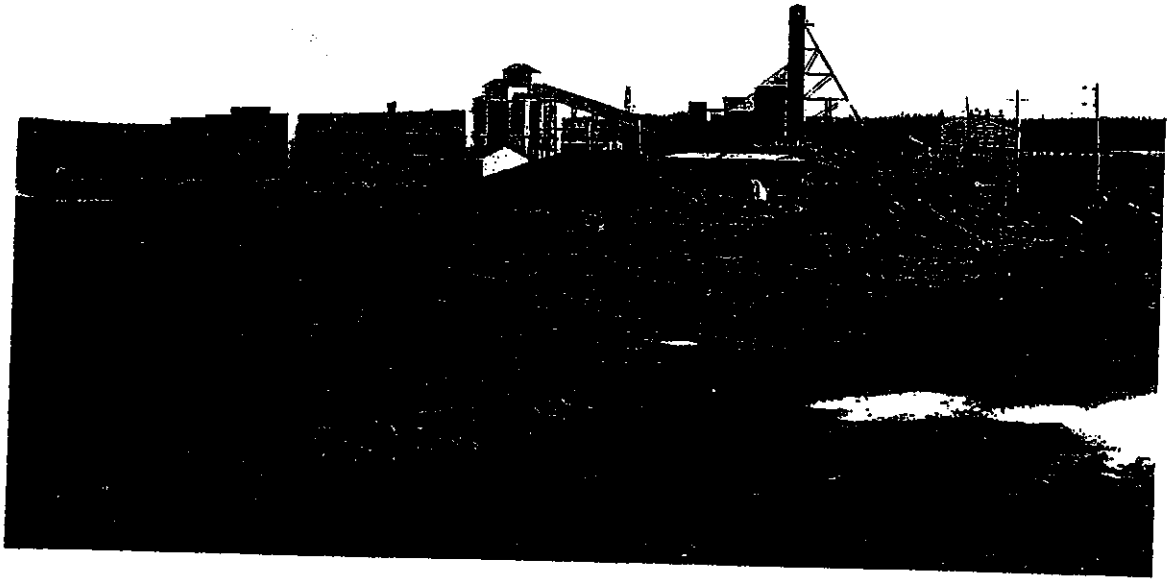
Photograph 4

View of abandoned mine headgear and connected processing plant.

Removal of buildings on site; dismantling of headgear; salvaging of materials; and, capping of mine shaft.

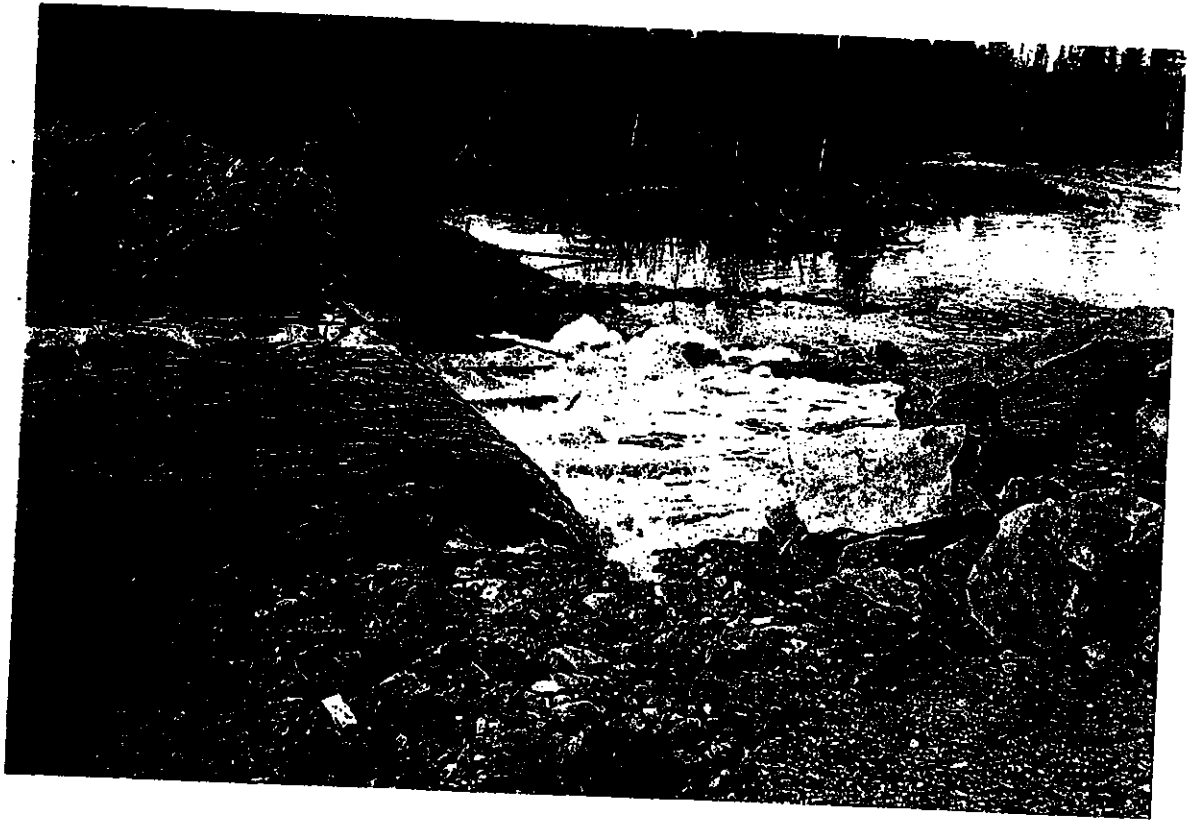
Photograph 5
Spillway

Inspection to ensure that heavy surface drainage from tailings during spring thaw does not erode areas adjacent to the buttresses. Placement of additional rock where indicated by inspection.

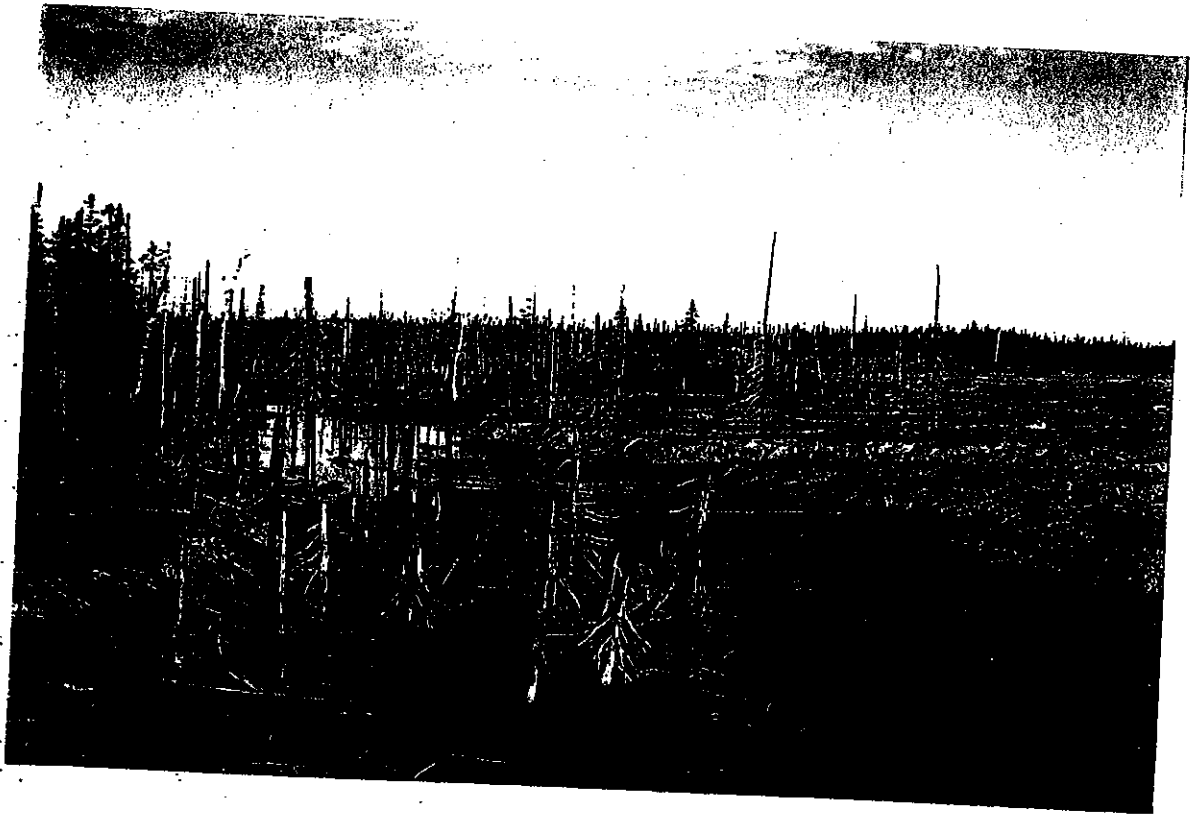
Photograph 7:
Flow of water from adjacent water shed surface onto tailings. Note that the resulting stream channel erodes the channel to a lower level. This in turn lowers the water table in the tailings, and thereby the thickness of the oxidation zone.

Establishment of a rock lined diversion channel would prevent this type of erosion and accelerated acid generation.

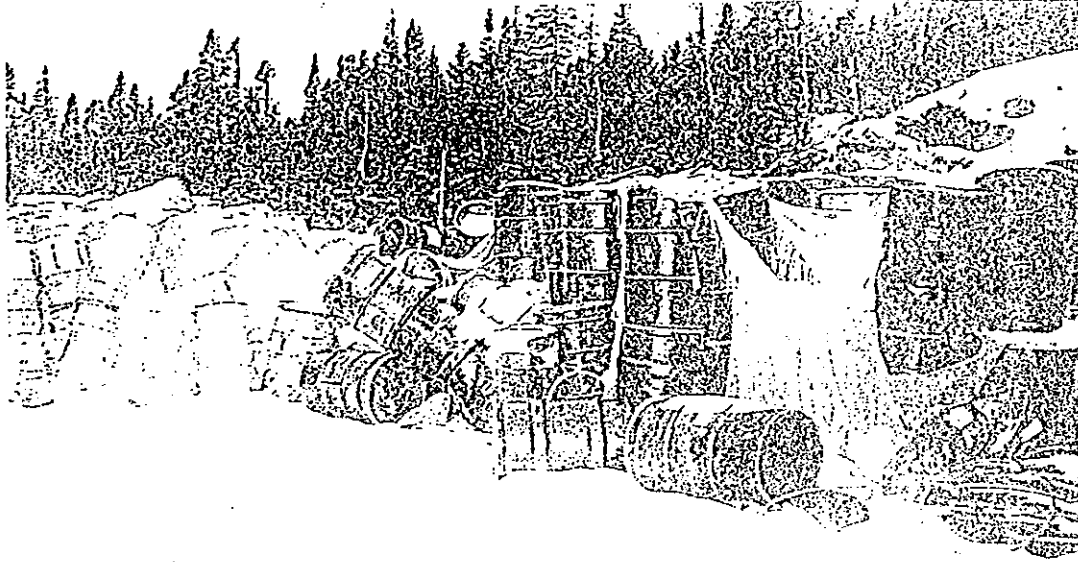
1(a) Used cyanide drums behind Raymo Processing

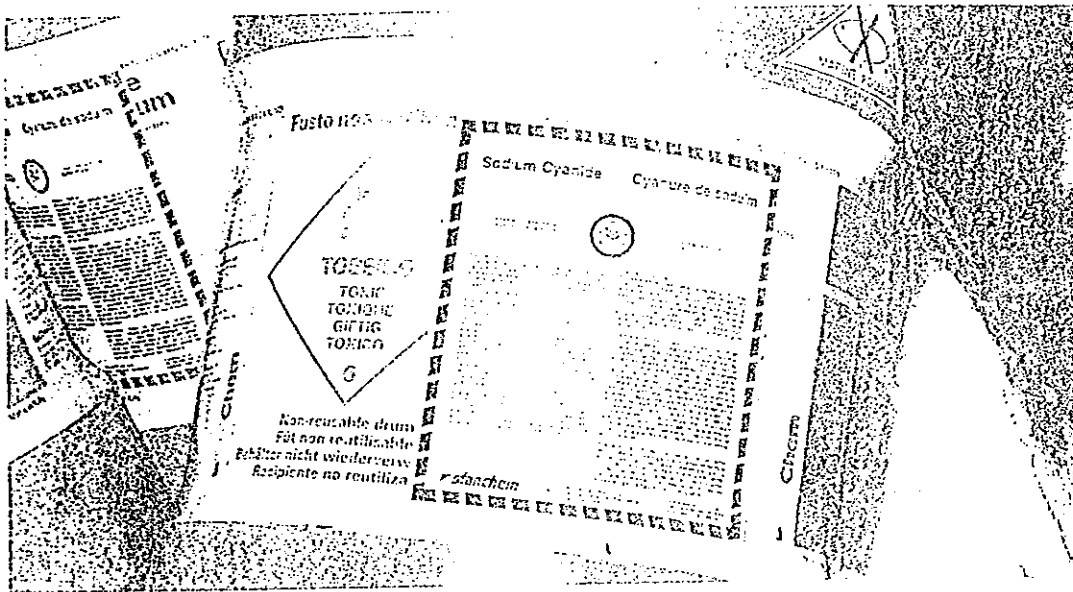
1(b) Typical cyanide drum stored behind Raymo Processing
