MEETINGS IN ST. JOHN'S AND VISITS TO LOWER CHURCHILL PROJECT SITES JUNE 13 TO 17, 2022

Prepared for: Natural Resources Canada and Nalcor Energy

Date: July 30, 2022

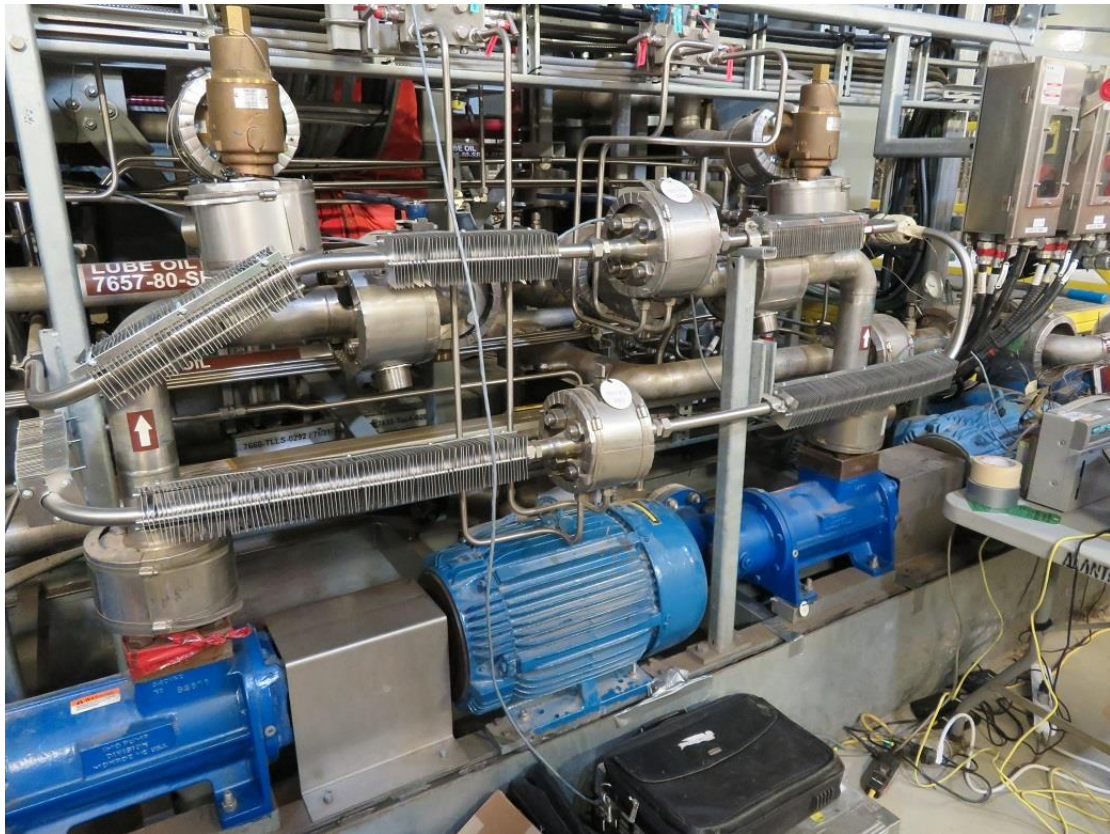
- SC1 reassembly is complete and the return to service is expected in July 2022. Glycol cooling system has to be flushed prior to return to service. The new elliptical bearing is tilting, and the tilting has been attributed to low viscosity of lubricating oil. This is a GE theory not accepted by LCP at this time. To achieve increase in its viscosity, the technicians will attempt to provide additional oil cooling prior to returning the unit to service.

Photo 1: Cooling fins recently added to lubricating oil lines on synchronous condenser, Soldiers Pond.

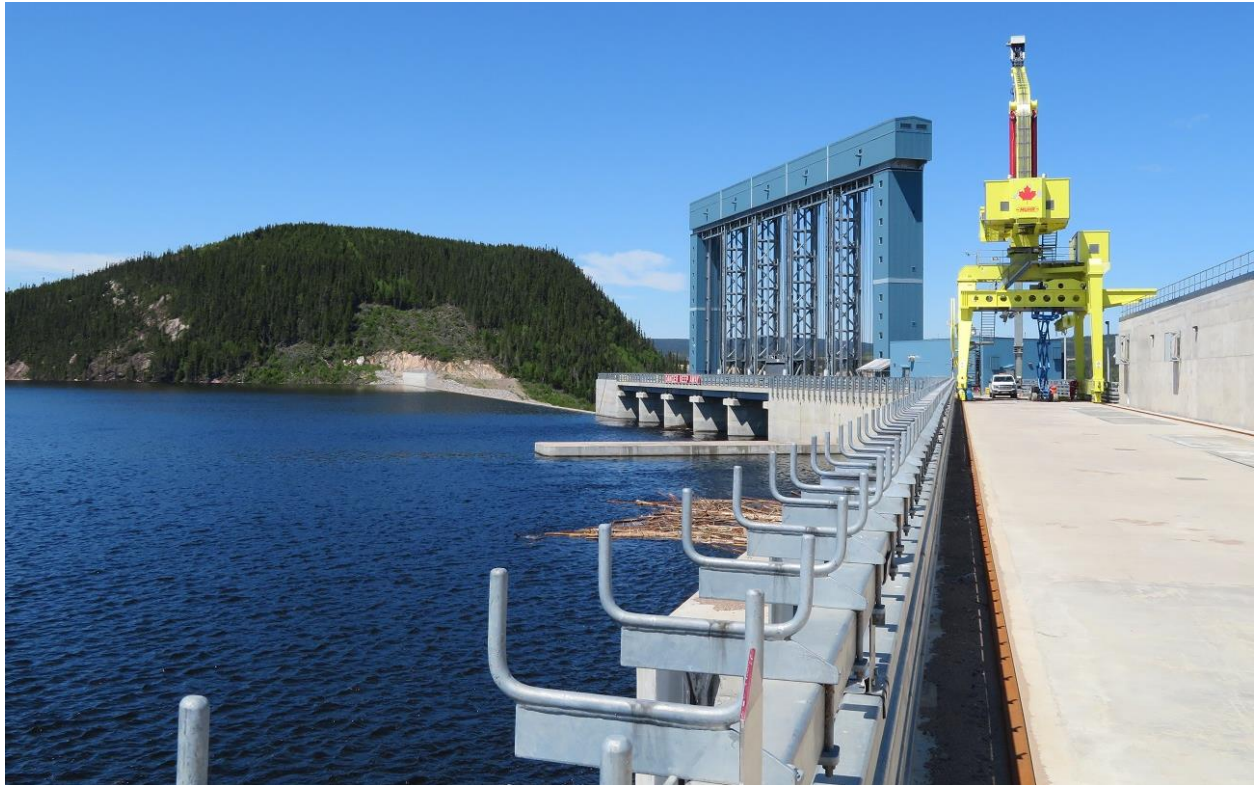
- Site staff reported that reservoir debris management has not been an issue to date. At the time of the IE site visit, there was a small number of woody debris pieces floating above the power intake trash racks and minimal debris deposited along the upstream side of the North Spur.

Photo 2: Muskrat Falls power intake deck and spillway with small number of woody debris pieces in front of intakes.

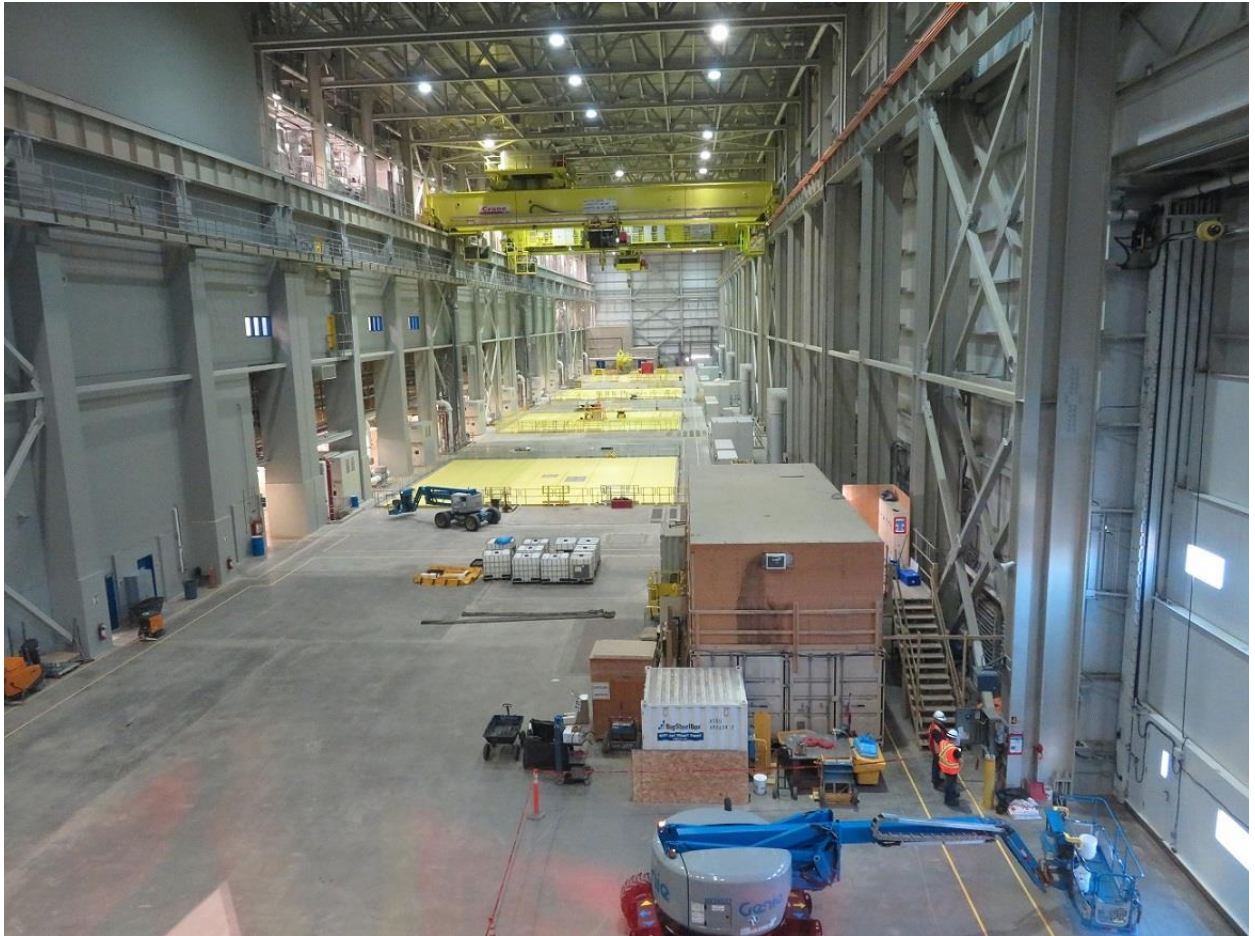
- Minor display anomalies on Unit Control Board HMI's were communicated to the shift operator.
- Generator and turbine floor are both clear of tools, spares, and construction equipment.

Photo 3: Muskrat Falls powerhouse generator floor viewed from control room.

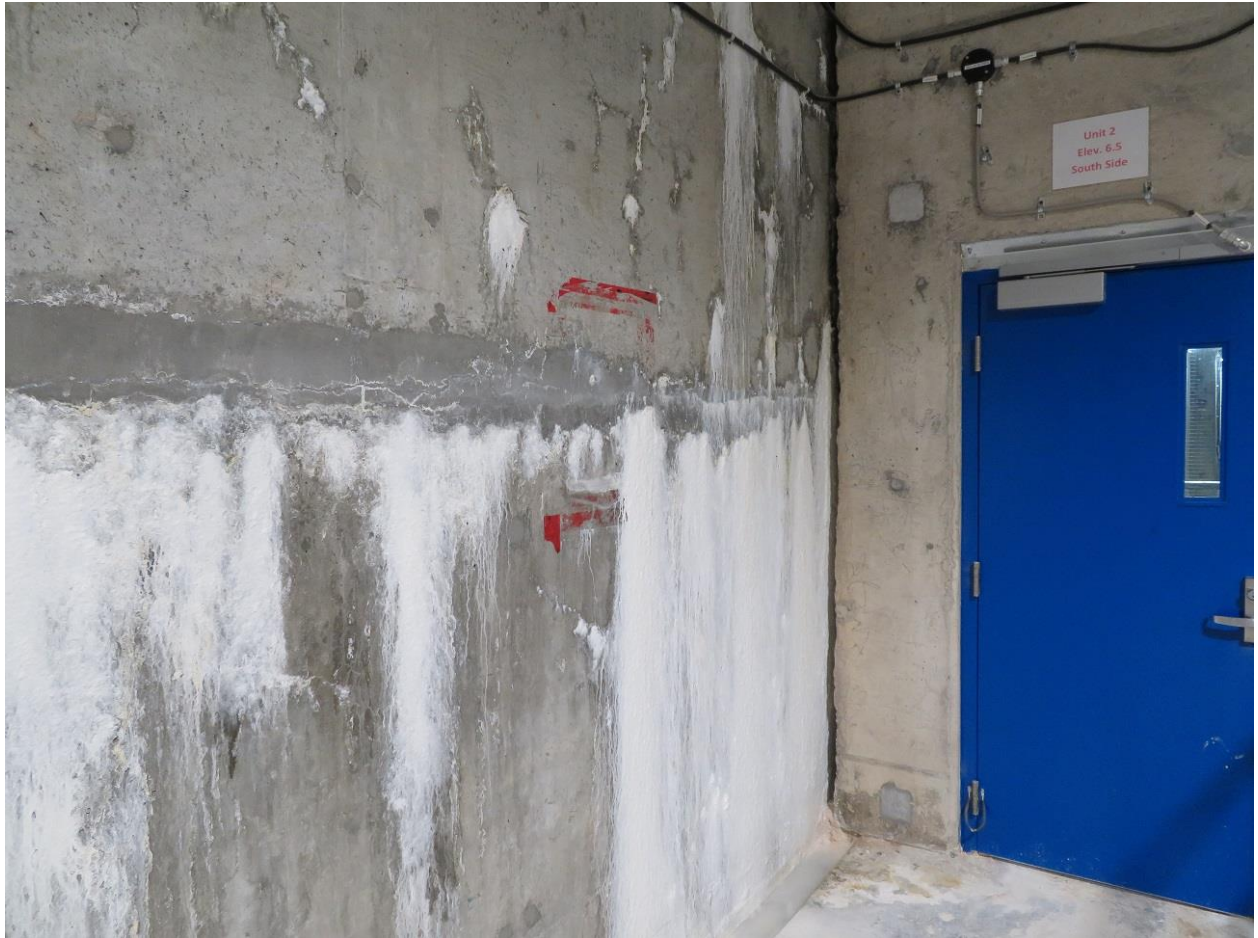
- Along the upstream wall of the turbine floor between units 1 and 2, it was observed that minor seepage from hairline cracks in the concrete is depositing what appears to be calcareous material on the lower wall and the floor. Such seepage is not unusual in hydro facilities but can be a nuisance issue. The calcareous deposits may eventually self-seal the cracks; alternatively epoxy or chemical grout could potentially be injected into the cracks.

Photo 4: Calcareous material deposited below hairline crack on upstream wall of turbine floor between Units 1 & 2.

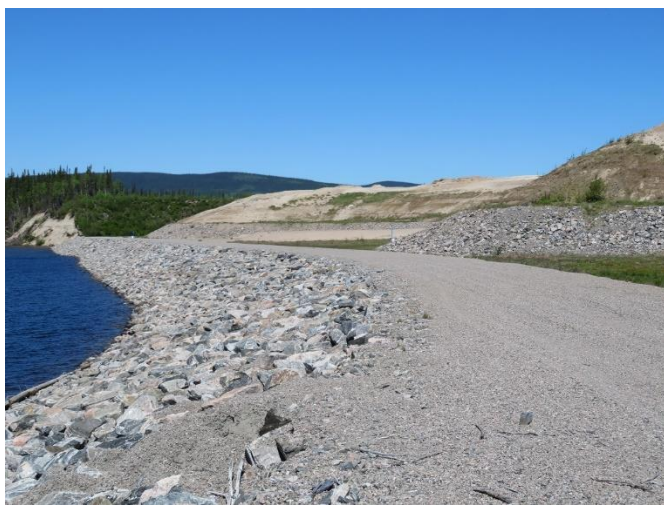
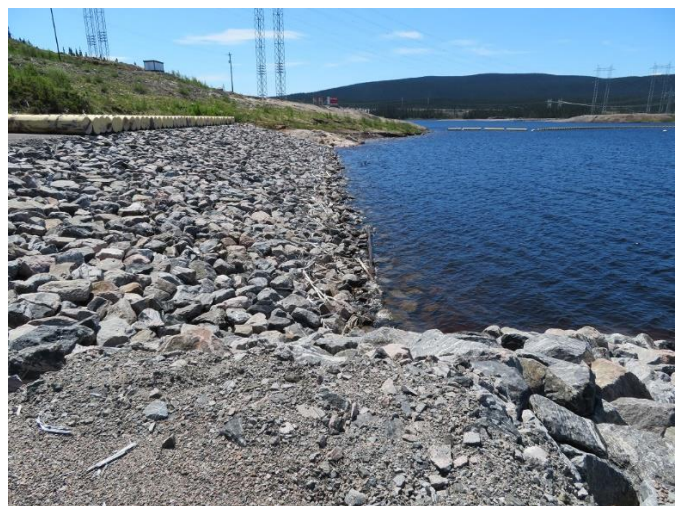
- At the North Spur, visual observations indicate that there have been no significant changes to the slopes on the upstream and downstream sides since the previous IE site visit in November 2021. Small vegetation and brush continue to become more established in local areas, but areas of the slopes that are steeper and more exposed to wind erosion remain mostly bare. The riprap along the upstream and downstream shorelines remains stable.

Photos 5 & 6: Upstream side of North Spur looking northerly (left photo) and southerly (right photo).

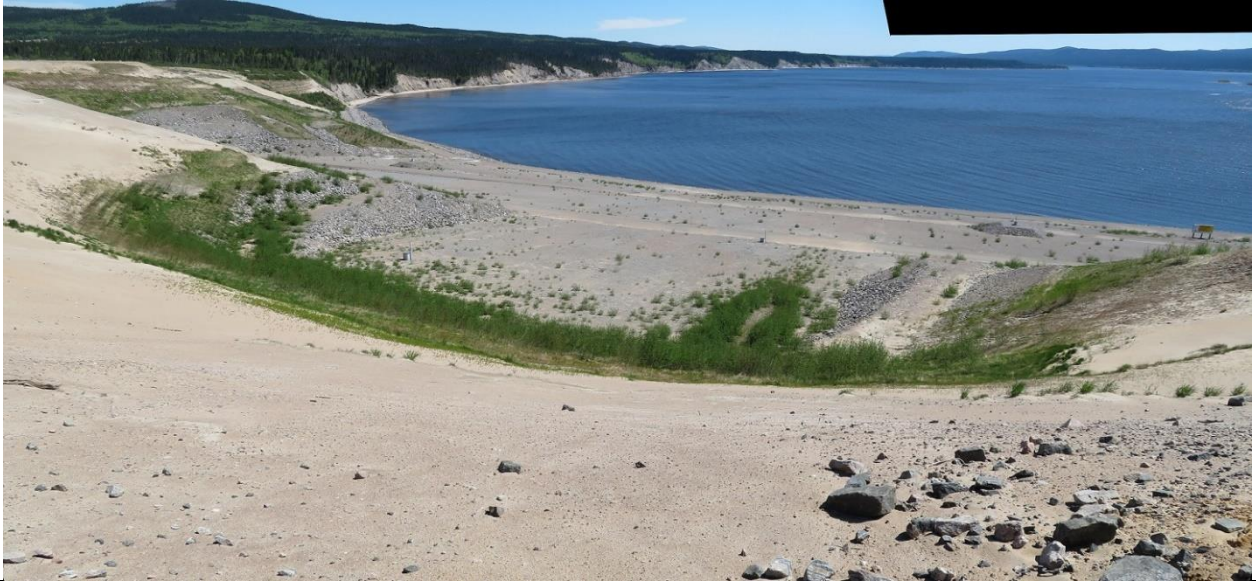
Photo 7: Downstream side of North Spur showing vegetation cover becoming established in sheltered areas.
