MEETINGS IN ST. JOHN'S AND VISITS TO LOWER CHURCHILL PROJECT SITES, NOVEMBER 18 TO 22, 2019

Prepared for: Natural Resources Canada and Nalcor Energy
IE Point of Contact: Nik Argirov
Date: December 12, 2019

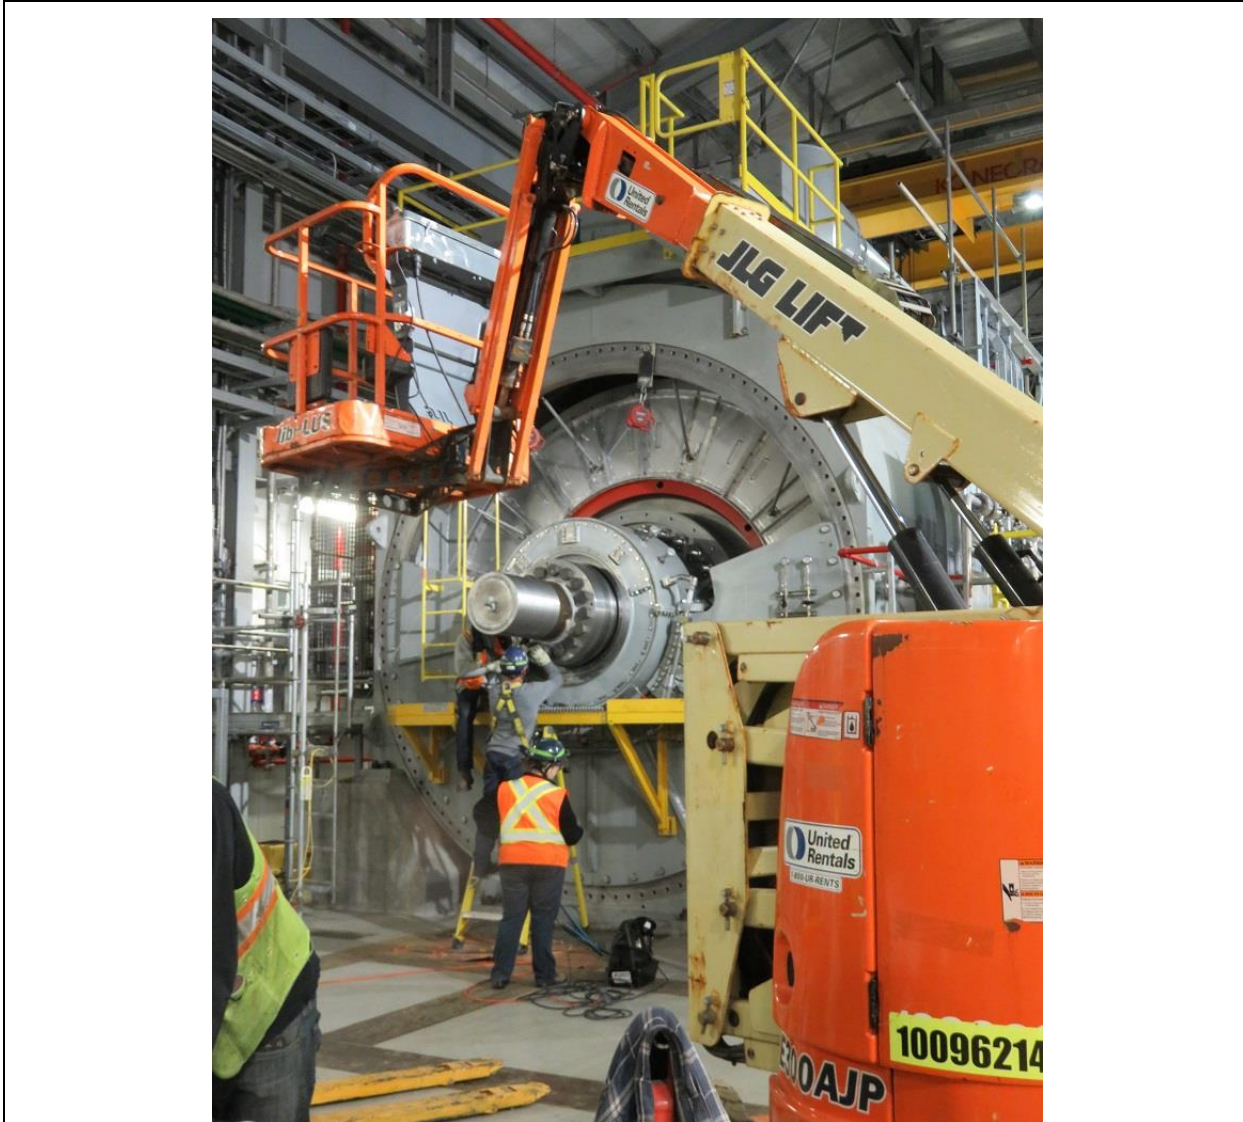
- SC2 bearing housing and bearing have been removed and undergoing investigation and modifications. Bearing housing tilt appears to have been addressed by stiffening brackets but the bearing is now deflecting in the housing and causing shaft binding.
- SC3 has been running but it experiences vibrations. It is not yet determined if the vibrations originate in the foundations or are mechanical vibrations of the machine itself. Vibration analysis is ongoing. Stiffeners will be added to bearing housing. *Post meeting note: Bearing housing stiffeners have been added to all 3 units.*

- Bearing tilt is as yet unresolved, bearing modifications that will allow better oil dispersion are being considered, as well as bearing housing modifications to allow better fit of the bearing in the housing.
- Converter building has been visited.

Photo 1: Soldiers Pond – synchronous condenser no. 2 with bearing housing removed.

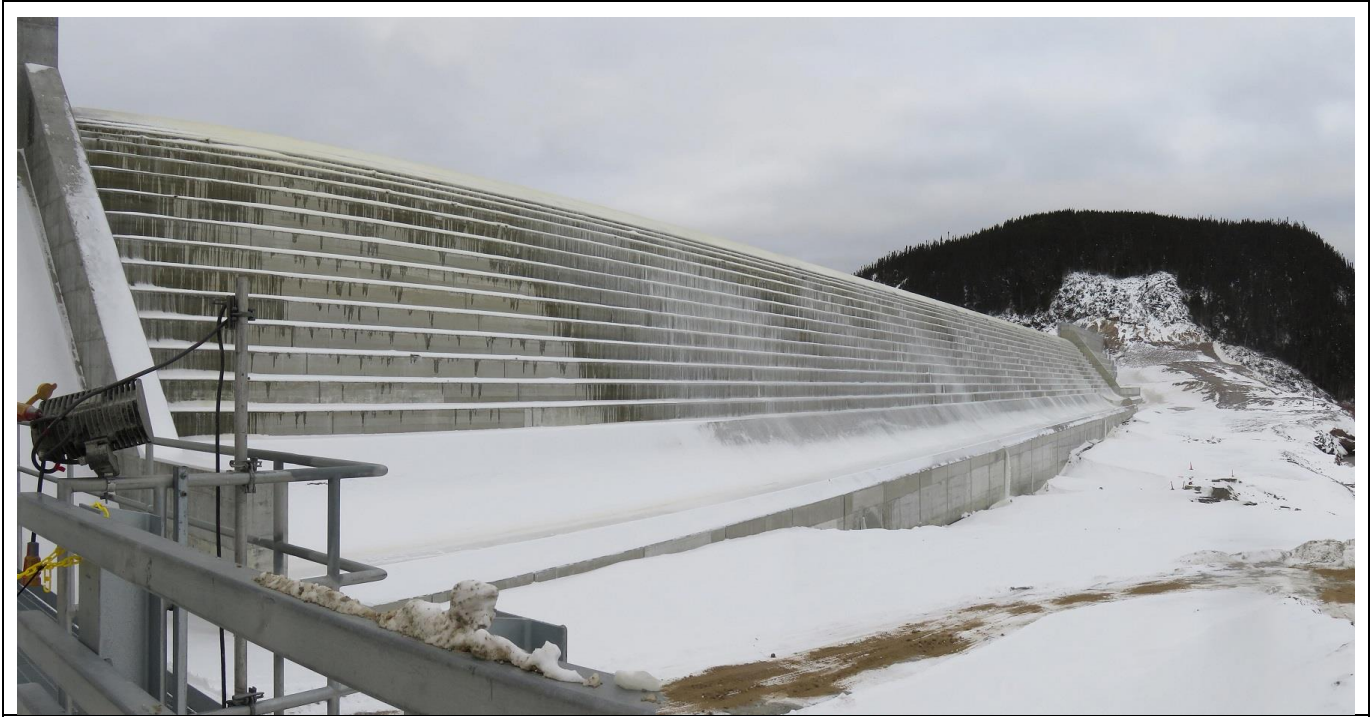
- Reservoir level continue to be maintained at El. 38.75 m \pm 0.25 m, using two spillway gates. It is reported that there is some minor wave splashover of the RCC dam during windy periods.

Photo 2: Downstream side of RCC dam at time of site visit – winter conditions.

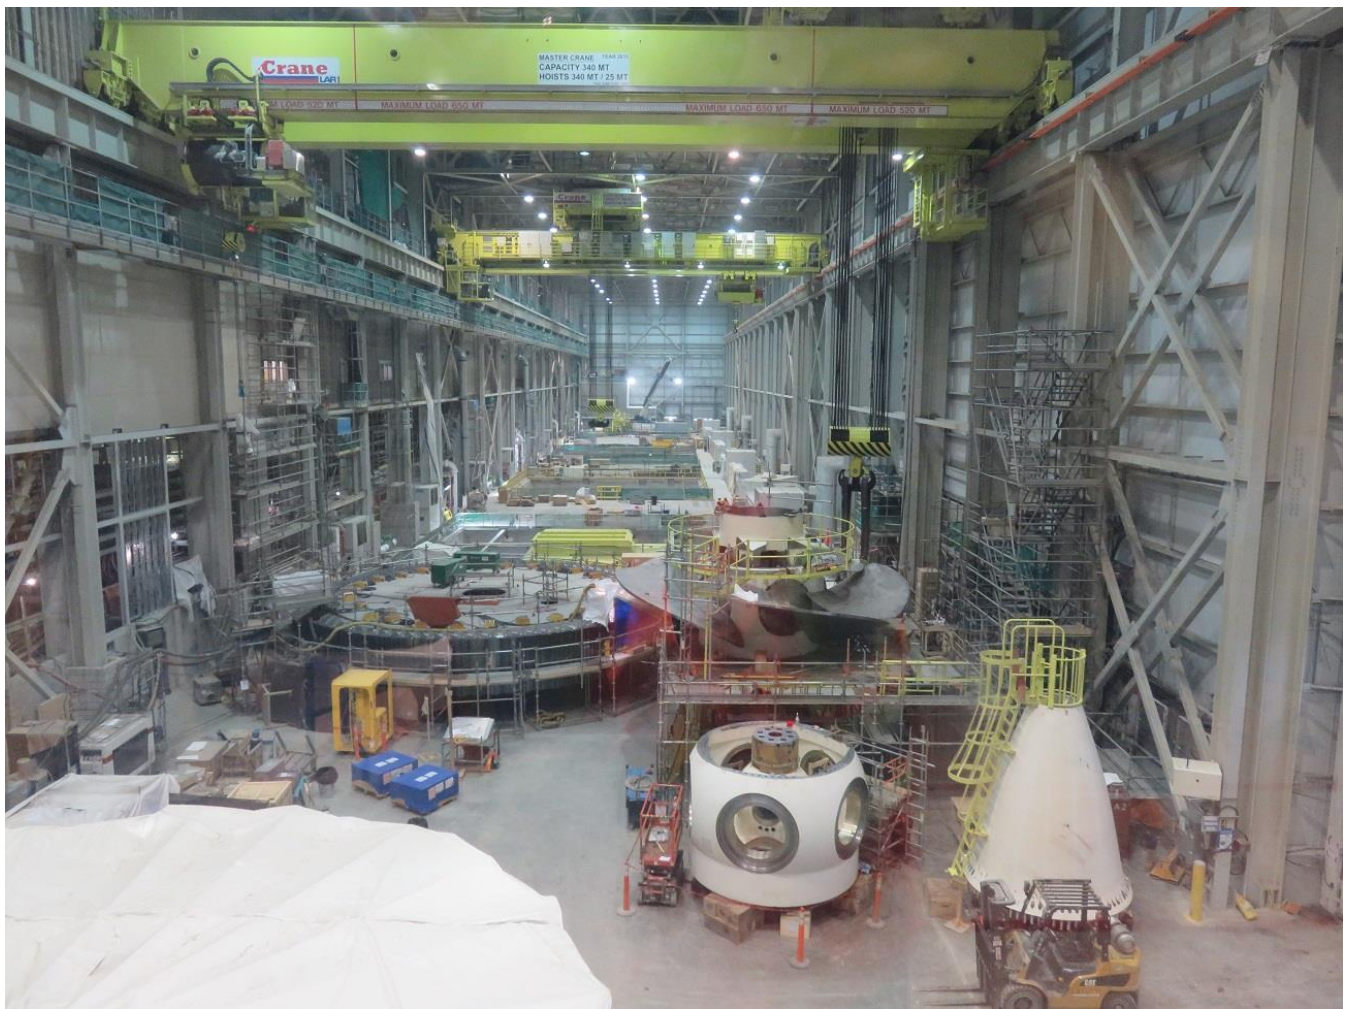
Photo 3: Northerly view of powerhouse interior with Unit #2 generator rotor (centre left); Unit #3 turbine runner (centre right); Unit #4 runner hub and cone (right foreground).

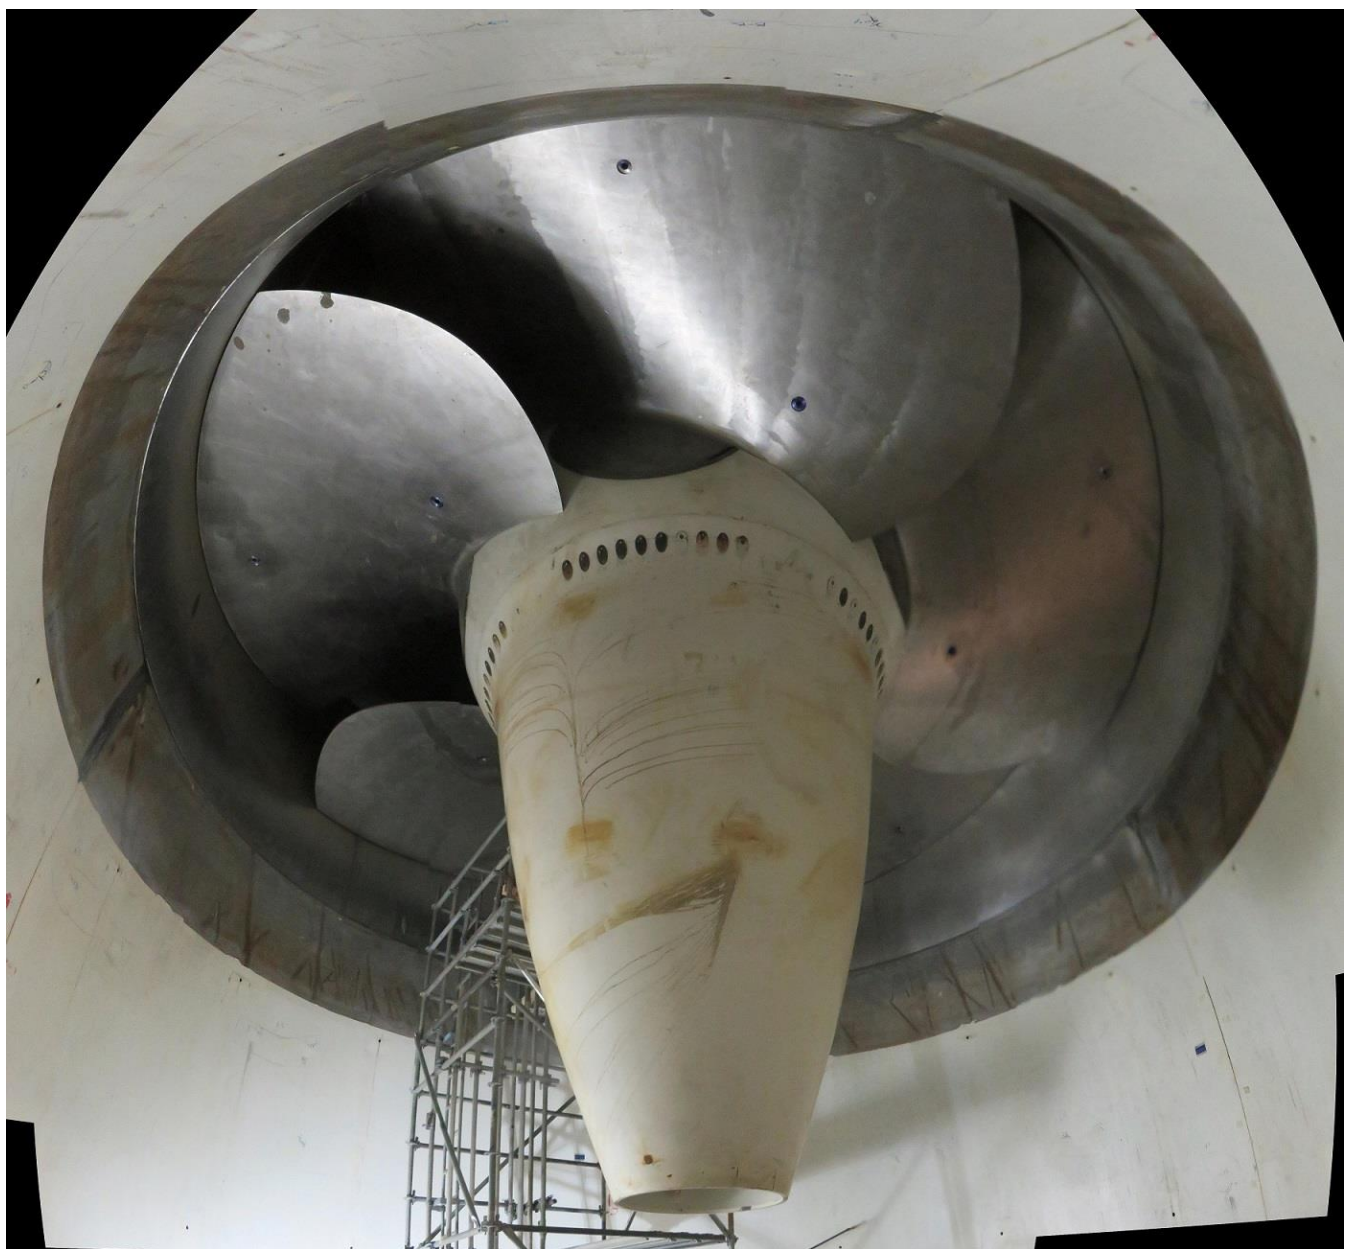
Photo 4: Unit #2 turbine runner viewed from below.

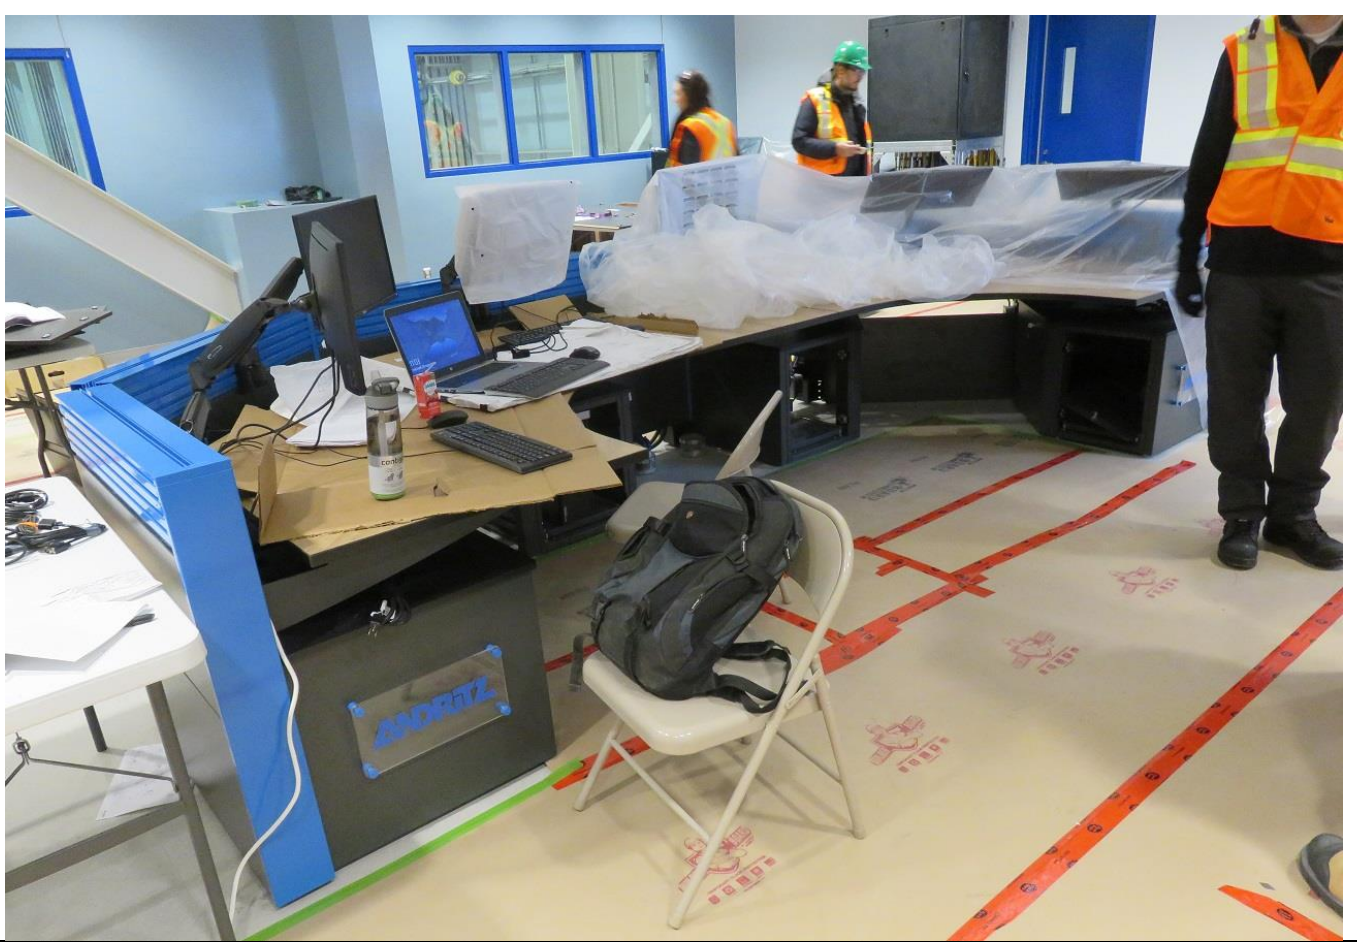
Photo 5: Control room equipment installation in progress.

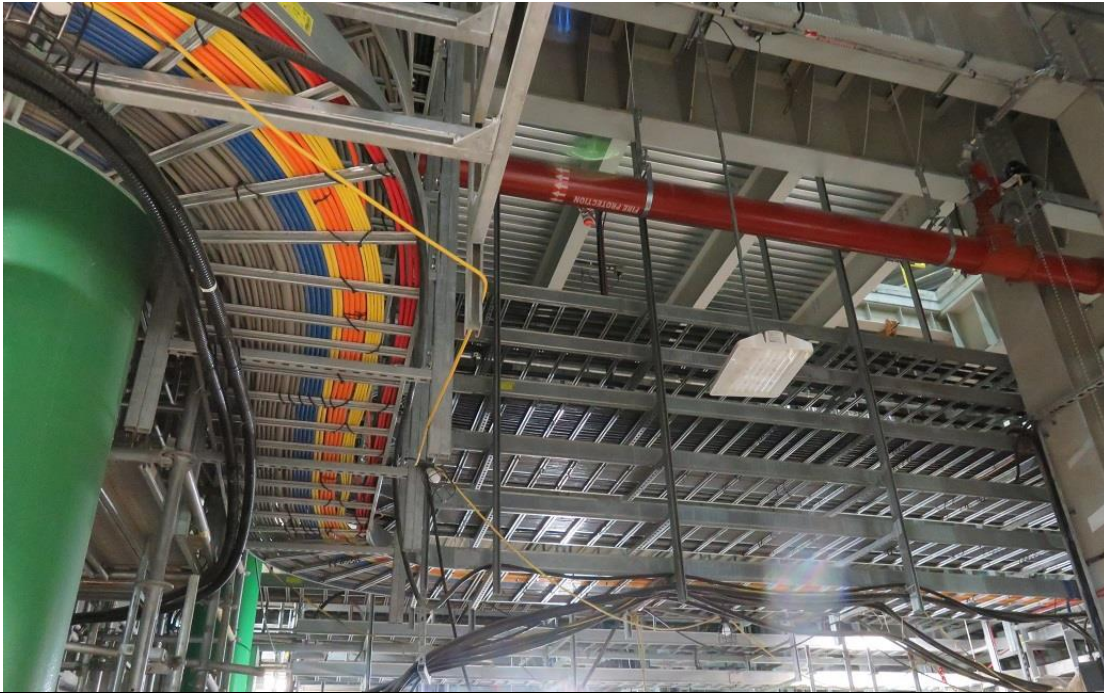
Photo 6: Typical view of balance of plant cabling installation; red pipe at upper right is fire protection water line.
