MEETINGS IN ST. JOHN'S AND VISITS TO LOWER CHURCHILL PROJECT SITES, OCTOBER 4 TO 8, 2021

Prepared for: Natural Resources Canada and Nalcor Energy

Date: November 02, 2021

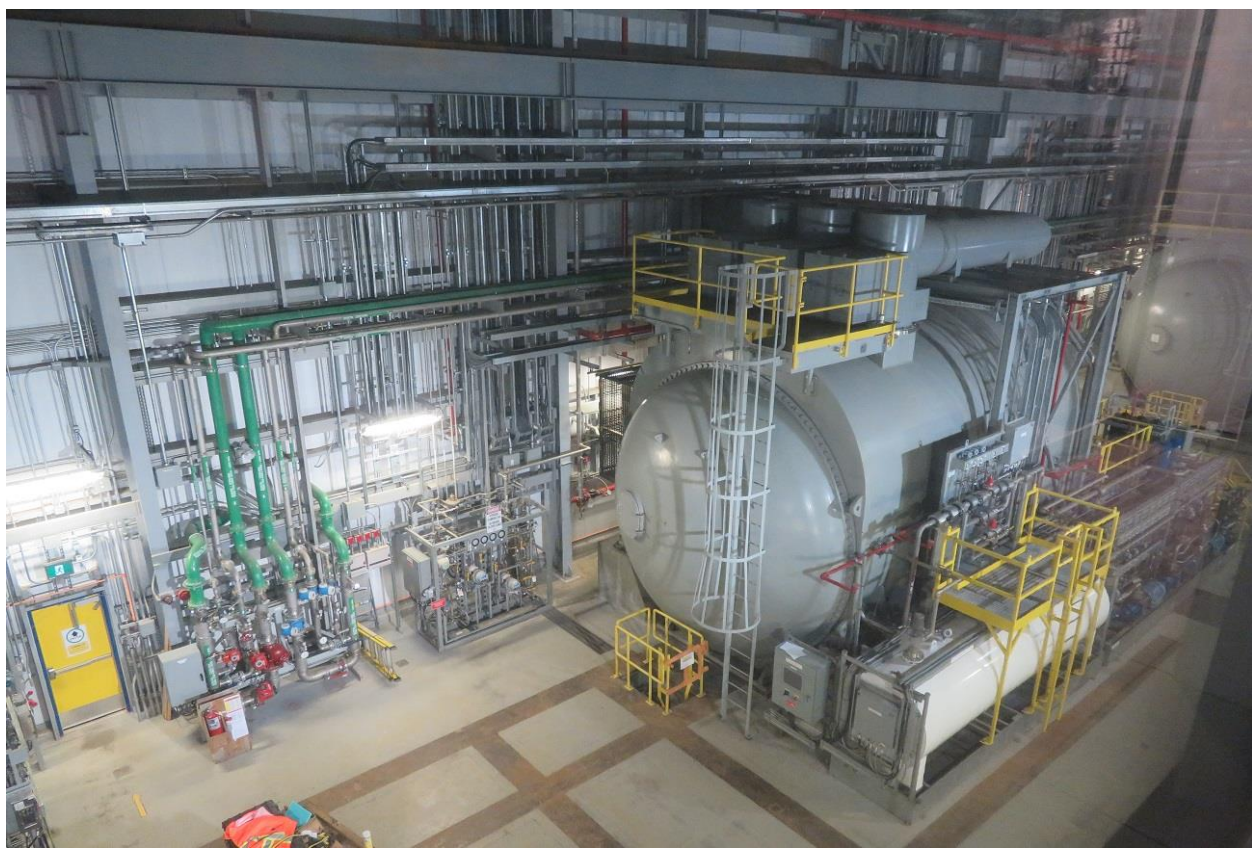
Photo 1: Synchronous condenser, Soldiers Pond.

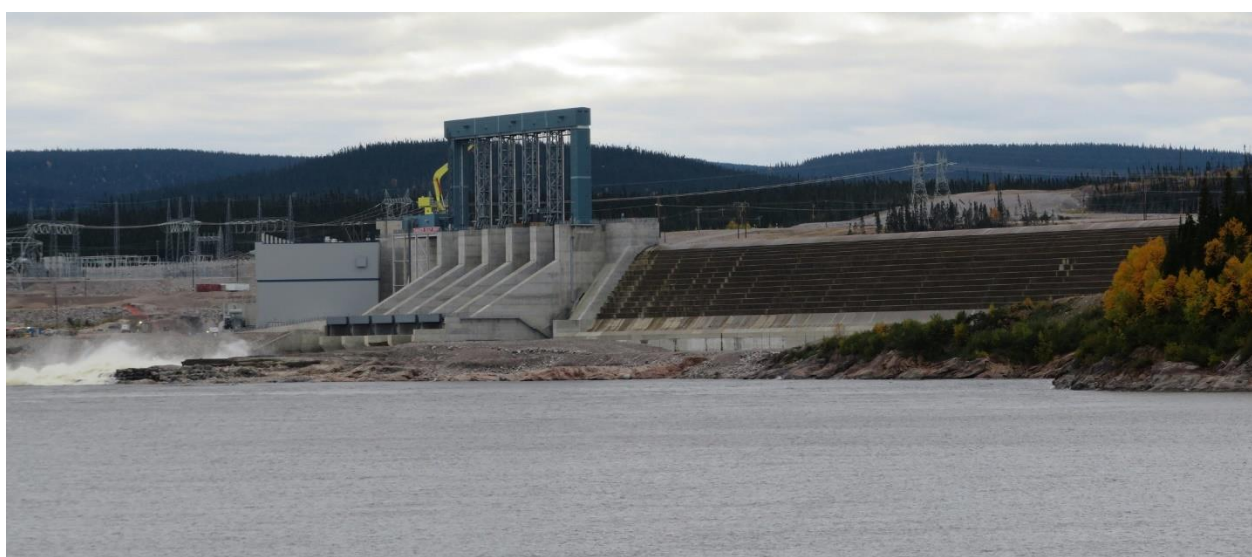
Photo 2: Muskrat Falls spillway and north dam.

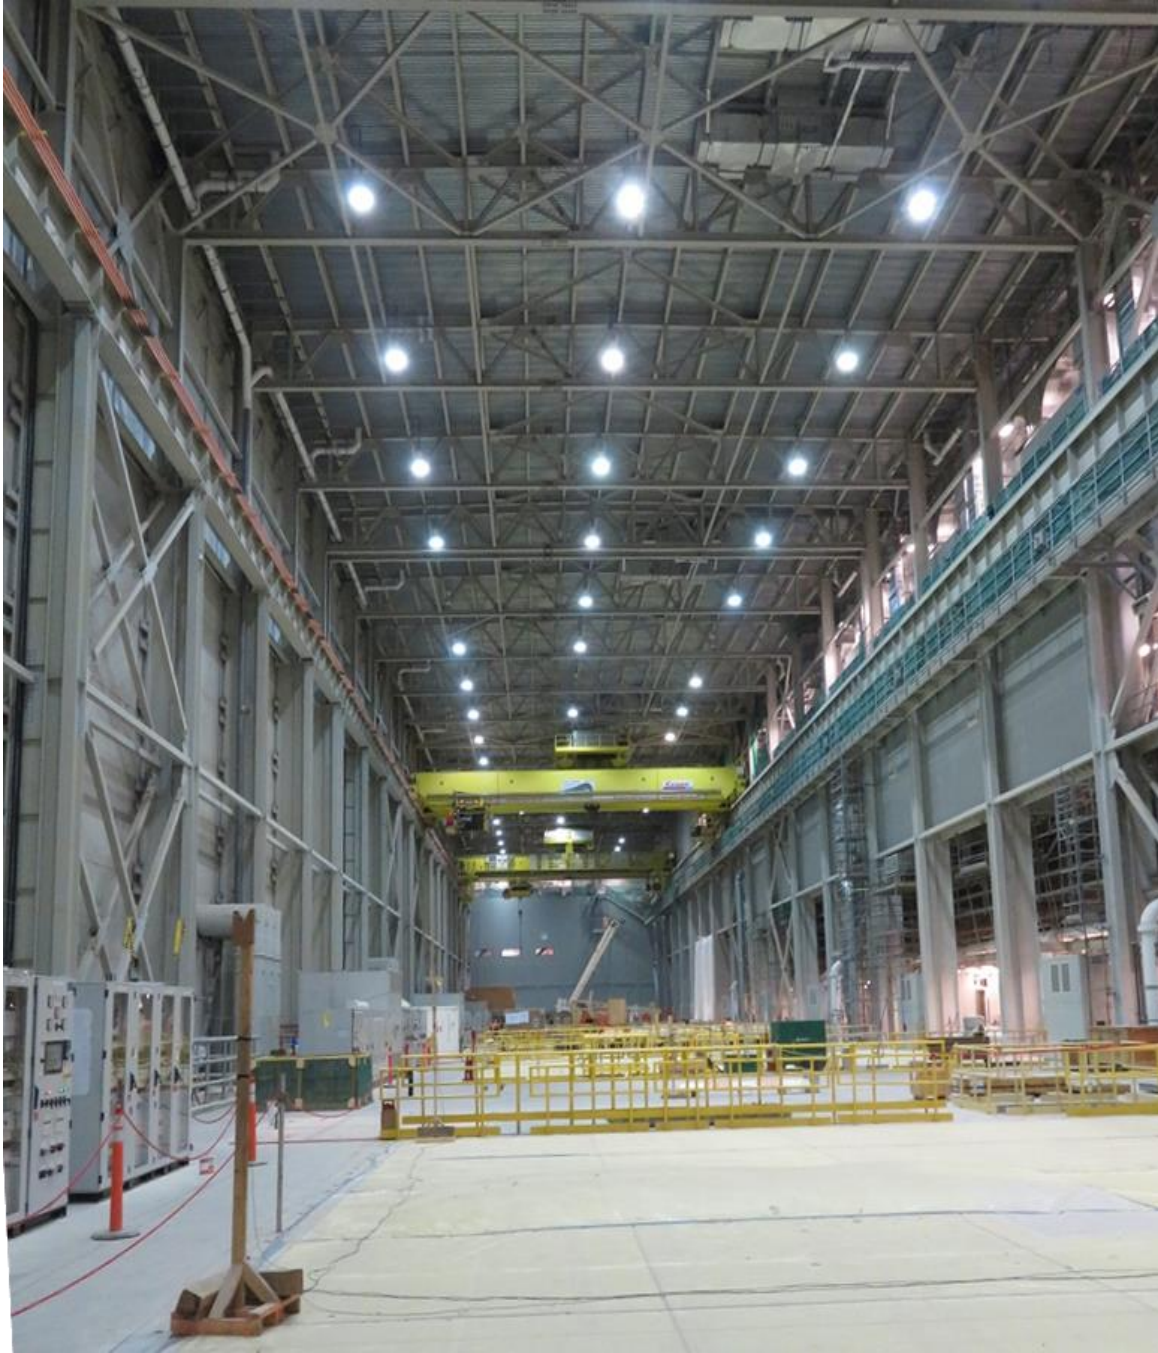
- Unit 1 and Unit 2 are down for remedial work, Unit 3 is operating. Unit 4 was readied for 130% overspeed test that was done later that day.
- Control Room is functional and attended by the operators.
- IE were advised there will be additional operational testing of all station services and emergency diesel generator automatic transfer schemes.
- The team conducted tours of the Generator & Turbine floors as well as of the intake gates and intake house.
- Rehabilitation and reclamation of the site is nearly completed.

Photo 3: Muskrat Falls powerhouse interior.

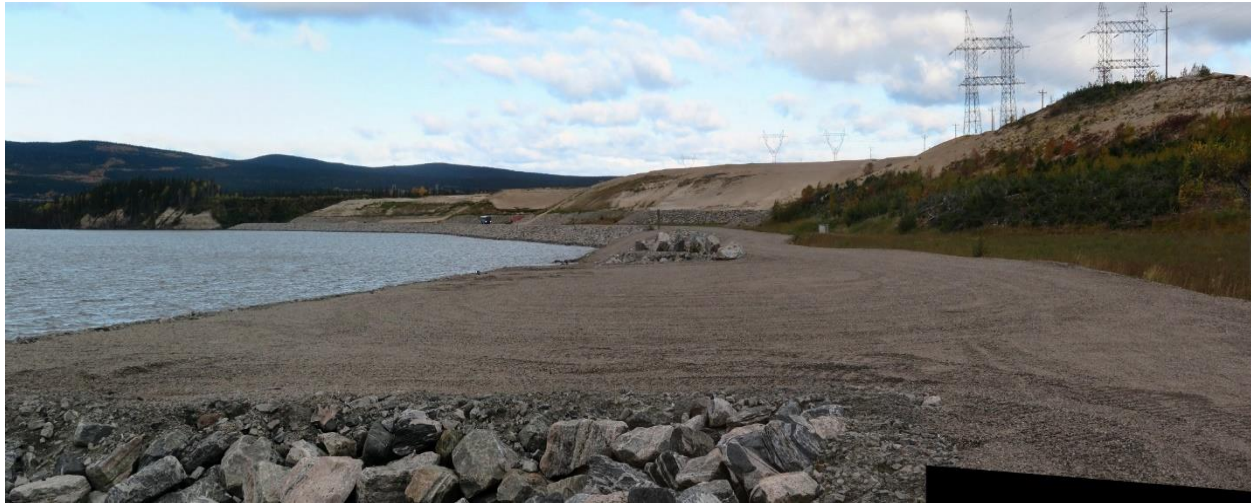
- Based on visual observation, there have been no significant changes to the slopes on the upstream and downstream sides of the North Spur. Areas of bare sand on portions of the slopes continue to experience some surficial erosion by wind and surface runoff; some small vegetation is beginning to take hold in some such areas, although that will likely be a slow process on the steeper exposed slopes. The riprap along the upstream face of the North Spur is stable and there is very little accumulated woody debris from the reservoir. Instrumentation in the North Spur indicates generally stable conditions, with a few piezometers in the intermediate aquifer still showing slowly increasing levels that are interpreted to reflect continued response of groundwater levels to both the effect of the new reservoir and the shutdown of pump wells in February 2019.

Photo 4: Upstream side of North Spur.

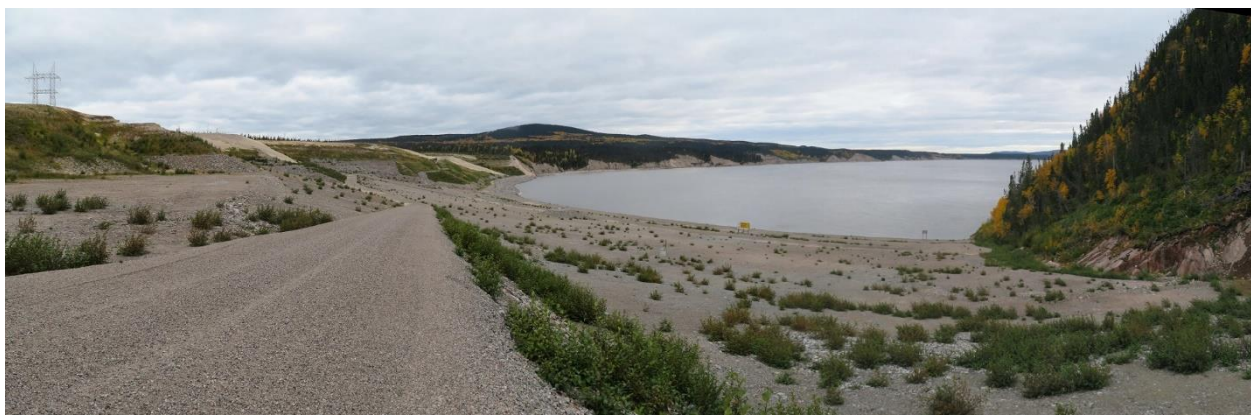
Photo 5: Downstream side of North Spur.

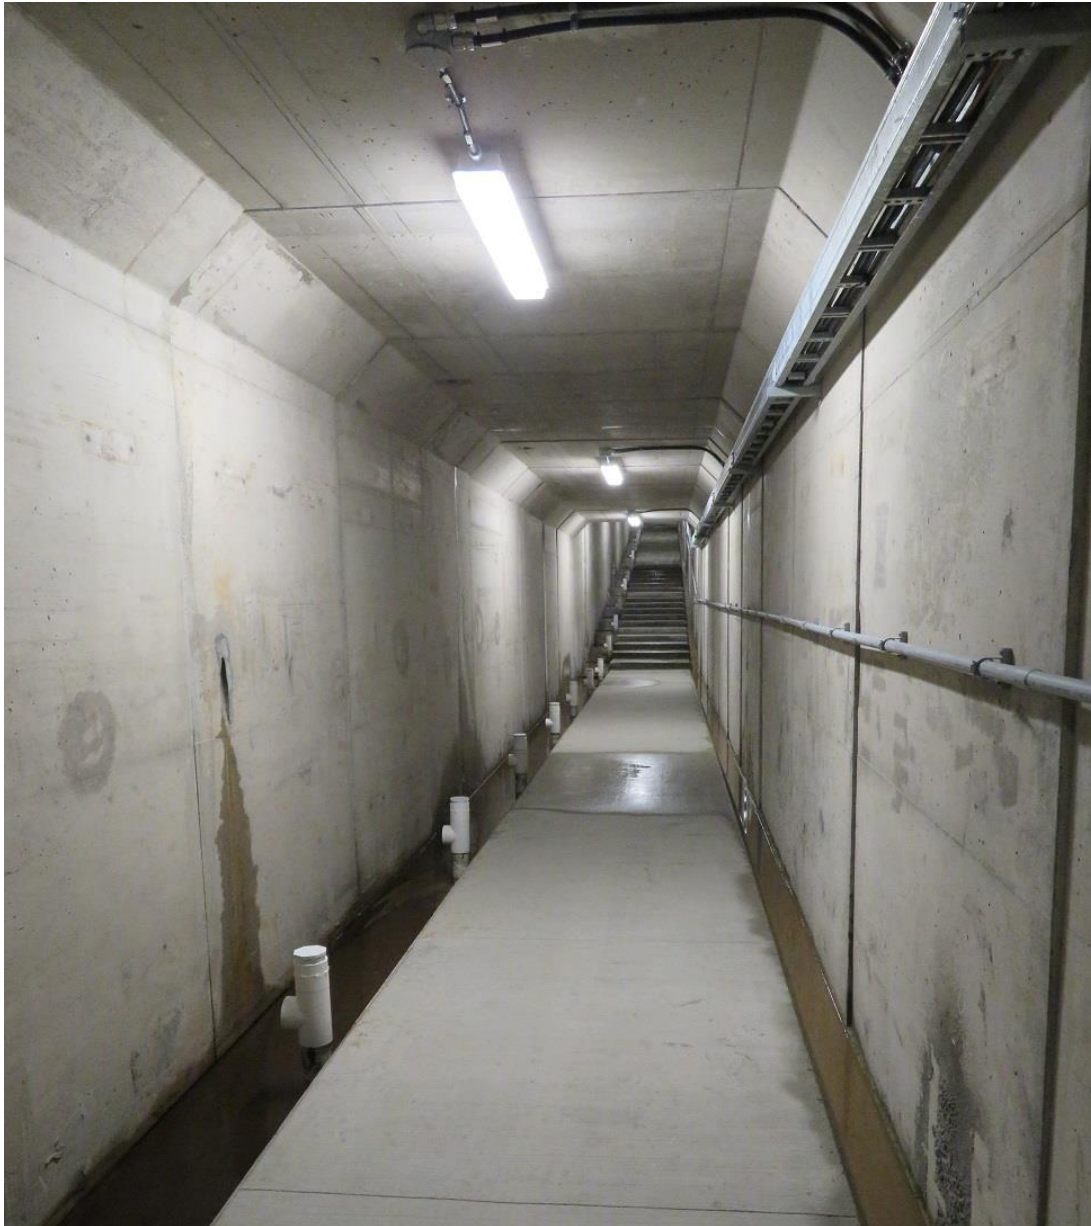
safety instruments in the dams and their foundations have continued to show stable conditions with some small cyclic trends that appear to be related to seasonal temperature variations. Seepage flows in the dam drainage galleries remain very low.

- The IE team visited the North Spur and accompanied an Operations Dam Safety team member on a typical routine inspection of all the dams, including exterior areas and drainage galleries. Conditions were observed to be consistent with those reported in the weekly monitoring reports and no anomalous or unusual conditions were noted.

Photo 6: North Dam drainage gallery.

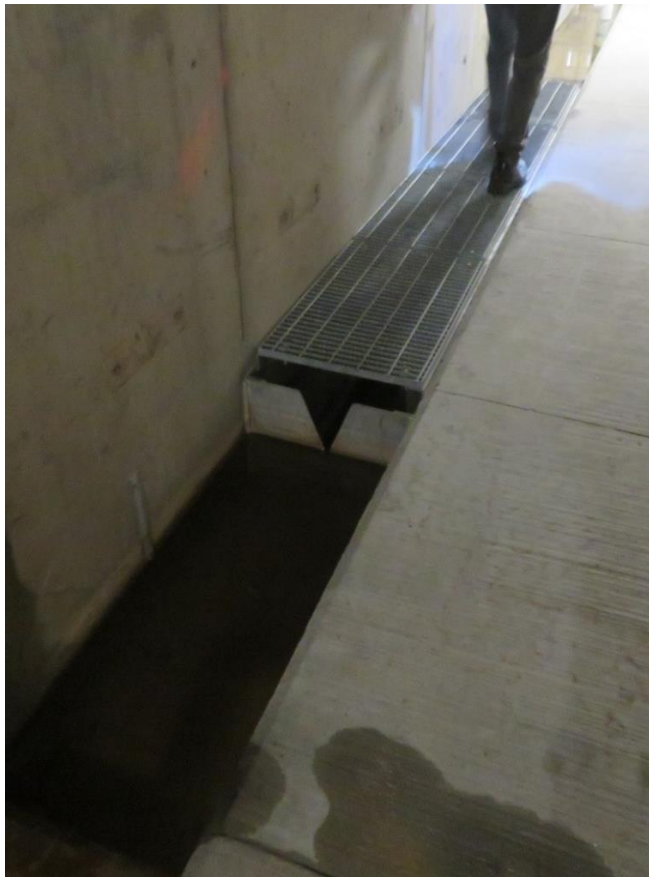
Left - Photo 7: Typical V-notch weir for measuring flow in drainage gallery ditch.

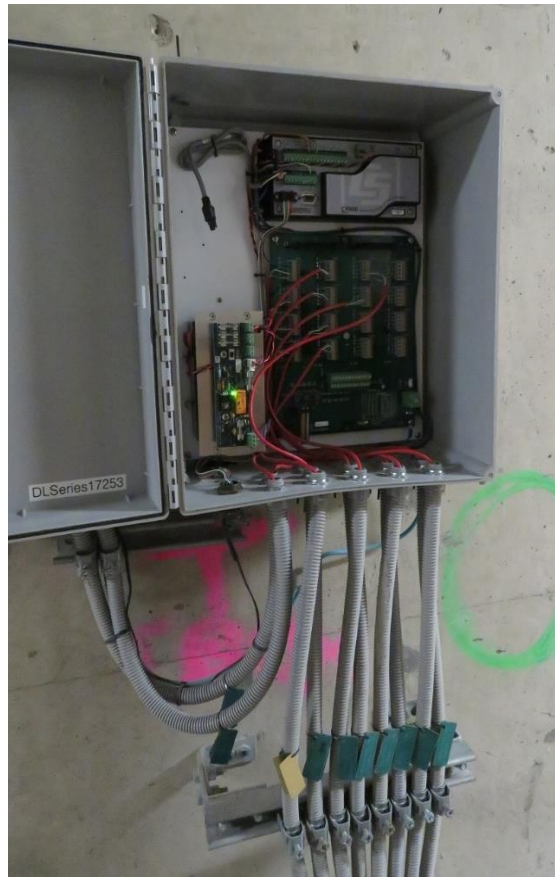
Right - Photo 8: Typical dam safety instrumentation cabinet.
