# MANUFACTURING INSPECTION GE FABRICATION FACILITY IN CLEARWATER, FLORIDA OCTOBER 12, 2017

Prepared for: Natural Resources Canada and Nalcor Energy

Date: January 10, 2018

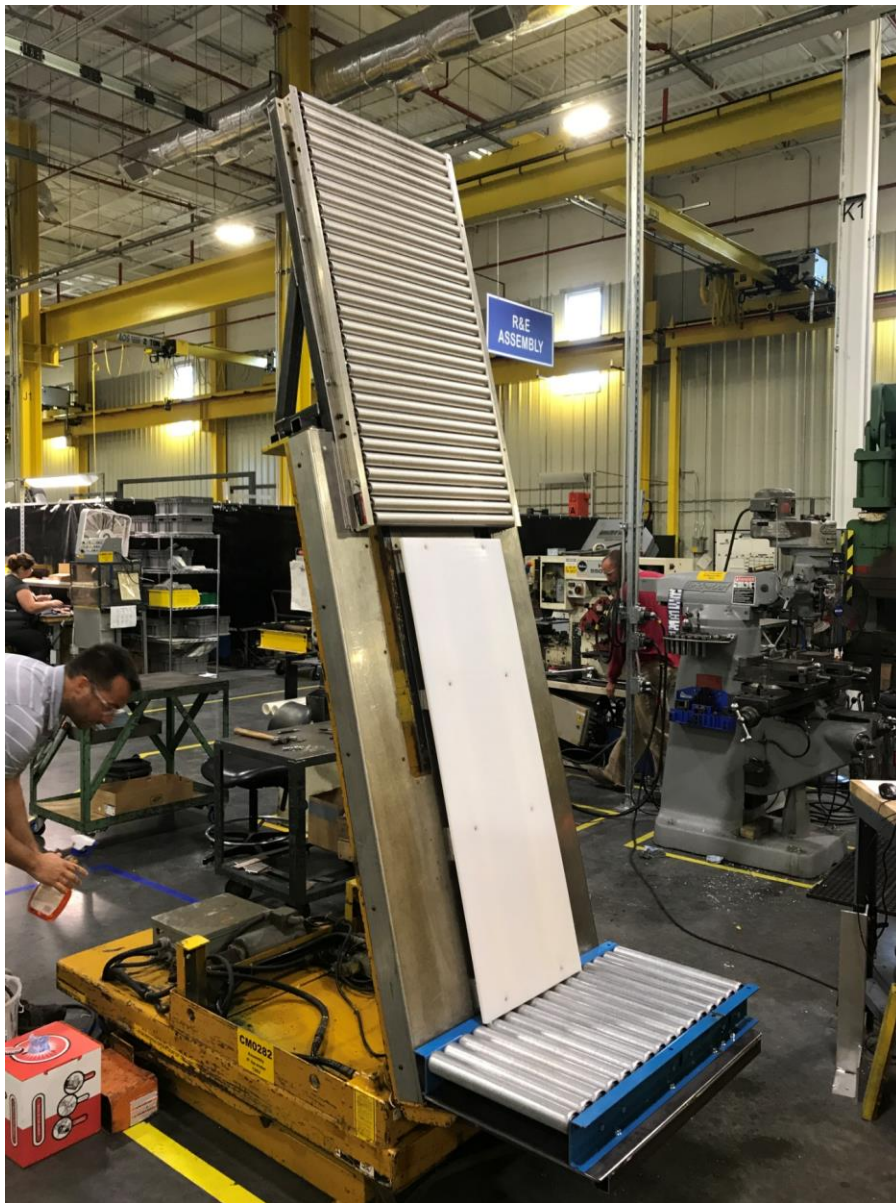
Photo 1: Assembly line.

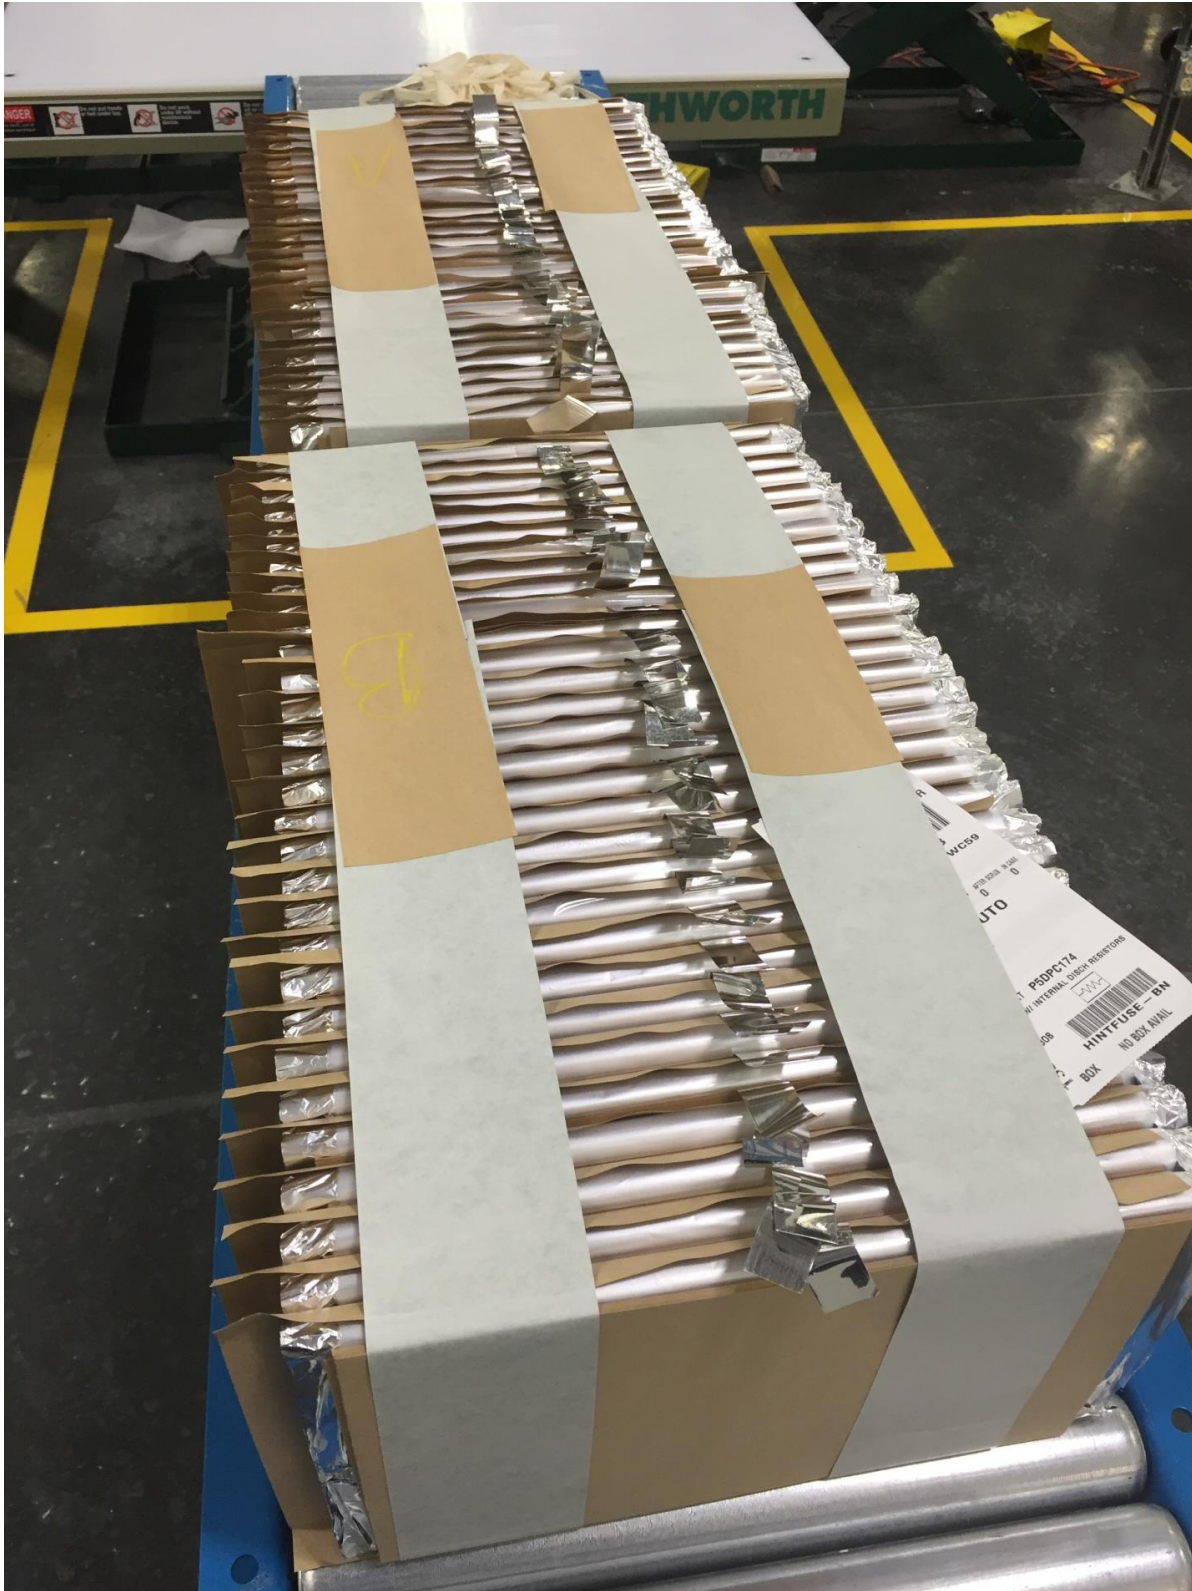
**Photo 2:** Capacitor bundles with connector tabs ready for assembly.

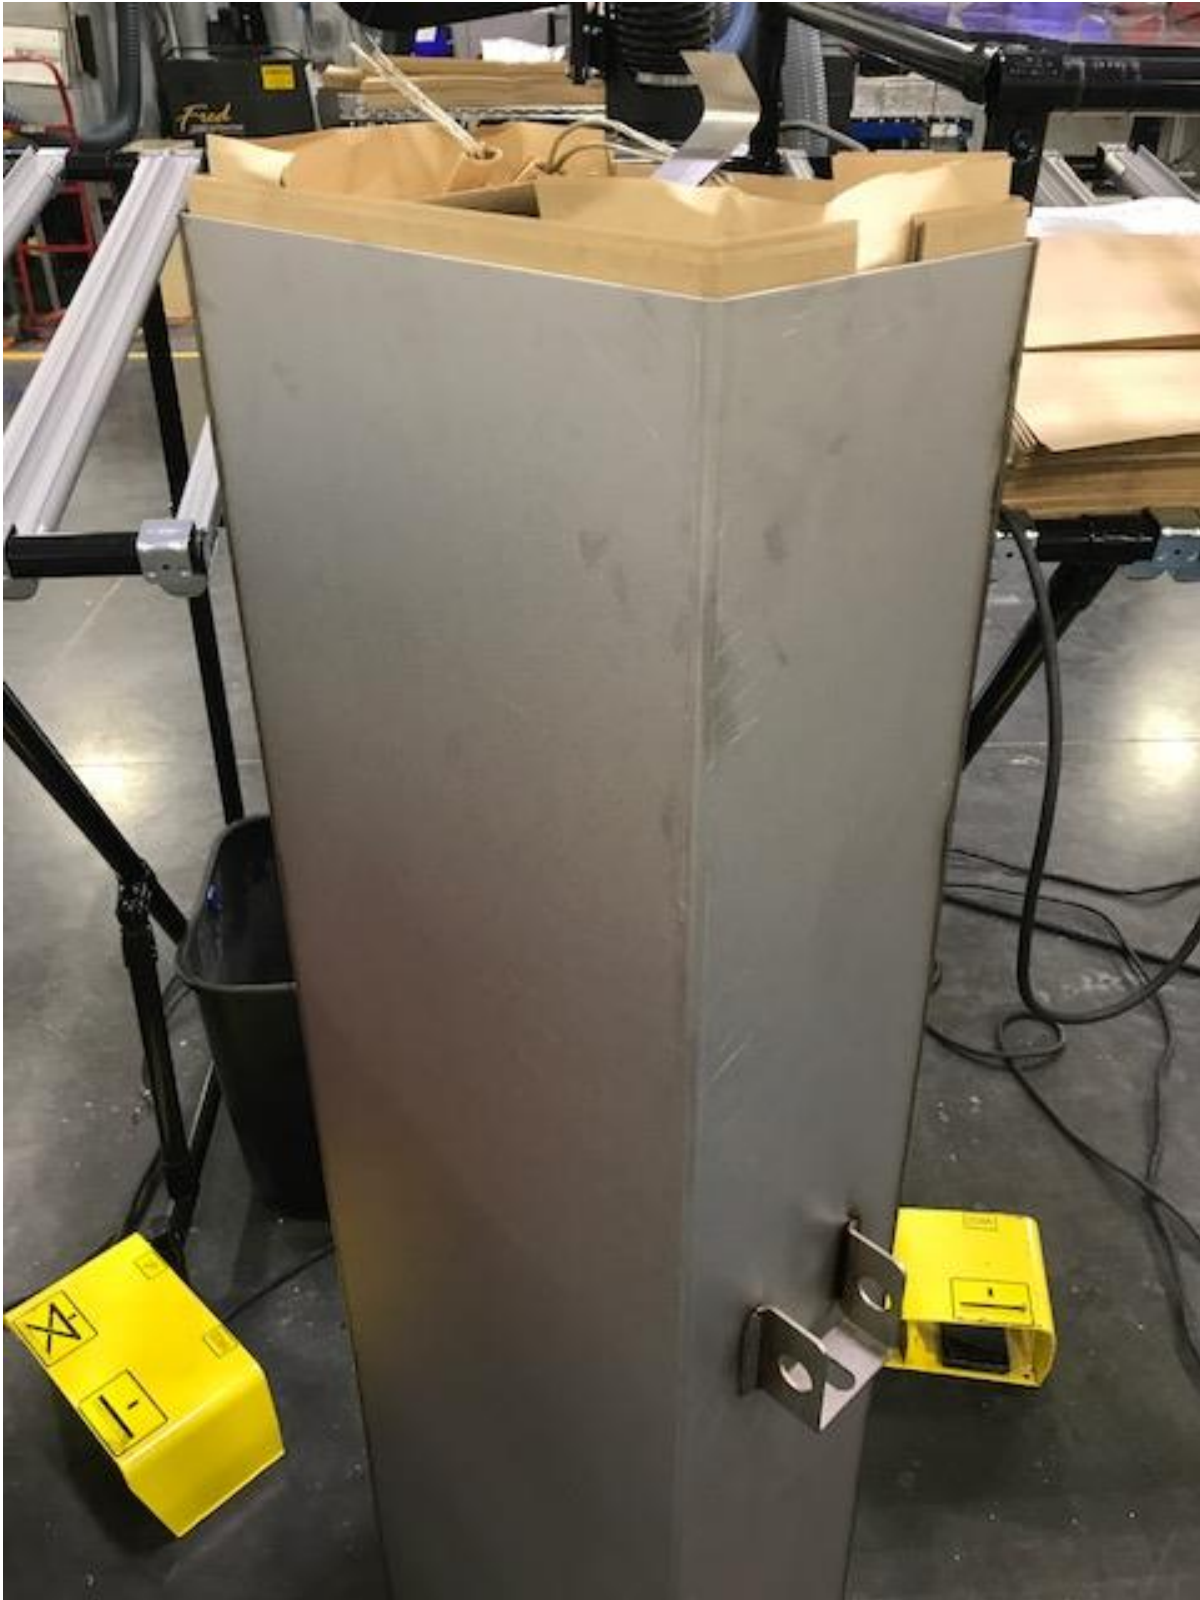
**Photo 3:** Capacitor inserted into the capacitor can.

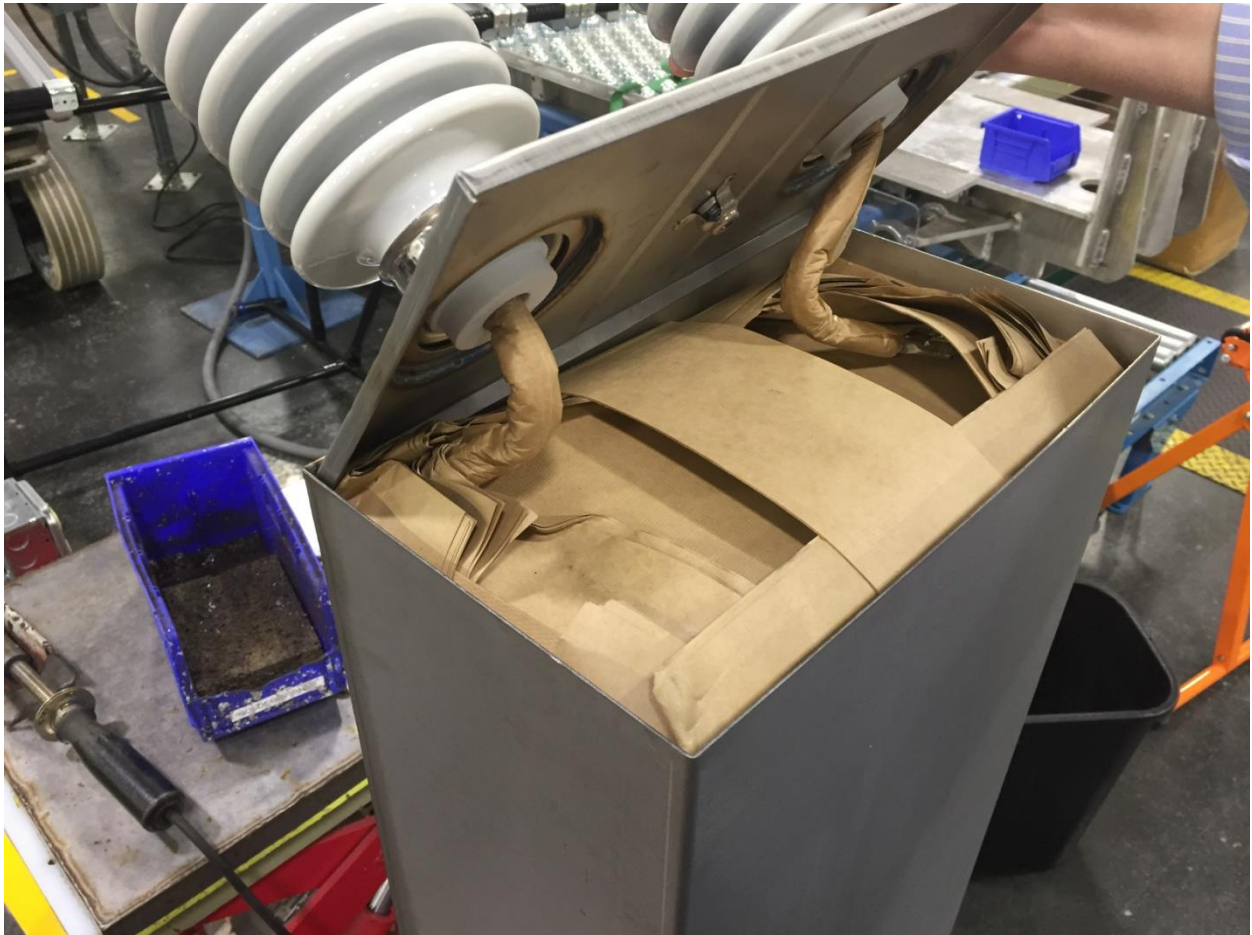
**Photo 4:** Final assembly prior to lid welding.

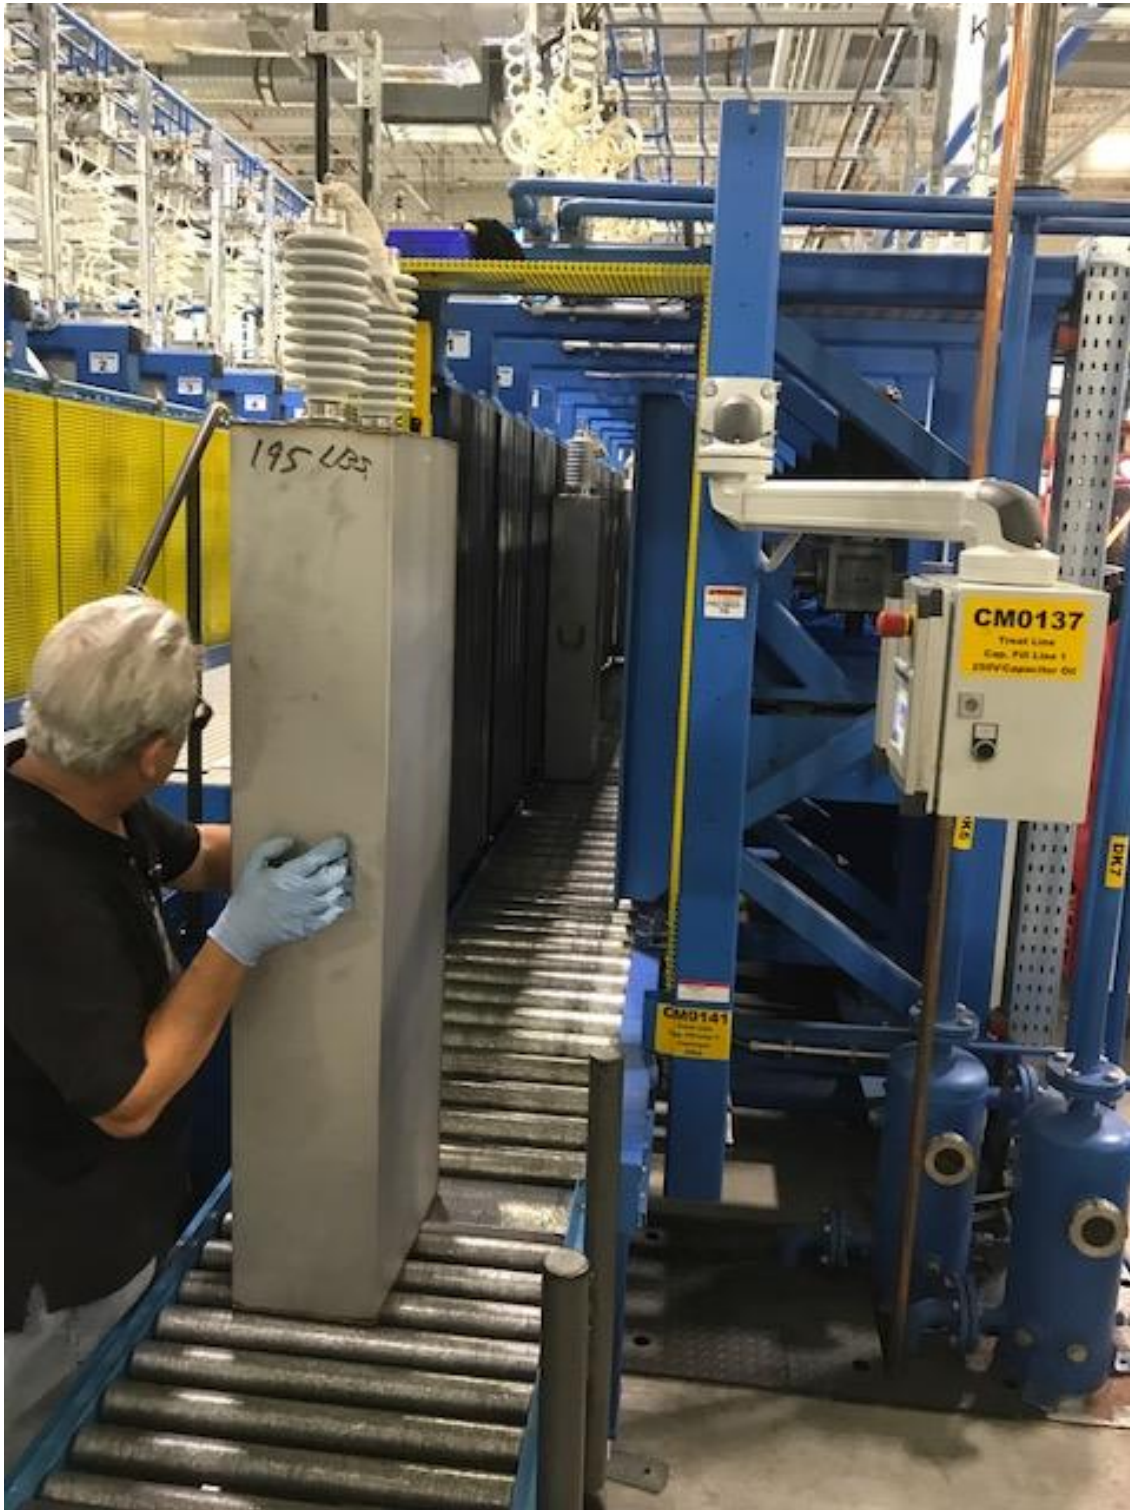
**Photo 5:** Drying and oil filling steps.

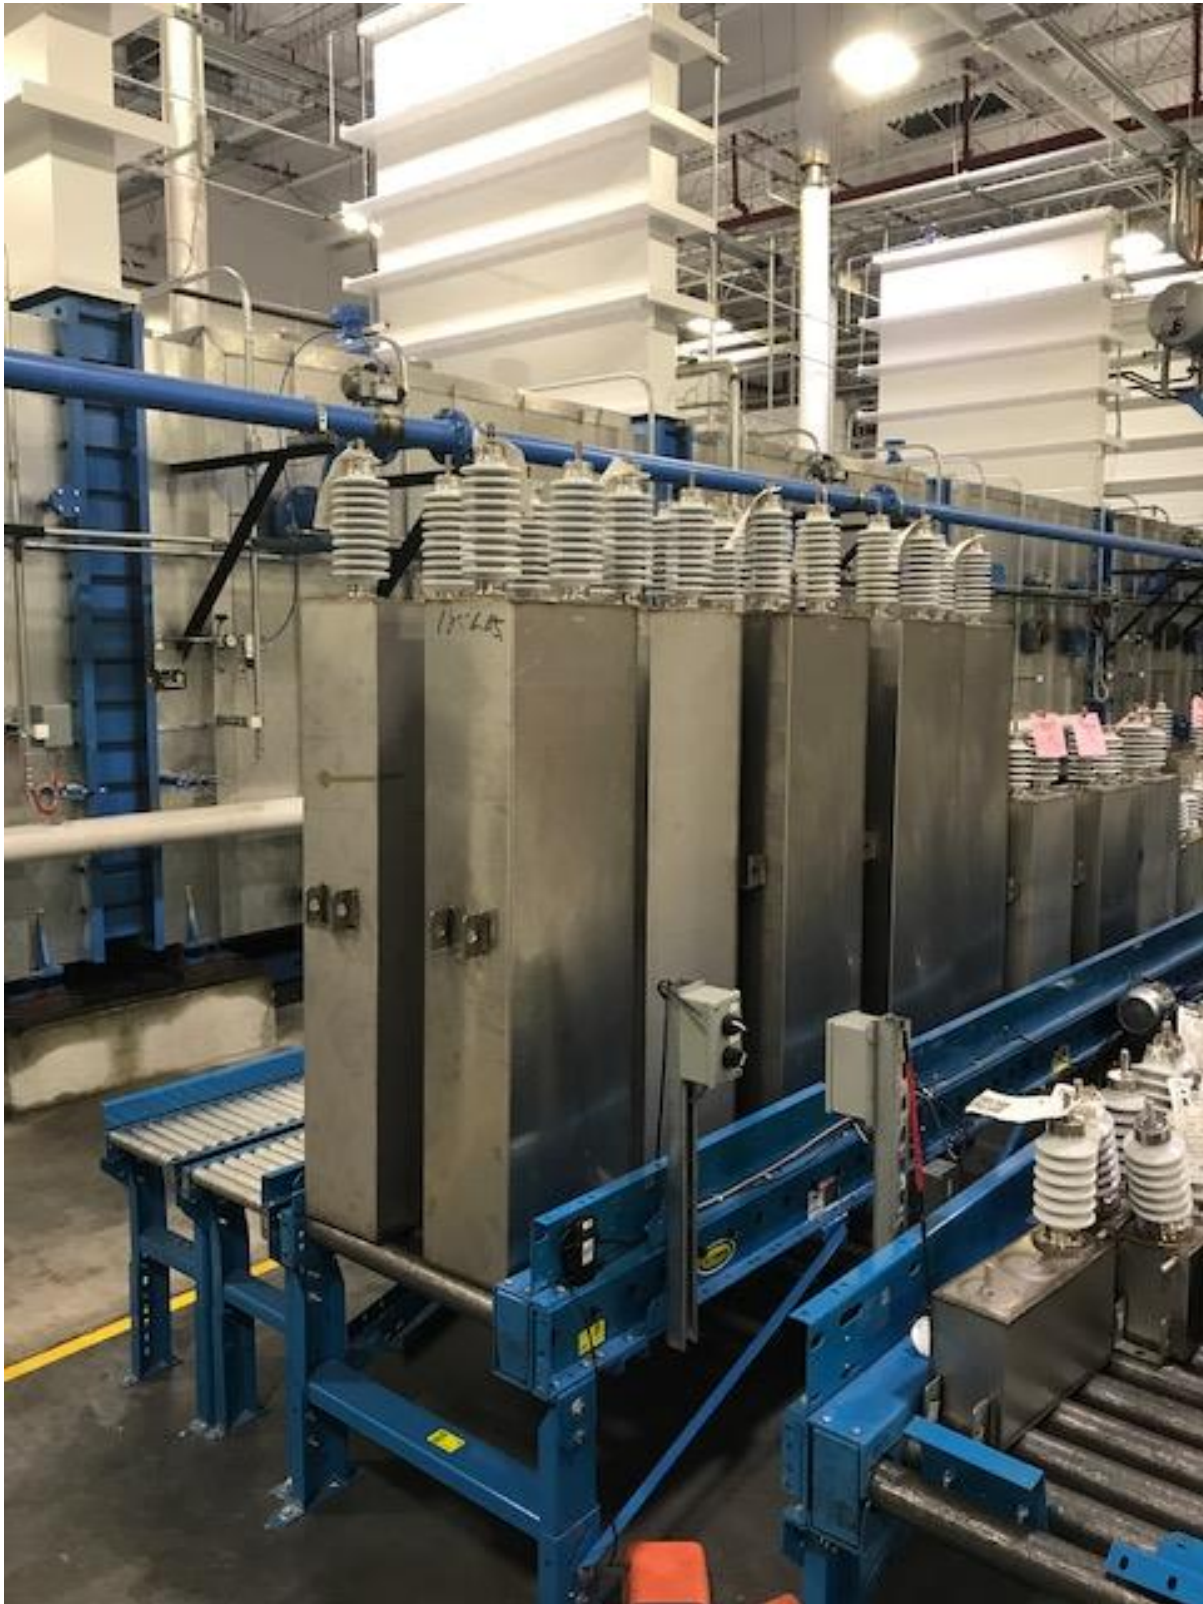
**Photo 6:** Drying and oil filling steps.

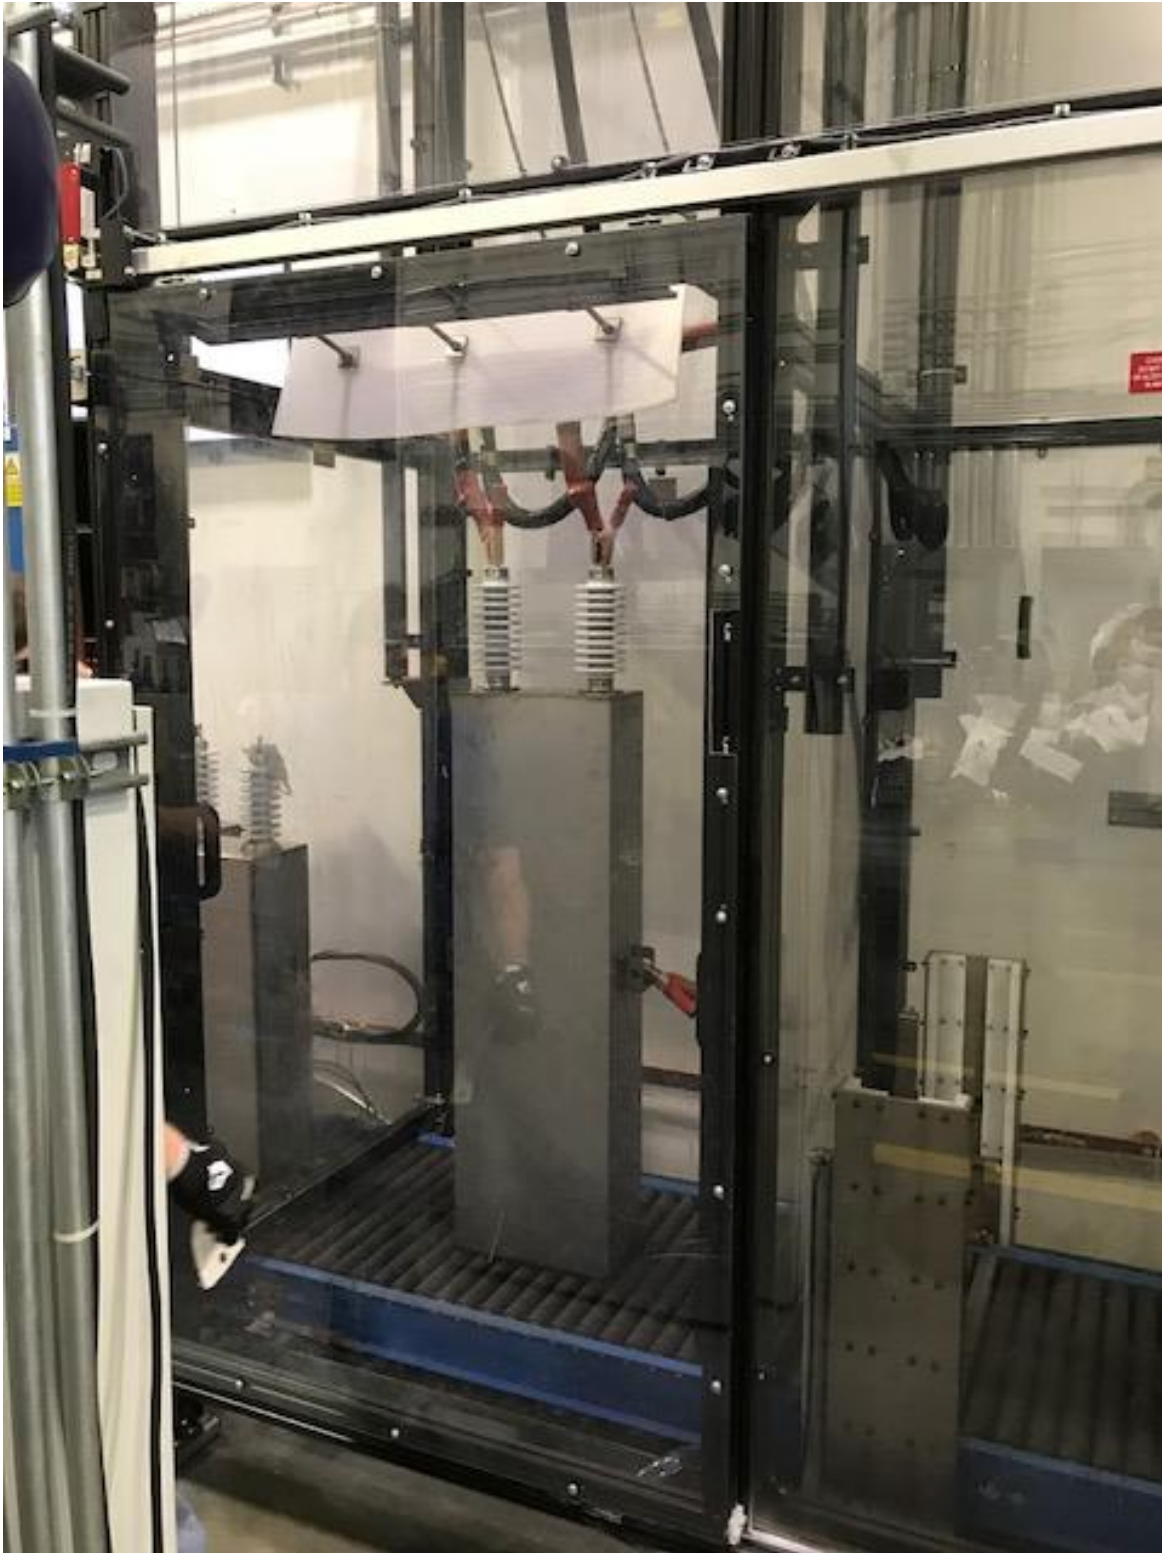
**Photo 7:** Electrical Test bay.

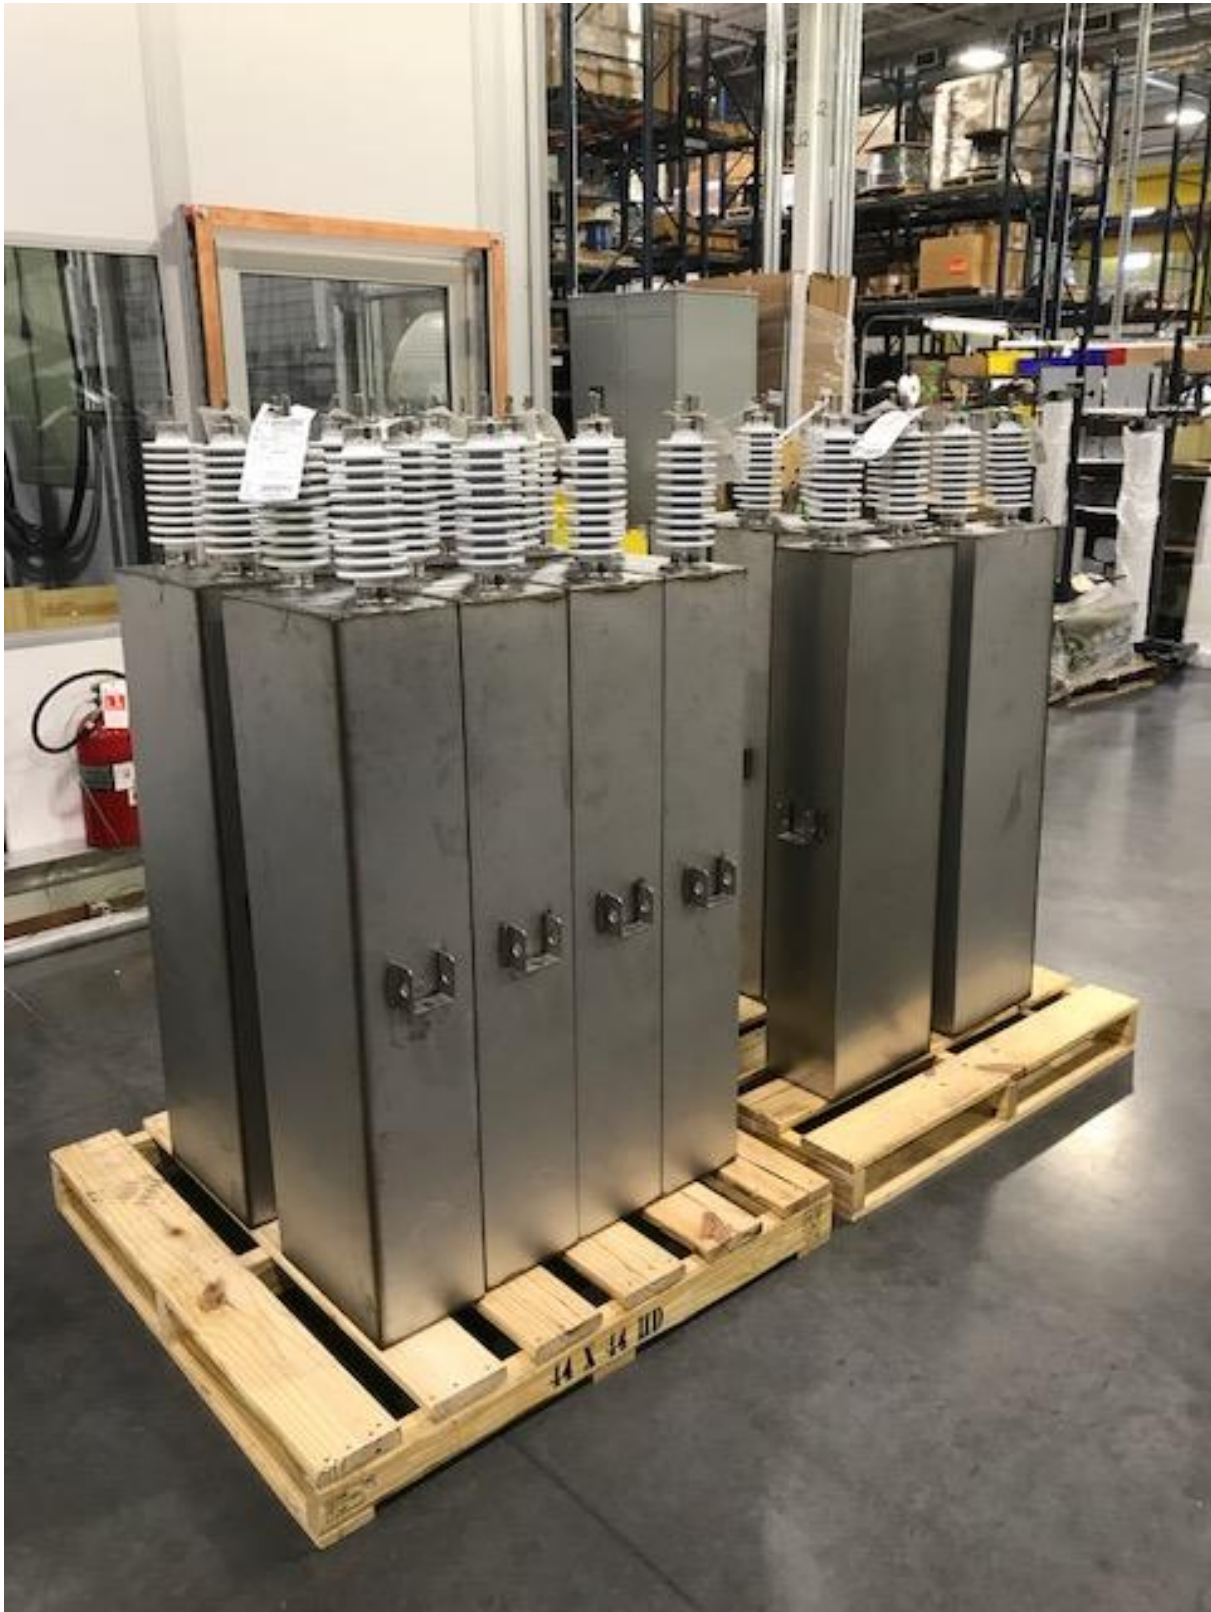
**Photo 8:** Finished product.
