## **Dam Safety Review Various Former Mine Sites Former Gullbridge Copper Mine, NL**

Final Inspection Report

File No. 121612646

Date: March 2, 2011

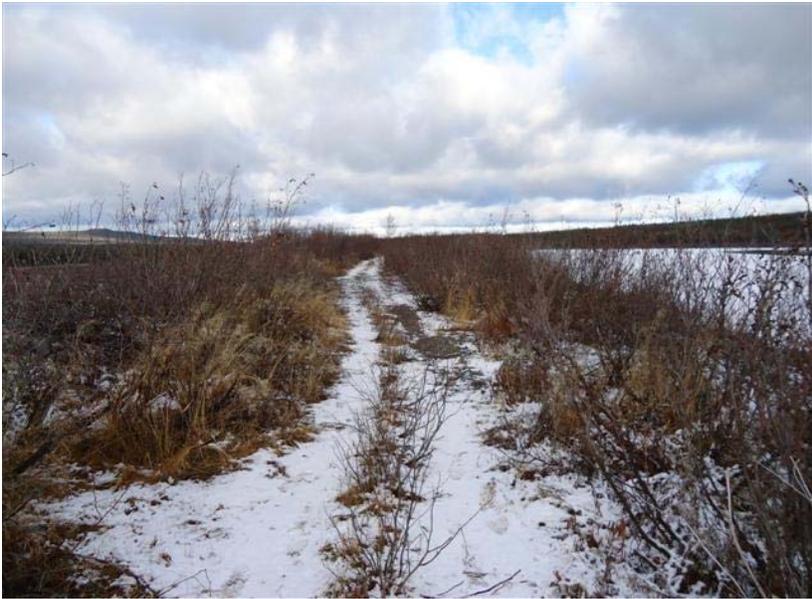
- The slopes and crest of the Gullbridge tailings dam were very densely vegetated along the length of the dam. Vegetation coverage was approximately 50-60% along the crest (Photo GB-1), 75-90% along the downstream slope, and 30% along the upstream slope. As such, it was difficult to observe and evaluate the condition of the dam shell.

Looking N along crest of dam - note heavy vegetation.	
Photograph GB-2

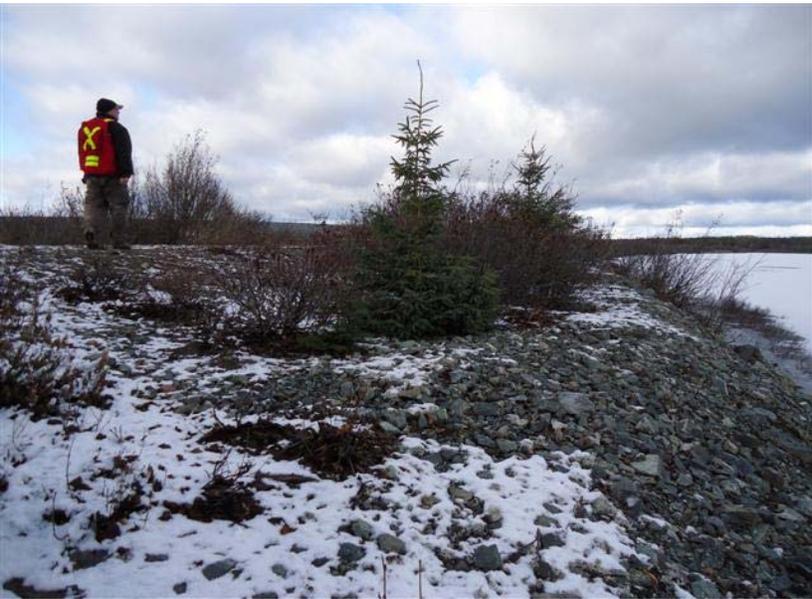
- Ice-jacking and/or shelling was observed at the crest and upstream slope area (Photo GB-10), and differential elevation was also apparent (Photo GB-2).

Looking N along crest and upstream slope - note differential elevation.

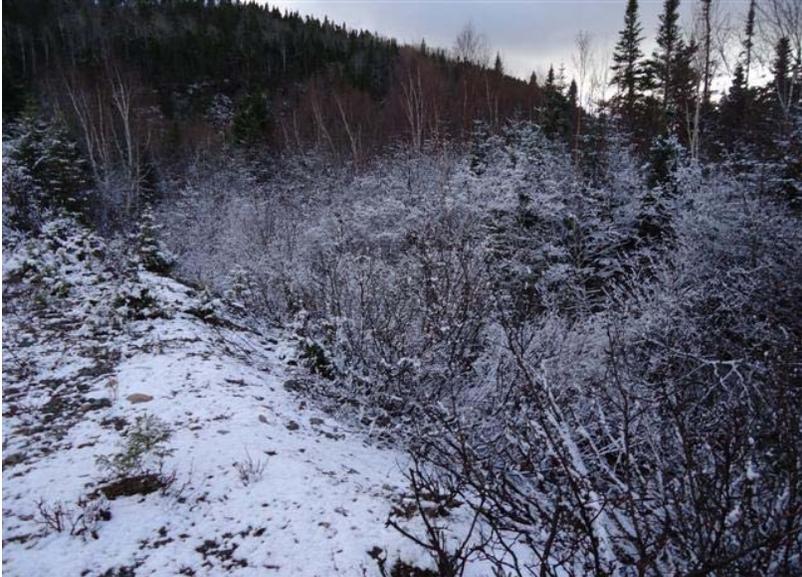
Looking SW along downstream slope at south end - note dense vegetation.	
<b>Photograph GB-4</b>

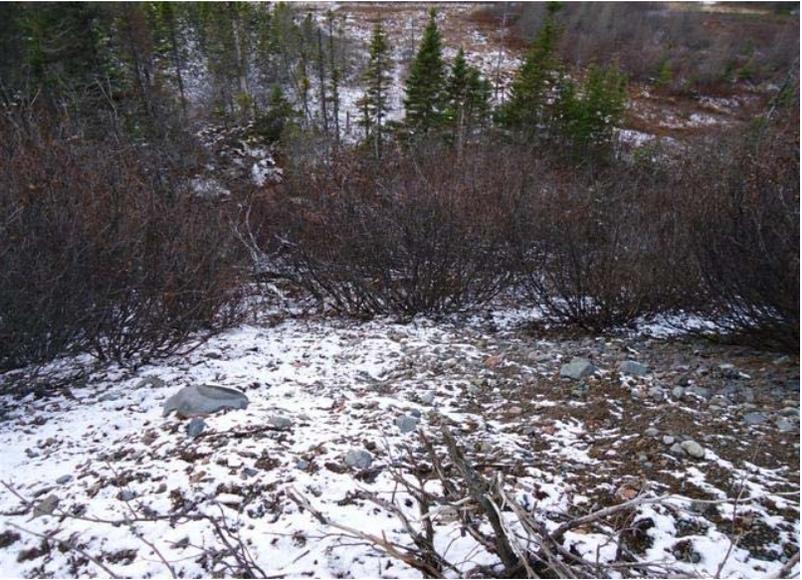
- Some erosion and shallow slope failures were noted where the dam shell material was exposed on the downstream slope (Photos GB-4 and 6). The shallow slope failures are believed to be in the same location as the cracks shown in the DNR photographs recorded June 10, 2010 (Photo GB-5). Since the construction history of the dam is unknown (i.e. if the dam is of rolled-earth cutoff construction, or if there is a rolled-earth core with dumped rock shells (slopes)), it is difficult to determine the cause of the failure (failure in Photo GB-6 / longitudinal crack in Photo GB-5) shown in the photos noted above. Further, the presence of significant vegetation on the adjacent downstream

slope prevented a detailed assessment of the area below these cracks. Given the age of the structure and condition of the remainder of the dam, it is anticipated that these are relatively shallow “sloughing” failures. Further assessment of this area is required once the vegetation is removed.

Looking W towards downstream slope and tow - note erosion and moose tracks.

Secondary priority should be to improve the stability of this dam. This should include grading and armoring of the upstream slopes of the dam. In addition, inspection of the failure/crack on the downstream slope of the dam to determine its extent, and stabilization of this slope should be considered using a toe berm and armoring of the slope. These activities would also require that the thick vegetation on the dam be removed and the slope surfaces regraded during this operation.

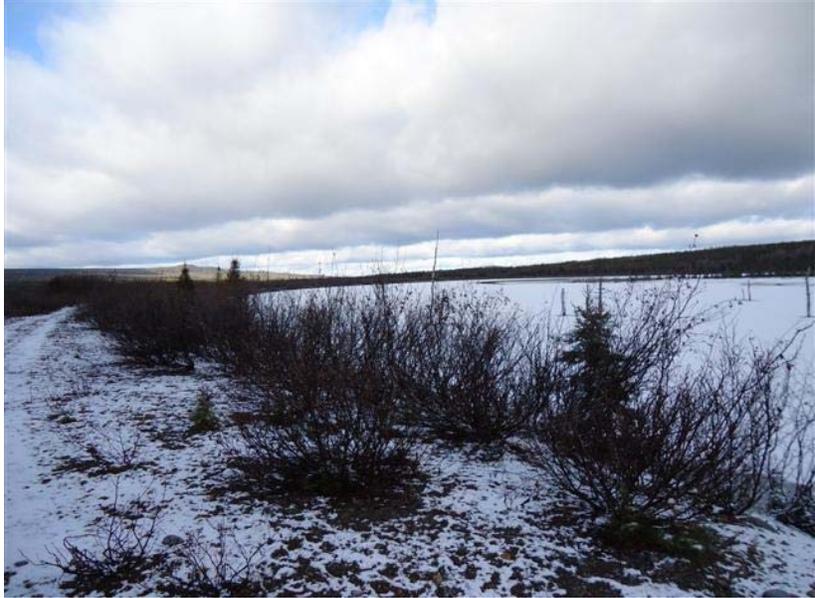
Looking N along upstream slope - note extent of vegetation.	
Photograph GB-10

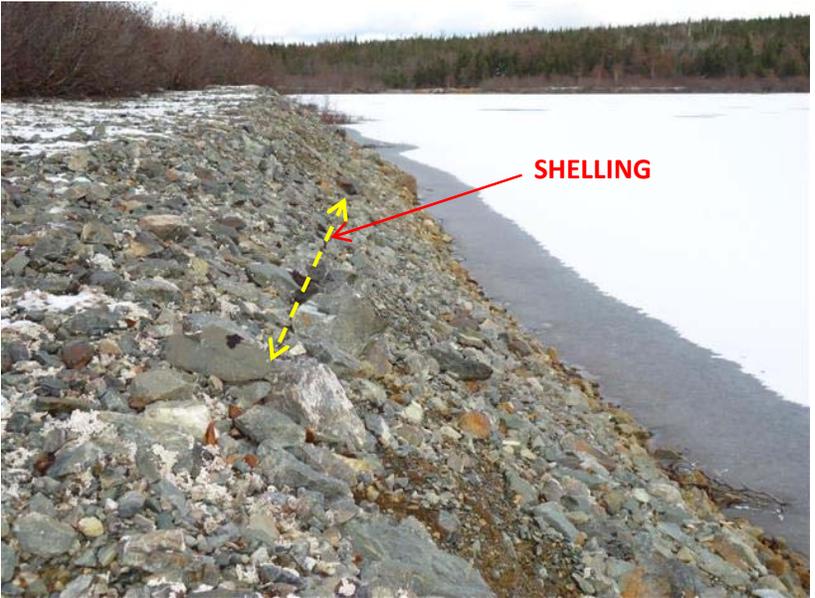
Looking N along upstream slope at north end.

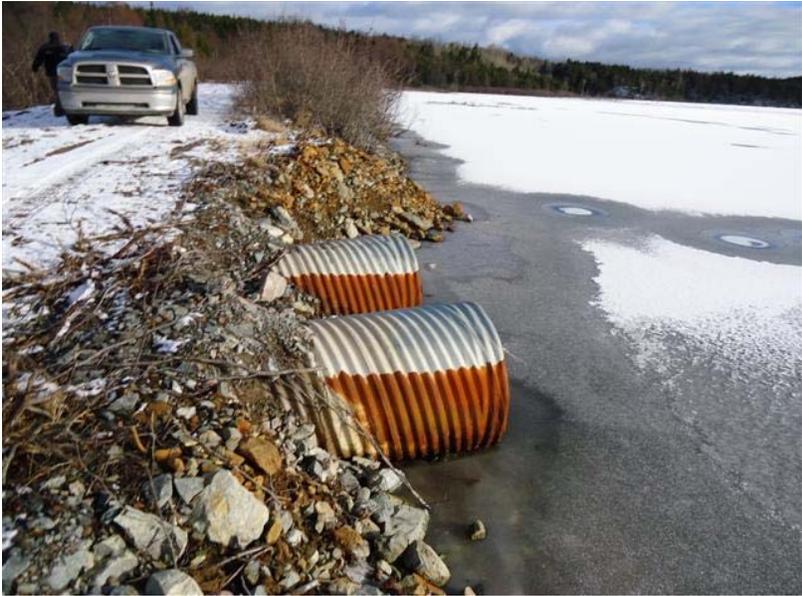
- Two (2) 900 mm culverts form the discharge outlet for the tailings pond. The culverts bottoms were severely eroded (rusted) on the upstream side. Due to the severe erosion of the culverts, flow through and erosion of the dam structure is occurring underneath the culverts. It is understood that DNR intends on replacing the culverts in the year 2011. Potentially acid generating (PAG) material was also observed in the dam embankment near the outlet upstream (Photo GB-11).

Looking N at outlet culverts - note bottoms rusted out and PAG material on upstream slope.	
Photograph GB-12

It is understood that DNR plans on replacing the culverts in the year 2011. However, depending on the timing of this replacement, in the interim, the priority for this dam should be to verify the spillway/culvert sizing (hydrology assessment) and ensure that it is properly sized for the appropriate design high water event. The spillway/culvert should be repaired and armoured, including armoring of the upstream side of the dam to approximately 10 m each side of the spillway.

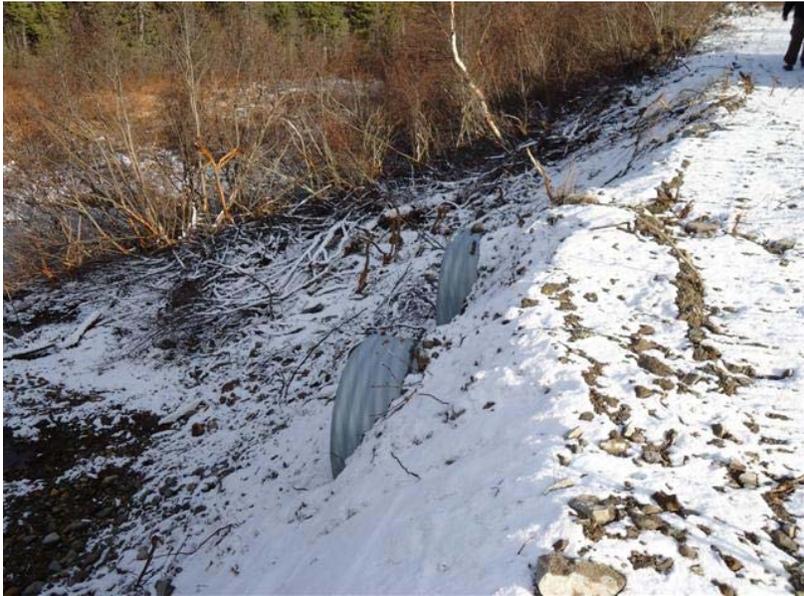
Looking NW at outlet culverts on downstream side - note no recent discharge.
