GOVERNMENT OF NEWFOUNDLAND AND LABRADOR Department of Transportation and Infrastructure	BRIDGE INSPECTION REPORT B07272021-2	
Date: 7/23/2021	Inspected By: Michael Button	Category: Office - Bridge Office	
BRIDGE INFORMATION			
Site:	1-012 - ADMIRAL'S COVE BRIDGE		
Route:		Overall Length:	16.5 m
Year Built:	1965	Est: Yes	Overall Width: 10.1 m
Year Last Rehab.:	1985	Est: Yes	Roadway Width: 6.2 m
Region:	AVALON PENINSULA		Sidewalk Width: 0 m
Jurisdiction:	Provincial		Clearance to R.D. or N.W.L.: 2.9 m
Type of Structure:	04 - Rigid Frame		Max Depth of N.W.L.: 0.1 m
Purpose of Structure:	04 - Over Non-Navigable Waters		Spans:
Type of Handrail:	01 - Aluminum Rail		<u>Span No.:</u> <u>Length</u> <u>Span No.:</u> <u>Length</u>
Roadway Surface:	02 - Asphalt	1	4.4 4 0
Alignment Vertical:	02 - Adequate	2	0 5 0
Alignment Horizontal:	01 - Good	3	0 6 0
Restrictions:	No		
BRIDGE PHOTOS

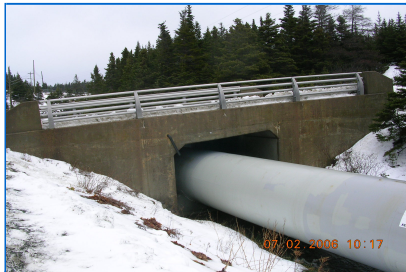
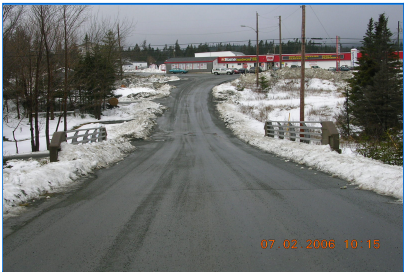
Bearing Seat:	I - Inapplicable
Comments:	- Older structure in the middle of the new ridged frame structure to widen the road. Older structure F1.		
SUPERSTRUCTURE			
Condition:	F2 - Fair	Expansion Joints:	I - Inapplicable
Comments:	- No overall comments, good condition. Alligator cracking on old structure in middle portion of the deck. Some mild efflorescence seen.		
DECK			
Condition:	F2 - Fair	Curbs:	F1 - Fair
Hand Rail:	F2 - Fair	Roadway Condition:	F1 - Fair

Approach Rail:	P3 - Poor		
Comments:	- Approach rail needed to be installed. Currently does not exist.		
HYDROLOGY			
Water Velocity:	n/a m/s	Ice Problem:	NA - Not Applicable
Water Depth:	n/a m	Scour Problem:	NA - Not Applicable
Waterway:	03 - Not Applicable	Debris Problem:	NA - Not Applicable
Comments:	Penstock Structure		
REPLACEMENT/REHABILITATION			
Next Rehab. Date:	2025	Replacement Year:	2060
Antic. Rehab. Cost:	\$20000	Replacement Cost:	\$1300000
Recommendations:	Install Approach rail. Structure in good condition overall.		
OBSERVATIONS			
Overall Condition:	F2 - Fair	Requires Further Inspection:	No
Additional Observations:	- Hazards: structure on a blind hill, consider traffic control, dense vegetation all sides, easiest to get down on west, downstream side.		
LEGEND:			
Condition Definitions:		Problem Definitions:	
1 - *Good - [discontinued code].	F2 - Fair.	C - Unsafe (Closed to Public).	N - No Problem.
