GOVERNMENT OF NEWFOUNDLAND AND LABRADOR Department of Transportation and Infrastructure	BRIDGE INSPECTION REPORT B06192019-3	
Date: 6/19/2019	Inspected By: Pickett R	Category: Eng. - Engineering	
BRIDGE INFORMATION			
Site:	1-258 - BANNERMAN BROOK BRDG-GLOVER RD,HR.G		
Route:	75	Overall Length:	6.1 m
Year Built:	1960	Overall Width:	5.6 m
Year Last Rehab.:		Roadway Width:	5.1 m
Region:	AVALON PENINSULA	Sidewalk Width:	0 m
Jurisdiction:	Provincial	Clearance to R.D. or N.W.L.:	1.5 m
Type of Structure:	04 - Rigid Frame	Max Depth of N.W.L.:	0.3 m
Purpose of Structure:	04 - Over Non-Navigable Waters	Spans:	
Type of Handrail:	02 - Concrete Rail	Span No.:	Length
Roadway Surface:	01 - Concrete	1	5.5
Alignment Vertical:	02 - Adequate	2	0
Alignment Horizontal:	01 - Good	3	0
Restrictions:	Yes	Span No.:	Length
Describe Restrictions:	Basically a one lane structure. Align Vertical: Road rises up at structure location.

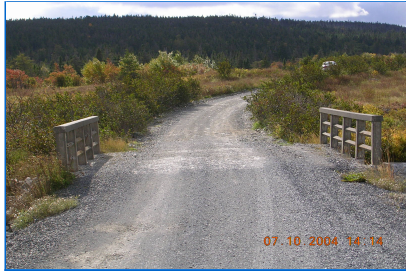
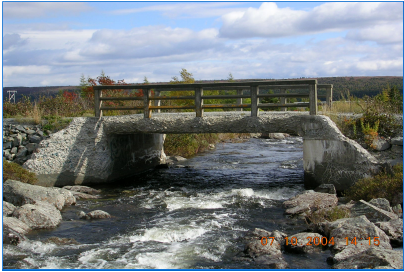
BRIDGE PHOTOS

SUBSTRUCTURE			
Condition:	P3 - Poor	Bearings:	I - Inapplicable
		Bearing Seat:	I - Inapplicable
Comments:	Assumed condition of buried submerged reinforcement concrete frame leg footings.		
SUPERSTRUCTURE			
Condition:	P - Poor	Expansion Joints:	I - Inapplicable
Comments:	Narrow wide horizontal cracks with efflor deposits in faces and corners of frame legs. Severe delamination spalling and disintegration to corners of frame leg footings and wingwals with section loss.		
DECK			
Condition:	P - Poor	Curbs:	I - Inapplicable
Hand Rail:	P - Poor	Roadway Condition:	I - Inapplicable

Approach Rail:	I - Inapplicable		
Comments:	Very severe concrete disintegration do deck soffit edges and facials. Heavy efflor deposits in deck soffit to ward edges. Interior soffit in fair condition delamination spalling exposed deck surface. Medium wide horizontal cracks spalling with exposed rebar on concrete handrails. Handrail has some missing section with poor conections to deteriorated deck.		
HYDROLOGY			
Water Velocity:	0.8 m/s	Ice Problem:	N - No Problem
Water Depth:	0.6 m	Scour Problem:	P - Possible Problem
Waterway:	01 - Adequate	Debris Problem:	N - No Problem
Comments:	Rv park in close proximity to structure (Earhart RV.park).		
REPLACEMENT/REHABILITATION			
Next Rehab. Date:	2019	Replacement Year:	2020
Antic. Rehab. Cost:	\$0	Replacement Cost:	\$200
Recommendations:	Possible weight restriction should be considered.		
OBSERVATIONS			
Overall Condition:	P - Poor	Requires Further Inspection:	Yes
