GOVERNMENT OF NEWFOUNDLAND AND LABRADOR Department of Transportation and Infrastructure	BRIDGE INSPECTION REPORT B06192019-6	
Date: 6/19/2019	Inspected By: lyver C	Category: Eng. - Engineering	
BRIDGE INFORMATION			
Site:	1-352 - BANNERMAN LAKE ROAD (CBN BYPASS)		
Route:	75	Overall Length:	17.2 m
Year Built:	2003	Est: No	Overall Width: 14.2 m
Year Last Rehab.:		Est: No	Roadway Width: 9.1 m
Region:	AVALON PENINSULA	Sidewalk Width:	0 m
Jurisdiction:	Provincial	Clearance to R.D. or N.W.L.:	5 m
Type of Structure:	04 - Rigid Frame	Max Depth of N.W.L.:	0 m
Purpose of Structure:	01 - Highway Grade Separation	Spans:	
Type of Handrail:	05 - Concrete Barrier	<u>Span No.:</u>	<u>Length</u>
Roadway Surface:	02 - Asphalt	<u>Span No.:</u>	<u>Length</u>
Alignment Vertical:	01 - Good	1	10
Alignment Horizontal:	02 - Adequate	2	0
Restrictions:	No	3	0
		4	0
		5	0
		6	0
BRIDGE PHOTOS

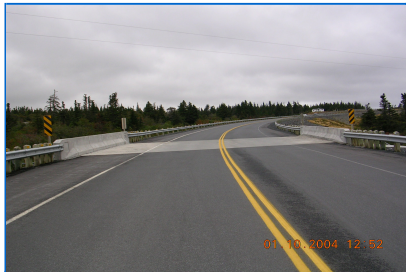
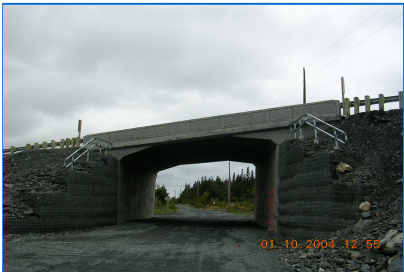
Bearing Seat:	I - Inapplicable
Comments:	Assumed condition of buried reinforcement. Concrete frame leg footings.		
SUPERSTRUCTURE			
Condition:	F1 - Fair	Expansion Joints:	I - Inapplicable
Comments:	Medium bulging shifting in welded wire mesh walls. Rock falling from some baskets in close to frame leg corners. Medium erosion continuous along top of North East reinforcement wall (Safety Rail cons to tip out). Medium wide angular vertical cracks with light efflor deposits in faces of frame legs falling hazard exists with tipping safety rails atop North East retaining wall.		
DECK			
Condition:	F1 - Fair	Curbs:	I - Inapplicable

Hand Rail:	F2 - Fair	Roadway Condition:	I - Inapplicable
Approach Rail:	G - Good		
Comments:	Numerous medium wide longitudinal transverse cracks in exposed deck surface. No hazard marker in North West end. Narrow vertical angular cracks in deck facias. Numerous medium angular longitudinal cracks with light efflor deposits in deck soffit. Medium vertical cracks in barrier walls and end blacks. Still no overhead clearance signs on Bannerman lake road.

Next Rehab. Date:	2036	Replacement Year:	2078
Antic. Rehab. Cost:	\$150	Replacement Cost:	\$1000
Recommendations:	Correct erosion problem atop North East retaining wall and straighten up steel safety rails. Monitor welded wire mesh retaining walls especially where rock is escaping from baskets. Apply new maintenance coating in the interim install overhead clearance signs. Missing hazard marker.
