GOVERNMENT OF NEWFOUNDLAND AND LABRADOR Department of Transportation and Infrastructure	BRIDGE INSPECTION REPORT B06202019-2	
Date: 6/20/2019	Inspected By: Hunt R	Category: Eng. - Engineering	
BRIDGE INFORMATION			
Site:	1-218 - BEAVER BROOK BRIDGE		
Route:	72	Overall Length:	9.7 m
Year Built:	1966	Overall Width:	8.5 m
Year Last Rehab.:		Roadway Width:	7.8 m
Region:	AVALON PENINSULA	Sidewalk Width:	0 m
Jurisdiction:	Provincial	Clearance to R.D. or N.W.L.:	1.2 m
Type of Structure:	03 - Reinforced Concrete Beam/Slab	Max Depth of N.W.L.:	0.3 m
Purpose of Structure:	04 - Over Non-Navigable Waters	Spans:	
Type of Handrail:	02 - Concrete Rail	<u>Span No.:</u>	<u>Length</u>
Roadway Surface:	02 - Asphalt	1	6.2
Alignment Vertical:	01 - Good	2	0
Alignment Horizontal:	01 - Good	3	0
Restrictions:	No	<u>Span No.:</u>	<u>Length</u>
		4	0
		5	0
		6	0
BRIDGE PHOTOS

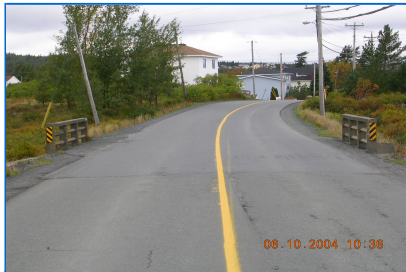
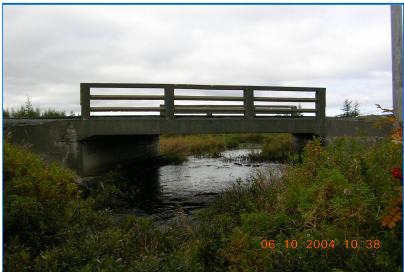
Bearing Seat:	P3 - Poor
Comments:	Medium erosion to faces of reinforced concrete abutment footings. Medium spalling along faces of west footing. Narrow vertical cracks in abutment corners and faces. Medium to severe delamination/spalling to North East and South East extension beam seats. Narrow vertical horizontal cracks in faces of wingwalls. Wide vertical cracks at the top of South West and North West wingwall. Medium spalling in faces of South West wingwall. Severe delamination, spalling, disintegration to top South East wingwall.		
SUPERSTRUCTURE			
Condition:	F2 - Fair	Expansion Joints:	F2 - Fair
Comments:	No visible signs of expansion joints (deck paved over).		
DECK

Condition:	F2 - Fair	Curbs:	I - Inapplicable
Hand Rail:	P3 - Poor	Roadway Condition:	I - Inapplicable
Approach Rail:	I - Inapplicable		
Comments:	Small hazard markers attached to structure. Narrow alligator cracks and medium honey combing in deck soffit. Wide vertical horizontal cracks and light medium spalling with exposed reinforcement in concrete handrails. One section of downstream concrete handrail is missing and replaced by a piece of wood. some road settlements at end of the structure

Water Velocity:	0.2 m/s	Ice Problem:	N - No Problem
Water Depth:	0.2 m	Scour Problem:	K - Known Problem
Waterway:	01 - Adequate	Debris Problem:	N - No Problem
Comments:	Some scouring under west footing.

Next Rehab. Date:	2020	Replacement Year:	2030
Antic. Rehab. Cost:	\$25	Replacement Cost:	\$250
Recommendations:	Repair concrete handrail defects. Install rip rap at upstream end of the structure. Install approach and exit rail and hazard markers where possible.
