GOVERNMENT OF NEWFOUNDLAND AND LABRADOR Department of Transportation and Infrastructure	BRIDGE INSPECTION REPORT B11182021-1	
Date: 10/22/2021	Inspected By: Mike Button	Category: Office - Bridge Office	
BRIDGE INFORMATION			
Site:	1-278 - BEAVER FALLS BROOK BRIDGE		
Route:	100-10	Overall Length:	22.1 m
Year Built:	1972	Est: No	Overall Width: 10 m
Year Last Rehab.:		Est: No	Roadway Width: 8.4 m
Region:	AVALON PENINSULA	Sidewalk Width:	0.8 m
Jurisdiction:	Provincial	Clearance to R.D. or N.W.L.:	2.3 m
Type of Structure:	02 - Double Tee	Max Depth of N.W.L.:	0.5 m
Purpose of Structure:	04 - Over Non-Navigable Waters	Spans:	
Type of Handrail:	02 - Concrete Rail	Span No.:	Length
Roadway Surface:	01 - Concrete	Span No.:	Length
Alignment Vertical:	02 - Adequate	1	10.2
Alignment Horizontal:	02 - Adequate	2	10.2
Restrictions:	No	3	0
		4	0
		5	0
		6	0
BRIDGE PHOTOS

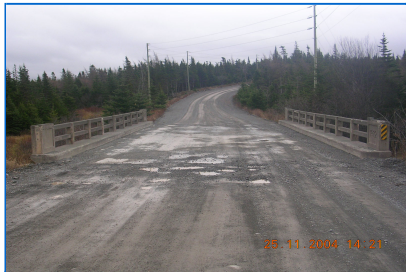
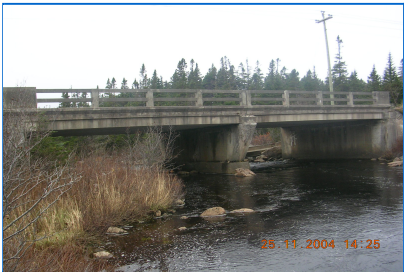
Bearing Seat:	P3 - Poor
Comments:	- Southeast wingwall has mild horizontal cracking with efflorescence, F1. The southeast side and corner of the abutment has mild spalling under the creep block with mild cracking with efflorescence throughout, F1. - Southwest wingwall has severe map cracking with efflorescence and a large wide vertical crack appearing to have split the wingwall in half, P3. The construction joint with the abutment has a small corner spall near the top. - The south abutment face is heavily leaking efflorescence through all extension construction joints and from the bearing seat above. Mild vertical cracking also exists throughout the face, P3. - Northeast wingwall has severe cracking with efflorescence throughout with severe disintegration to the top of the wingwall, P3. The northeast side and corner of the abutment has medium spalling undermining the creep block with visible leakage from above, P3. - Northwest wingwall has extreme concrete disintegration and extreme map cracking with efflorescence on the remaining concrete, P1. The northwest side and corner of the abutment has efflorescent deposits along the face but is in fair condition. - The north abutment face has moderate cracking with efflorescence throughout the face, P3. Both faces of the pier have moderate arch like cracking with efflorescence throughout. Upstream and downstream extension joints are opening up. The upstream corbel extension has

moderate disintegration throughout the nose face. The downstream corbel extension has moderate spalling throughout the tail face with moderate to severe map cracking with efflorescence. The bearing seat has various spalls along the exterior edge. Whole superstructure is in poor condition, P3.

Condition: F1 - Fair **Expansion Joints:** P3 - Poor
Comments: - Double tees have stirrups showing throughout due to low cover. No visible leakage between panel joints, F1. All expansion joints leaking, P3.

Condition: F1 - Fair **Curbs:** P3 - Poor
Hand Rail: P3 - Poor **Roadway Condition:** P1 - Poor
Approach Rail: I - Inapplicable
Comments: - No asphalt on structure or approaches. Most of the concrete deck is not visible due to heavy gravel build up on the deck, no visible potholes in the concrete. Gravel on the deck has numerous potholes with significant standing water over the structure, P1. - Heavy gravel build up with mild vegetation growth along and over the curbs which has blocked several deck drains, P1. Roadway curb condition cannot be clearly viewed. - No approach/exit guiderail or hazard markers. - End blocks in fair condition with mild spalls. - Original concrete handrail has several spalls and heavy cracking to both the post and rail, P3. - Both the upstream and downstream fascia's are in fair condition with isolated locations of cracking and efflorescence.

Overall Condition: P3 - Poor **Requires Further Inspection:** No
Additional Observations: - Extension on this structure is upstream, downstream and vertical. Bridge is in a constant state of moisture due to ponding on the bridge deck. - Hazards, mild traffic, steep slopes and negotiating heavy brush.

Next Rehab. Date: **Replacement Year:** 2025
Antic. Rehab. Cost: \$ **Replacement Cost:** \$1,500,000
Recommendations: - Substructure deterioration is extensive and not repairable. Replace the bridge.
