GOVERNMENT OF NEWFOUNDLAND AND LABRADOR Department of Transportation and Infrastructure	BRIDGE INSPECTION REPORT B08202021-2	
Date: 8/12/2021	Inspected By: Mike Button	Category: Office - Bridge Office	
BRIDGE INFORMATION			
Site:	1-087 - BISHOP'S COVE BRIDGE		
Route:	70	Overall Length:	7.4 m
Year Built:	1970	Est: Yes	Overall Width: 9.4 m
Year Last Rehab.:		Est: No	Roadway Width: 7.2 m
Region:	AVALON PENINSULA	Sidewalk Width:	1.2 m
Jurisdiction:	Provincial	Clearance to R.D. or N.W.L.:	1.1 m
Type of Structure:	02 - Double Tee	Max Depth of N.W.L.:	0.5 m
Purpose of Structure:	04 - Over Non-Navigable Waters	Spans:	
Type of Handrail:	04 - Steel Rail	Span No.:	Length
Roadway Surface:	02 - Asphalt	1	6
Alignment Vertical:	01 - Good	2	0
Alignment Horizontal:	01 - Good	3	0
Restrictions:	No	Span No.:	Length
		4	0
		5	0
		6	0
BRIDGE PHOTOS

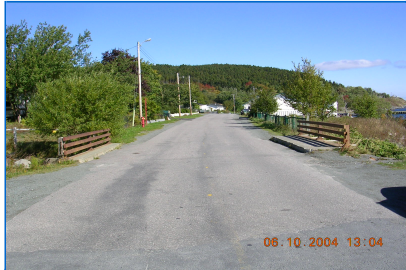
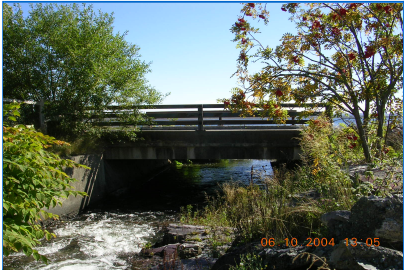
Comments:	- Southeast wing wall has a large spall under the waterline and has a large wide crack running from the spall to the footing (adjacent to CJ). - Northwest wingwall has lost ~90% of its bearing capability due to undermining/scour (P). - Bearing area looks ok, no spalls under double tee bearing areas. - Most diaphragm formwork remains in place between double tees. - Both abutments have medium erosion to footing construction joint, both have narrow cracking in both the vertical and horizontal directions and mild reinforcement staining along their river side faces. (P) Northwest wingwall, F1 remainder.		
SUPERSTRUCTURE			
Condition:	P1 - Poor	Expansion Joints:	U - Uninspectable
Comments:	- Underside of deck around the upstream deck drains have circumferential spalls, with exposed reinforcement with medium-severe corrosion. Possible exposed stressing strand. Leakage running down over double tees causing cracks/spalls (P1). - All other double tees have stirrups showing randomly across them (F1). - Mild cracks

with efflorescence between double tees on the underside of the deck.

Condition:	F1 - Fair	Curbs:	F1 - Fair
Hand Rail:	P - Poor	Roadway Condition:	F1 - Fair
Approach Rail:	I - Inapplicable		
Comments:	- Curb has some small spalls with light narrow-cracks. East handrail on southeast corner of the structure has a post cracked off. Poor construction methods were used for both the east and west handrails (back of HSS torched off to promote bolting). - Asphalt has two cracks the full width of structure over both expansion joints. Medium cracking elsewhere with potholes starting. - Deck drains clogged, downstream deck drains patched over (permanently sealed). - Both fascia's in good condition with light weathering & narrow horizontal cracks. - No end blocks. - No approach/exit rail (nor is it possible).

Water Velocity:	0.5 m/s	Ice Problem:	N - No Problem
Water Depth:	0.5 m	Scour Problem:	K - Known Problem
Waterway:	01 - Adequate	Debris Problem:	N - No Problem
Comments:	- Water too deep to inspect north abutment footing for scour. South abutment footing mostly out of water and no scour visible. - Northwest wingwall has lost ~90% of its bearing capability due to undermining/scour.

Overall Condition:	F1 - Fair	Requires Further Inspection:	Yes
Additional Observations:	- Waterline on downstream side of structure. - P northwest retaining wall and handrail. - F1 remainder. - Installation of approach/exit rail not possible due to many properties around this structure. - Lots of vegetation growth on downstream side of structure. - Low traffic, steep slopes.

Next Rehab. Date:	2022	Replacement Year:	2035
Antic. Rehab. Cost:	\$100000	Replacement Cost:	\$650000
Recommendations:	- Replace northwest wing wall or repair with trimming concrete as soon as possible. - Install hazard markers. - Repair all concrete defects around deck drains and all other areas. - Clean upstream deck drains. Re-open downstream deck drains. Extend deck drains below structure by 500mm. - Cut down vegetation on downstream side of structure (bamboo?)
