GOVERNMENT OF NEWFOUNDLAND AND LABRADOR Department of Transportation and Infrastructure	BRIDGE INSPECTION REPORT B10292015-8	
Date: 9/30/2015	Inspected By: Rodger Hussey	Category: Eng. - Engineering	
BRIDGE INFORMATION			
Site:	1-125 - BLACKHEAD ROAD OVERPASSES (EAST & WEST)		
Route:		Overall Length:	0 m
Year Built:	1972	Est: Yes	Overall Width: 0 m
Year Last Rehab.:		Est: No	Roadway Width: 0 m
Region:	AVALON PENINSULA	Sidewalk Width:	0 m
Jurisdiction:	Provincial	Clearance to R.D. or N.W.L.:	0 m
Type of Structure:	01 - AASH to Girder	Max Depth of N.W.L.:	0 m
Purpose of Structure:	01 - Highway Grade Separation	Spans:	
Type of Handrail:	05 - Concrete Barrier	Span No.:	Length
Roadway Surface:	02 - Asphalt	1	0
Alignment Vertical:	01 - Good	2	0
Alignment Horizontal:	01 - Good	3	0
Restrictions:	No	Span No.:	Length
		4	0
		5	0
		6	0
BRIDGE PHOTOS

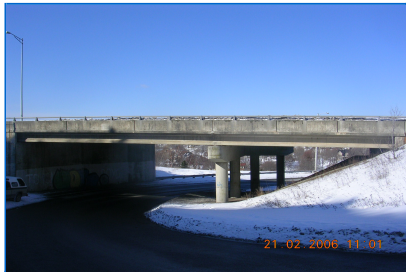
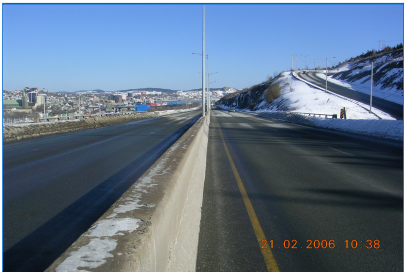
Comments:	Minor cracking throughout abutment walls and headwalls.		
SUPERSTRUCTURE			
Condition:	F2 - Fair	Expansion Joints:	F2 - Fair
Comments:	Minor cracking and delamination on soffit; Moderate spalling on soffit, moderate corrosion to exposed reinforcement; Moderate cracking and staining at eastern expansion joints.		
DECK			
Condition:	F2 - Fair	Curbs:	F2 - Fair
Hand Rail:	F2 - Fair	Roadway Condition:	F2 - Fair

Approach Rail:	F2 - Fair		
Comments:	Approach rail missing on eastbound approach; Approach rail is too low in areas.		
HYDROLOGY			
Water Velocity:	0 m/s	Ice Problem:	NA - Not Applicable
Water Depth:	0 m	Scour Problem:	NA - Not Applicable
Waterway:	03 - Not Applicable	Debris Problem:	NA - Not Applicable
Comments:			
REPLACEMENT/REHABILITATION			
Next Rehab. Date:	2015	Replacement Year:	2015
Antic. Rehab. Cost:	\$0	Replacement Cost:	\$0
Recommendations:	Install hazard markers; Install approach rail; Reinstall/modify approach rail that is too low.		
OBSERVATIONS			
Overall Condition:	F2 - Fair	Requires Further Inspection:	No
Additional Observations:	No hazard markers; Lighting fixtures attached to pier caps; Utility lines attached to structure.		
LEGEND:			
Condition Definitions:			
1 - *Good - [discontinued code].	F2 - Fair.	C - Unsafe (Closed to Public).	Problem Definitions:
2 - *Fair - [discontinued code].	F1 - Fair.	U - Uninspectable.	N - No Problem.
