GOVERNMENT OF NEWFOUNDLAND AND LABRADOR Department of Transportation and Infrastructure	<b>BRIDGE INSPECTION REPORT</b> <b>B05112021-1</b>	
<b>Date:</b> 5/11/2021	<b>Inspected By:</b> Justine Geddes	<b>Category:</b> Office - Bridge Office	
<b>BRIDGE INFORMATION</b>			
<b>Site:</b>	1-155 - BROAD COVE BROOK BRIDGE, NO. 1		
<b>Route:</b>		<b>Overall Length:</b>	12 m
<b>Year Built:</b>	1965	<b>Est: Yes</b>	<b>Overall Width:</b> 7.9 m
<b>Year Last Rehab.:</b>		<b>Est: No</b>	<b>Roadway Width:</b> 7.3 m
<b>Region:</b>	AVALON PENINSULA	<b>Sidewalk Width:</b>	0 m
<b>Jurisdiction:</b>	Provincial	<b>Clearance to R.D. or N.W.L.:</b>	1.7 m
<b>Type of Structure:</b>	03 - Reinforced Concrete Beam/Slab	<b>Max Depth of N.W.L.:</b>	0.3 m
<b>Purpose of Structure:</b>	04 - Over Non-Navigable Waters	<b>Spans:</b>	
<b>Type of Handrail:</b>	02 - Concrete Rail	<u>Span No.:</u>	<u>Length</u>
<b>Roadway Surface:</b>	02 - Asphalt	1	8

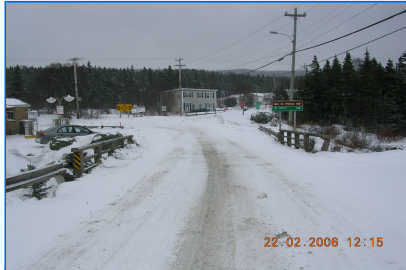
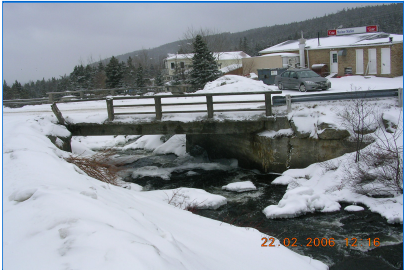
<b>SUBSTRUCTURE</b>			
<b>Condition:</b>	F1 - Fair	<b>Bearings:</b>	I - Inapplicable
		<b>Bearing Seat:</b>	F1 - Fair
<b>Comments:</b>	Cracking, showing small areas of scour		
<b>SUPERSTRUCTURE</b>			
<b>Condition:</b>	P3 - Poor	<b>Expansion Joints:</b>	I - Inapplicable
<b>Comments:</b>	Double T's strands exposed in some areas, degradation will be ongoing (cannot repair adequately). Estimate 5-10 years before this would lead to reduced load carrying capacity.		
<b>DECK</b>			
<b>Condition:</b>	P1 - Poor	<b>Curbs:</b>	P1 - Poor
<b>Hand Rail:</b>	P1 - Poor	<b>Roadway Condition:</b>	P1 - Poor

<b>Approach Rail:</b>	P1 - Poor		
<b>Comments:</b>	Several pieces of concrete rail broken off. Edges of deck are eroding, estimated 3-5 years before all rail gone due to either the deck or the rail degradation. Narrow bridge, would have to reduce to one lane if temporary barriers were needed. Asphalt has small holes due to geotechnical coring last year.		
<b>HYDROLOGY</b>			
<b>Water Velocity:</b>	0 m/s	<b>Ice Problem:</b>	N - No Problem
<b>Water Depth:</b>	0 m	<b>Scour Problem:</b>	P - Possible Problem
<b>Waterway:</b>	01 - Adequate	<b>Debris Problem:</b>	N - No Problem
<b>Comments:</b>	Fast, steep waterway, shouldn't be an issue hydraulically. Abutments are keyed into rock but potential to get scoured out over time.		
<b>REPLACEMENT/REHABILITATION</b>			
<b>Next Rehab. Date:</b>	2021	<b>Replacement Year:</b>	2022
<b>Antic. Rehab. Cost:</b>	\$0	<b>Replacement Cost:</b>	\$0
<b>Recommendations:</b>	This structure is at end of life, due to be replaced in 2022 with arch or box culvert structure. Sidewalks for downstream side, unlikely to be able to put sidewalks on upstream side due to property restrictions.

<b>OBSERVATIONS</b>			
<b>Overall Condition:</b>	P1 - Poor	<b>Requires Further Inspection:</b>	No
<b>Additional Observations:</b>	Tight road, with properties close on 3 sides. Rail/Road condition will need to be managed until replacement.		
<b>LEGEND:</b>			
<b>Condition Definitions:</b>		<b>Problem Definitions:</b>	
1 - *Good - [discontinued code].	F2 - Fair.	C - Unsafe (Closed to Public).	N - No Problem.
2 - *Fair - [discontinued code].	F1 - Fair.	U - Uninspectable.	P - Possible Problem.
3 - *Poor - [discontinued code].	P3 - Poor.	I - Inapplicable.	K - Known Problem.
4 - *Unsafe - [discontinued code].	P1 - Poor.		NA - Not Applicable.
G - Good.	P - Poor.		
<b>Category Definitions:</b>			
Maint. - Maintenance.			
Eng. - Engineering.			
Office - Bridge Office.			
<b>PHOTO GUIDELINES:</b>			
<b>Inspection Photos:</b>			
Please provide photos using guidelines below:			
<ul style="list-style-type: none"> <li>● Any item which inspector feels should be documented by photograph</li> <li>● All items noted above as being P3, P1, P, or C</li> <li>● Any evidence of known ice, scour, debris, waterway problems</li> </ul>
