GOVERNMENT OF NEWFOUNDLAND AND LABRADOR Department of Transportation and Infrastructure	BRIDGE INSPECTION REPORT B06282019-2	
Date: 6/28/2019	Inspected By: Pickett R	Category: Eng. - Engineering	
BRIDGE INFORMATION			
Site:	1-250 - BUTLERVILLE BRIDGE		
Route:	70	Overall Length:	24.7 m
Year Built:	1965	Est: Yes	Overall Width: 9.5 m
Year Last Rehab.:		Est: No	Roadway Width: 8.8 m
Region:	AVALON PENINSULA	Sidewalk Width:	1 m
Jurisdiction:	Provincial	Clearance to R.D. or N.W.L.:	2 m
Type of Structure:	04 - Rigid Frame	Max Depth of N.W.L.:	0.3 m
Purpose of Structure:	04 - Over Non-Navigable Waters	Spans:	
Type of Handrail:	02 - Concrete Rail	Span No.:	Length
Roadway Surface:	02 - Asphalt	1	5.5
Alignment Vertical:	01 - Good	2	0
Alignment Horizontal:	01 - Good	3	0
Restrictions:	No	4	0
		5	0
		6	0
BRIDGE PHOTOS

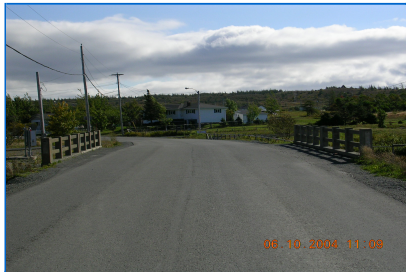
SUBSTRUCTURE			
Condition:	P3 - Poor	Bearings:	I - Inapplicable
		Bearing Seat:	P3 - Poor
Comments:	Original structure extended 1.5m upstream and downstream. Medium erosion to face and tops of abutment footings. Wide vertical cracks in faces of original east abutment. Numerous cracks with effloresce deposits in faces of abutment and piers. Sever erosion at bottom of east abutment. Construction joints at abutment tops and deck handles opening up. South West wingwall has disintegration, severe delamination and spalling. Severe delamination and spalling at base North West wingwall. All wingwalls have numerous cracks.

SUPERSTRUCTURE			
Condition:	P3 - Poor	Expansion Joints:	I - Inapplicable
Comments:	No visible signs of expansion joints at abutments. Expansion gap exists over center pier in curbs (paved over on deck). Numerous medium alligator cracks with heavy efflor deposits in most of deck soffit. Spalling to deck soffit at North East.

DECK			
Condition:	P3 - Poor	Curbs:	F1 - Fair
Hand Rail:	F1 - Fair	Roadway Condition:	F1 - Fair
Approach Rail:	I - Inapplicable		
Comments:	Medium horizontal vertical cracks with effloresce deposits and spalling to concrete handrails. Numerous transverse cracks in asphalt at end of structure.		
HYDROLOGY			
Water Velocity:	0.2 m/s	Ice Problem:	N - No Problem
Water Depth:	0.3 m	Scour Problem:	P - Possible Problem
Waterway:	01 - Adequate	Debris Problem:	N - No Problem
Comments:	Rip rap at South West corner of structure has migrated into river. Medium erosion at North East wingwall.		
REPLACEMENT/REHABILITATION			
Next Rehab. Date:	2020	Replacement Year:	2030
Antic. Rehab. Cost:	\$150	Replacement Cost:	\$600
Recommendations:	Repair concrete defects and install rip rap.		
OBSERVATIONS			
Overall Condition:	P3 - Poor	Requires Further Inspection:	No
Additional Observations:	Driveways at South East and South West corners.
