GOVERNMENT OF NEWFOUNDLAND AND LABRADOR Department of Transportation and Infrastructure	BRIDGE INSPECTION REPORT B10072021-5	
Date: 10/3/2021	Inspected By: Mike Button	Category: Office - Bridge Office	
BRIDGE INFORMATION			
Site:	TCH-201 - CARRICK DRIVE UNDERPASS		
Route:		Overall Length:	42.6 m
Year Built:	2001	Est: No	Overall Width: 12 m
Year Last Rehab.:		Est: No	Roadway Width: 8 m
Region:	AVALON PENINSULA	Sidewalk Width:	2 m
Jurisdiction:	Provincial	Clearance to R.D. or N.W.L.:	5.3 m
Type of Structure:	05 - Pre-stressed Concrete Slab	Max Depth of N.W.L.:	0 m
Purpose of Structure:	01 - Highway Grade Separation	Spans:	
Type of Handrail:	01 - Aluminum Rail	Span No.:	Length
Roadway Surface:	02 - Asphalt	1	18.5
Alignment Vertical:	01 - Good	2	18.5
Alignment Horizontal:	01 - Good	3	0
Restrictions:	No	6	0
BRIDGE PHOTOS

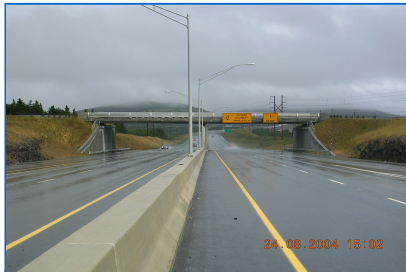
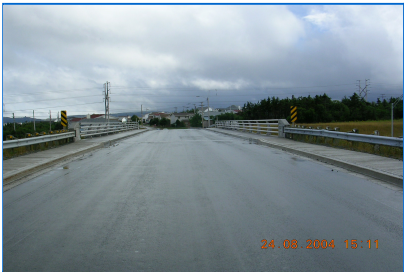
Comments:	- Both abutment faces and bearing seats in fair condition. Pier in fair condition with mild vertical cracking with some graffiti present. - Bearing plates have severe corrosion on the bearing seat and plate attached to bottom of deck while the slider/contact plates were uninspectable, P3. Bearings viewed from side as clearance from top of MSE wall to ground level was confined. Pier bearings viewed from below and appear to be in similar condition. - All wingwalls in fair condition. - MSE wall in good condition with graffiti present.		
SUPERSTRUCTURE			
Condition:	F2 - Fair	Expansion Joints:	F1 - Fair
Comments:	- Fascia's on both sides have mild vertical hairline cracking throughout. - Bottom of deck in good condition. - Expansion joint lightly damaged on southeast curb, likely from plough. No evidence of leaking below, F1.		
DECK

Condition:	F2 - Fair	Curbs:	F2 - Fair
Hand Rail:	F2 - Fair	Roadway Condition:	F2 - Fair
Approach Rail:	F1 - Fair		
Comments:	- Asphalt in fair condition. - Aluminum handrail in good condition. - Approach/exit rails in fair condition complete with hazard markers and connected to end blocks. - Northeast rail at ORR level needs replacement due to plough damage.

Next Rehab. Date:	2030	Replacement Year:	2070
Antic. Rehab. Cost:	\$200000	Replacement Cost:	\$2000000
Recommendations:	- Potentially replace bearings and expansion joints within 5-10 years (2030), \$200,000. These tasks will likely have to be done together in order to jack up the bridge.
