GOVERNMENT OF NEWFOUNDLAND AND LABRADOR Department of Transportation and Infrastructure	BRIDGE INSPECTION REPORT B09092021-4	
Date: 3/13/2020	Inspected By: Hunt R	Category: Eng. - Engineering	
BRIDGE INFORMATION			
Site:	1-301 - CLAM RIVER BRIDGE		
Route:	91	Overall Length:	14 m
Year Built:	1985	Est: No	Overall Width: 10.7 m
Year Last Rehab.:		Est: No	Roadway Width: 10 m
Region:	AVALON PENINSULA	Sidewalk Width:	0.35 m
Jurisdiction:	Provincial	Clearance to R.D. or N.W.L.:	1 m
Type of Structure:	04 - Rigid Frame	Max Depth of N.W.L.:	0.5 m
Purpose of Structure:	04 - Over Non-Navigable Waters		
Type of Handrail:	01 - Aluminum Rail	Spans:	
Roadway Surface:	01 - Concrete	<u>Span No.:</u>	<u>Length</u>
Alignment Vertical:	01 - Good	1	5.7
Alignment Horizontal:	02 - Adequate	2	5.7
Restrictions:	No	3	0
		4	0
		5	0
		6	0
BRIDGE PHOTOS

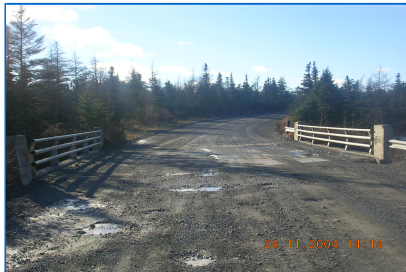
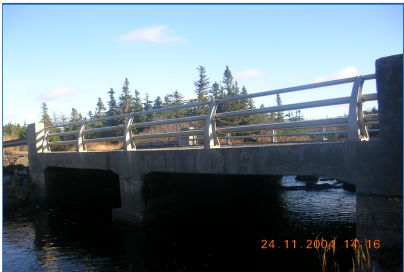
Comments:	- Assumed condition of buried and submerged reinforced concrete leg-pier footings - Original structure extended approx. 6m D/S, new deck placed atop original legs and piers. - Possible asphalt impregnated board bearings atop frame legs - Inspection restarted on sub-surface due to low clearance, flow and ice		
SUPERSTRUCTURE			
Condition:	P1 - Poor	Expansion Joints:	F2 - Fair
Comments:	- P1 (U/S center pier. - F1 (original structure). - F2 (extension) - Severe delamin./disintegration of U/S center pier. - Medium spalling to U/S corners of original frame legs. - Numerous wide vert./horiz. cracks with heavy efflor. in upstream legs, wingwalls, and piers. - Heavy efflor deposits around construction joints on deck bottom.		
DECK

Condition:	F1 - Fair	Curbs:	F1 - Fair
Hand Rail:	P3 - Poor	Roadway Condition:	F1 - Fair
Approach Rail:	G - Good		
Comments:	- Numerous med. horiz.. cracks light efflor. deposits in original U/S deck fascias - Numerous wide long./trans. cracks with heavy efflor. deposits in original deck soffits - Medium/severe spalling with medium corrosion to exposed reinf. in exposed deck surface at extension const. joints and pier exp. joints. - SE end block and curb structure cracked and tipping out. - Aluminum handrail has minor damage, scrapes and dents as wall end caps missing - Rail sticks out beyond endblock on NE corner - Numerous large potholes in gravel road surface

Next Rehab. Date:	2020	Replacement Year:	2035
Antic. Rehab. Cost:	\$100	Replacement Cost:	\$700
Recommendations:	- Repair all concrete defects, resurface deck, possibly replace pier expansion joint, repair aluminum handrails - Fix SE end block
